# Assessment of Dam Safety

## Coal Combustion Surface Impoundments (Task 3)

Northern States  
Power Company –  
Minnesota

Sherburne County  
Power Station

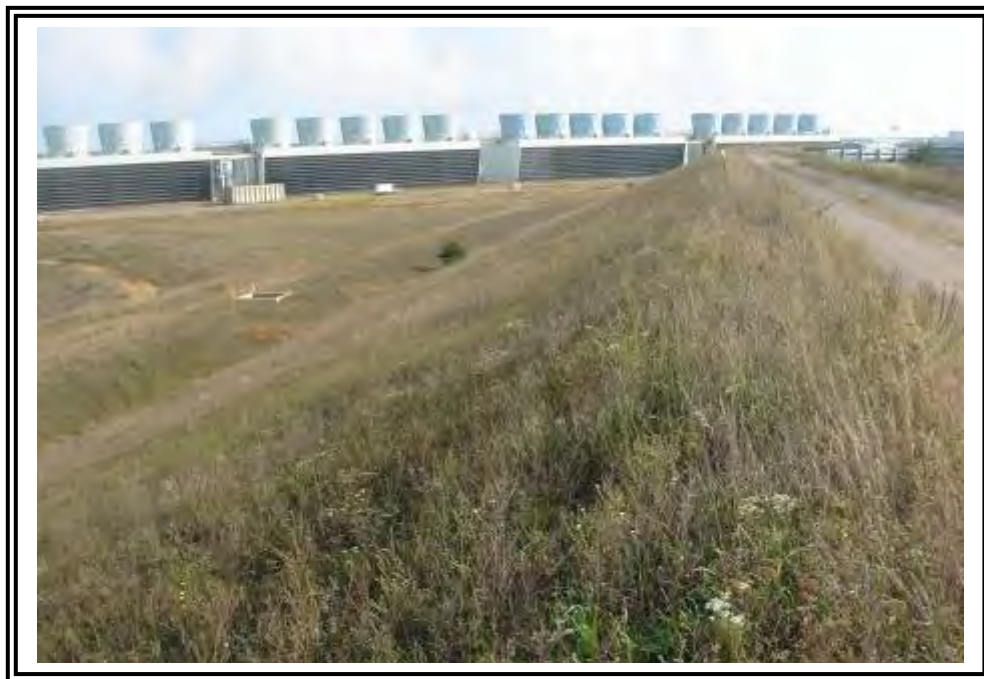
10

Downstream embankment slope West Dam, facing northeast.

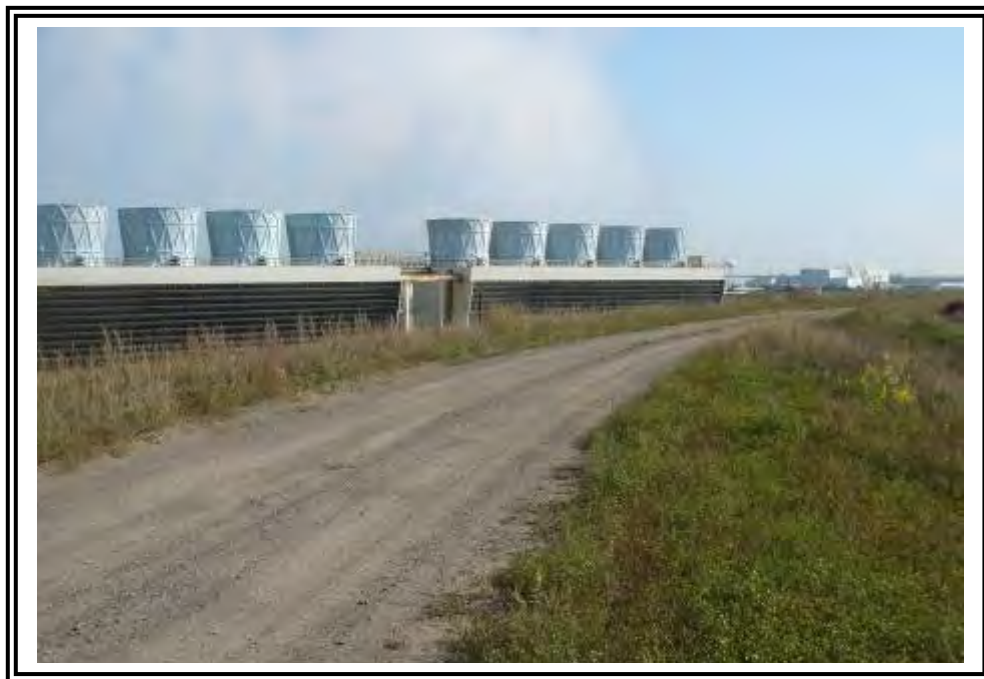
14

Crest of North Dam, facing east.

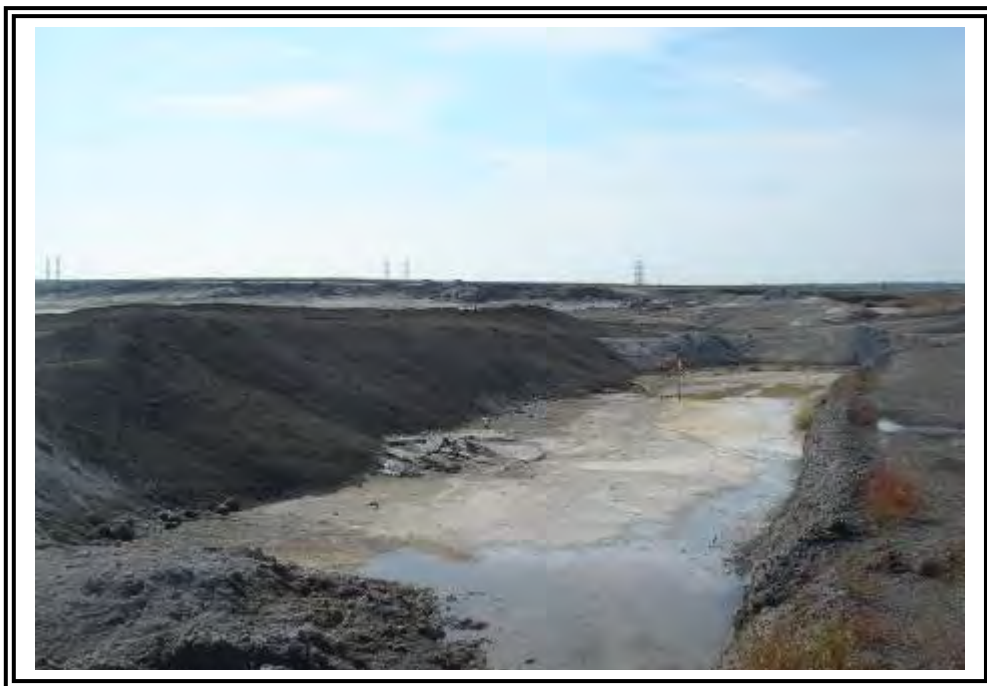
47

Pond No. 2 contains a temporary interior dam which was measured to be approximately 17 feet wide. The freeboard measured approximately 1.5 feet. Erosion was observed along the interior dam slope.

Temporary Dam in Pond 2, facing south.

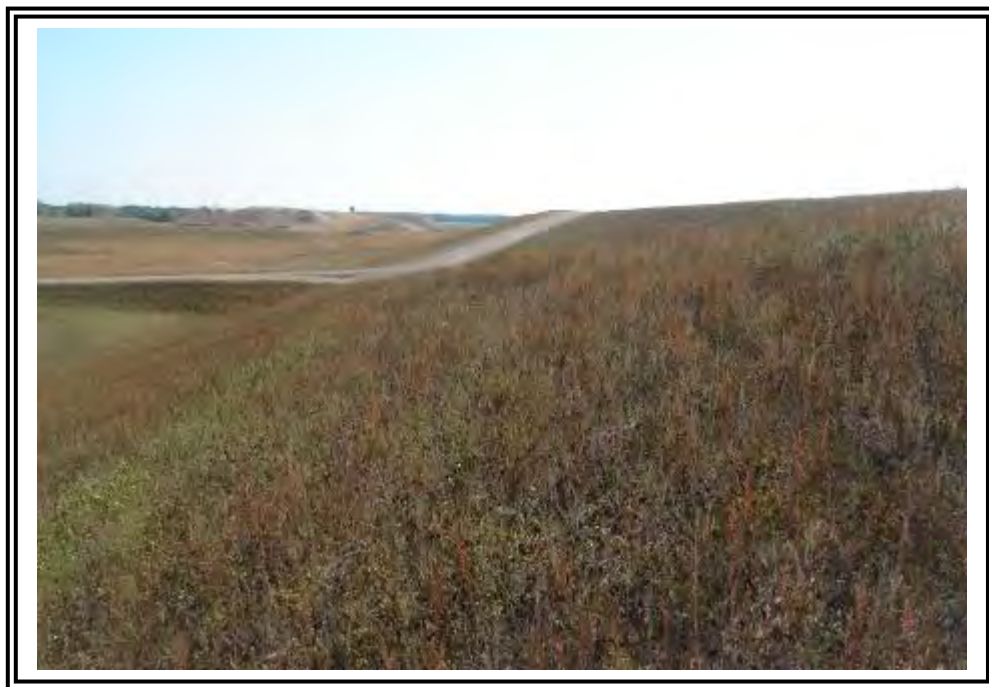
61

Downstream slope of East Embankment, facing south.

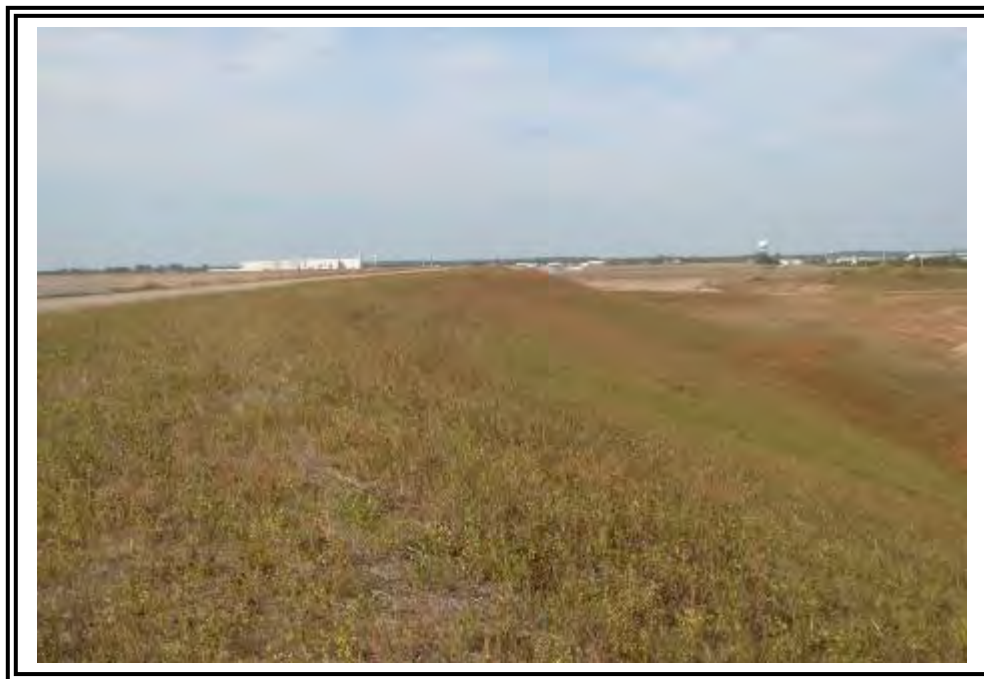
64

Downstream slope of East Embankment, facing north.
