DRAFT
Specific Site Assessment for
Coal Combustion Waste
Impoundments at Reid
Gardner Generating Station

NV Energy
Moapa, Nevada

April 2011
Project 092885

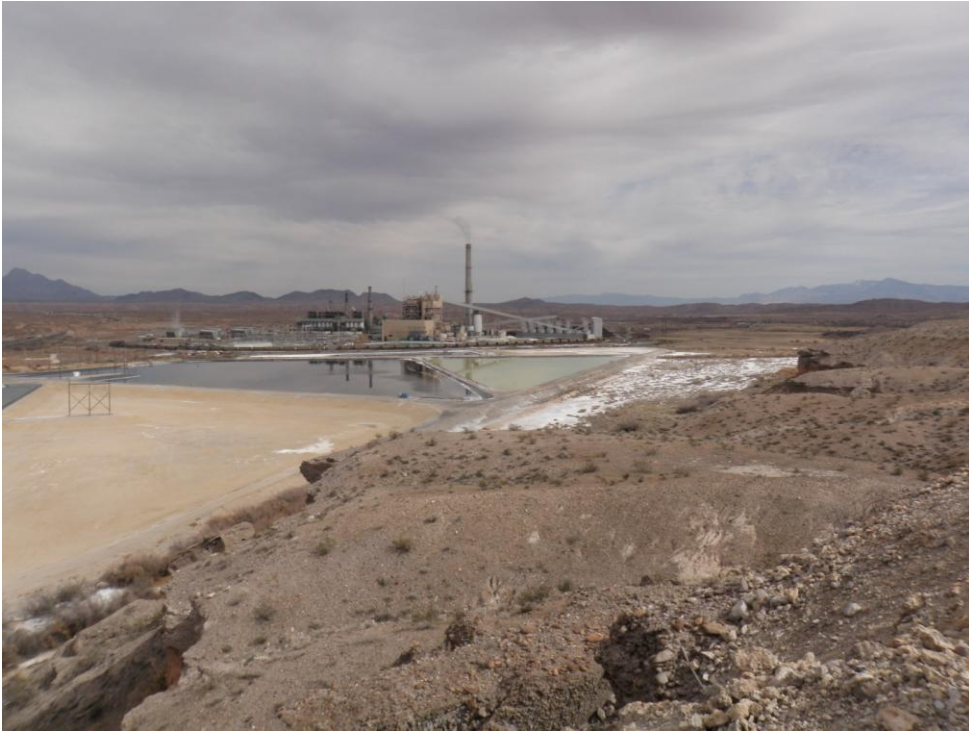
Photo 1: Site overview from Mesa Landfill Area. Looking northeast. Reid Gardner Generating Station in background. From right to left Pond E1 – E2 – former pond D.

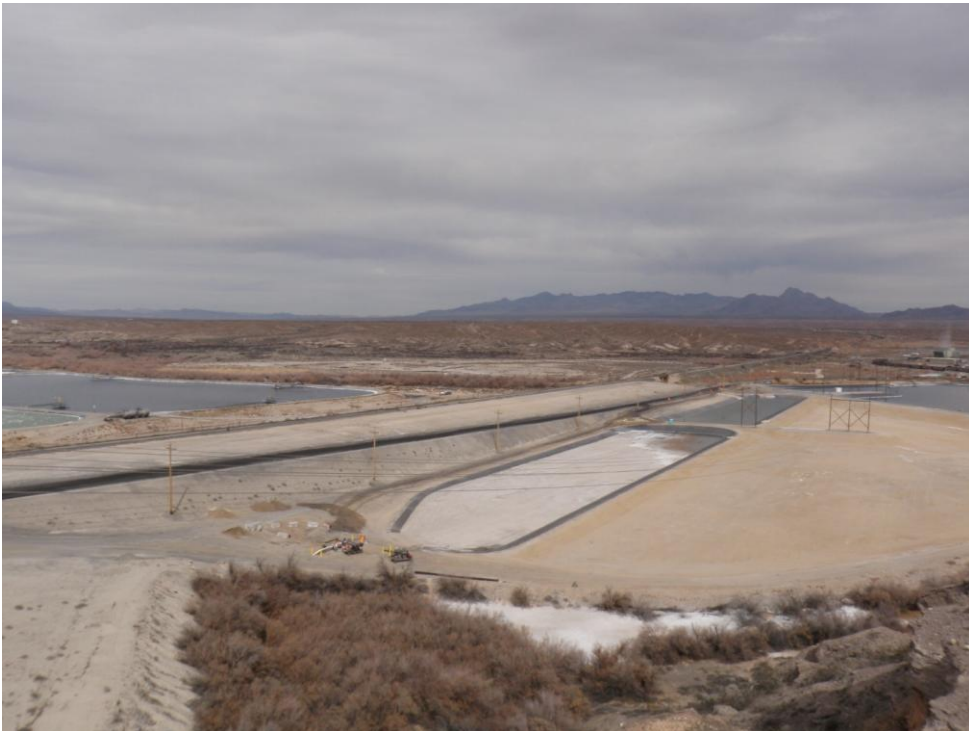
Photo 2: Site overview from Mesa Landfill Area. Looking north. From right to left, Pond E2 – Former pond D with stormwater ponds – B1 – B2.

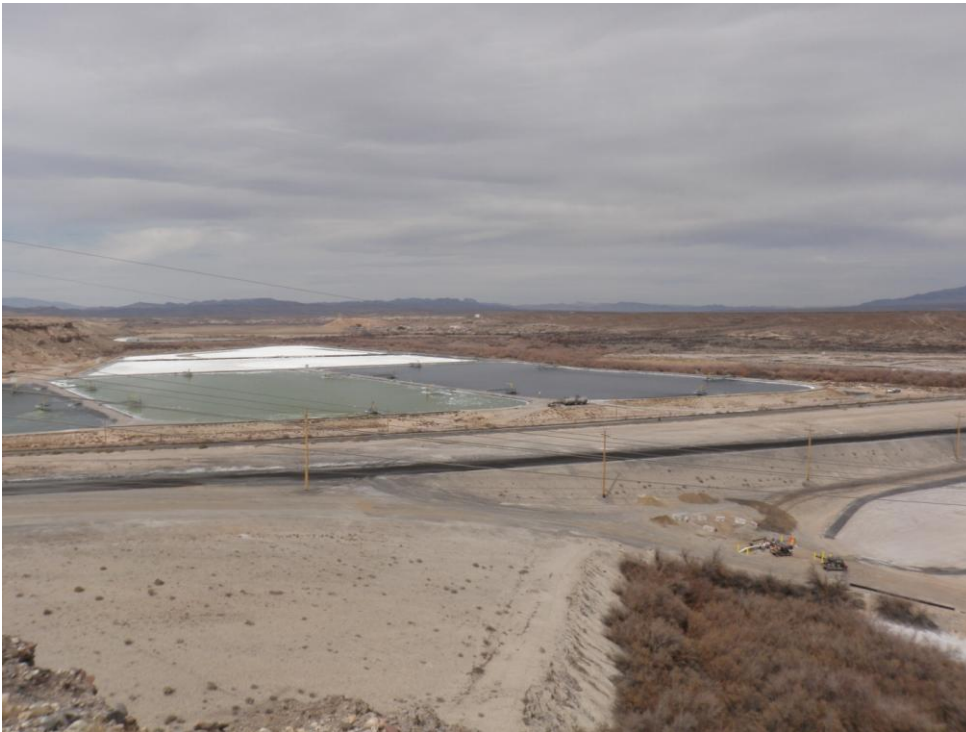
Photo 3: Site overview from Mesa Landfill Area. Looking northwest. From right to left, Pond B1 – B2 – B3. Ponds C1 and C2 in the background – white solids.

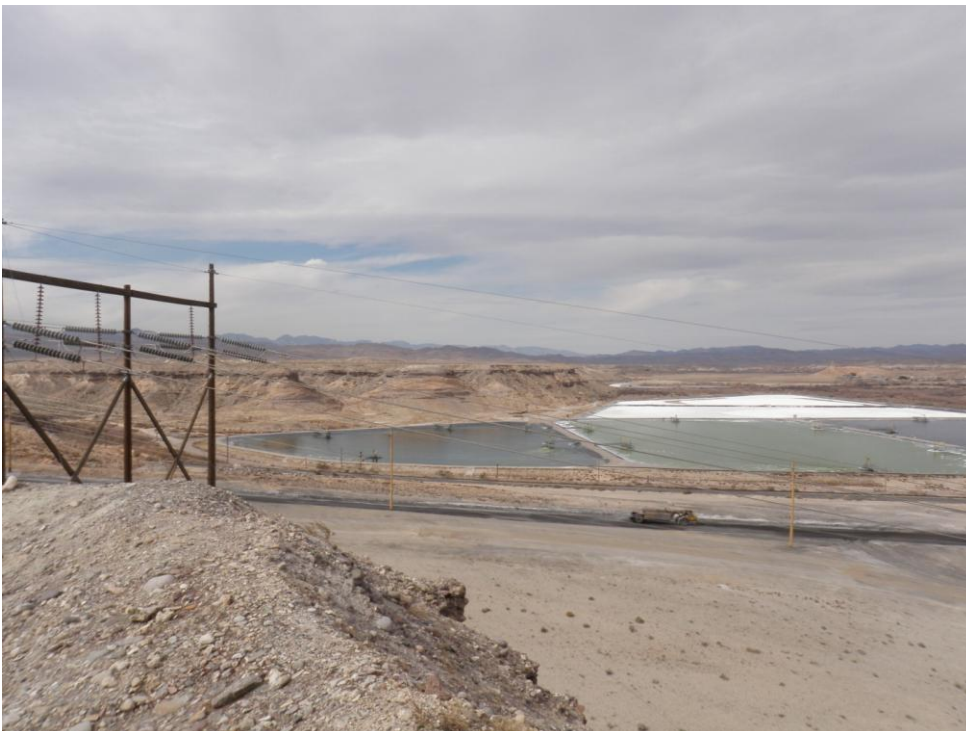
Photo 4: Site overview from Mesa Landfill Area. Looking west. From right to left, Pond B1 – B2 – B3. Ponds C1 and C2 in the background – white solids.

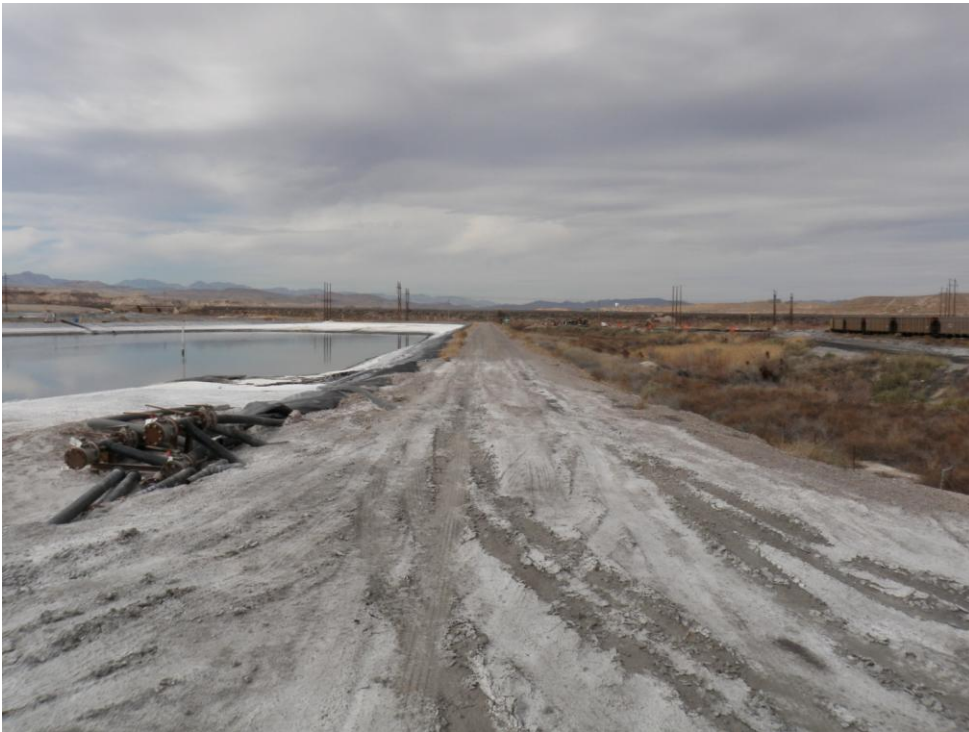
Photo 5: Looking northwest. North dike of Pond F. Muddy River drainage at right.

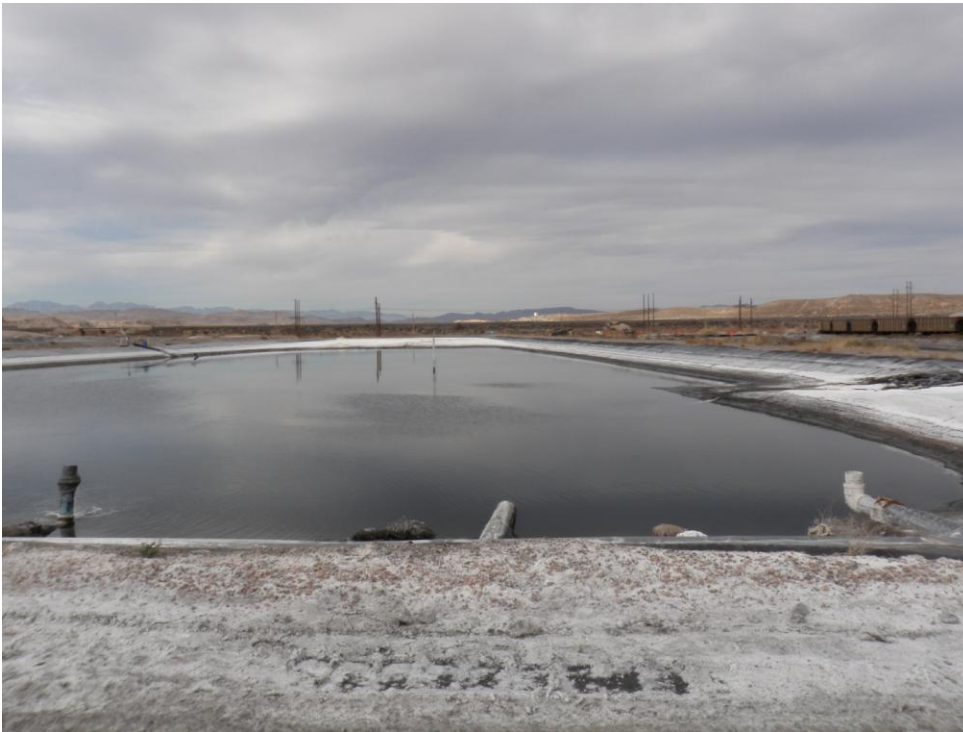
Photo 7: Looking northwest. Pond F from divider dike. Inlet on left.

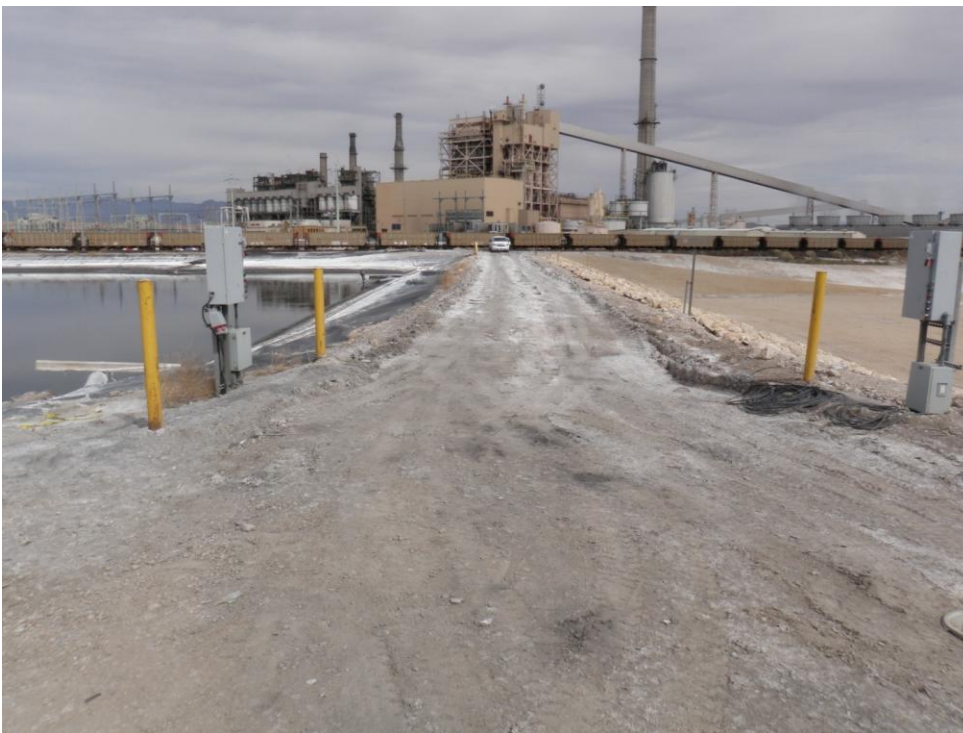
Photo 8: Looking northeast. Pond F on left. Former pond G on right.

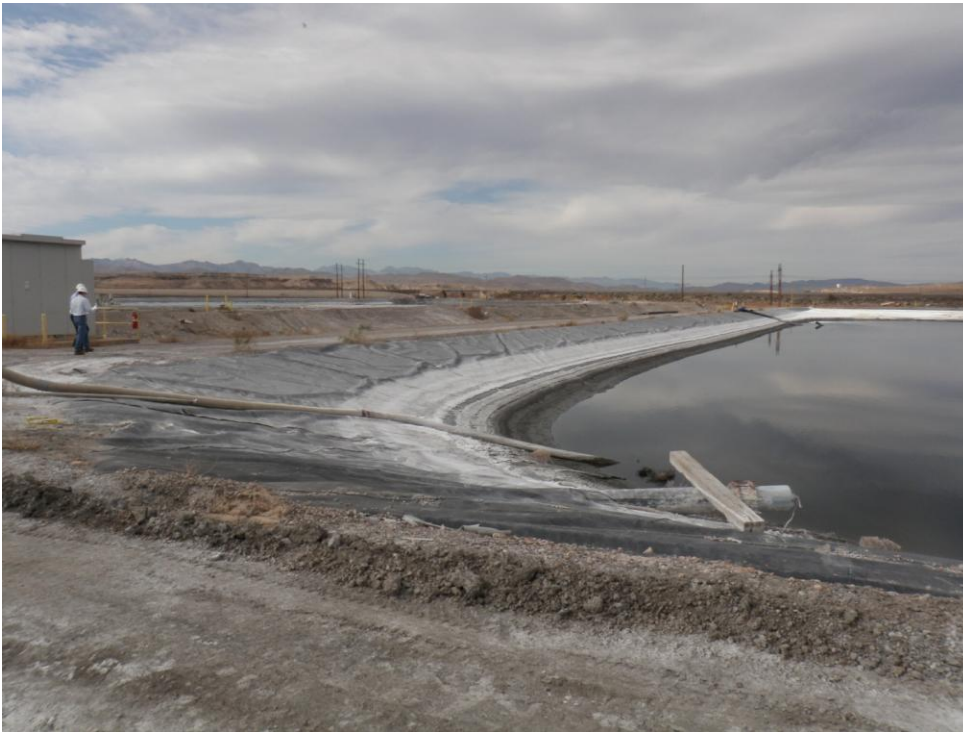
Photo 9: Looking west. Pond F in foreground. Overland outlet pipe to pumphouse at left. Pond E2 in the background at left.

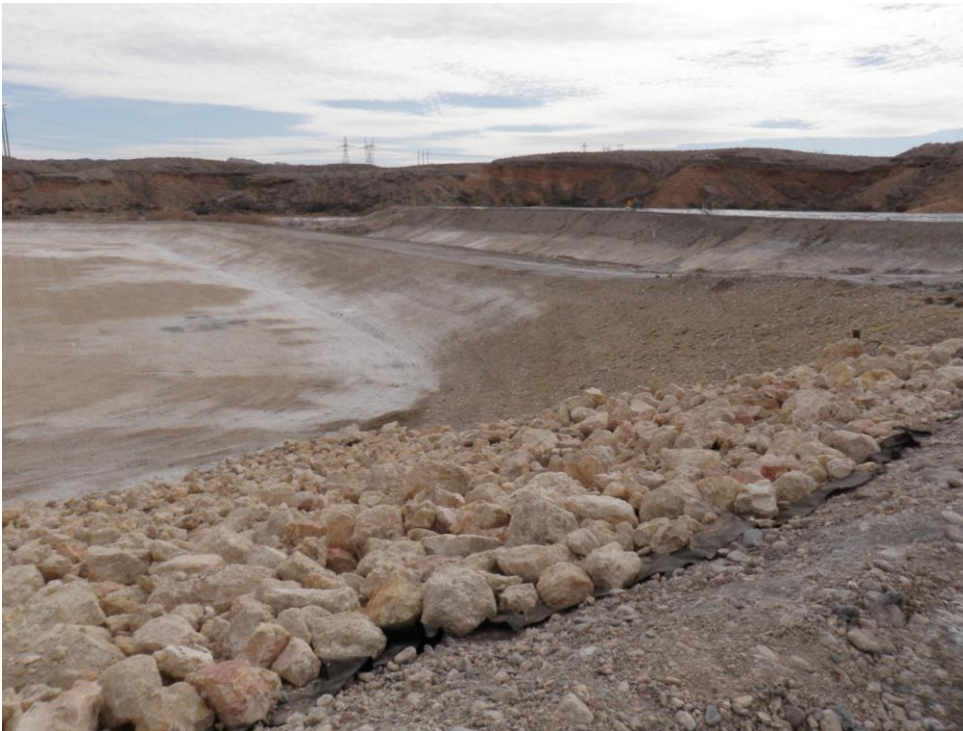
Photo 10: Looking south. Former Pond G. Riprap slope protection and partially removed dike. North dike of Pond E1 at right.

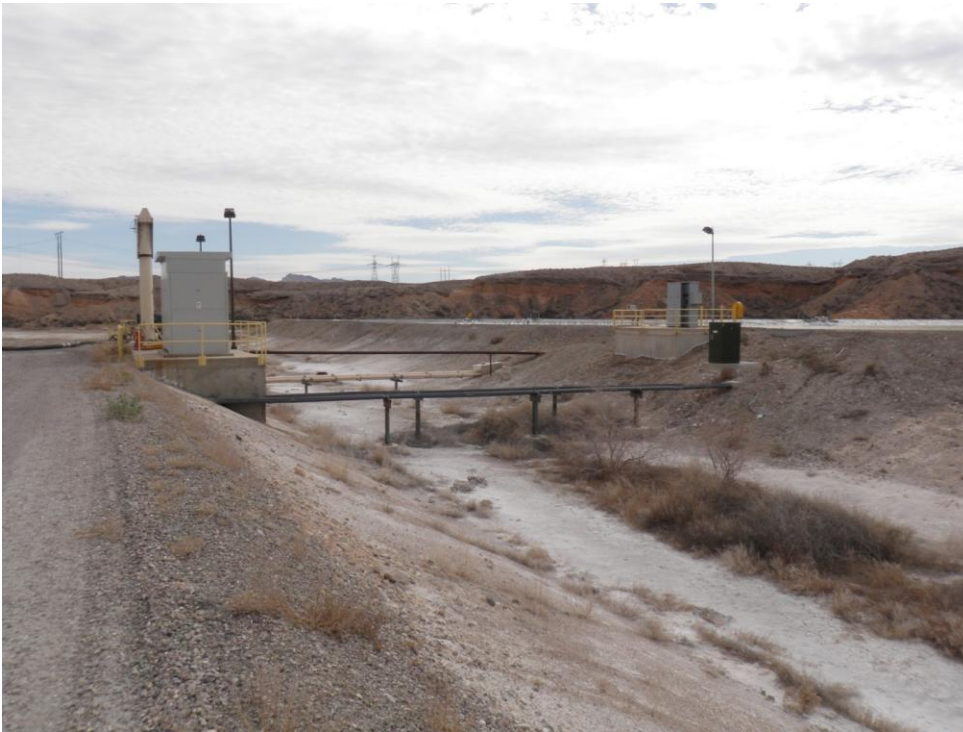
Photo 11: Looking east. From south dike of Pond F. Pumphouse at left and pipes to Ponds E1 and E2. The only pipes in service are the cream colored set in the background near the ground.

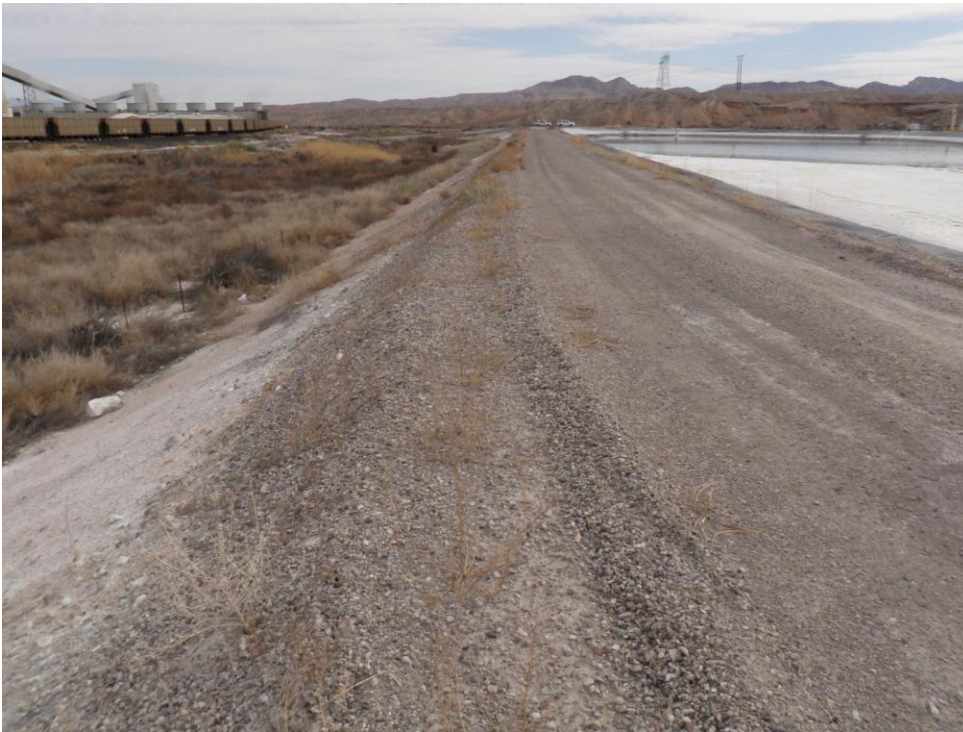
Photo 13: Looking southeast. North dike of Pond F. Typical soil cement slope protection. Muddy River located at left.

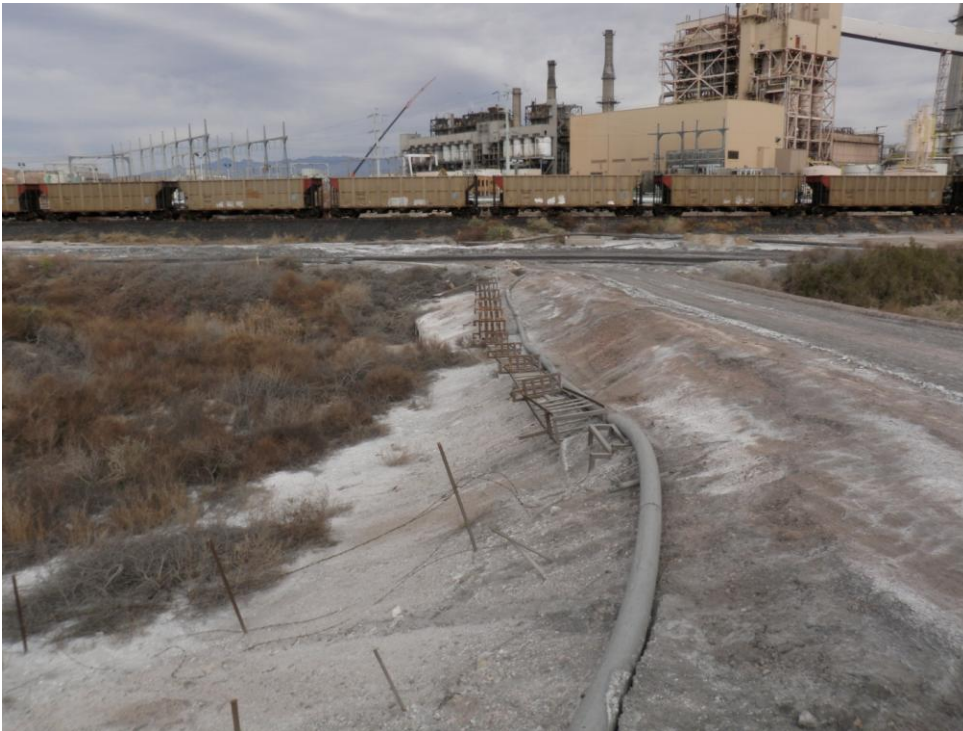
Photo 16: Looking northeast. Piping from Reid Gardner Station to Pond F.

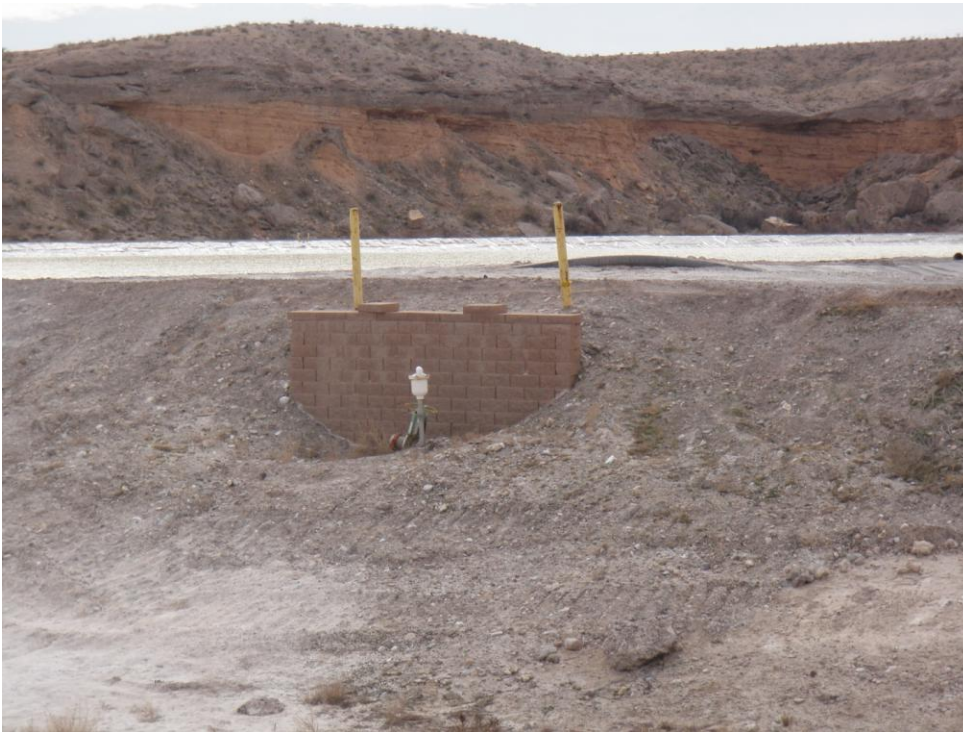
Photo 19: Typical retaining wall to protect air release valve. Looking west at east dike of Pond E2.

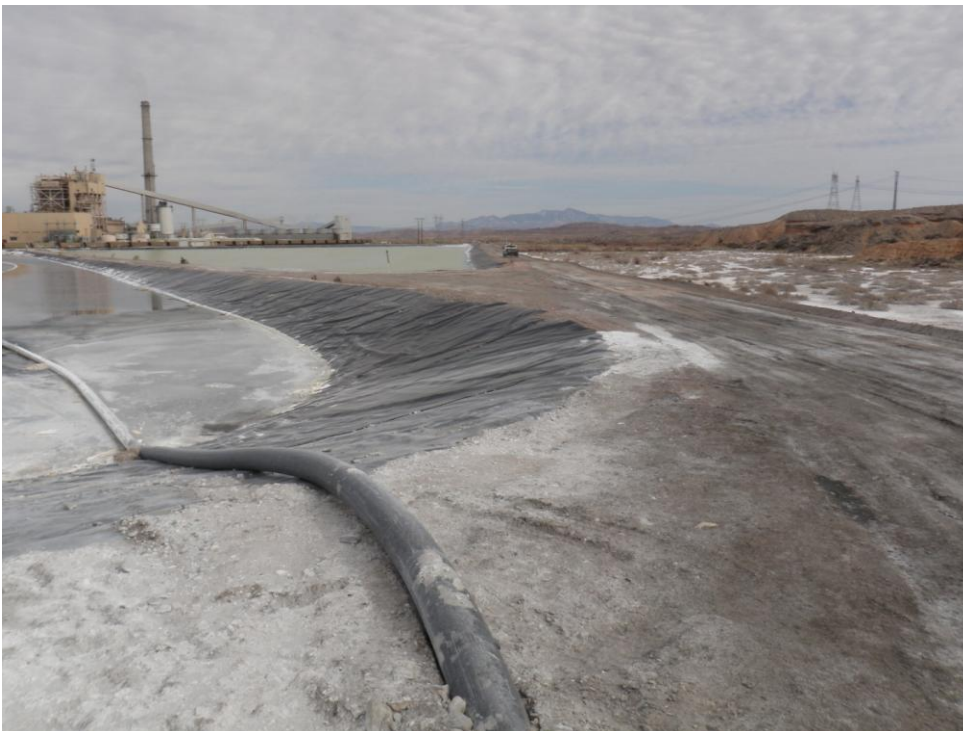
Photo 20: Looking east. Pond E1 in background. Pond E2 with outlet pipe in foreground.

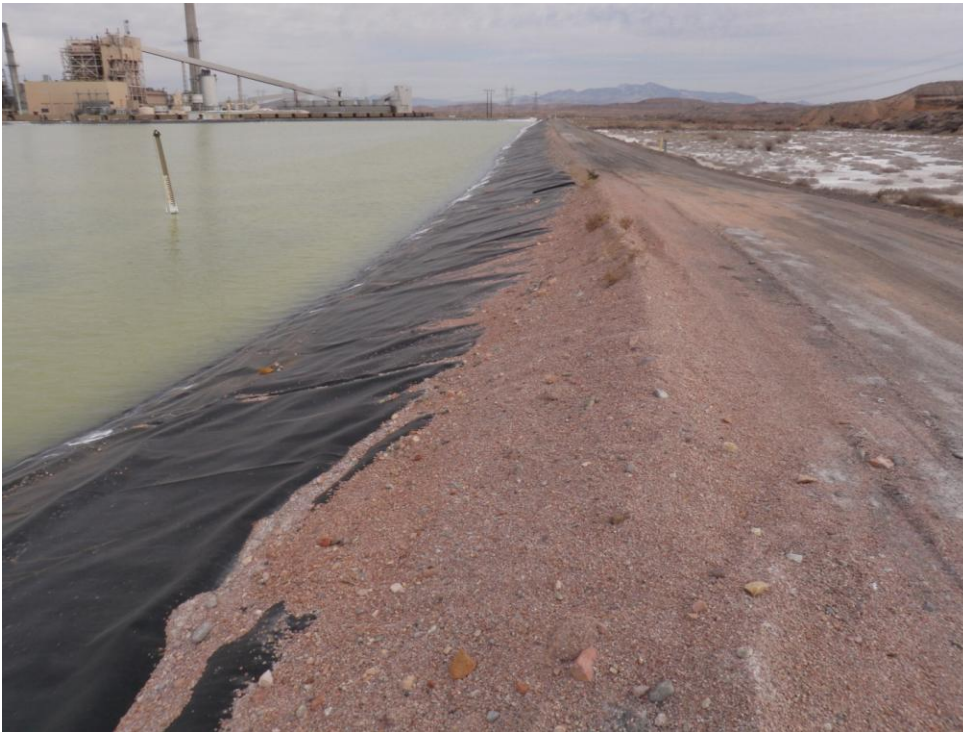
Photo 21: Looking east. Pond E1 south dike - HDPE liner and staff gage.

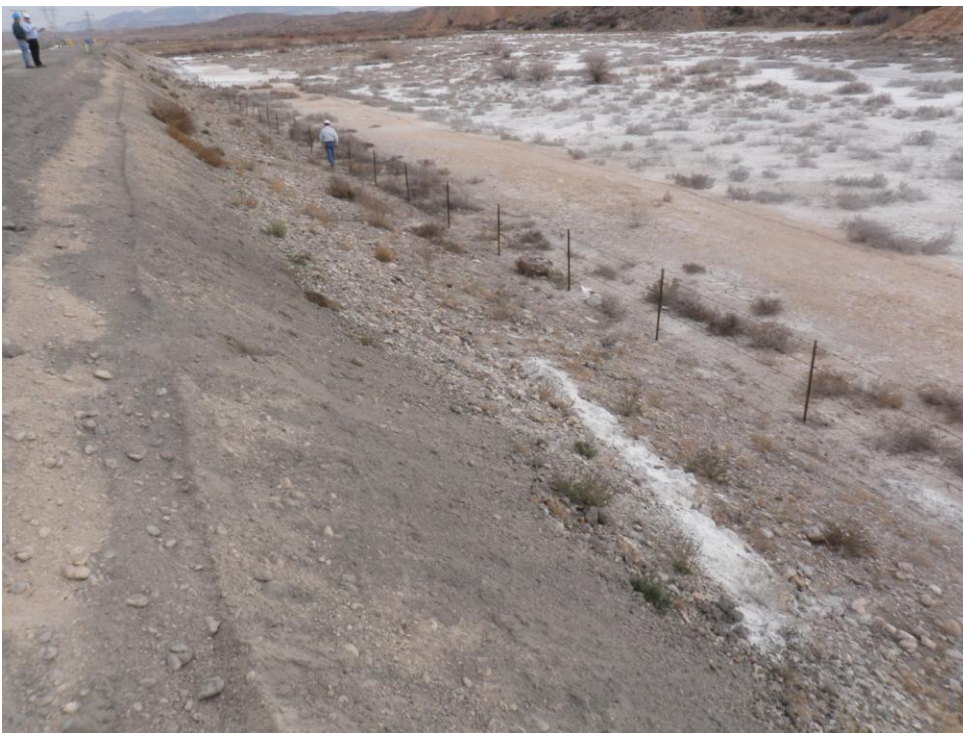
Photo 22: Looking east. Pond E1 south dike.

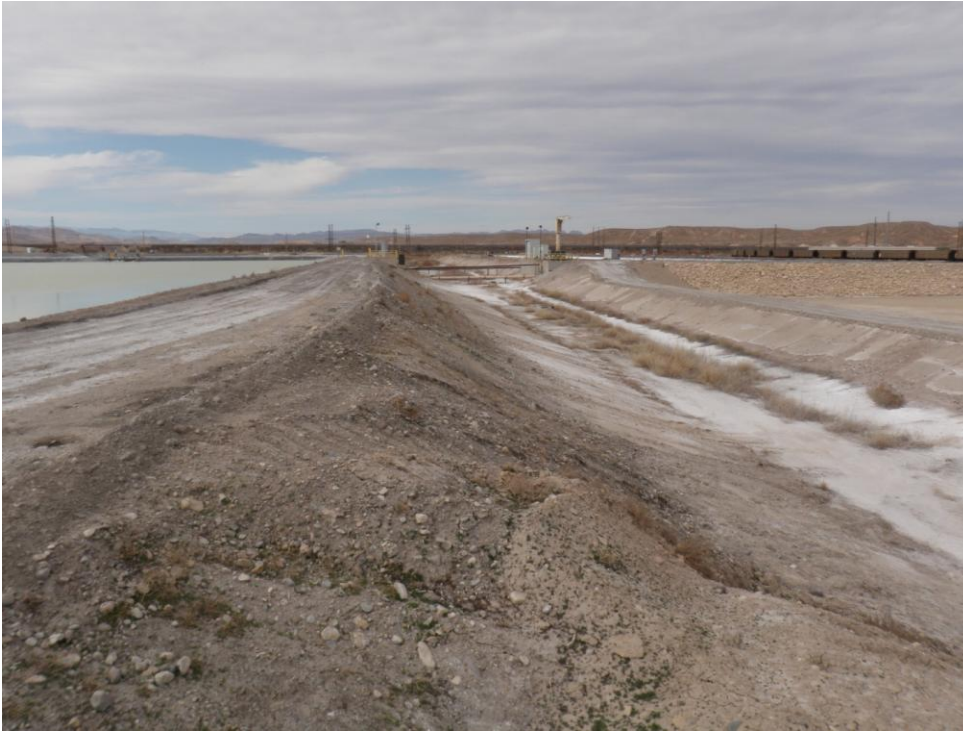
Photo 23: Looking northwest. Pond E1 east dike. Former Pond G on right with partially removed dike and rip rap slope protection on former divider dike with Pond F. Pipes connecting Pond F with Pond E1 in the center-background.

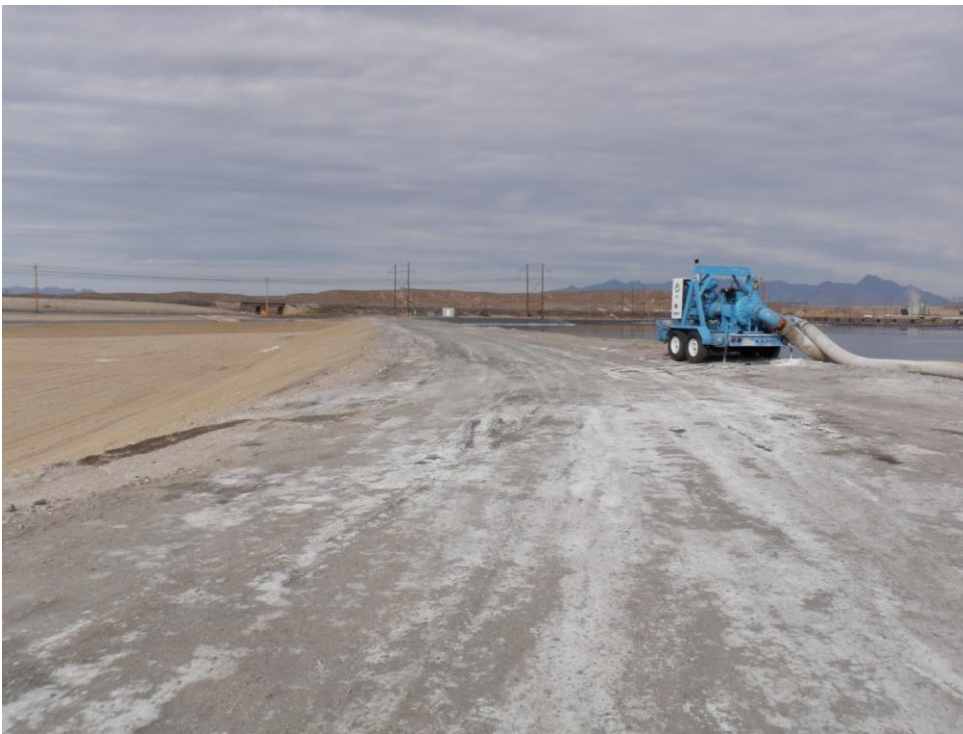
Photo 24: Looking north. Pond E2 west dike. Pond E2 on right. Former Pond D on left.

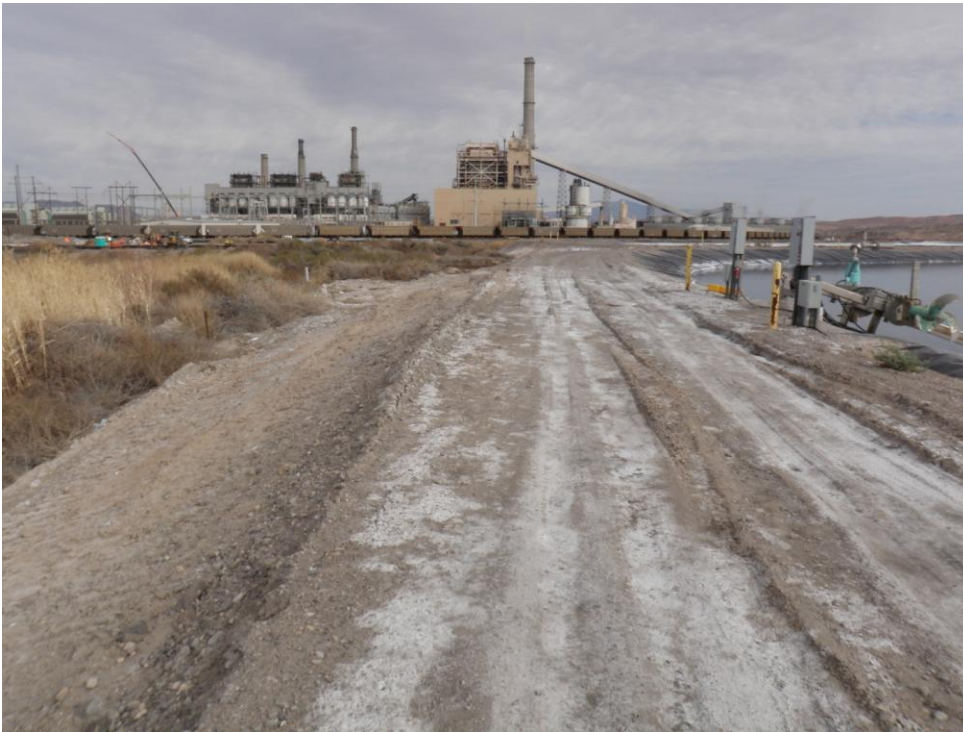
Photo 25: Looking east. Pond E2 north dike near northeast corner. Muddy River on right.

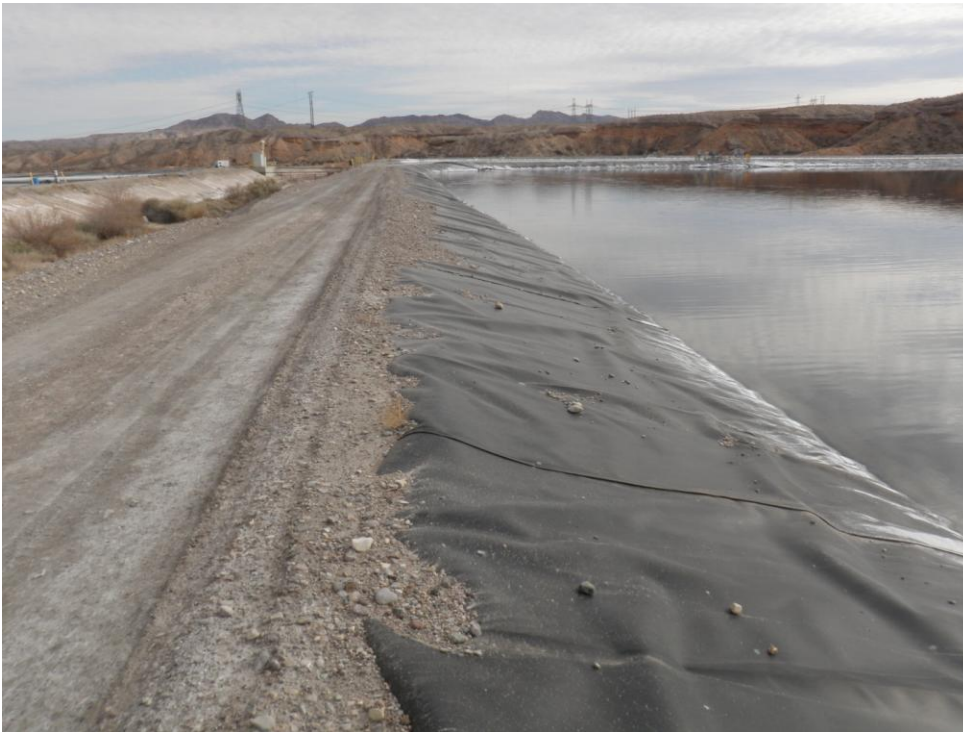
Photo 27: Looking southeast. Pond E2 east dike.

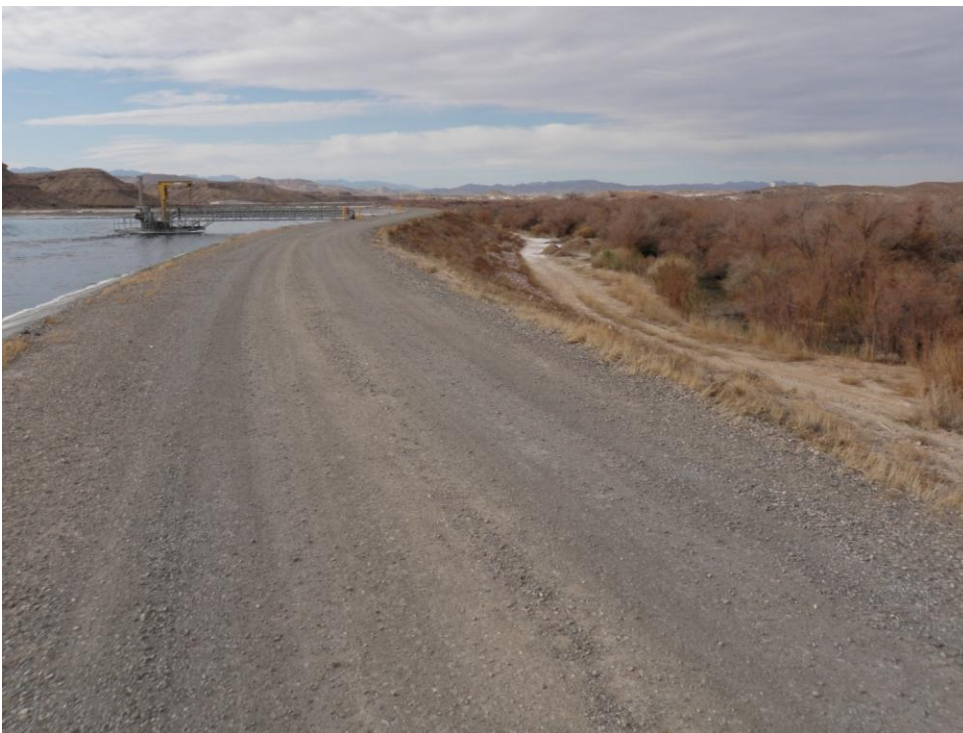
Photo 28: Looking northwest. Pond B1 north dike. Muddy River at right.

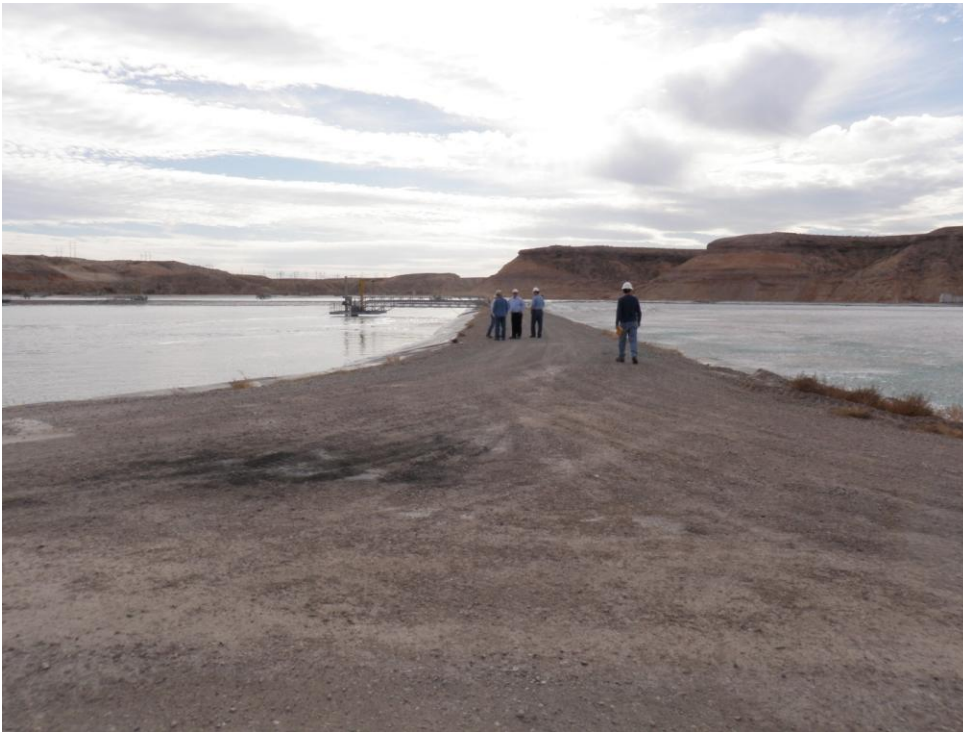
Photo 29: Looking southwest. Divider dike. Pond B1 on left. Pond C1 on right.

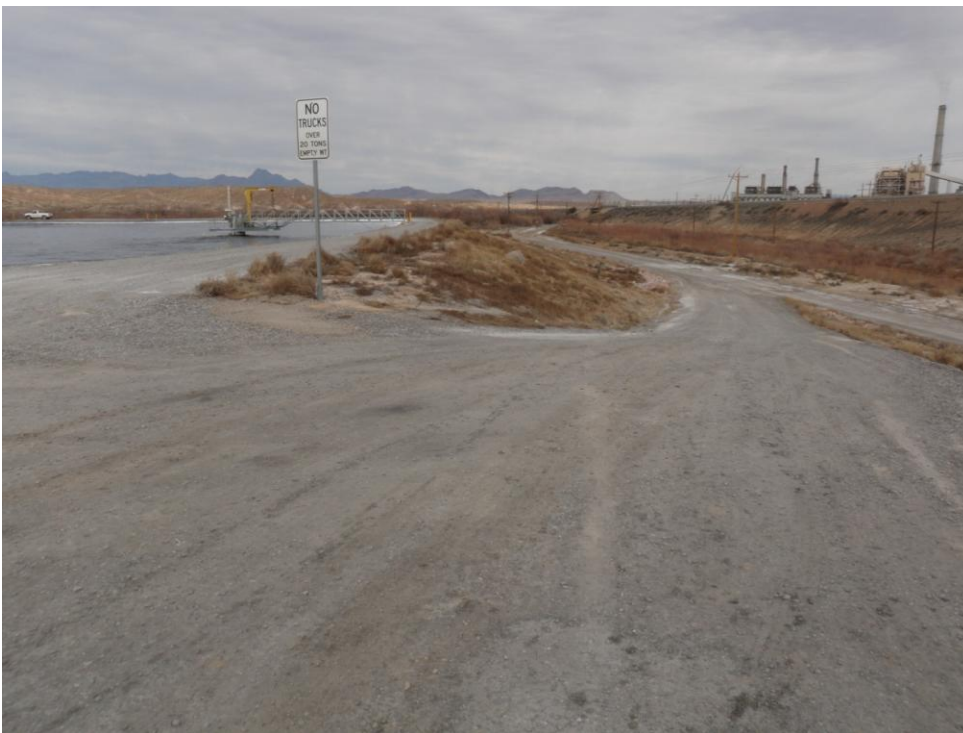
Photo 30: Looking northeast. Pond B1 east dike.

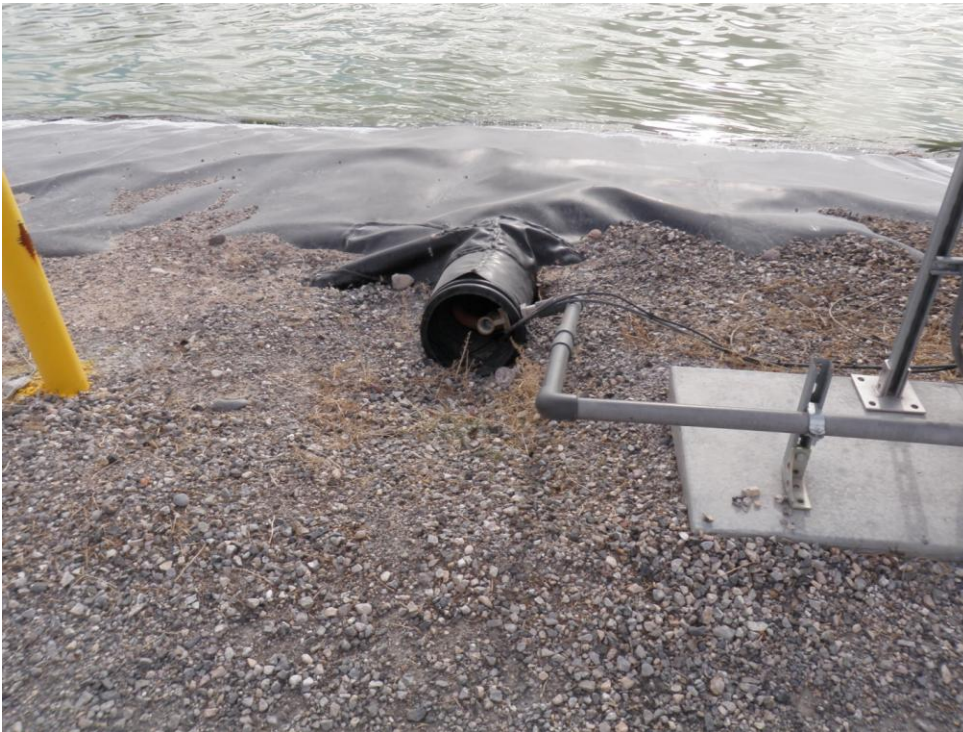
Photo 31: Typical interstitial drain.

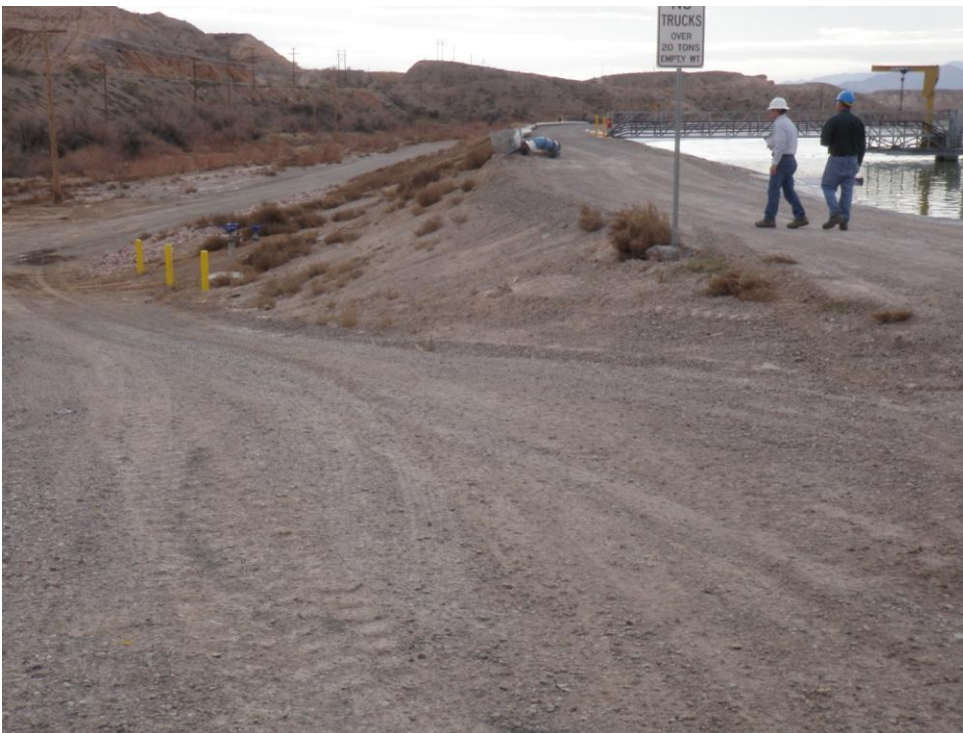
Photo 32: Looking southwest. Pond B2 east dike. Riprap at toe.

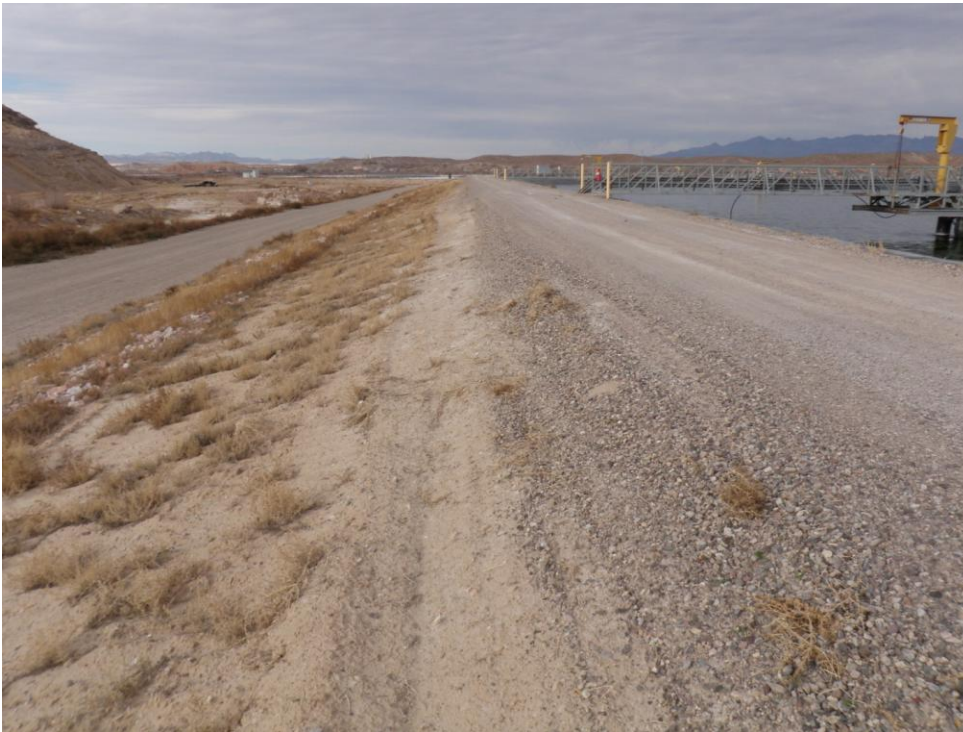
Photo 33: Looking north. Pond B3 west dike.

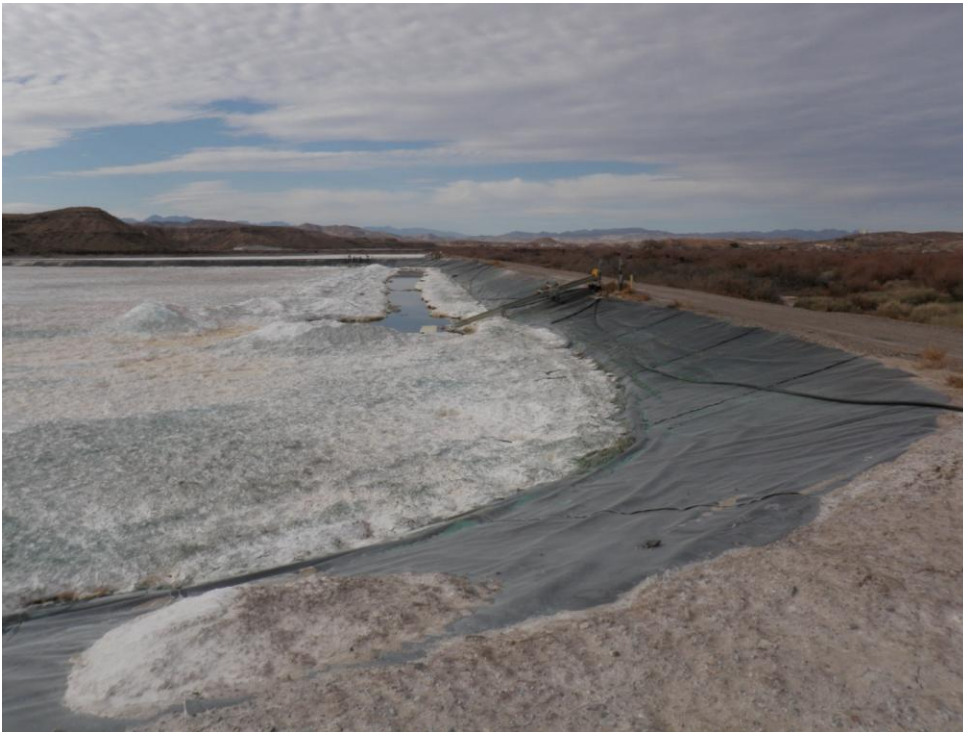
Photo 35: Looking northwest. Pond C1 HDPE liner north dike. Pond C2 in background. Muddy River at right.

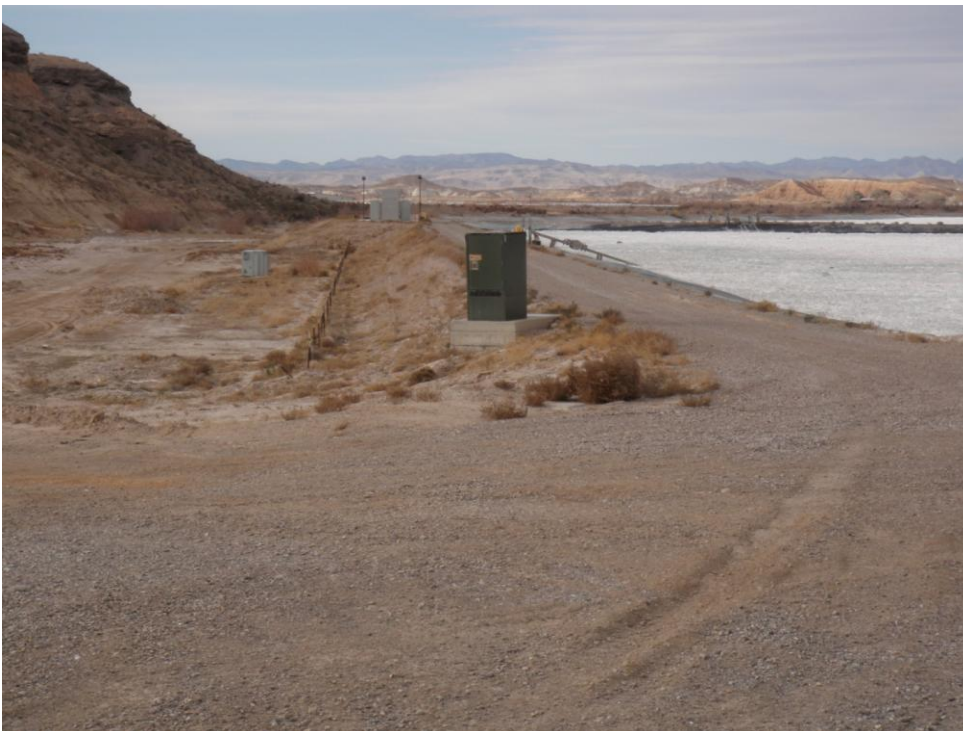
Photo 36: Looking northwest. Pond C1 south dike. Pond C2 in background at the right.

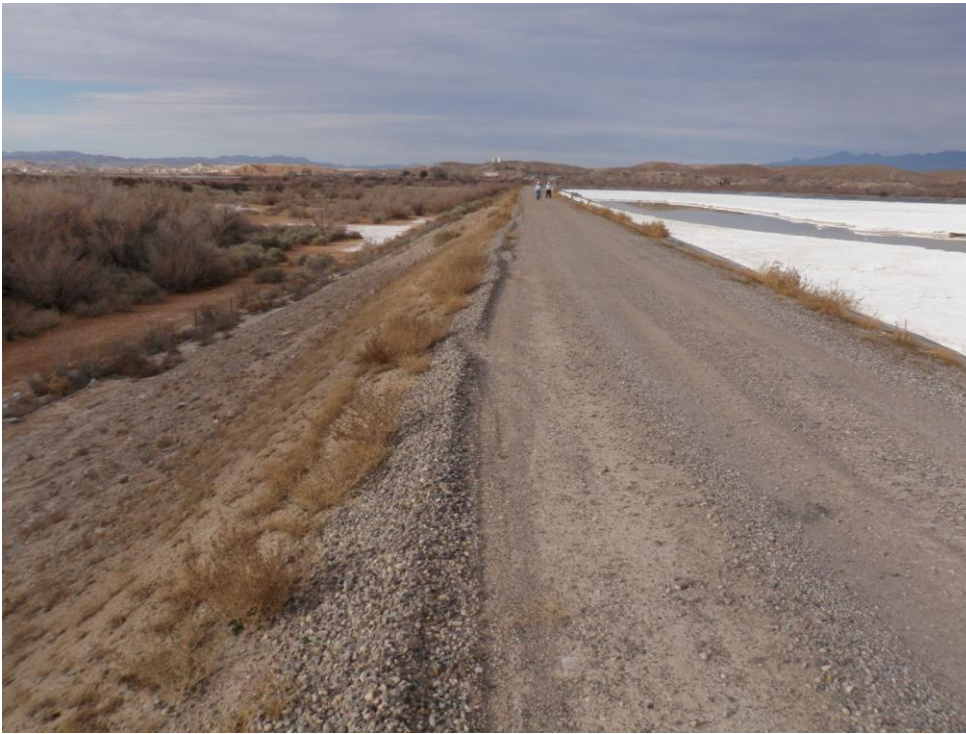
Photo 37: Looking north. Pond C2 west dike. Muddy River at left.

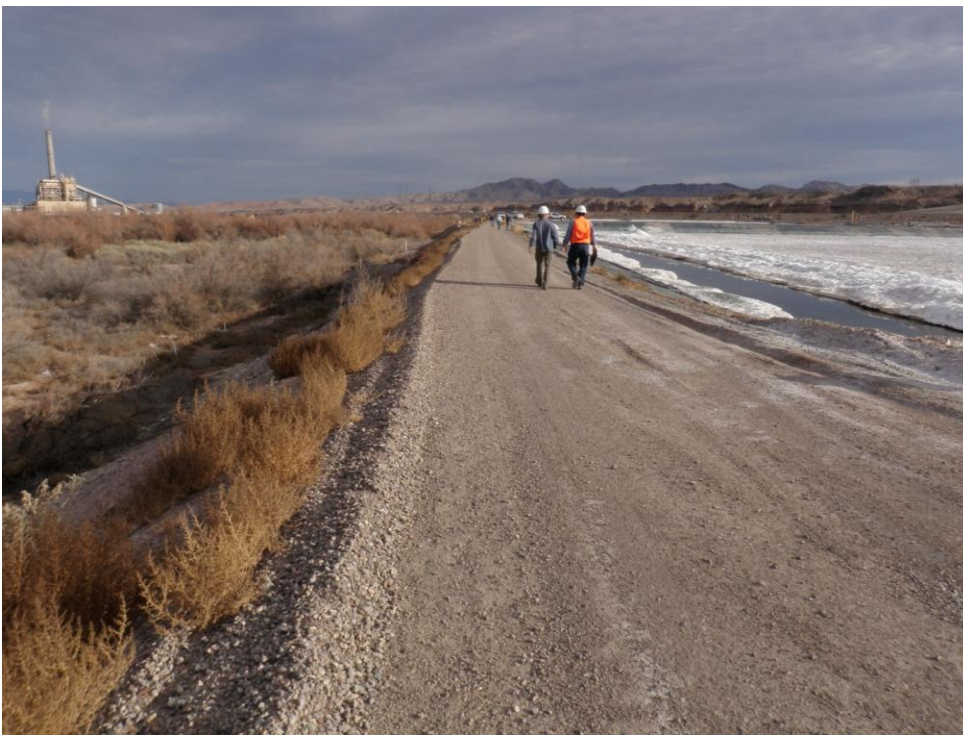
Photo 40: Looking southeast. Pond C1 north dike.

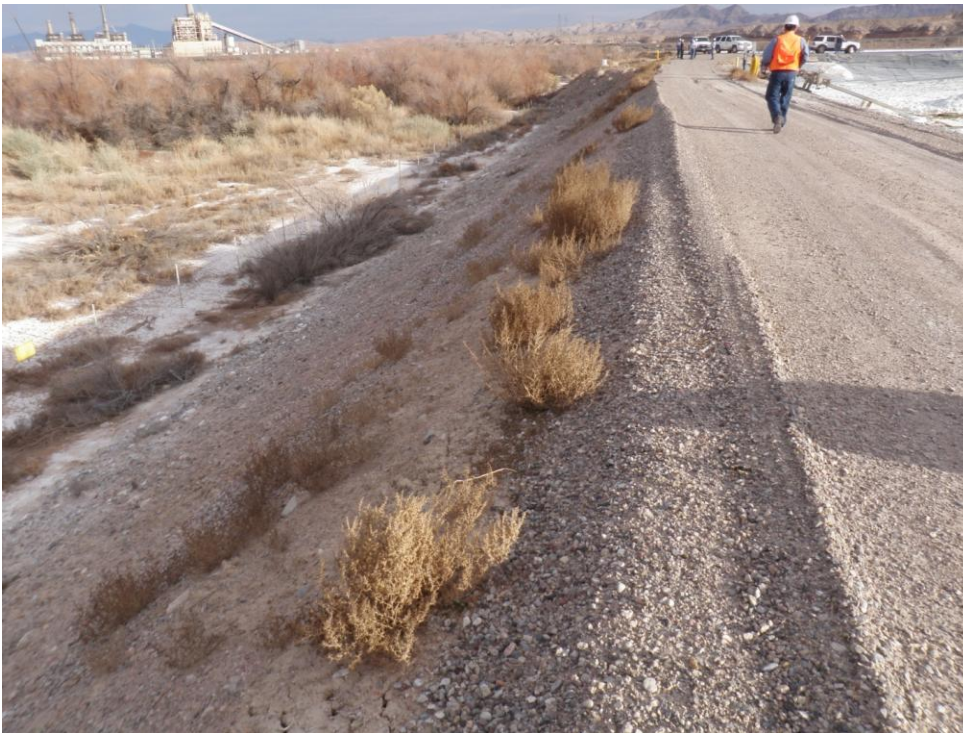
Photo 42: Looking southeast. Pond C1 north dike.
