COAL ASH IMPOUNDMENT  
SITE ASSESSMENT DRAFT REPORT

Coy Station  
Ottawa Oil Power Company  
Beulah, North Dakota

KLEINFELDER PROJECT NUMBER 118953-3

June 26, 2011

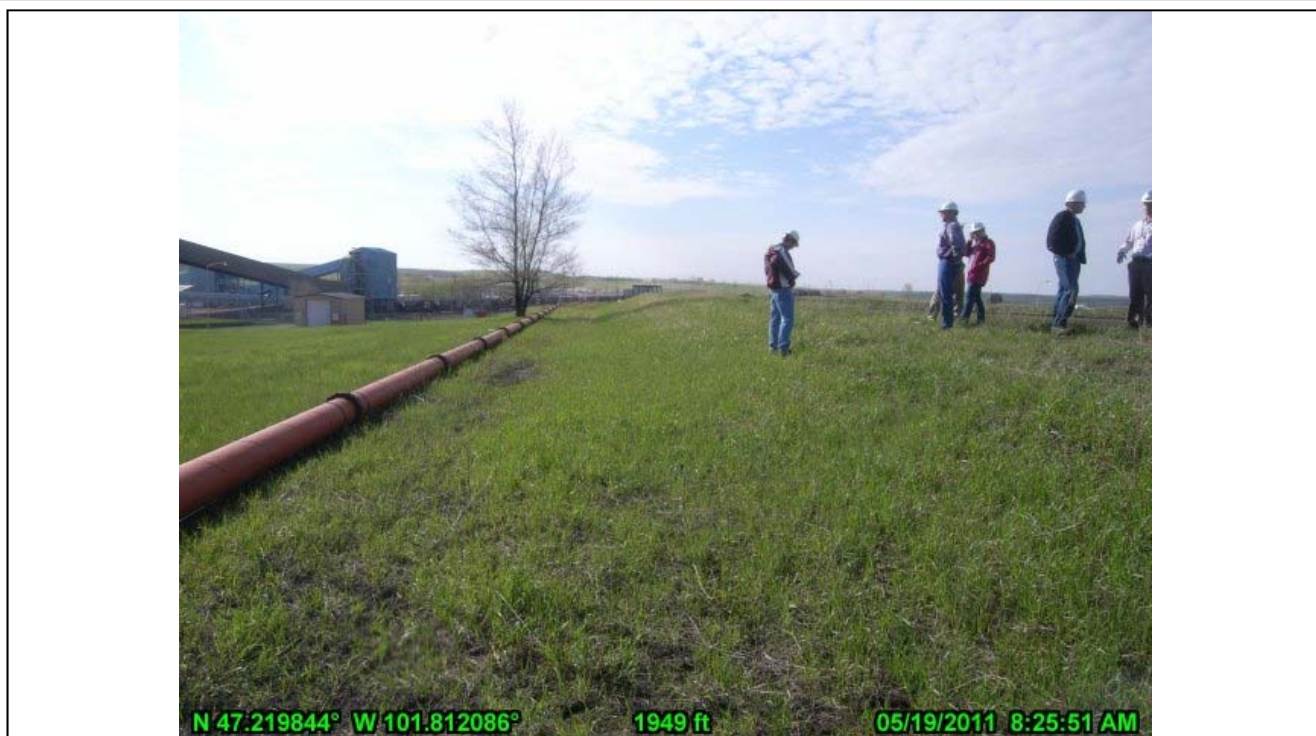
Overall, the downstream slope was in Satisfactory condition. Photos 5, 8, 19, 22, 23, and 25 show the condition of the downstream slope. Specific observations include:

The toe areas of the embankment were in Satisfactory condition. See photos 5, 8, 19, 23, 24, and 25 for the condition of these areas. Key features and observations of these areas include:

5-Nelson Pond Northeast Landside Embankment and Sluice Pipe (looking SE)

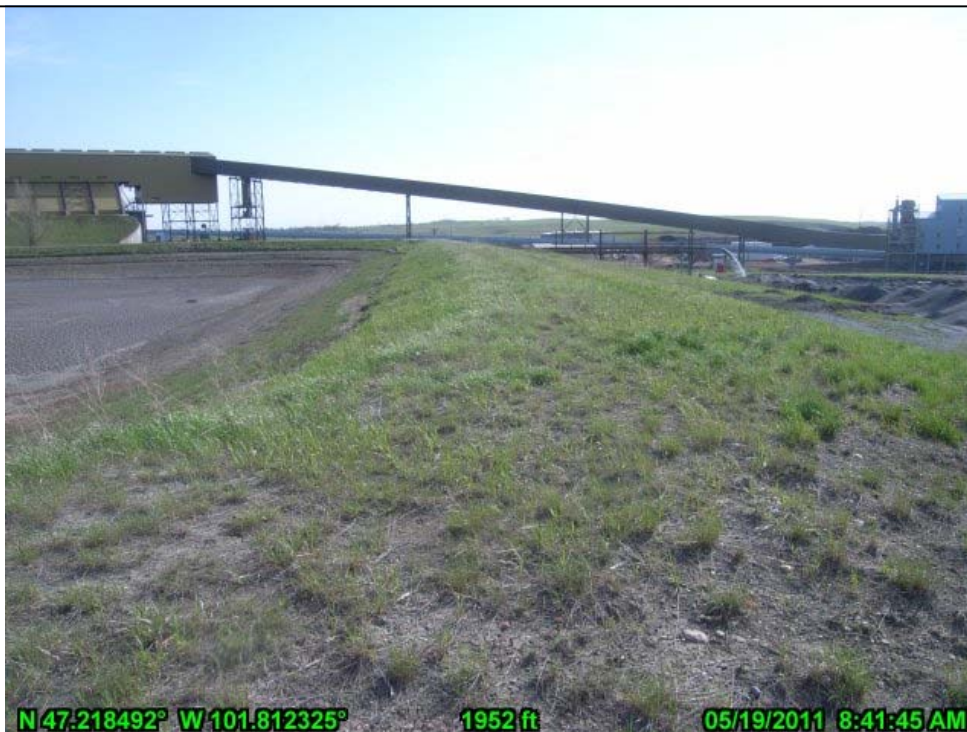
Overall, the upstream slope of the impoundment was in Satisfactory condition. Photos 1, 3, 7, 15, 21, and 22 show the conditions of the upstream slope. Specific observations include:

Overall, the crest of the impoundment was in Satisfactory condition. Photos 1, 2, 7, 15, 19, 21, and 22 show the condition of the crest. Specific observations include:

21-Nelson Pond Southeast Waterside Embankment (looking NE)

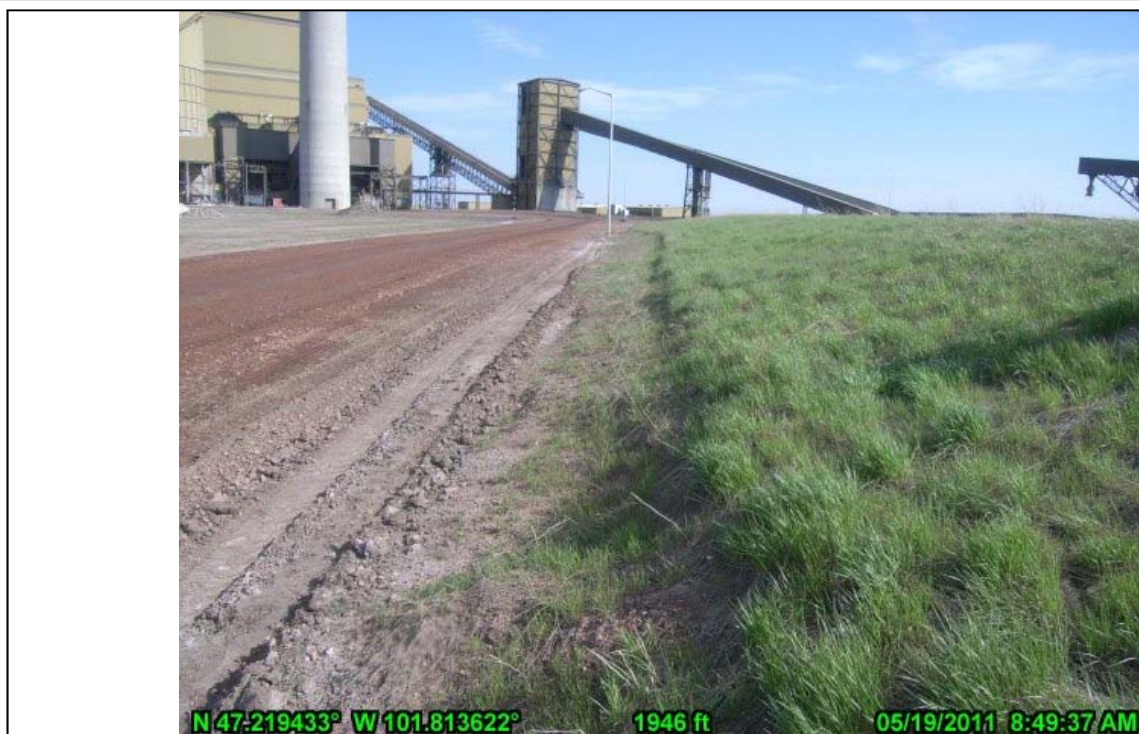
25-Nelson Pond West Landside Embankment Toe (looking N)

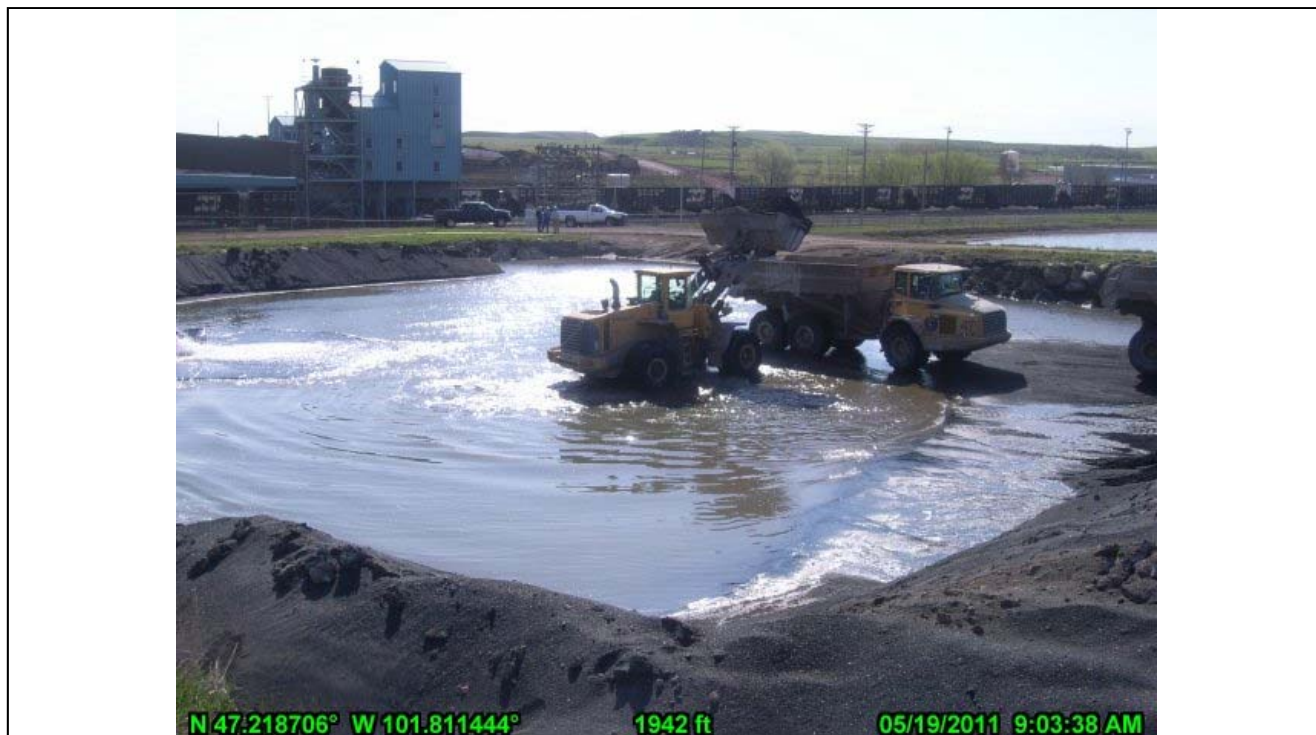
Overall, the upstream slopes of the incised pond were in Fair condition. Photos 28 through 34 show the condition of the upstream slope within the pond. The eastern side of the pond is also an access road for mining trucks, and because the pond is constructed on sloping land, the east side is primarily incised with roadway embankment. Specific observations include:

Overall, the crest of the pond perimeter was in Fair condition. Photos 28 through 34 also show the condition of the perimeter crest. Specific observations include:

30-Sluice Pond Dredging (looking E)

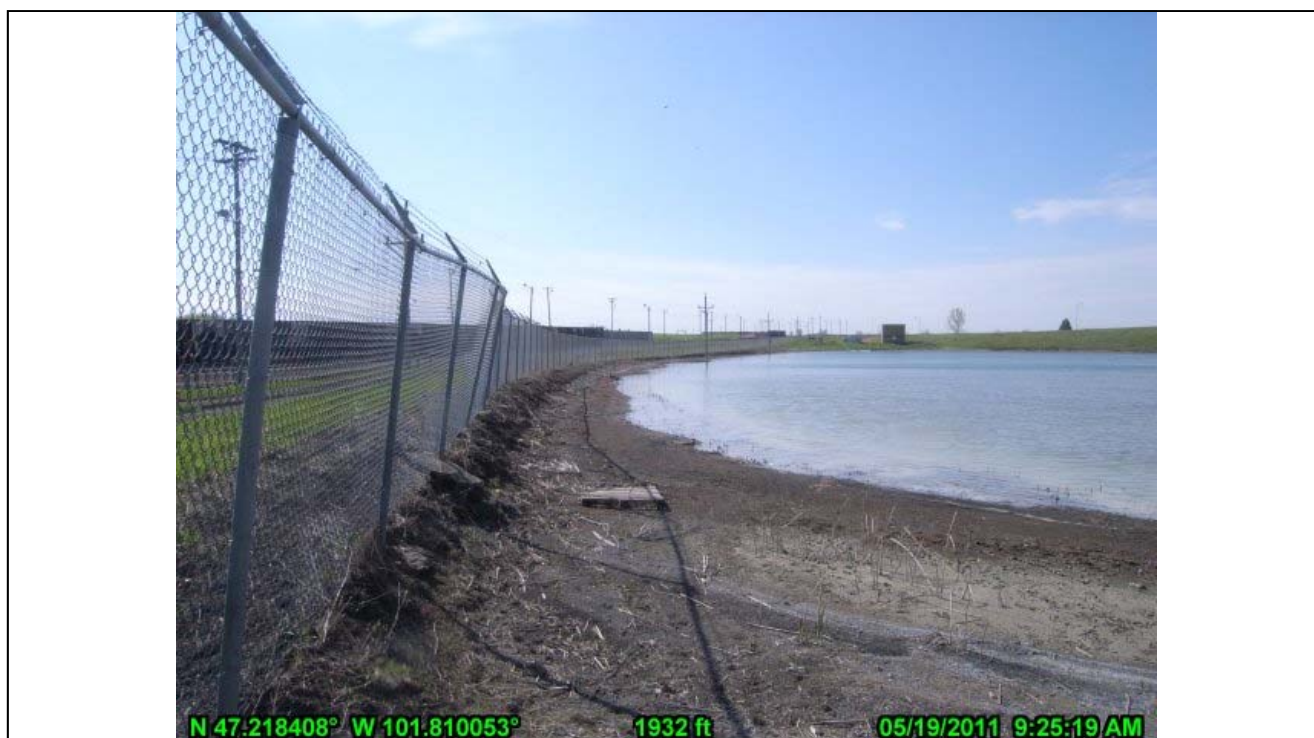
The Ash Pond is almost completely incised. Overall, the upstream slope of the pond is in fair condition. Photos 39, 40, and 42 through 46 show the conditions of the upstream slope. Specific observations include:

40-Ash Pond East Incised Embankment (looking S)
