**COAL ASH IMPOUNDMENT
SITE ASSESSMENT FINAL REPORT**

**Coyote Station
Otter Tail Power Company, Montana-
Dakota Utilities, Co., Northern
Municipal Power Agency, and
NorthWestern Energy**

KLEINFELDER PROJECT NUMBER 118953-3

February 28, 2013

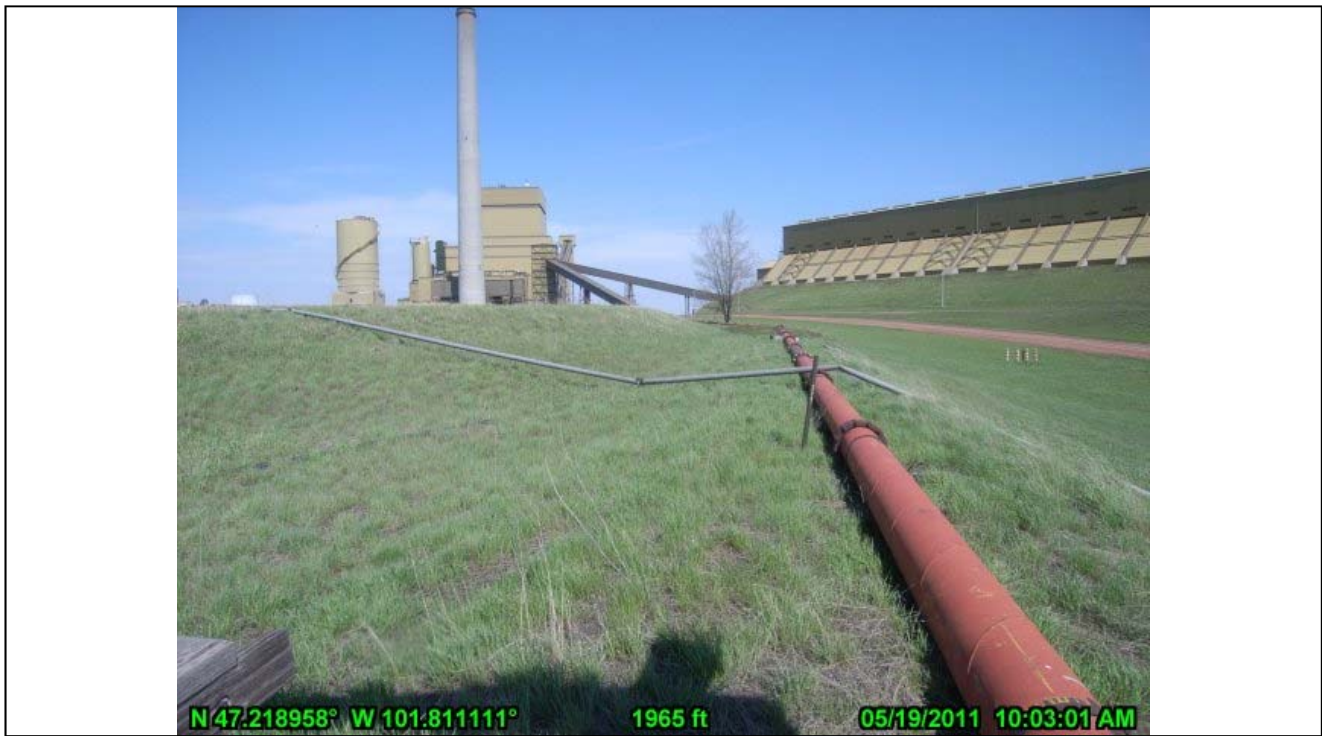
9-Nelsen Pond East Landside Embankment and Sluice Pipe (looking NW)

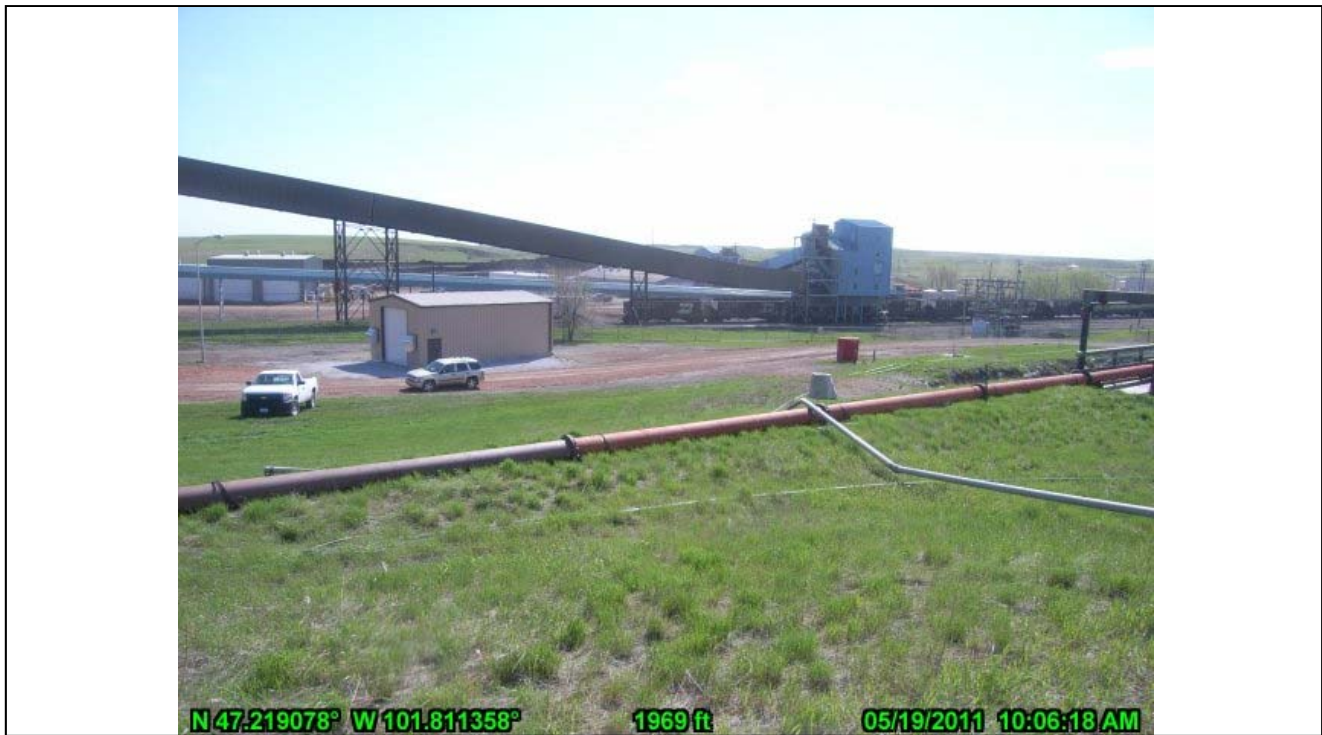
10-Down Gradient Area Adjacent to Max Height of Nelsen Pond (looking E)

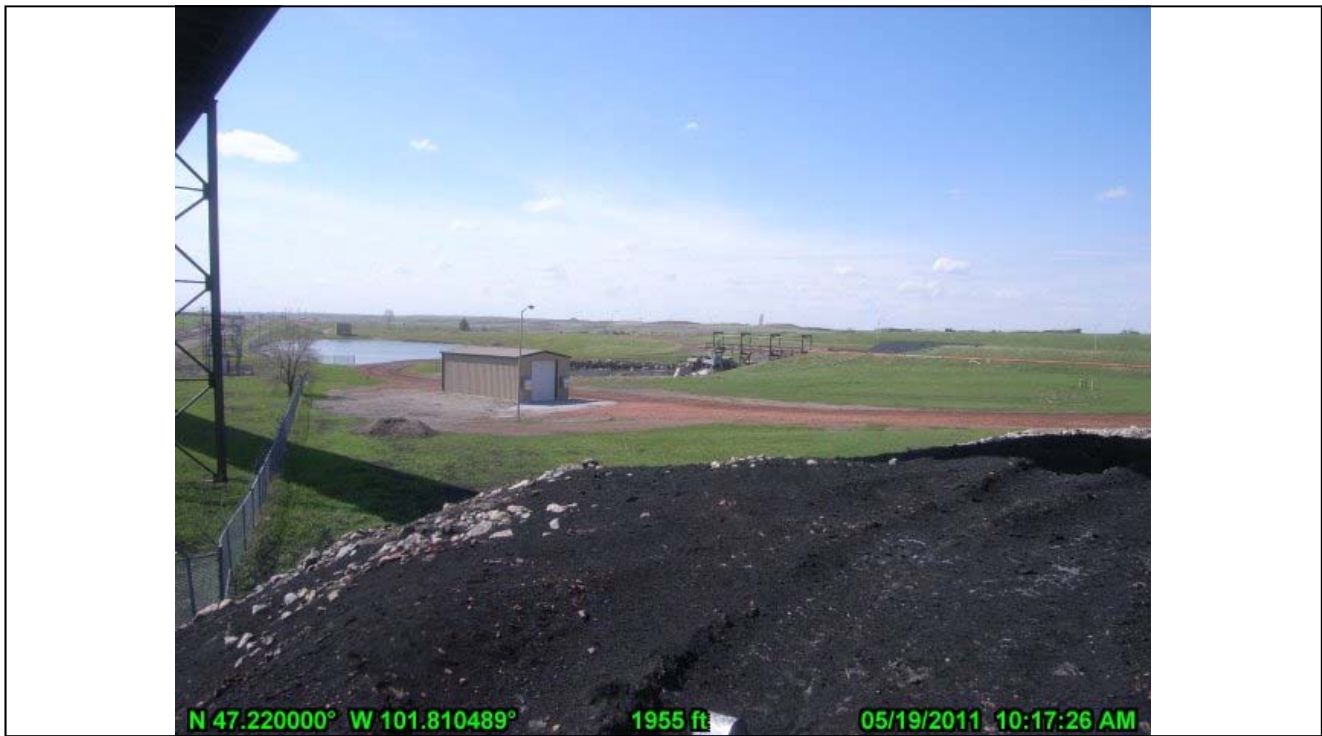
11-Continued Down Gradient Area Adjacent to Max Height of Nelsen Pond (looking S)

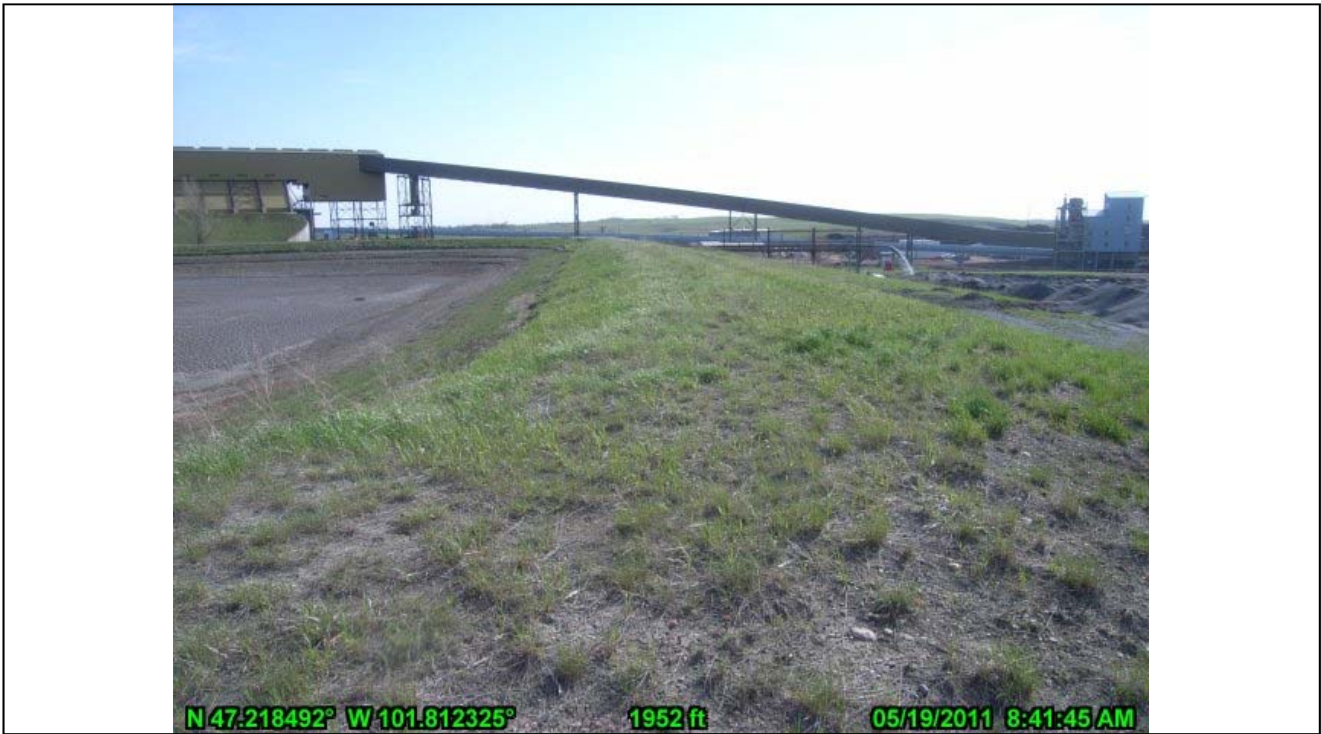
Overall, the upstream slope of the impoundment was in Satisfactory condition. Photos 1, 3, 7, 15, 21, and 22 show the conditions of the upstream slope. Specific observations include:

Overall, the crest of the impoundment was in Satisfactory condition. Photos 1, 2, 7, 15, 19, 21, and 22 show the condition of the crest. Specific observations include:

21-Nelsen Pond Southeast Waterside Embankment (looking NE)

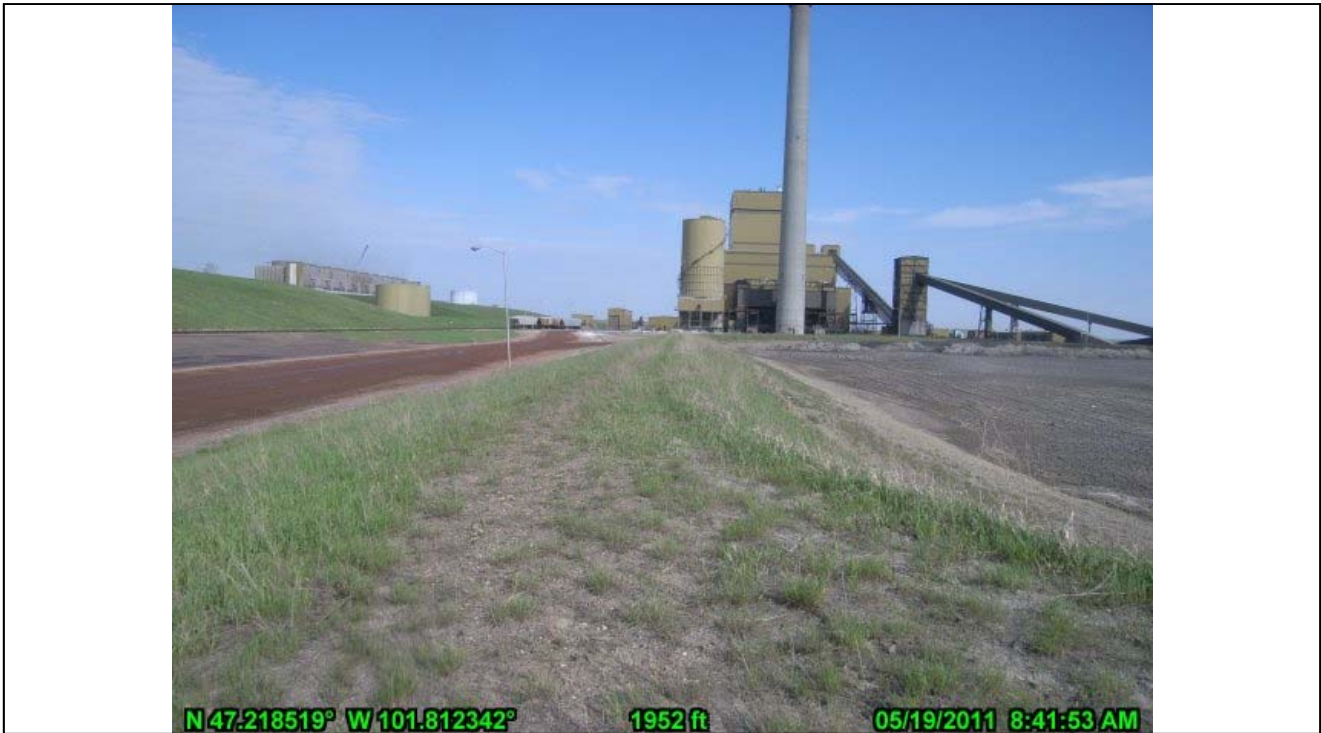
Overall, the downstream slope was in Satisfactory condition. Photos 5, 8, 19, 22, 23, and 25 show the condition of the downstream slope. Specific observations include:

22-Nelsen Pond Southwest Embankment Crest (looking NW)

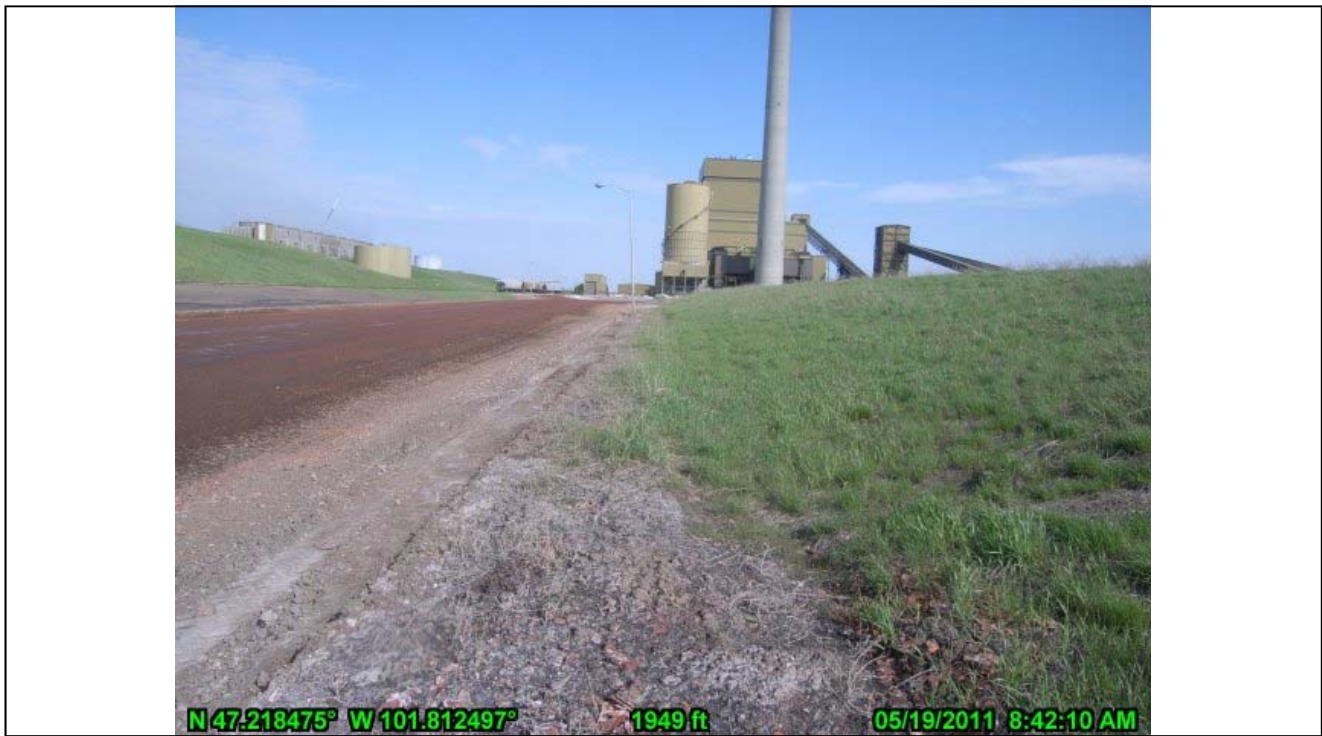
- The slopes were well vegetated and appeared stable.
- No slope scarps or depressions were noted.
- A few small animal burrows were noted.

The toe areas of the embankment were in Satisfactory condition. See Photos 5, 8, 19, 23, 24, and 25 for the condition of these areas. Key features and observations of these areas include:

23-Nelsen Pond Southwest Landside Embankment (looking NW)

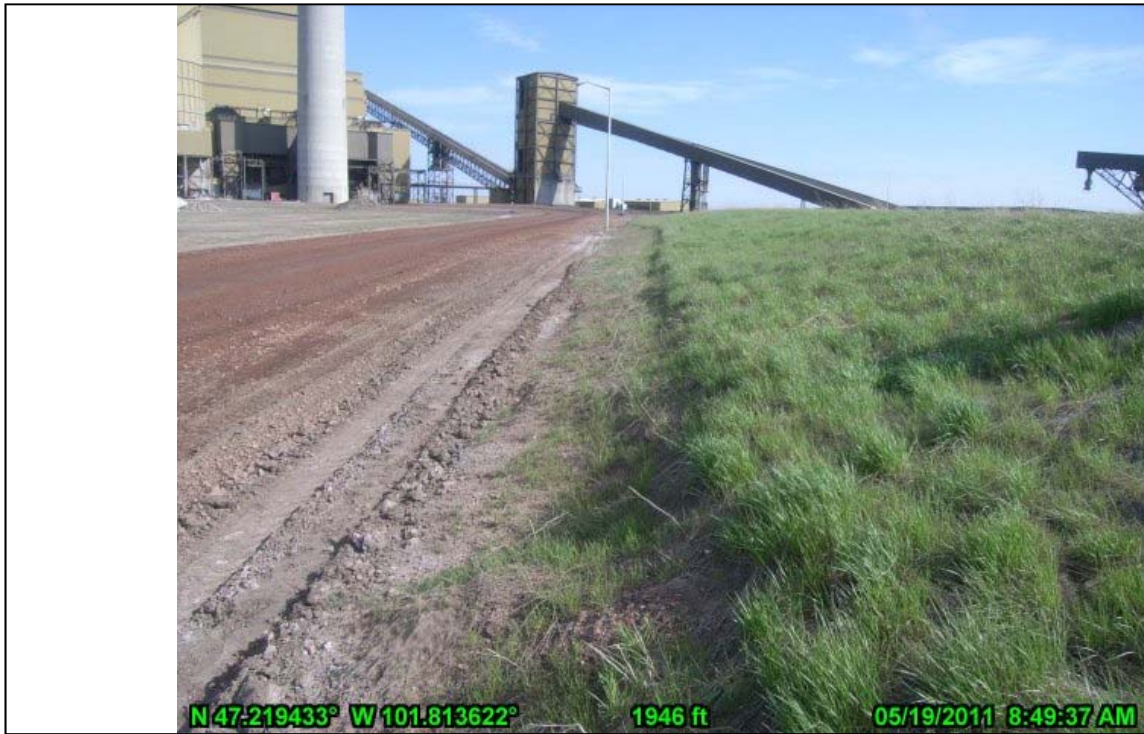
25-Nelsen Pond West Landside Embankment Toe (looking N)

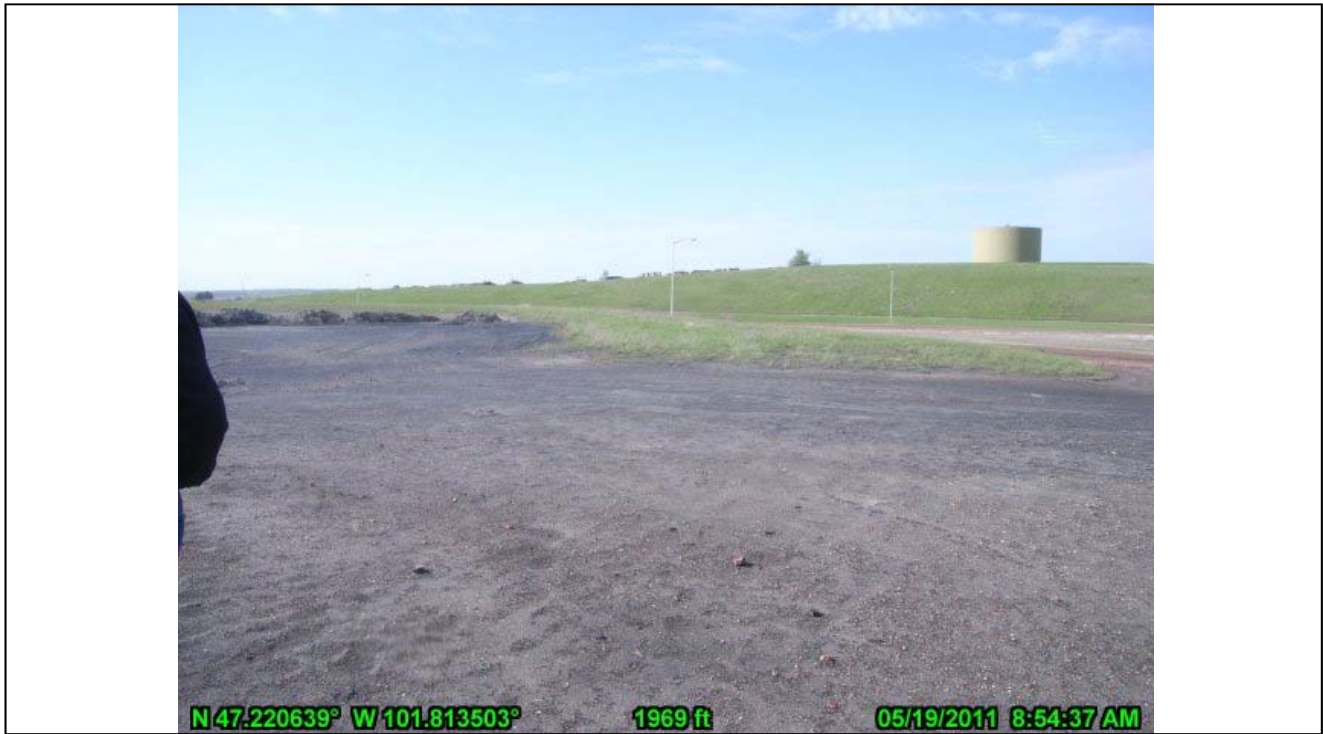
27-Nelsen Pond North Embankment and Dredging Ramp Entrance (looking W)

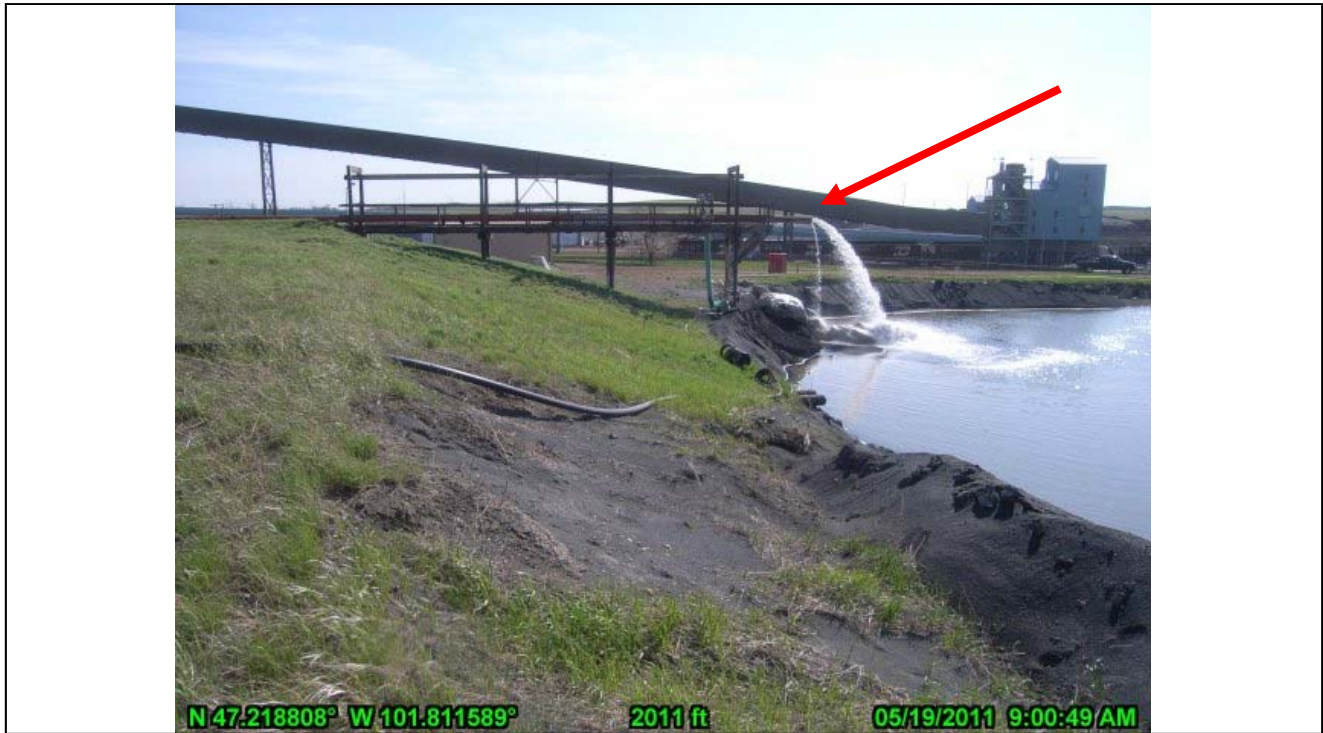
The Sluice Pond is incised and was not assigned a Hazard Classification; therefore, the upstream slopes were not given a condition rating, however they appeared to function properly. Photos 28 through 34 show the condition of the upstream slope within the pond. The eastern side of the pond is also an access road for mining trucks, and because the pond is constructed on sloping land, the east side is primarily incised with roadway embankment. Specific observations include:

- The upstream slope was in fair condition, appeared stable, but was oversteepened over much of its perimeter.
- There were no design drawings of the Sluice Pond available for review.
- The pond lining type, if any, is unknown.
- There was riprap placed on portions of the upstream north slope where a separate economizer ash settling channel has been constructed.

The Sluice Pond is incised and was not assigned a Hazard Classification; therefore, the crest was not given a condition rating, but appeared to function properly. Photos 28 through 34 also show the condition of the perimeter crest. Specific observations include:

- Much of the perimeter crest also serves as an access road.
- No major depressions, erosion, or rutting were noted on the pond crest.
- A trestle structure supports the sluice pipe entering the west side of the pond, as shown in Photos 28 and 32.

28-Sluice Pond Inlet and Northwest Waterside Embankment (looking NE)

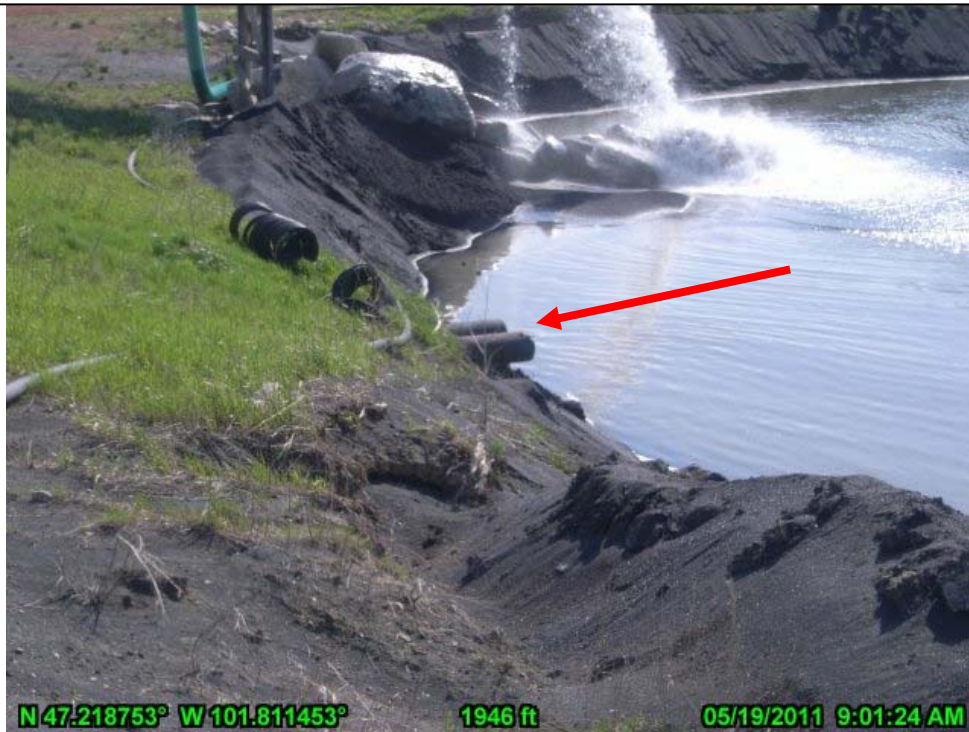
29-Outlet Pipes from Nelsen Pond (Steel Drain Pipe and Overflow Pipe)

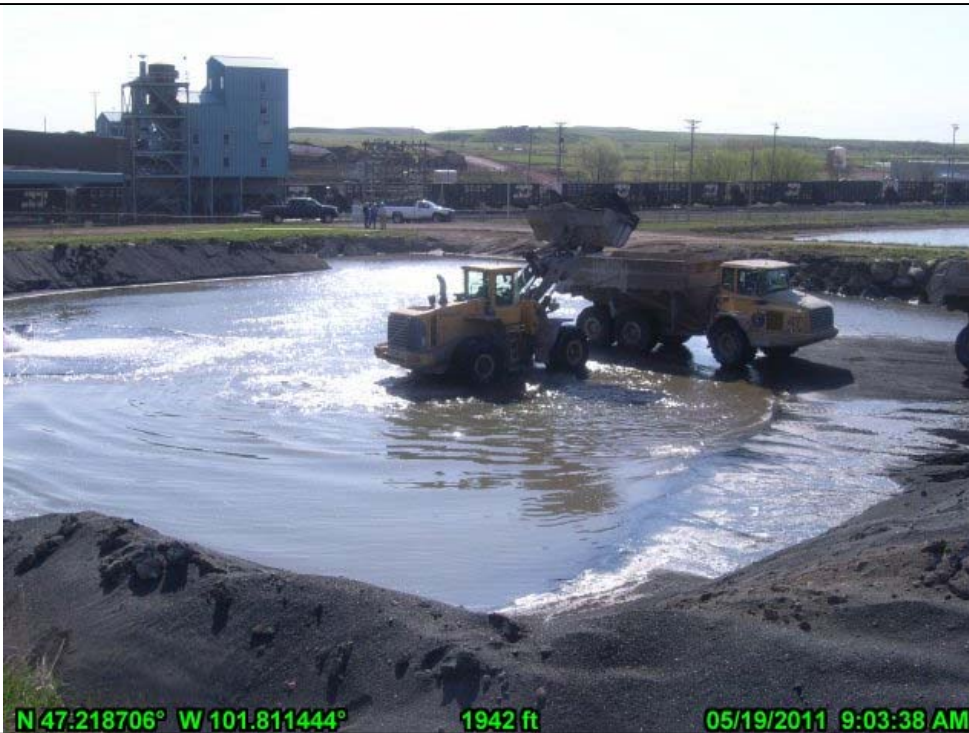
30-Slucice Pond Dredging (looking E)

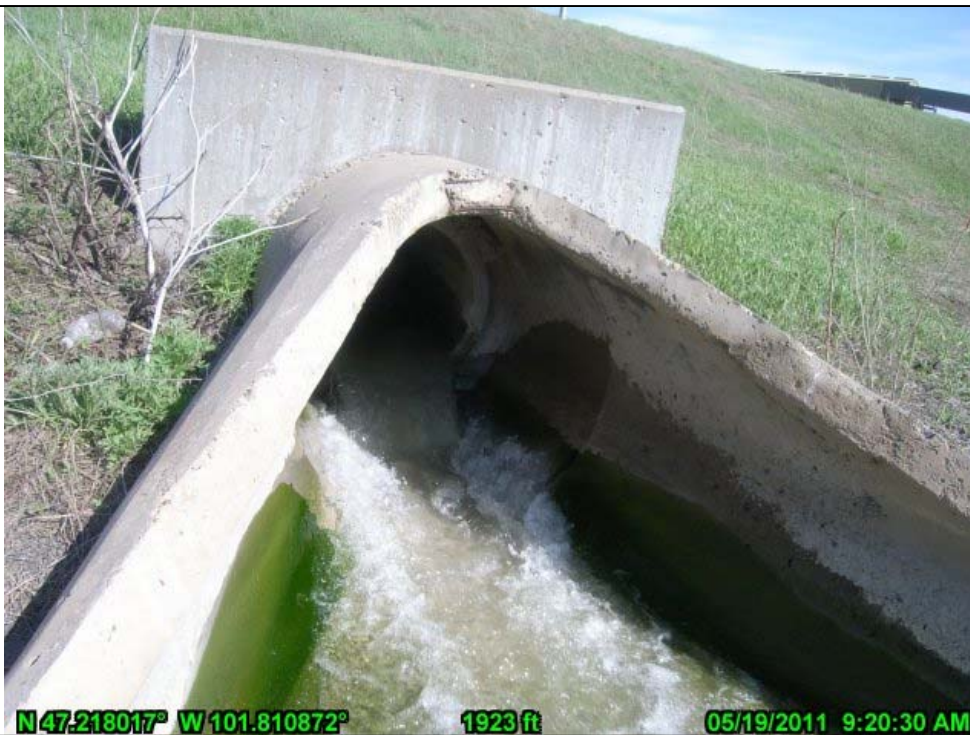
38-Ash Pond Inlet from the Sluice Pond

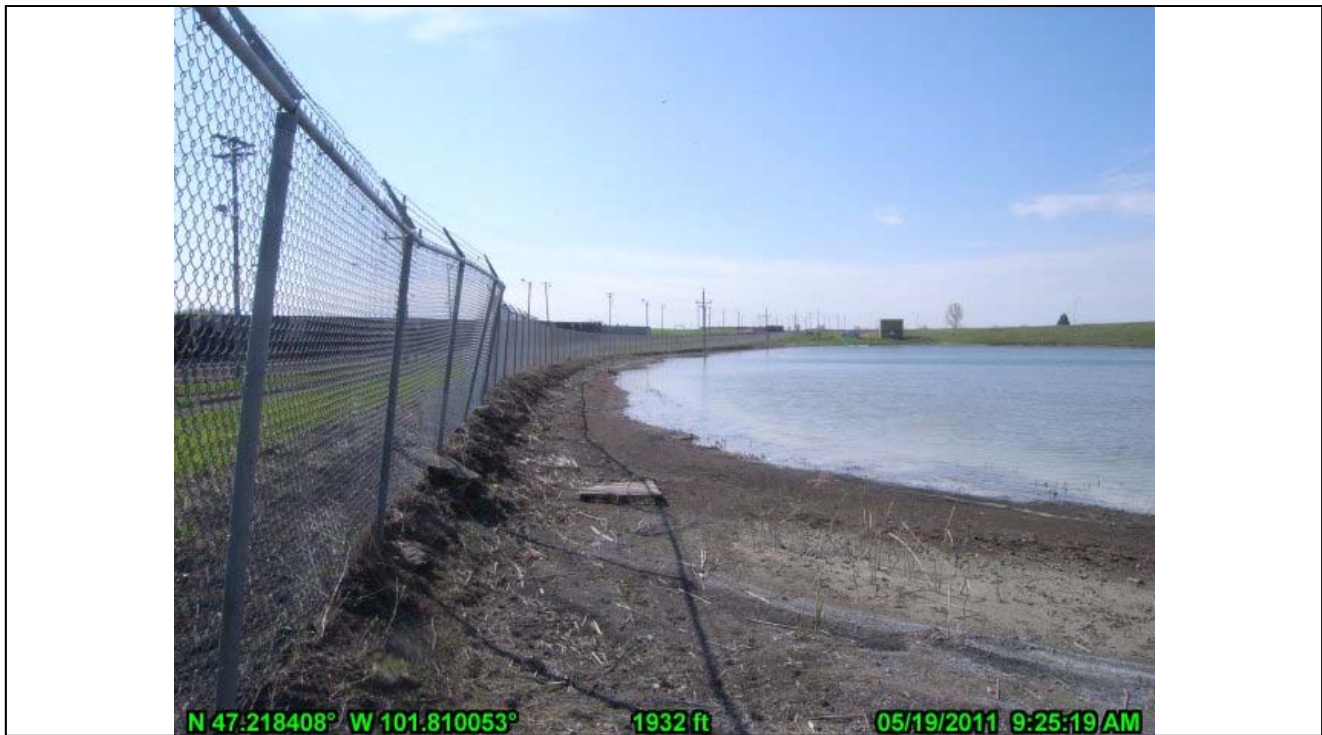
The Ash Pond is incised and was not assigned a Hazard Classification; therefore, the upstream slope was not given a condition rating, but appeared to function properly. Photos 39, 40, and 42 through 46 show the conditions of the upstream slope. Specific observations include:

40-Ash Pond East Incised Embankment (looking S)

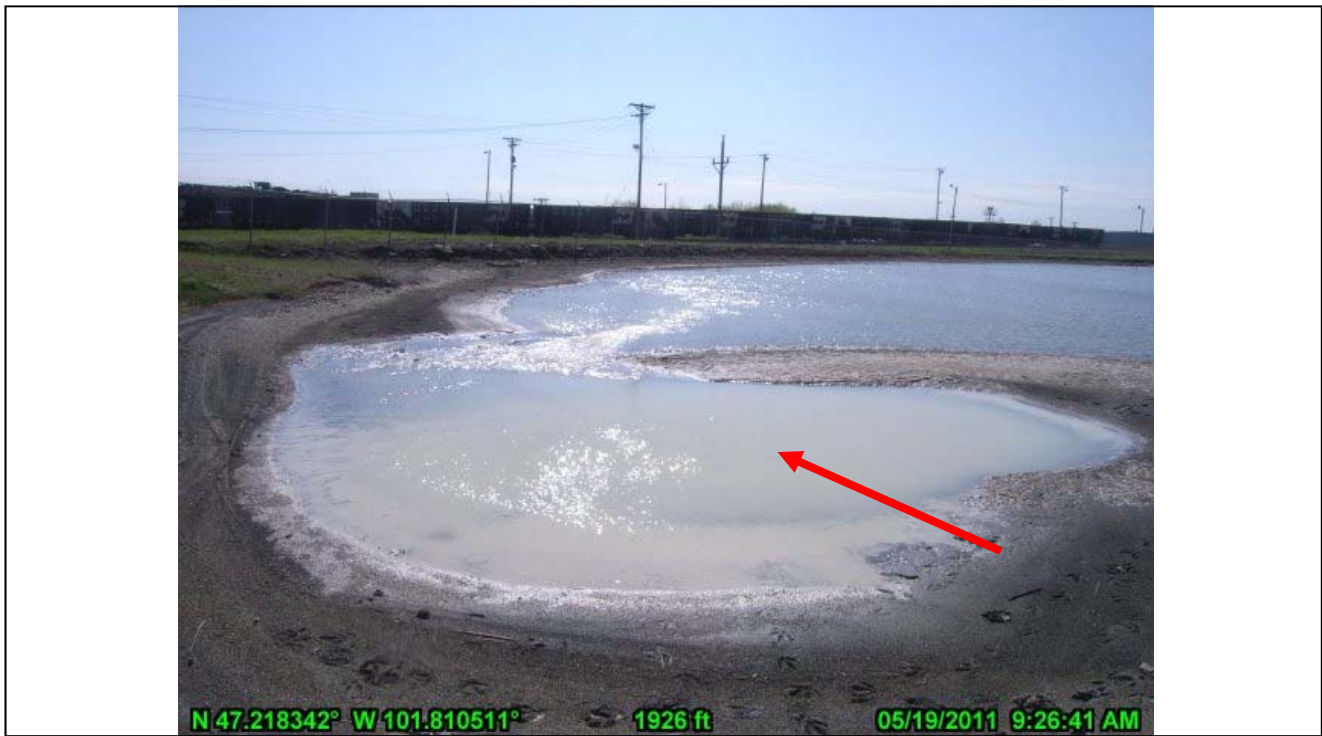
41-Ash Pond Inlet (underwater) from Plant Drains (looking SE)
