Assessment of Dam Safety of Coal Combustion Surface Impoundments (Task 3) Draft Report

Ohio Valley
Electric Corporation

Kyger Creek Power Station

December 9, 2009

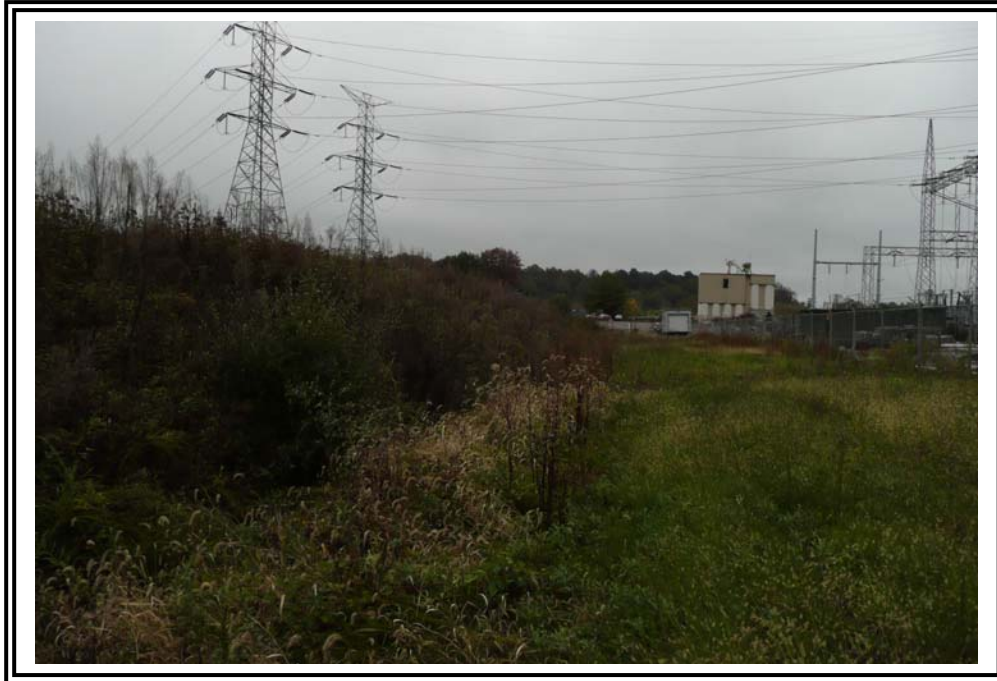
1

At the time of the site visit, the north dike was not actively impounding water. An access road runs the length of the crest of the north dike (Photo No. 12), which runs parallel to the plant. The interior embankment slope is generally covered by granular material and sparsely vegetated, with occasional erosion features observed (Photo Nos. 6, 9, 10, and 11). Heavier vegetation was noted near the transmission towers on the interior embankment slope (Photo Nos. 7 and 8). The exterior slope of the north dike was observed to be moderately to heavily vegetated (Photo Nos. 2, 3, 5). The dike is only 5 to 8 feet in height as the north end where it is predominately incised (Photo No. 1). No slumps or bulges were observed in the interior or exterior embankment slopes.

Exterior slope of north dike, looking west. Dike is approximately 5 to 8 feet high in this location where the pond is predominately incised.

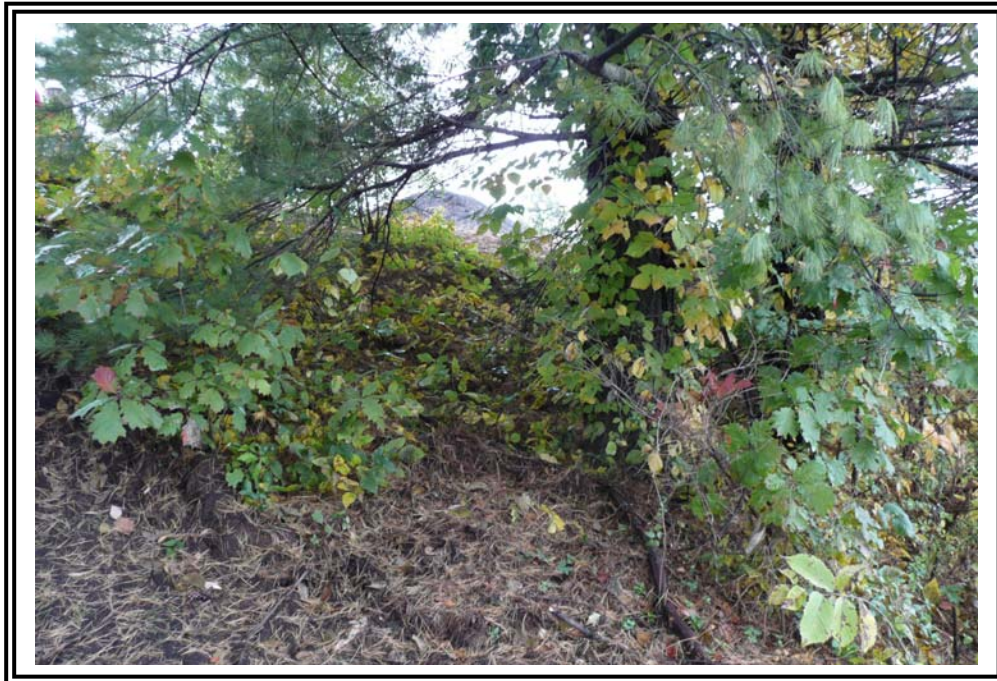
2

Exterior slope of north dike. This area does not currently impound water.

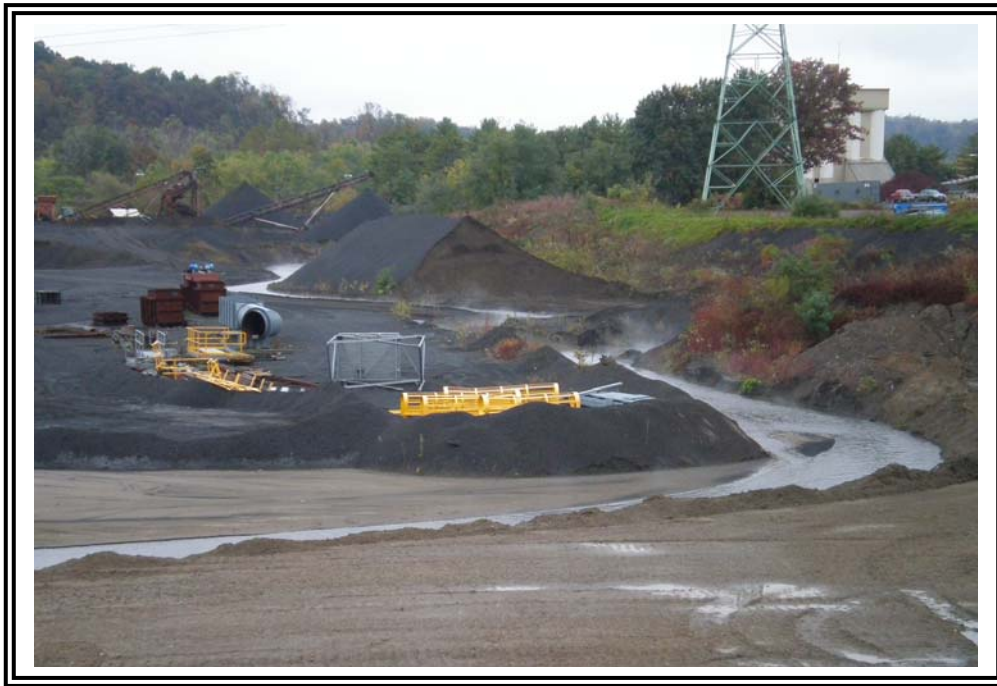
4

Looking across the northern end of the Bottom Ash Pond at the north dike.

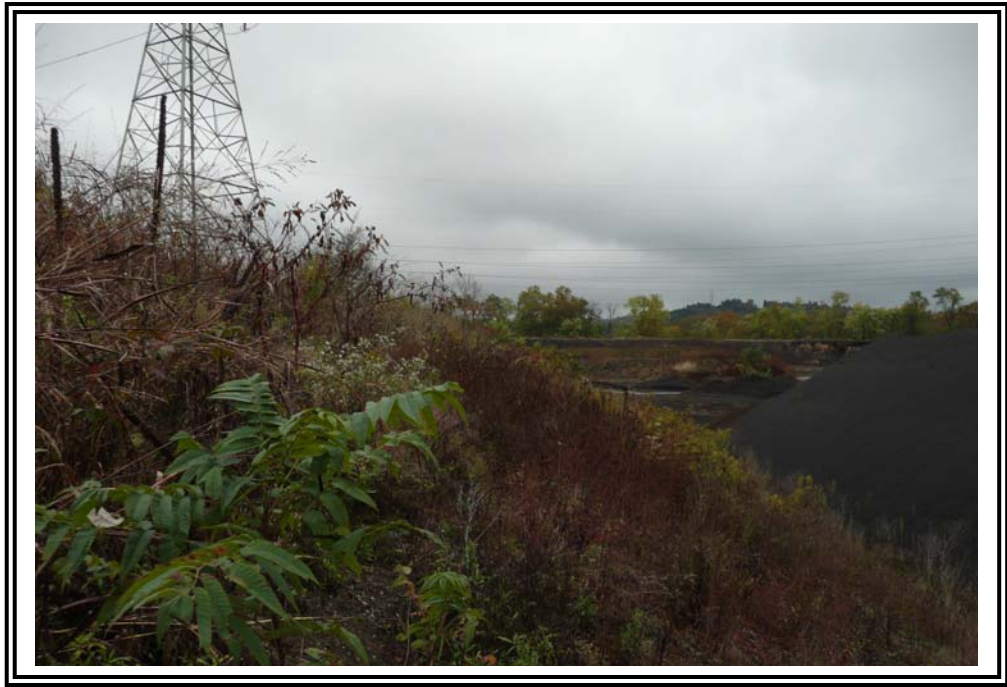
7

Interior slope of north dike, looking east.

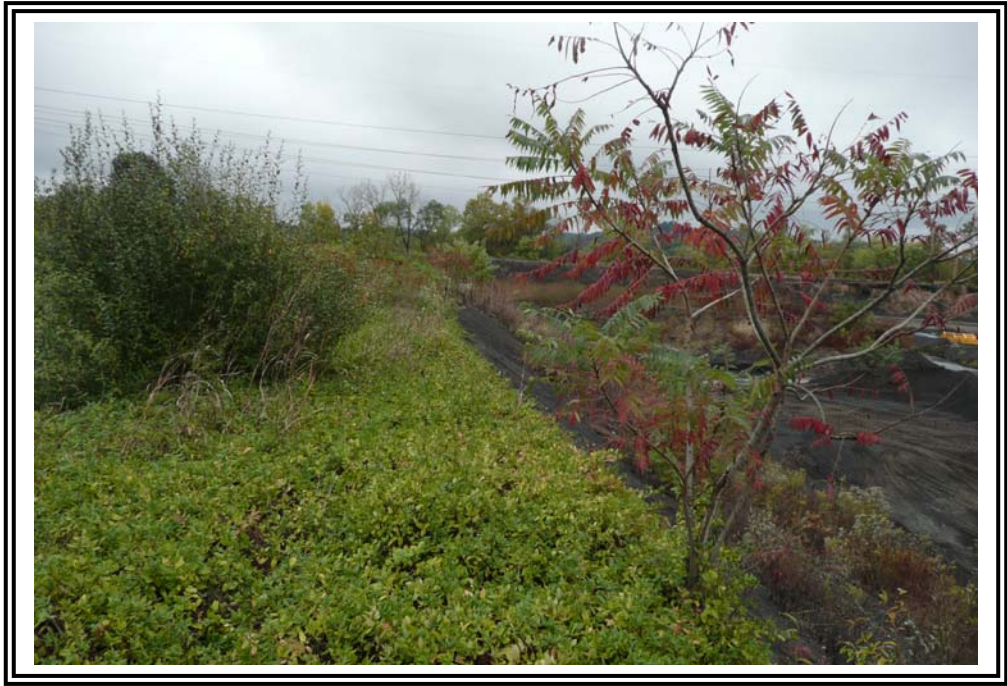
8

Interior slope of north dike, looking east.

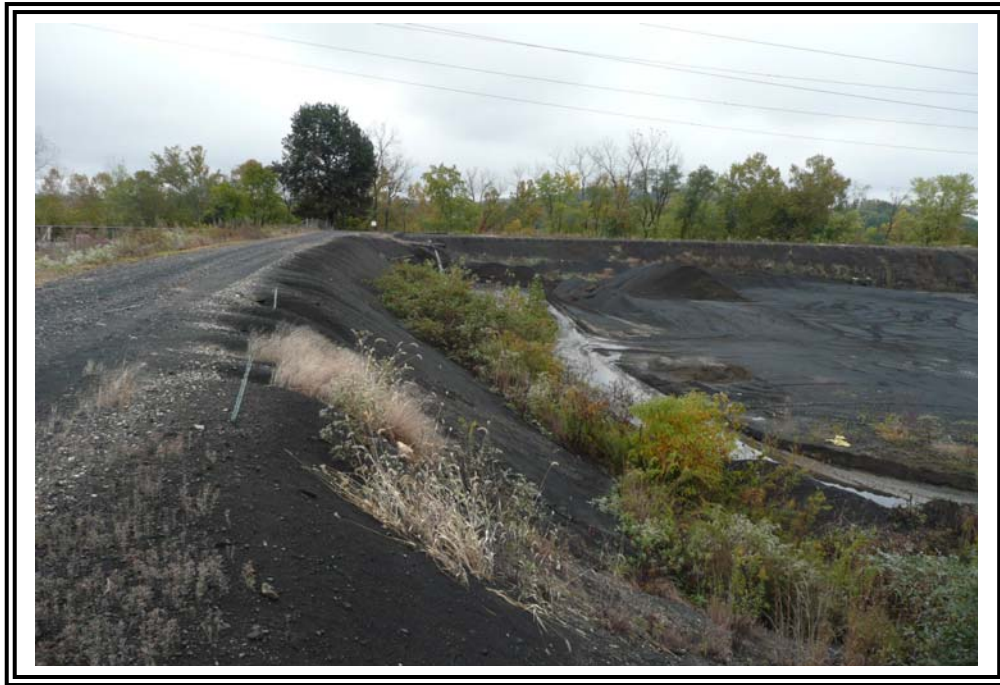
9

Interior slope and crest of north dike at northeast corner of pond, looking east. This area does not actively impound water.

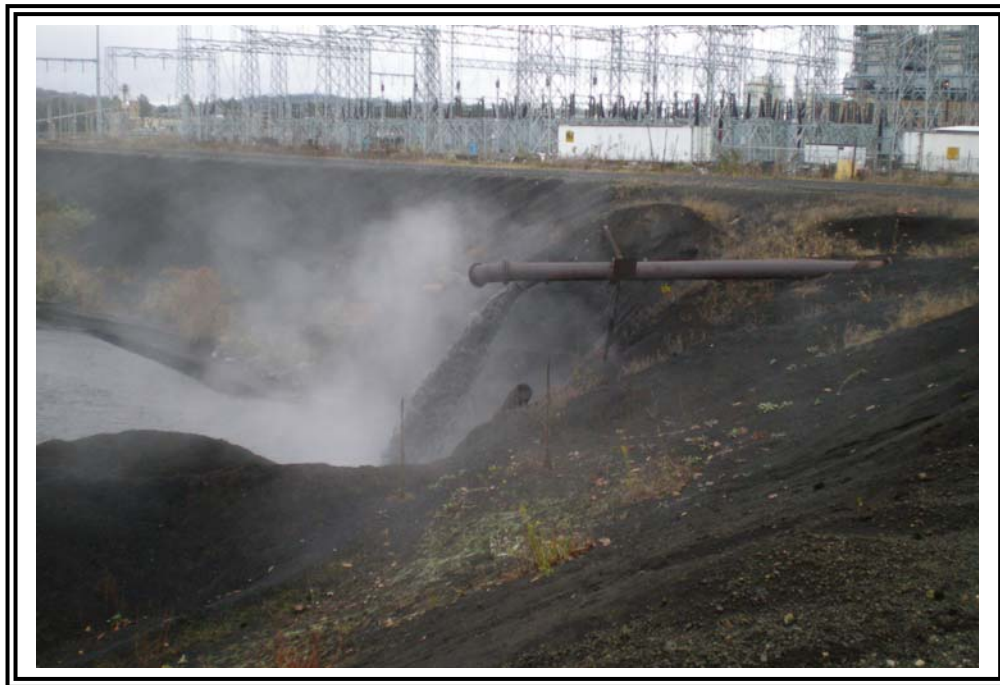
10

Sluice lines entering the Bottom Ash Pond in the northeast corner of the pond, facing northwest.

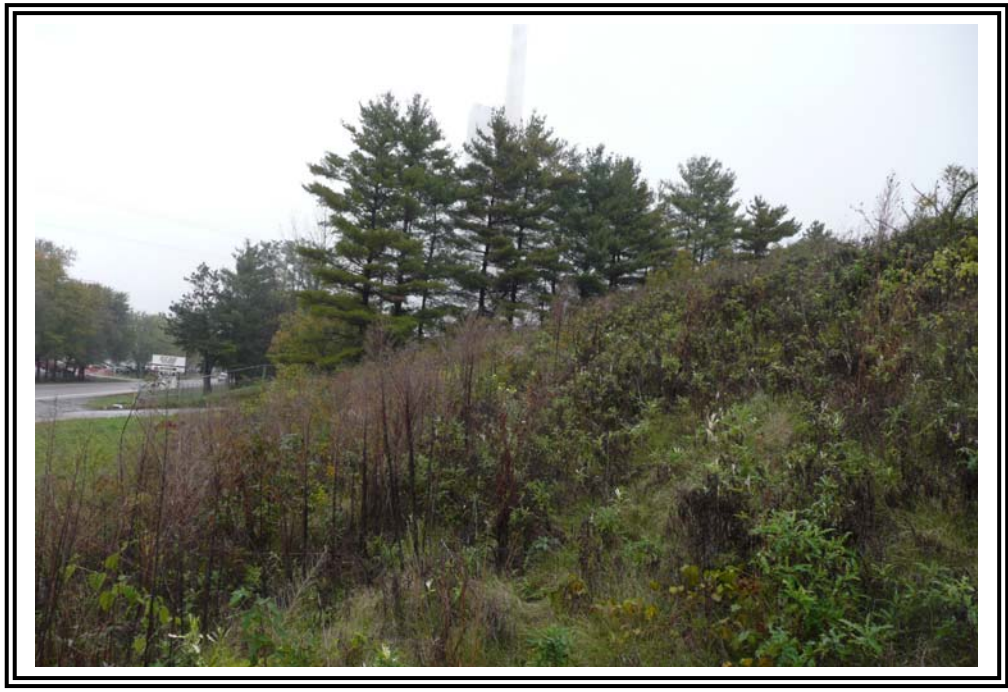
The crest and interior embankment slope of the west dike was observed to be gravel and bottom ash covered (Photo No. 15 and 16). The exterior embankment slope was noted to be moderately to heavily vegetated (Photo Nos. 13 and 14). Occasional erosion rills were observed in the interior embankment slope surface from concentrated stormwater runoff from the crest. The exterior embankment slope toe terminated at the State Route 7 right-of-way where a change in vegetation from field grasses, leafy weeds, and brush to maintained grass occurs (Photo No. 14). Probing in these areas revealed relatively firm conditions. Heavy vegetation, including isolated woody vegetation, present on the embankment slope at the time of the site assessment hindered

Exterior slope of west dike, looking north.

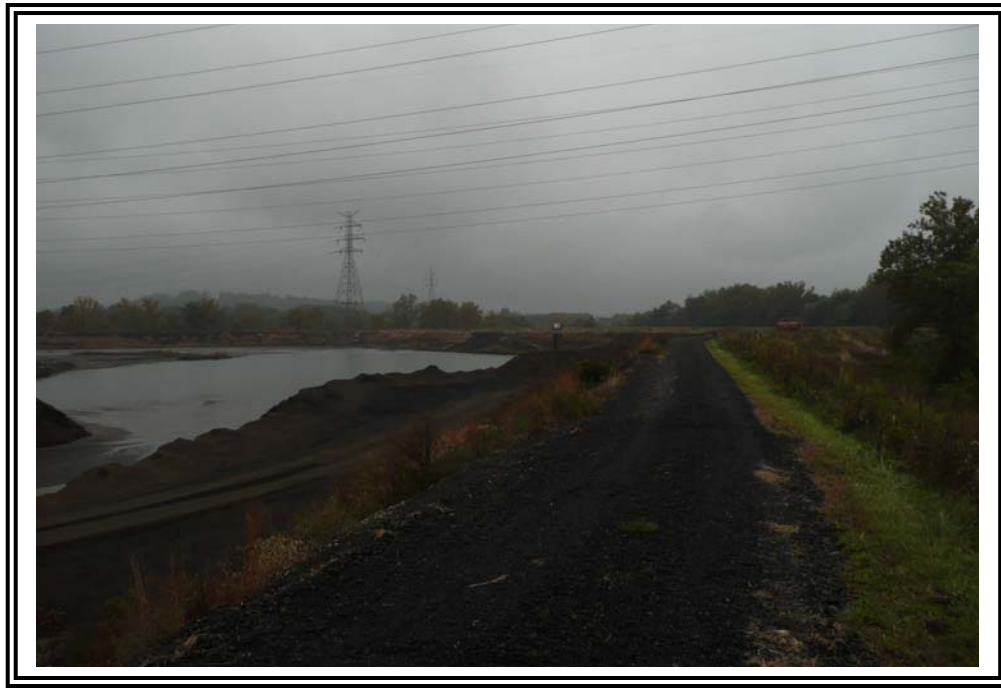
15

Crest of west dike, looking south. The separator dike forming the Clearwater Pond is visible in the distance.

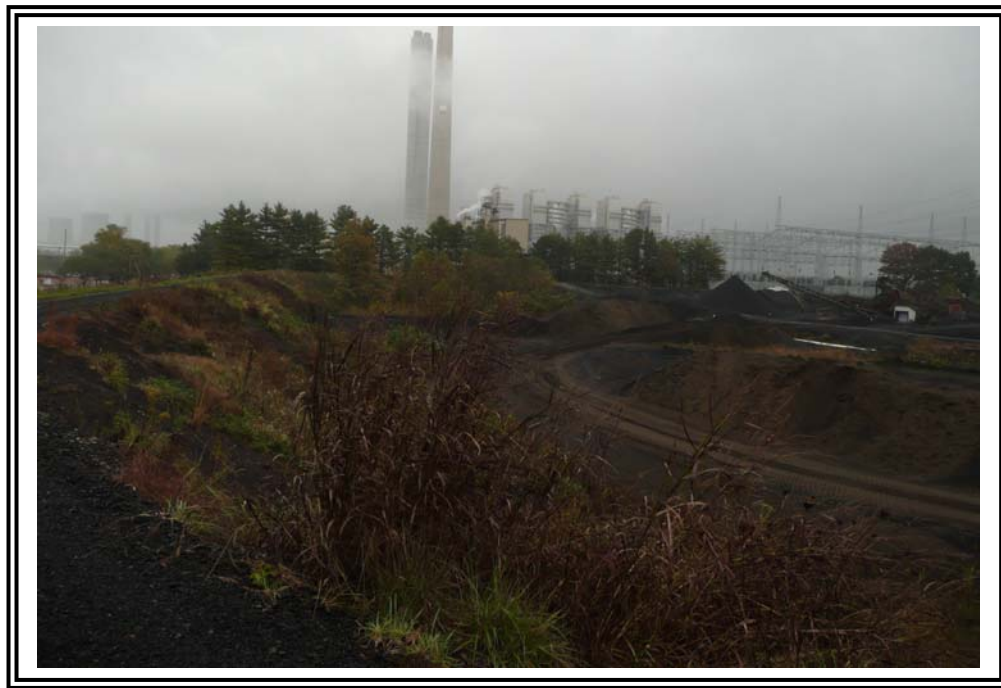
16

Interior slope of west dike and bottom ash processing area, looking north.

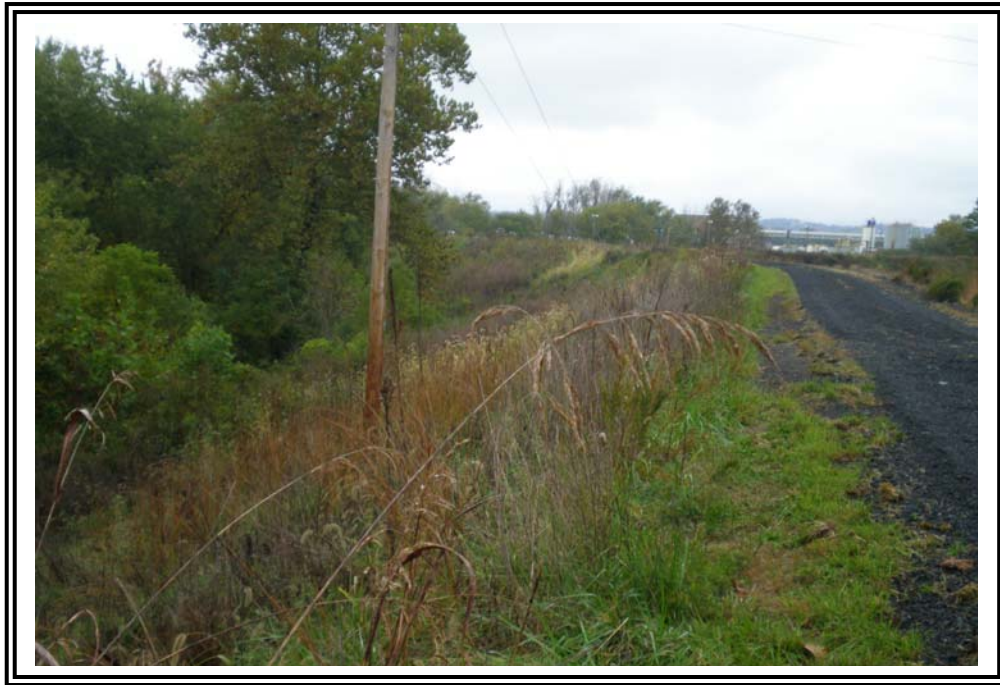
21

An access road runs the length of the crest of the south dike (Photo No. 21). The interior slope of this dike is generally vegetated with occasional erosion features observed (Photo No. 22). The exterior embankment was noted to be moderately vegetated for the top $\frac{1}{4}$ to $\frac{1}{3}$ portion of the slope and more heavily vegetated, with brush, bushes, and briars below this level, extending to the toe of the slope (Photo Nos. 20, 23, and 24). Smaller juvenile trees, about 3 to 5 inches in diameter, were observed in isolated areas of the heavy vegetation and larger, mature trees, about 24 to 30 inches in diameter, were observed near the toe of the slope along Kyger Creek (Photo Nos. 18). Several trees were observed to curve toward the dike crest and away from the creek (Photo Nos. 19). Loss of grass cover was observed on the exterior embankment slope (Photo Nos. 26 and 27) and an animal burrow was observed (Photo No. 17).

Exterior slope and crest of south dike, looking north.

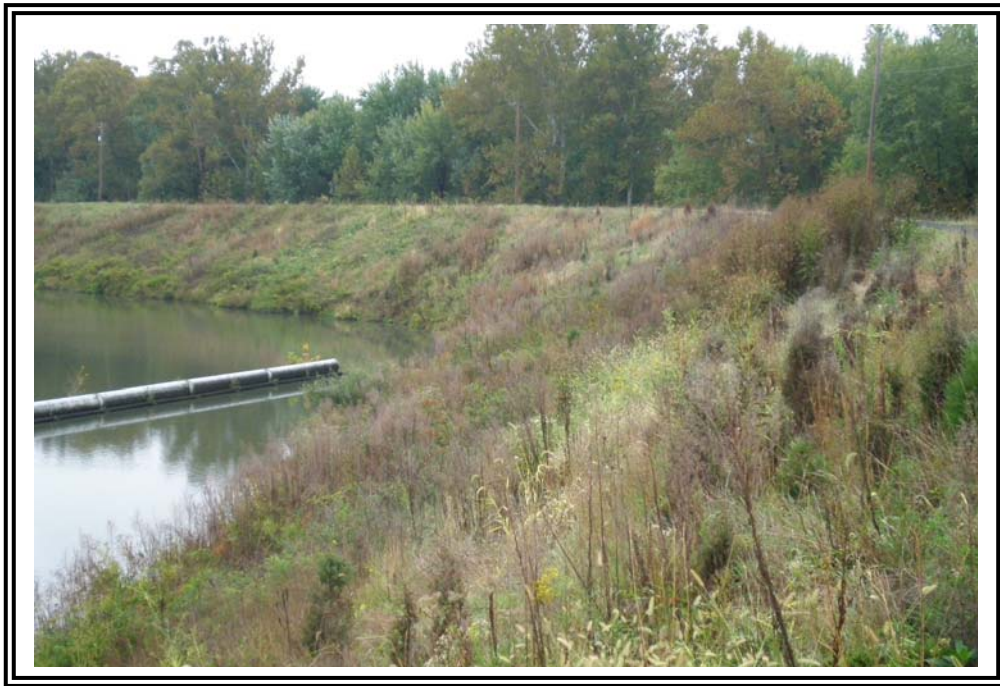
22

Interior slope of south dike, facing south.

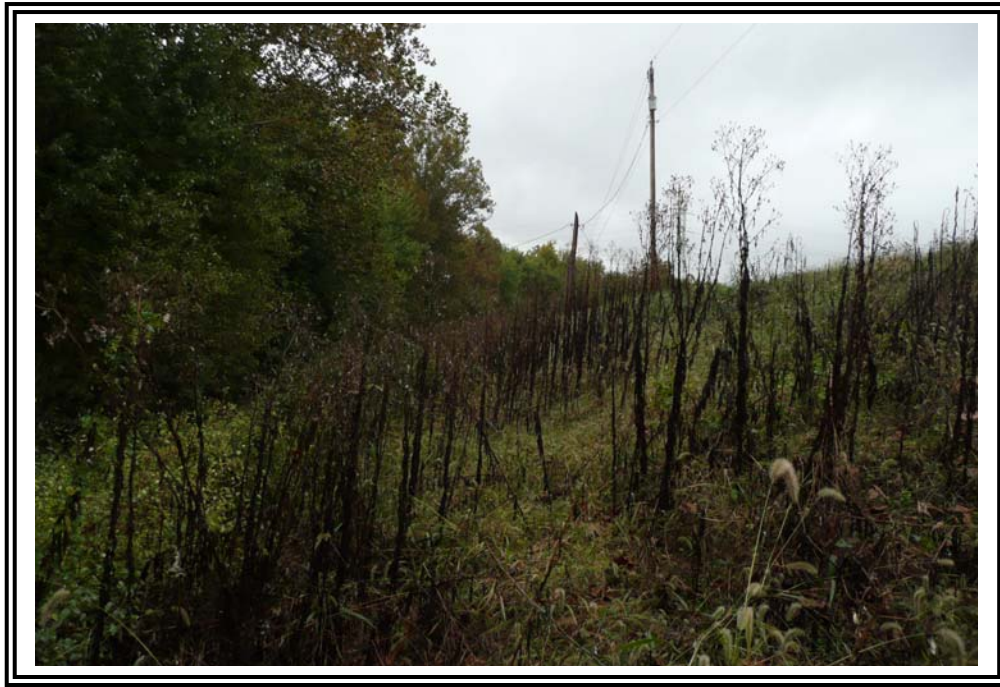
23

Exterior slope of south dike (Clearwater Pond section), looking west.

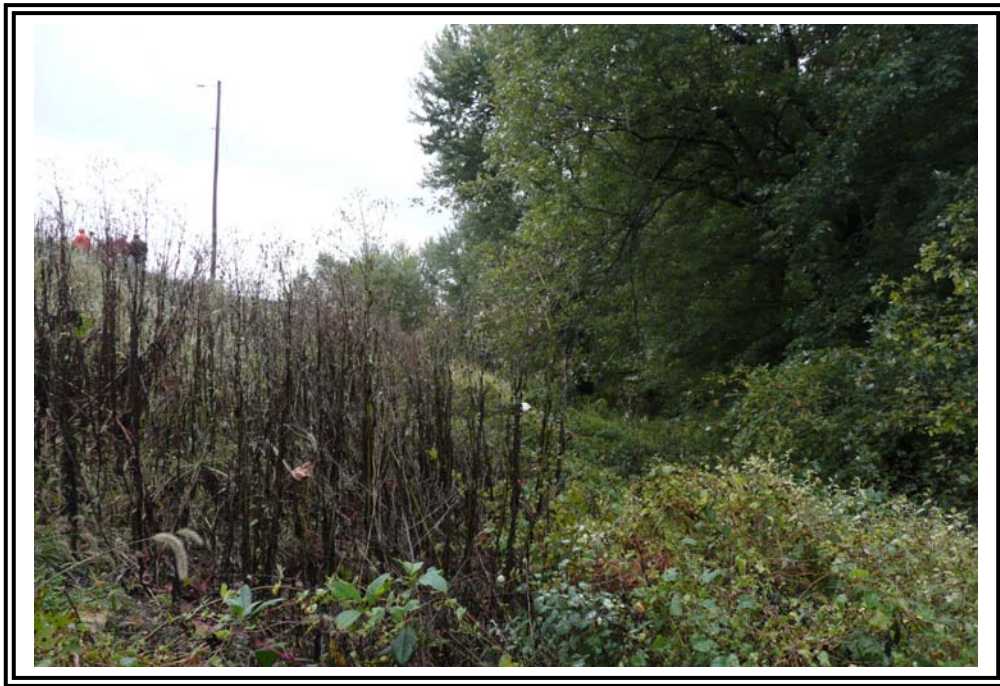
24

Exterior slope of south dike (Clearwater Pond section), looking east.

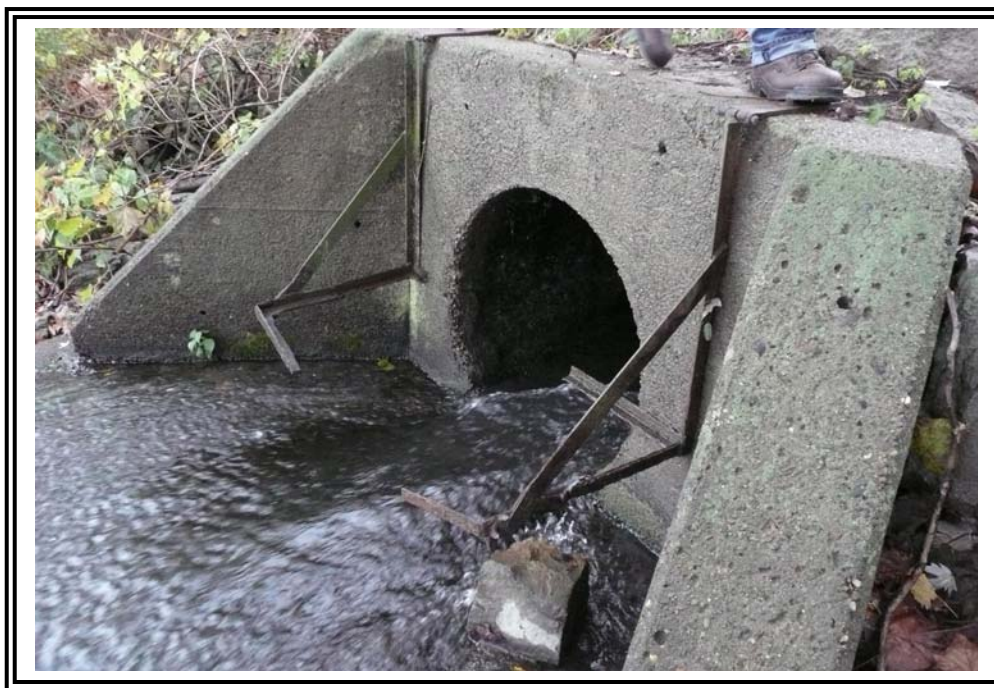
25

36-inch diameter Bottom Ash Pond outlet.

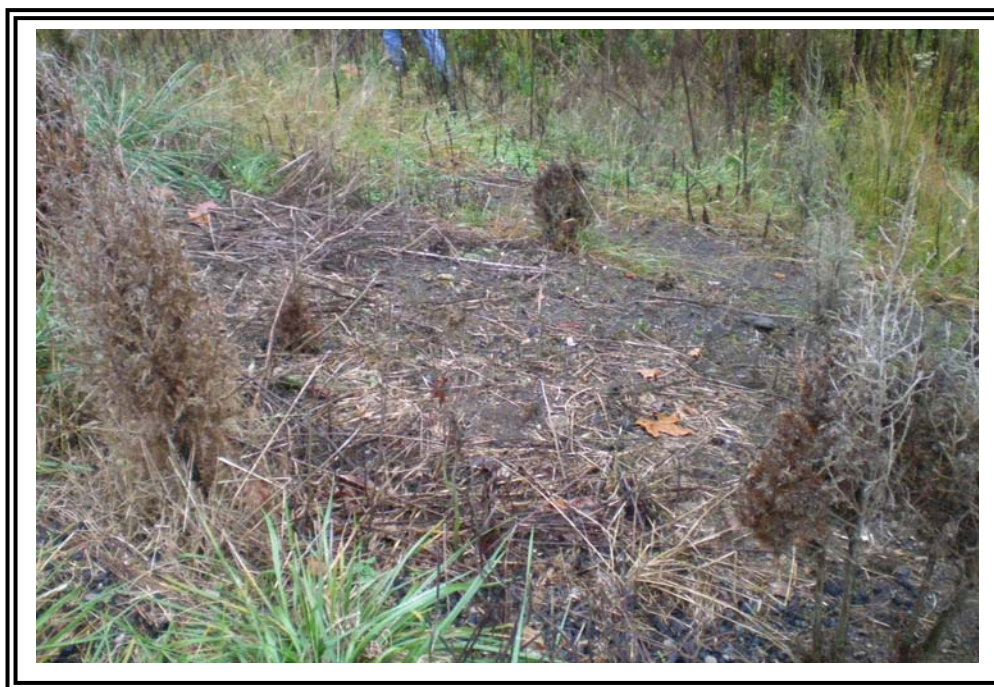
26

Loss of ground cover and some erosion of exterior slope of south dike.

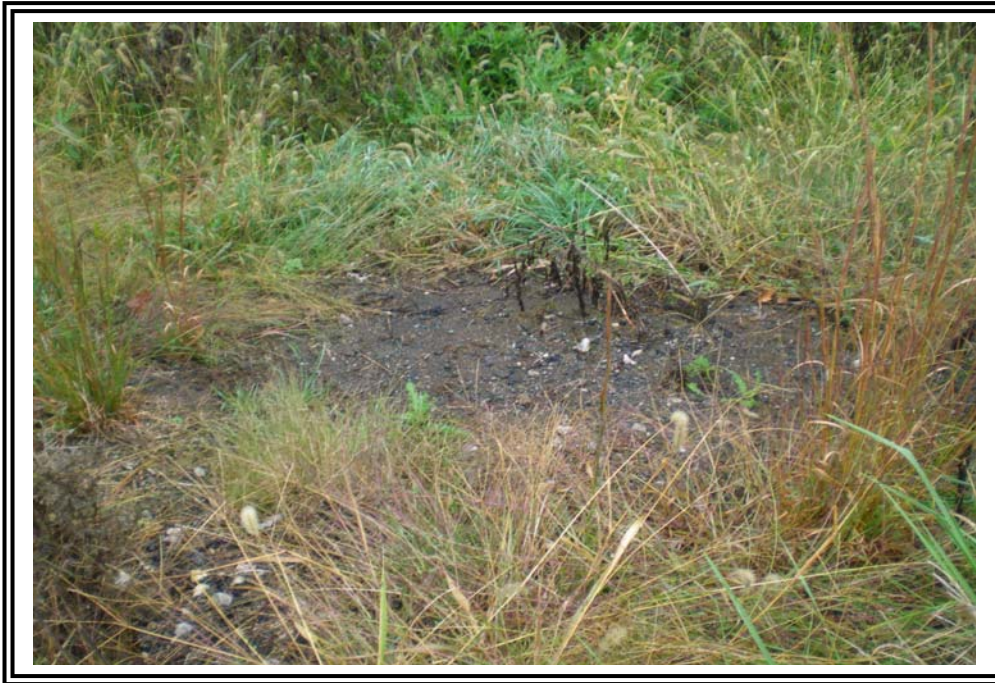
27

Loss of ground cover and some erosion of exterior slope of south dike.

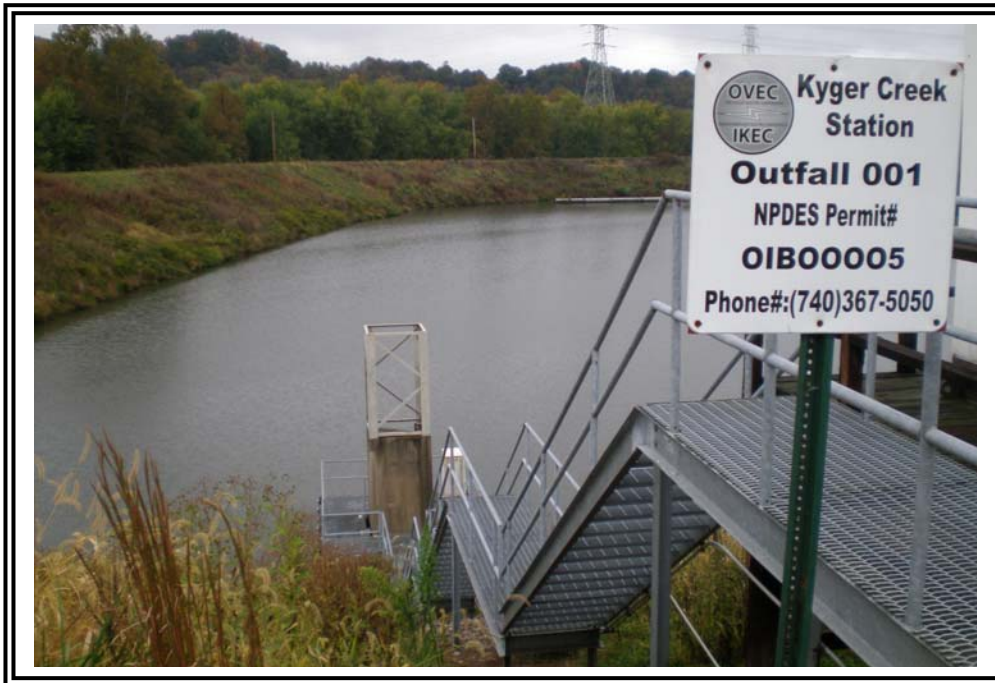
28

Clearwater Pond outfall structure.

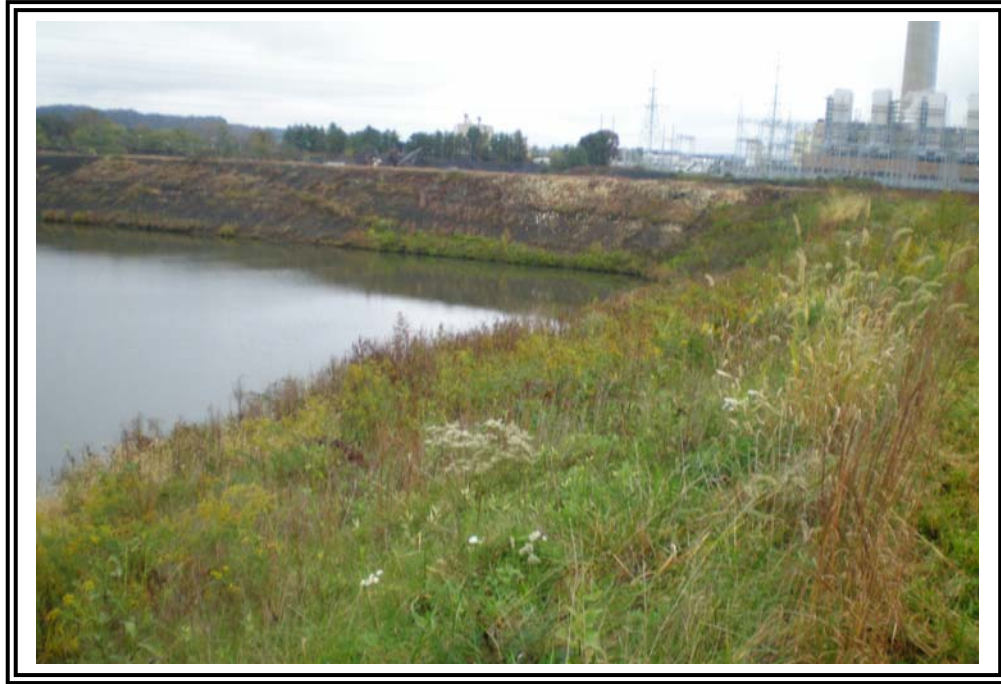
29

Interior slope of Clearwater Pond (south dike), looking northeast.

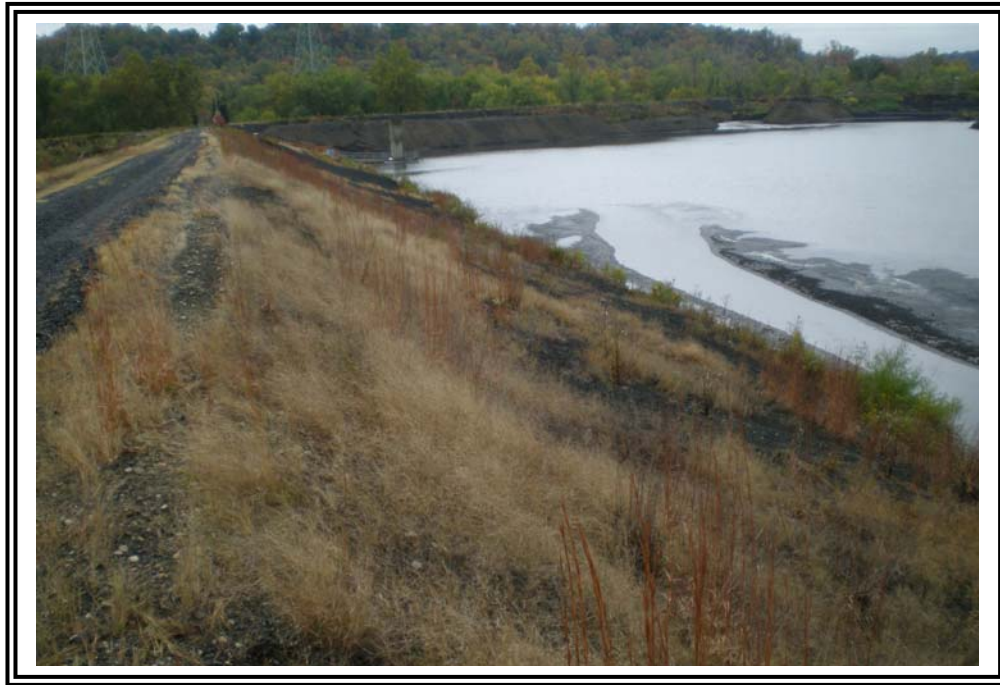
30

Crest of splitter dike and interior slope of Bottom Ash Pond, looking north.

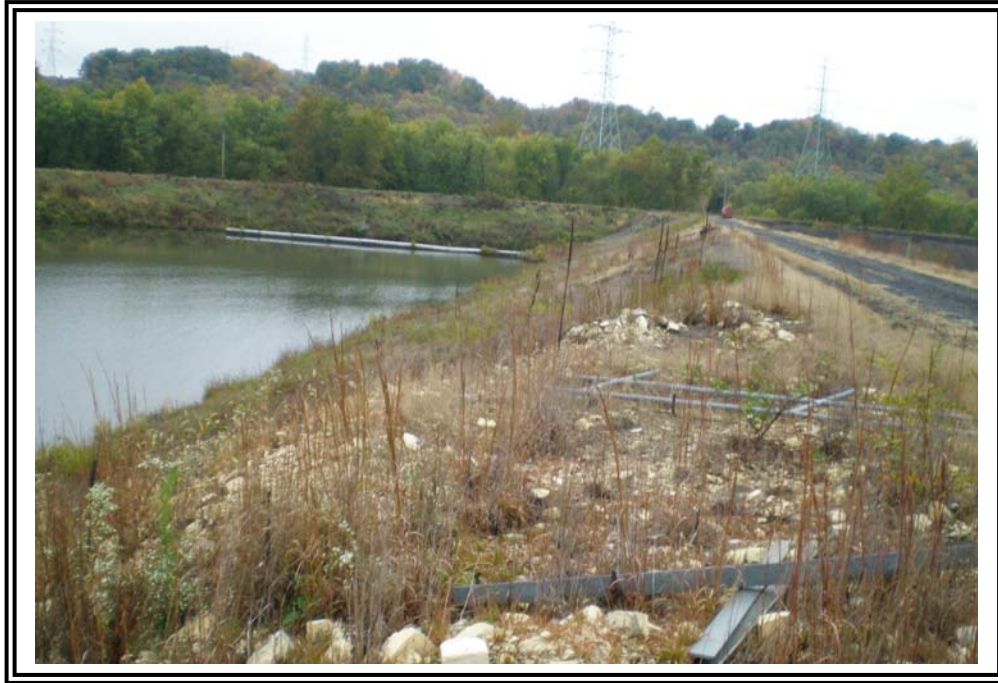
31

Crest of splitter dike and interior slope of Clearwater Pond, looking north.

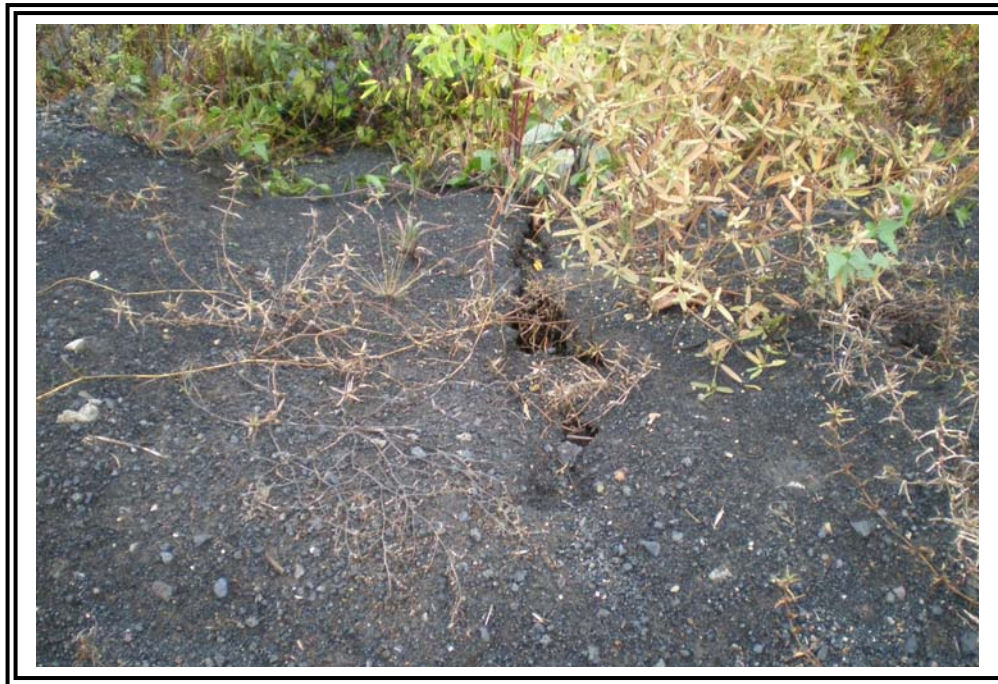
32

The crest of the separator dike was measured to be approximately 31 feet wide, which is about 10 feet wider than shown in the original site drawings. The embankments of the separator dike are generally covered with granular material and are sparsely vegetated (Photo Nos. 29, 30, and 31). Erosion features were observed on the embankment slopes (Photo No. 32).

Crest of splitter dike and interior slope of Bottom Ash Pond, looking north.

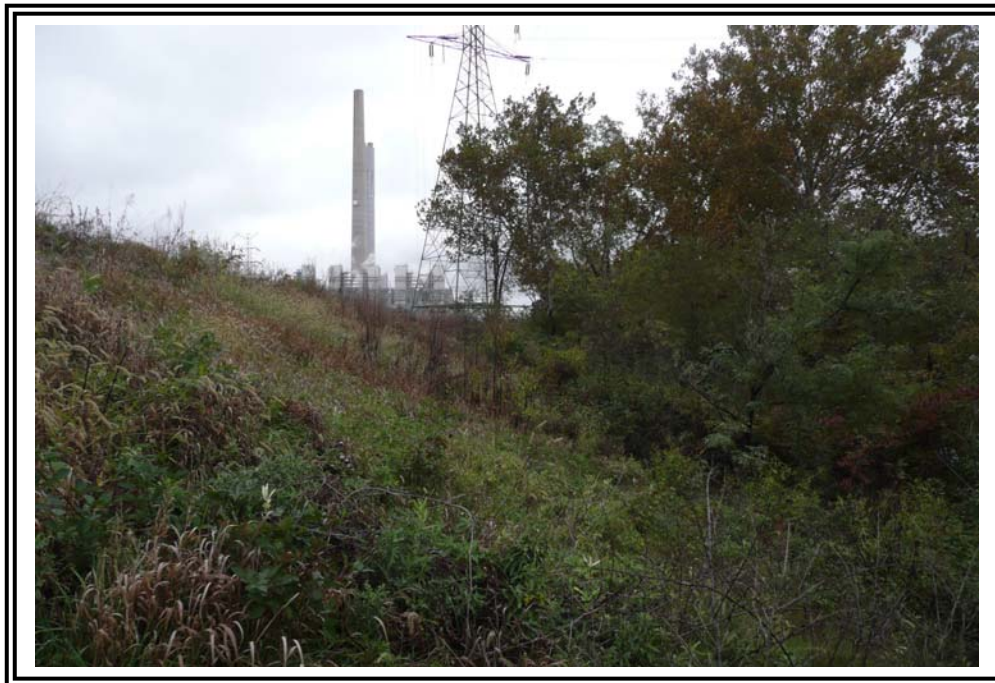
34

Exterior slope of east dike (Clearwater Pond section), looking north.

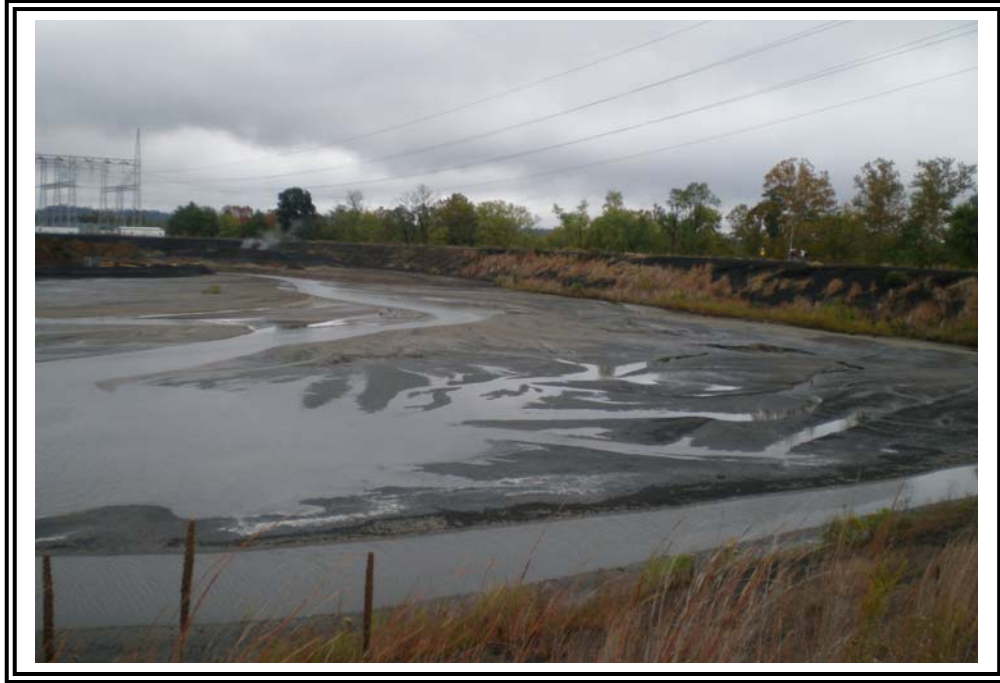
35

The east dike runs parallel to the Ohio River (Photo No. 38). The interior embankment slope is generally covered with granular material and sparsely vegetated with occasional erosion features (Photo No. 35, 39, and 41). Areas were observed where erosion and undercutting of bottom ash material at the crest has occurred where it appears to have been over built due to grading activities (Photo No. 40). The exterior embankment slope was observed to be moderately vegetated along the top $\frac{1}{4}$ to $\frac{1}{3}$ portion of the slope and more heavily vegetated, with brush, bushes, briars and trees, nearer to the toe (Photo No. 34, 36, and 37). Mature trees, approximately 24 to 30 inches in diameter, were observed near the toe along the Ohio River. There was an area of exposed slope where there has been a loss of vegetation cover and erosion rills have developed (Photo Nos. 41 and 42).

Looking west across Bottom Ash Pond at the east dike.

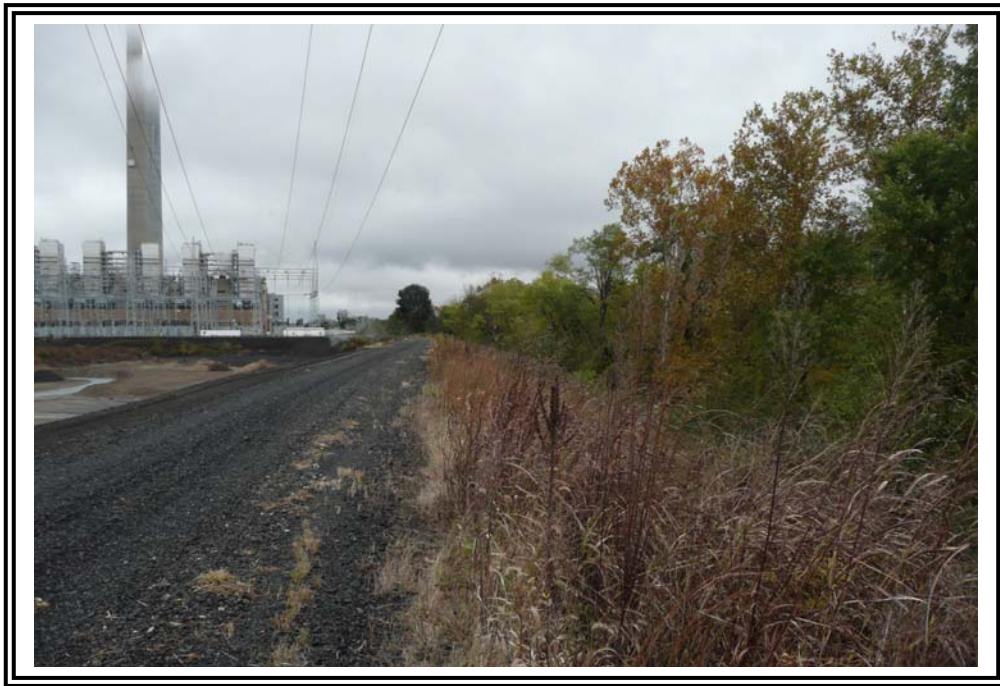
38

East dike crest and exterior slope, looking north.

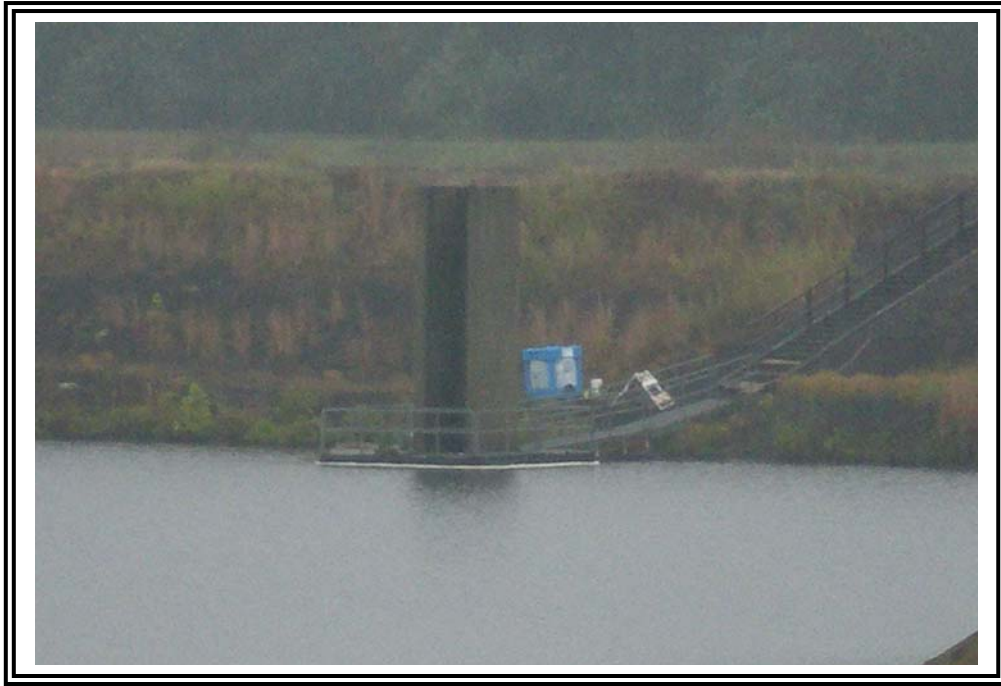
43

Overflow structure, looking south.

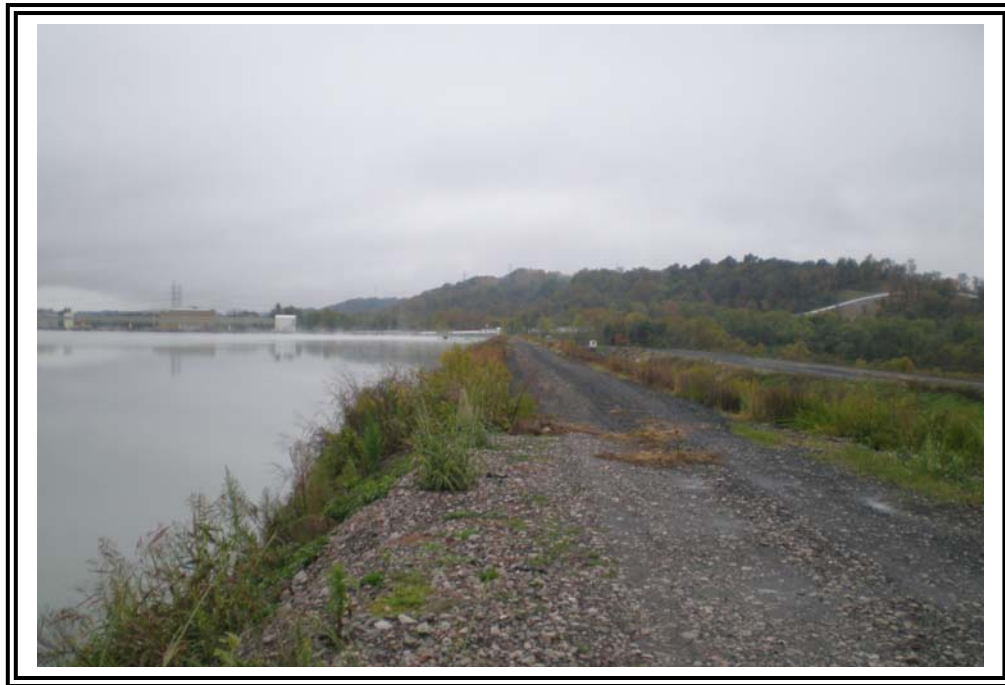
44

West dike crest and interior slope, looking south.

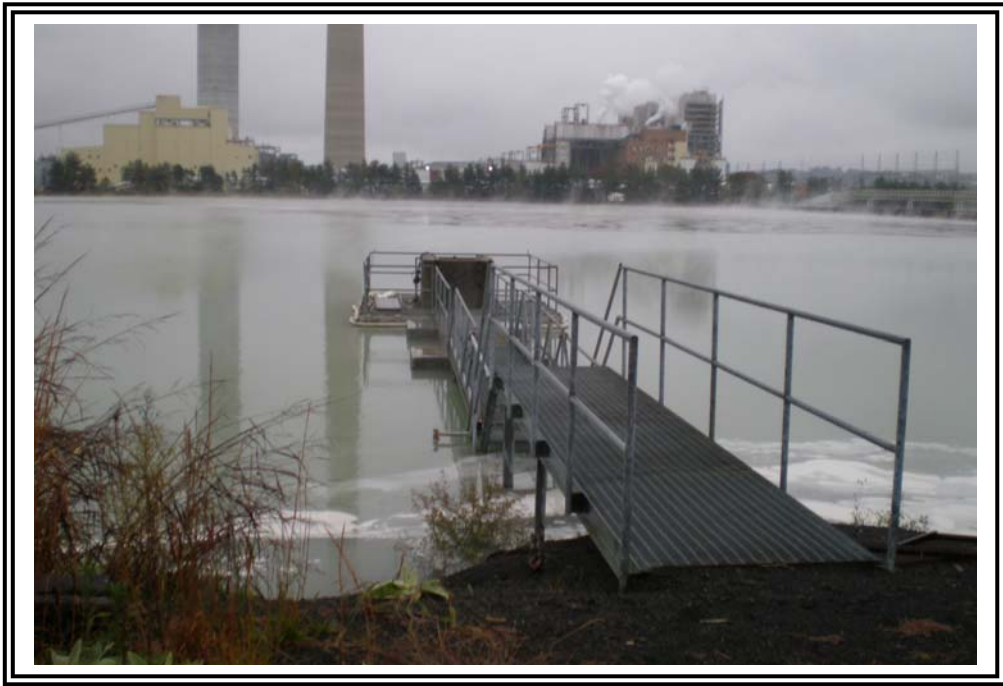
47

South Fly Ash Pond outlet structure, looking southeast.

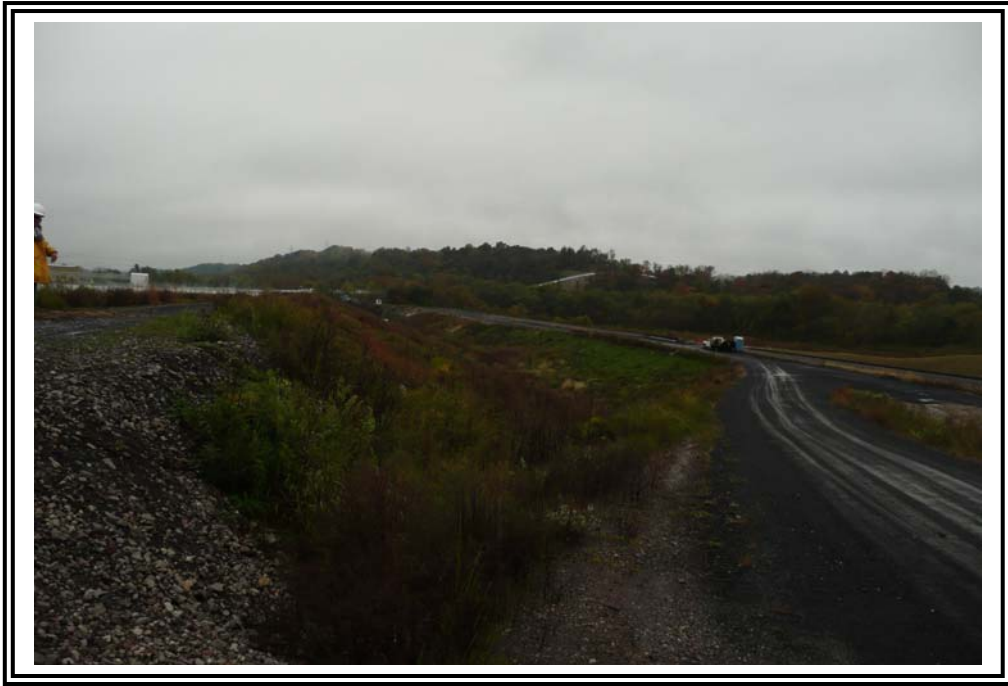
48

West dike exterior slope, looking south.

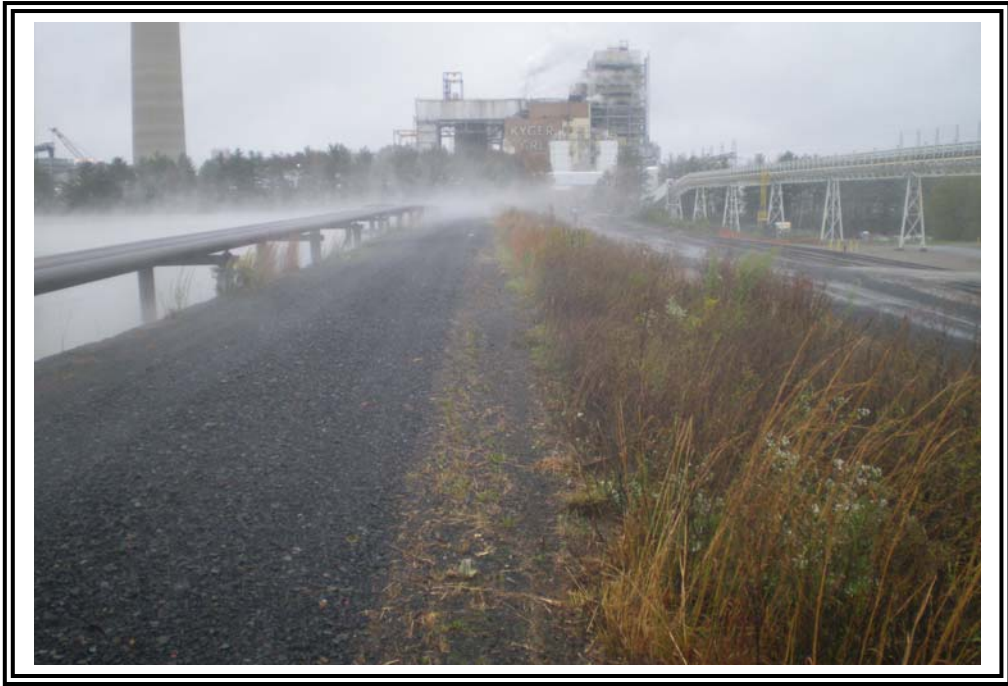
56

South dike crest, facing southeast.

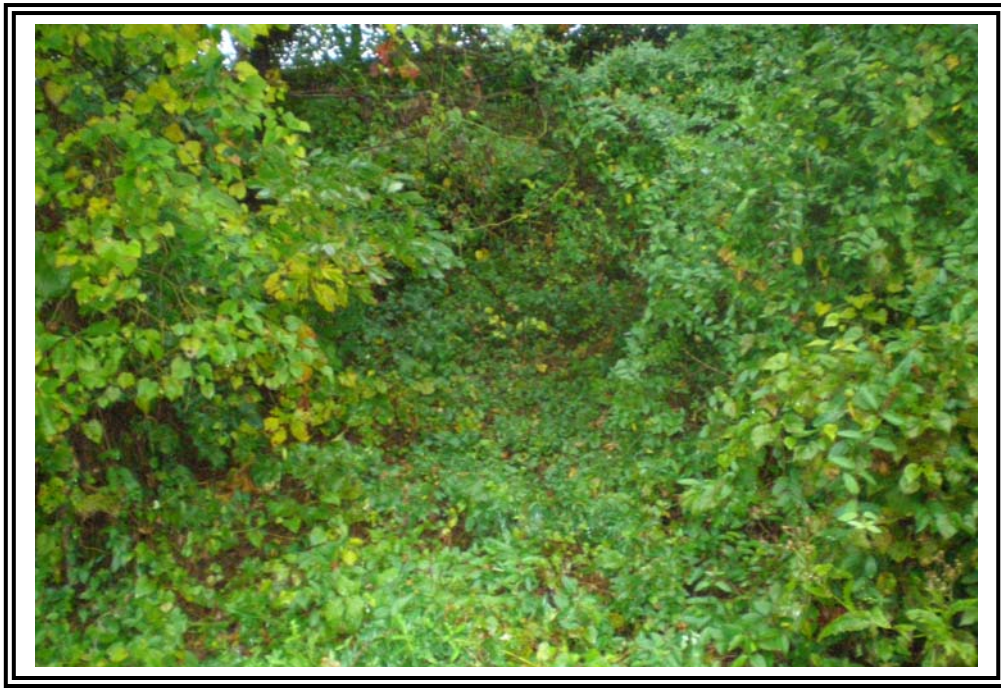
62

Looking west from the toe of the east dike towards the crest of the dike along the exterior slope.
