Assessment of Dam Safety of Coal Combustion Surface Impoundments (Task 3) Draft Report

Ohio Valley
Electric Corporation

Kyger Creek Power Station

December 9, 2009

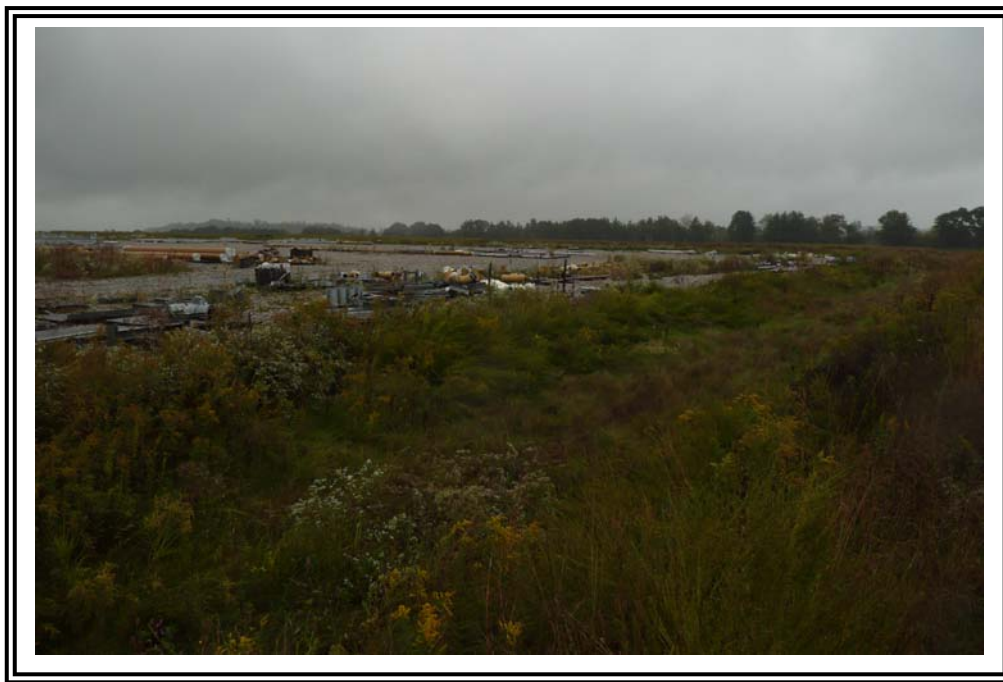
65

Looking northeast across the closed and capped North Fly Ash Pond.

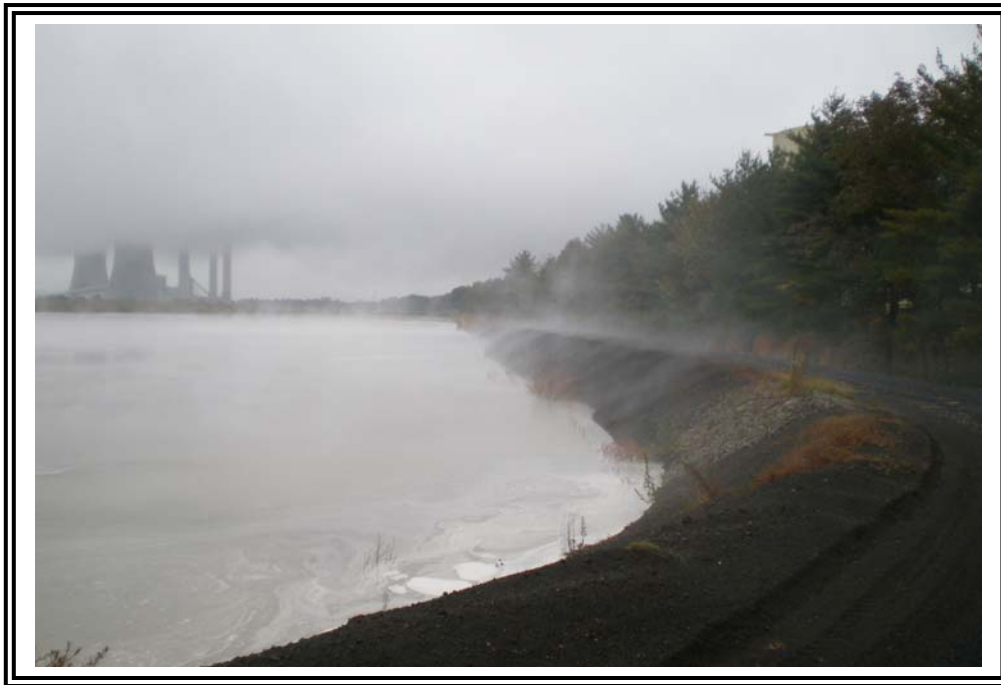
66

Interior slope of east dike, facing northeast.

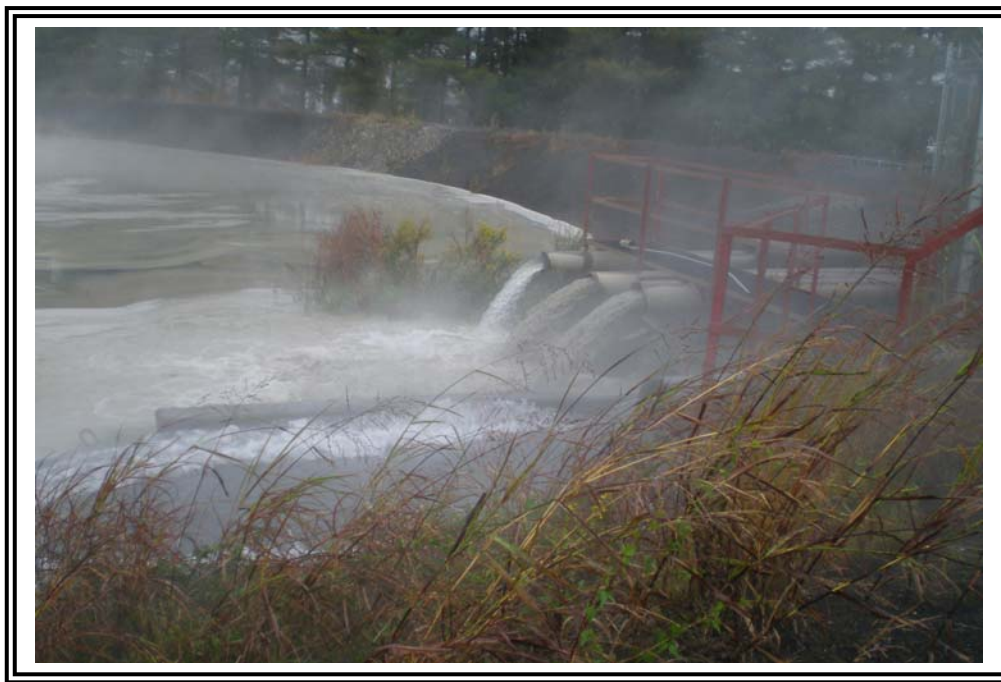
67

Sluice lines entering the South Fly Ash Pond at the southeast corner of the pond, facing east.

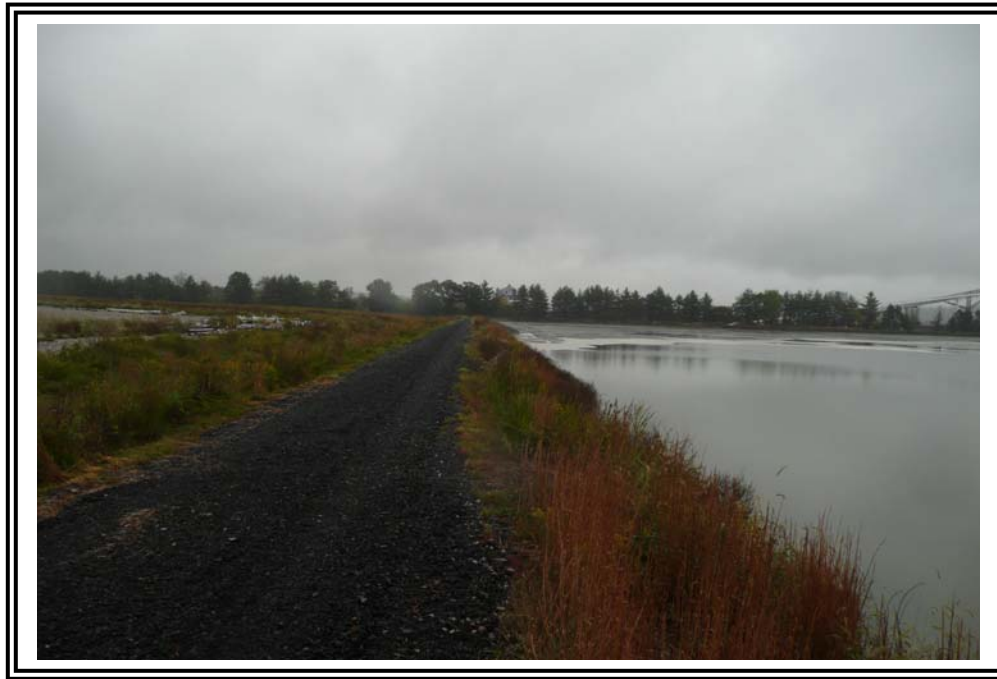
68

Crest and interior slope of north dike, looking east. Slope is covered with bottom ash and vegetation.

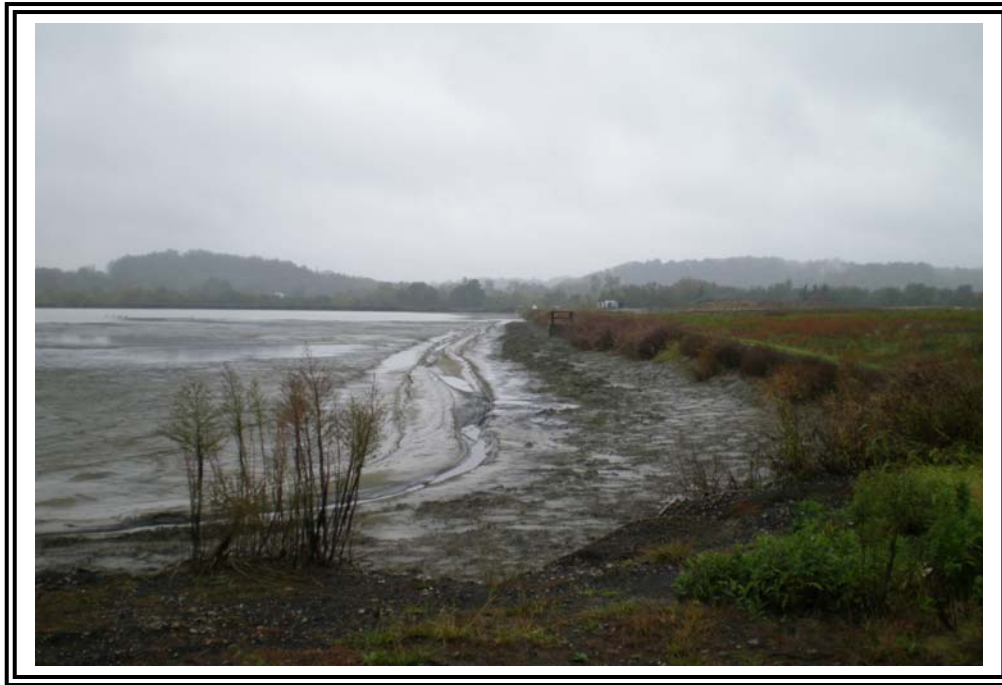
70

Interior slope of north dike, looking northwest.

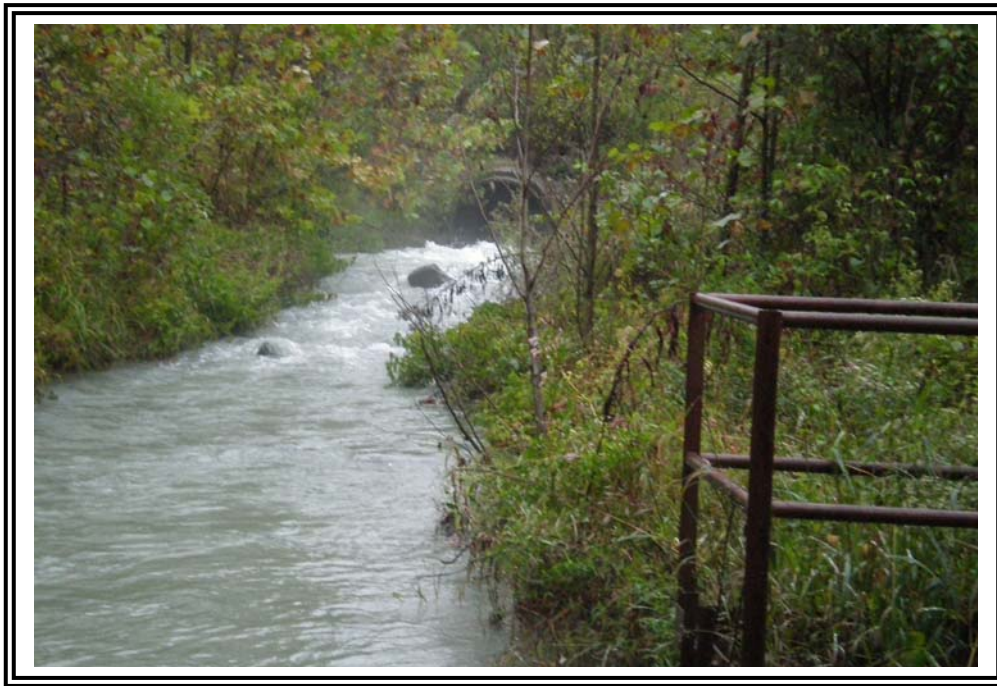
71

Outfall, facing north.

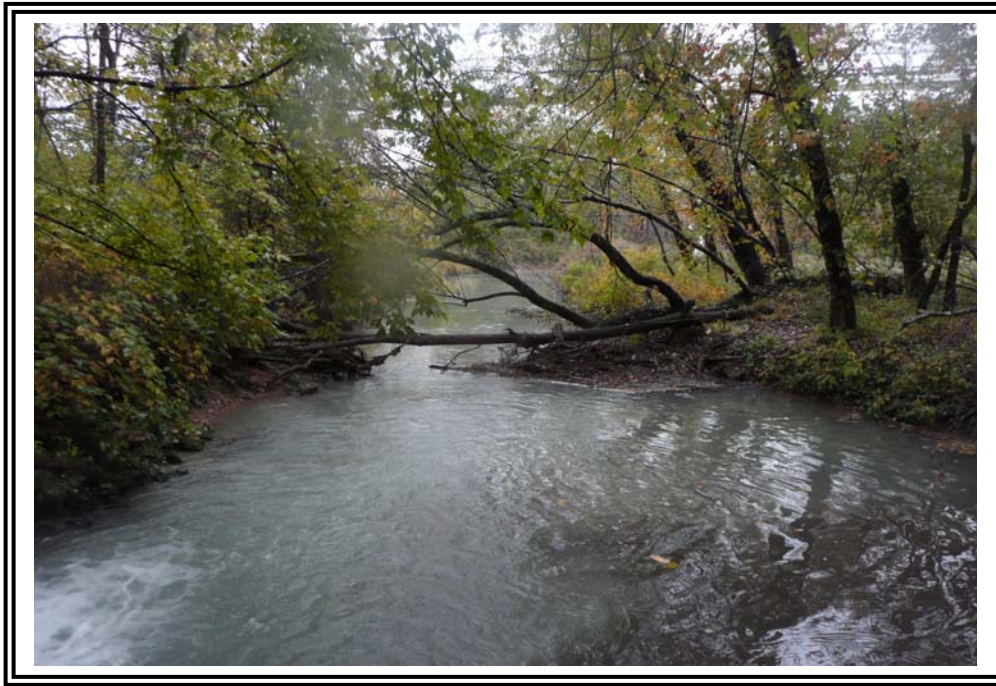
72

Confluence of the South Fly Ash Pond effluent (left) and Kyger Creek (right).
