Assessment of Dam Safety Coal Combustion Surface Impoundments (Task 3) Final Report

Progress Energy
Carolinas
Cape Fear Plant

Moncure, North Carolina

September 14, 2009

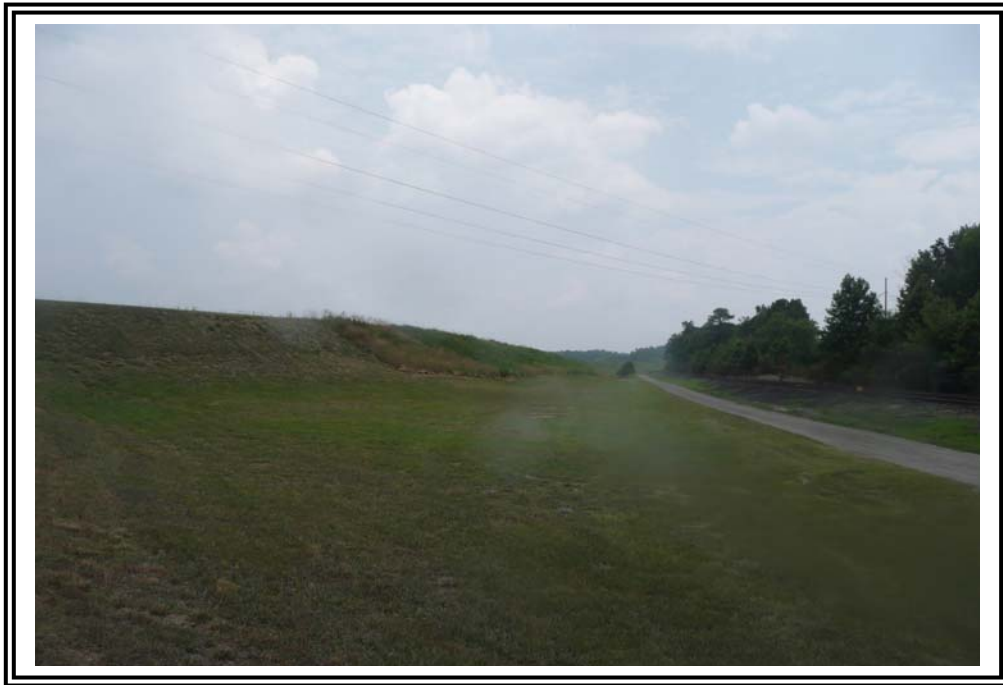
1

Northwest end of 1985 Ash Pond West Dike, looking southeast.

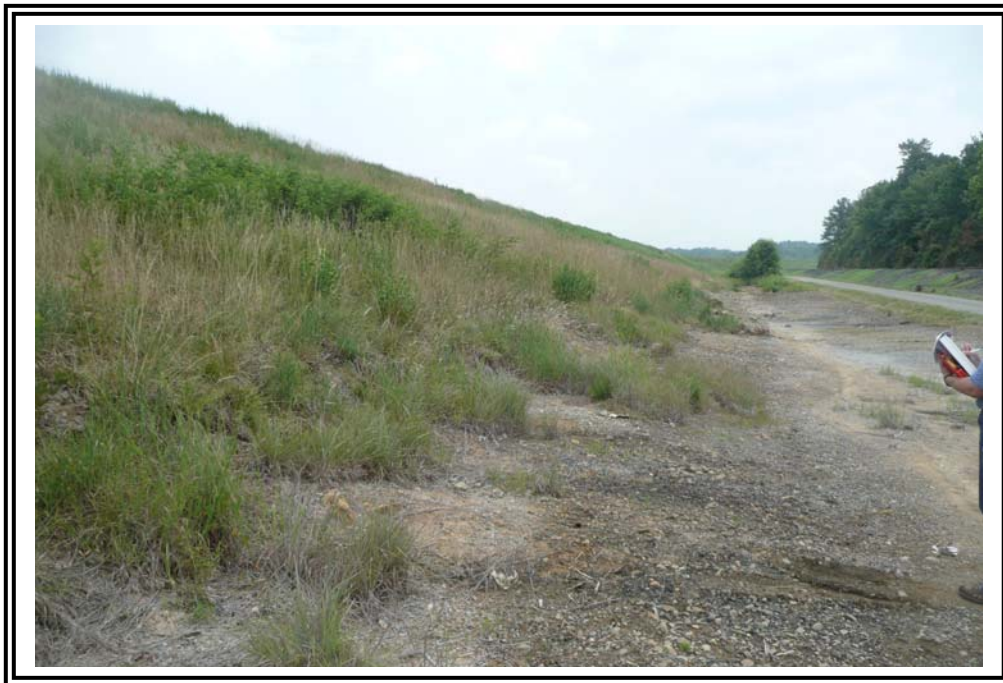
2

1985 Ash Pond West Dike toe along the northern portion of Dike.

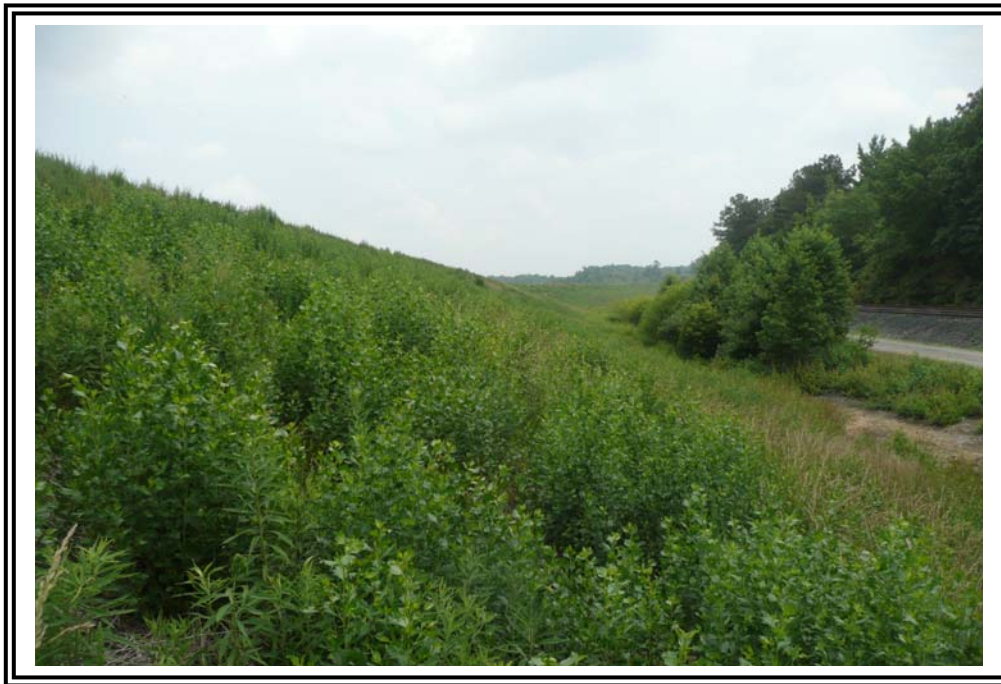
4

1985 Ash Pond West Dike approaching bend, looking southeast.

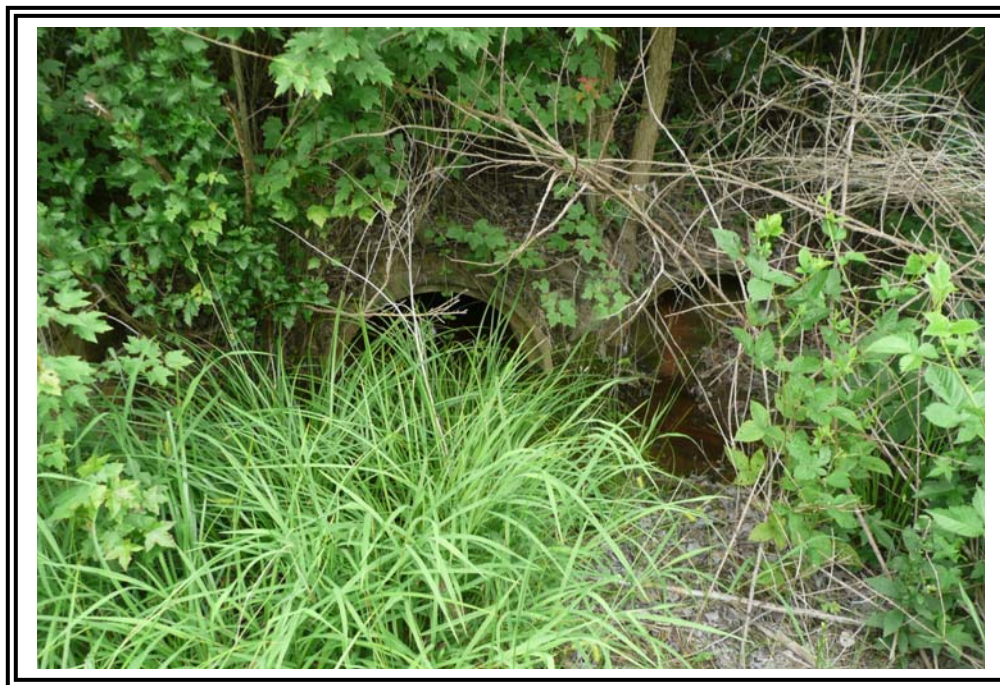
6

Double culvert under railroad spur for ditch line along West Dike of 1985 Ash Pond.

Along the west dike of the 1985 Ash Pond, an area of ponded water occurs between the toe of the dike and the access road. While there is a twin culvert extending below the access road and railroad tracks, it appears from evidence of the depth of ponding and erosion from this ponding observed during CHA's visit, that the capacity and or pitch of these culverts is inadequate to drain the area. The result of the standing water is not only the softening exhibited in Photos 8 and 9 but beaching erosion resulting in toe loss as shown in Photo 3.

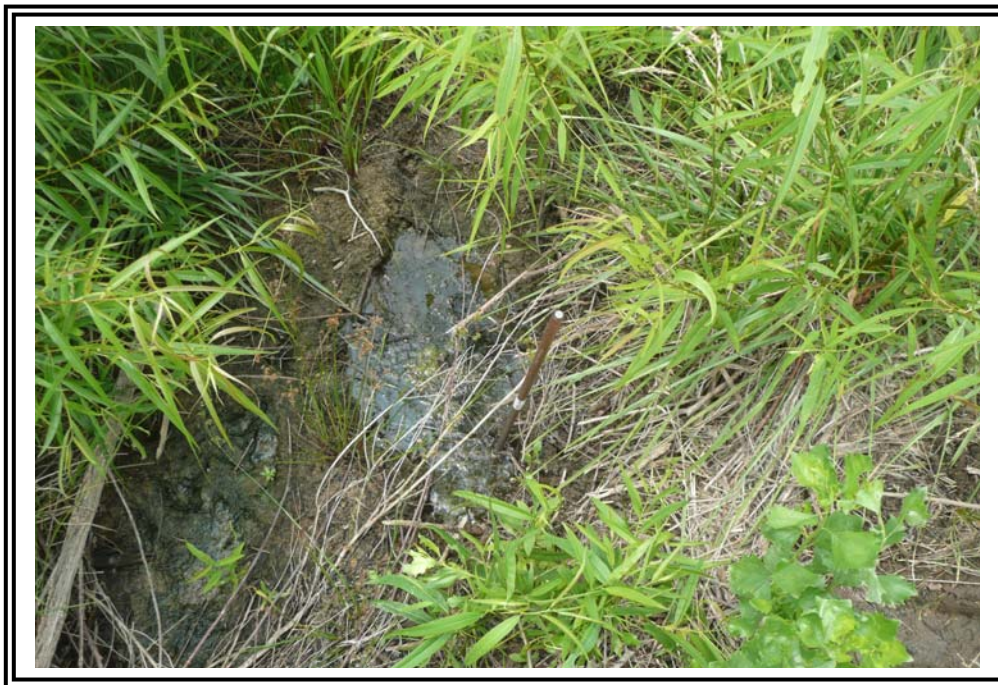
9

Possible seepage at the toe of the 1985 Ash Pond West Dike.

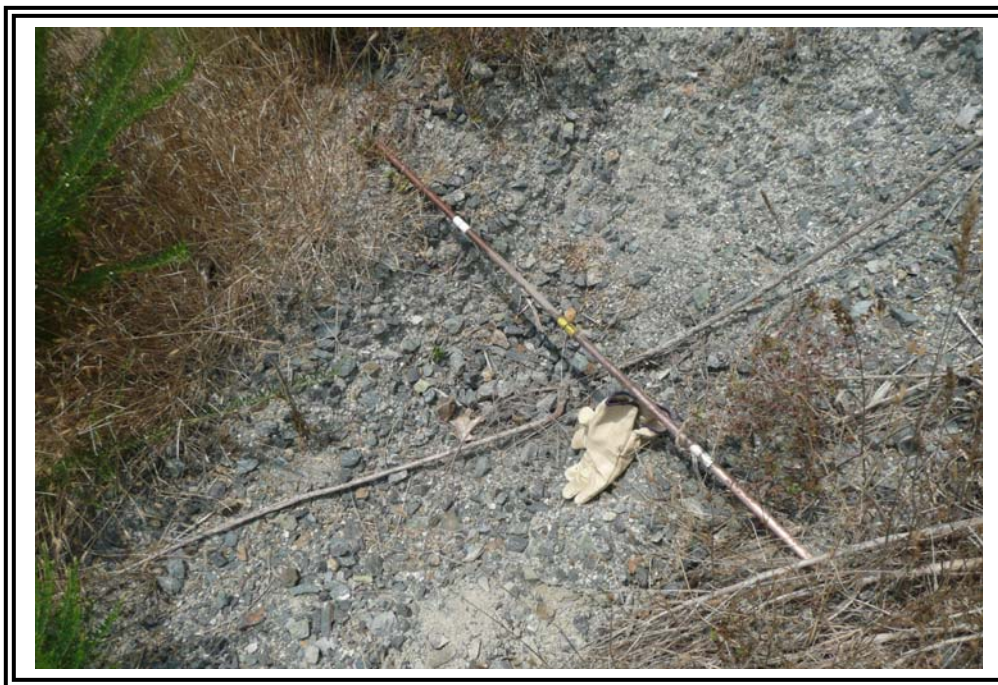
12

Stone filled erosion and /or abandoned rodent hole on the 1985 Ash Pond West Dike.
Progress Energy reports filling rodent holes and erosion features with gravel.

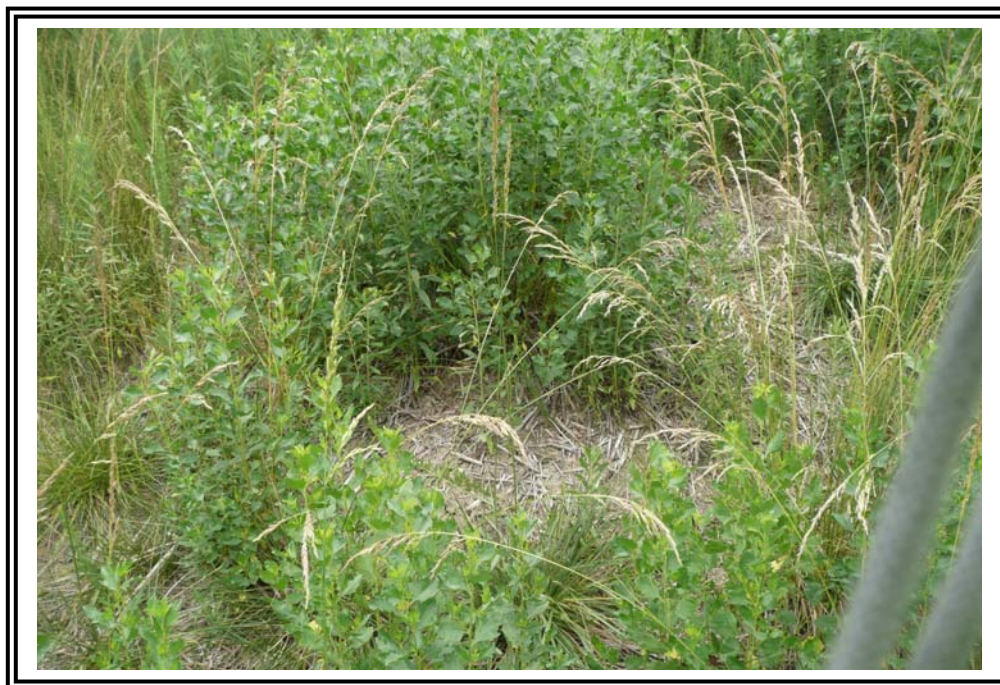
11

Sparse and weedy vegetation cover on the 1985 Ash Pond West Dike.

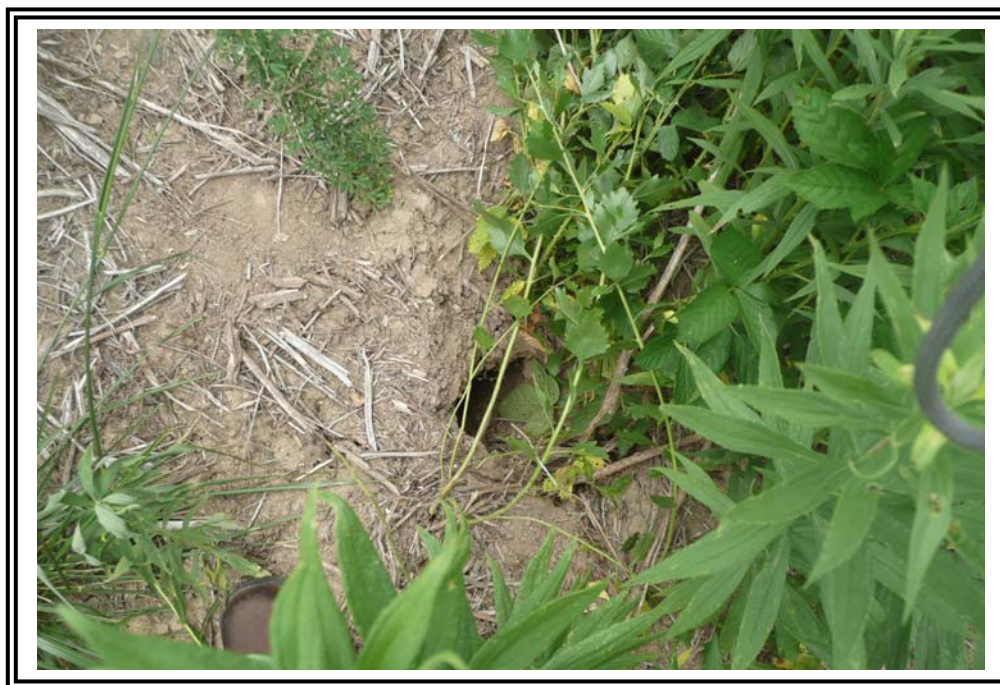
Rodent hole on the 1985 Ash Pond West Dike.

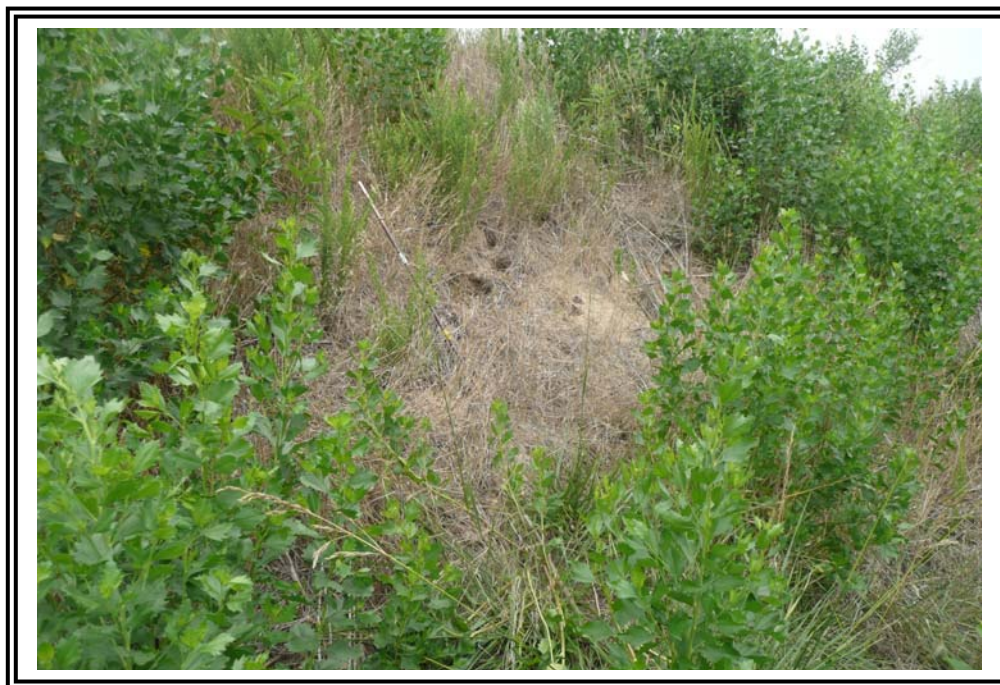
13

Scarp about 3 to 4 feet high near the top of the 1985 Ash Pond West Dike.

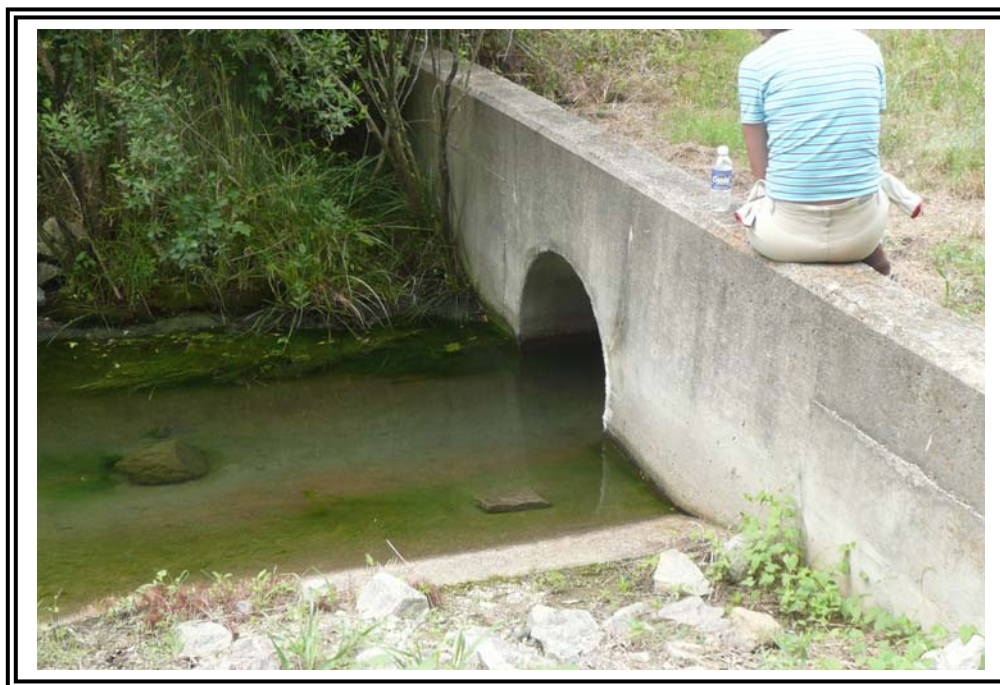
14

Culvert under the access road at the toe of the 1985 Ash Pond West Dike outlet channel.

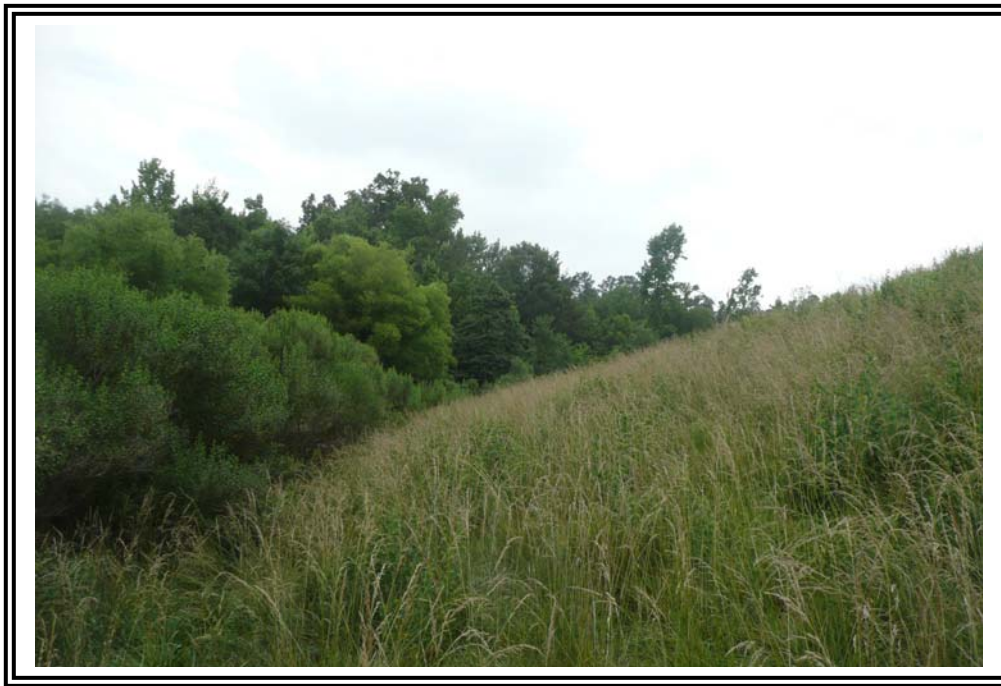
16

Southeast corner of the 1985 Ash Pond Dike, looking southwest.

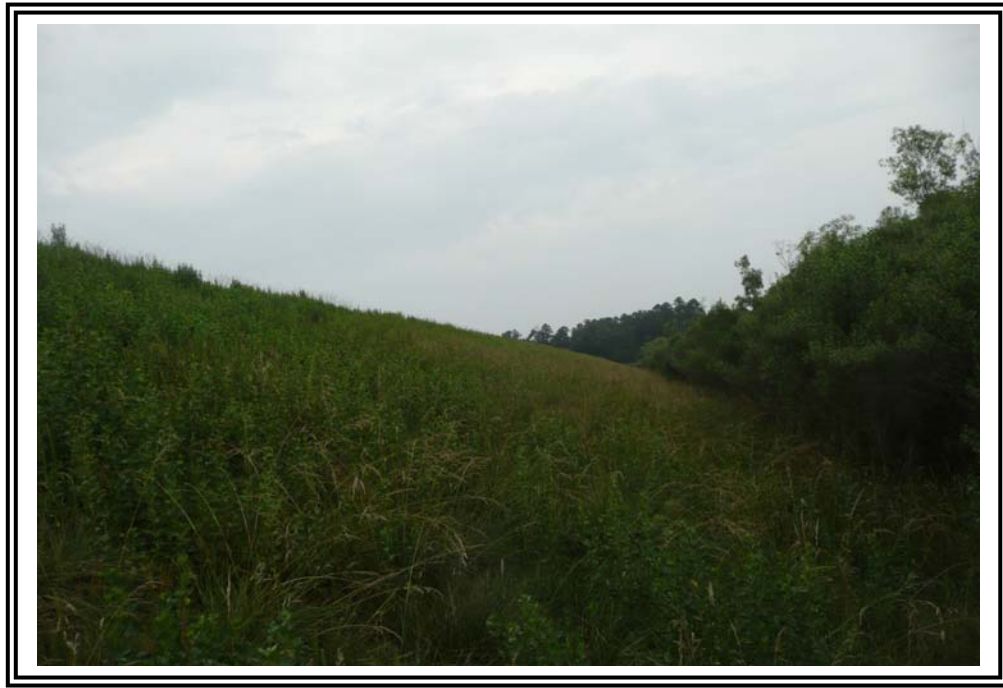
17

South Dike of the 1985 Ash Pond, looking northeast.

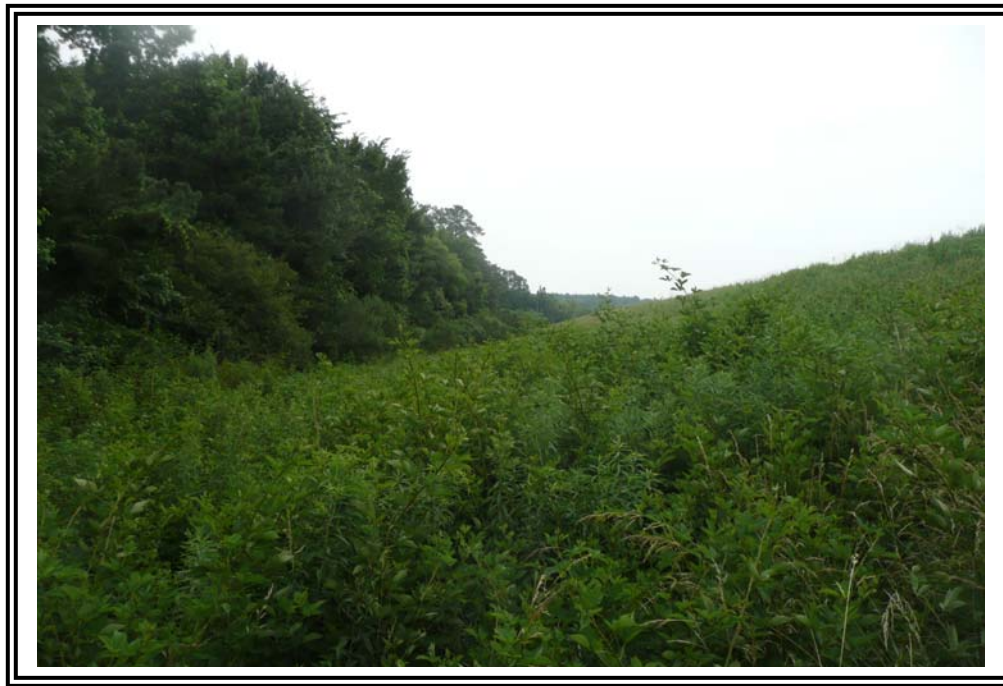
18

East Dike of the 1985 Ash Pond, looking south.

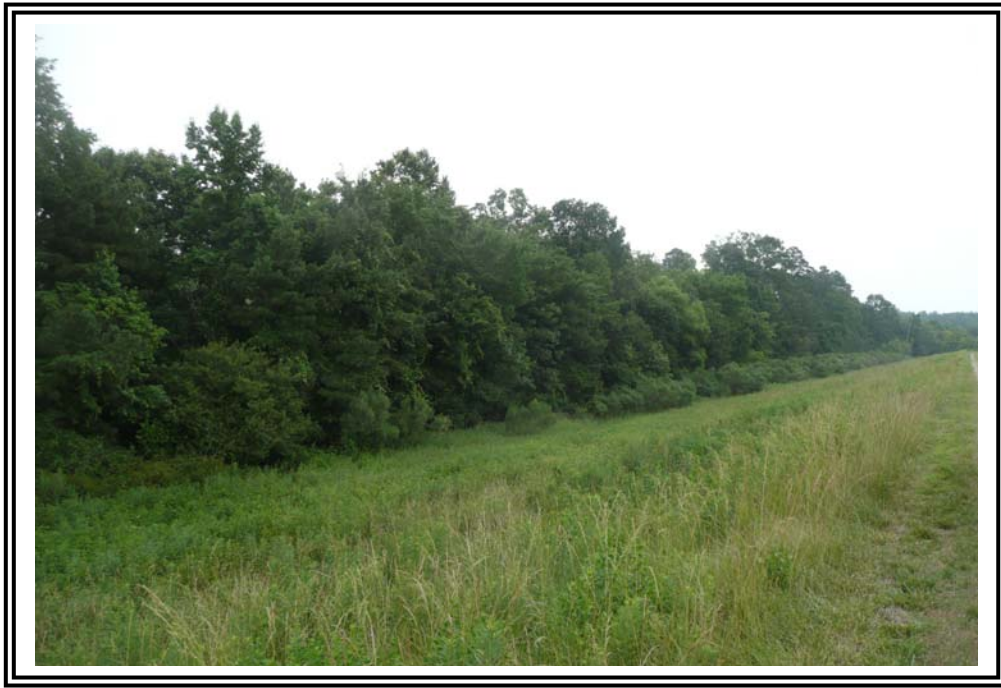
19

East Dike of the 1985 Ash Pond, looking southeast.

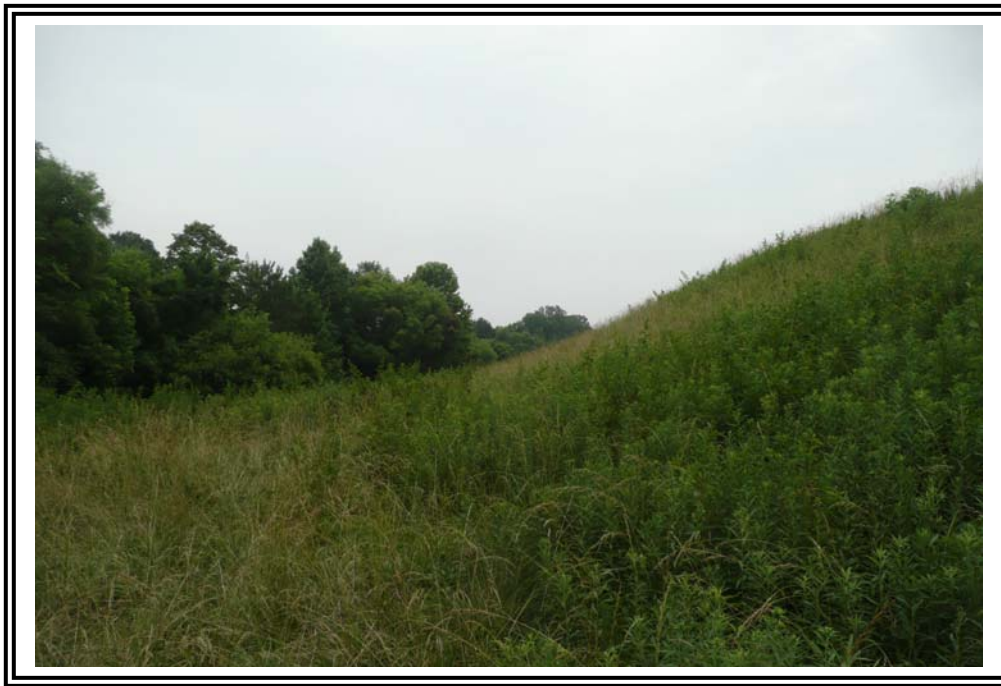
20

Corner at the north and northeast Dike of the 1985 Ash Pond, looking east.

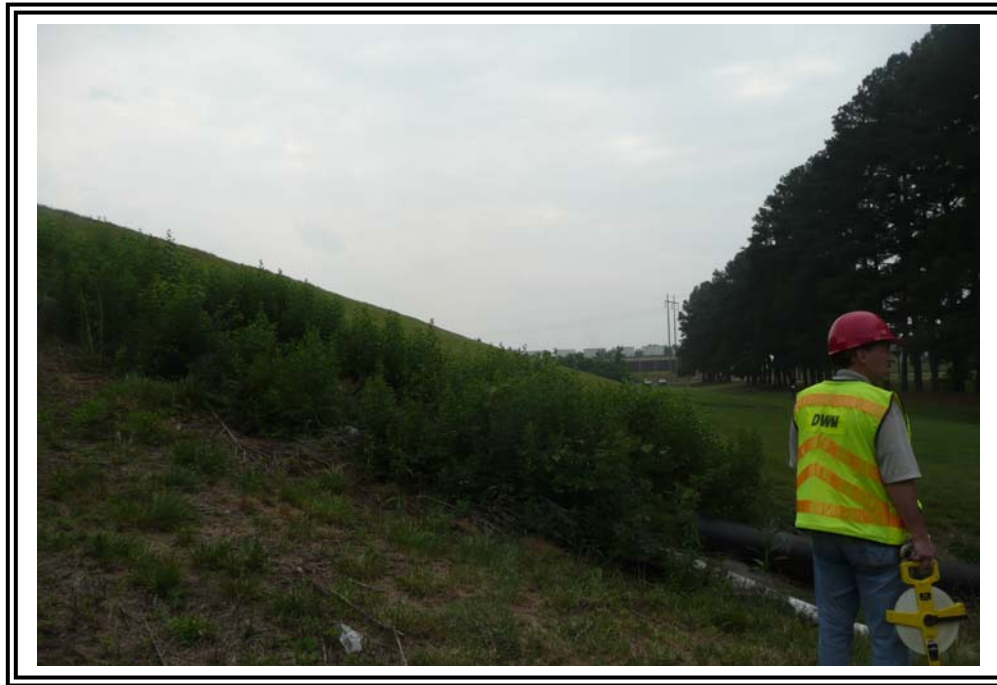
21

North Dike of the 1985 Ash Pond, looking southwest.

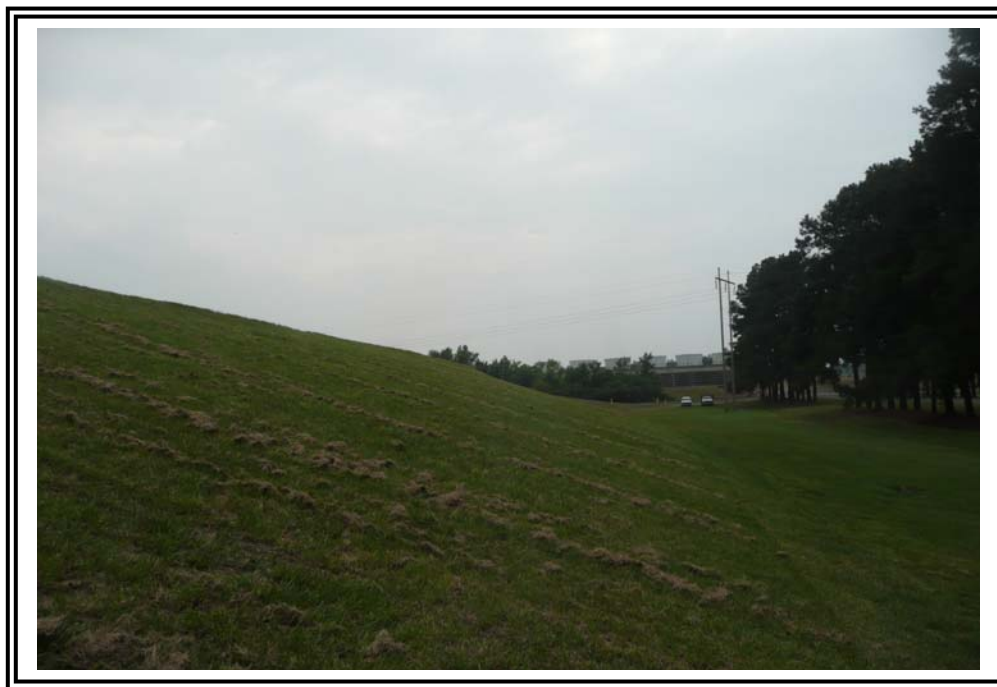
23

North Dike of the 1985 Ash Pond, looking southwest.

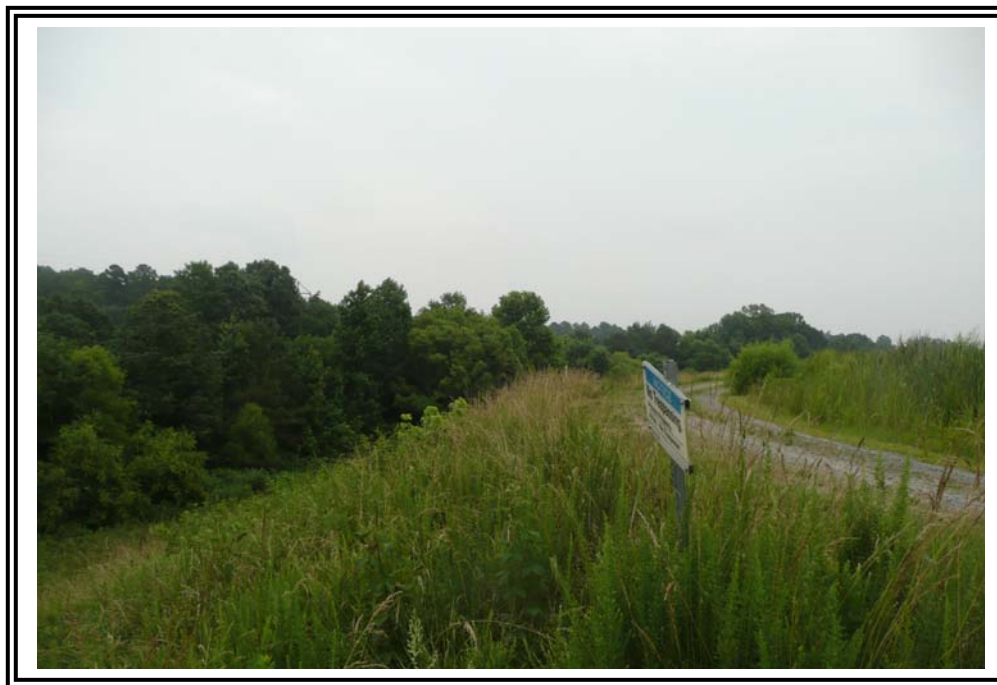
24

Dike crest at the north corner of the 1985 Ash Pond, near the ash line crossing.

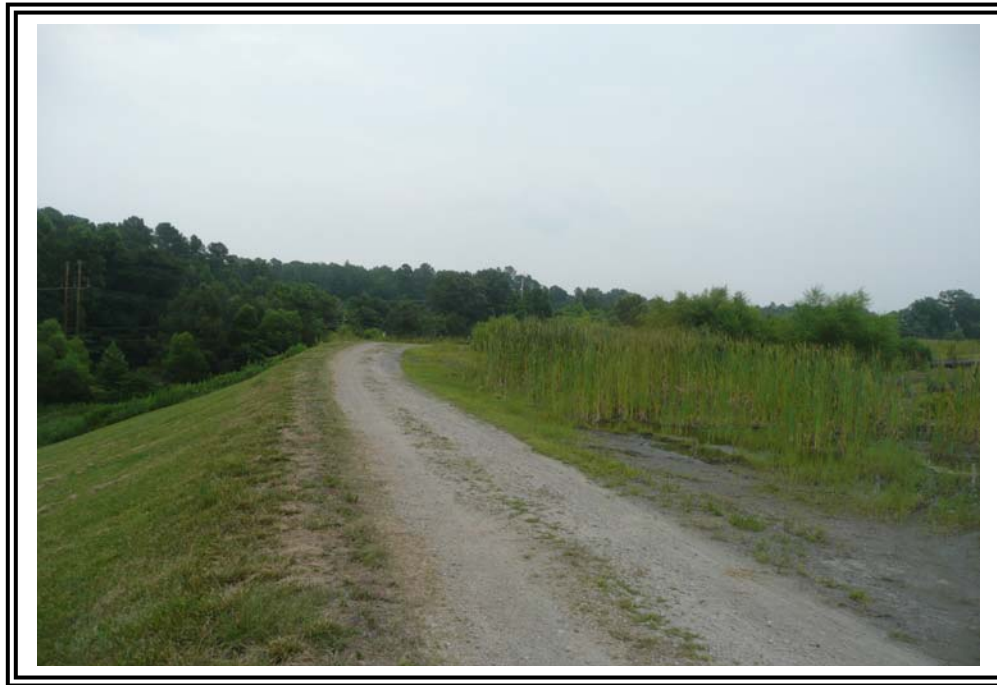
25

North Dike crest of the 1985 Ash Pond, looking northeast.
Note: Ash level is approximately at the crest of the Dike.

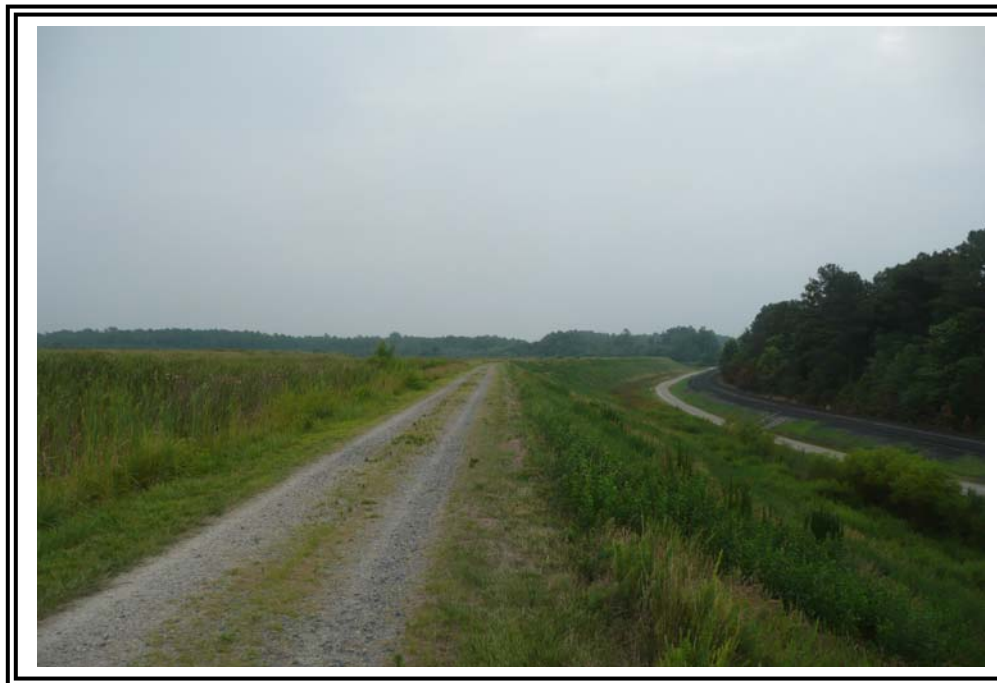
26

West Dike crest of the 1985 Ash Pond, looking southeast. Note: "Pond within a pond" to the upstream side of the crest. Ash in 1985 Ash Pond approximately at the crest of the dike.

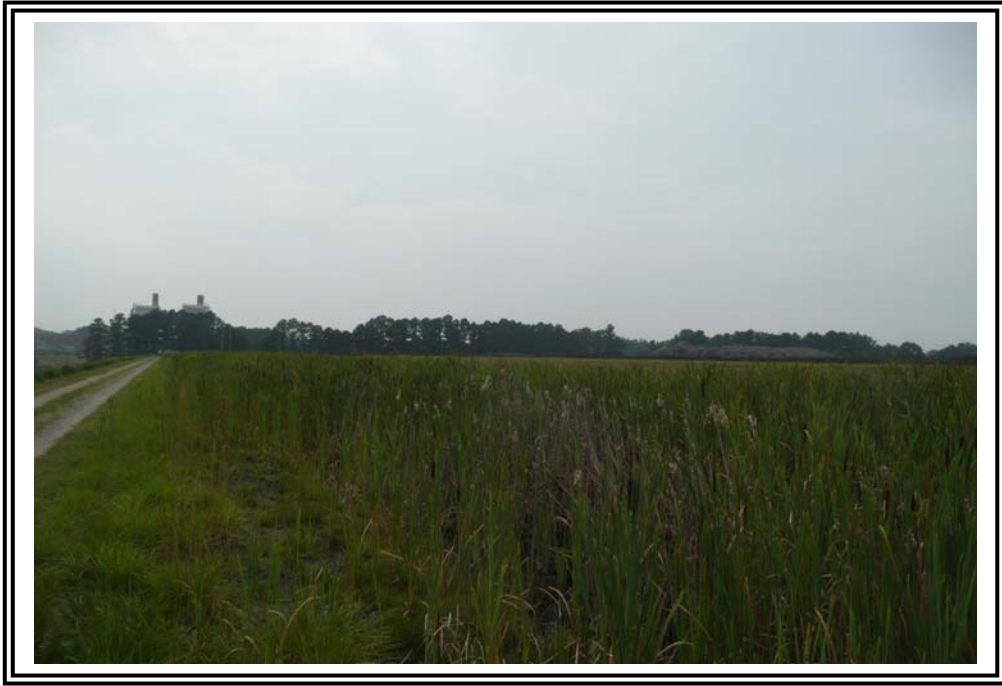
27

1985 Ash Pond, looking north.
Note: stacked ash in the "Pond within a pond".

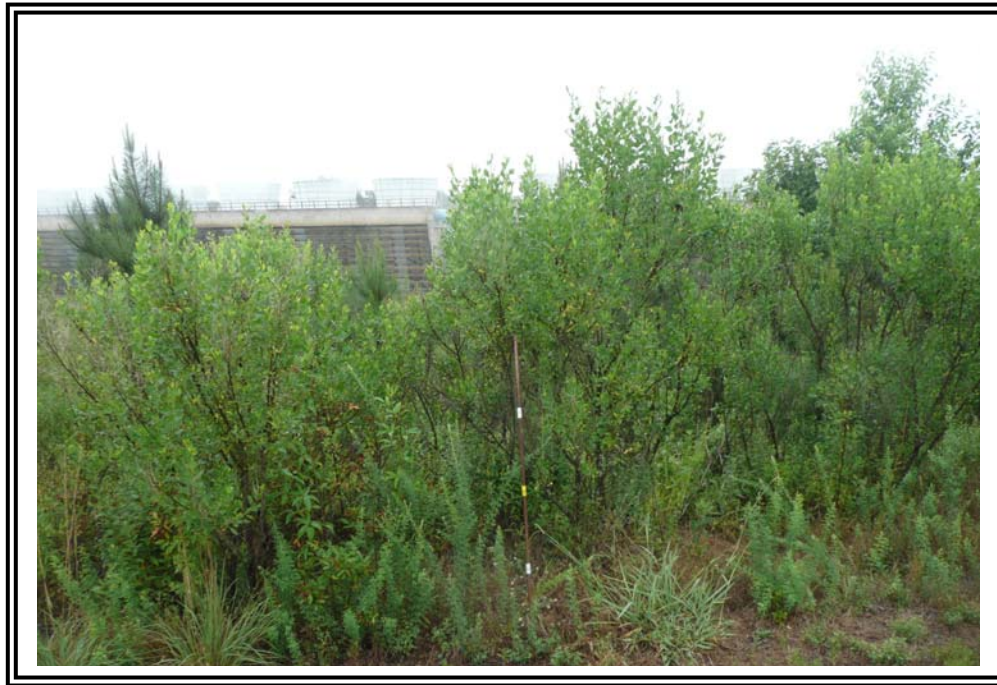
41

North end of 1978 Ash Pond Dike, downstream slope is covered with large brush.

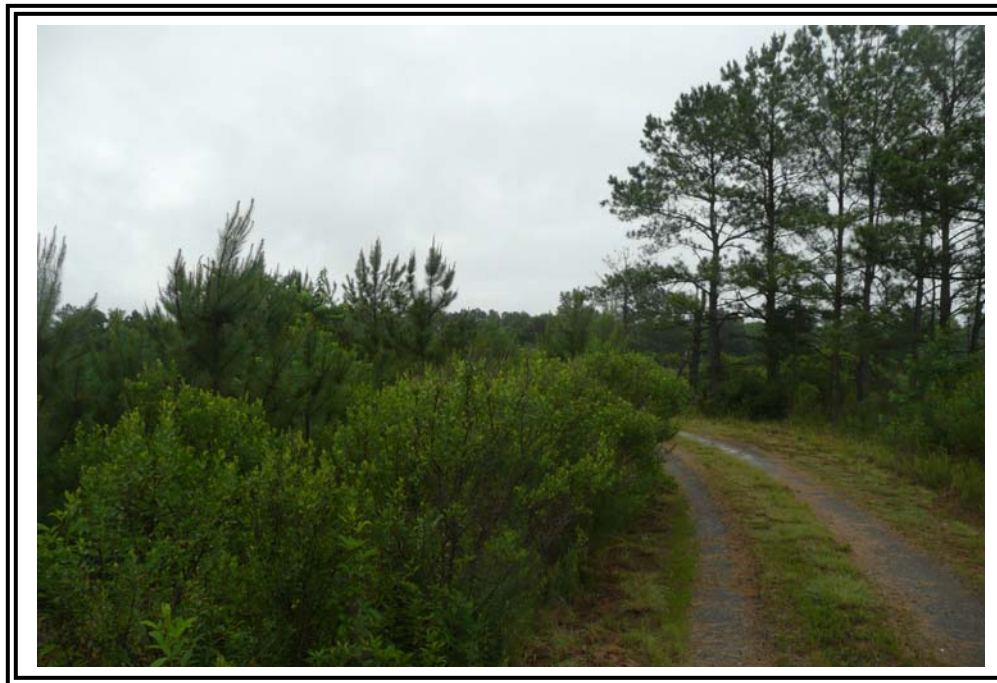
42

North end of 1978 Ash Pond Dike crest. Brush and small Pine trees are in the left of the photo and are on the downstream slope. Tall Pine trees on the right of the photo are in deposited ash within the pond.

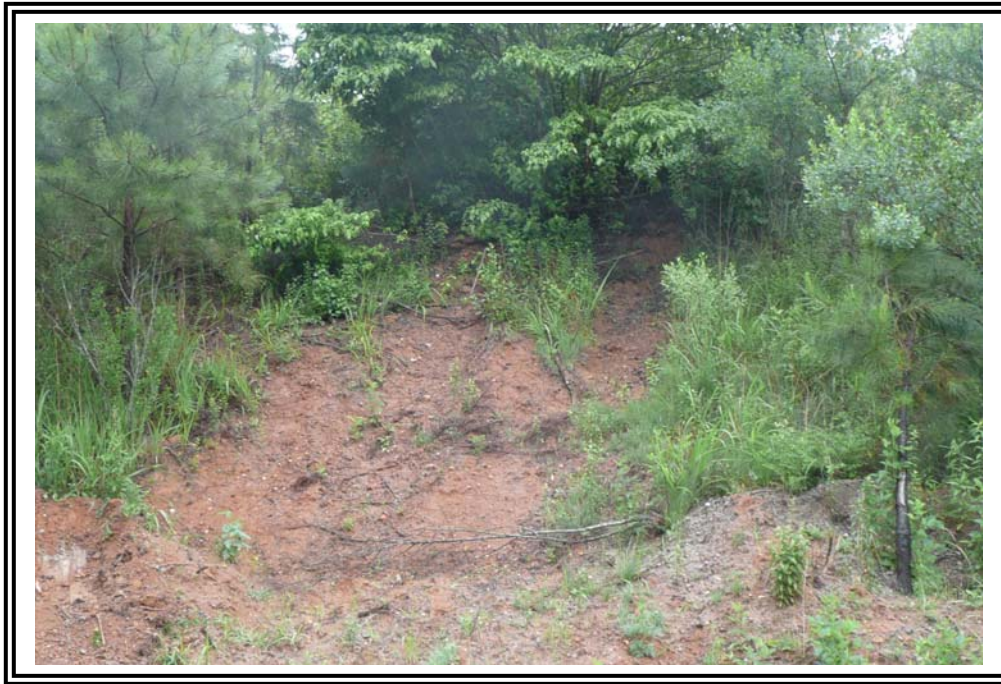
Example of poor vegetative cover, erosion, and probable human activity on the downstream slope of the 1978 Ash Pond Dike.

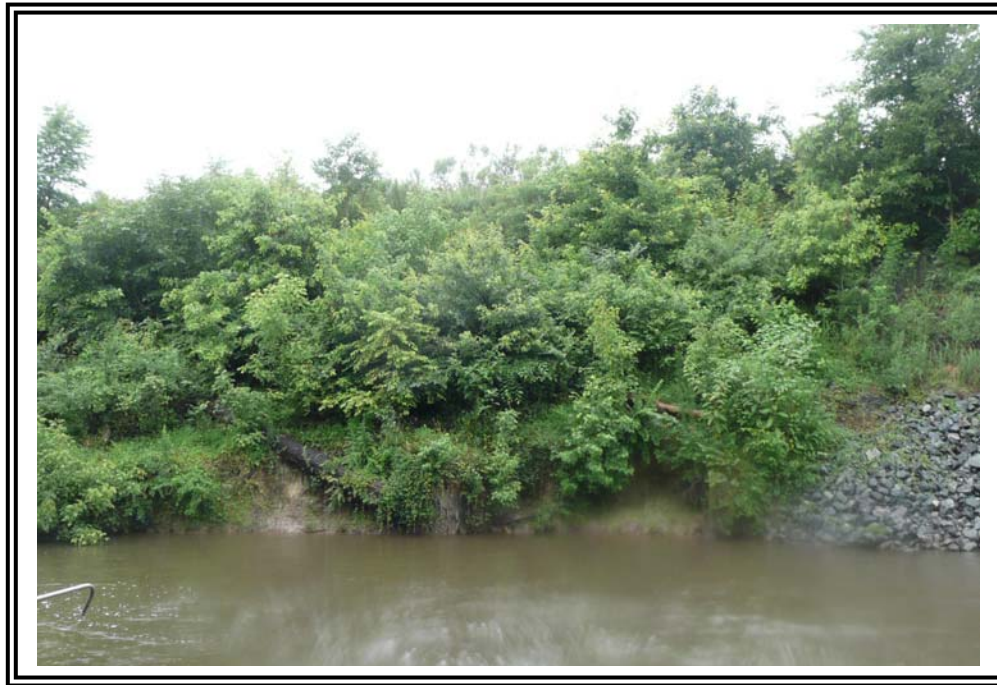
Along the easternmost portion of the dike where it parallels the Discharge Canal, undercutting of the dike toe from flows in the Discharge Channel in combination with fallen (uprooted) trees has resulted in sloughing of the slope. An area where a tree reportedly had uprooted was repaired in late 2006 or early 2007 with rip rap as shown in Photo 47. Photo 48 shows sloughing in this area and Photo 49 shows the undercutting of the toe from the Discharge Channel flows.

Erosion at the toe of the 1978 Ash Pond at discharge canal. Also note the fallen tree.

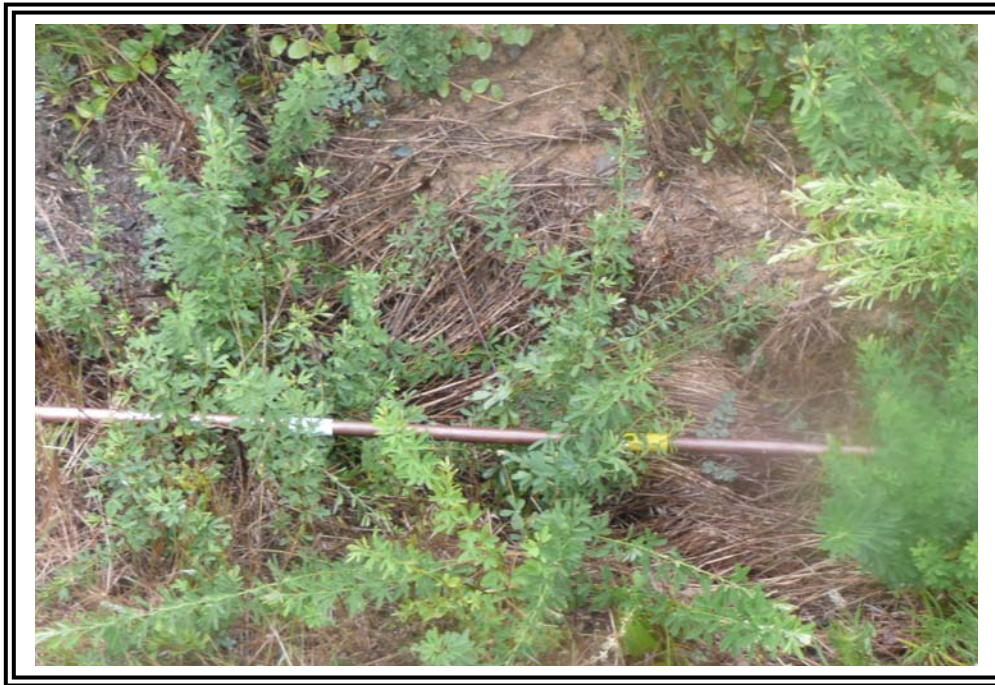
51

Irregular ground surface on the downstream slope at the east side of the 1978 Ash Pond Dike.

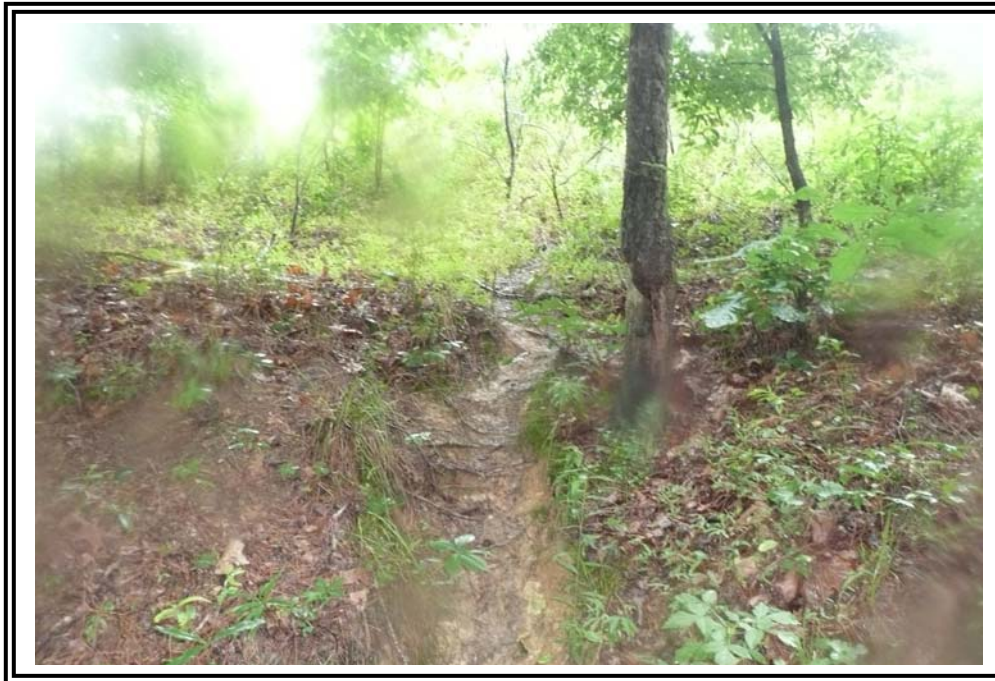
Evidence of soil disturbance from animal activity was observed in a few locations. Photo 52 shows a slide likely resulting from beaver or muskrat activity, and Photo 63 shows an animal burrow.

Animal slide (likely beaver or muskrat) on the downstream slope of the 1978 Ash Pond Dike.

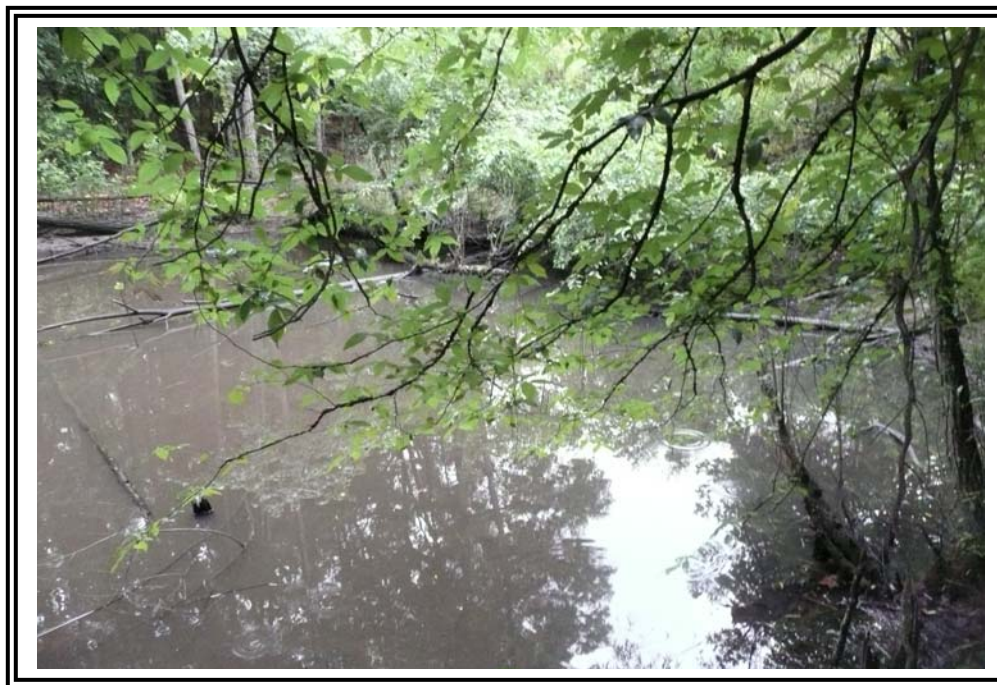
To the west of the outlet pipe discharge is an area of ponded water. The nature of the silty/clayey soils comprising the dikes is to be susceptible to softening when subjected to excess moisture. Photo 58 shows this area.

Ponded area south of the discharge pipe at the toe of the 1978 Ash Pond Dike. Reportedly excavated area from former adjacent property owner, who was a brick manufacturer.

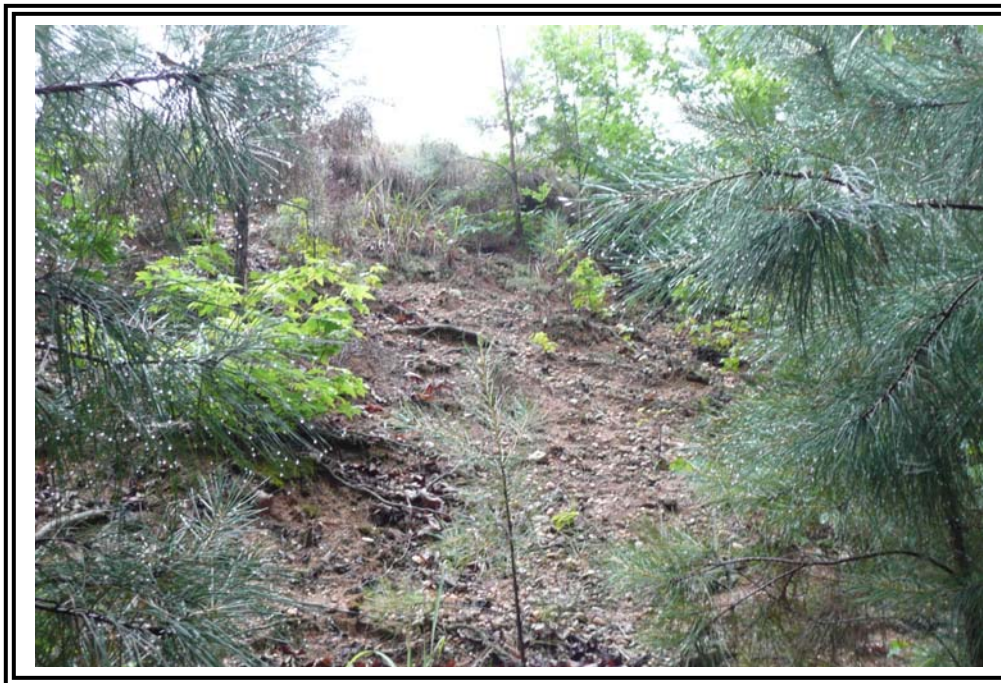
60

Surface erosion southeast of the downstream slope of the 1978 Ash Pond Dike.

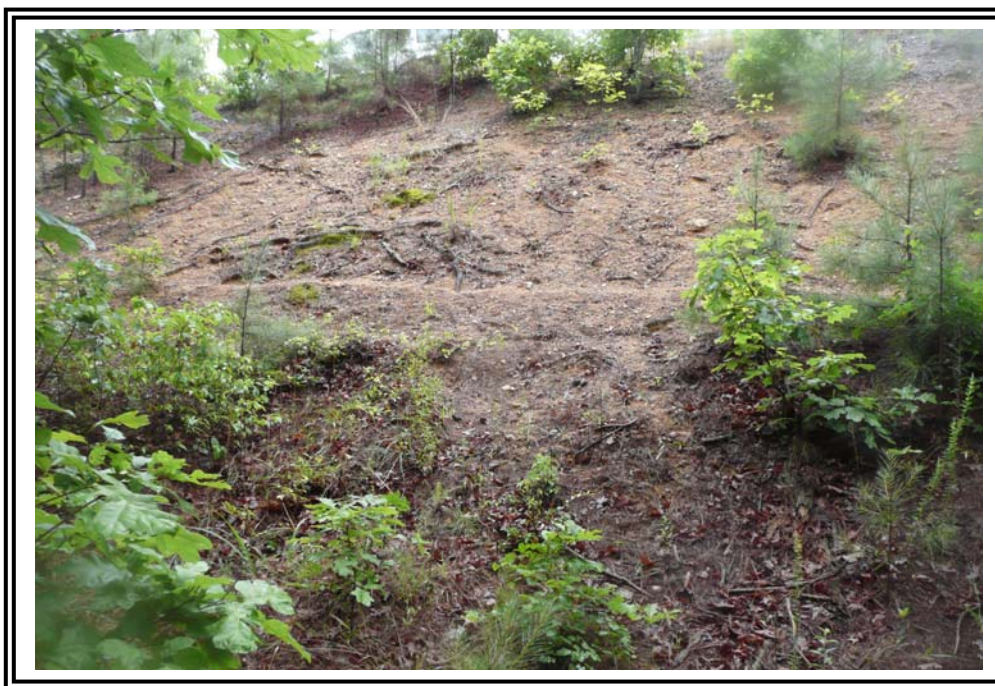
62

Downstream slope at the south end of the 1978 Ash Pond Dike is devoid of vegetation.

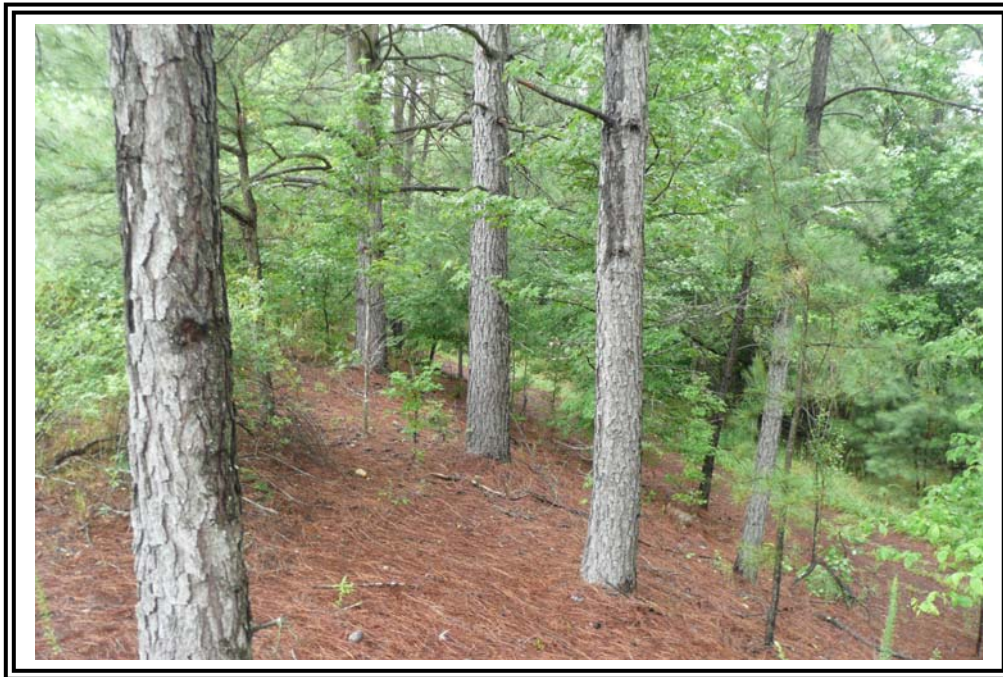
68A

Example of tree coverage on 1978 pond east dike.

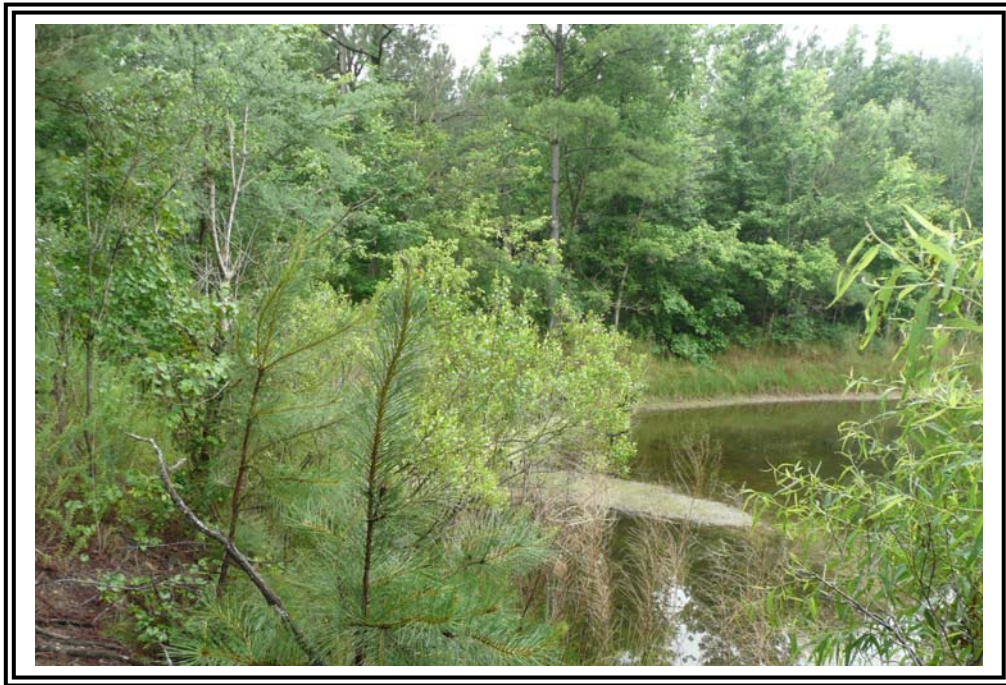
The south dike conditions are very similar to those of the east dike. At these two dikes, the dikes are about 8 to 10 feet high, and the slopes were relatively uniform. Photos 73 and 74 show the condition of the south dike.

Upstream slope of south dike at 1970 Ash Pond looking southwest from east dike.
