Assessment of Dam Safety Coal Combustion Surface Impoundments (Task 3) Final Report

Progress Energy
Carolinas
Cape Fear Plant

Moncure, North Carolina

September 14, 2009

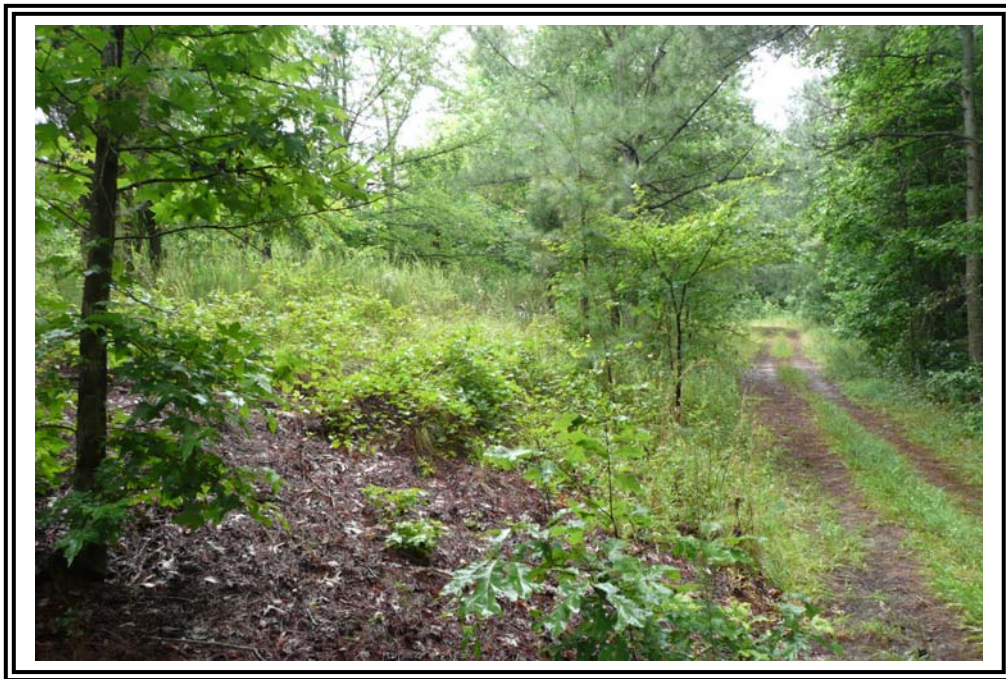
74

1970 Ash Pond south dike downstream slope looking east.

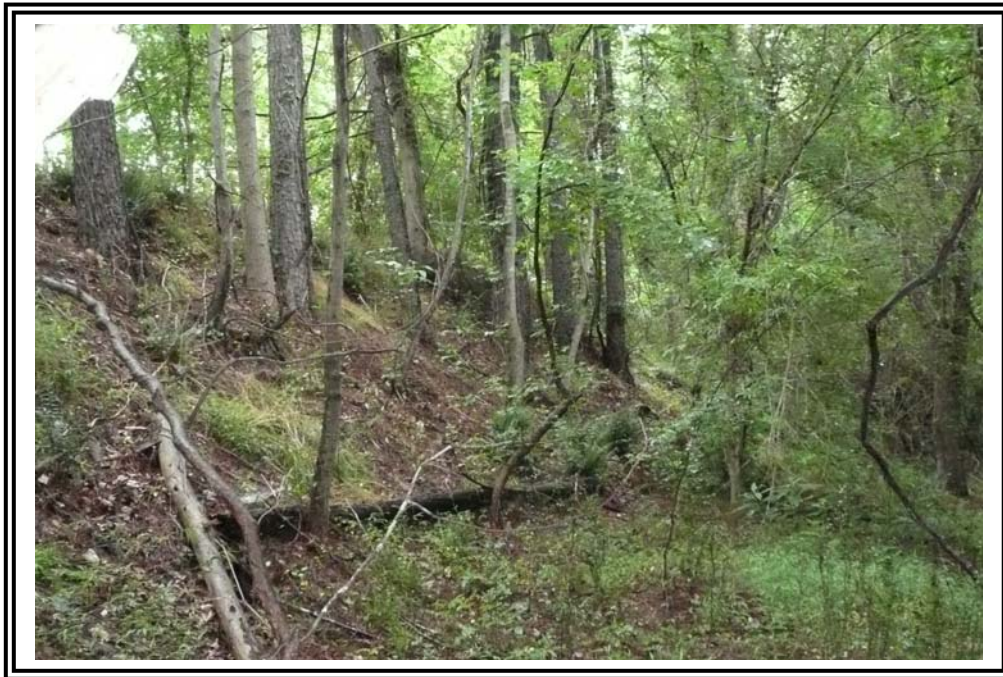
76

1970 Ash Pond downstream slope near southwest corner.

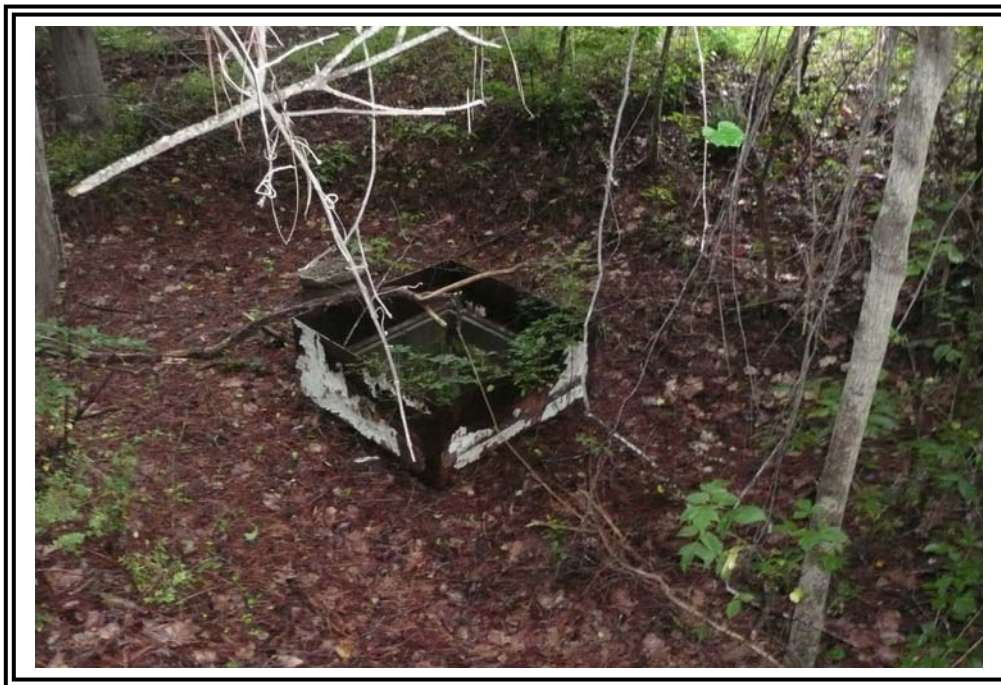
77

1970 Ash Pond outlet control structure. Note: water level in south end of pond was several feet lower than outlet during our visit.

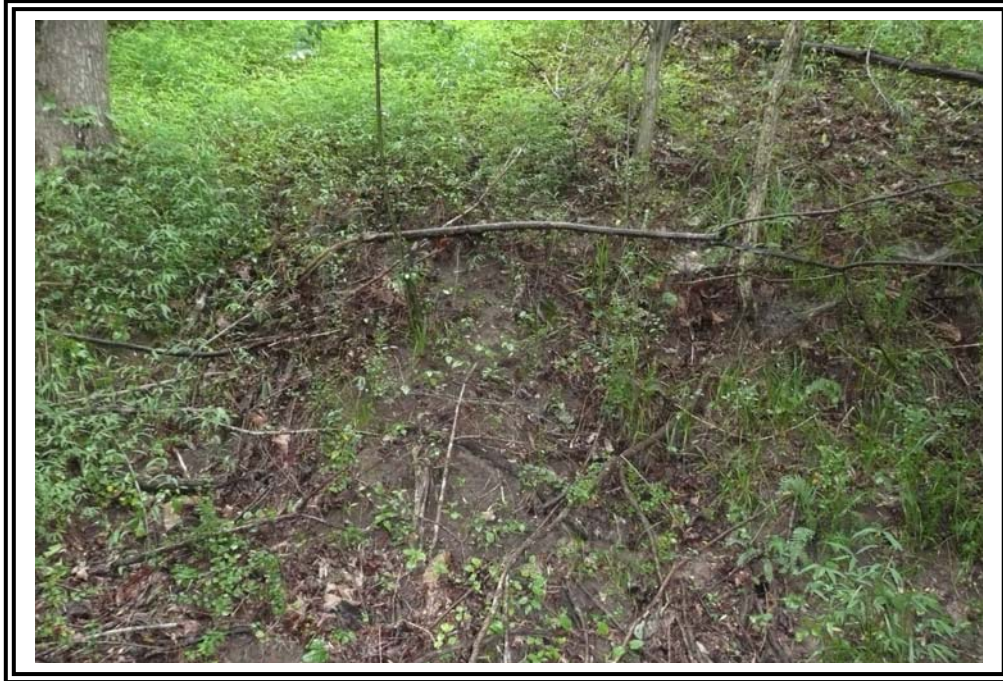
83

Surface erosion on 1970 Ash Pond west dike downstream slope.

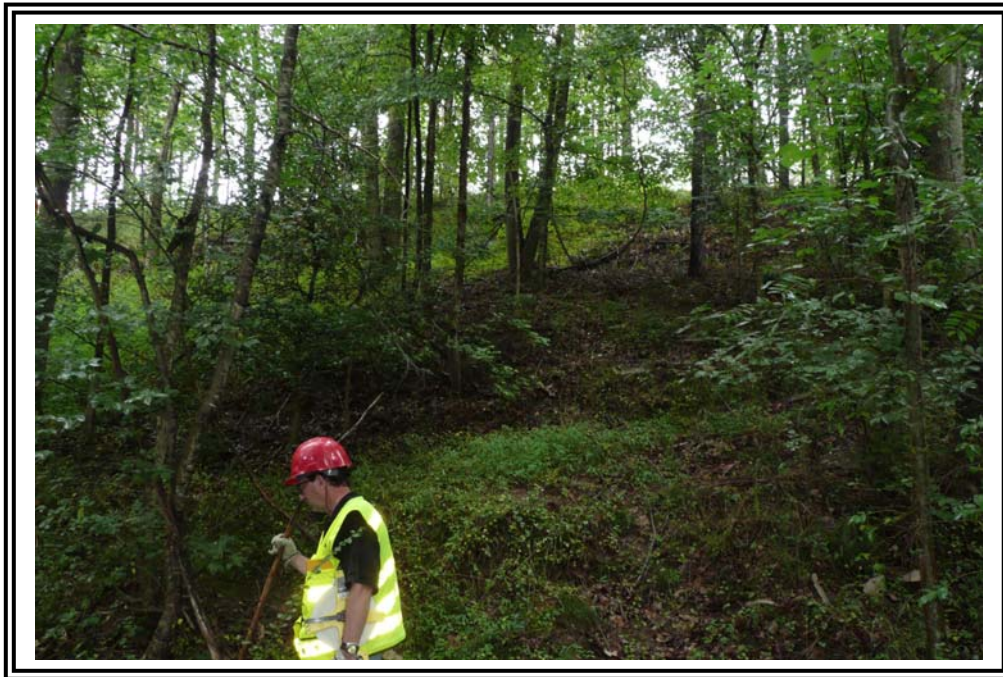
84

Surface erosion and sloughing on 1970 Ash Pond west dike downstream slope.

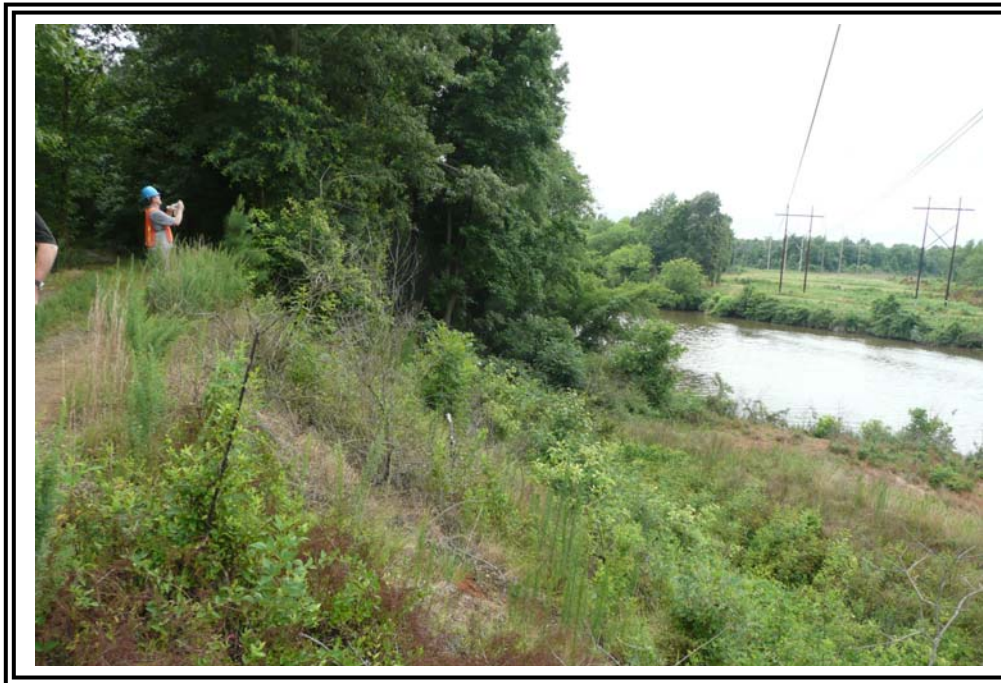
89

North end of 1963 Ash Pond west dike looking south. This is adjacent to the 1982 slide area. Water in background is the Cape Fear River.

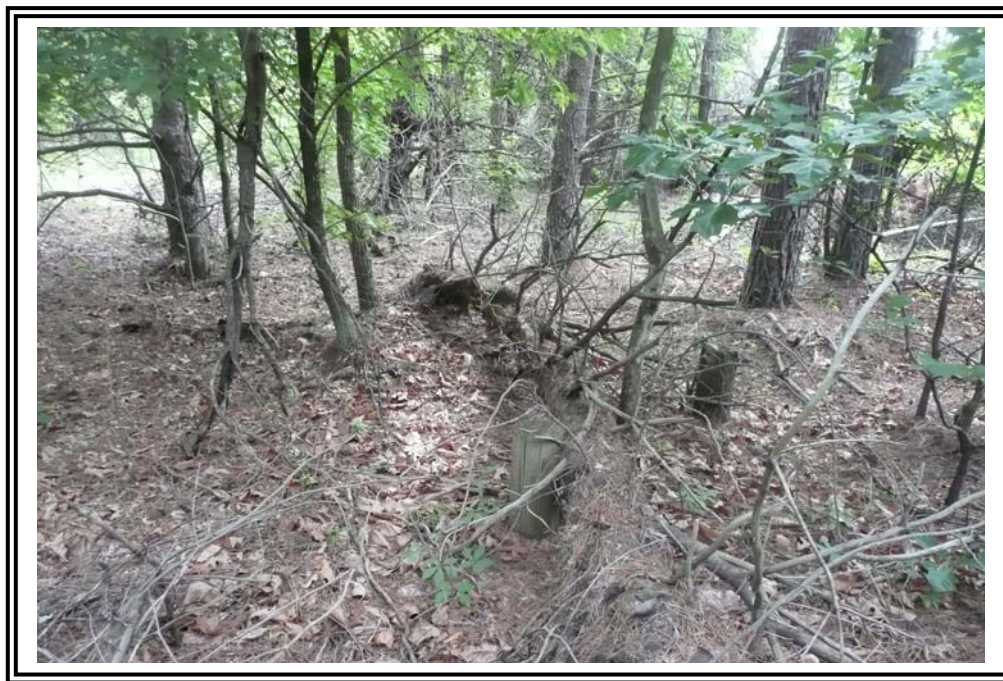
95

Remains of outlet structure at southwest corner of 1956 Ash Pond.

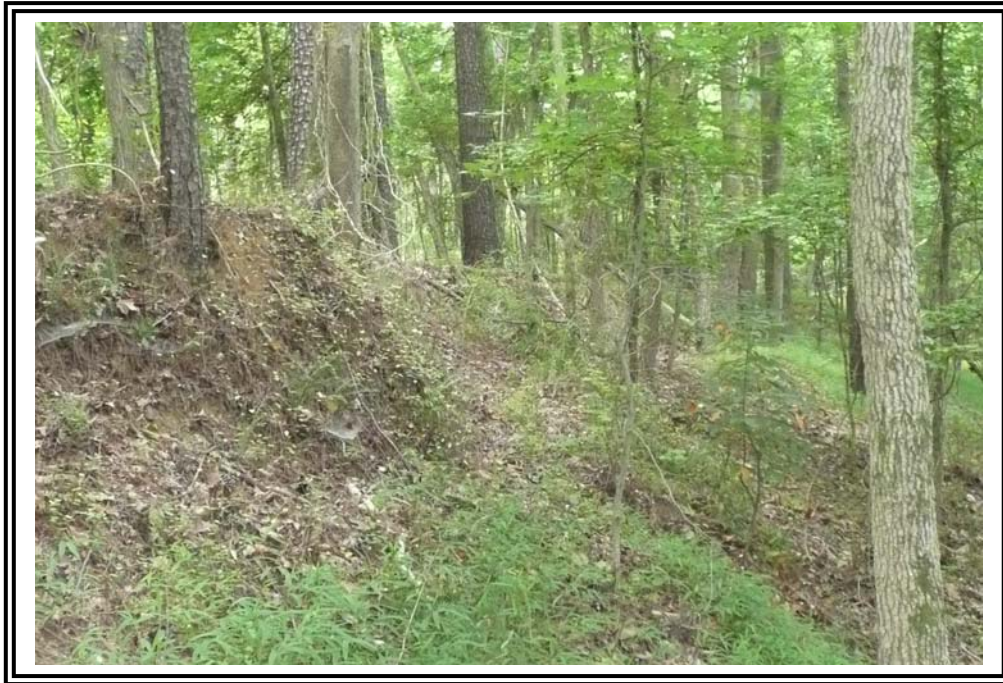
98

Typical of frequent areas of erosion on the downstream slopes of the 1956 Ash Pond Dikes.

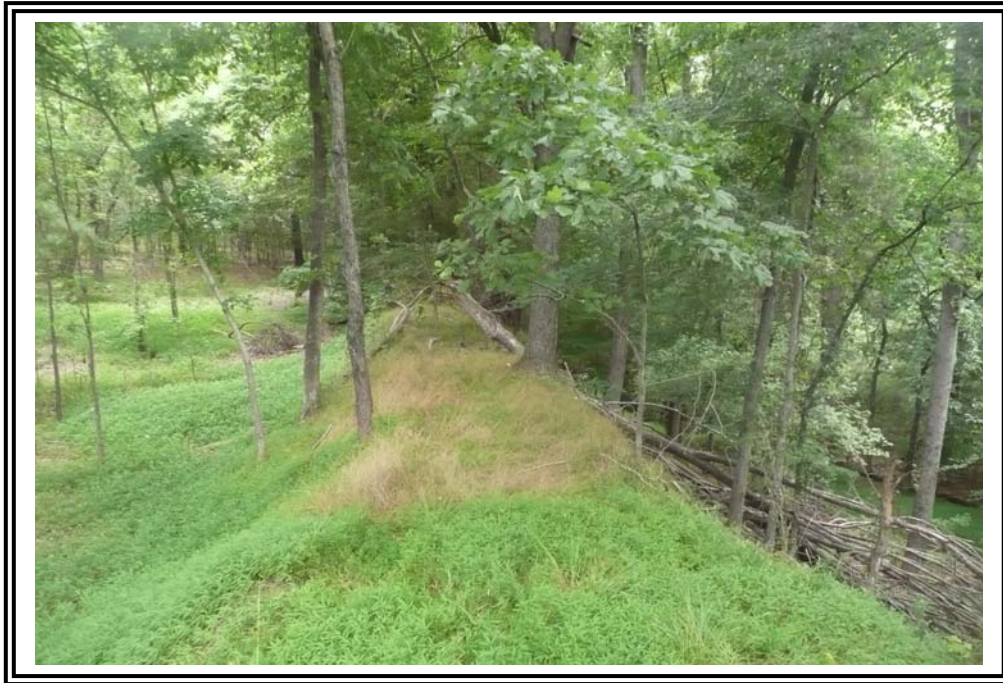
104

Crest of the 1956 Ash Pond Dike.

Note: Some areas of the ash surface inside the pond was approximately equal to the top of the Dike.

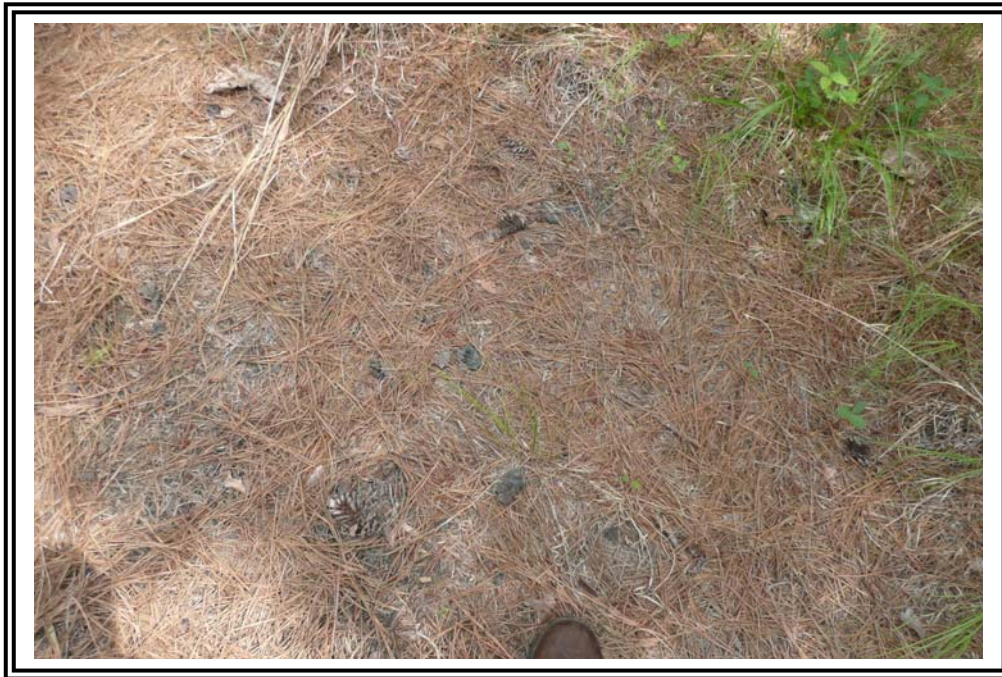
107

Exposed ash at the ground surface within the 1956 Ash Pond.
