Coal Combustion Residue Impoundment

Round 9 - Dam Assessment Report

Cross Generation Station

Santee Cooper

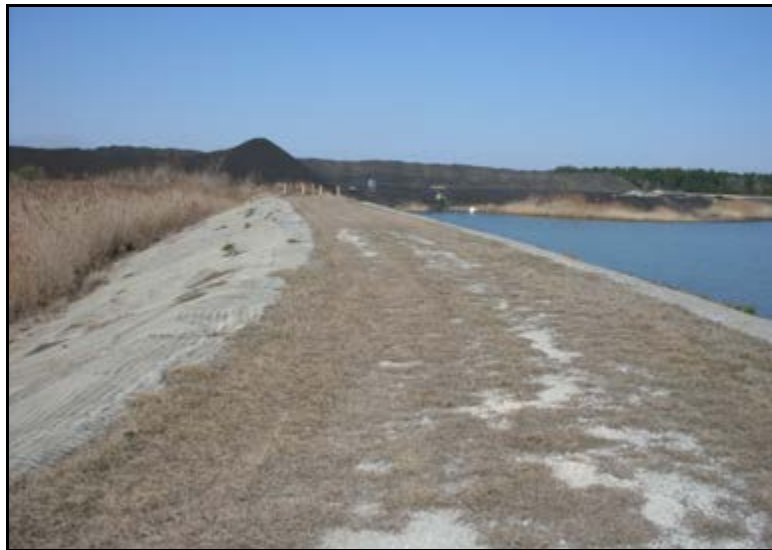
Photograph 5.2. View of crest and inside slope of Bottom Ash Pond 1 northeast dike, looking northwest.

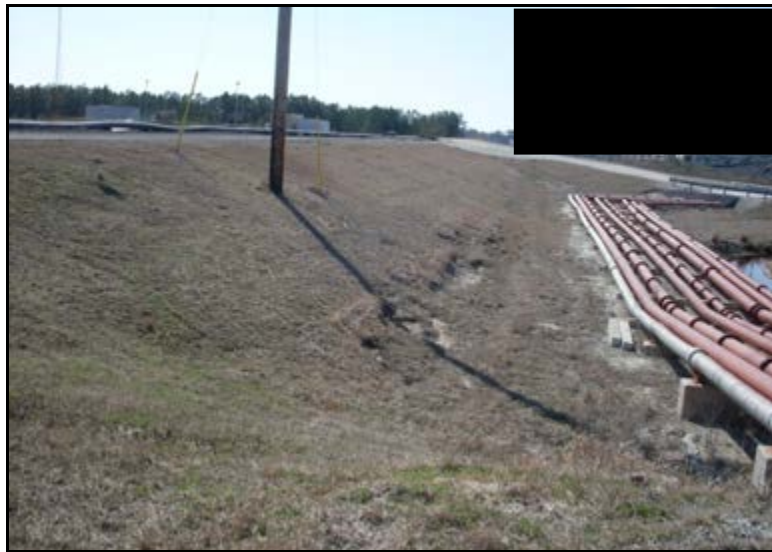
The area along the outside toe of the dike on the southeast side was observed to be covered in woody vegetation (Photograph 5.4). The outside slope of the dike on the northwest side was observed to be covered with mowed grass; however, some erosion was observed along the outside toe of this section of the dike, as shown in Photograph 5.5. There were no indications of seepage.

Photograph 5.5. View of outside slope and toe, northwest side looking southwest.

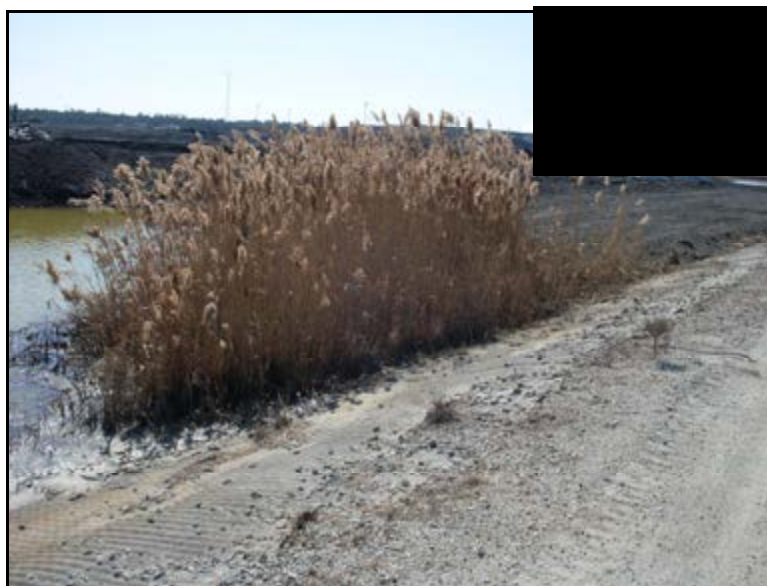
A typical view of the inside slope of Bottom Ash Pond 2 is shown in Photograph 5.6b (see also Photograph 5.6a). The Fabriform revetment on the upstream inside slopes appeared to be serviceable and in generally satisfactory condition with no major depressions and no significant areas of deterioration. Patches of vegetation (primarily Phragmites) were observed on the upstream slopes, generally along and just above the water line or ash sediment line, as shown in Photograph 5.6c. No slumps, slides, or other signs of shear failure were observed in the visible parts of the slopes above the water surface or ash surface.

Photograph 5.6c. View of reeds (Phragmites) growing on inside slope, northwest side looking south.

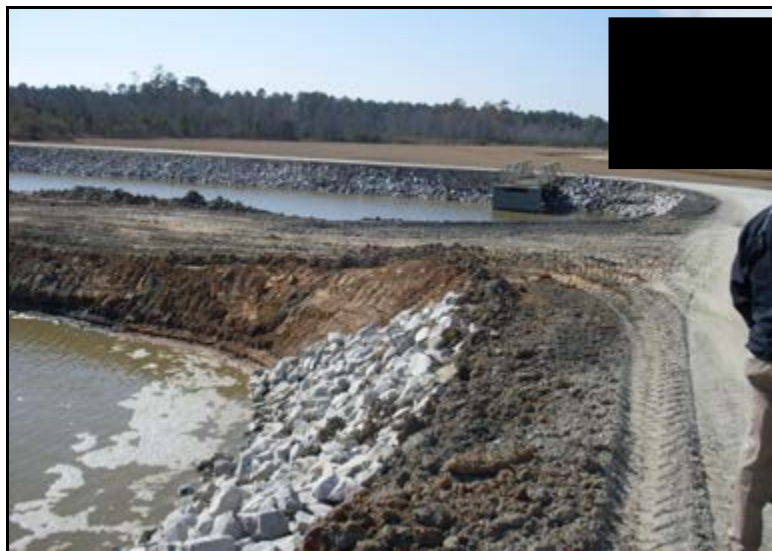
Photograph 5.9a. View of crest, inside slope, finger dike, and emergency overflow structure, northwest side looking southwest.

Typical views of the inside slope of the Gypsum Pond are shown in Photographs 5.9a and 5.9b. Riprap was observed to cover the inside slope of the dike embankment.

The slope of the riprap above the water level appeared steeper than the 3H to 1V design slope of the embankment. The slopes of the finger dike within the pond were observed to be bare earth. No slumps, slides, or other signs of shear failure were observed in the visible parts of the slopes above the water surface.

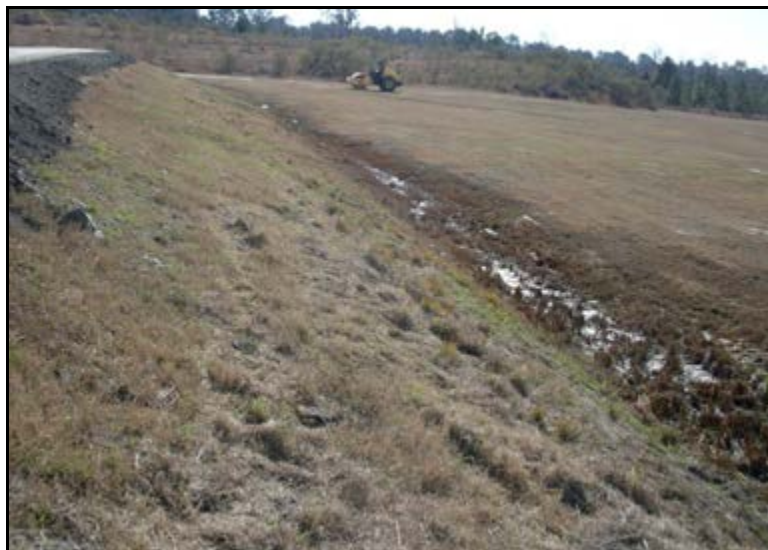
A typical view of the outside slope and toe of the Gypsum Pond dike embankment is shown in Photograph 5.10. As shown, the grass on the outside slope was typically observed to be maintained in satisfactory condition. No areas of significant erosion were observed. No obvious signs of slumps, slides, bulges, tension cracks, seepage, or animal holes were observed.

A drainage ditch along the outside toe of the pond conveys runoff to a ditch downstream of the emergency overflow outfall. There were no obvious signs of seepage from the toe.

Photograph 5.10. View of outside slope and toe, southwest side looking southeast.

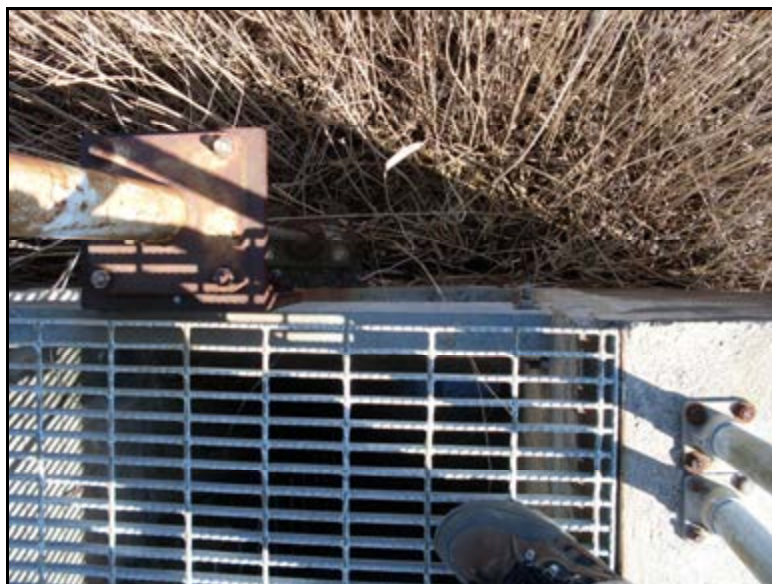
Photograph 5.11b. View (from above) down toward weir in emergency overflow structure.

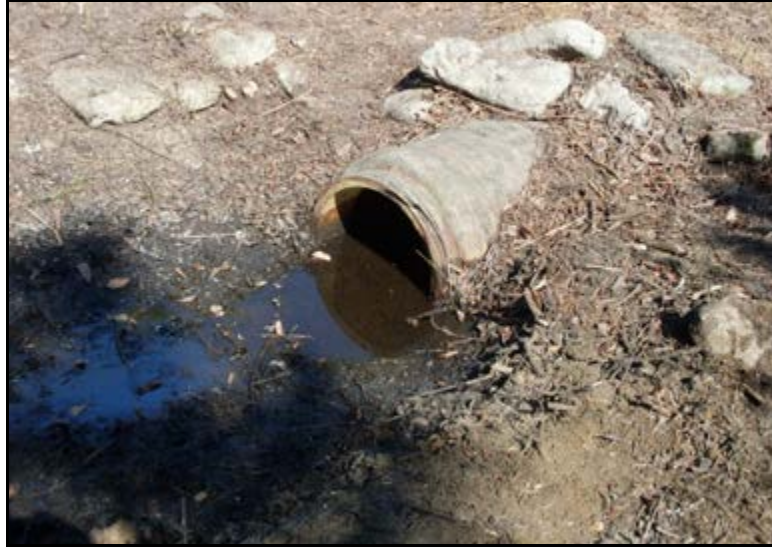
The emergency overflow structure has bottom discharge into an 18-inch diameter conduit through the dike. The discharge end of the emergency outlet conduit, shown in Photograph 5.12, appeared to be steel pipe with a smooth PVC liner. The visible part of the emergency outlet conduit appeared to be sound. It appeared that discharges from the pipe would flow into a wetland area and ultimately into the Diversion Canal.

Photograph 5.12. Discharge end of emergency outlet conduit.

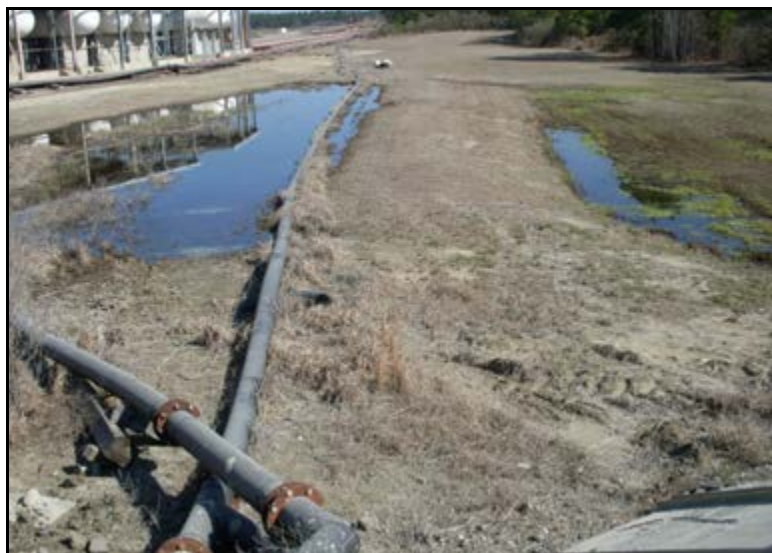
There is a pump structure that conveys water from the Gypsum Pond to Bottom Ash Pond 2. The pump is triggered once the water surface elevation reaches a set elevation. An auxiliary pump is located adjacent to the permanent pump structure. A view of the pump platform is shown in Photograph 5.17. The pump structure and associated equipment appeared to be in satisfactory condition. The pipe outlet conduits from the pump system at the Gypsum Pond are shown in Photograph 5.18. The pipes convey water from the Gypsum Pond to Bottom Ash Pond 2.

Photograph 5.18. View of pipes conveying water from Gypsum Pond to Bottom Ash Pond 2.
