**Coal Combustion Waste Impoundment
Round 7- Dike Assessment Report (Site #007)**

Lawrence Energy Center

Ash Impoundment Dike

Westar Energy

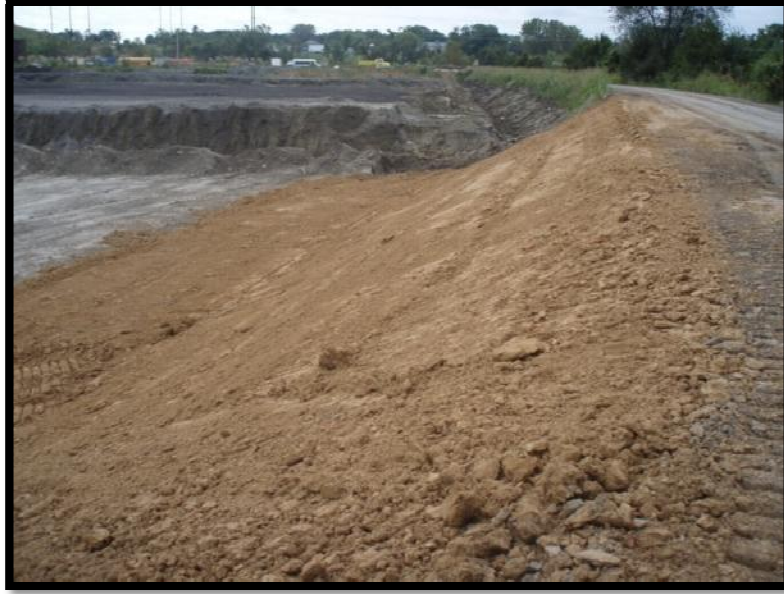
At the time of the site visit, Area 3 was drained and the ash was being removed. A clay liner was being installed and the slope was being restored to 3:1, see Figure 5.3.2-2.

Figure 5.3.2-2: Inside Slope of West Dike (Area 3).

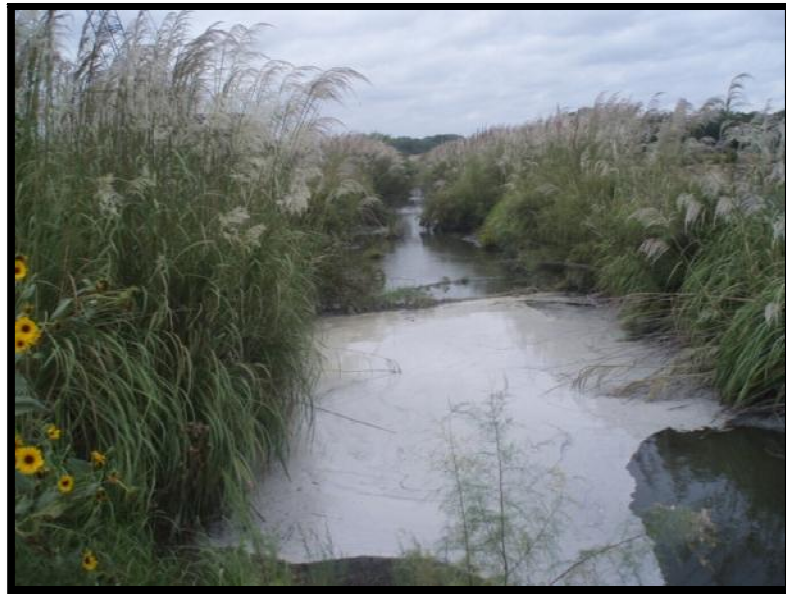
A shallow ditch connecting Areas 2 and 3 is immediately adjacent to the southern portion of Area 2 of the ash pond area, see Figure 5.4.3-2.

Figure 5.4.3-2: Ditch Connecting Areas 2 and 3.

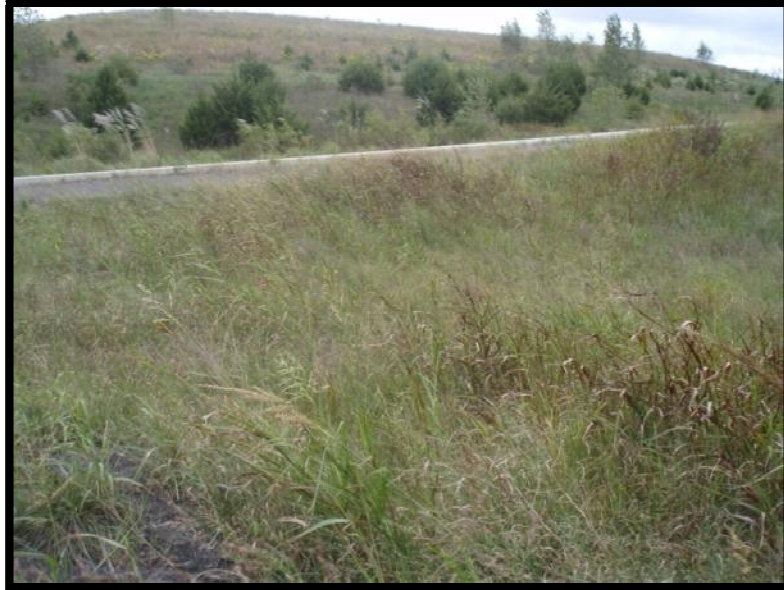
The east end of the south storm water pond dike ties into a road embankment, see Figure 5.4.4-1.

Figure 5.4.4-1: Tie-in of south dike to road embankment.

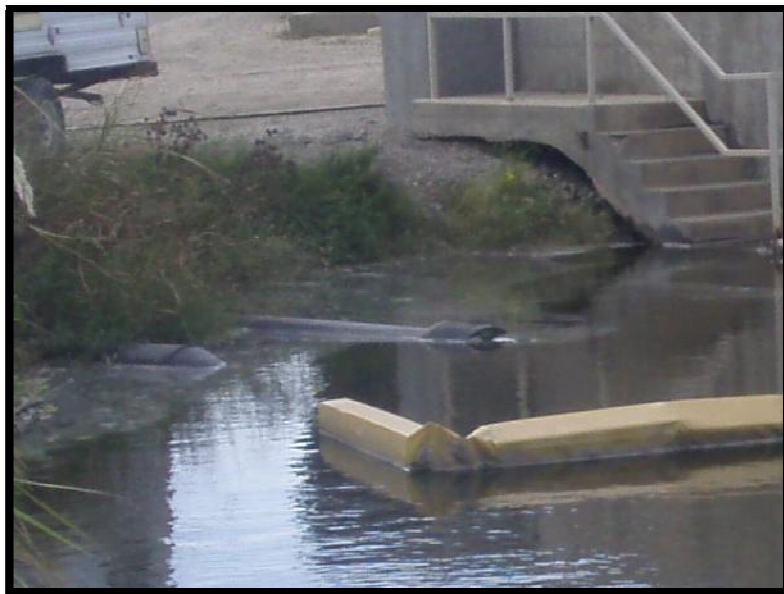
Water from the clear water pond is discharged via a pipe in the northeast corner of Area 1 to the Kansas River (Figure 5.5.2-1).

Figure 5.5.2-1: Inlet end of the Clear Water Pond Outlet Structure that leads to the Kansas River.

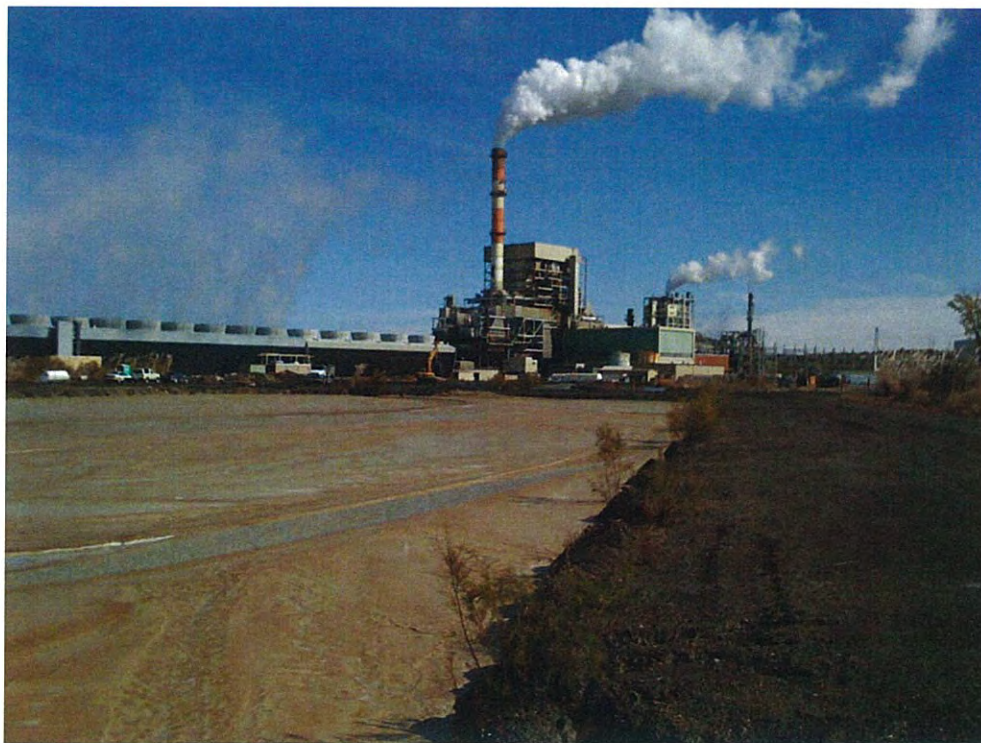
Photograph 2 – CCP storage facility (looking east)

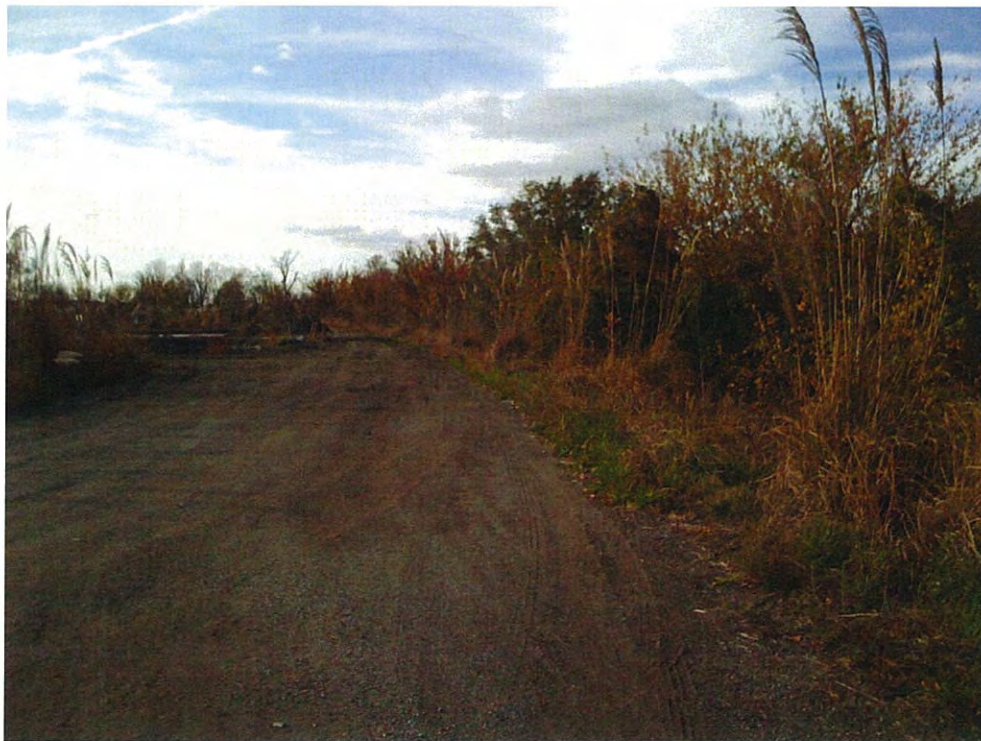
Photograph 3 – CCP storage facility (looking east)

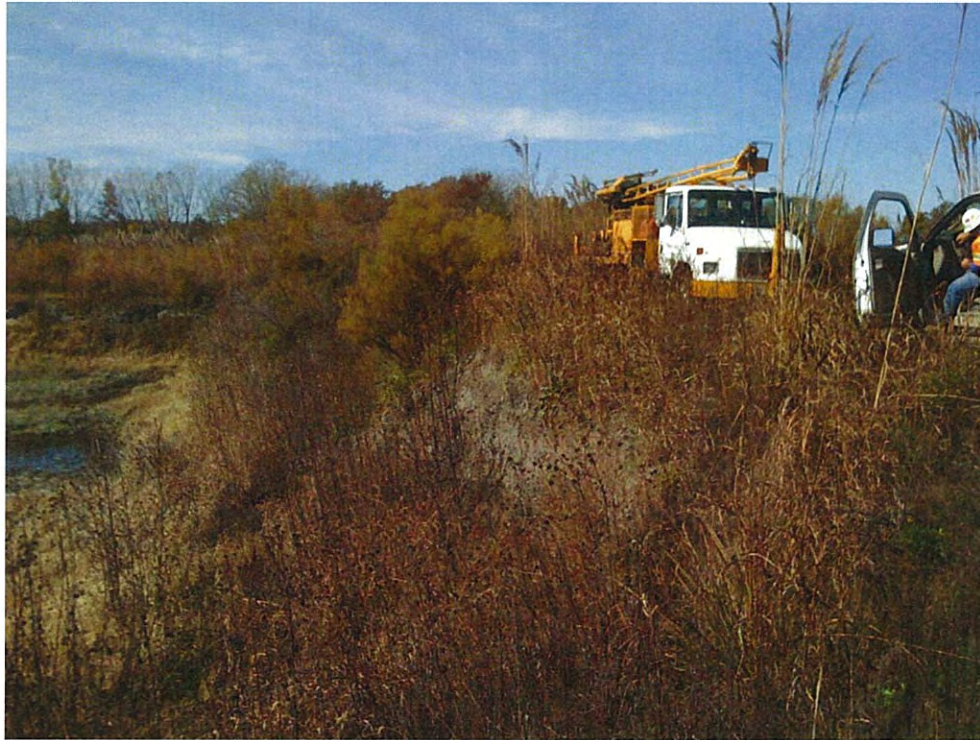
Photograph 4 – Berm crest near Borehole LEC-1 (looking northwest)

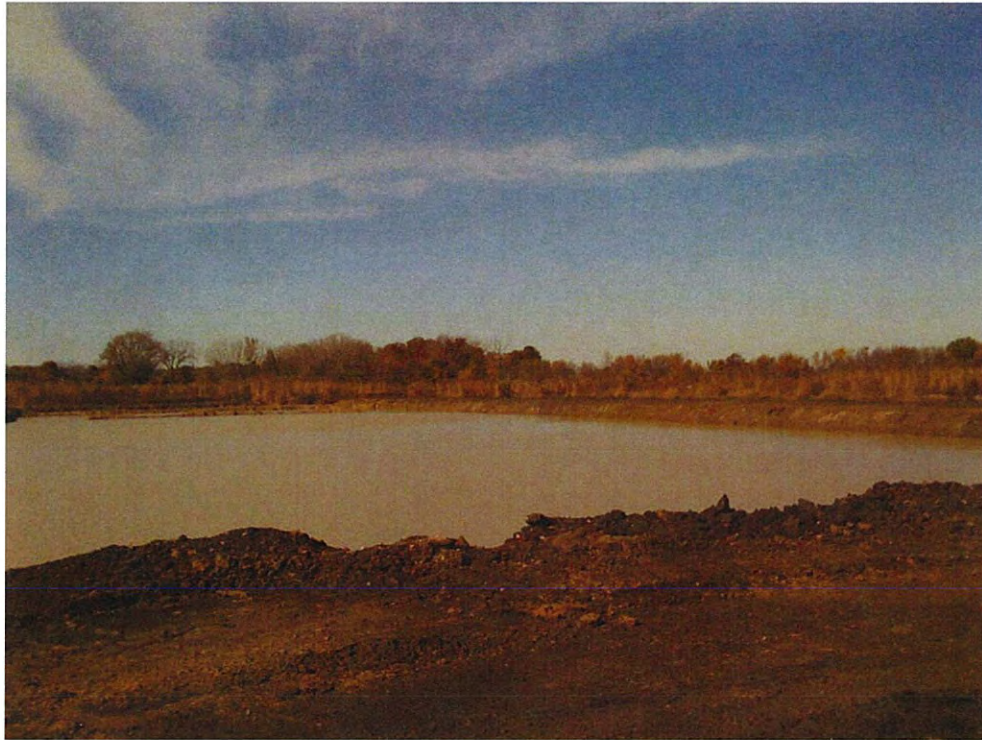
Photograph 1 – CCP storage facility (looking northwest)

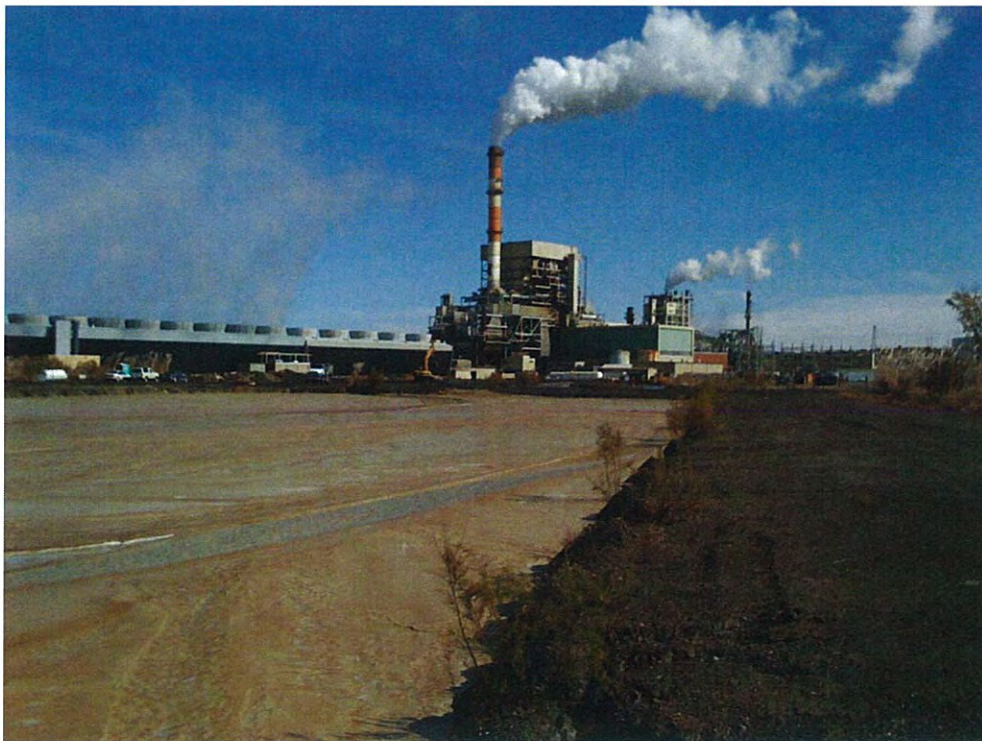
Photograph 2 – CCP storage facility (looking east)

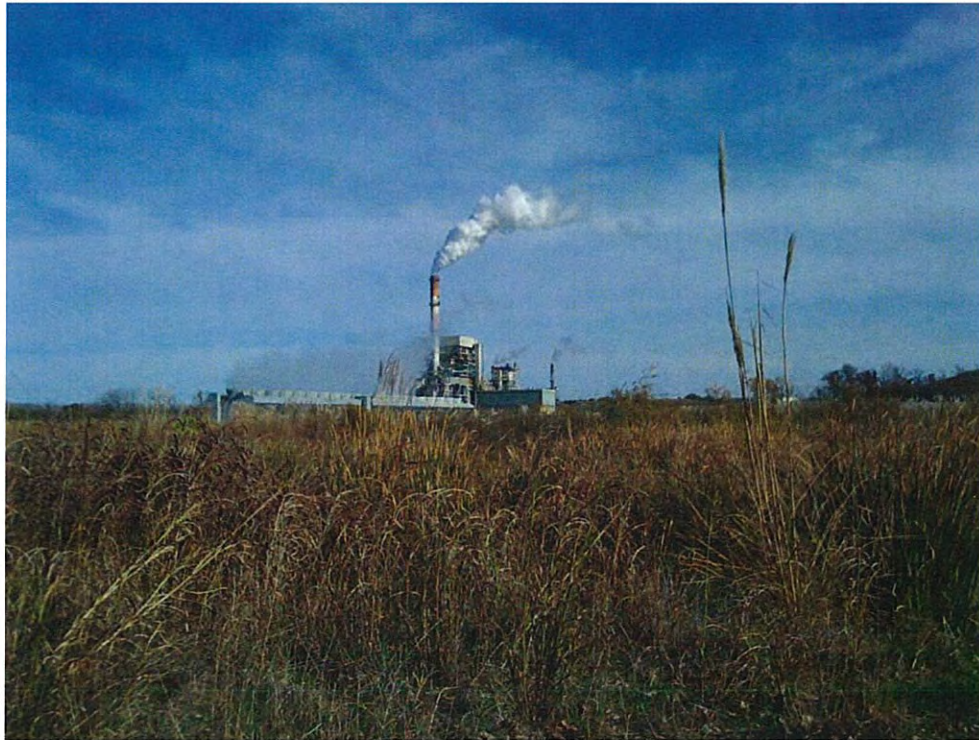
Photograph 3 – CCP storage facility (looking east)

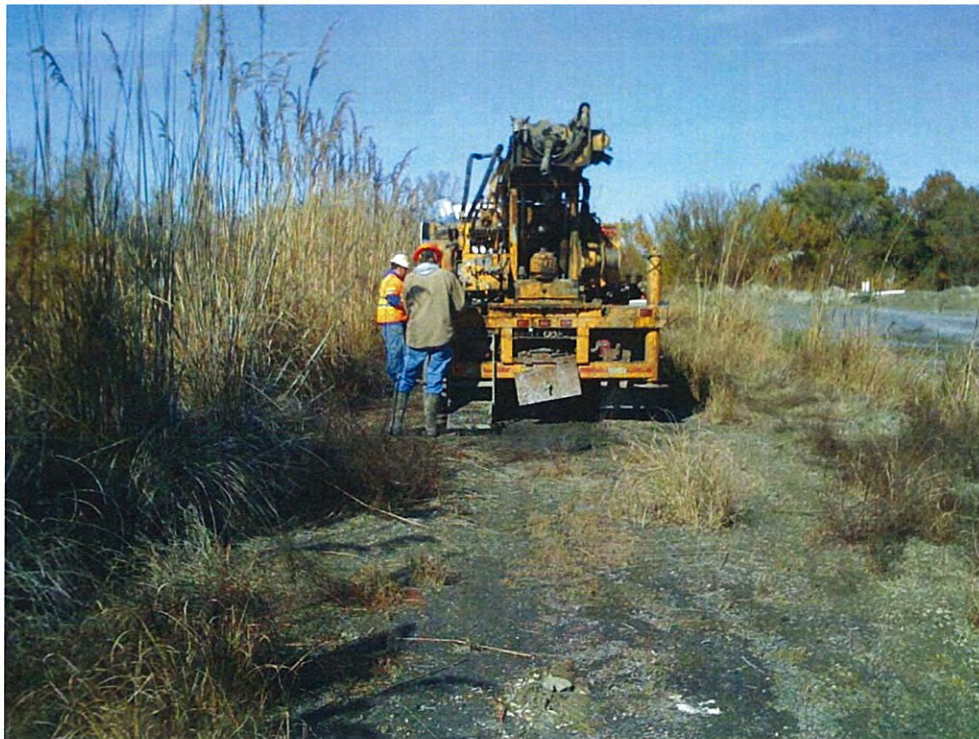
Photograph 4 – CME drill rig used to complete boreholes (looking north)

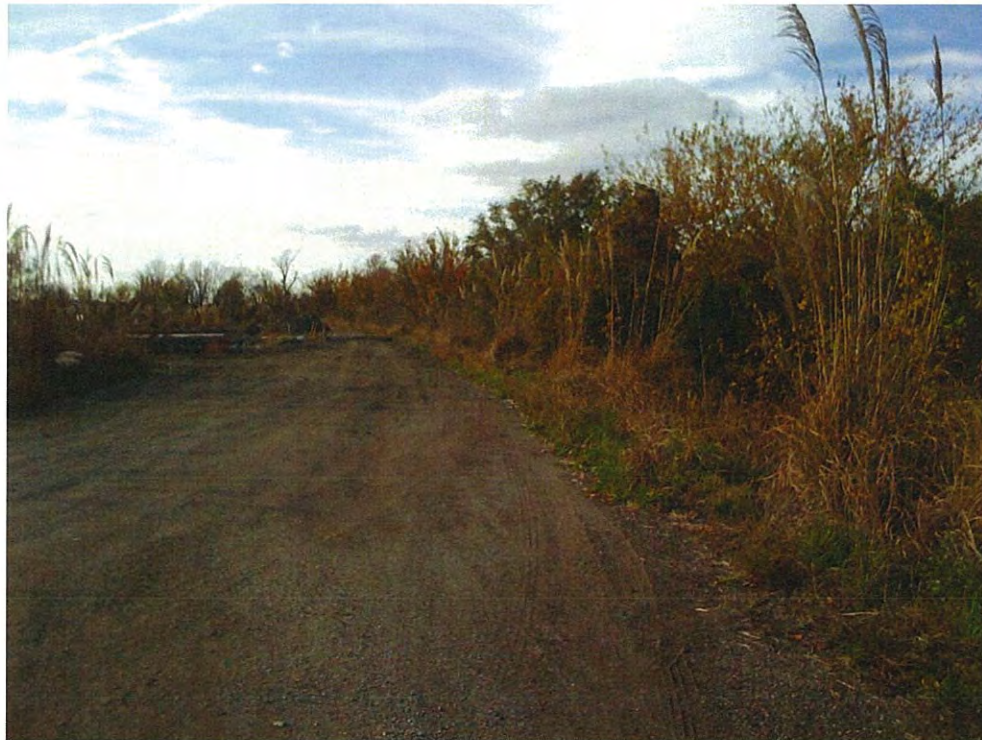
Photograph 5 – Berm crest (looking northwest)

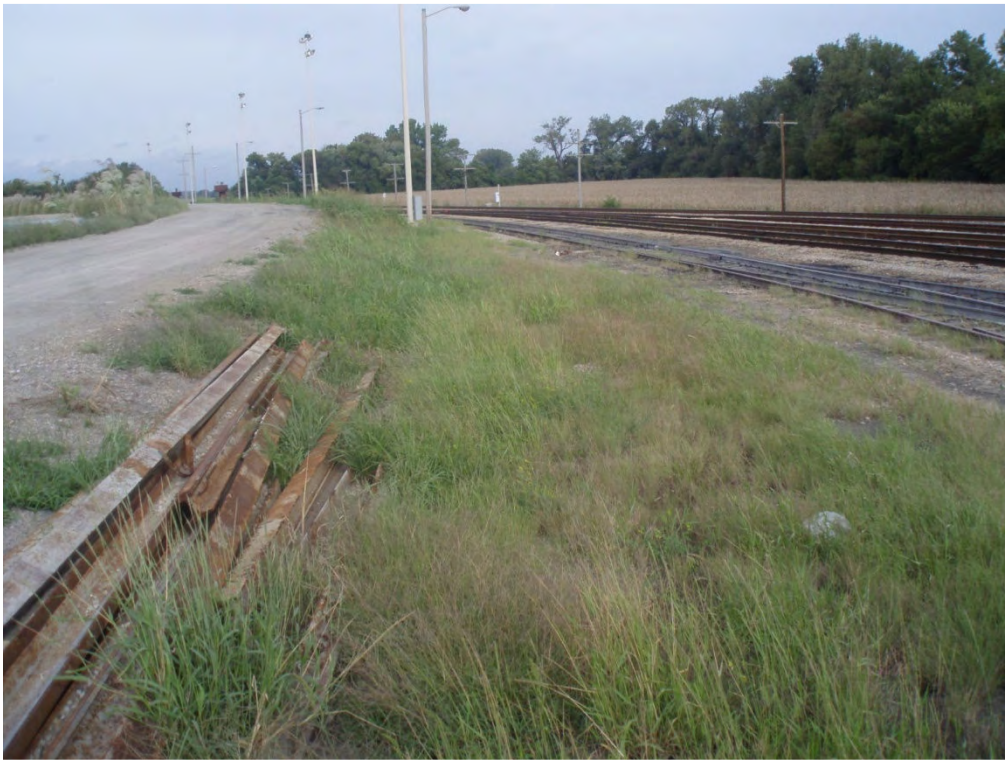
1. Exterior of north dike – Taken from east end of Area 1, looking west

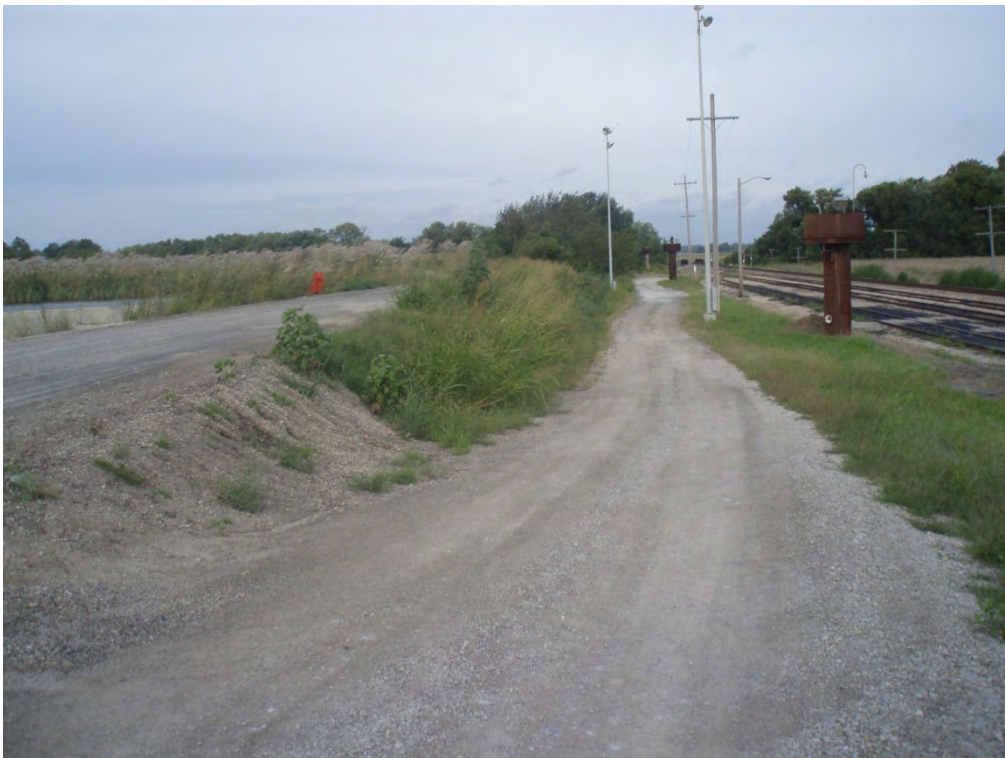
3. Interior of north dike – Taken from east end of Area 1, looking west

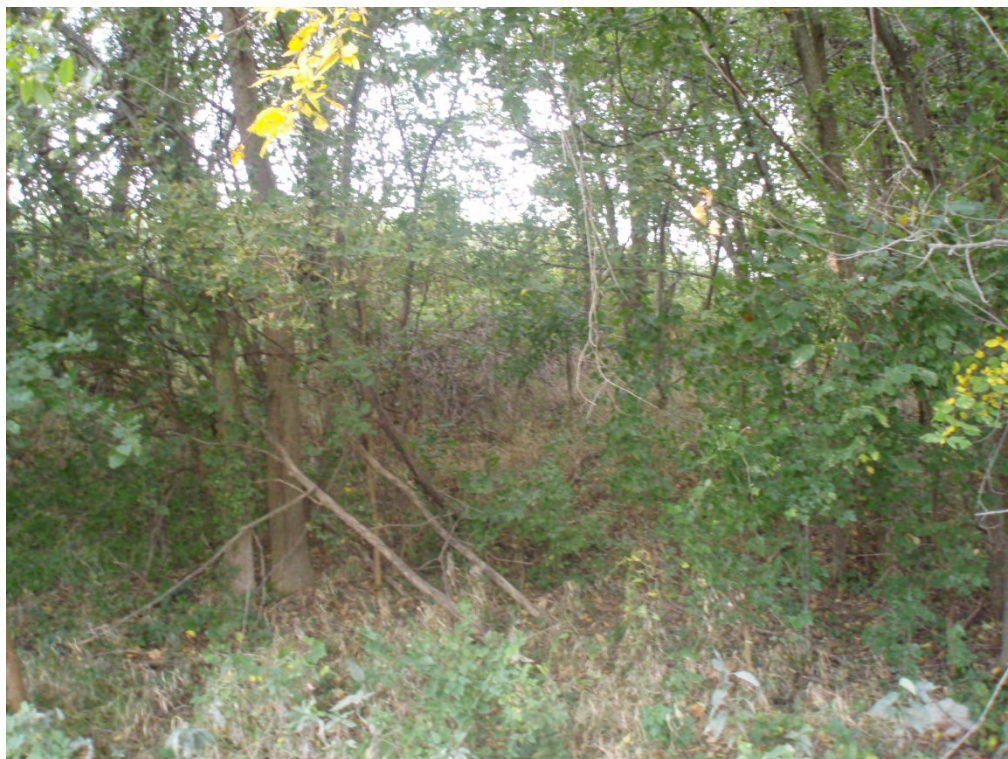
6. Outfall of emergency overflow structure – exterior of north side of Area 1 dike. Heavy vegetation made access to the outfall impractical.

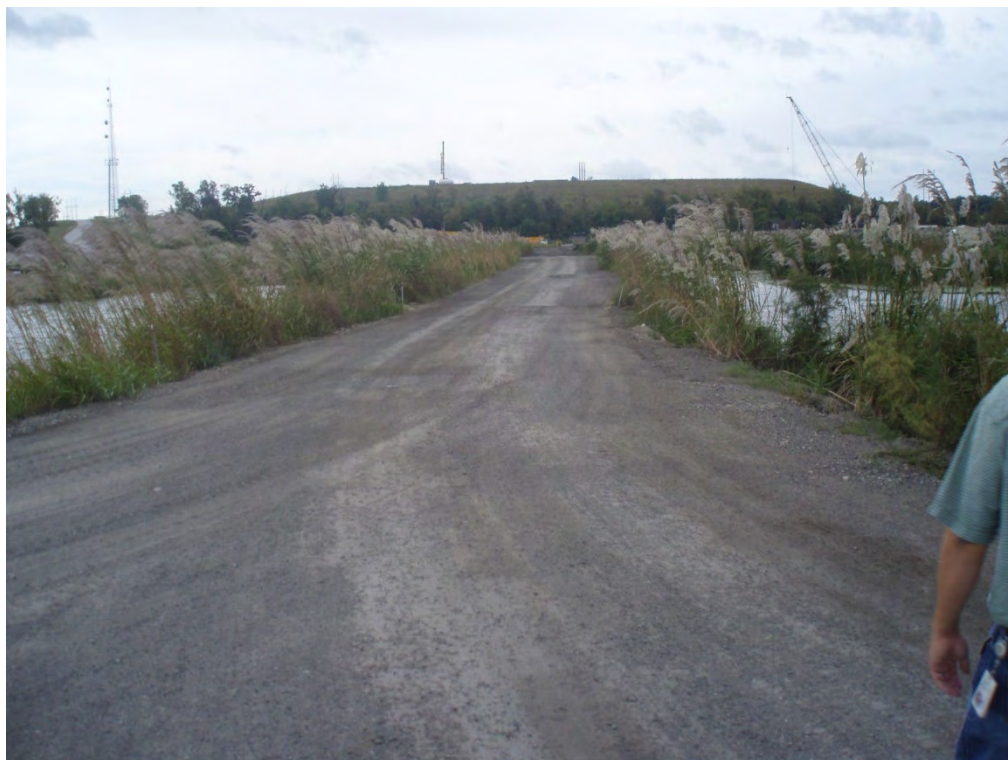
7. Exterior of dike – Taken from north side of Area 2 looking south, up side of dike.

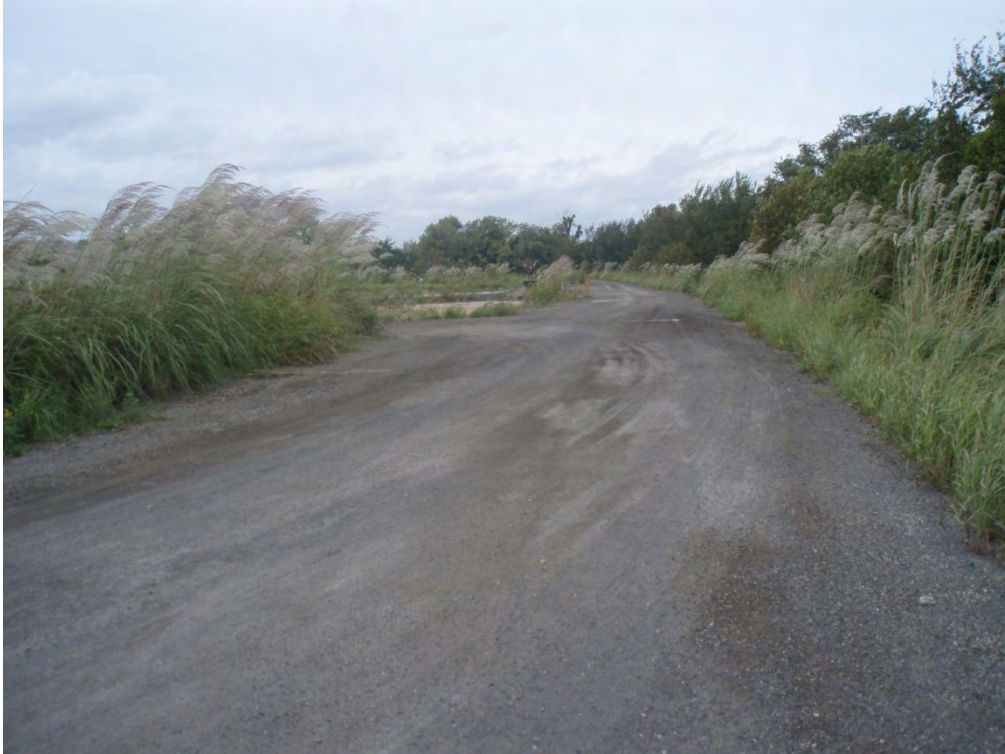
8. Interior separation dike, separating Area 1 from Area 2 - Taken from north end, looking south.

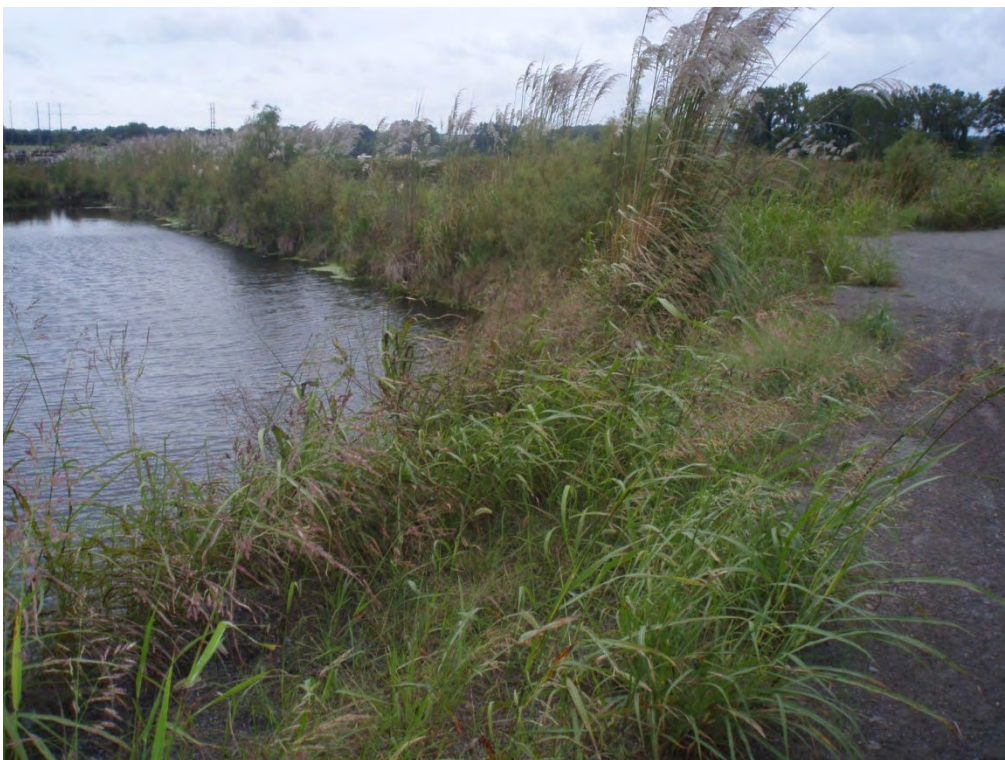
13. Exterior of northwestern dike (Area 4) – heavy vegetation and trees observed.

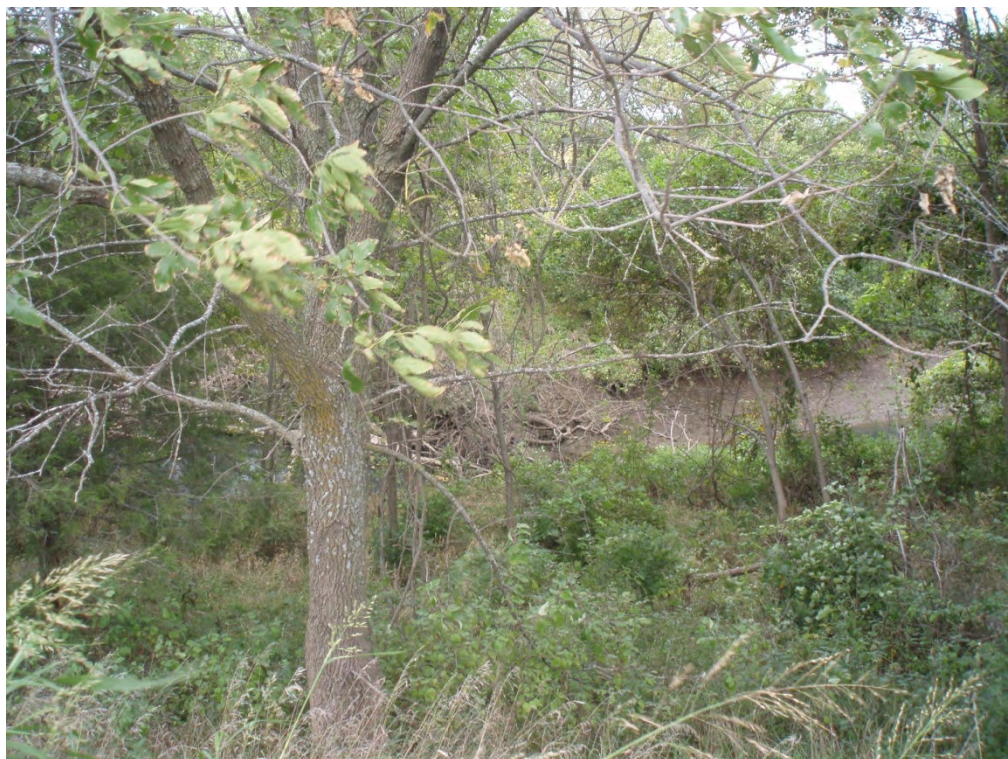
16. Exterior of northwestern dike (Area 4) – multiple trees observed on embankment.

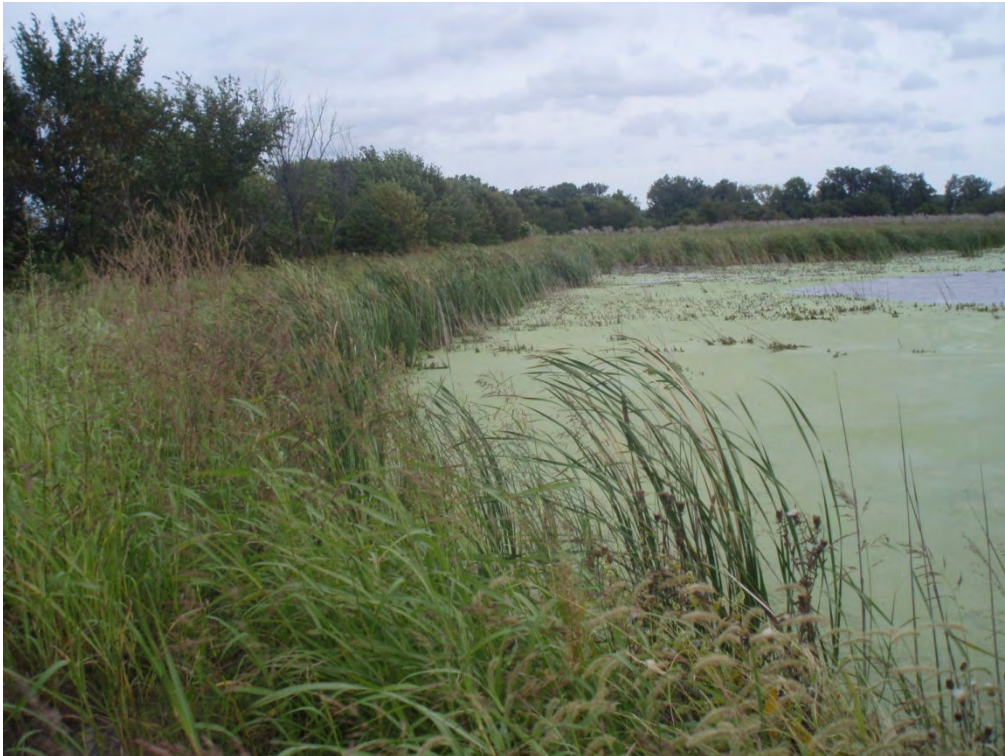
18. Exterior of northwestern dike (Area 4) – 10" tree observed at toe of embankment.

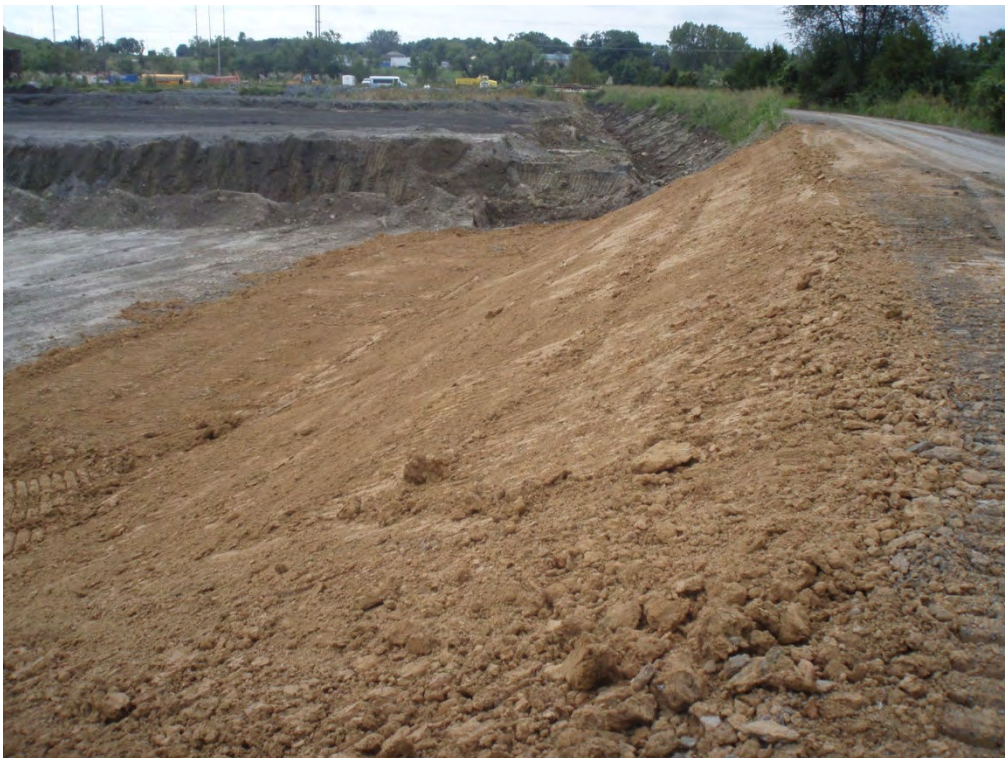
19. Interior of western dike – Taken from midpoint (between Area 3 and 4) looking north

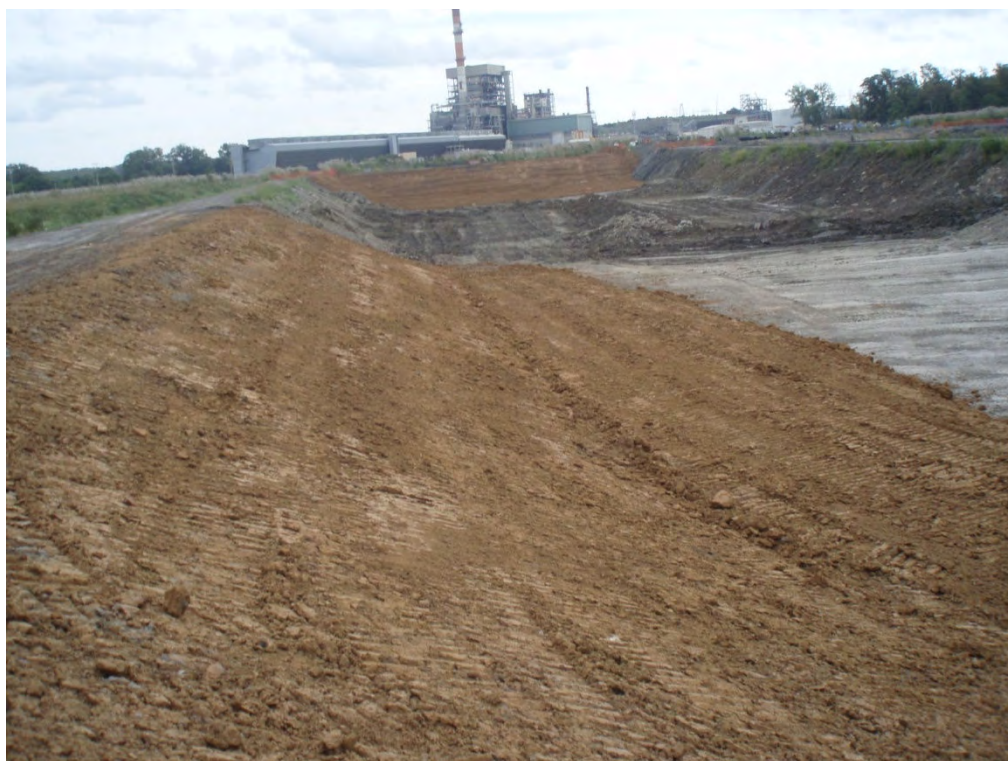
20. Interior of western dike (Area 3) – Taken from western dike looking south along interior of dike. Clay liner being installed

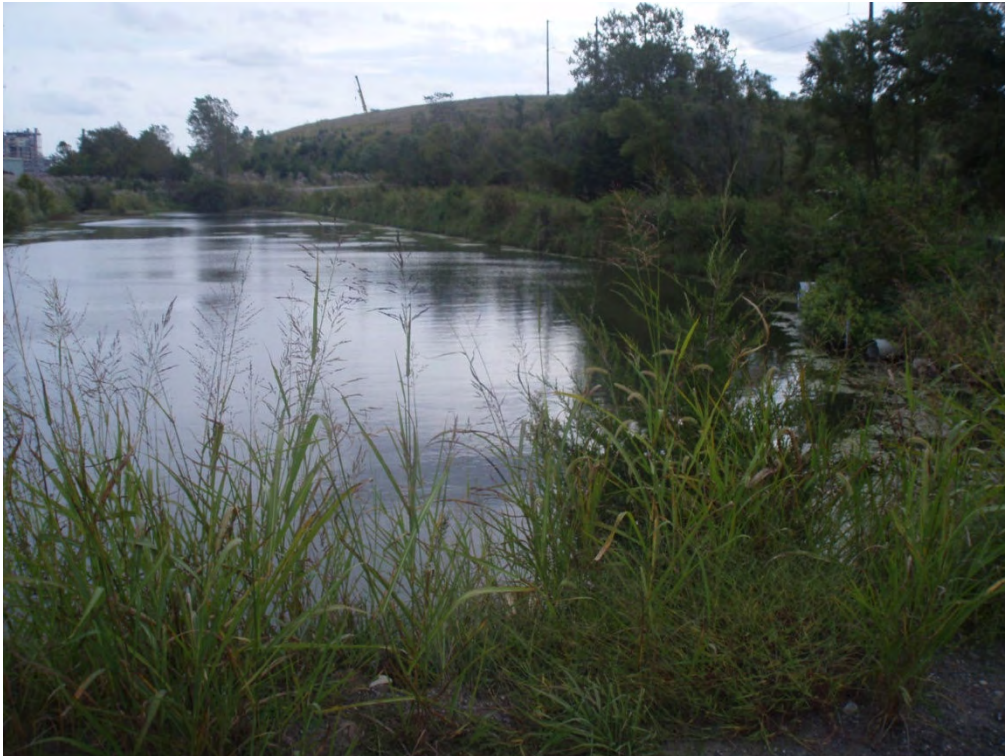
22. Looking west towards agricultural fields – Taken from top of western dike.

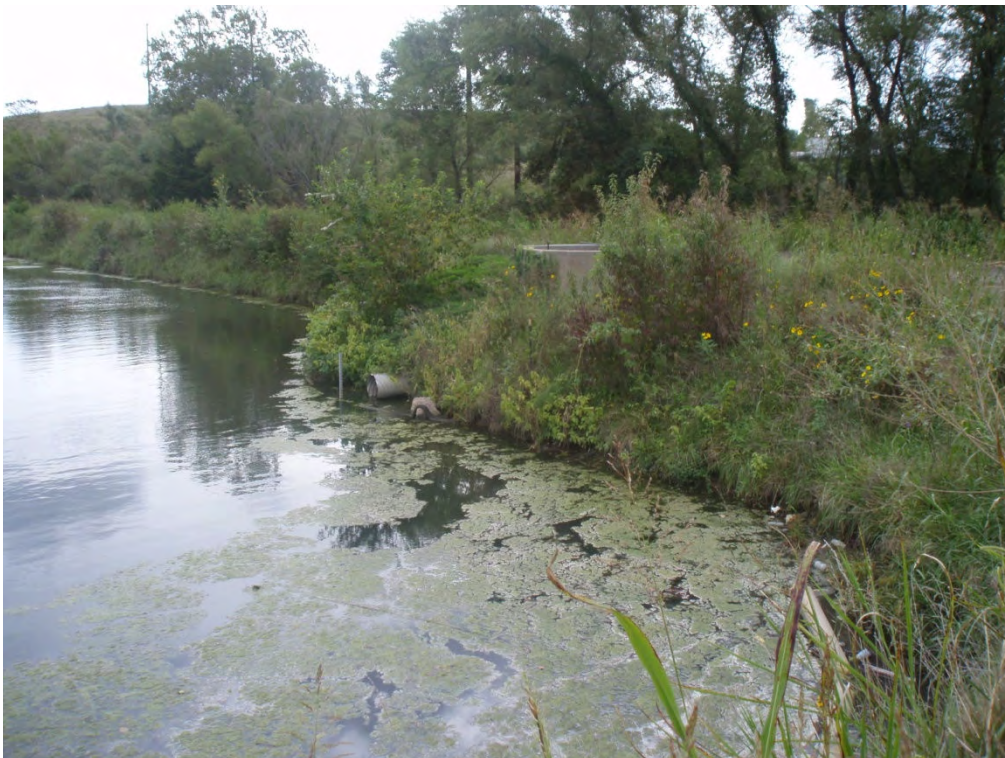
23. Storm water pond at south end of ash pond area/Area 3 – Taken from western dike looking east.

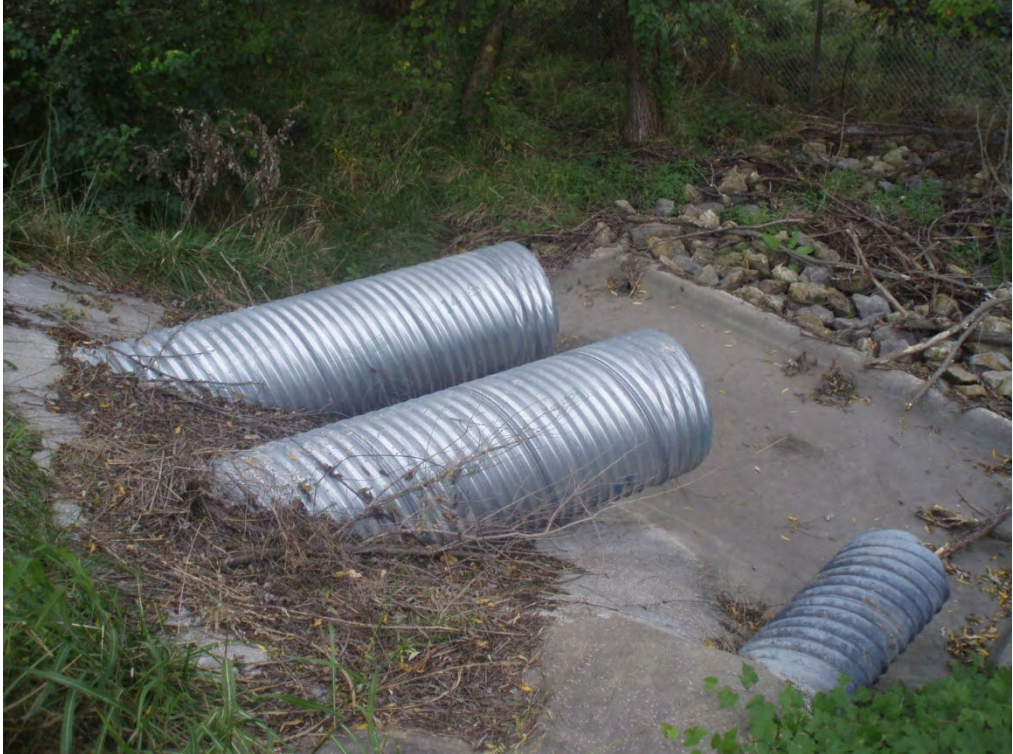
24. Storm water pond discharge pipe on interior of south side of dike.

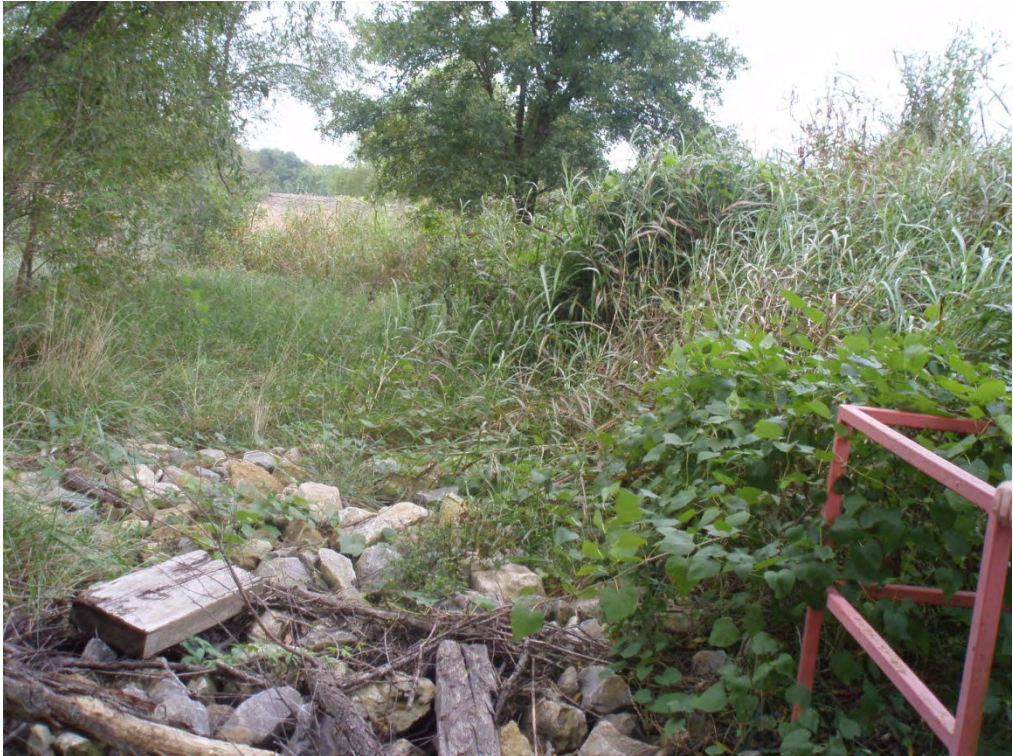
25. Storm water pond outfall pipes on exterior of south side of dike.

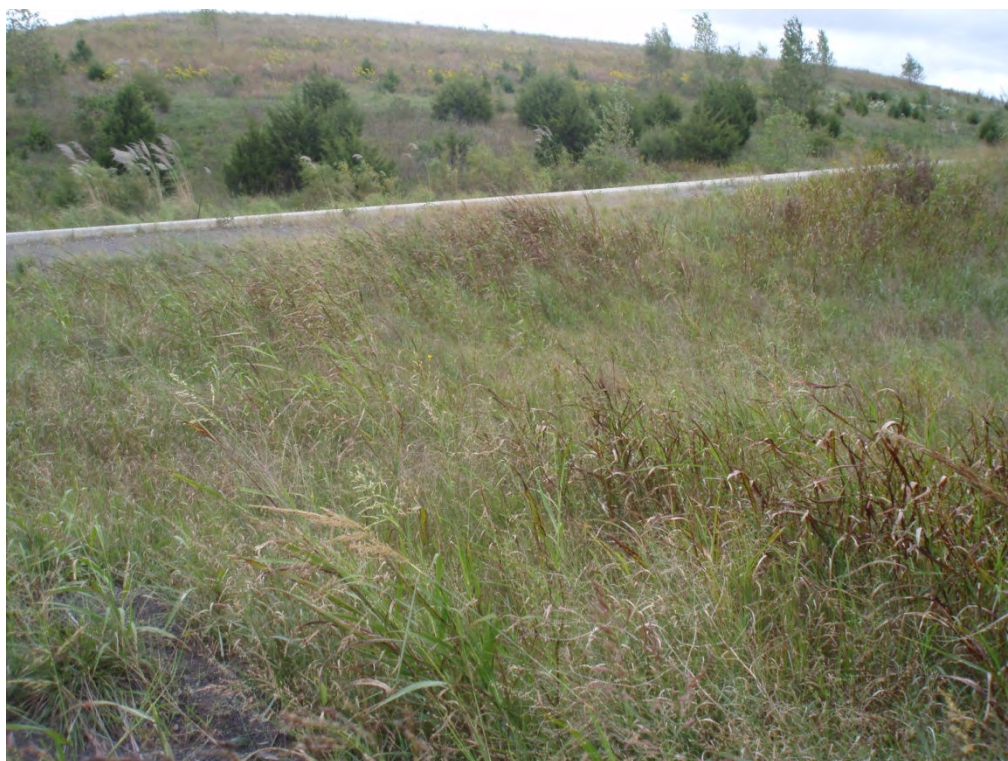
26. South dike – south side of storm water pond (Area 3).

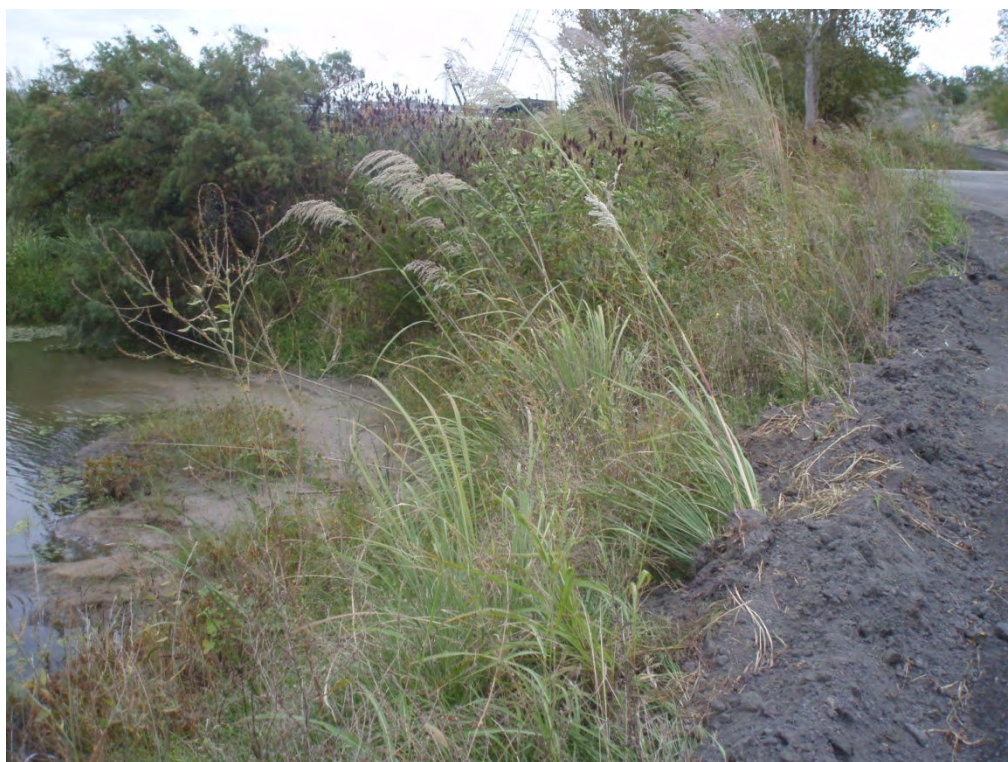
27. Exterior tie-in of south dike to existing grade/road embankment.

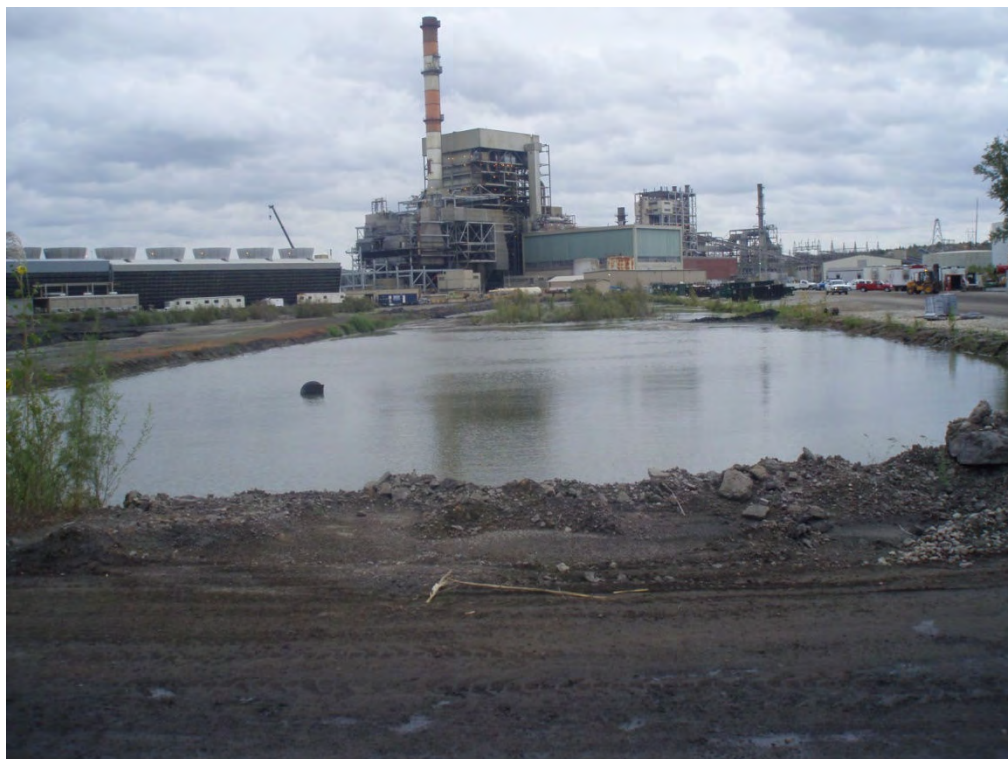
30. Channel connecting Area 2 and Area 3 – Taken from east end looking west.
