PROPERTY TRANSFER ASSESSMENT:
OLIVER PROPERTY
NORWEGIAN TOWNSHIP
SCHUYLKILL COUNTY, PENNSYLVANIA

PHASE I REPORT

Versar Job No. 6115.36

February 24, 1988

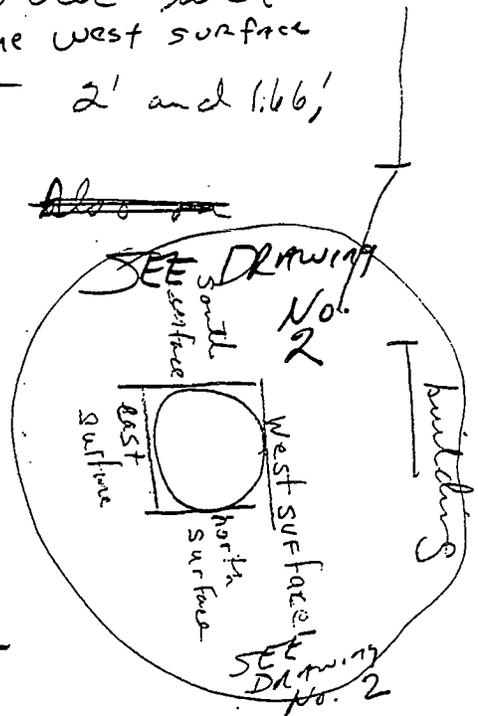
(4)

(b) Hole # 3 - Water slowly leaking into the hole at 3ft depth from the west surface. Two other wet spots were noticed ^{on the west surface} at 2' and 1.66', but no water leakage. ~~also on~~

Since water was leaking into the hole, two samples were

as usual scraping the entire perimeter at 4 foot ^{level} and ~~one~~ ^{another sample} at four foot level

avoiding the leakage from the 3 foot

level. The wet soil was checked for pH; 5gms of wet soil was placed in 50mls of distilled water (pH 5.44), mixed, and pH tested the pH was 5.67. Therefore no acidity was present.
