**WEDGEWIRE SCREEN SITE-SPECIFIC STUDY  
ENGINEERING EVALUATION**

**GSP SCHILLER LLC – SCHILLER STATION  
PORTSMOUTH, NEW HAMPSHIRE**

**Submitted by:**  
Enercon Services, Inc.  
7677 Oakport Street, #950  
Oakland, CA 94621  
**July 28, 2020**

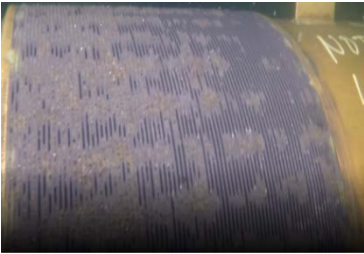
| Downstream Riverside | | |

Images of the damaged subsections of the 0.8 mm wedgewire screen are provided in Table C-6. No equivalent or comparative images of the 3.0 mm wedgewire screen are provided due to the

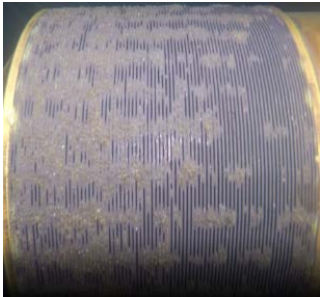
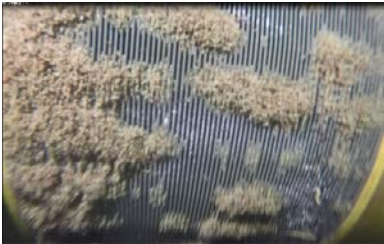
| October 1, 2019 | December 7, 2019 | On Shore January 23, 2020 |
|---|---|---|
| Downstream Riverside | | |

**Table E-8: Imagery of Measured Damage on Pilot Wedgewire Screens**
