Municipality/Organization: City of Malden
EPA NPDES Permit Number: MA041046
MADEP Transmittal Number: 041088
**Annual Report Number
& Reporting Period:** No. 1: April 1, 2010-March 31, 2011

NPDES PII Small MS4 General Permit Annual Report

Figure 1 - Dry Weather Inspection/GPS Mapped Areas (4-29-2011)

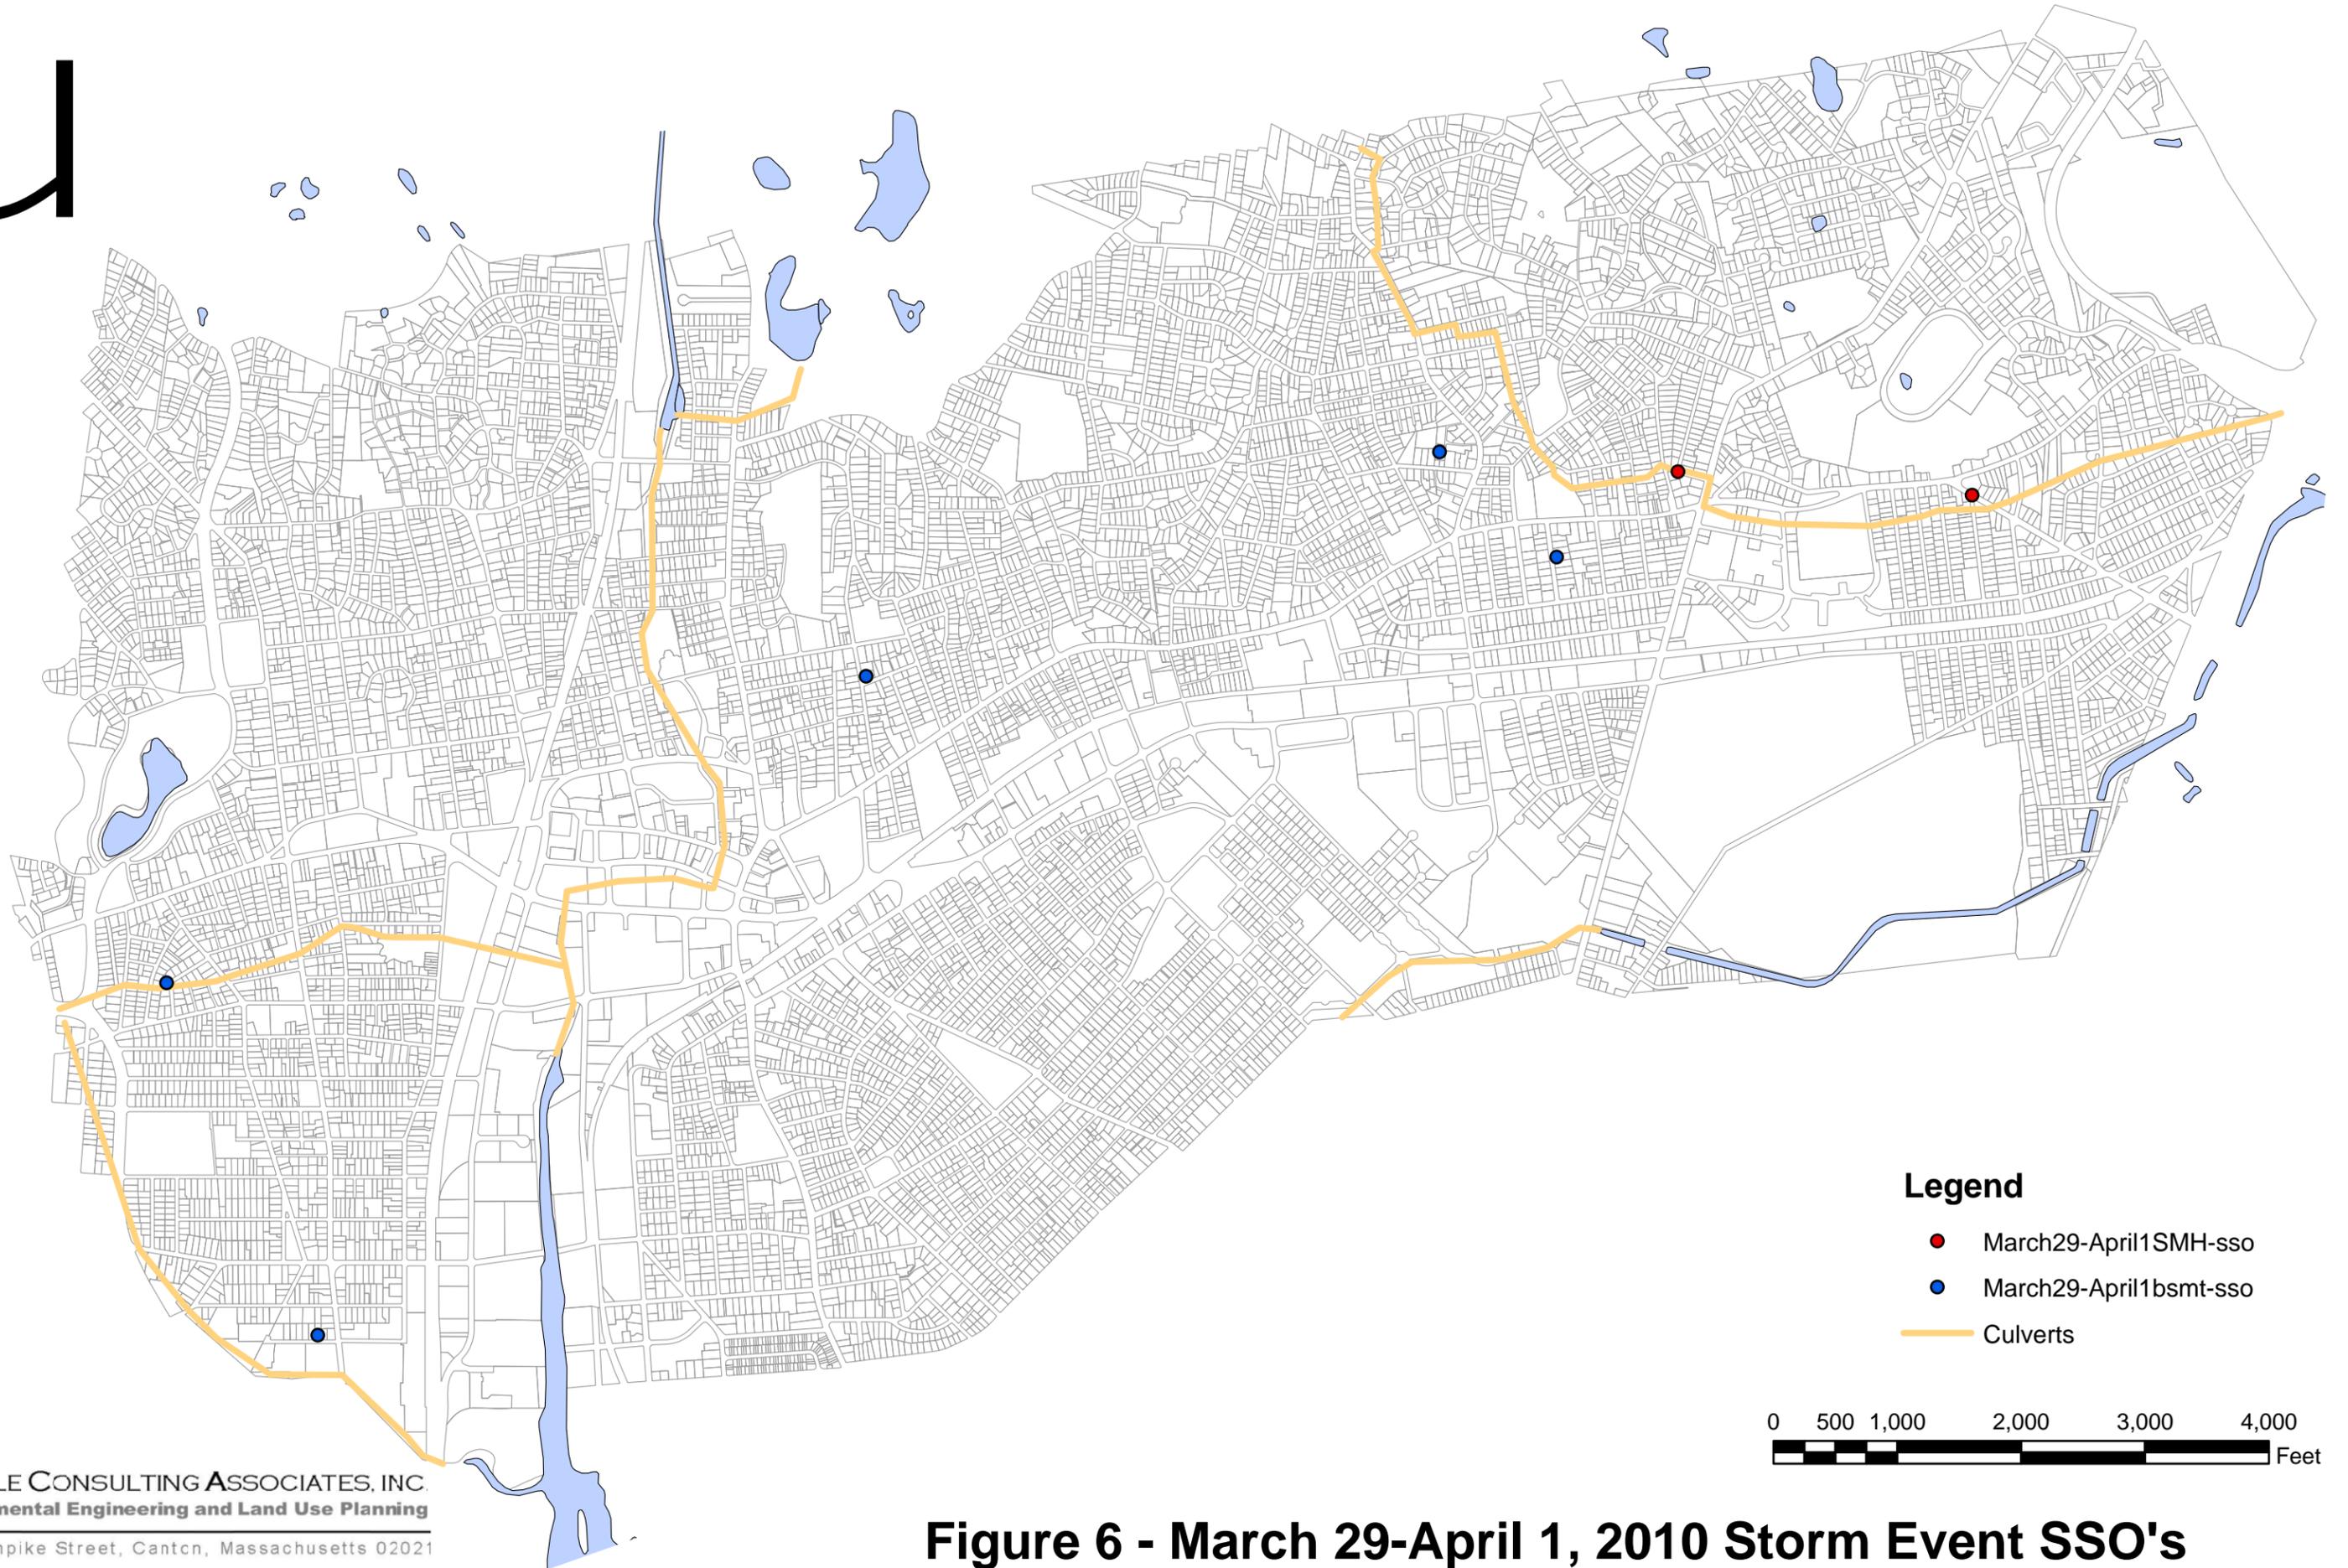
Figure 6 - March 29-April 1, 2010 Storm Event SSO's

A second storm event began on 29 March 2010 and the City was notified by the MWRA that previously sealed bypass structures to the Malden River would be opened to mitigate the potential for surcharging within the City. Significant volumes (5-10 million gallons) of waste water were also discharged by the MWRA during this storm event within downstream portions of the system to prevent treatment system damage and mitigate up stream SSO's. As evidence from a review of Figure 6 as compared to Figure 5, a significantly less number of occurrences were reported following the second storm event, which may be due in part to the relief in downstream flow due to emergency measures taken by the MWRA. A listing of all of the SSO locations that was included within the City's notification to USEPA is included within Appendix B of this report. Other than the two storm events described above, no additional SSO's have been identified during this reporting period. A map depicting the location of all prior SSO's that have been identified to date is presented as Figure 7.
