Municipality/Organization: City of Malden
EPA NPDES Permit Number: MA041046
MADEP Transmittal Number: 041088
**Annual Report Number
& Reporting Period:** No. 9: April 1, 2011-March 31, 2012

NPDES PII Small MS4 General Permit Annual Report

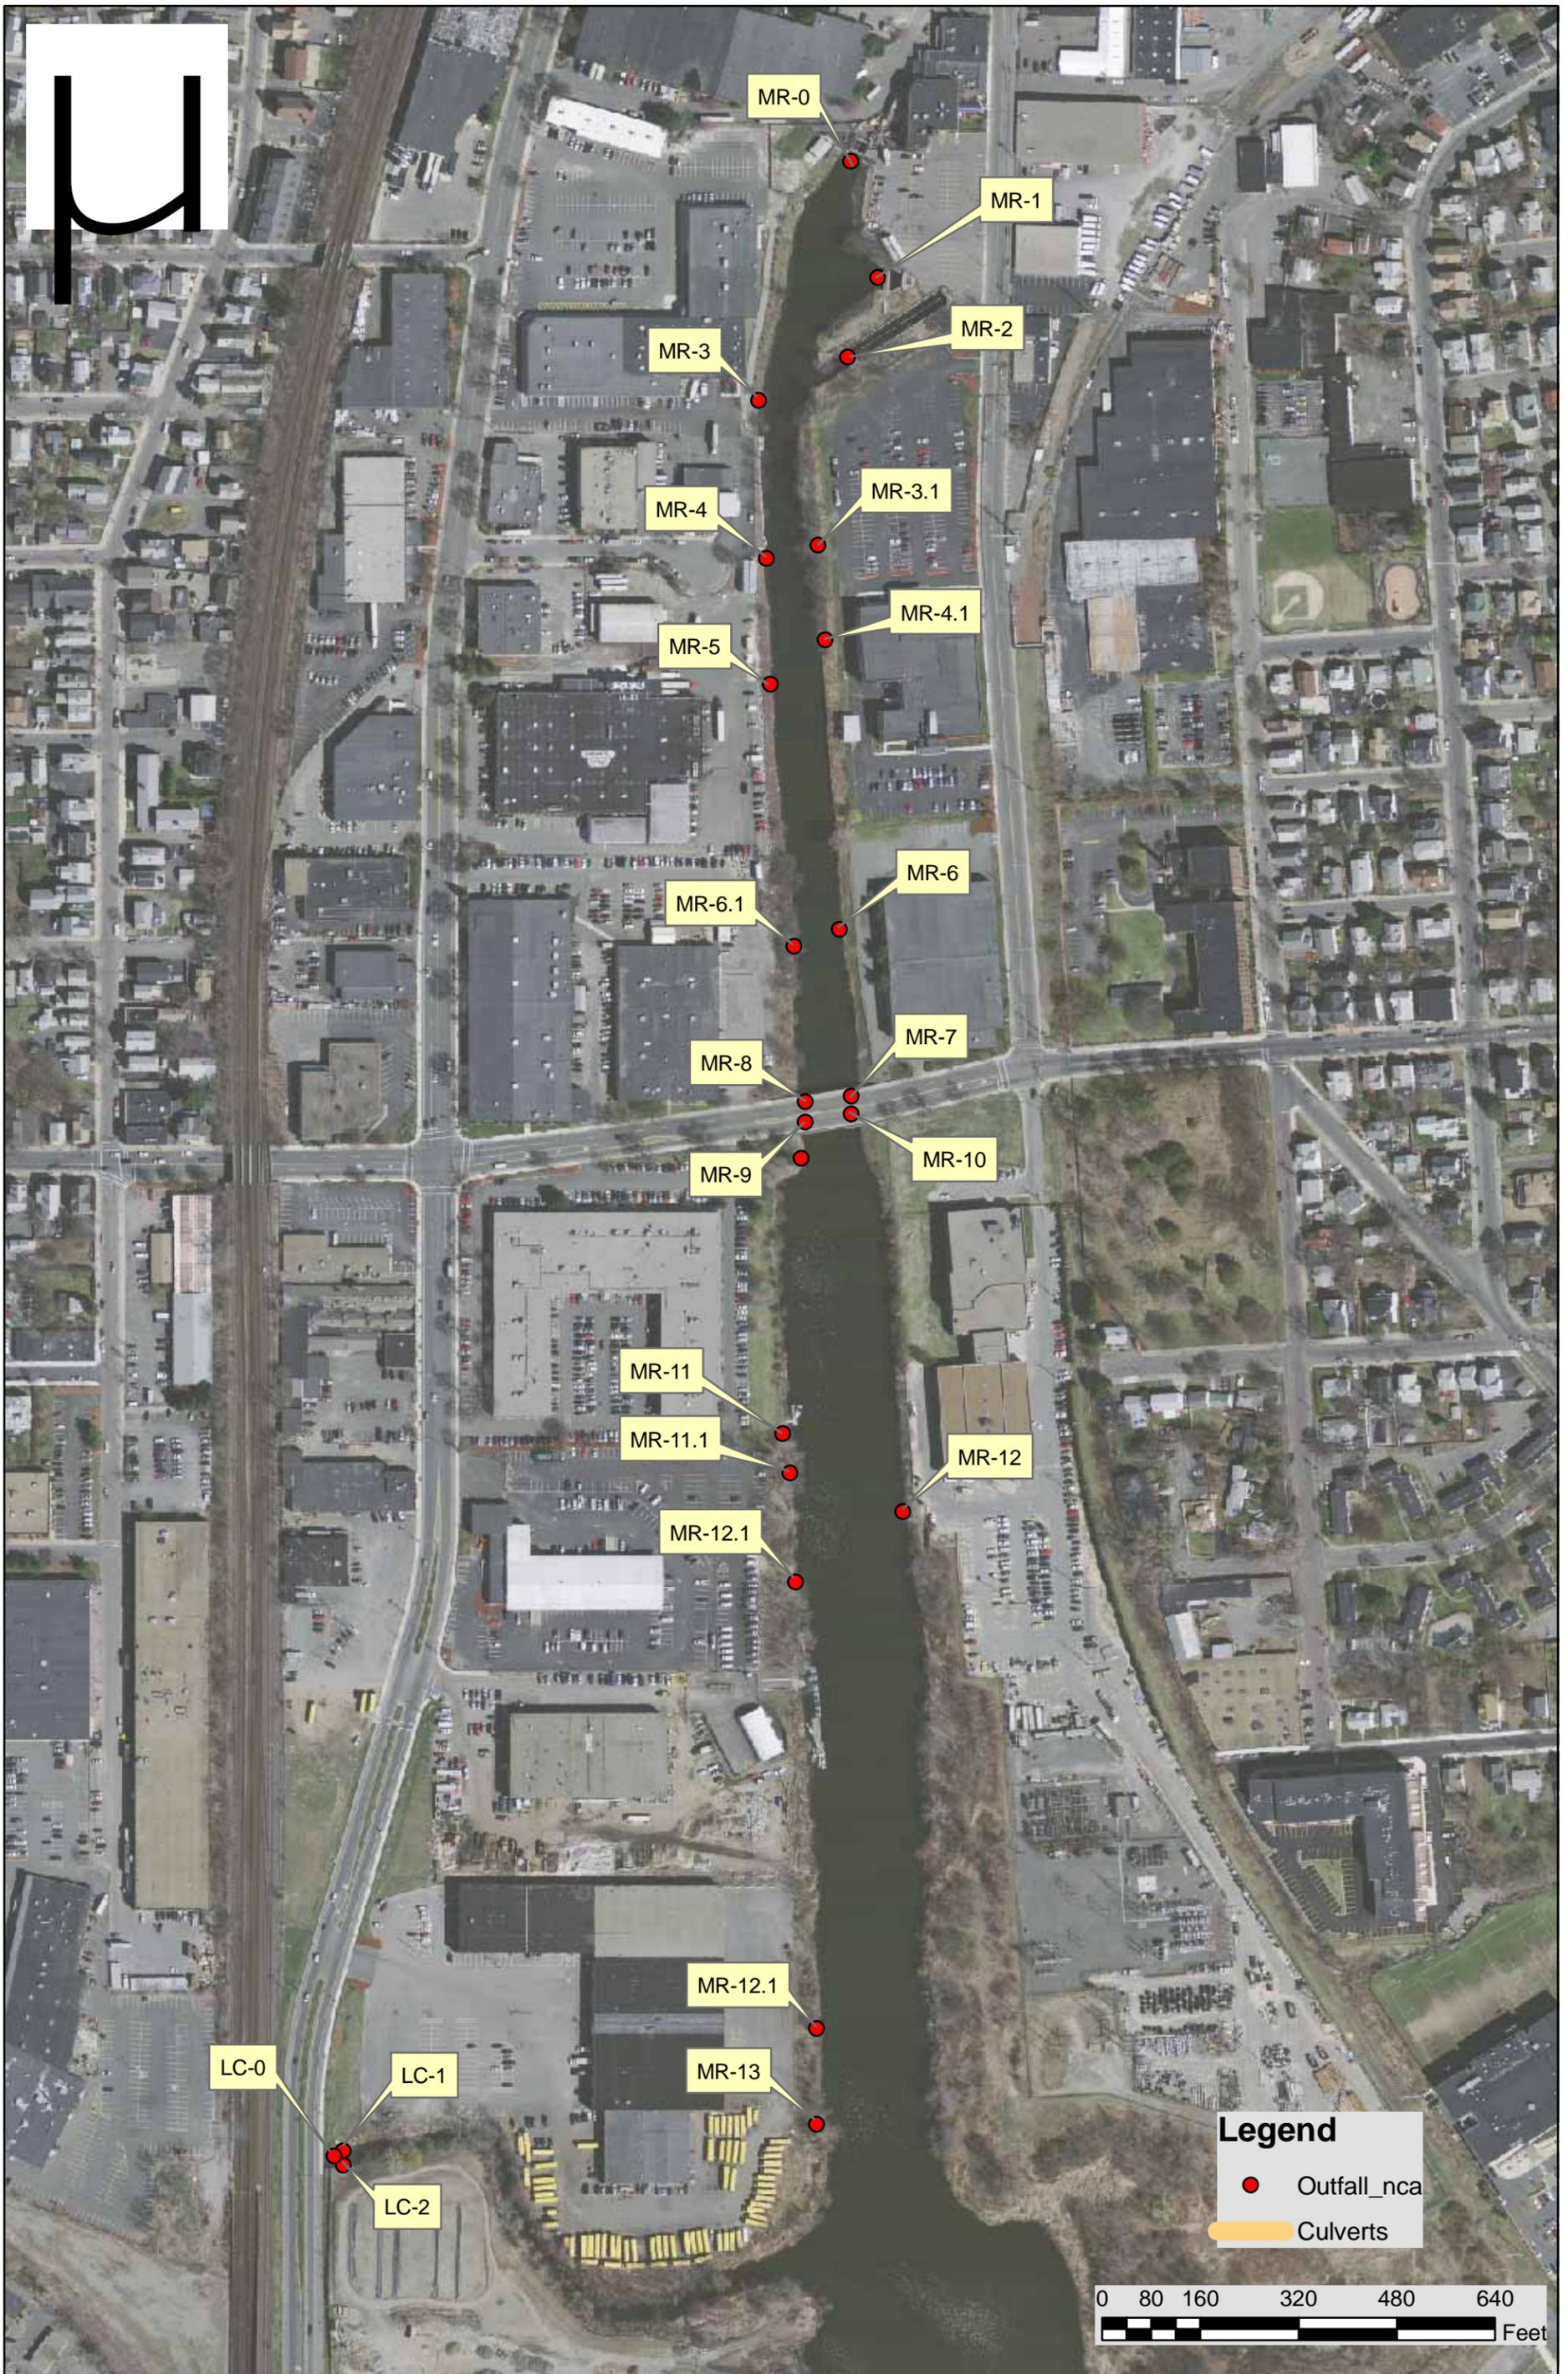
Figure 4 - Dry Weather Flow Map (as of 12-31-10)

During the course of the dry weather inspections, a number of dry weather flows, consisting primarily of waterline leaks and culverted surface waters have been identified. A summary of these flows within the municipal system that have been identified to date are shown on Figure 4, and are described as follows.
