**Municipality/Organization:** City of Malden  
**EPA NPDES Permit Number:** MA041046  
**MADEP Transmittal Number:** 041088  
**Annual Report Number & Reporting Period:** No. 10: April 1, 2012-March 31, 2013

## NPDES PII Small MS4 General Permit Annual Report

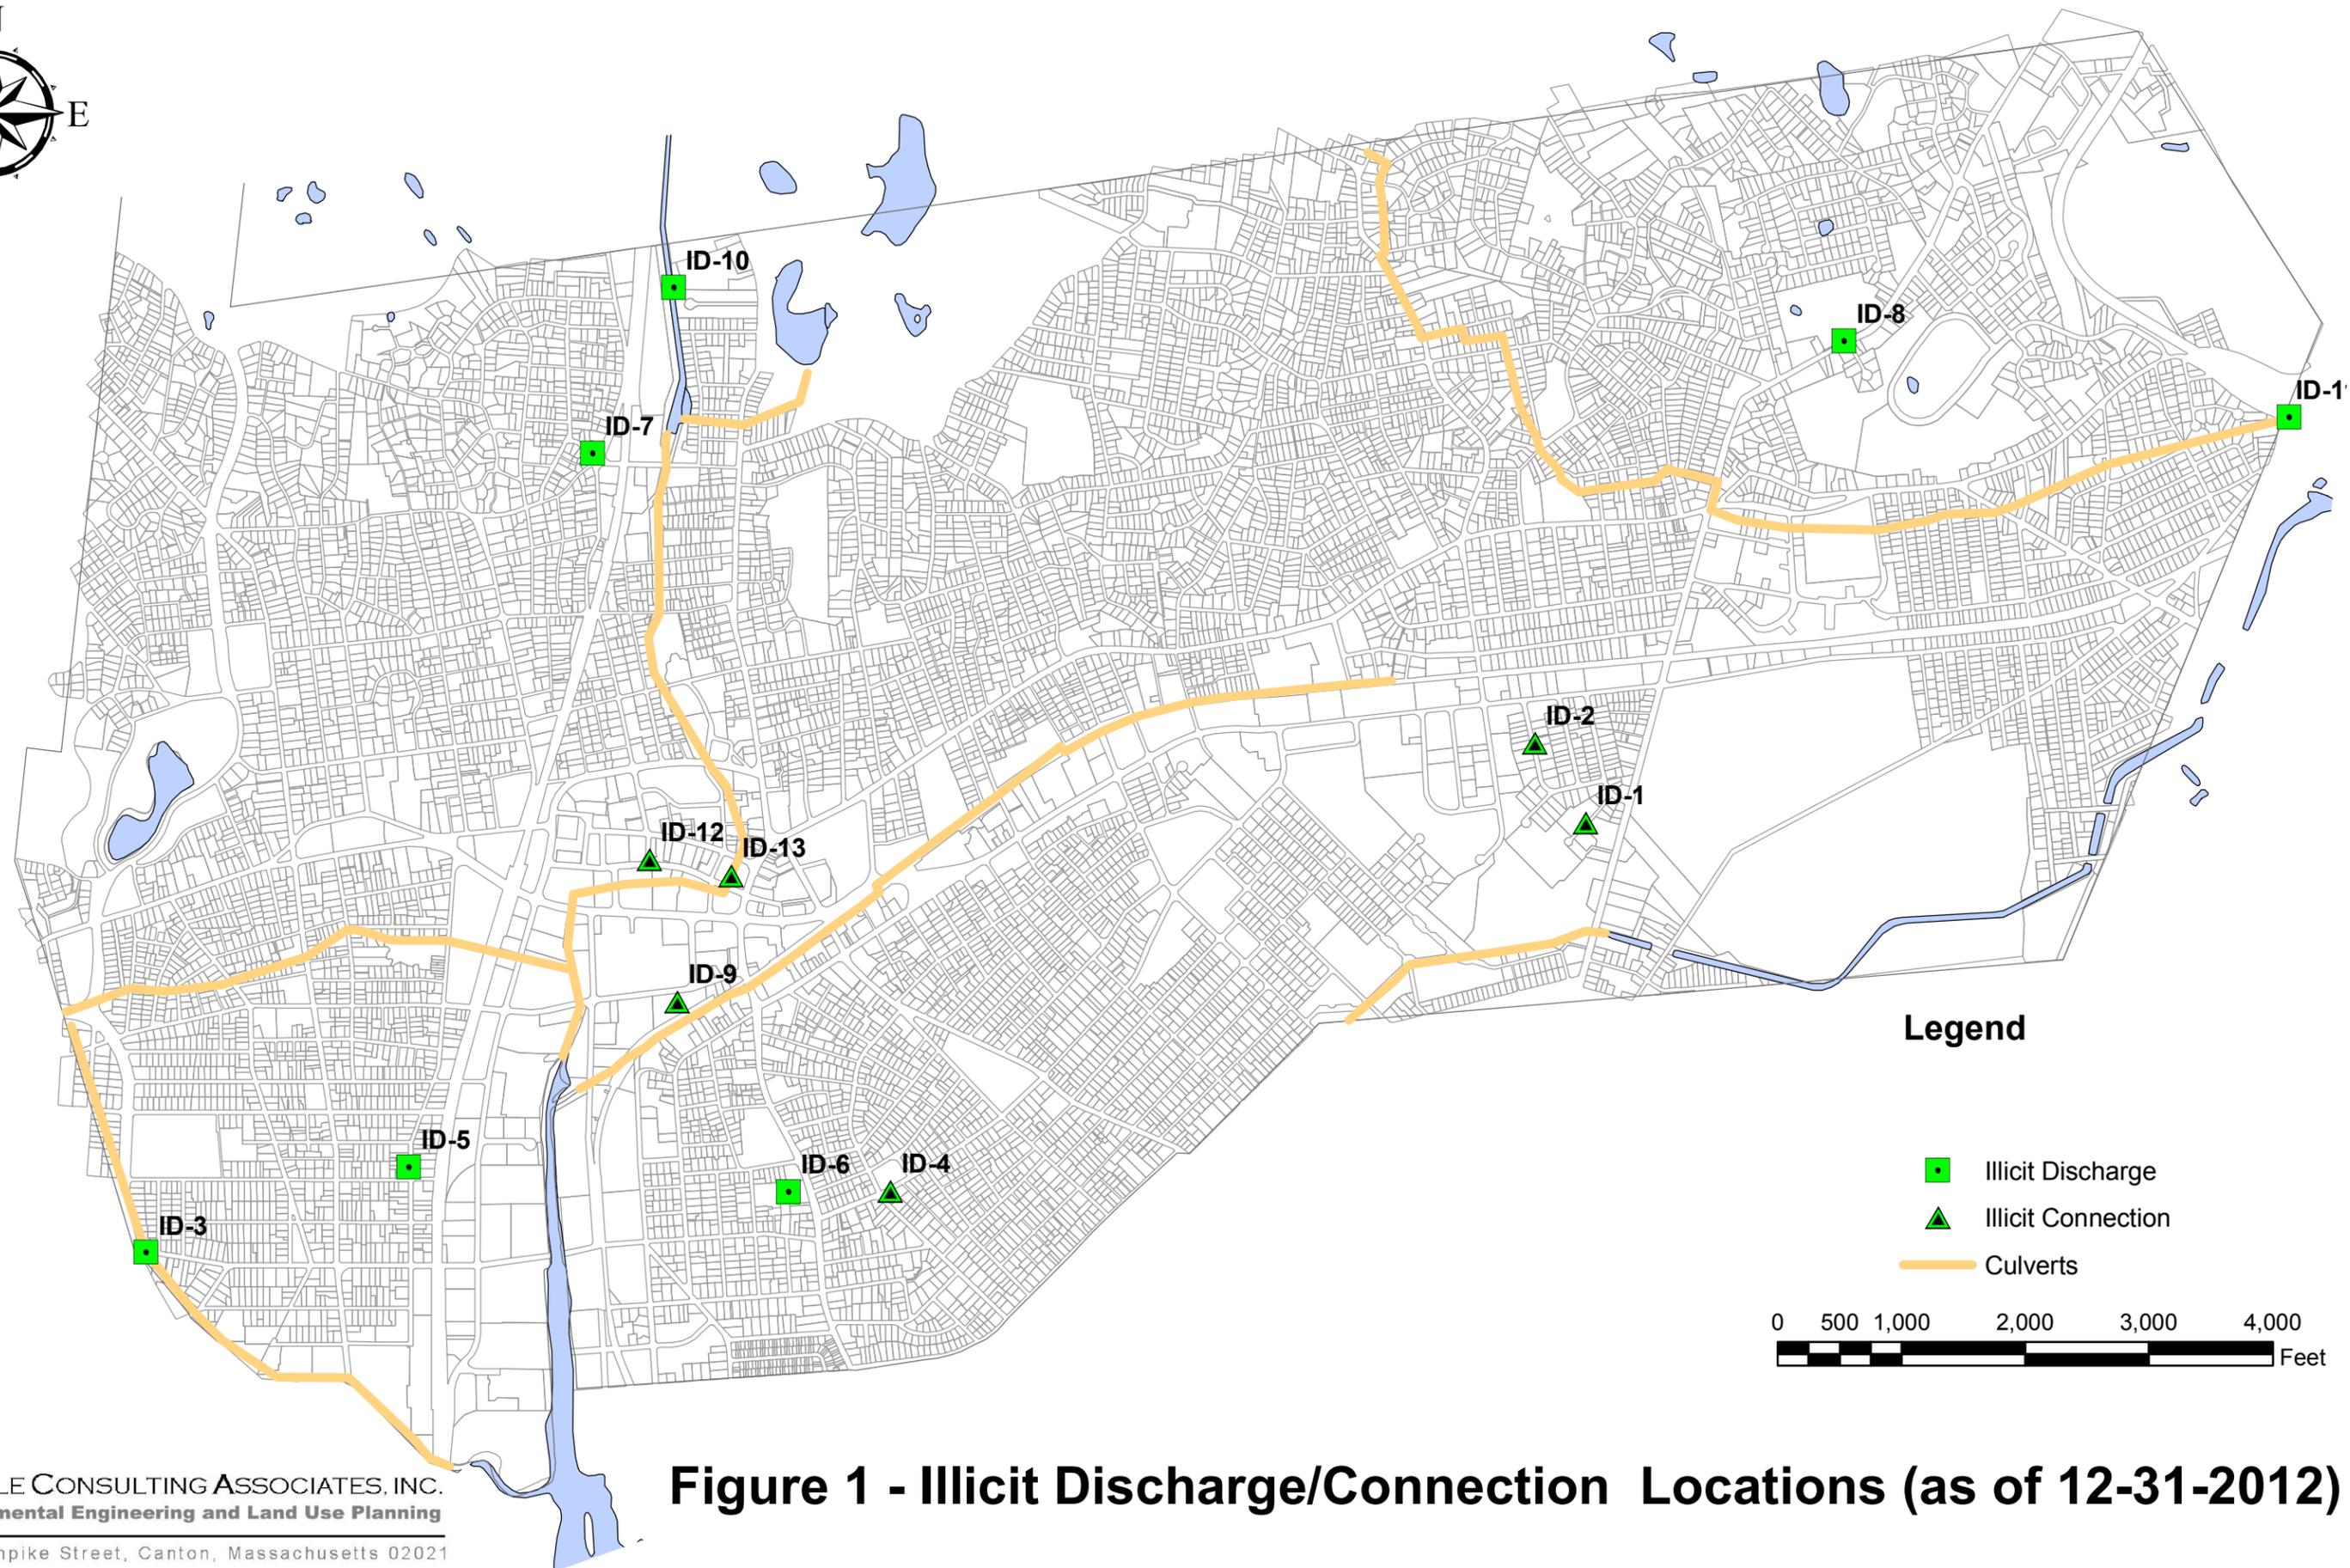
**Figure 1 - Illicit Discharge/Connection Locations (as of 12-31-2012)**

During this reporting period, one illicit discharge in the form of a compromise to sewer lateral connections for a residential complex was identified. A summary of the illicit discharges/connections identified to date is presented on Figure 1 and Table 1.0.

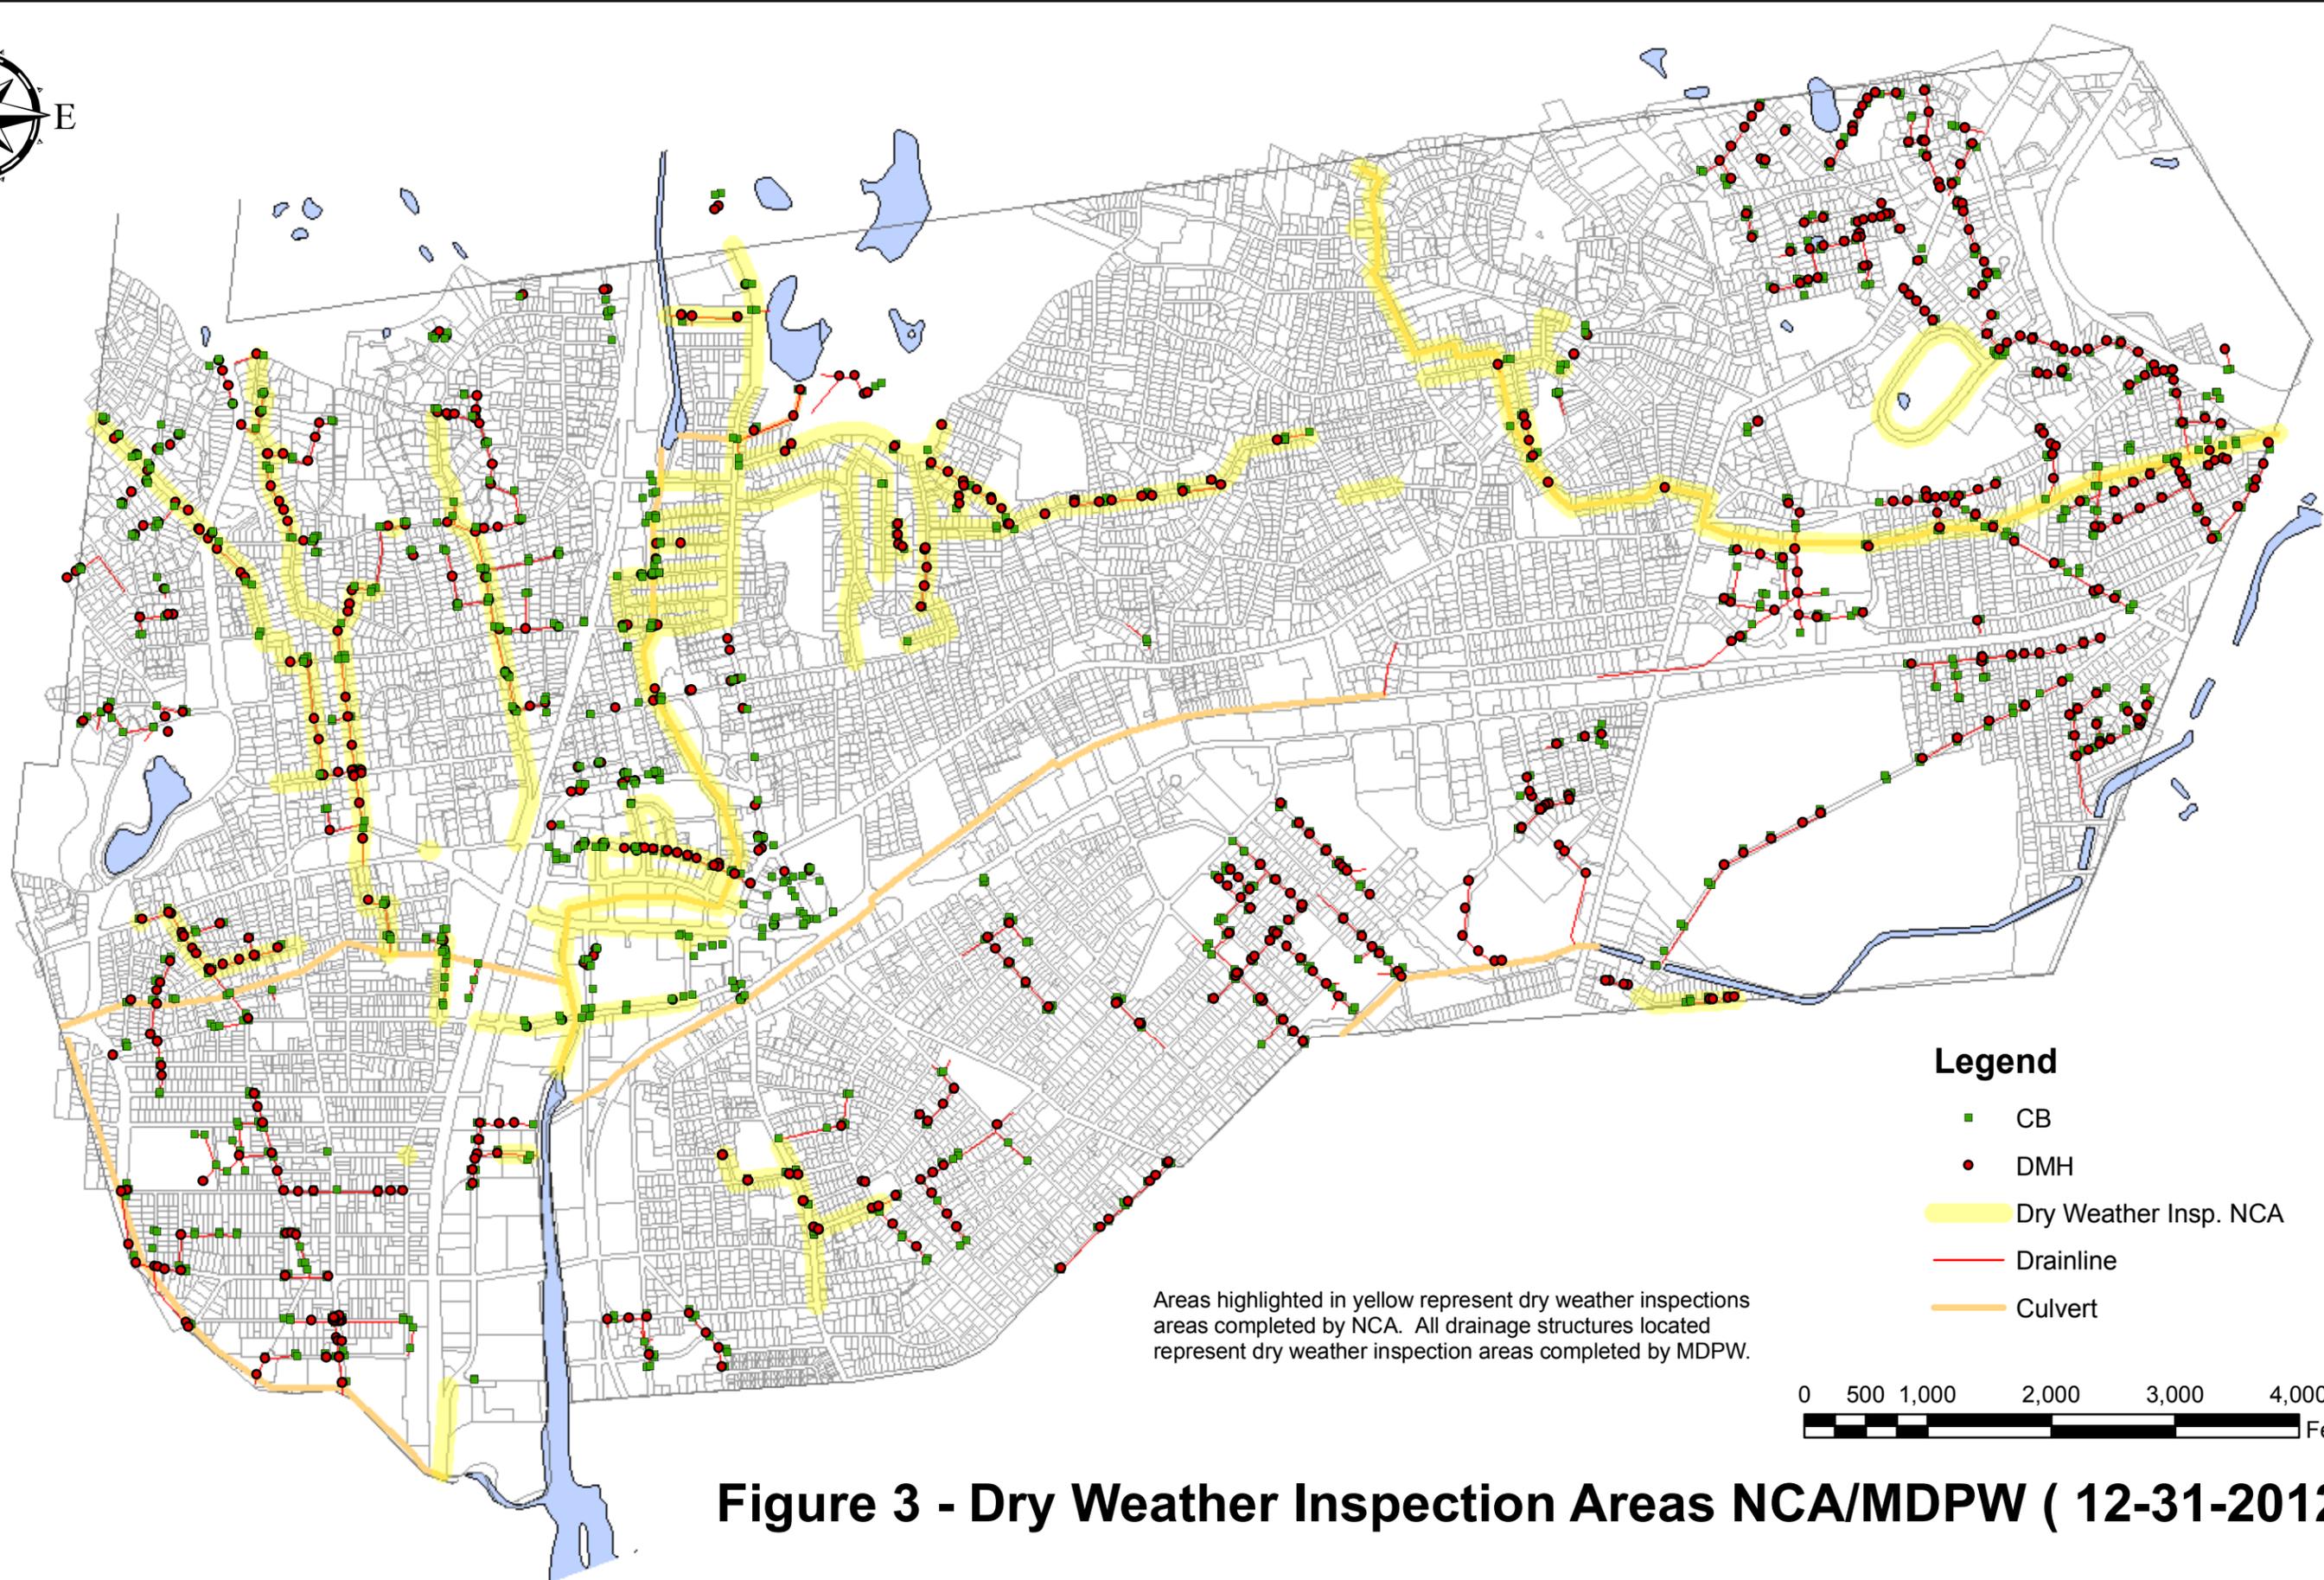
Areas highlighted in yellow represent dry weather inspections areas completed by NCA. All drainage structures located represent dry weather inspection areas completed by MDPW.

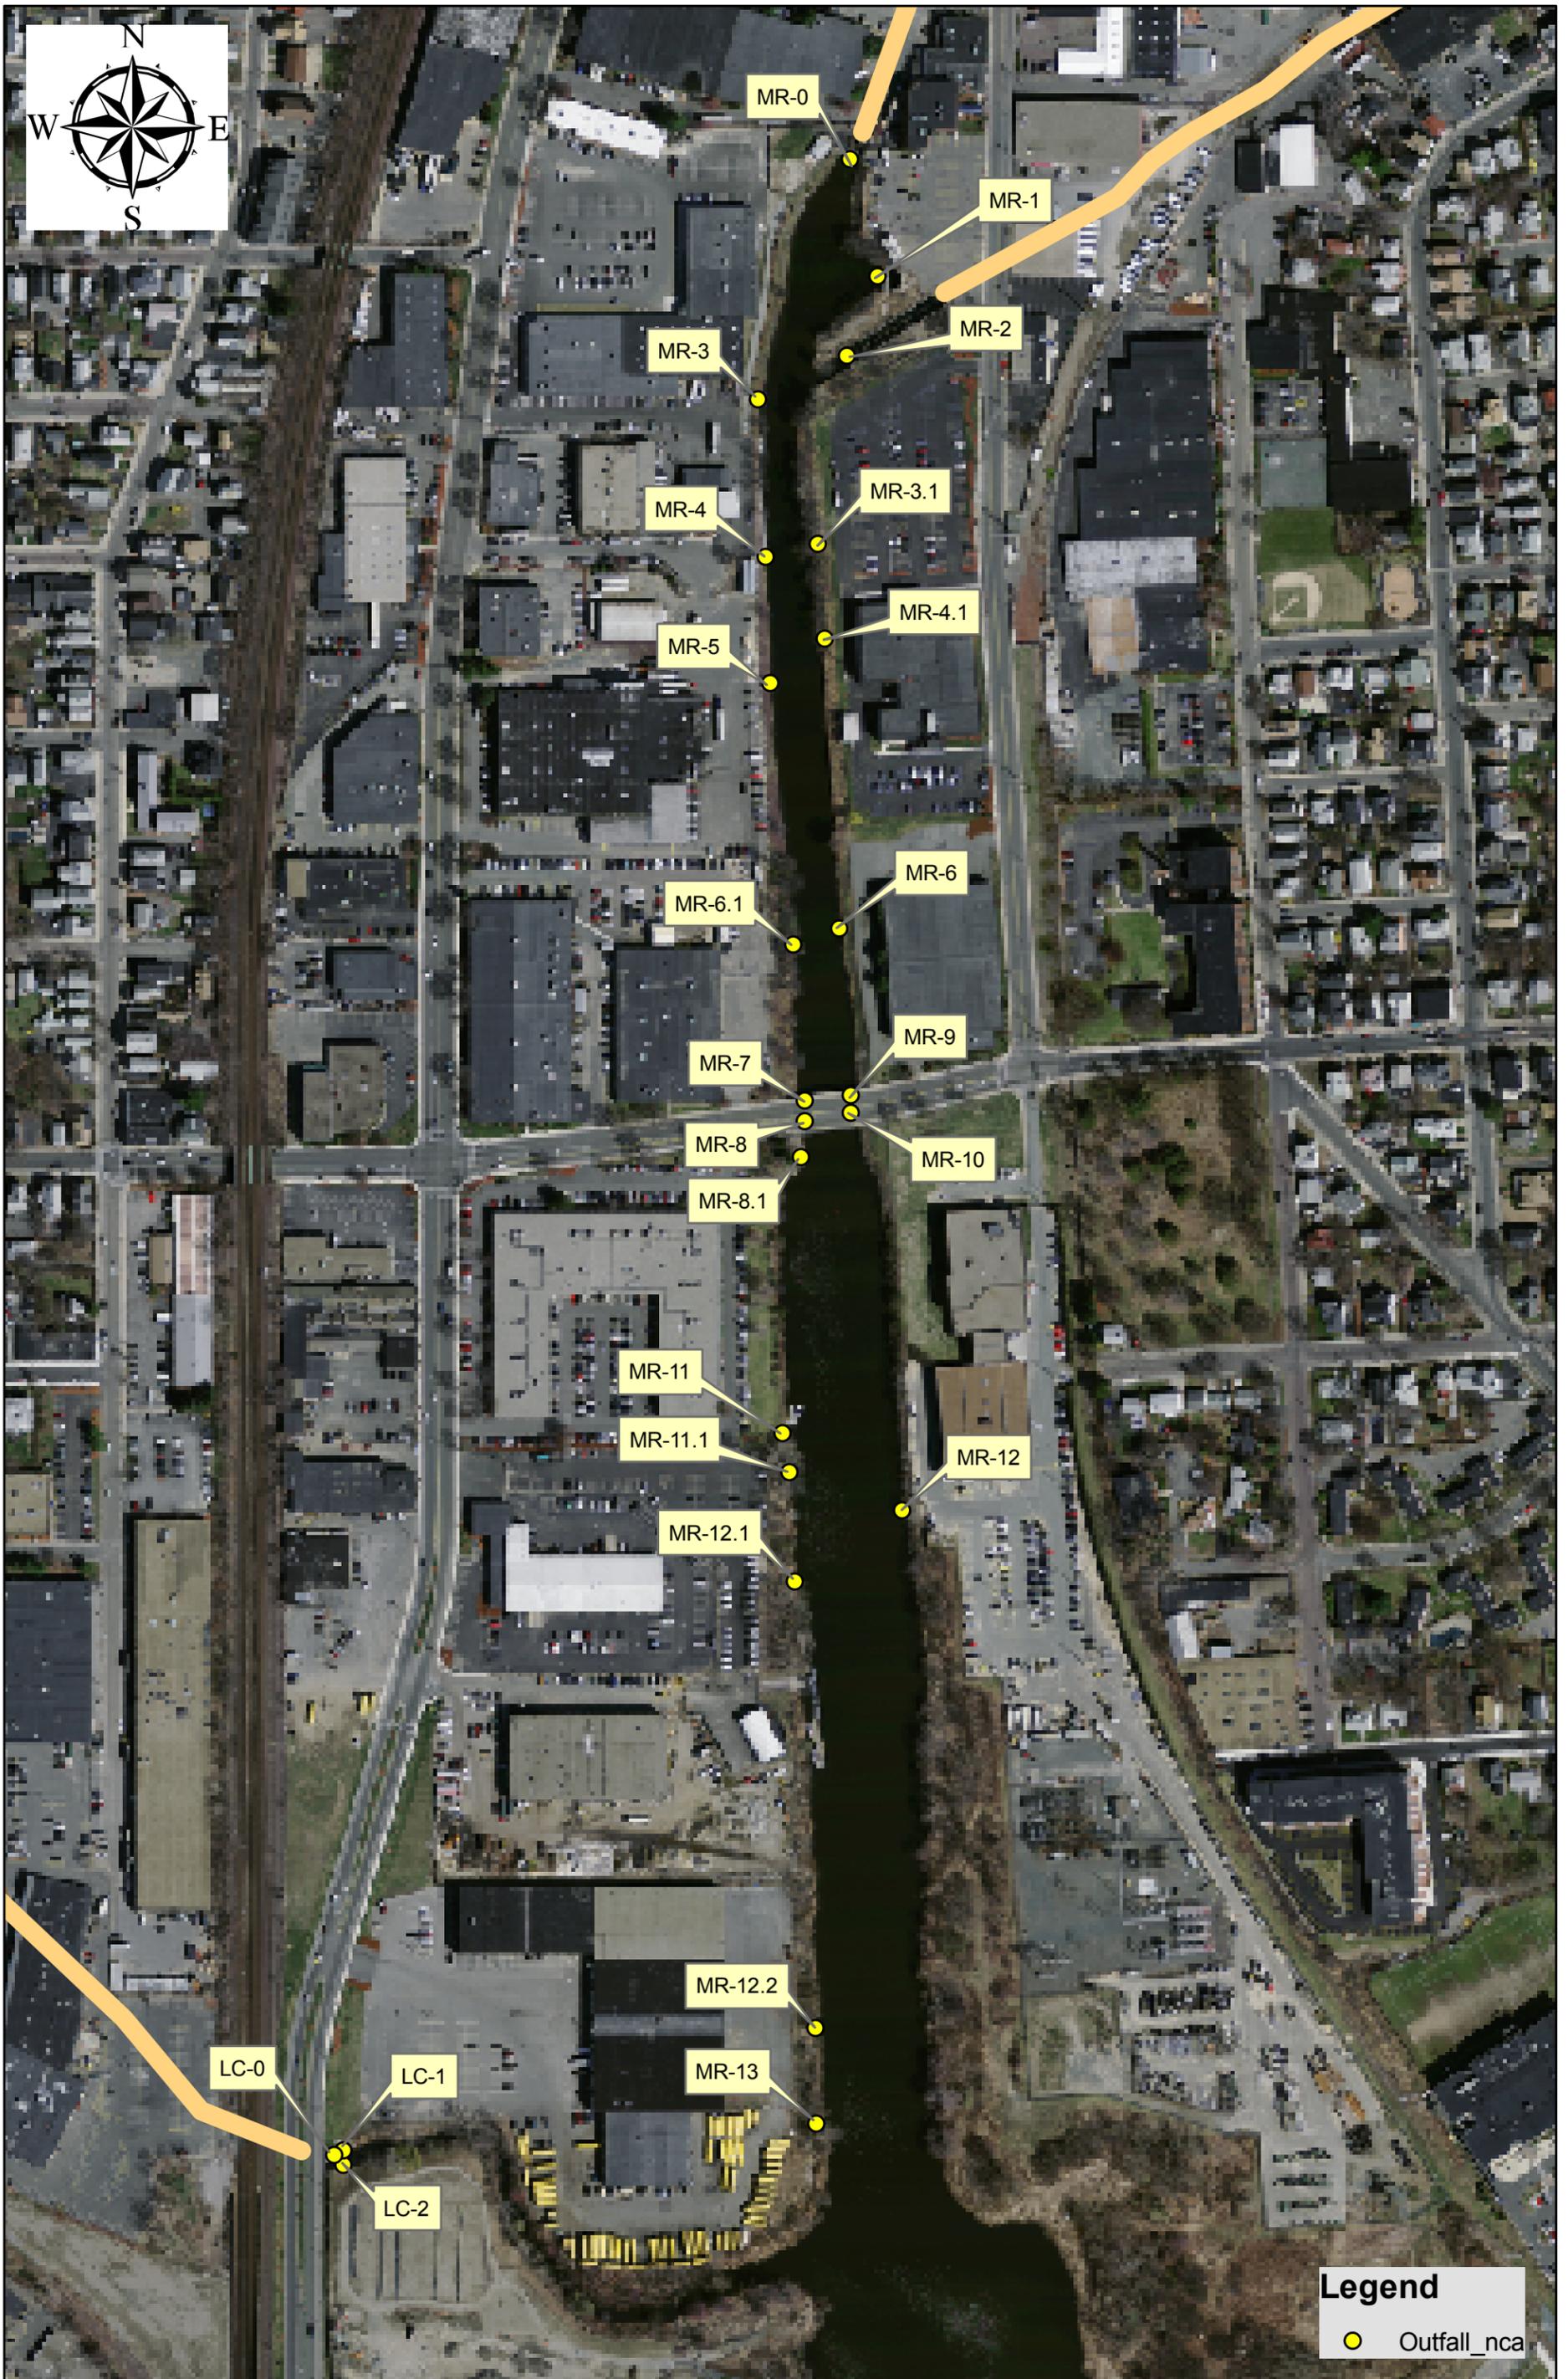
**Figure 5 - Malden River Outfalls**

The City of Malden's stormwater compliance team initially targeted potential illicit discharges to the Malden River as its highest priority. Utilizing the outfall monitoring data and information obtained during sampling events, the City has identified significant base flow as surface waters, to the Malden River during dry weather conditions. Consistent with the original design of the MDC/DCR conveyance network; this occurs primarily through culverted channels/brooks located in northwestern portions of the City. This flow includes contributions that originate from the Fells Reservation and Lower Spot Pond Brook. As shown on Figure 5, a total of 23 outfalls to the Malden River have been identified, nine (9) of which have been identified as flowing during dry weather conditions. Periodic dry weather sampling has been performed both by NCA and the regional watershed group, Mystic River Watershed Association (MyRWA).

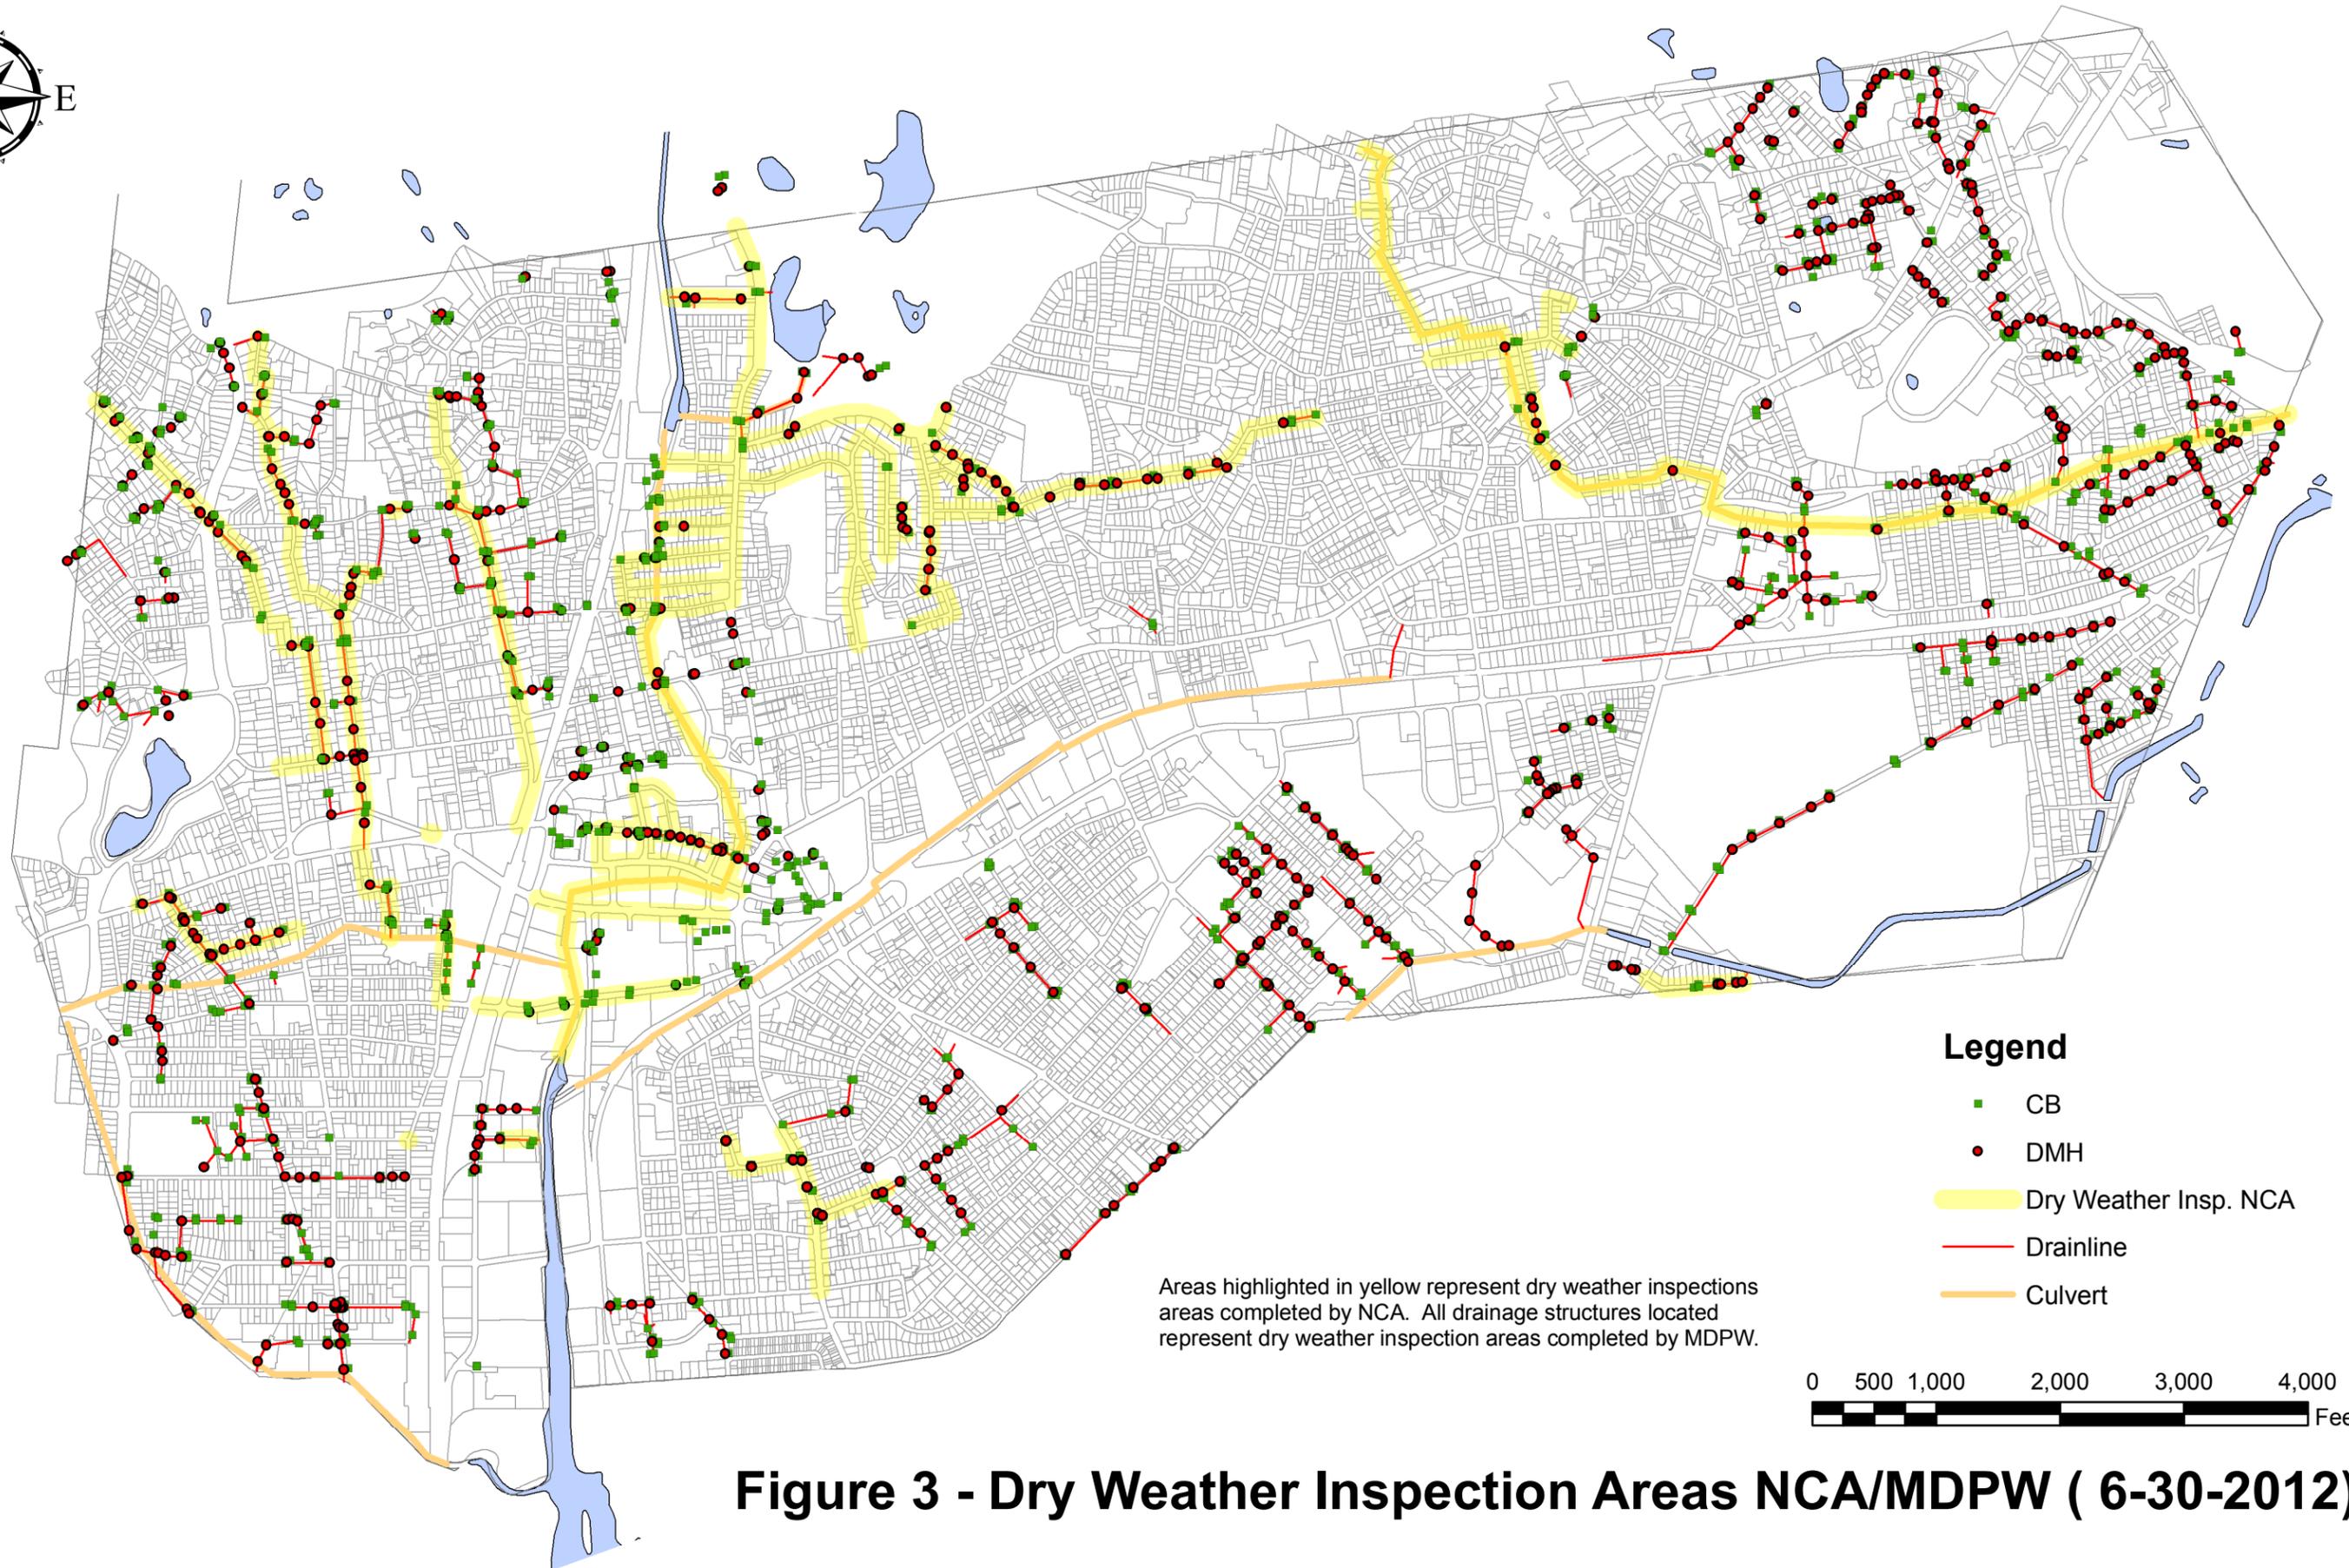
**Figure 3 - Dry Weather Inspection Areas NCA/MDPW ( 6-30-2012)**

As described in Section 3.1.1 a compromise to sewer service connections was identified at a residential complex located on Eldrich Drive. This condition was identified during a program implemented to identify bacteria sources for the levels detected at LSP-4, which is referenced to as Dry Weather Flow 11 below. A map depicting the approximate locations where targeted dry weather inspections have been conducted by NCA to date is presented as Figure 2. Areas inspected by DPW staff for illicit connections/discharges consist of portions of the infrastructure that are addressed during the catch basin cleaning program. During this effort, infrastructure components are mapped and the corresponding attributes are located. During this reporting period, the frequency of dry weather inspections by MDPW personnel was hindered due to the restructuring of responsibilities and staffing at the MDPW. Overall portions of the municipal infrastructure that have been addressed by the compliance team including the targeted subset areas are summarized on Figure 3.

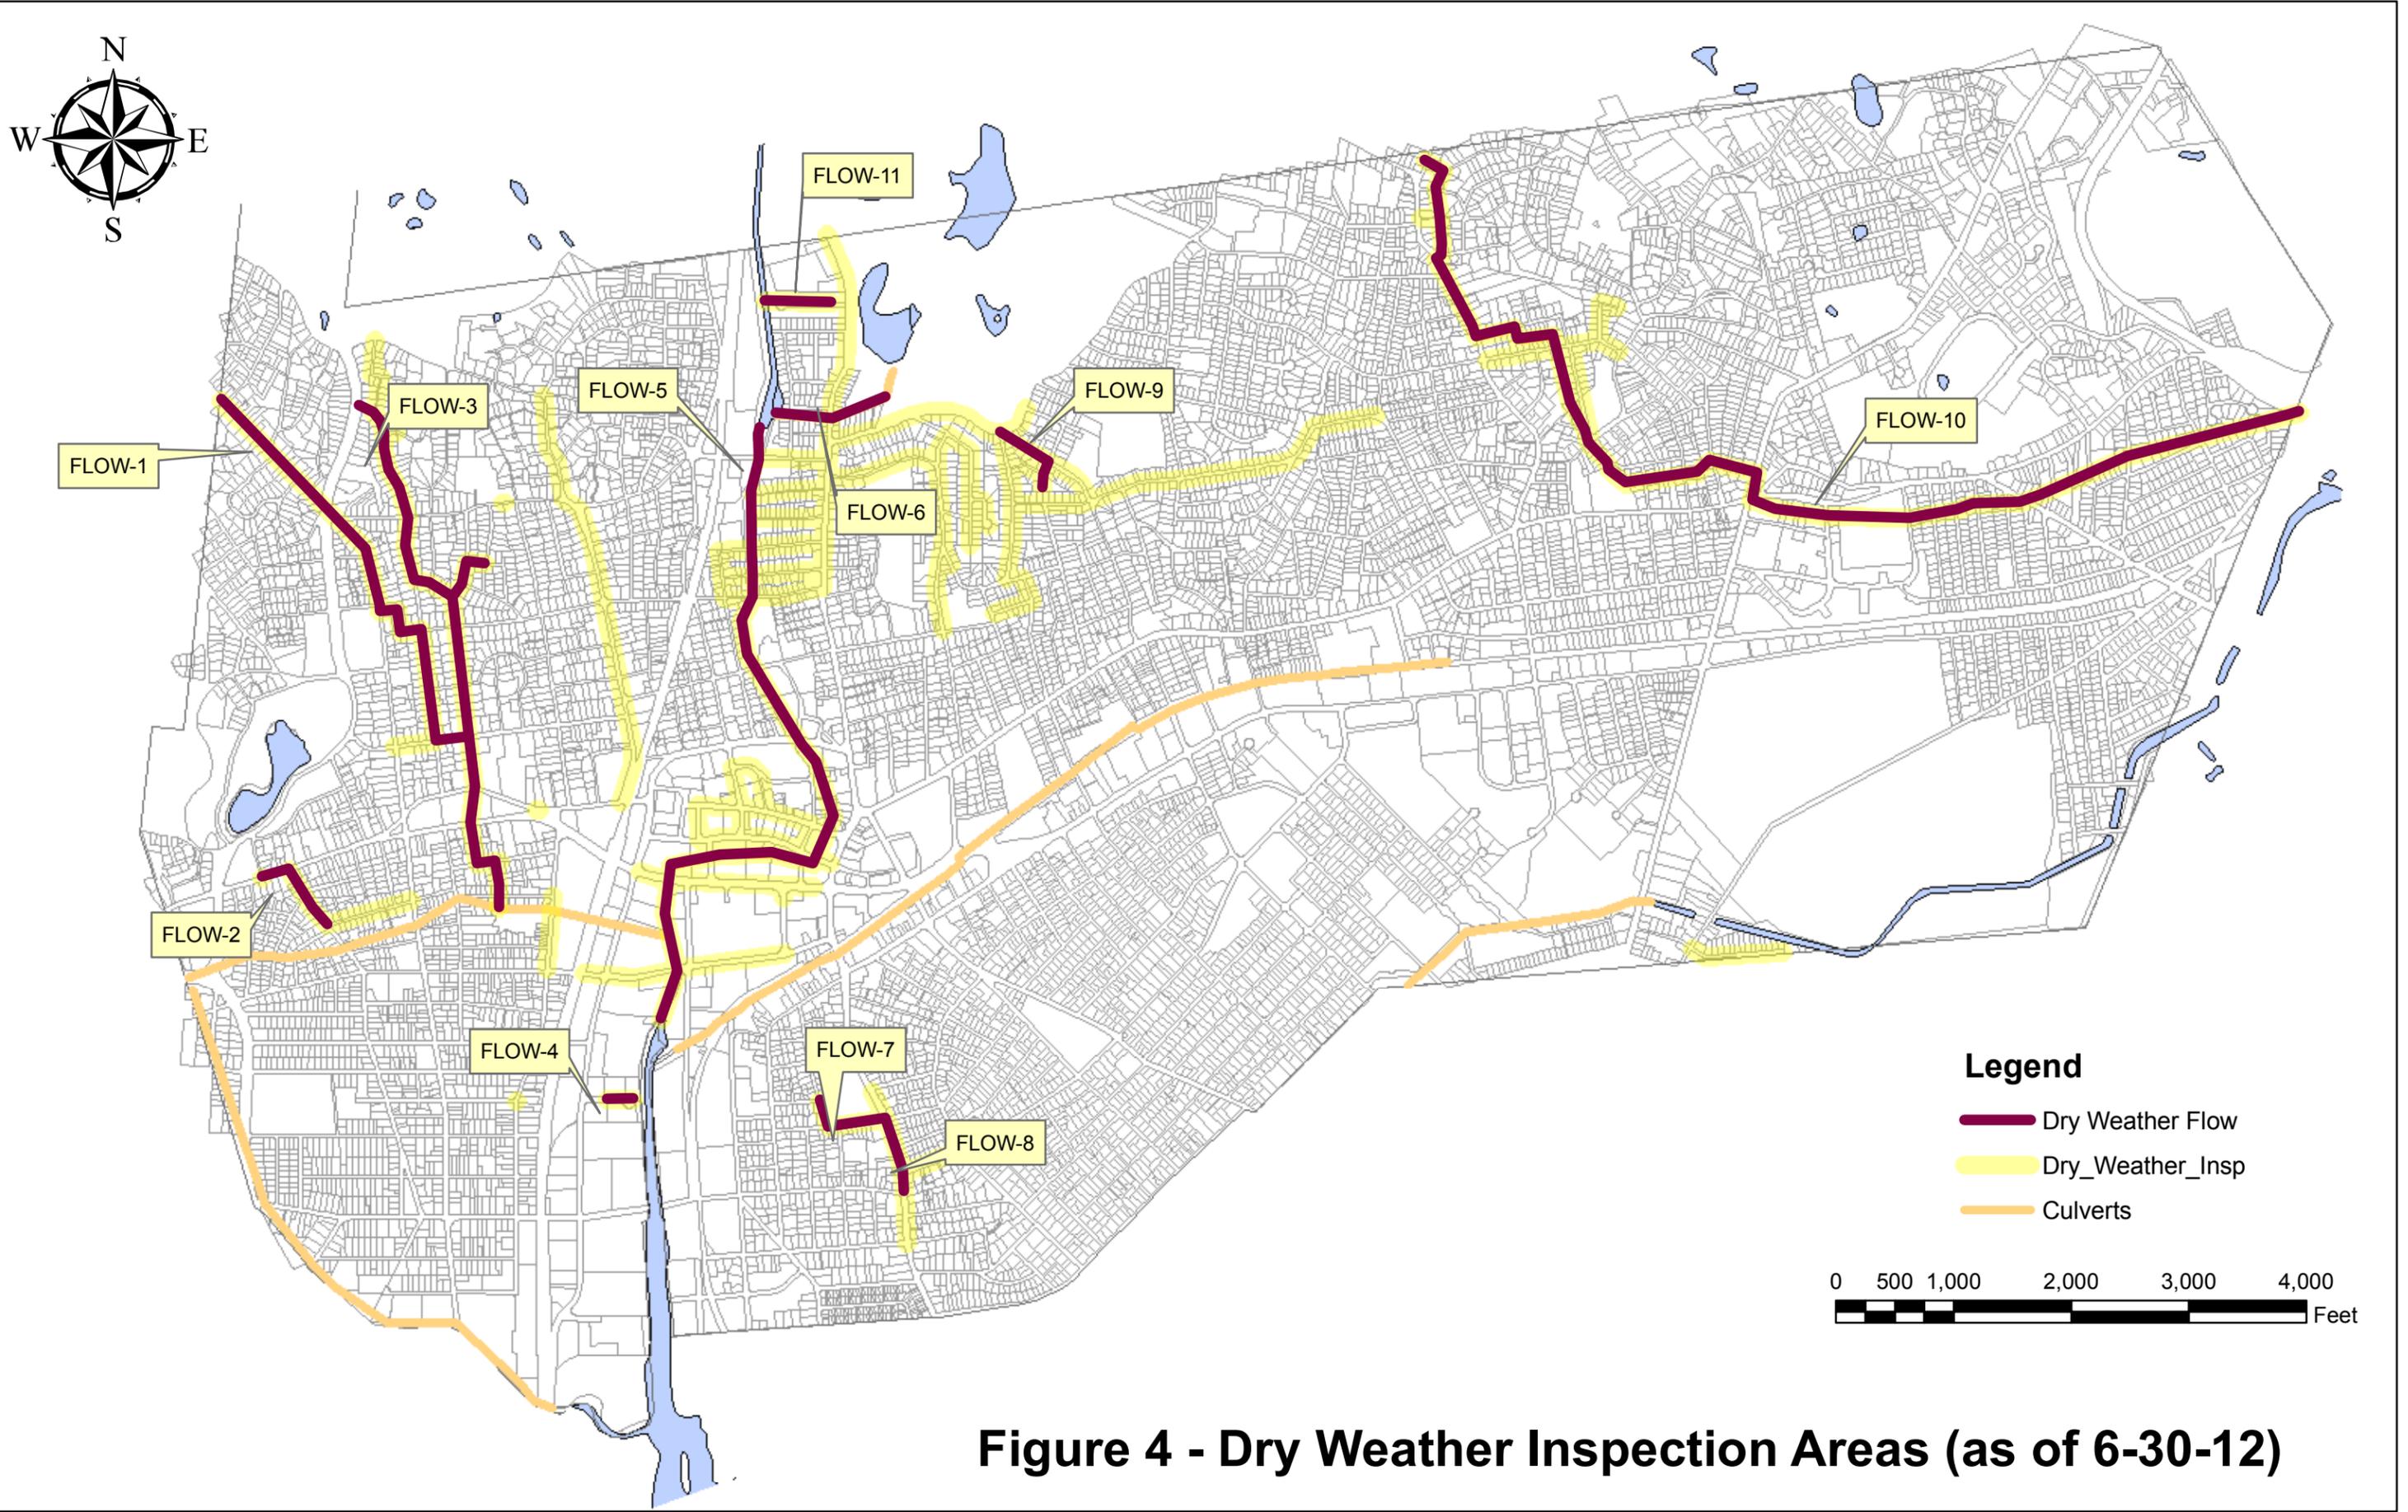
**Figure 4 - Dry Weather Inspection Areas (as of 6-30-12)**

As stated above, during the course of the dry weather inspections, a number of dry weather flows, consisting primarily of waterline leaks and culverted surface waters have been identified. A summary of these flows within the municipal system that have been identified to date are shown on Figure 4, and are described as follows.
