**Municipality/Organization:** City of Malden  
**EPA NPDES Permit Number:** MA041046  
**MADEP Transmittal Number:** 041088  
**Annual Report Number & Reporting Period:** No. 10: April 1, 2012-March 31, 2013

## NPDES PII Small MS4 General Permit Annual Report

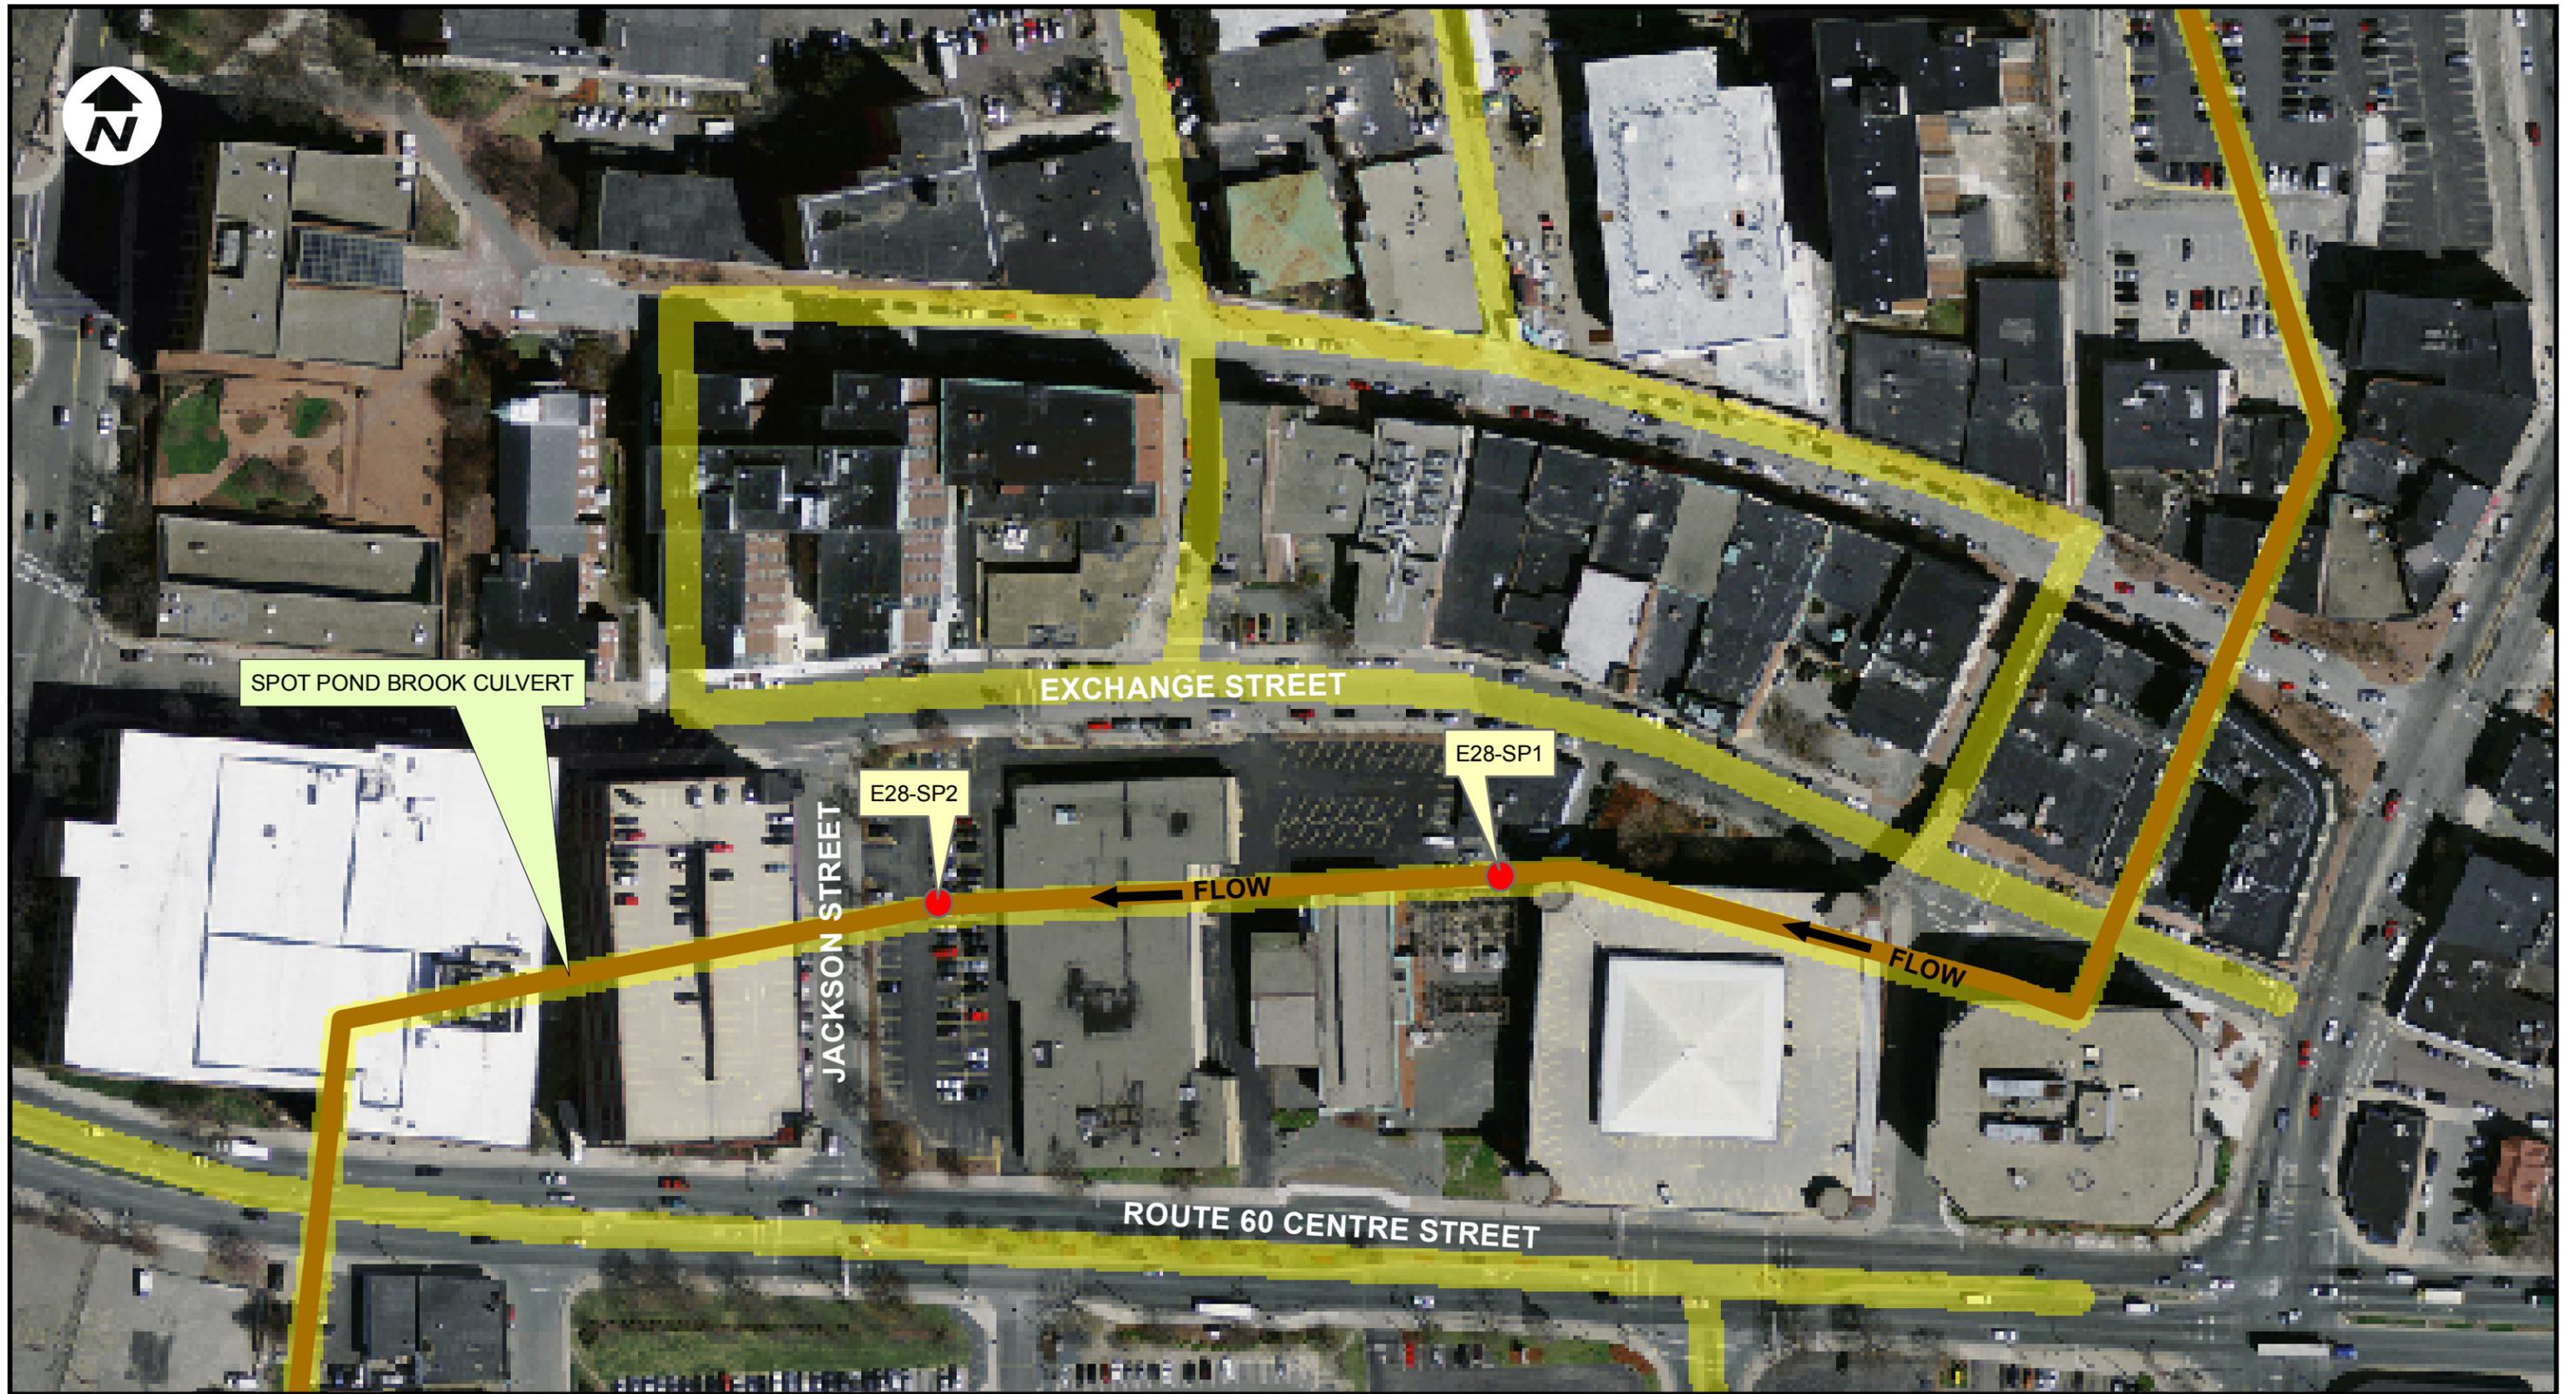
Figure 6 - Exchange Street Detail - Dry Weather Sampling Program

In response to odor complaints in the central downtown area and to further assess flows into the Malden River, a characterization of the Spot Pond Brook Culvert in the area of Exchange Street was performed by the Stormwater Compliance Team in April of 2012. The focus of this investigation involved that portion of the drainage infrastructure located within and proximate to Exchange Street, including the culverted flows of Spot Pond Brook that flow in an easterly direction parallel to Exchange Street as shown on Figure 6. According to City personnel a strong sewerage odor was identified on several occurrences emanating from the grated cover over the Spot Pond Brook culvert located in the parking lot on the corner of Jackson and Exchange Streets (Figure 6). To investigate potential sources for this condition the entire drainage system within the area depicted on Figure 6 was inspected. This revealed no flows as a source condition, however, one (1) no-flow illegal connection to a catch basin located at the corner of Exchange and Washington Streets was identified. Over the course of the investigation program, which was carried out on multiple days, intermittent odors were confirmed at the culvert location of concern (E28-SP2).

Based upon the absence of contributing flows upstream, the focus of the investigation was directed to a laundromat located adjacent to the upstream grated cover (E28-SP1), as well as the regional sewer main that passes by E28-SP2. An interior inspection of the laundromat indicated the presence of a high temperature discharge to the sewer main that runs parallel to the Brook. Through continued monitoring it was determined that these high temperature discharges were likely causing off gassing of sewer gasses between the grated covers to Spot Pond Brook. To support this condition samples were collected from the locations depicted on Figure 6 and submitted for laboratory analysis for E. coli. As shown on Table 2.0, fairly uniform, though high levels were identified at E28-SP1 (6,100 col/100ml) and E28-SP2 (5,200 col/100ml). This
