Municipality/Organization: City of Malden
EPA NPDES Permit Number: MA041046
MADEP Transmittal Number: 041088
Annual Report Number & Reporting Period: No. 11: April 1, 2013-March 31, 2014

NPDES PII Small MS4 General Permit Annual Report

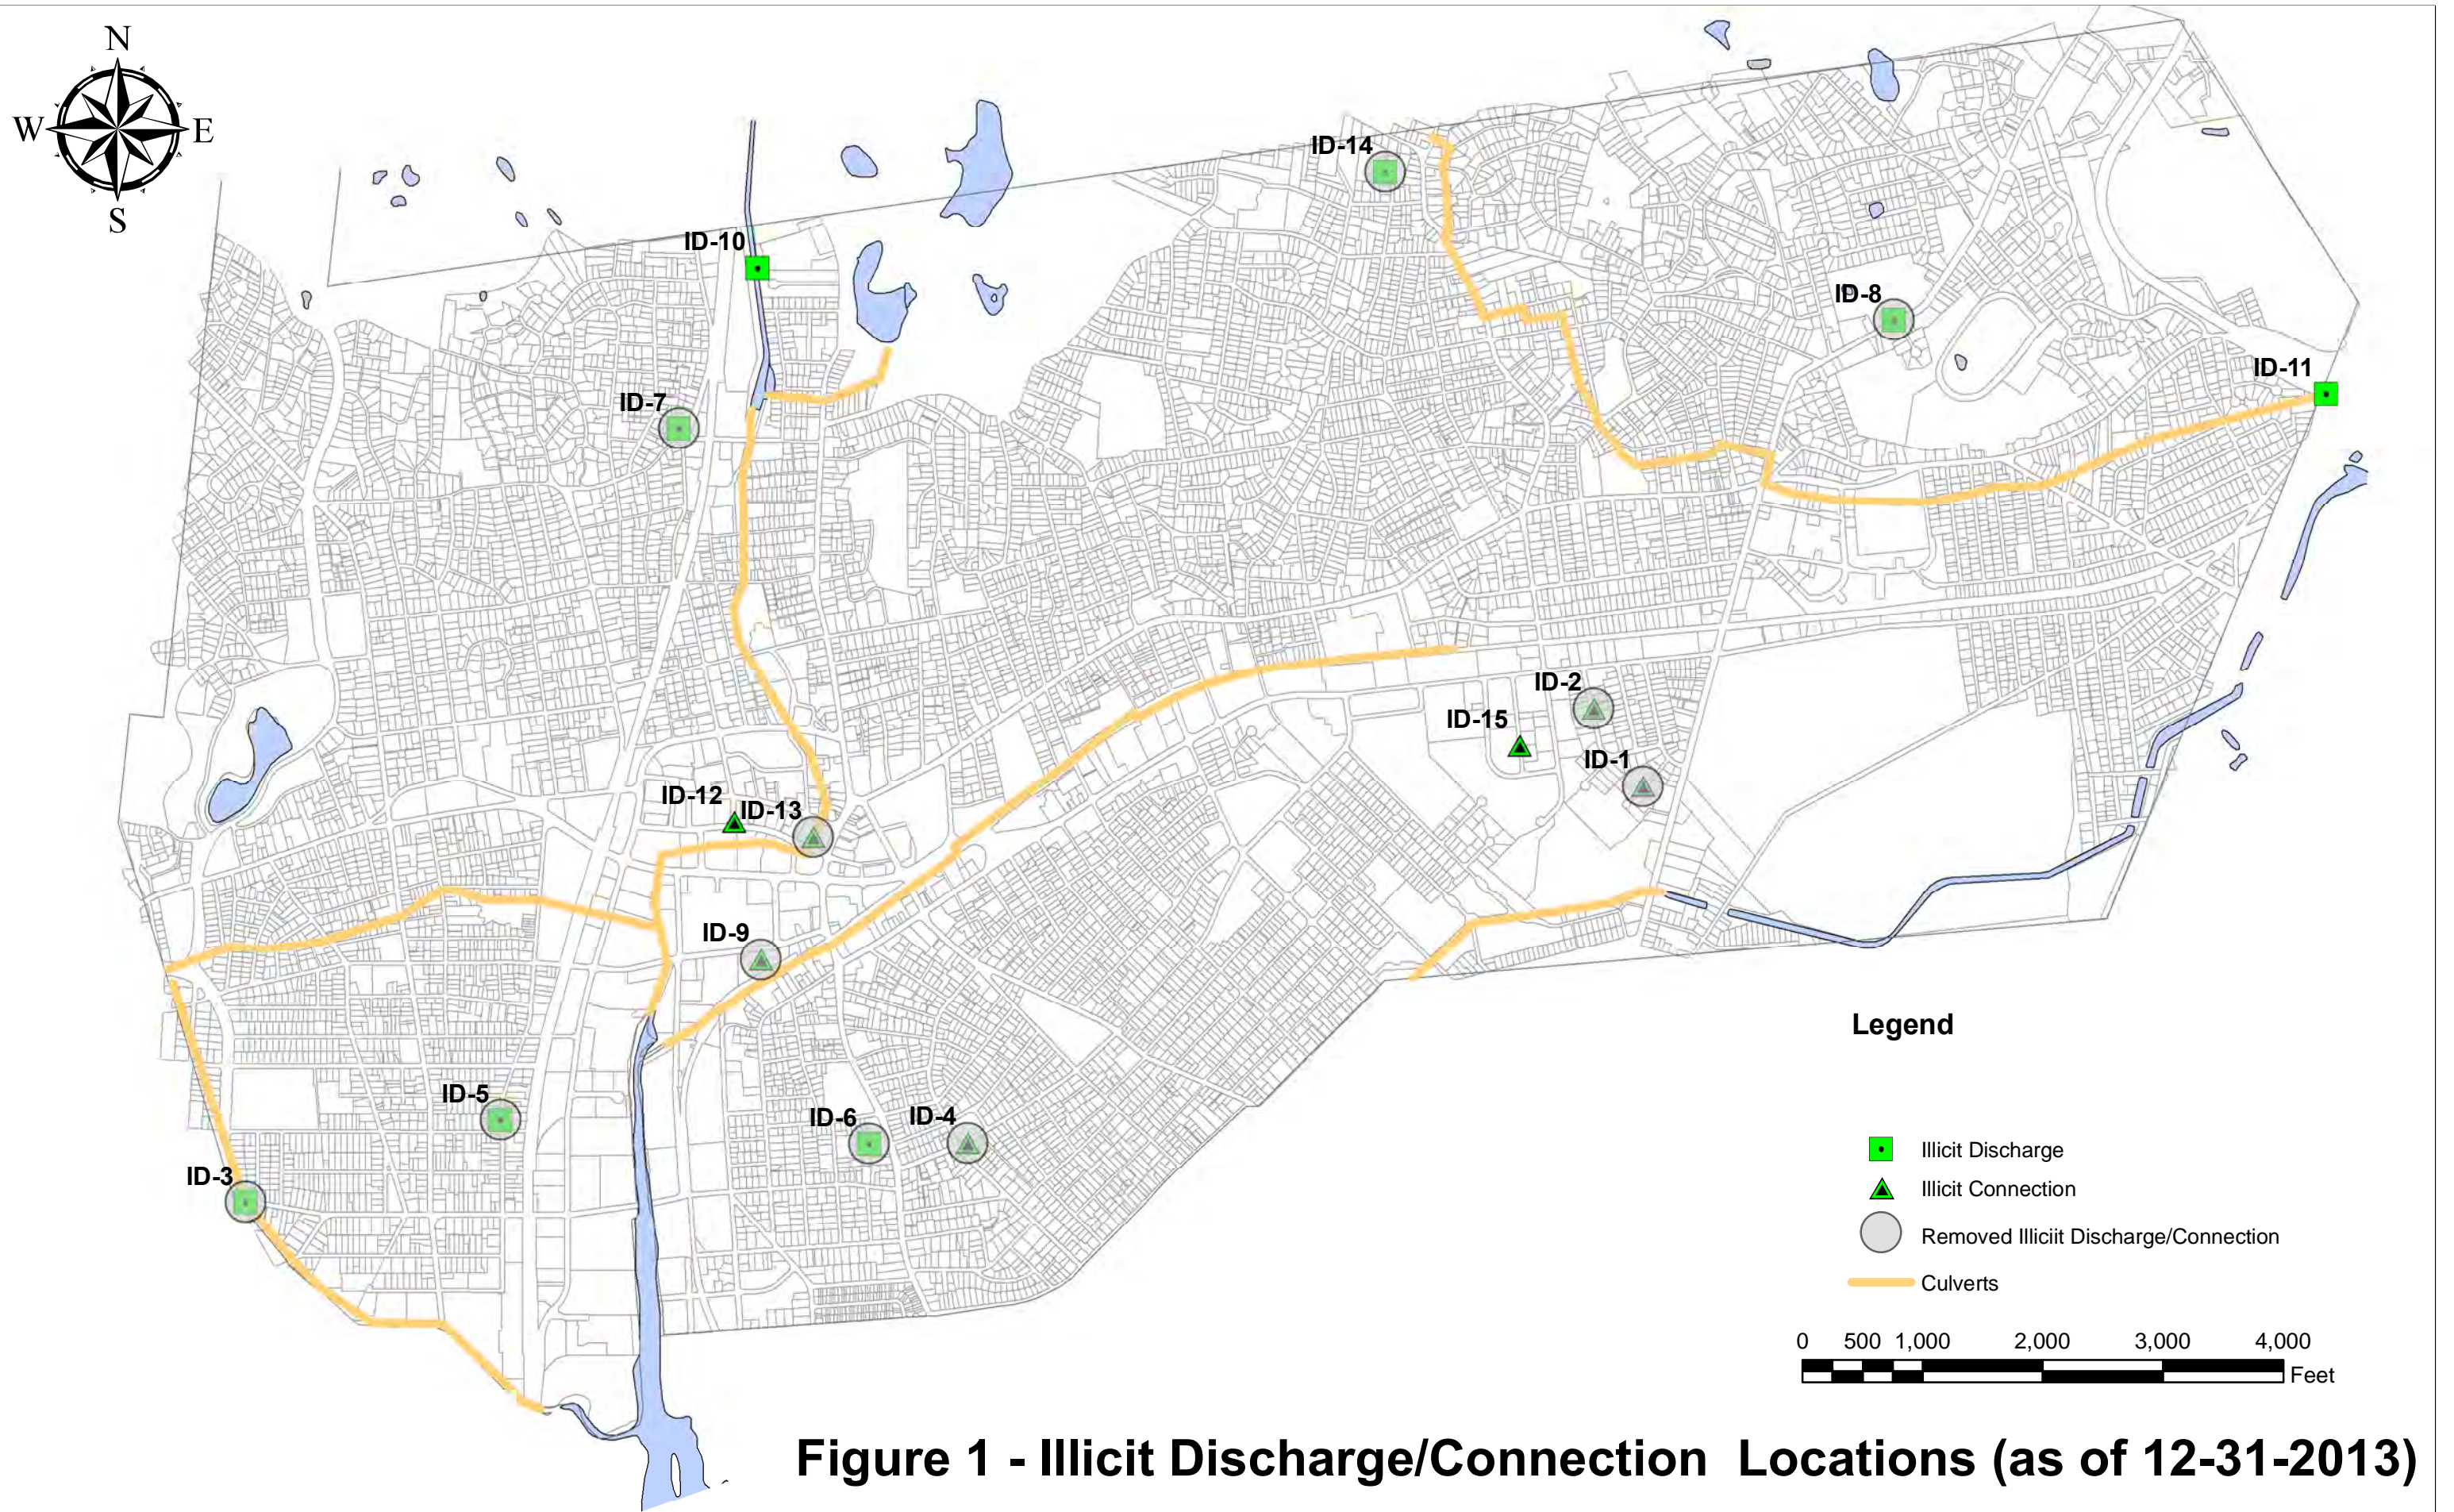
Figure 1 - Illicit Discharge/Connection Locations (as of 12-31-2013)

During this reporting period, one (1) possible illicit connection and one (1) illicit discharge were identified. To assist in the review of the information contained within this report, a summary of the illicit discharges/connections identified to date is presented on Figure 1 and Table 1.0. The possible illicit connection was identified by the stormwater compliance team in a drainage manhole on Sharon Street during a dry weather inspection of the area. Inspection of the manhole revealed a dry weather flow discharging from a pipe which appeared to be emanating from the rear of the building located at 50 Crystal Street (Viking Seafoods Inc). A subsequent evaluation of the drainage manhole revealed that the discharge appears to be intermittent, with flows observed to be approximately 10 – 12 gallons per minute. This discharge slowed to a trickle over an approximate 10 minute timeframe. The City Engineering Department is in the process of working with the owners of the Viking Seafoods property to further investigate this condition.

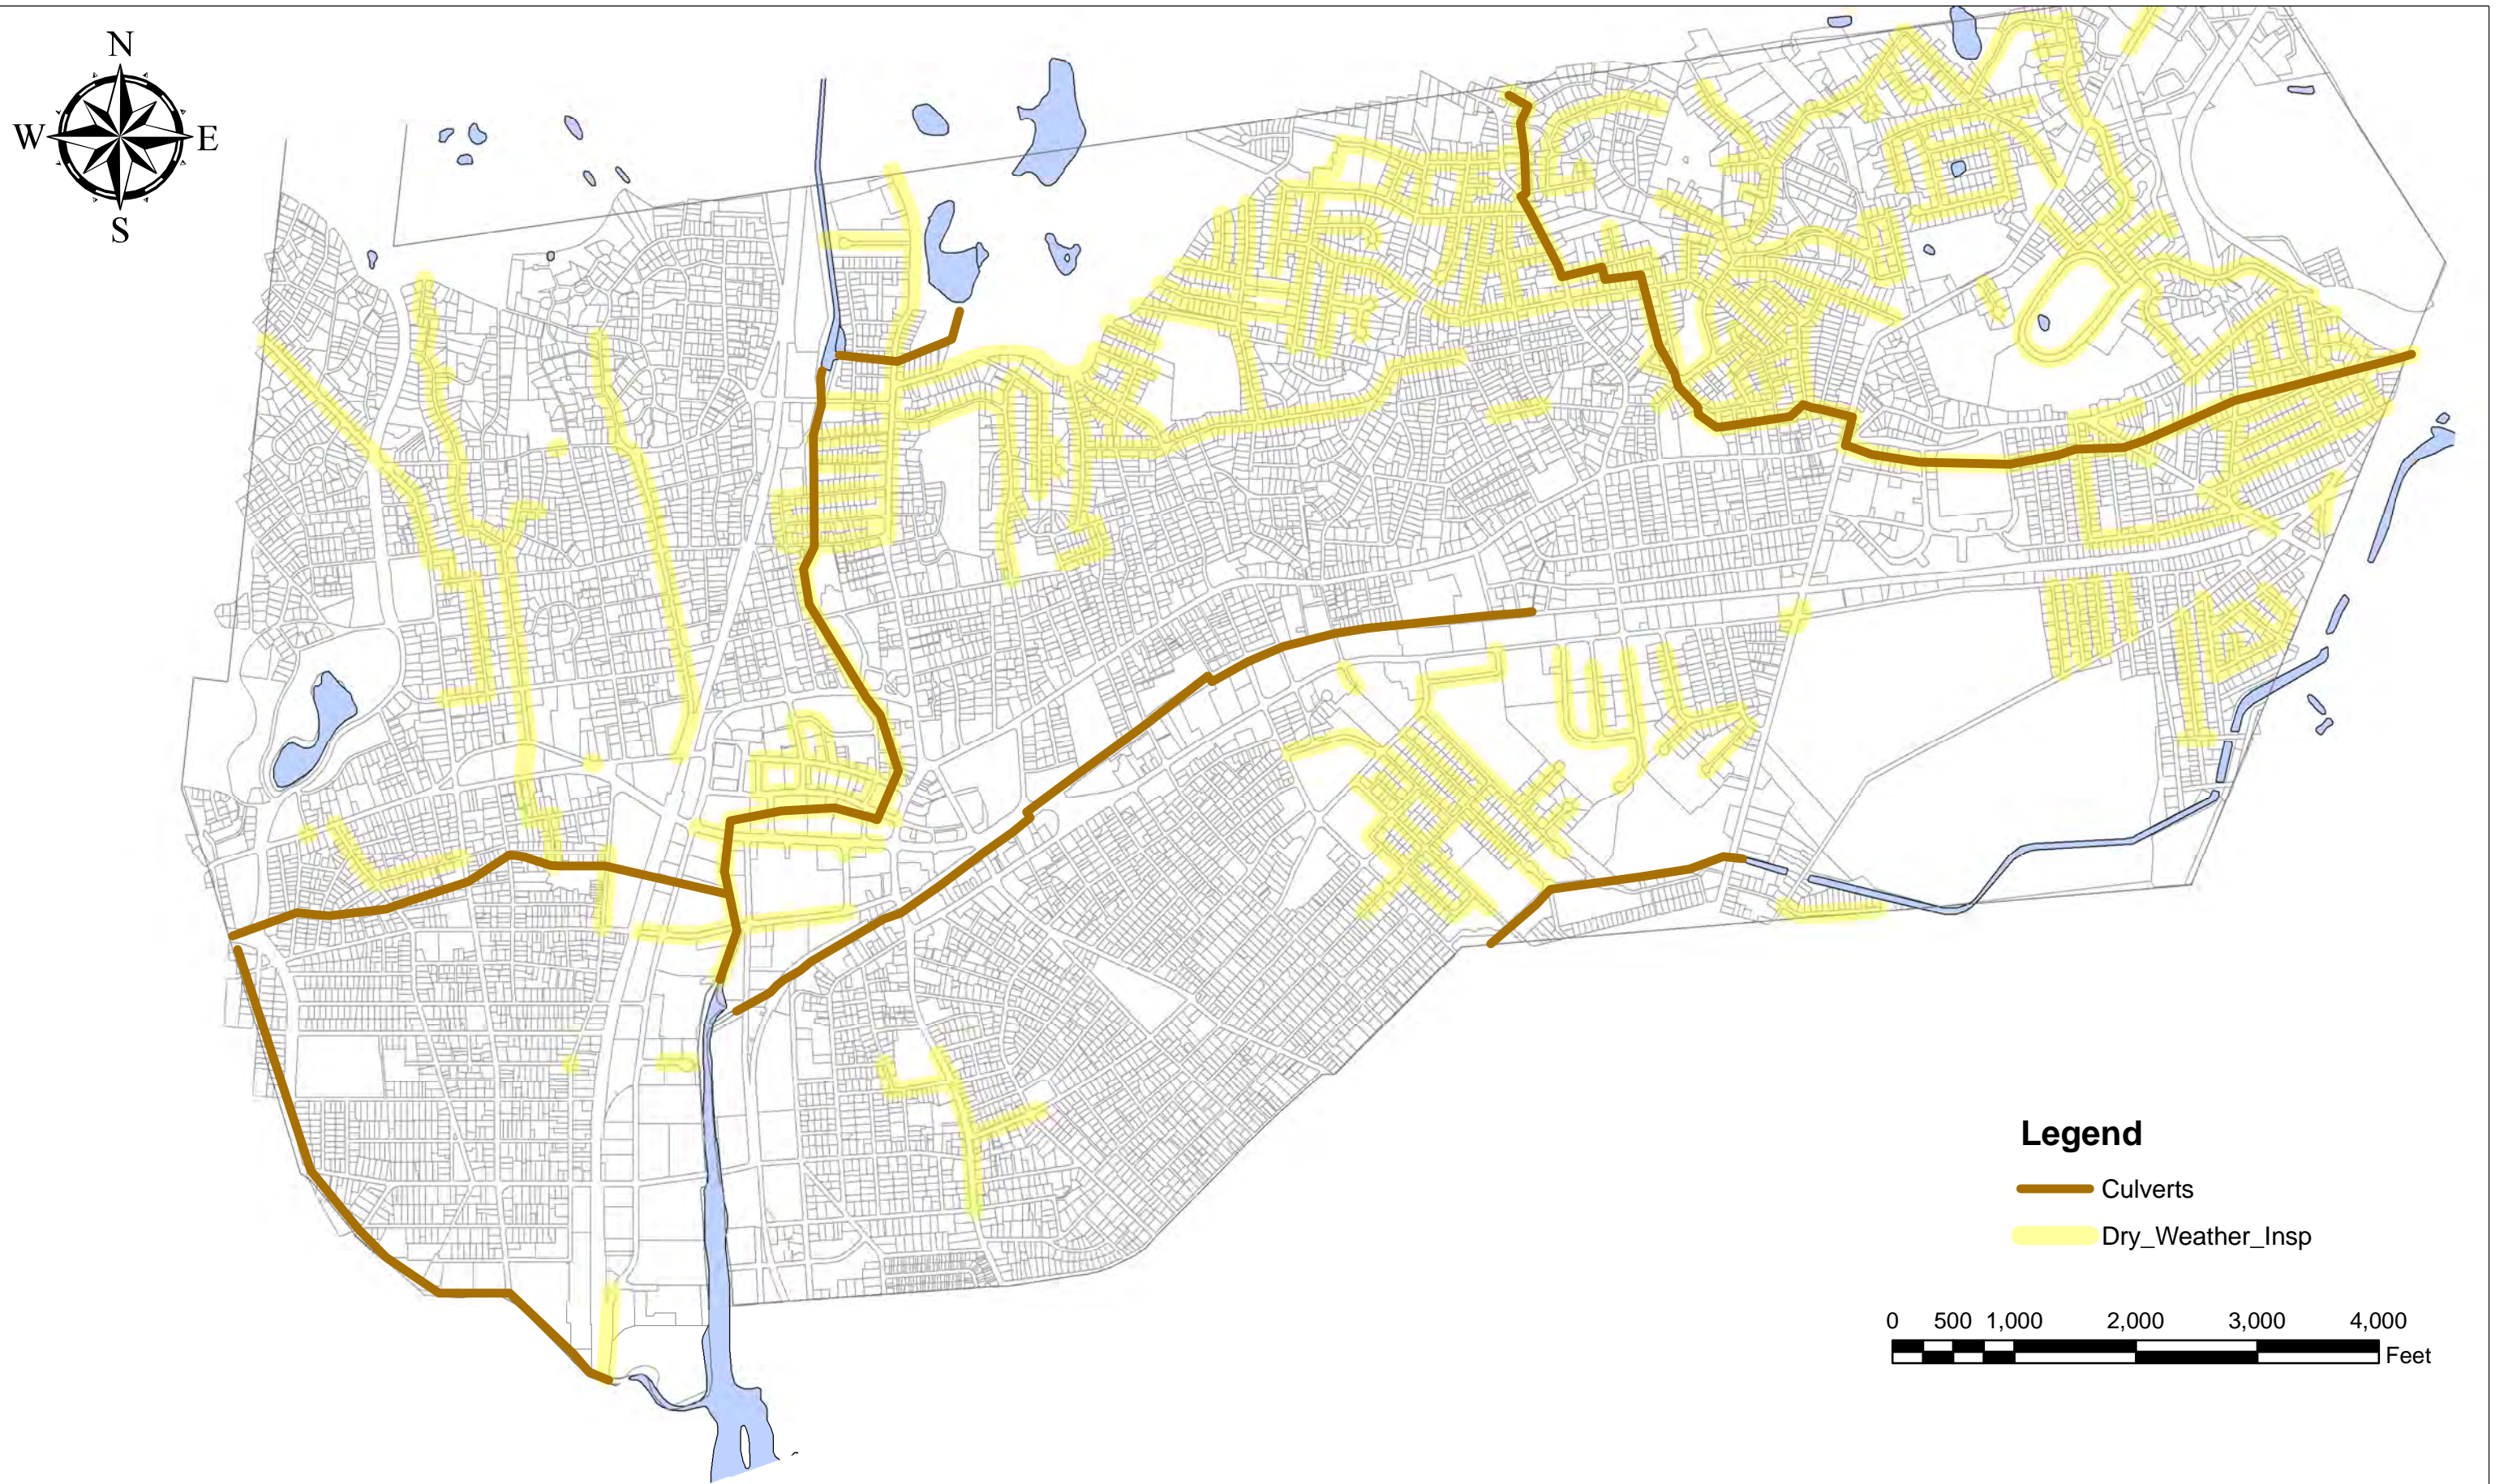
Figure 2 - Dry Weather Inspection Areas (as of 12-31-13)

A map depicting the approximate locations where targeted dry weather inspections have been conducted by NCA to date is presented as Figure 2. In addition, the drainage infrastructure is also inspected by DPW during the catch basin cleaning program. Upon the identification of previously unknown dry weather flows, the Engineering Department and NCA are immediately notified by MDPW personnel and targeted mass balance sampling efforts are performed. During dry weather inspections completed under the IDDE program, various dry weather flows have been identified. A summary of these flows within the municipal system that have been identified to date are shown on Table 2.0 and Figure 3. As stated above, during this reporting period, multiple dry weather investigations were performed within three (3) key areas that warranted further flow isolation efforts based upon prior dry weather sampling data. These areas include the northeast and southeast sections of Malden, which contribute flows to Linden Brook and Town Line Brook, respectively. In addition, the north central portion of Malden was also targeted, which discharges to Lower Spot Pond Brook, and ultimately the Malden River.

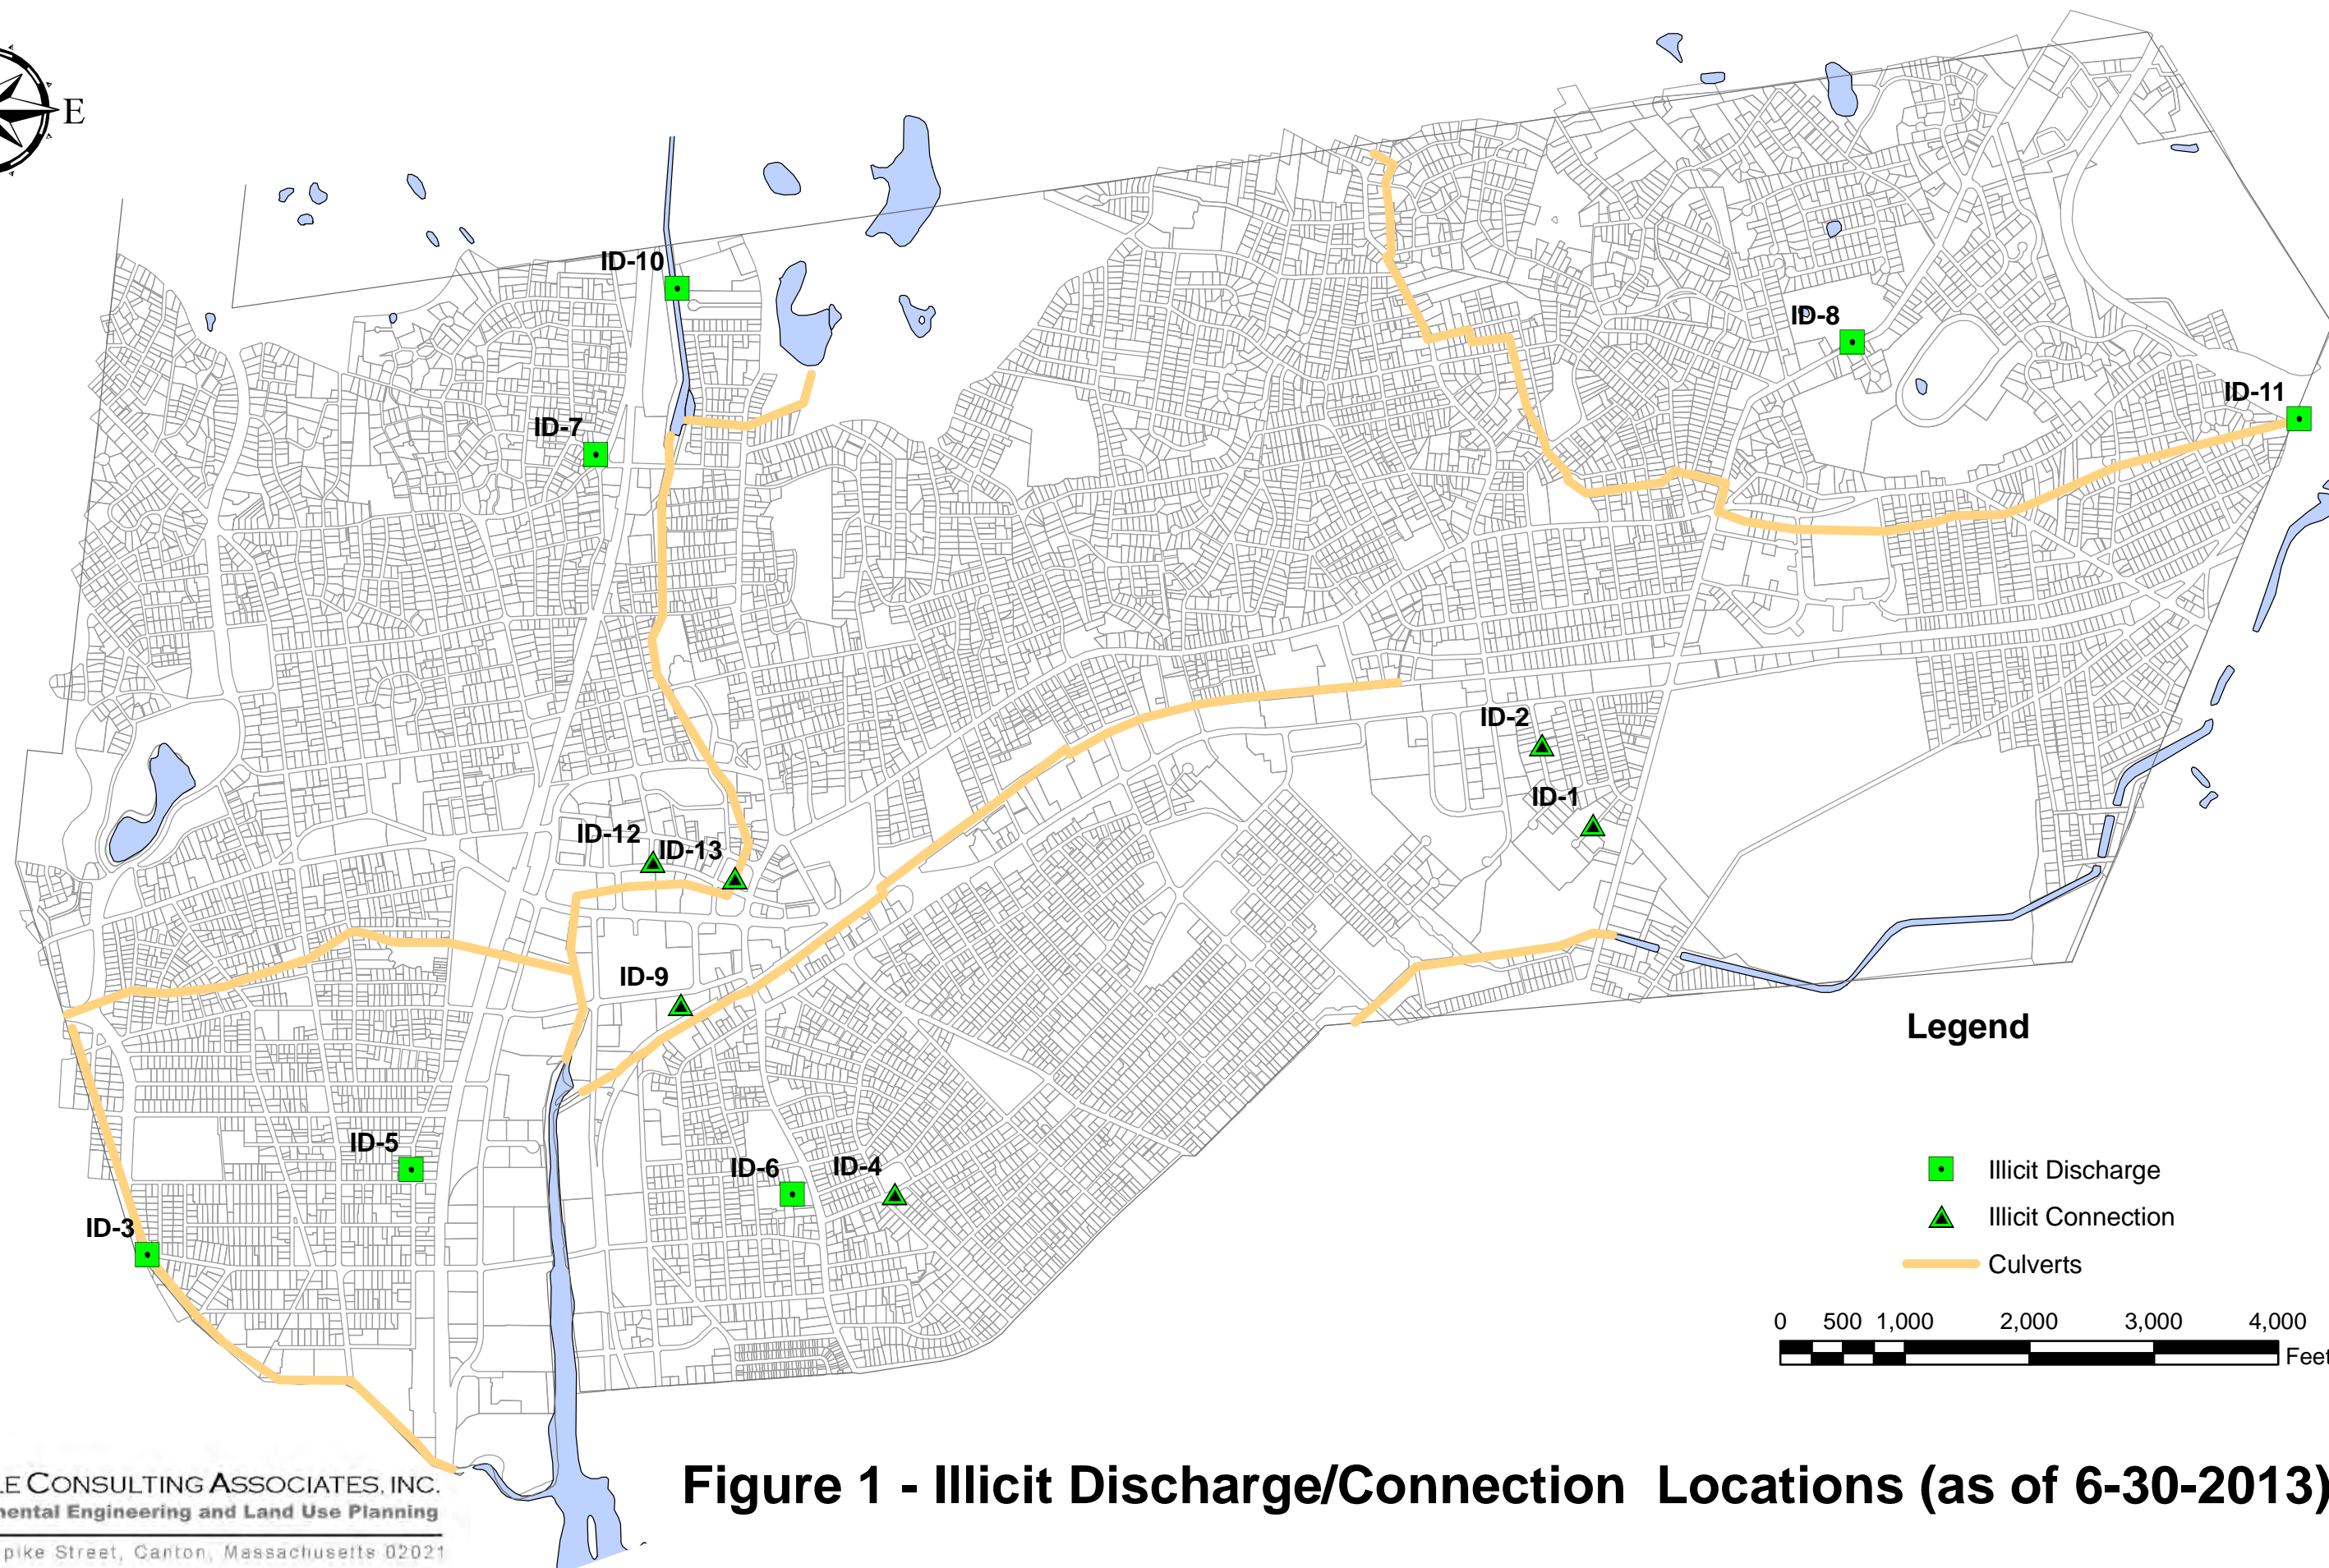
Figure 1 - Illicit Discharge/Connection Locations (as of 6-30-2013)

During this reporting period, no illicit discharges were identified. However, last reporting period; one (1) potential illicit discharge was identified, in the form of a possible grease blockage within a sewer siphon located at the intersection of Salem and Lynn Streets that passes beneath Linden Brook. This structure is located at the City line between Malden and Revere. Additional details pertaining to the ongoing investigation and inspection program may be referenced from Section 3.1.3. To assist in the review of the information contained within this report, a summary of the illicit discharges/connections identified to date is presented on Figure 1 and Table 1.0.

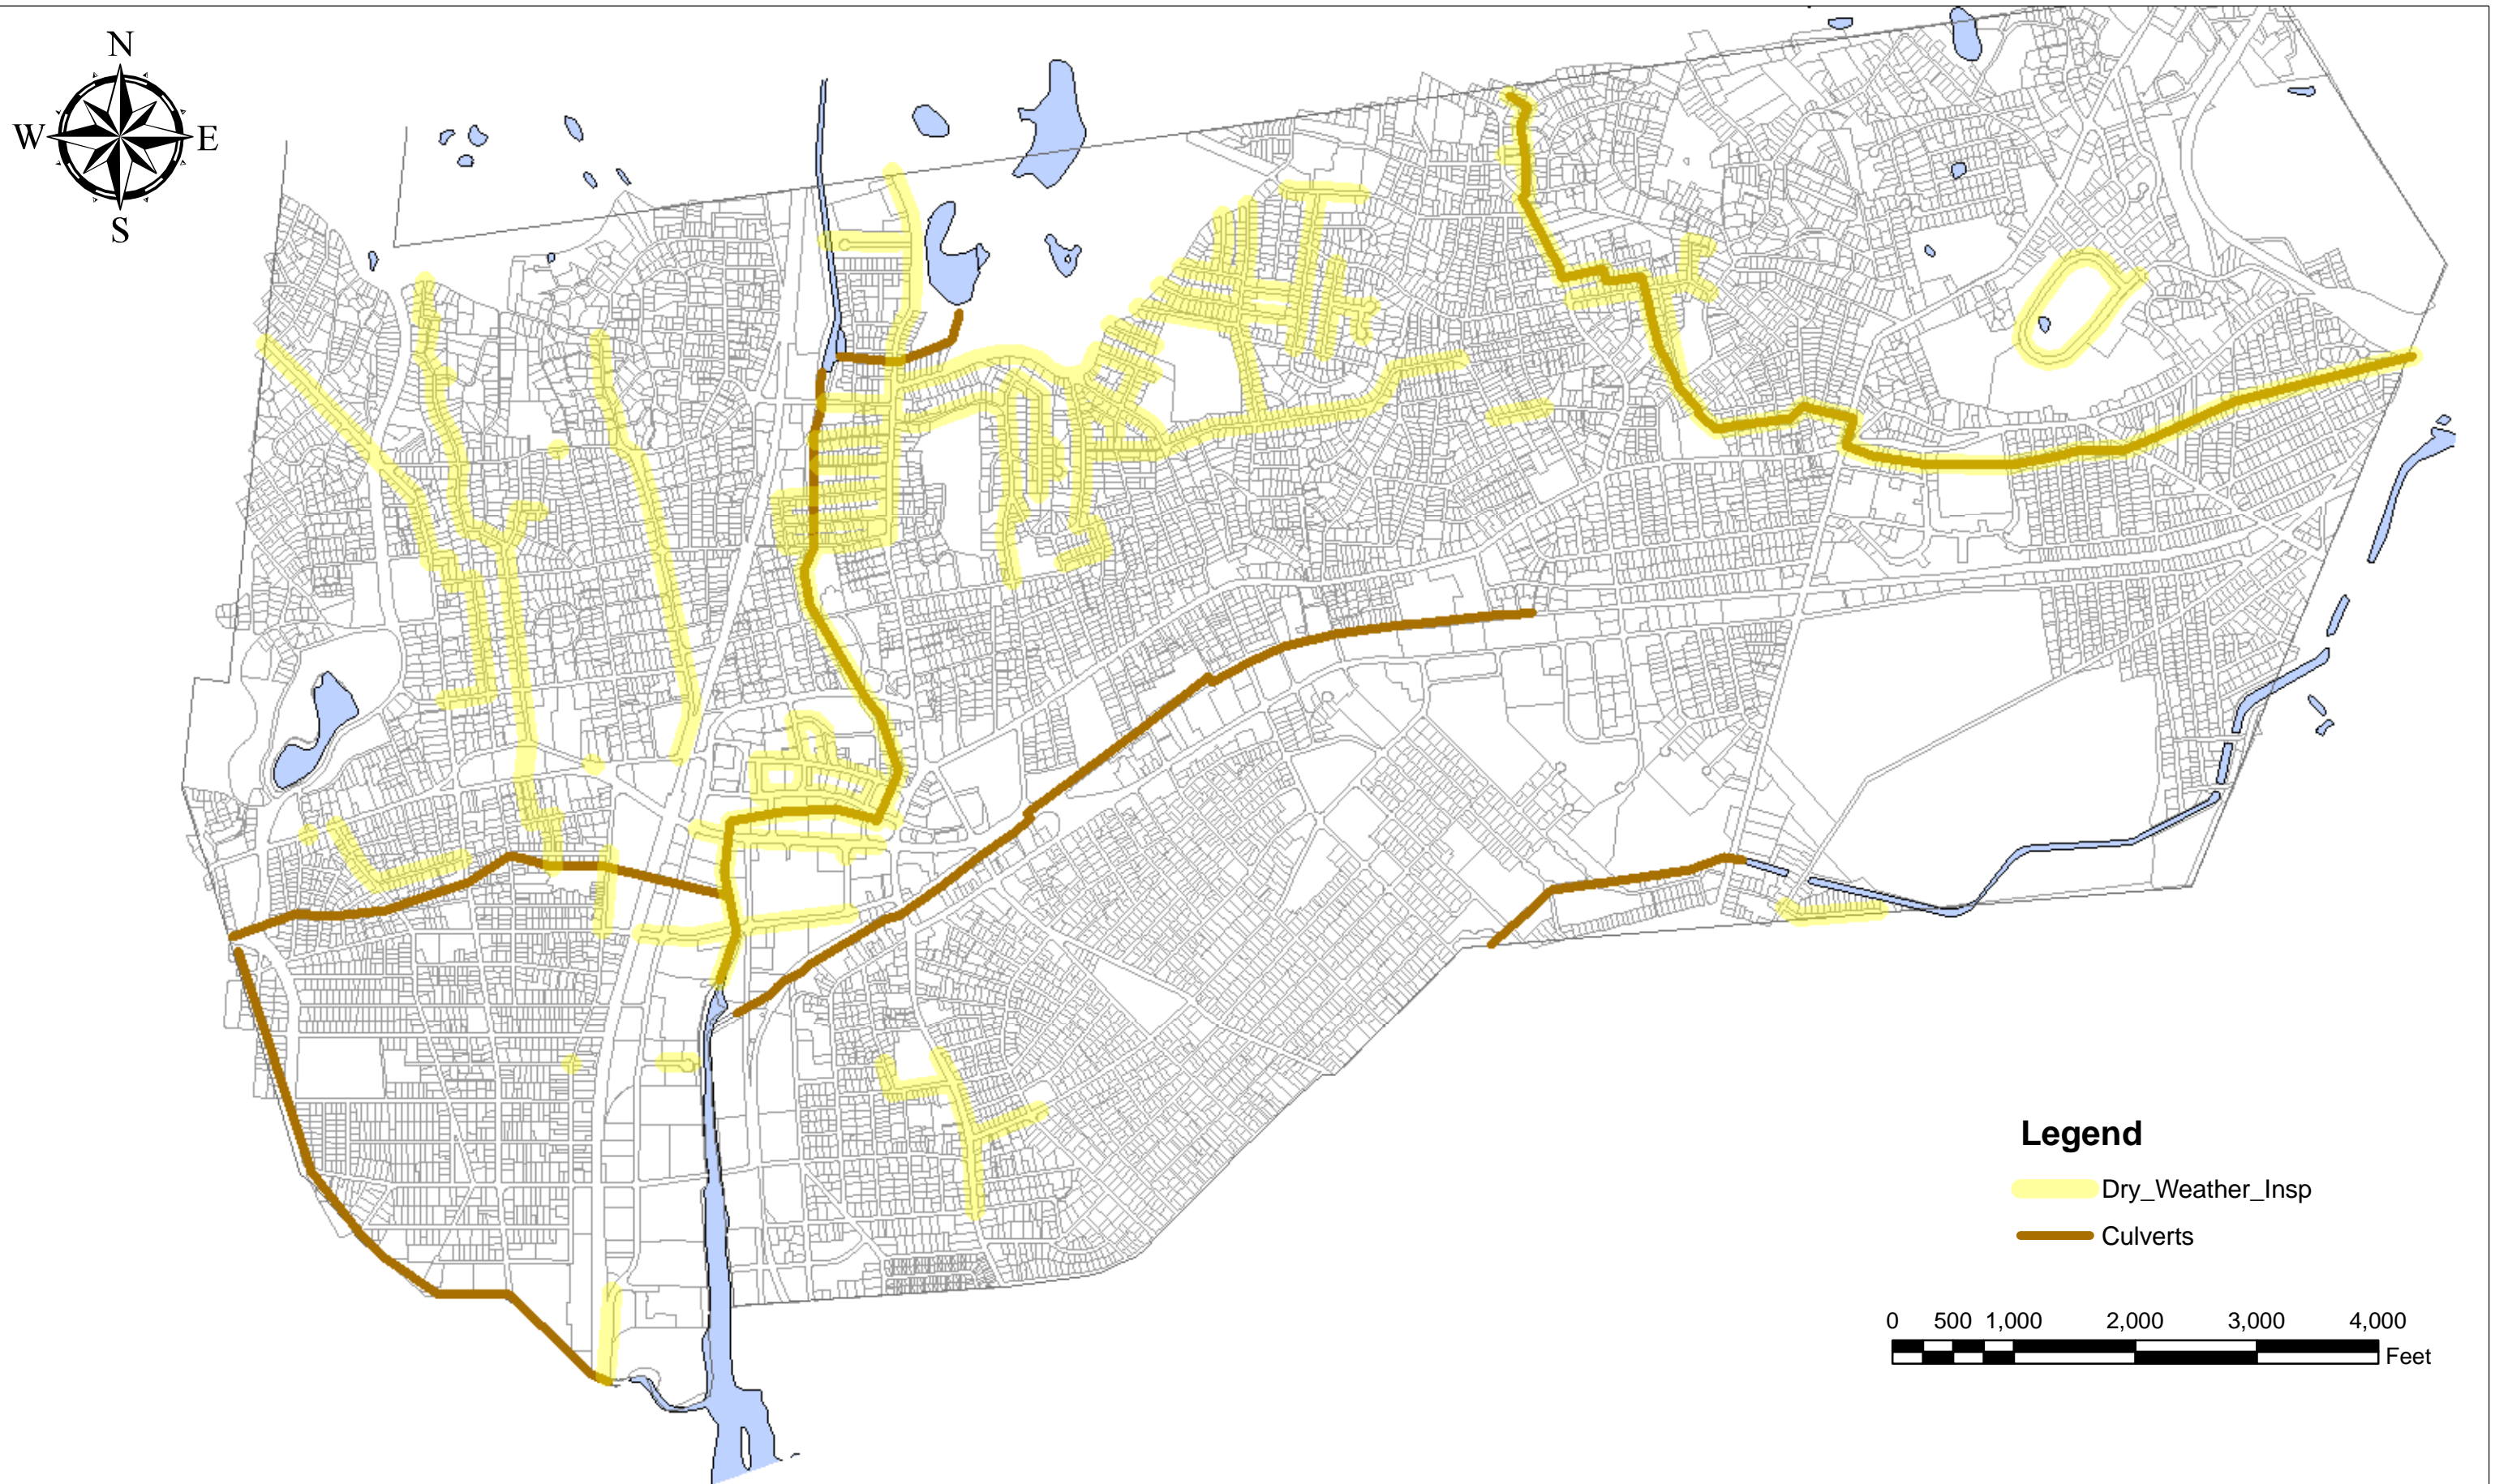
Figure 2 - Dry Weather Inspection Areas (as of 6-30-13)

A map depicting the approximate locations where targeted dry weather inspections have been conducted by NCA to date is presented as Figure 2. Areas inspected by DPW staff for illicit connections/discharges consist of portions of the infrastructure that are addressed during the catch basin cleaning program. During this effort, infrastructure components are mapped and the corresponding attributes are located. Upon the identification of previously unknown dry weather flows, the Engineering Department and NCA are immediately notified by MDPW personnel and targeted mass balance sampling efforts are performed. Portions of the municipal infrastructure that have been addressed by the compliance team including these targeted subset areas are summarized on Figure 3.

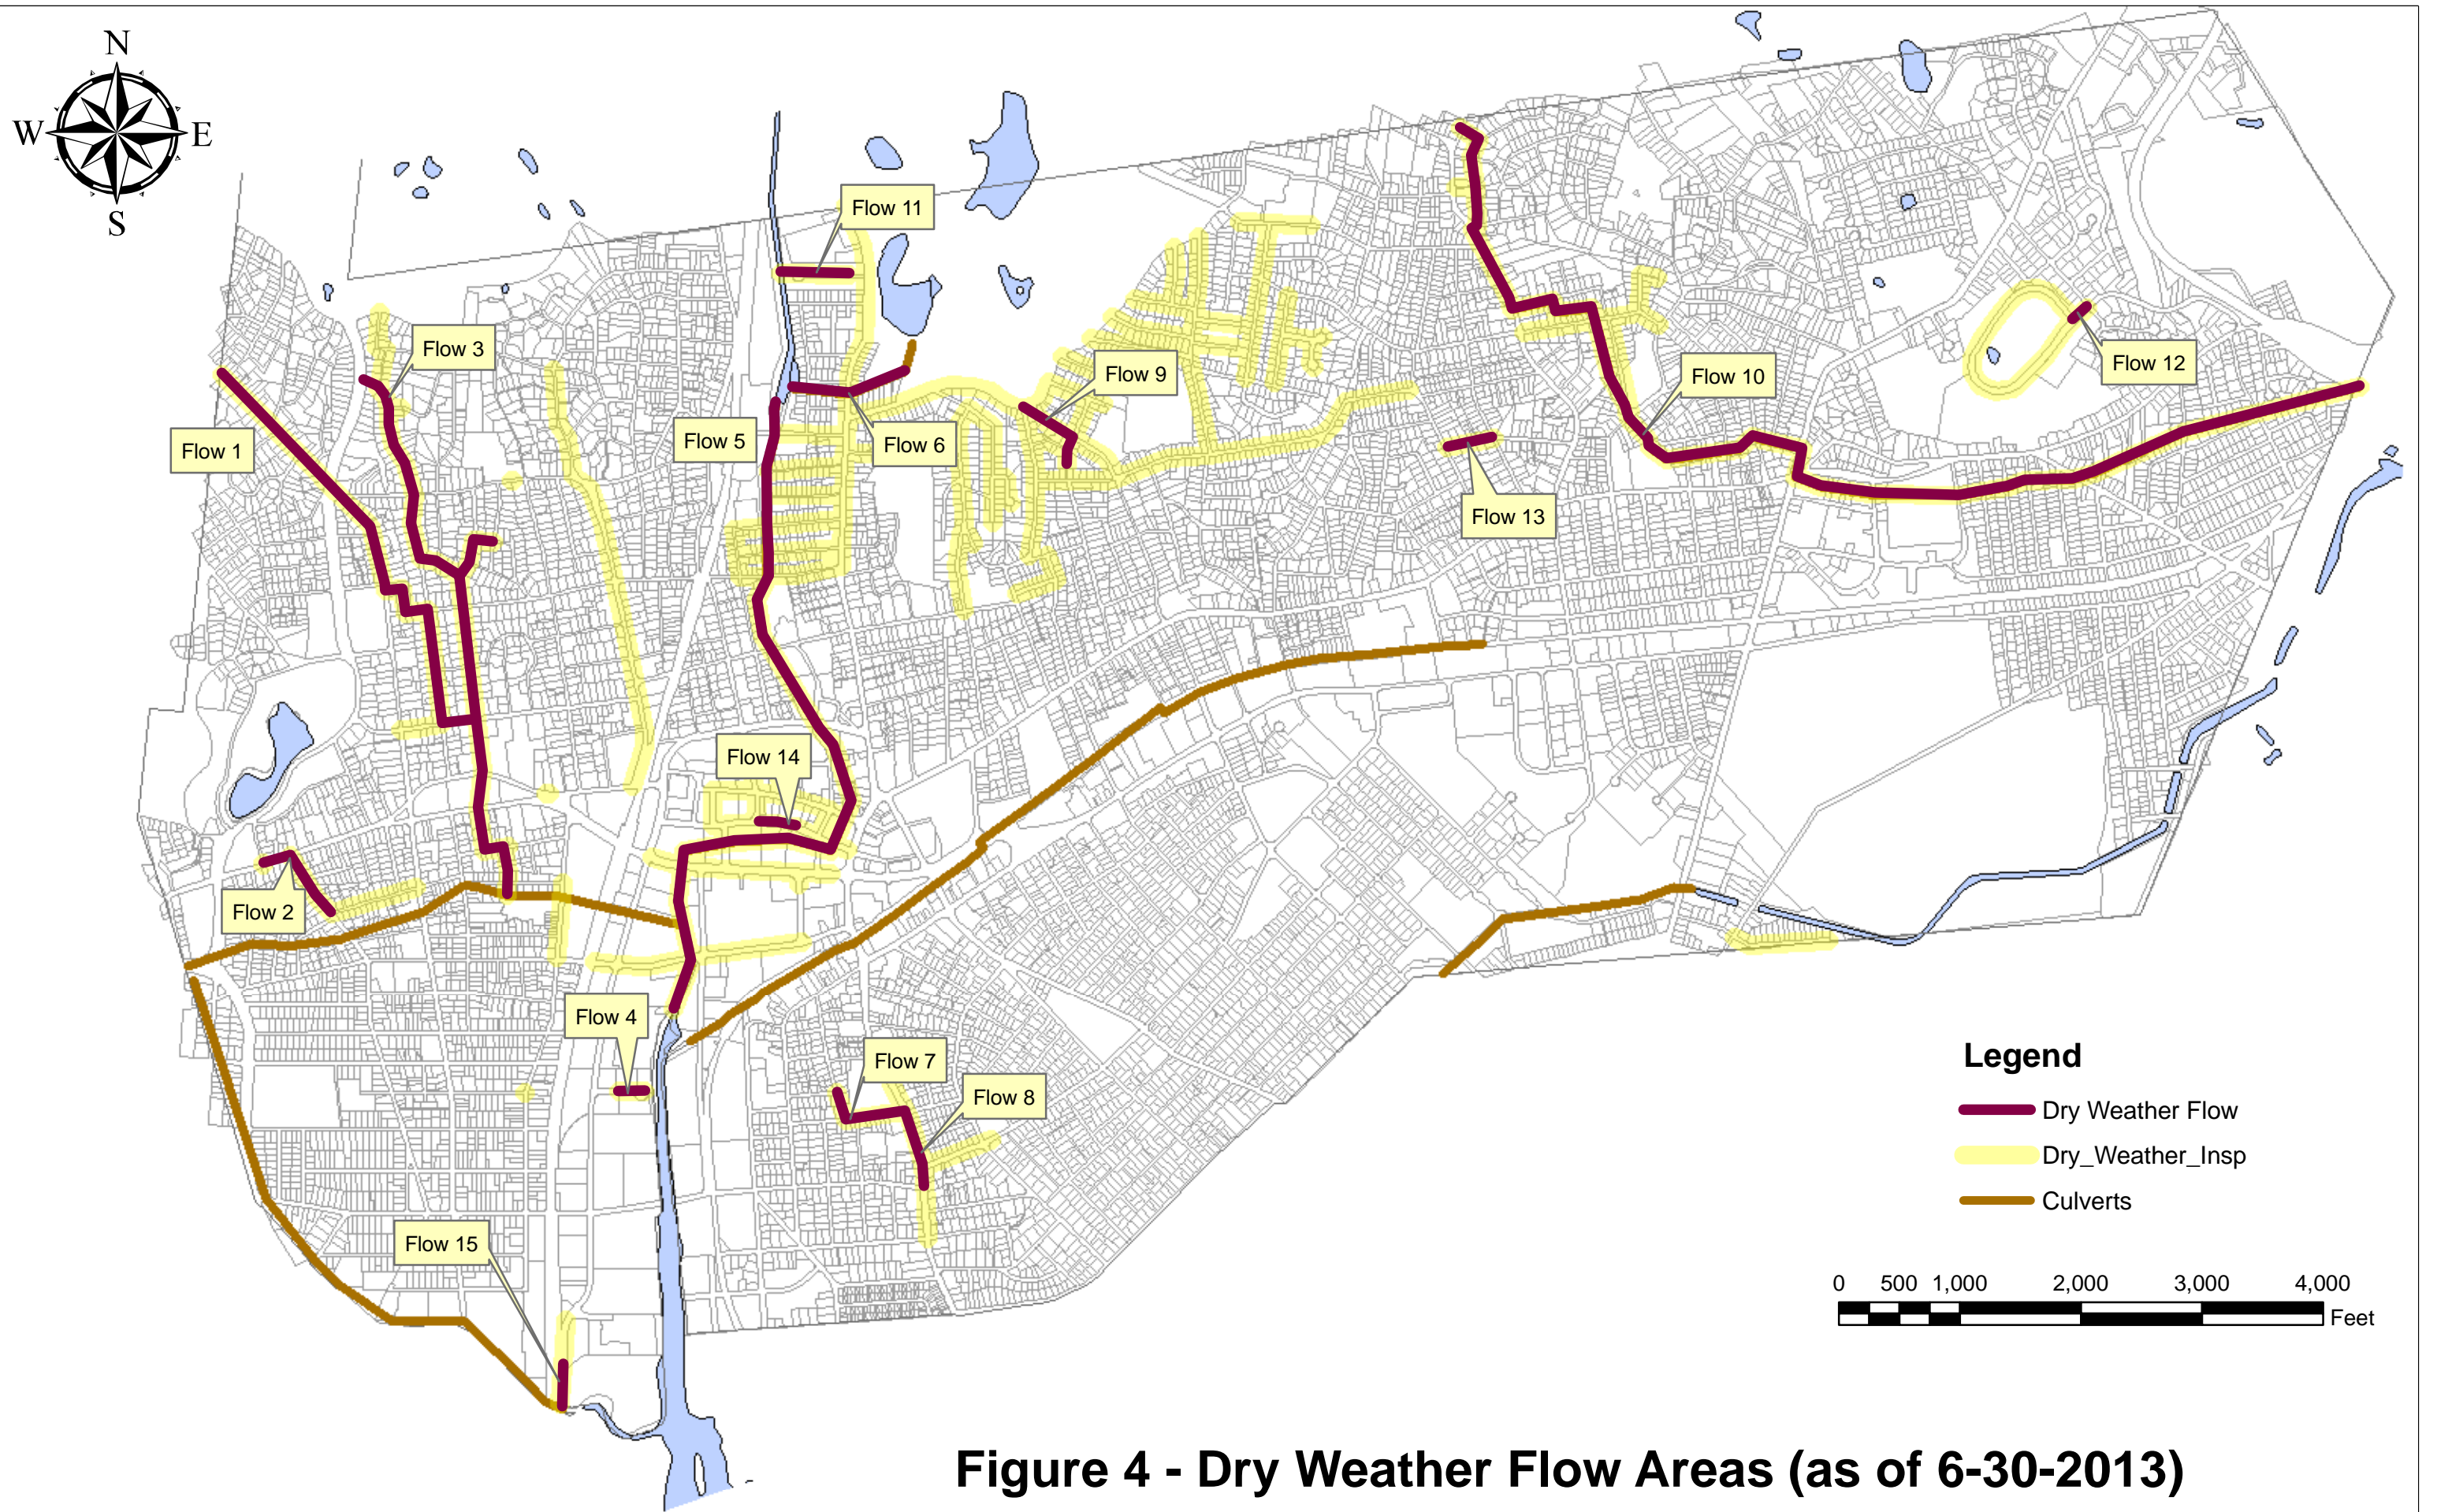
Figure 4 - Dry Weather Flow Areas (as of 6-30-2013)

A summary of these flows within the municipal system that have been identified to date are shown on Figure 4, and are described as follows.
