Municipality/Organization: City of Malden
EPA NPDES Permit Number: MA041046
MADEP Transmittal Number: 041088
Annual Report Number & Reporting Period: No. 11: April 1, 2013-March 31, 2014

NPDES PII Small MS4 General Permit Annual Report

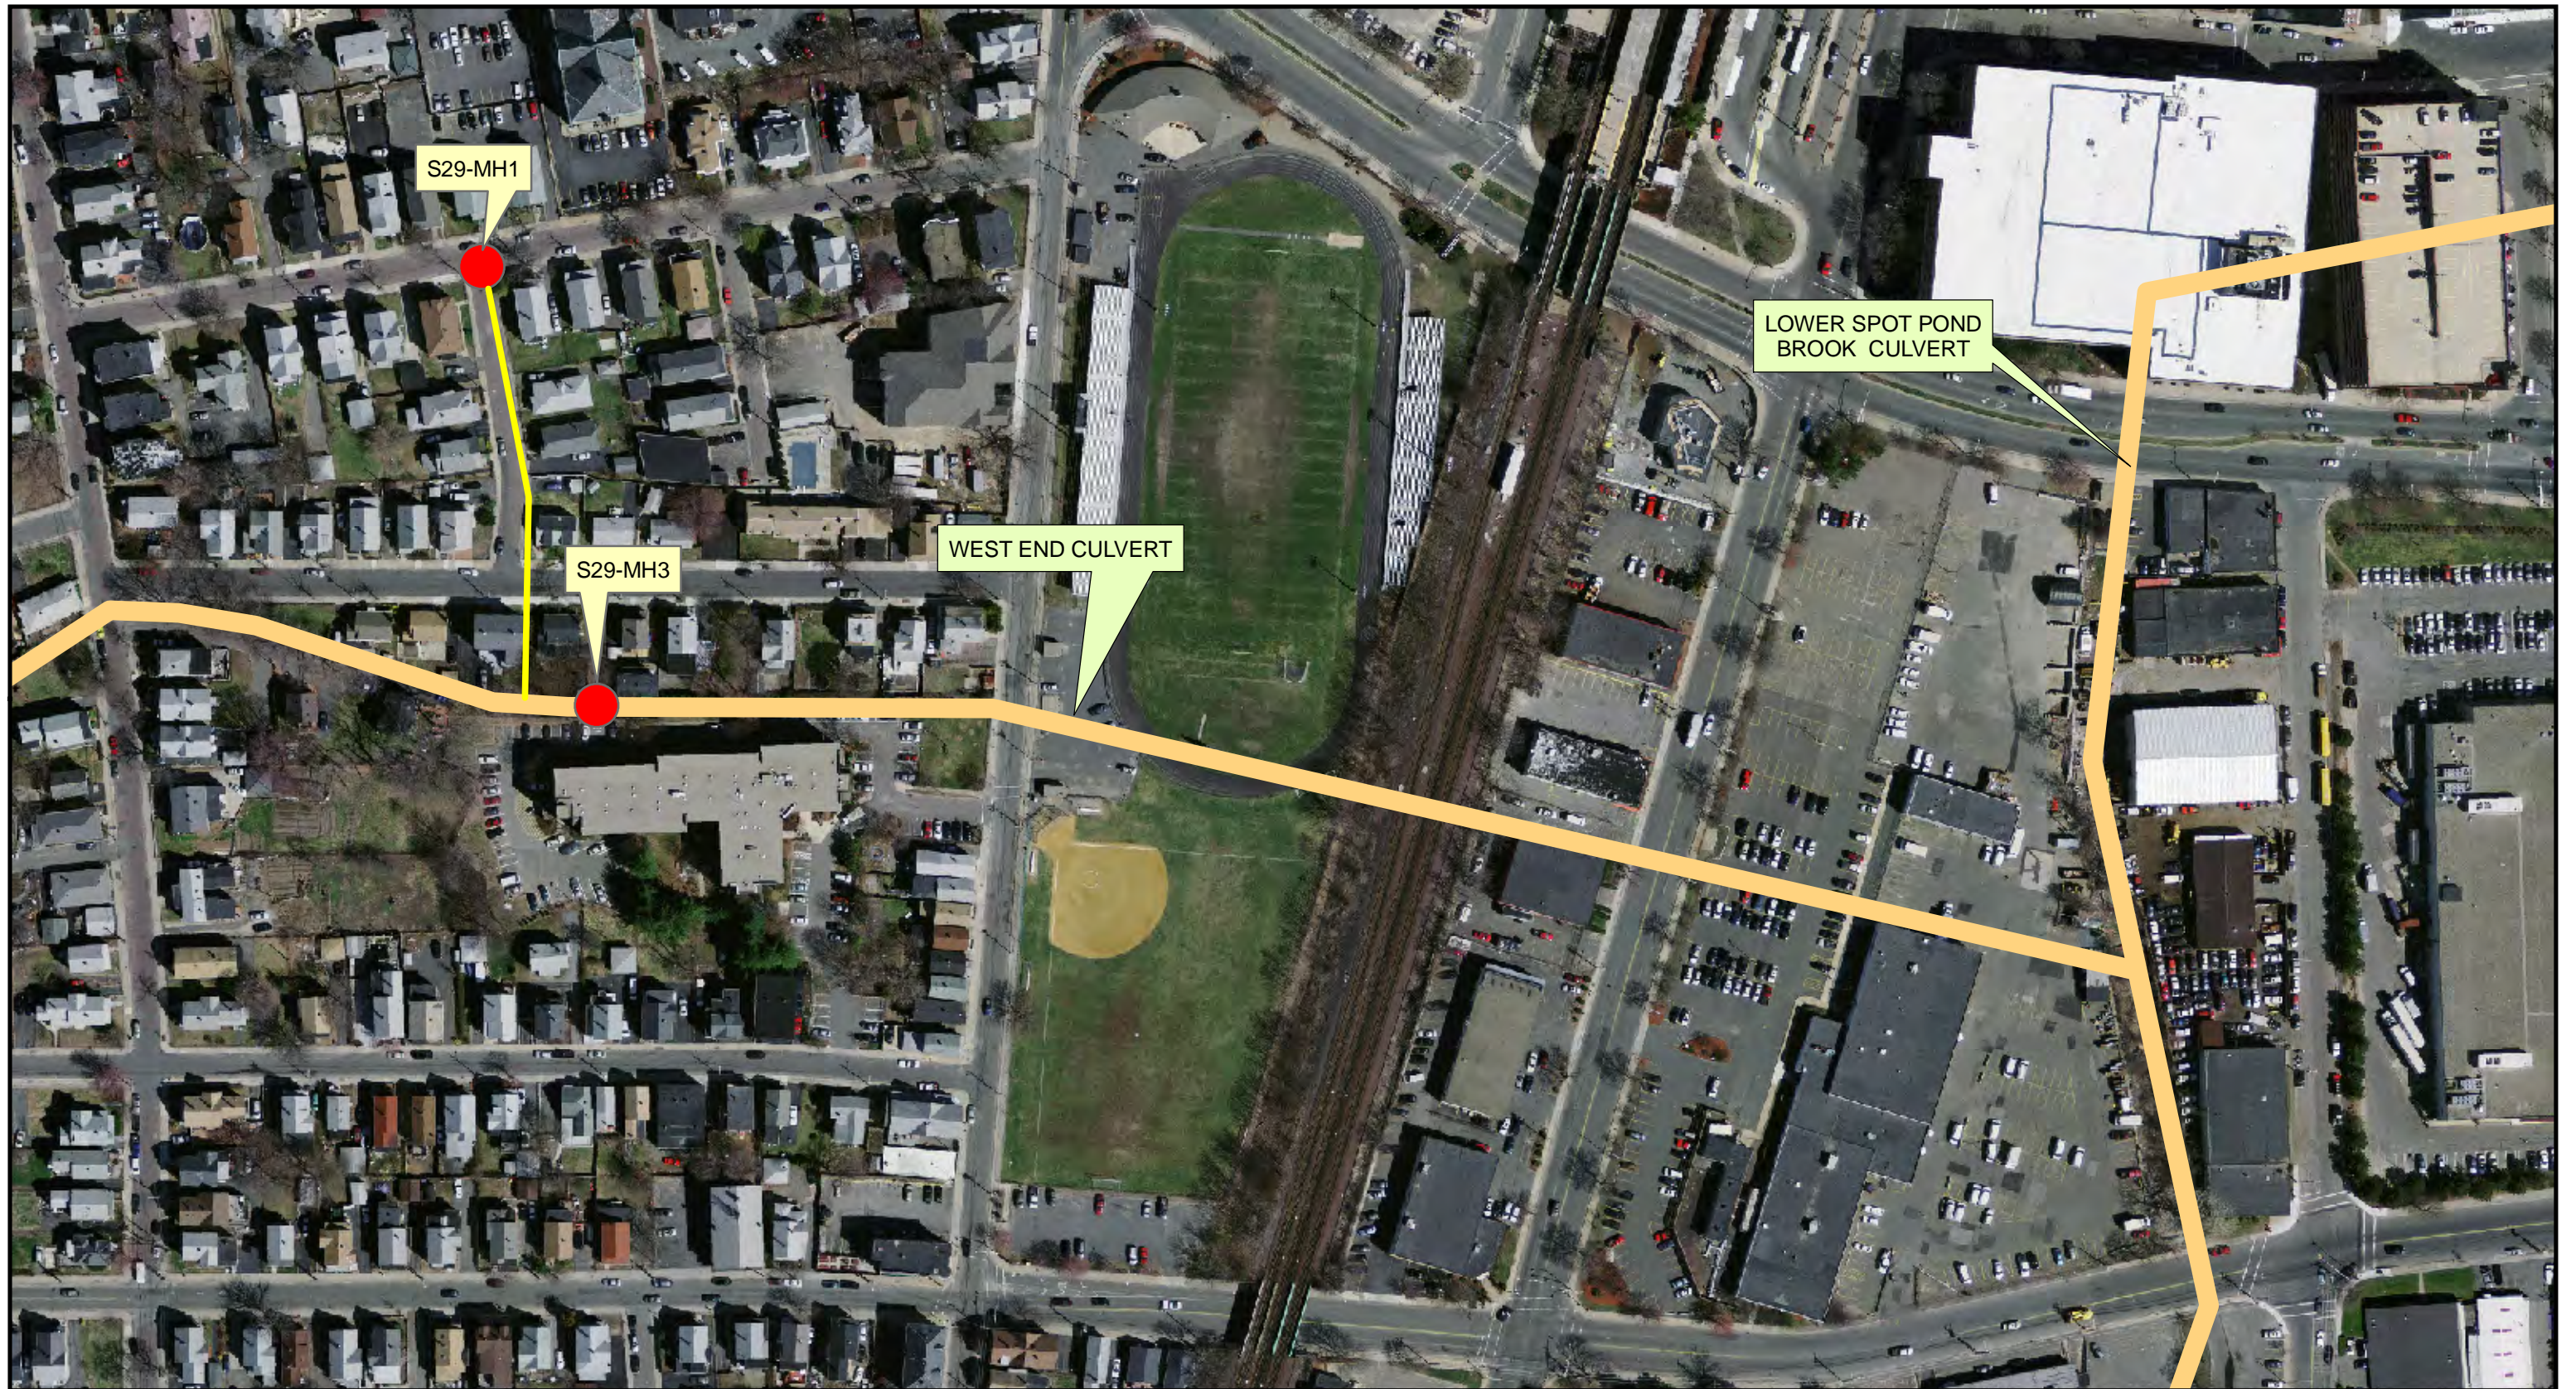
Figure 6 - 6 April 2013 Dry Weather Sampling Program
WEST END/ SPOT POND BROOK CULVERTS - MALDEN, MA

As indicated previously, prior dry weather inspections have identified dry weather flows within the West End Brook Culvert at the manhole identified as S29-MH3 (Figure 6). Reference to Table 2.0 reveals that elevated levels of bacteria (13,330 MPN/100 ml) were detected during the September 11, 2012 sampling event at this location, which was in marked contrast to those obtained during prior sampling events. To further assess this area of the drainage system, another dry weather sample was collected on 5 April 2013. In addition, manhole S29-MH1 (Figure 6), which is located upstream of S29-MH3 was also sampled at that time. Consistent with prior results, the sampling of West End Brook Culvert during this reporting period revealed bacteria levels of 160 MPN/100ml at S29-MH1 and 190 MPN/100ml at S29-MH3, as summarized on Table 2.0.
