**Municipality/Organization:** City of Malden  
**EPA NPDES Permit Number:** MA041046  
**MADEP Transmittal Number:** 041088  
**Annual Report Number  
& Reporting Period:** No. 12: April 1, 2014-March 31, 2015

## NPDES PII Small MS4 General Permit Annual Report

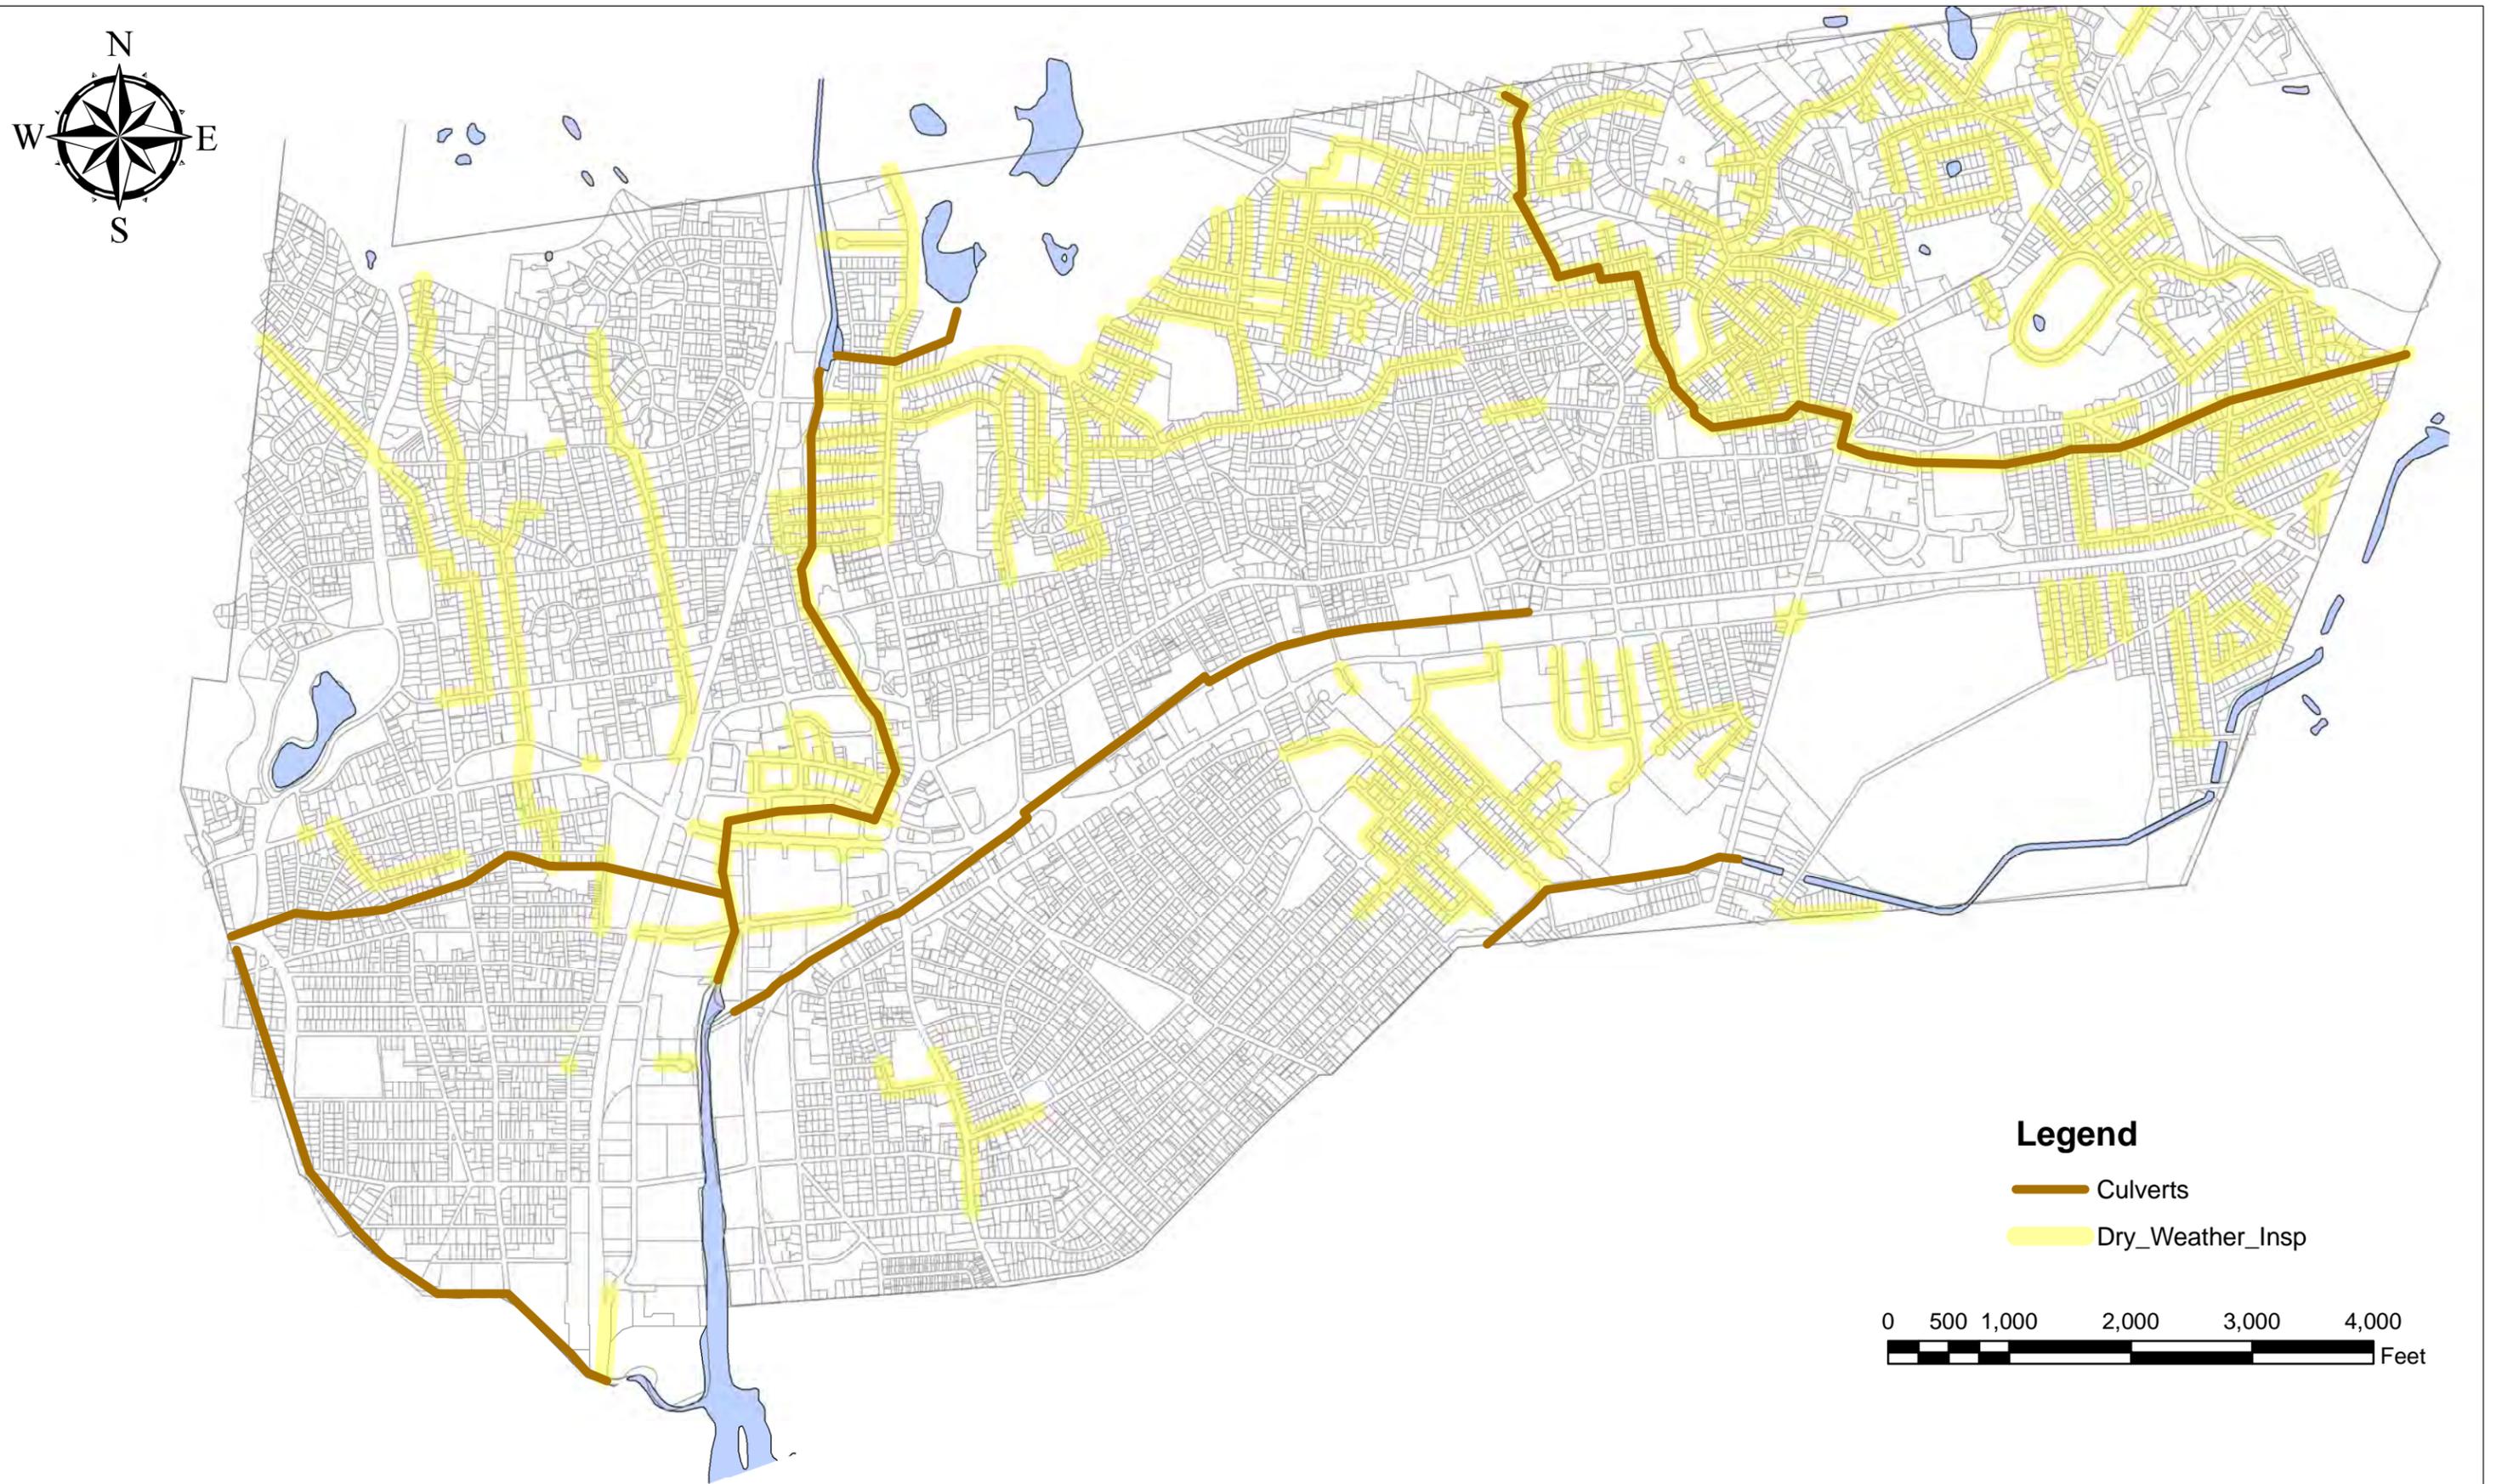
**Figure 2 - Dry Weather Inspection Areas (as of 6-30-14)**

A map depicting the approximate locations where targeted dry weather inspections have been conducted by NCA to date is presented as Figure 2. In addition, the drainage infrastructure is also inspected by DPW during the catch basin cleaning program. Upon the identification of previously unknown dry weather flows, the Engineering Department and NCA are immediately notified by MDPW personnel and targeted mass balance sampling efforts are performed. During dry weather inspections completed under the IDDE program, various dry weather flows have been identified. A summary of these flows within the municipal system that have been identified to date are shown on Table 2.0 and Figure 3. As stated above, during this reporting period, dry weather investigations were performed within three (3) key areas that warranted further flow isolation efforts based upon prior dry weather sampling data. These areas include the northeast and southeast sections of Malden, which contribute flows to Linden Brook and Town Line Brook, respectively. In addition, the central portion of Malden was also targeted, which discharges to Lower Spot Pond Brook, and ultimately the Malden River.
