Municipality/Organization: City of Malden
EPA NPDES Permit Number: MA041046
MADEP Transmittal Number: 041088
**Annual Report Number
& Reporting Period:** No. 13: April 1, 2015-March 31, 2016

NPDES PII Small MS4 General Permit Annual Report

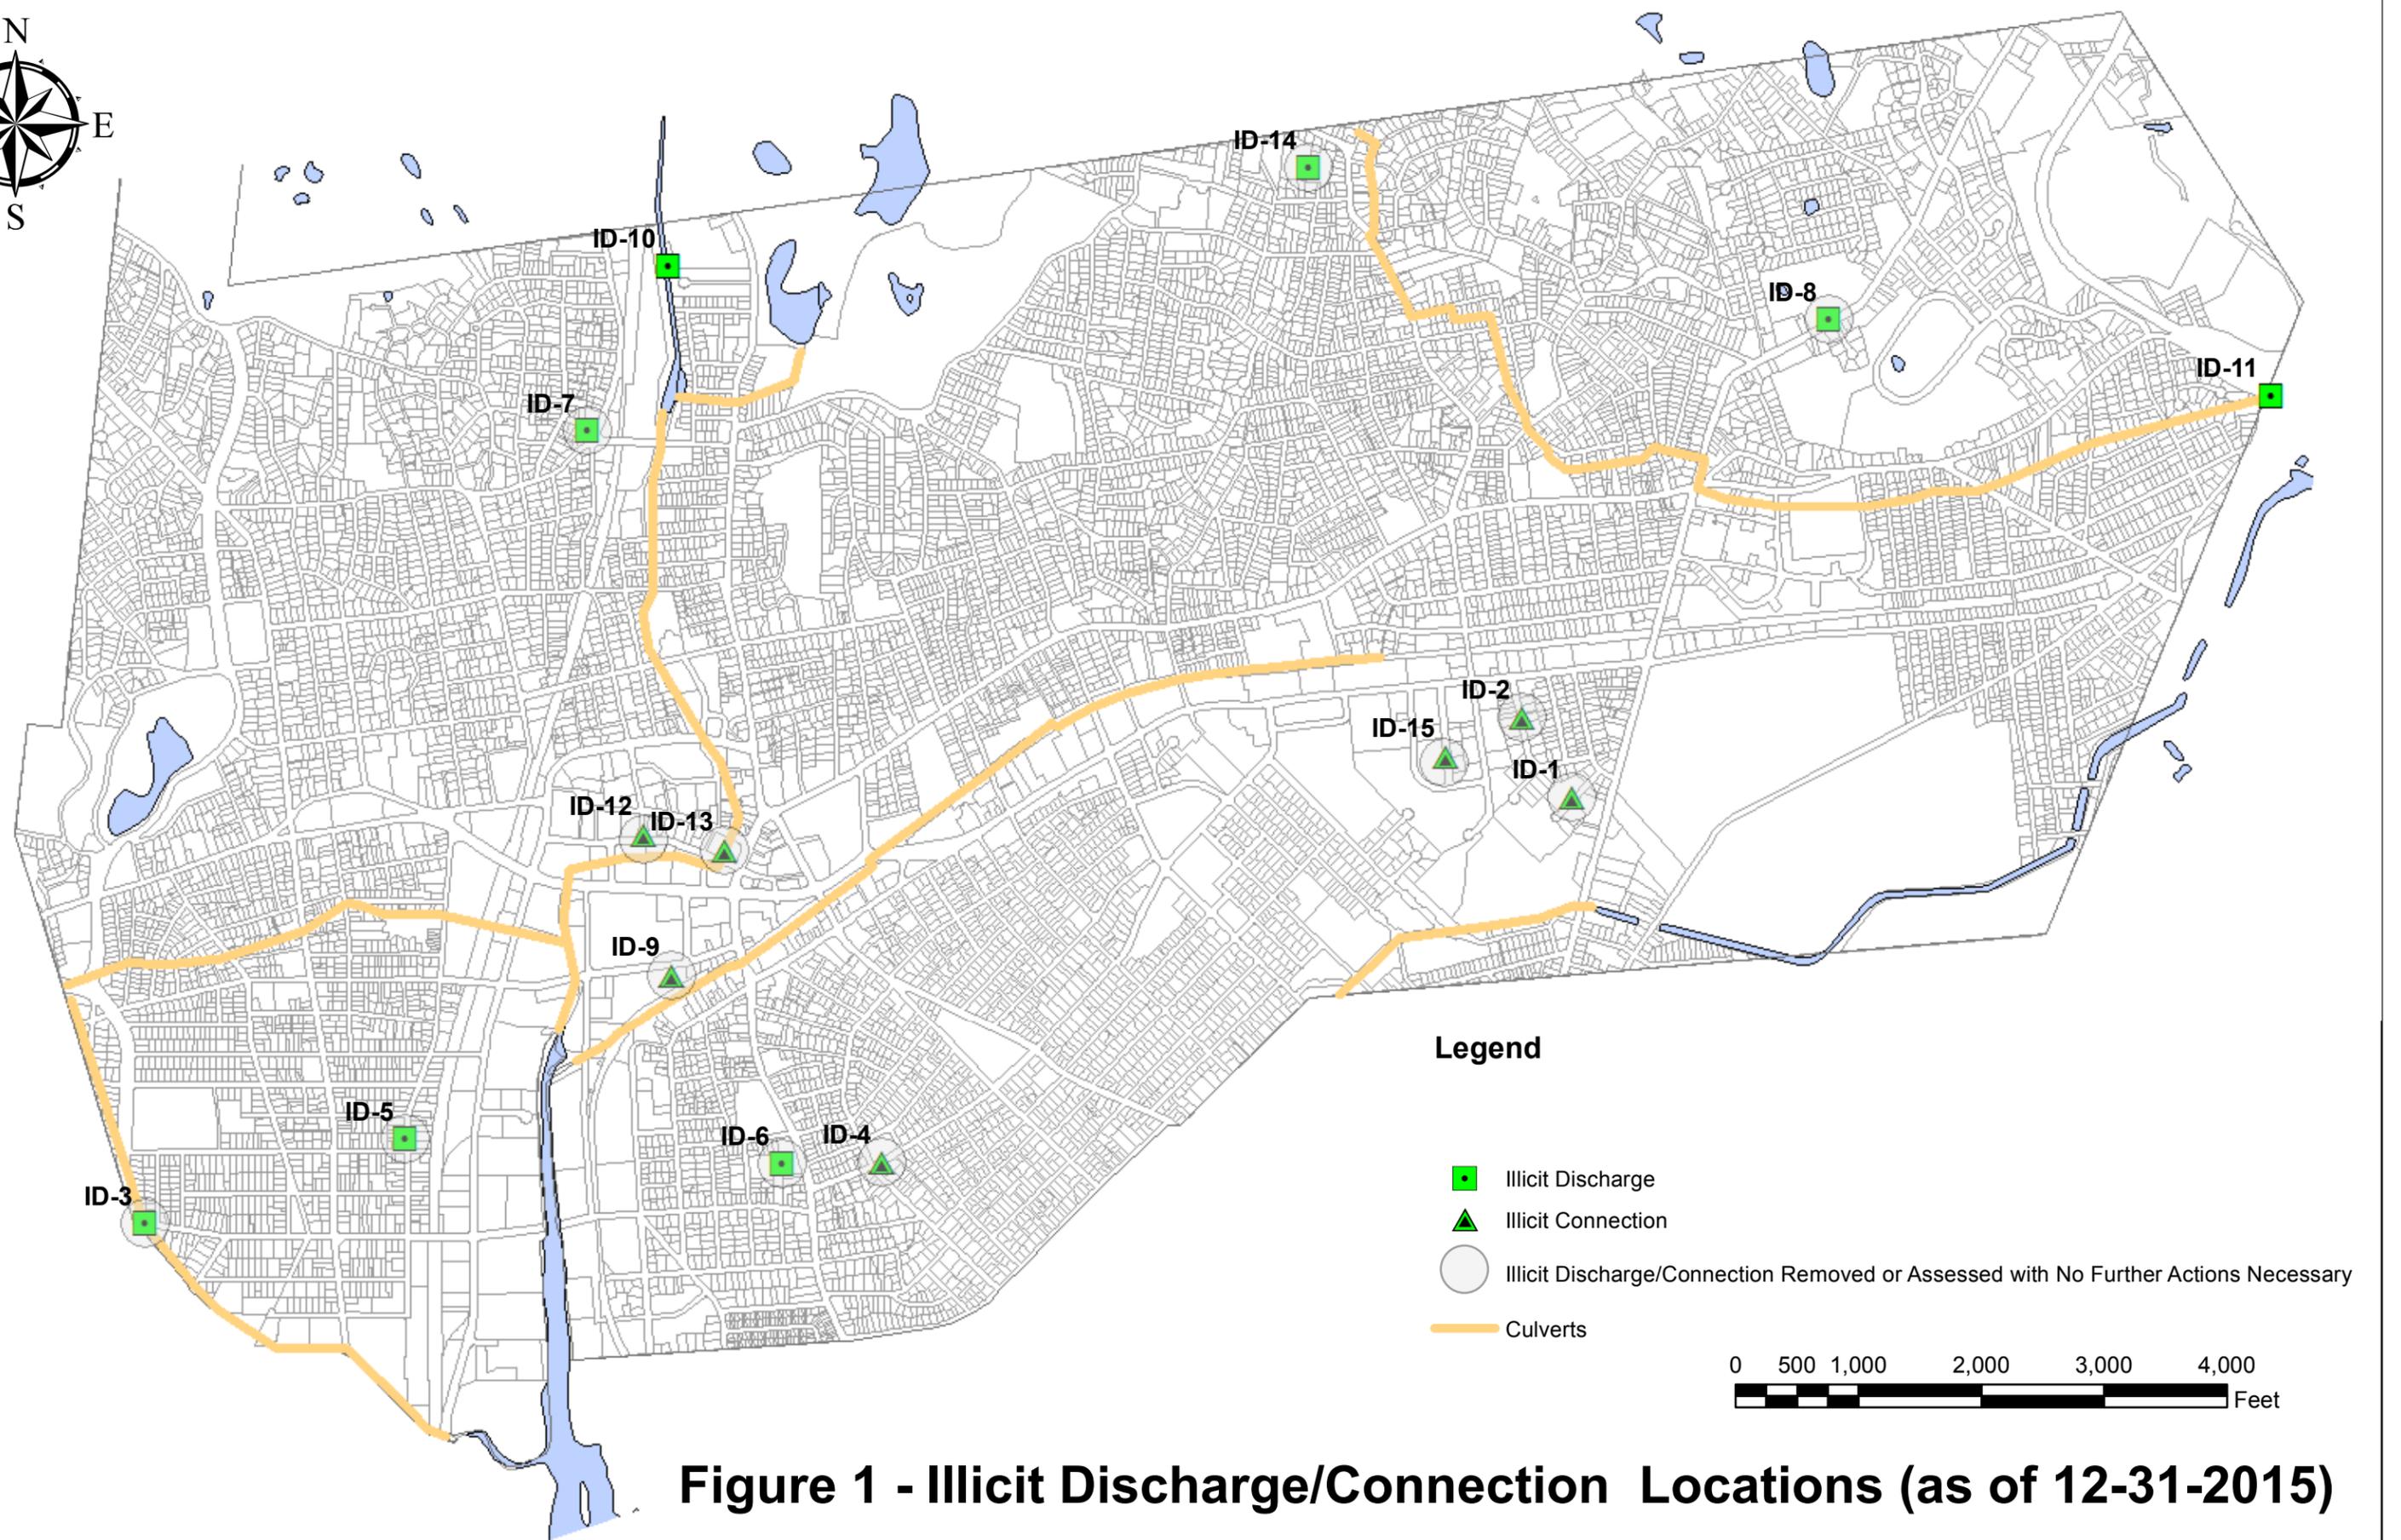
Figure 1 - Illicit Discharge/Connection Locations (as of 12-31-2015)

During this reporting period, no illicit discharges/connections were identified. A summary of the illicit discharges/connections identified to date is presented on Figure 1 and Table 1.0.

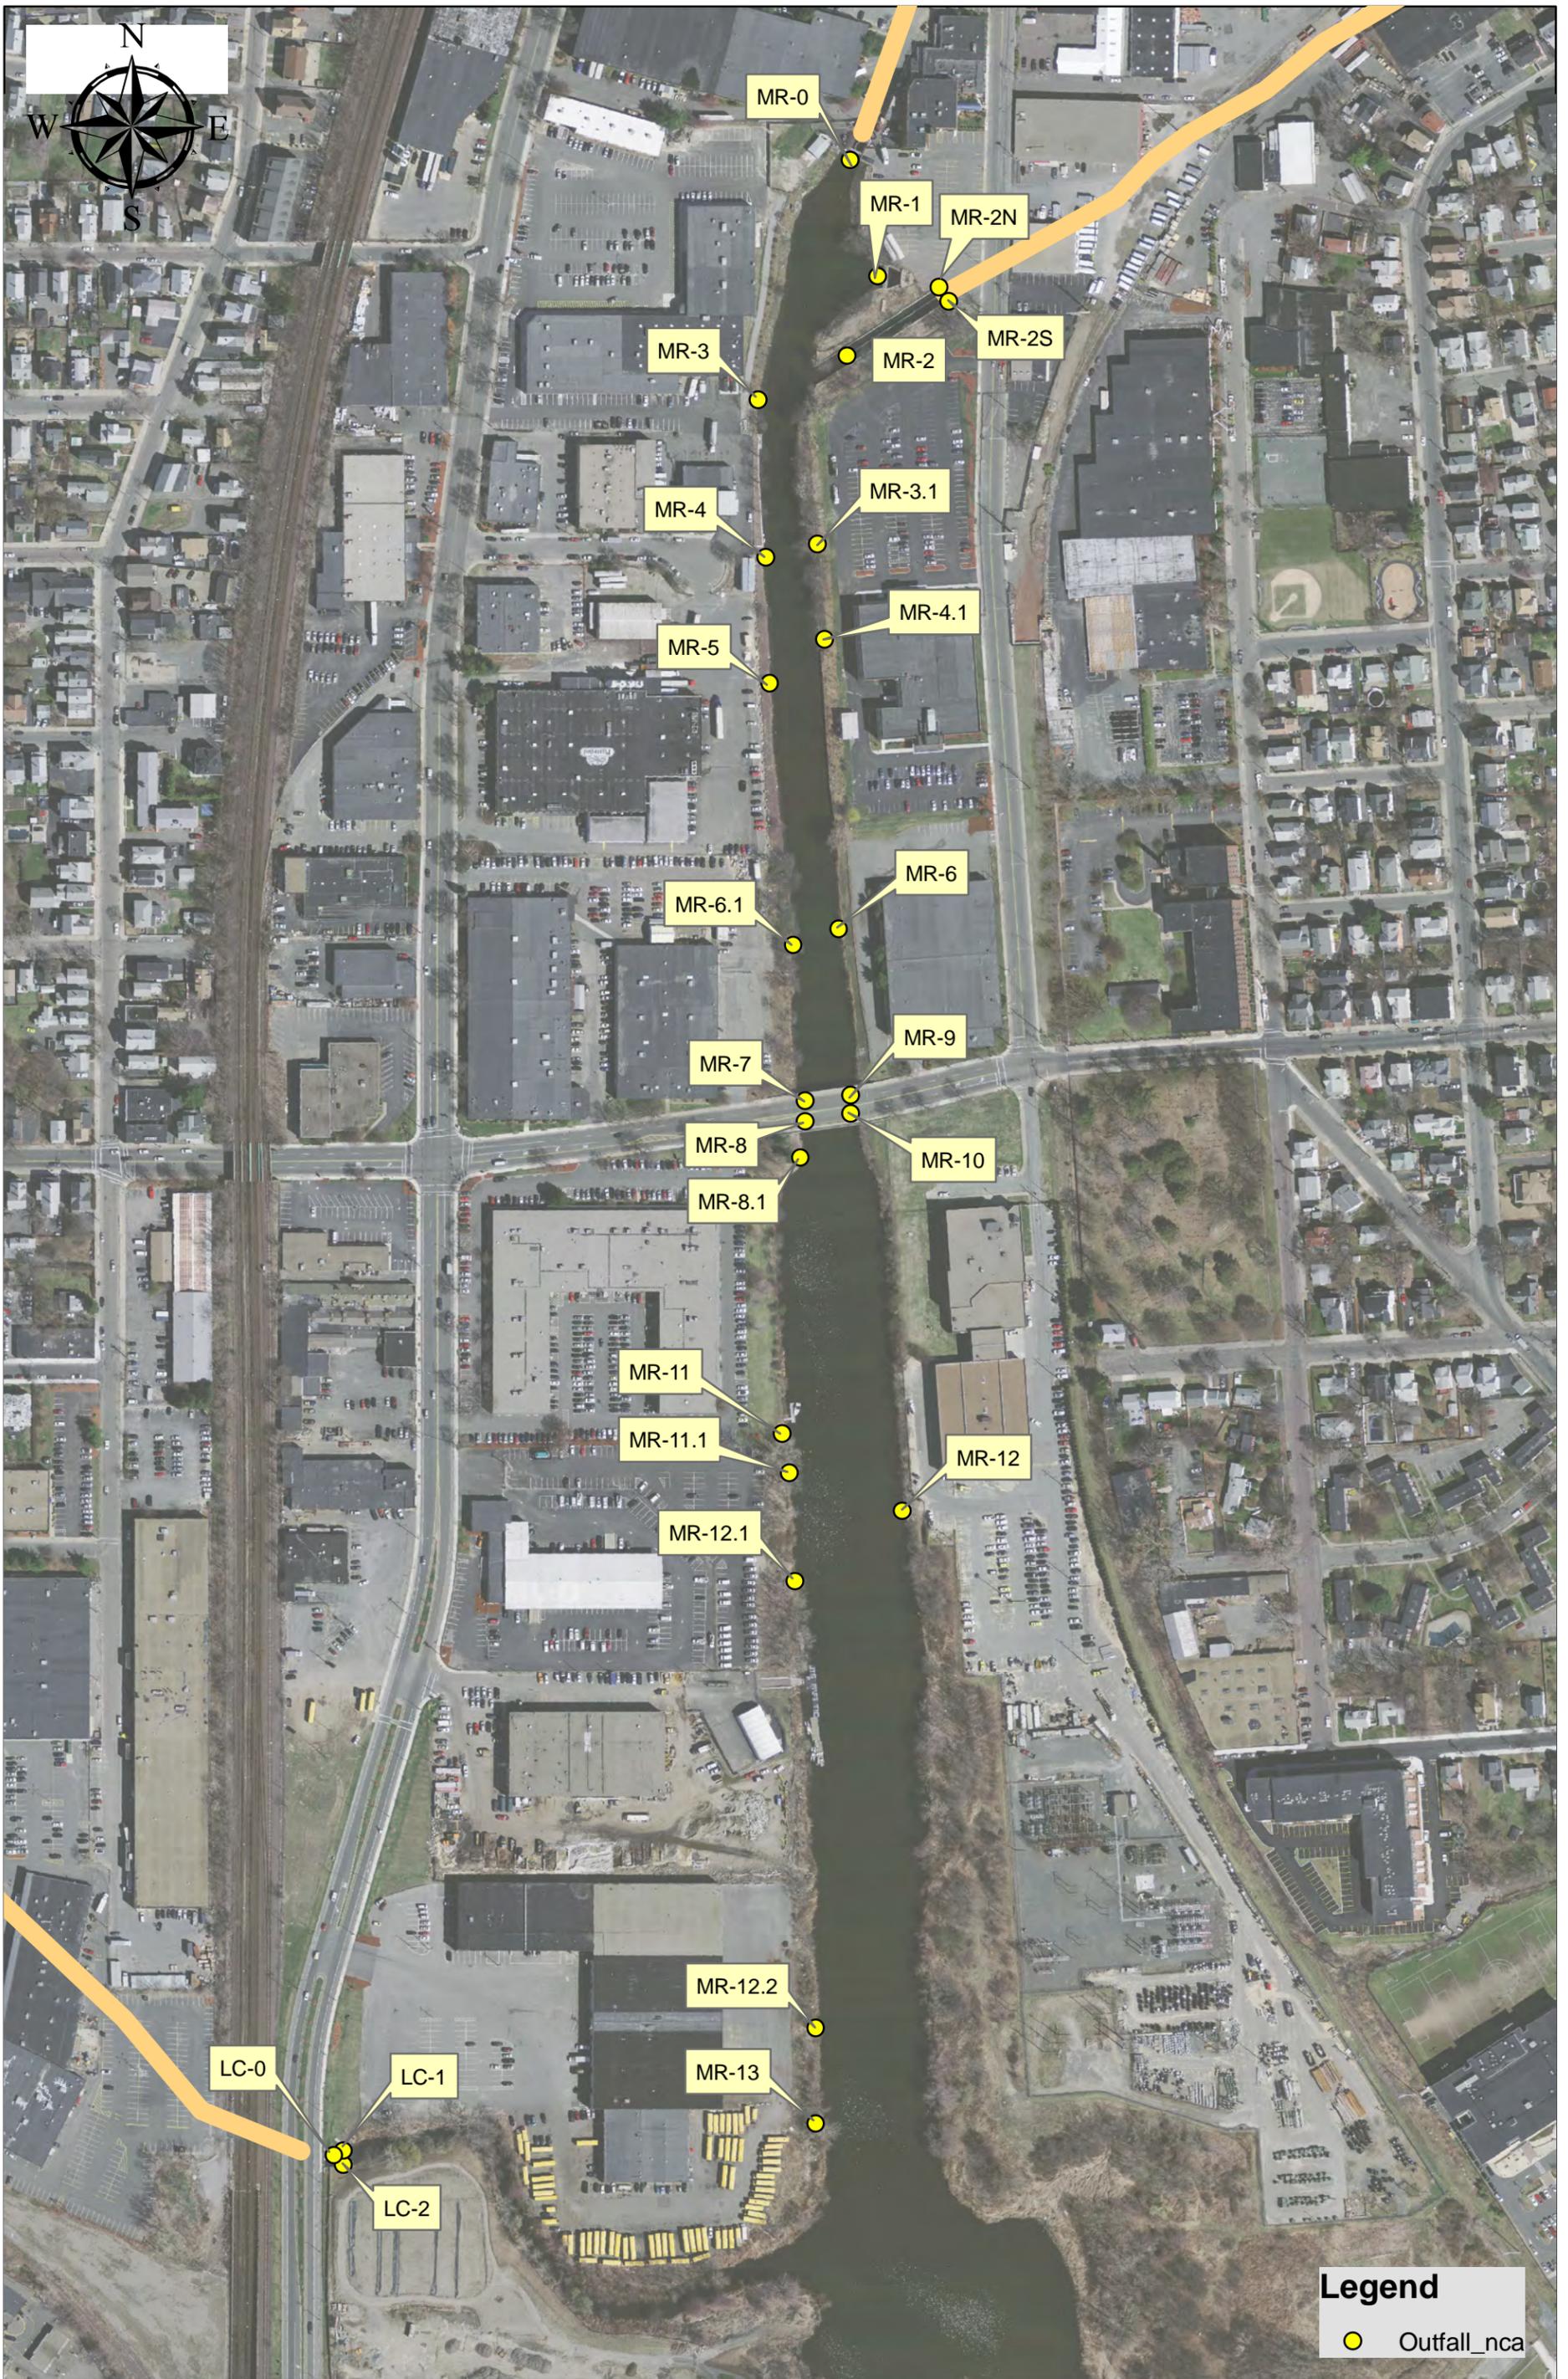
Figure 4 - Malden River Outfalls

As described in earlier submittals, the City of Malden's stormwater compliance team initially targeted potential illicit discharges to the Malden River as its highest priority. Utilizing the outfall monitoring data and information obtained during dry weather sampling events, the City has identified significant base flow as surface waters, to the Malden River. Consistent with the original design of the MDC/DCR conveyance network; this occurs primarily through culverted channels/brooks located in northwestern portions of the City. This flow includes contributions that originate from the Fells Reservation and Lower Spot Pond Brook. As shown on Figure 4, a total of 26 outfalls to the Malden River have been identified, nine (9) of which have been identified as flowing during dry weather conditions. Periodic dry weather sampling has been performed by NCA, MyRWA and the USEPA.

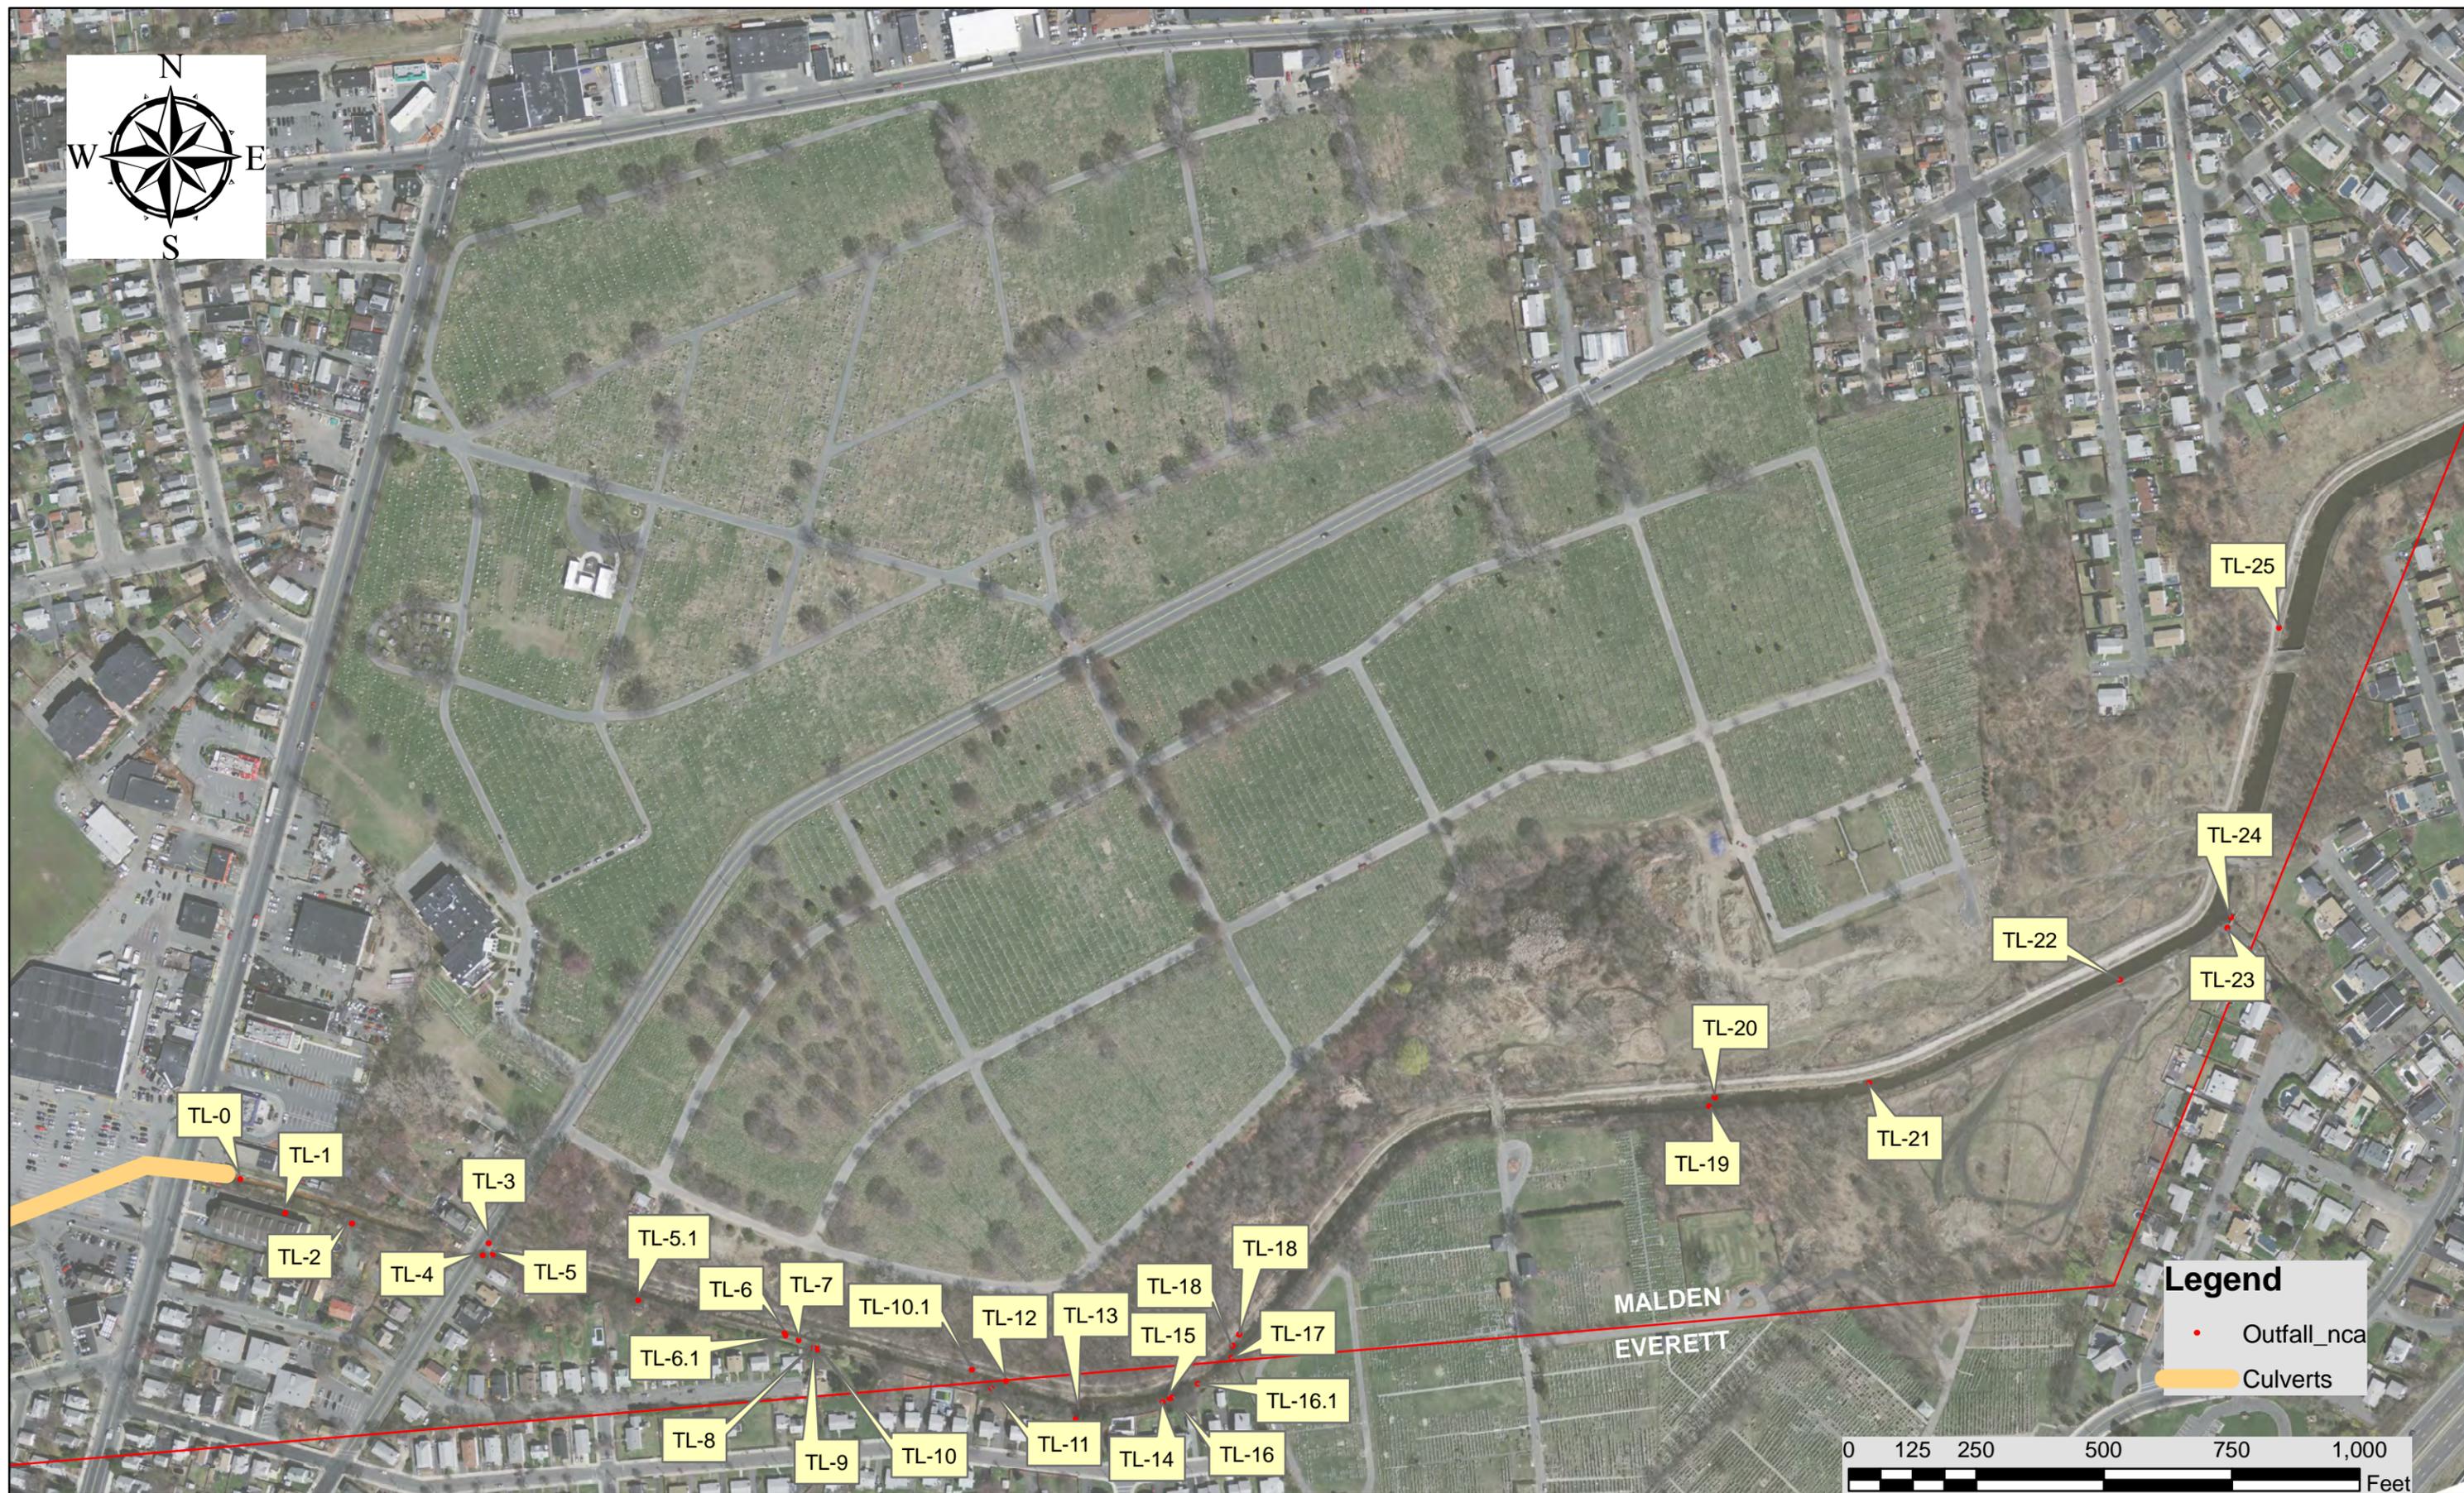
Figure 7 - Town Line Brook Outfalls

Town Line Brook in Malden begins at the Malden and Everett city boundary and is culverted until it daylight into an open concrete lined trapezoidal channel at Broadway. Significant tidal influences exist in the form of an approximate 2-3 foot change in surface water elevation between Broadway and the remaining length of the culvert to the Revere City line. As shown on Figure 7, a total of 29 outfalls to Town Line Brook in Malden have been identified. The historic monitoring data of Town Line Brook has revealed relatively uniform bacteria levels during dry weather sampling events. Several outfall locations have consistently exhibited bacteria loadings during dry weather sampling events, including S3-MH12, TL-0, TL-9 and Trifone Brook (TL-24). Manhole sample point S3-MH12 is the upstream sampling point for this section of the Brook as it enters the Malden system from Everett, while TL-0 is located at Broadway, where Town Line Brook daylight. TL-9 is located proximate to the terminus of Hadley Street in Malden and receives dry weather flows from the City of Everett, with Trifone Brook (TL-24), also flowing from Everett prior to discharging into Town Line Brook. Based upon the historic monitoring of these outfalls, it is apparent that contributions continue to enter the Malden system from upstream areas and the focus of dry weather sampling has been directed towards the area described within this submittal.

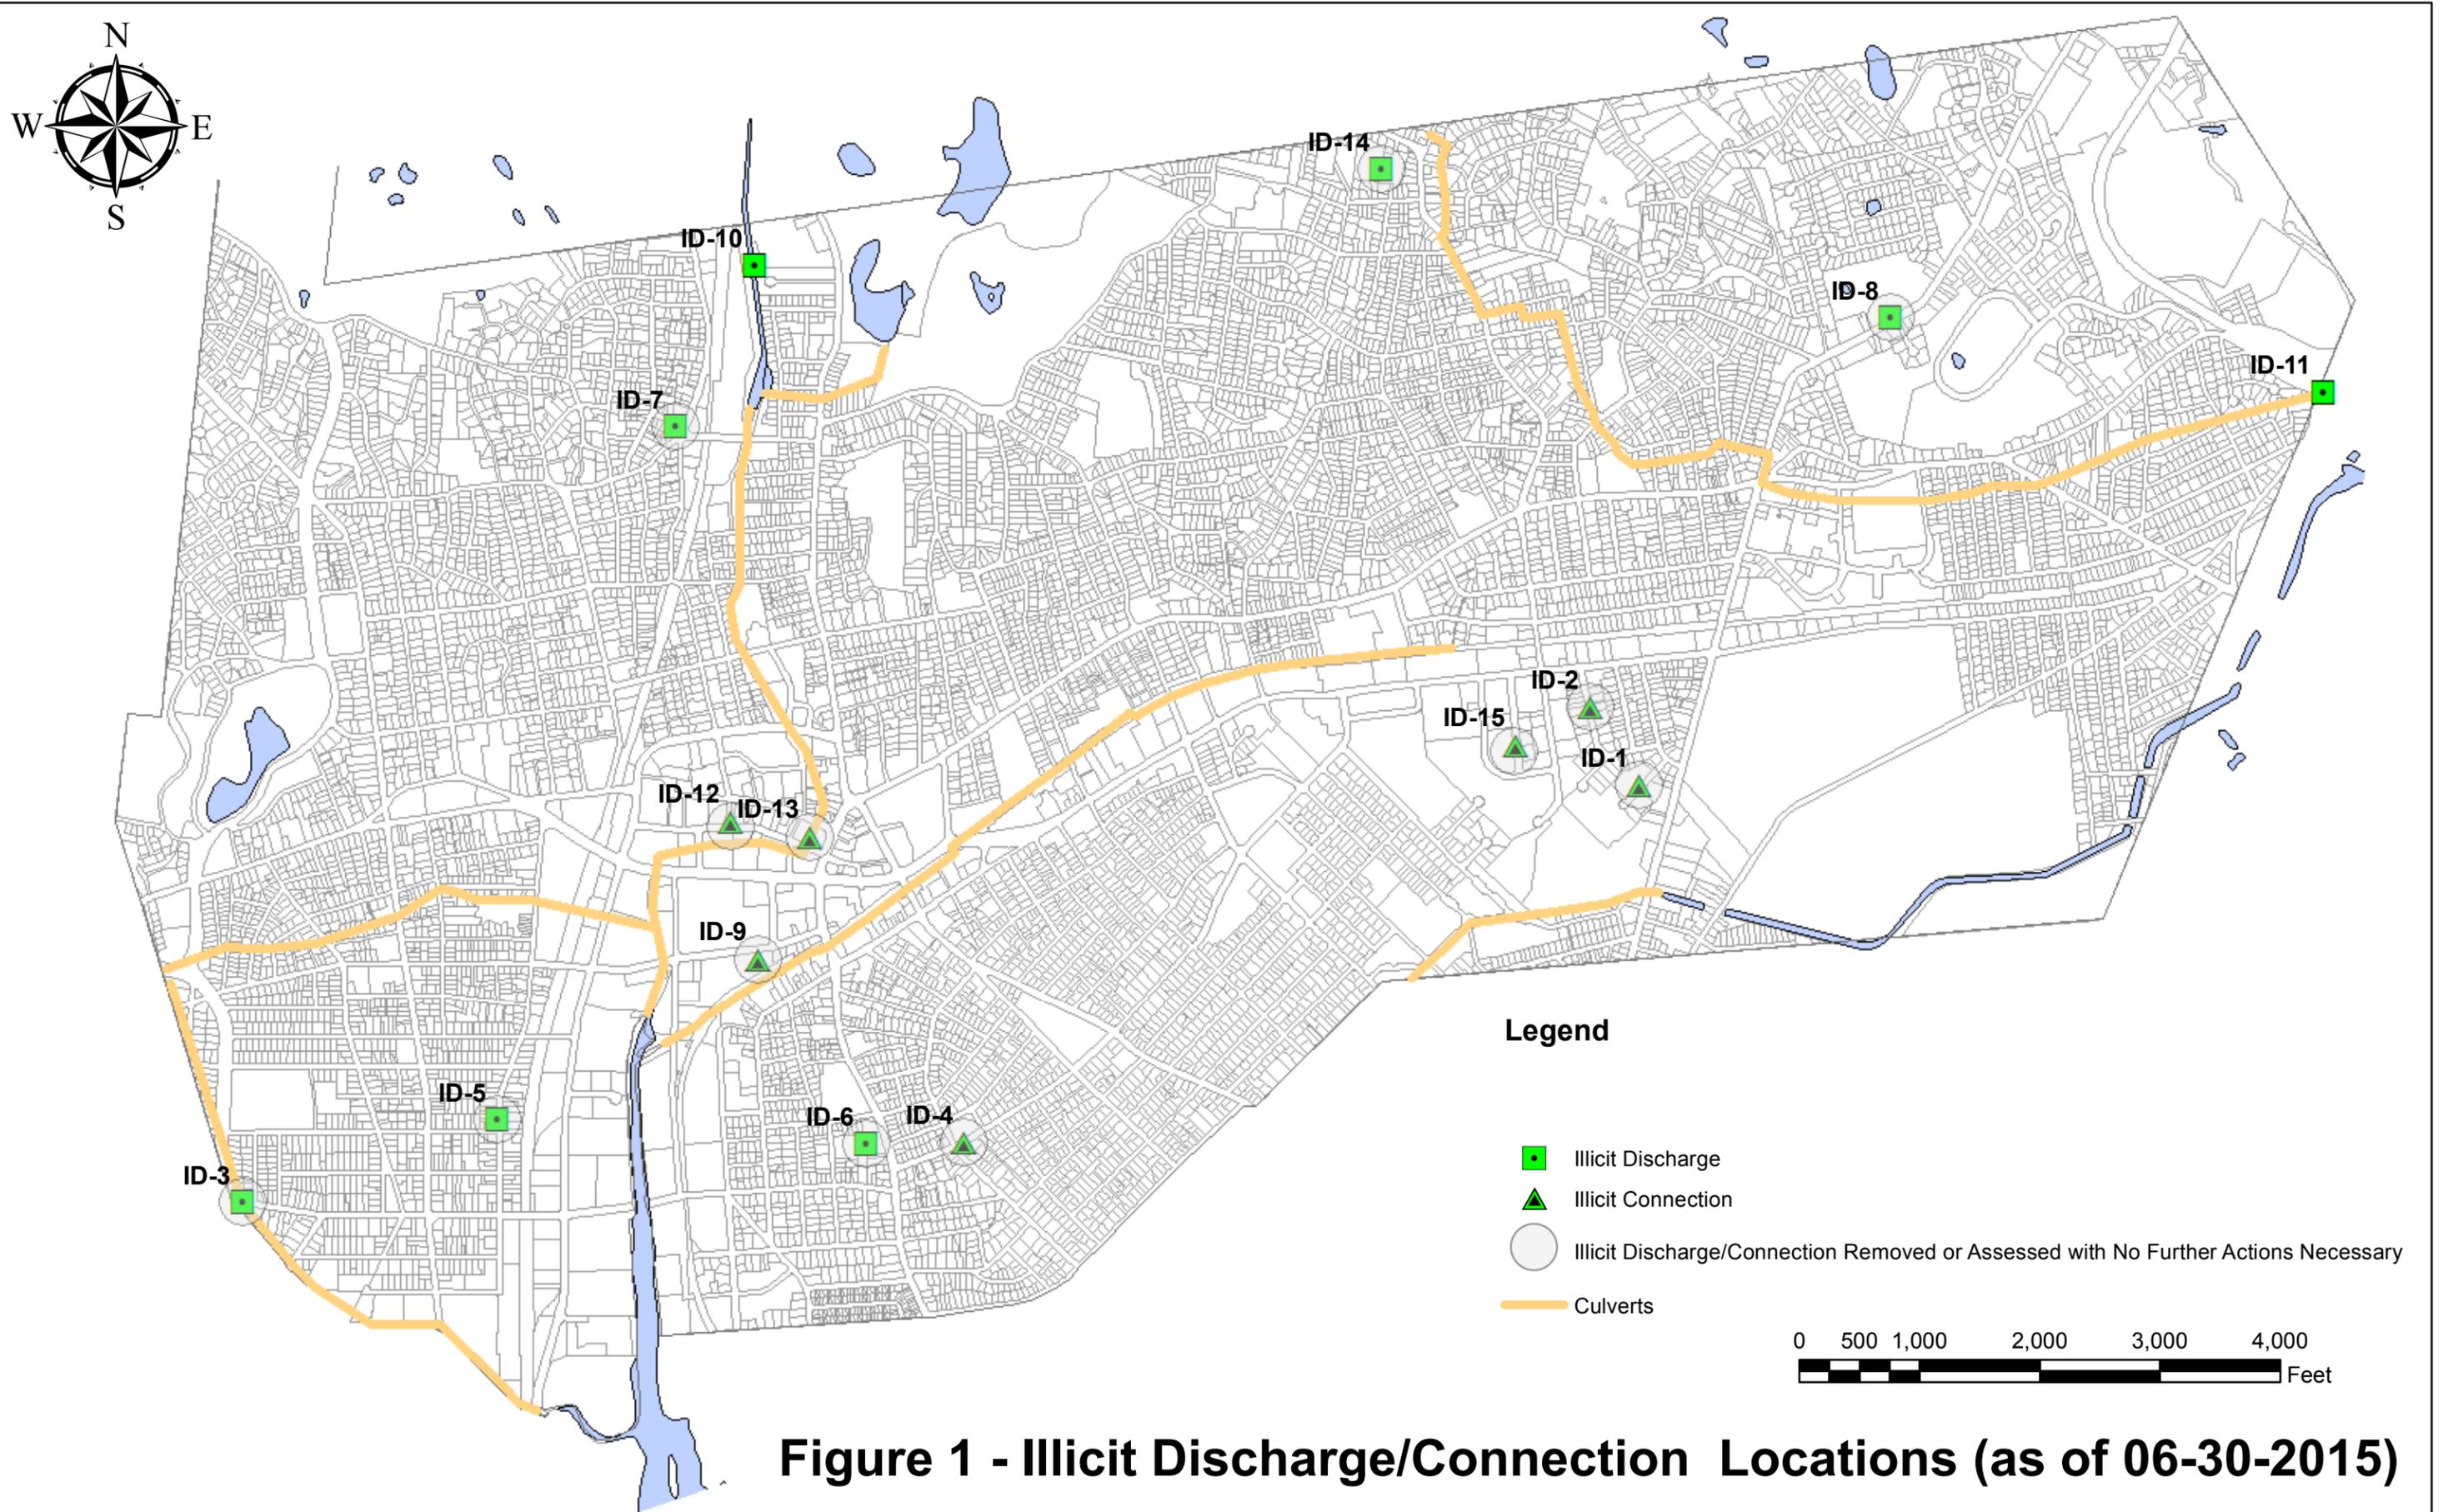
Figure 1 - Illicit Discharge/Connection Locations (as of 06-30-2015)

During this reporting period, no illicit discharges/connections were identified. A summary of the illicit discharges/connections identified to date is presented on Figure 1 and Table 1.0.

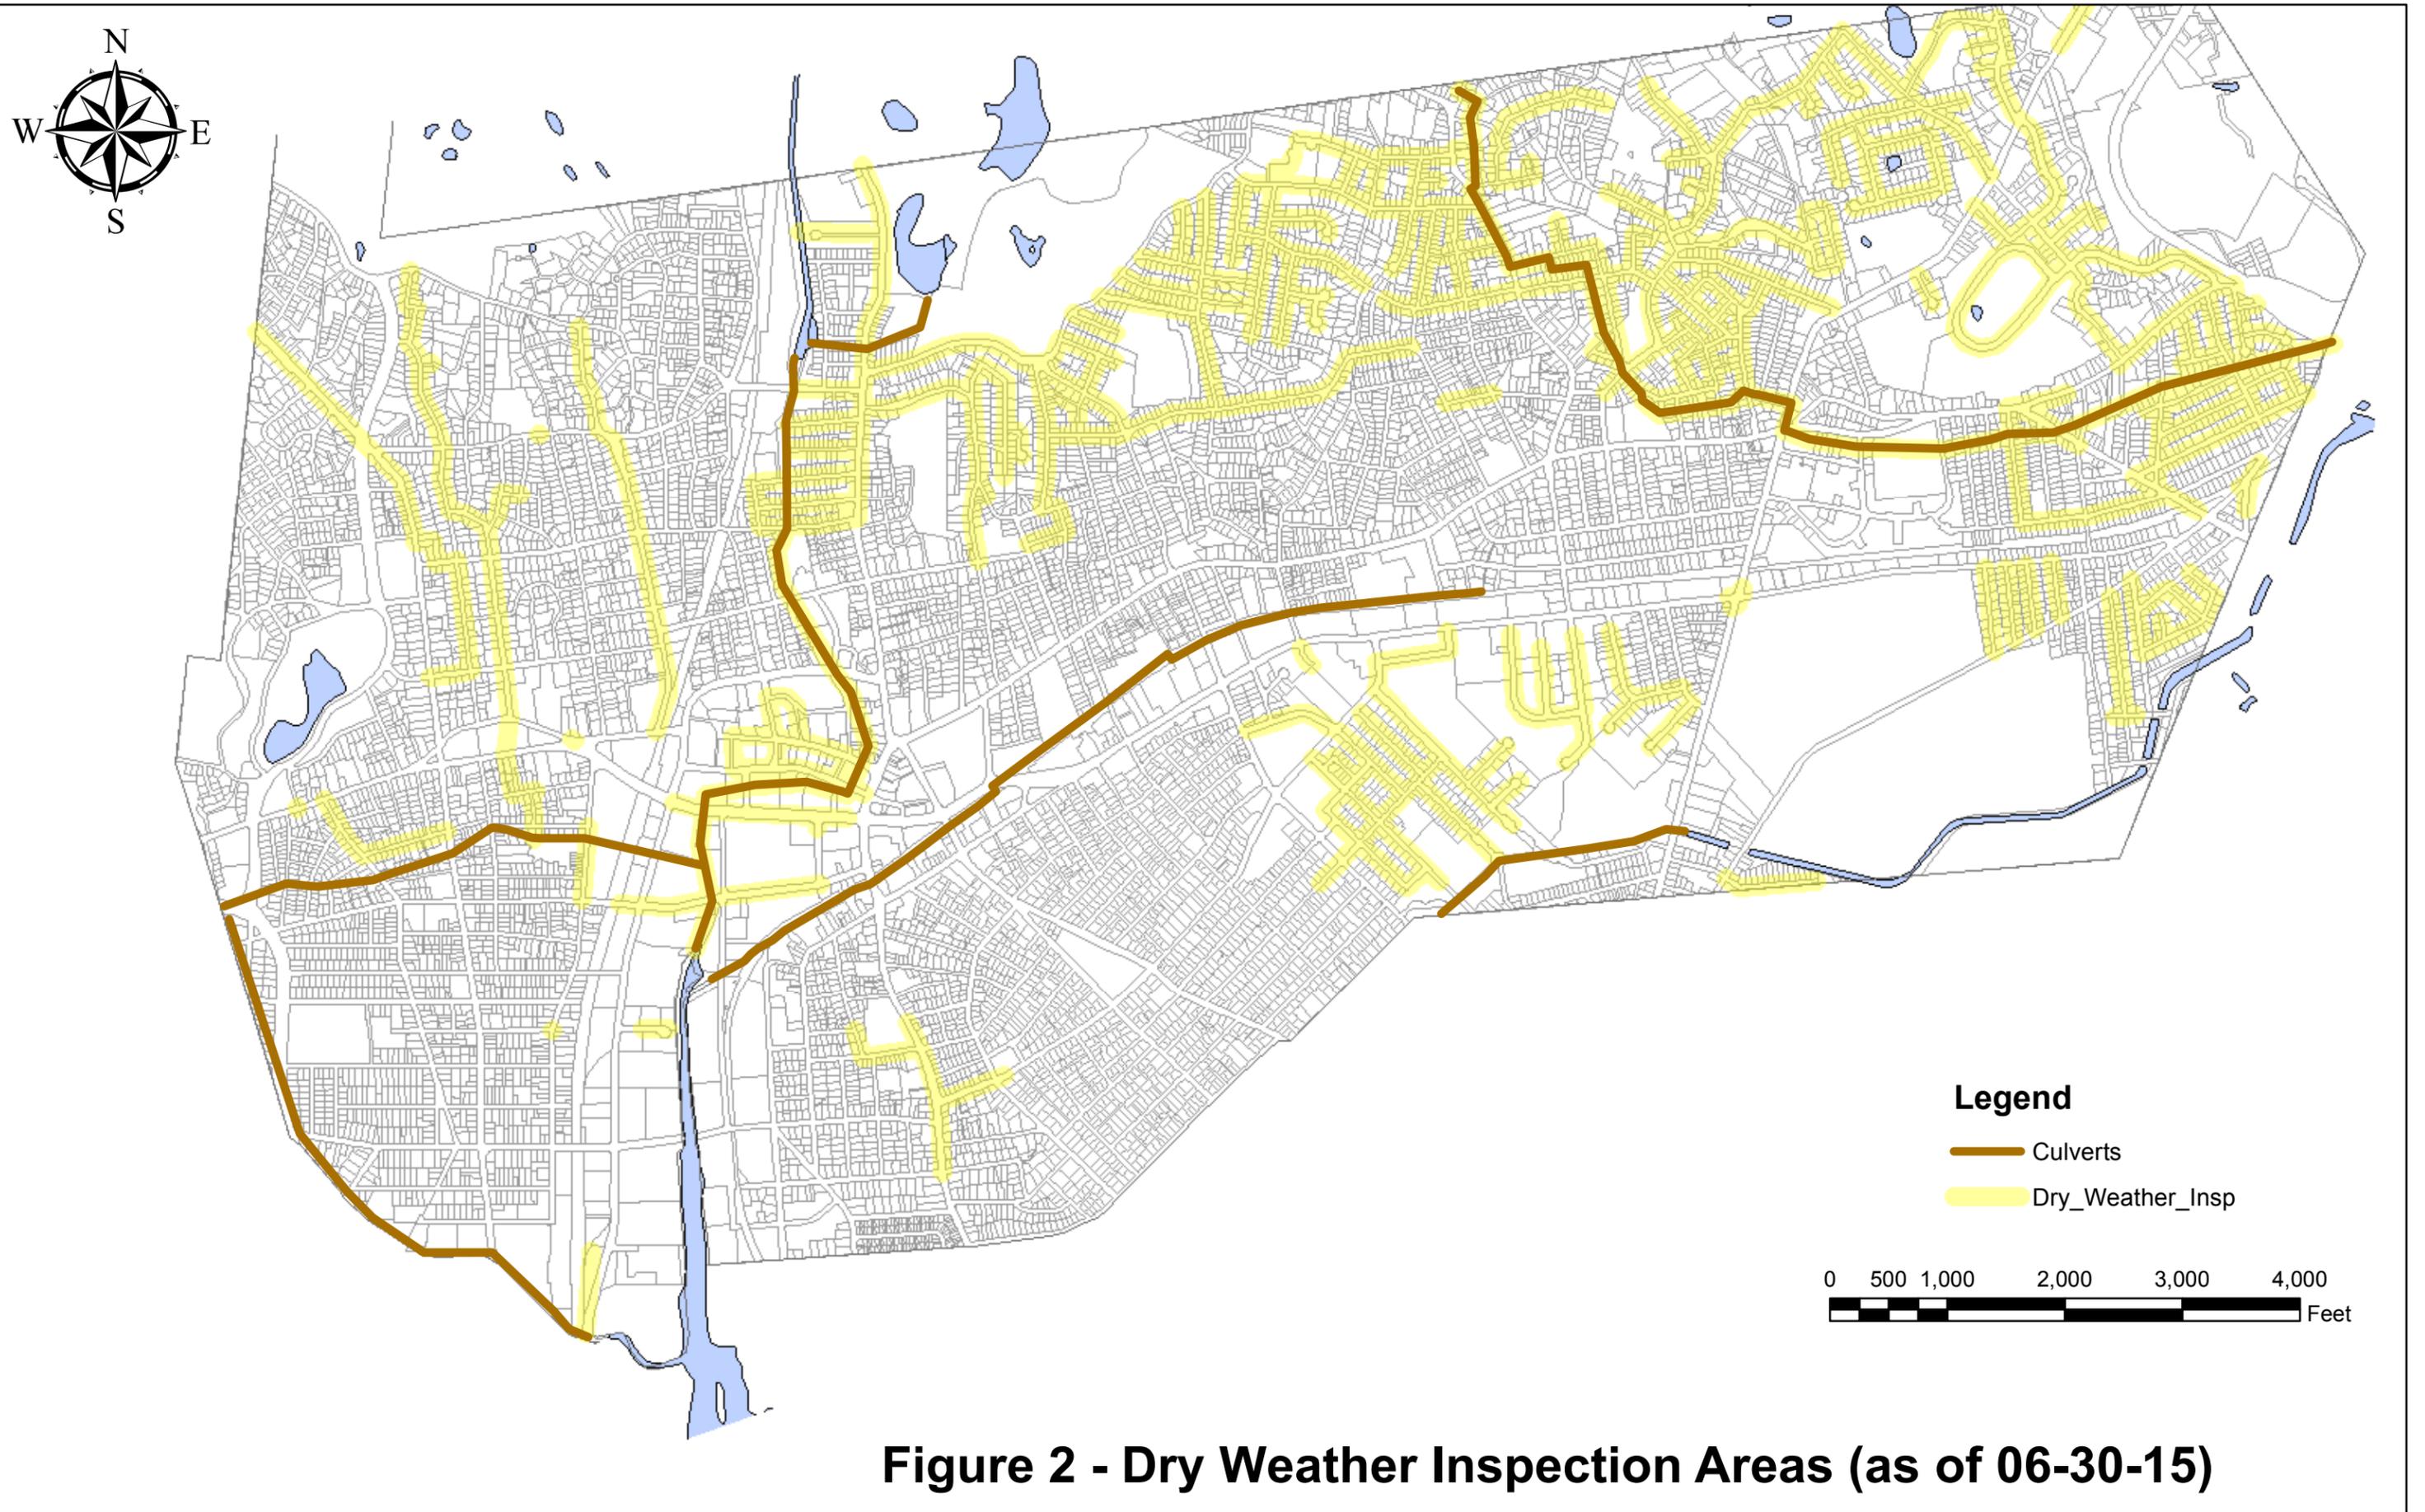
A map depicting the approximate locations where targeted dry weather inspections have been conducted by NCA to date is presented as Figure 2. In addition, the drainage infrastructure is also inspected by the MDPW during the catch basin cleaning program. Upon the identification of previously unknown dry weather flows, the Engineering Department and NCA are immediately notified by MDPW personnel and targeted mass balance sampling efforts are performed. During dry weather inspections completed under the IDDE program, various dry weather flows have been identified. A summary of these flows within the municipal system that have been identified to date are shown on Table 2.0 and Figure 3. As stated previously, during this reporting period, dry weather investigations were performed within the Malden River watershed. Details pertaining to the sampling results may be referenced with Section 3.1.1.
