Municipality/Organization: Town of Blackstone

NPDES PII Small MS4 General Permit Annual Report (Due: May 1, 2017)

**National Pollutant Discharge
Elimination System (NPDES)
Phase II Stormwater Management Plan
Outfall Inspection Report**

Blackstone, Massachusetts

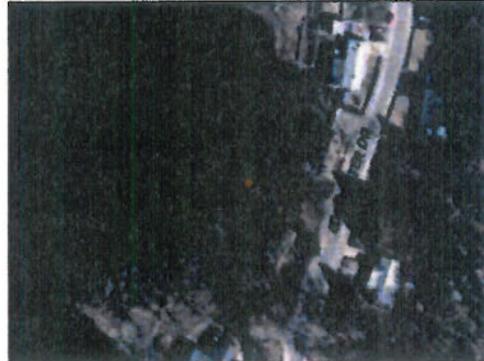
Photo Name: OF_014Locus.jpg

Outfall No.	Finding	Action Item
14	Excessive washed out road sand; invert has rusted away.	Clear flow channel. Sweep roadway tributary area. Clean catch basin sumps, which may be washing out because they are full. In the long term, consider replacing the outfall pipe.
45	The mouth of this outfall is covered by a welded steel grate, which is approximately 75% obstructed by captured leaves, sticks and debris.	Outfall grate should be cleaned and cleared of obstructions as soon as possible to prevent possible upstream flooding.
47	Outfall is obscured by weeds, debris, and creeping woody plant growth.	Clear a path to the outfall, uncover it for easy location. Ensure flow path is clear and unobstructed. Remove plants and roots which might compromise the outfall pipe.
49	Outfall pipe invert has rusted away.	In the long term, consider replacing the outfall pipe.
84 (High Priority Outfall)	Pipe shows considerable cracking, invert has rotted away. Pipe may be approaching the end of useful life; failure could compromise the headwall it is located in, causing a collapse.	In the long term, consider replacing this outfall pipe as structural collapse could compromise the headwall. Locate record drawings and/or televise the pipe to determine length, age, condition, and probable cost to replace.

Structural Damage: Squashed Laterally

Several of the outfalls in Table 1 (14, 49, and 84) appear to be nearing the end of their useful lives. The Town should consider a replacement program, prioritizing areas where pipe failure may damage other property or infrastructure. As is the nature of stormwater outfalls, a majority of these structures are located in wooded areas, along the banks of rivers or other bodies of water, and in other areas that are not easily accessible. A path to each outfall should be established and kept clear for ease of inspection and maintenance. In addition, each outfall should be inspected semi-annually for structural integrity and signs of illicit discharge. The town should develop and implement an outfall maintenance program to address structural issues identified during inspections. Maintenance of drainage manholes and catch basins should be included as part of this plan as rocks, sediment and other debris may damage or obstruct the outfalls. The town should also stencil or otherwise label all catch basins with a "no dumping" message. It may also be productive to post a permanent sign (with the outfall number) in the vicinity of each outfall to make them easier to locate for inspections and in the case of emergencies.

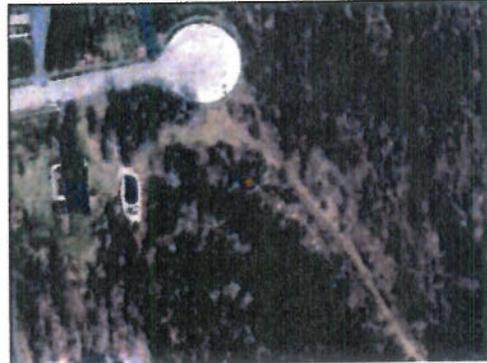
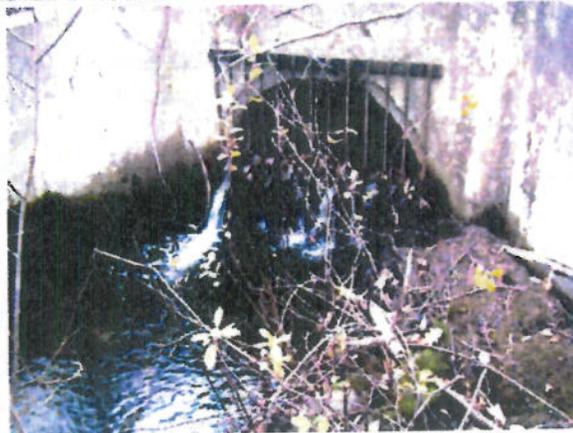
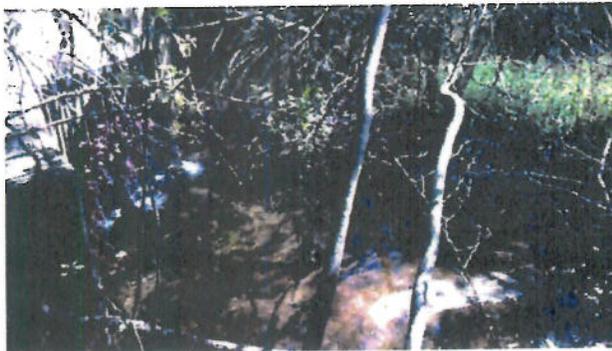
Outfall #: 45 GPS Location Date: 11/15/2011
Location: End of Crestwood Dr.
Land Use: Residential
Land Use Comment:

Flow: 20 gpm

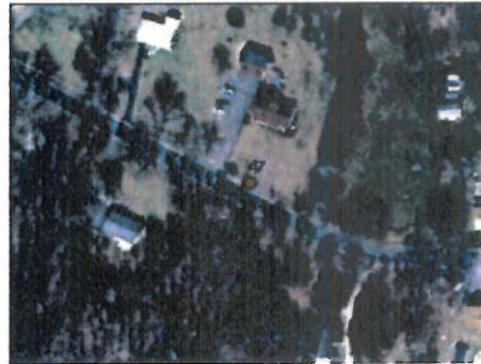
Photo Name: OF_047Locus.jpg

Structural Damage: Fair, some rusting out

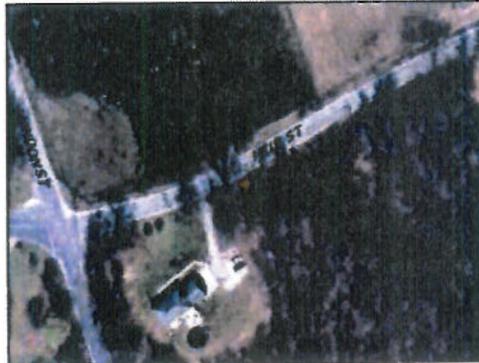
Outfall #: 49 GPS Location Date: 11/15/2011
Location:
Land Use: Residential
Land Use Comment: Agricultural

Blockage:
Floatables: None
Deposits: Sediment
Vegetation Growth: Some
Structural Damage: Invert of Pipe Rotted at exit; Appr
Comment:

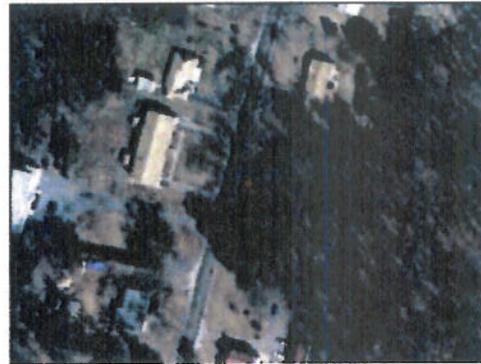
Photo Name: OF_061Locus.jpg

Outfall 61: This circular 18 inch concrete outfall is located on Federal Street near house number 155. This outfall was added to the "High Priority" list due to the presence of dry weather flow and foam. This outfall has been monitored each year, but the observations did not indicate an illicit discharge. A small amount of bubbles/foam were noted during the 2016 inspection. It was observed that the foam was not chemically perfumed, broke apart easily when disturbed, and generally appeared to be natural, biological foam which occurs when organic materials release compounds into water as they decompose. Additionally, outfall 61 is in a low lying area with some wetland characteristics. Dry weather flow and foam during the spring may be expected in such areas. Therefore, the available evidence at this time indicates that sampling is not required at this outfall. AECOM recommends that town personnel continue to monitor this outfall during their regular operations. Based on this inspection and past inspections, this outfall should remain on the "High Priority" list and should be formally inspected again during the next annual outfall inspections. If the outfall at any time begins to show any signs of illicit connections, its flow should be sampled and tested. If the sampling indicates an illicit discharge, the IDDE plan should be followed to eliminate the illicit discharge.

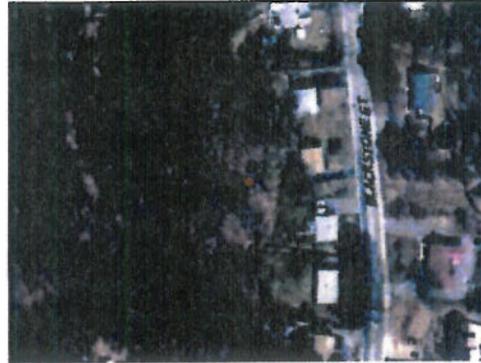
Photo Name: OF_064Locus.jpg

Outfall 64: This circular concrete outfall is located on Blackstone Street near house number 146. This outfall was added to the "High Priority" list due to the presence of dry weather flow and foam. This outfall has been monitored each year, but the observations did not indicate an illicit discharge. Dry weather flow was noted during the 2016 inspection. Foam was not noted. Dry weather flow during the spring may be expected in low lying areas with wetland characteristics, such as outfall 64's location. Therefore, the available evidence at this time indicates that sampling is not required at this outfall. AECOM recommends that town personnel continue to monitor this outfall during their regular operations. This outfall should be formally inspected again during the next annual outfall inspections. If the outfall at any time begins to show any signs of illicit connections, its flow should be sampled and tested. If the sampling indicates an illicit discharge, the IDDE plan should be followed to eliminate the illicit discharge. AECOM also noted that the 30 inch concrete bell end of this outfall has broken off. However, this does not appear to be affecting the outfall's performance.

Structural Damage: Good (see comment)

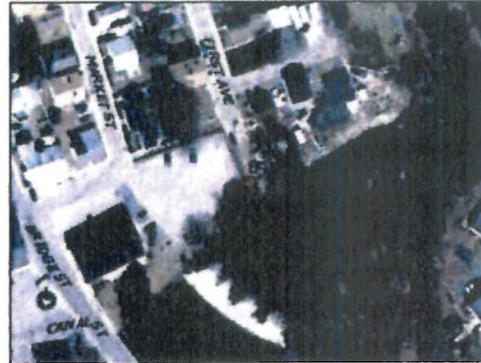
Photo Name: OF_084Locus.jpg

Outfall 84: This outfall is located in the bank of the Blackstone River at the south end of First Avenue. This outfall was added to the "High Priority" list due to the presence of dry weather flow, odor and the presence of foam. During the 2015 inspection, the outfall was found to be completely inaccessible due to dumping of residential yard waste. AECOM recommended that the town clear this yard waste and post "no dumping" signs in the area, which the town accomplished. The 2016 inspection did not show any indicators of illicit discharges. However, this outfall pipe is in poor condition. It is cracked in numerous places and the invert has broken away. The town should begin planning and budgeting for repairs/replacement of this pipe. AECOM recommends that this outfall should remain on the "High Priority" list and be formally inspected again during the next annual outfall inspections. If the outfall at any time begins to show any signs of illicit discharges, its flow should be sampled and tested. If the sampling indicates an illicit discharge, the IDDE plan should be followed to eliminate the illicit discharge.

Structural Damage: Last section at exit broken in ???
