**Municipality/Organization:** City of Malden  
**EPA NPDES Permit Number:** MA041046  
**MADEP Transmittal Number:** 041088  
**Annual Report Number & Reporting Period:** No. 15: April 1, 2017-March 31, 2018

## NPDES PII Small MS4 General Permit Annual Report

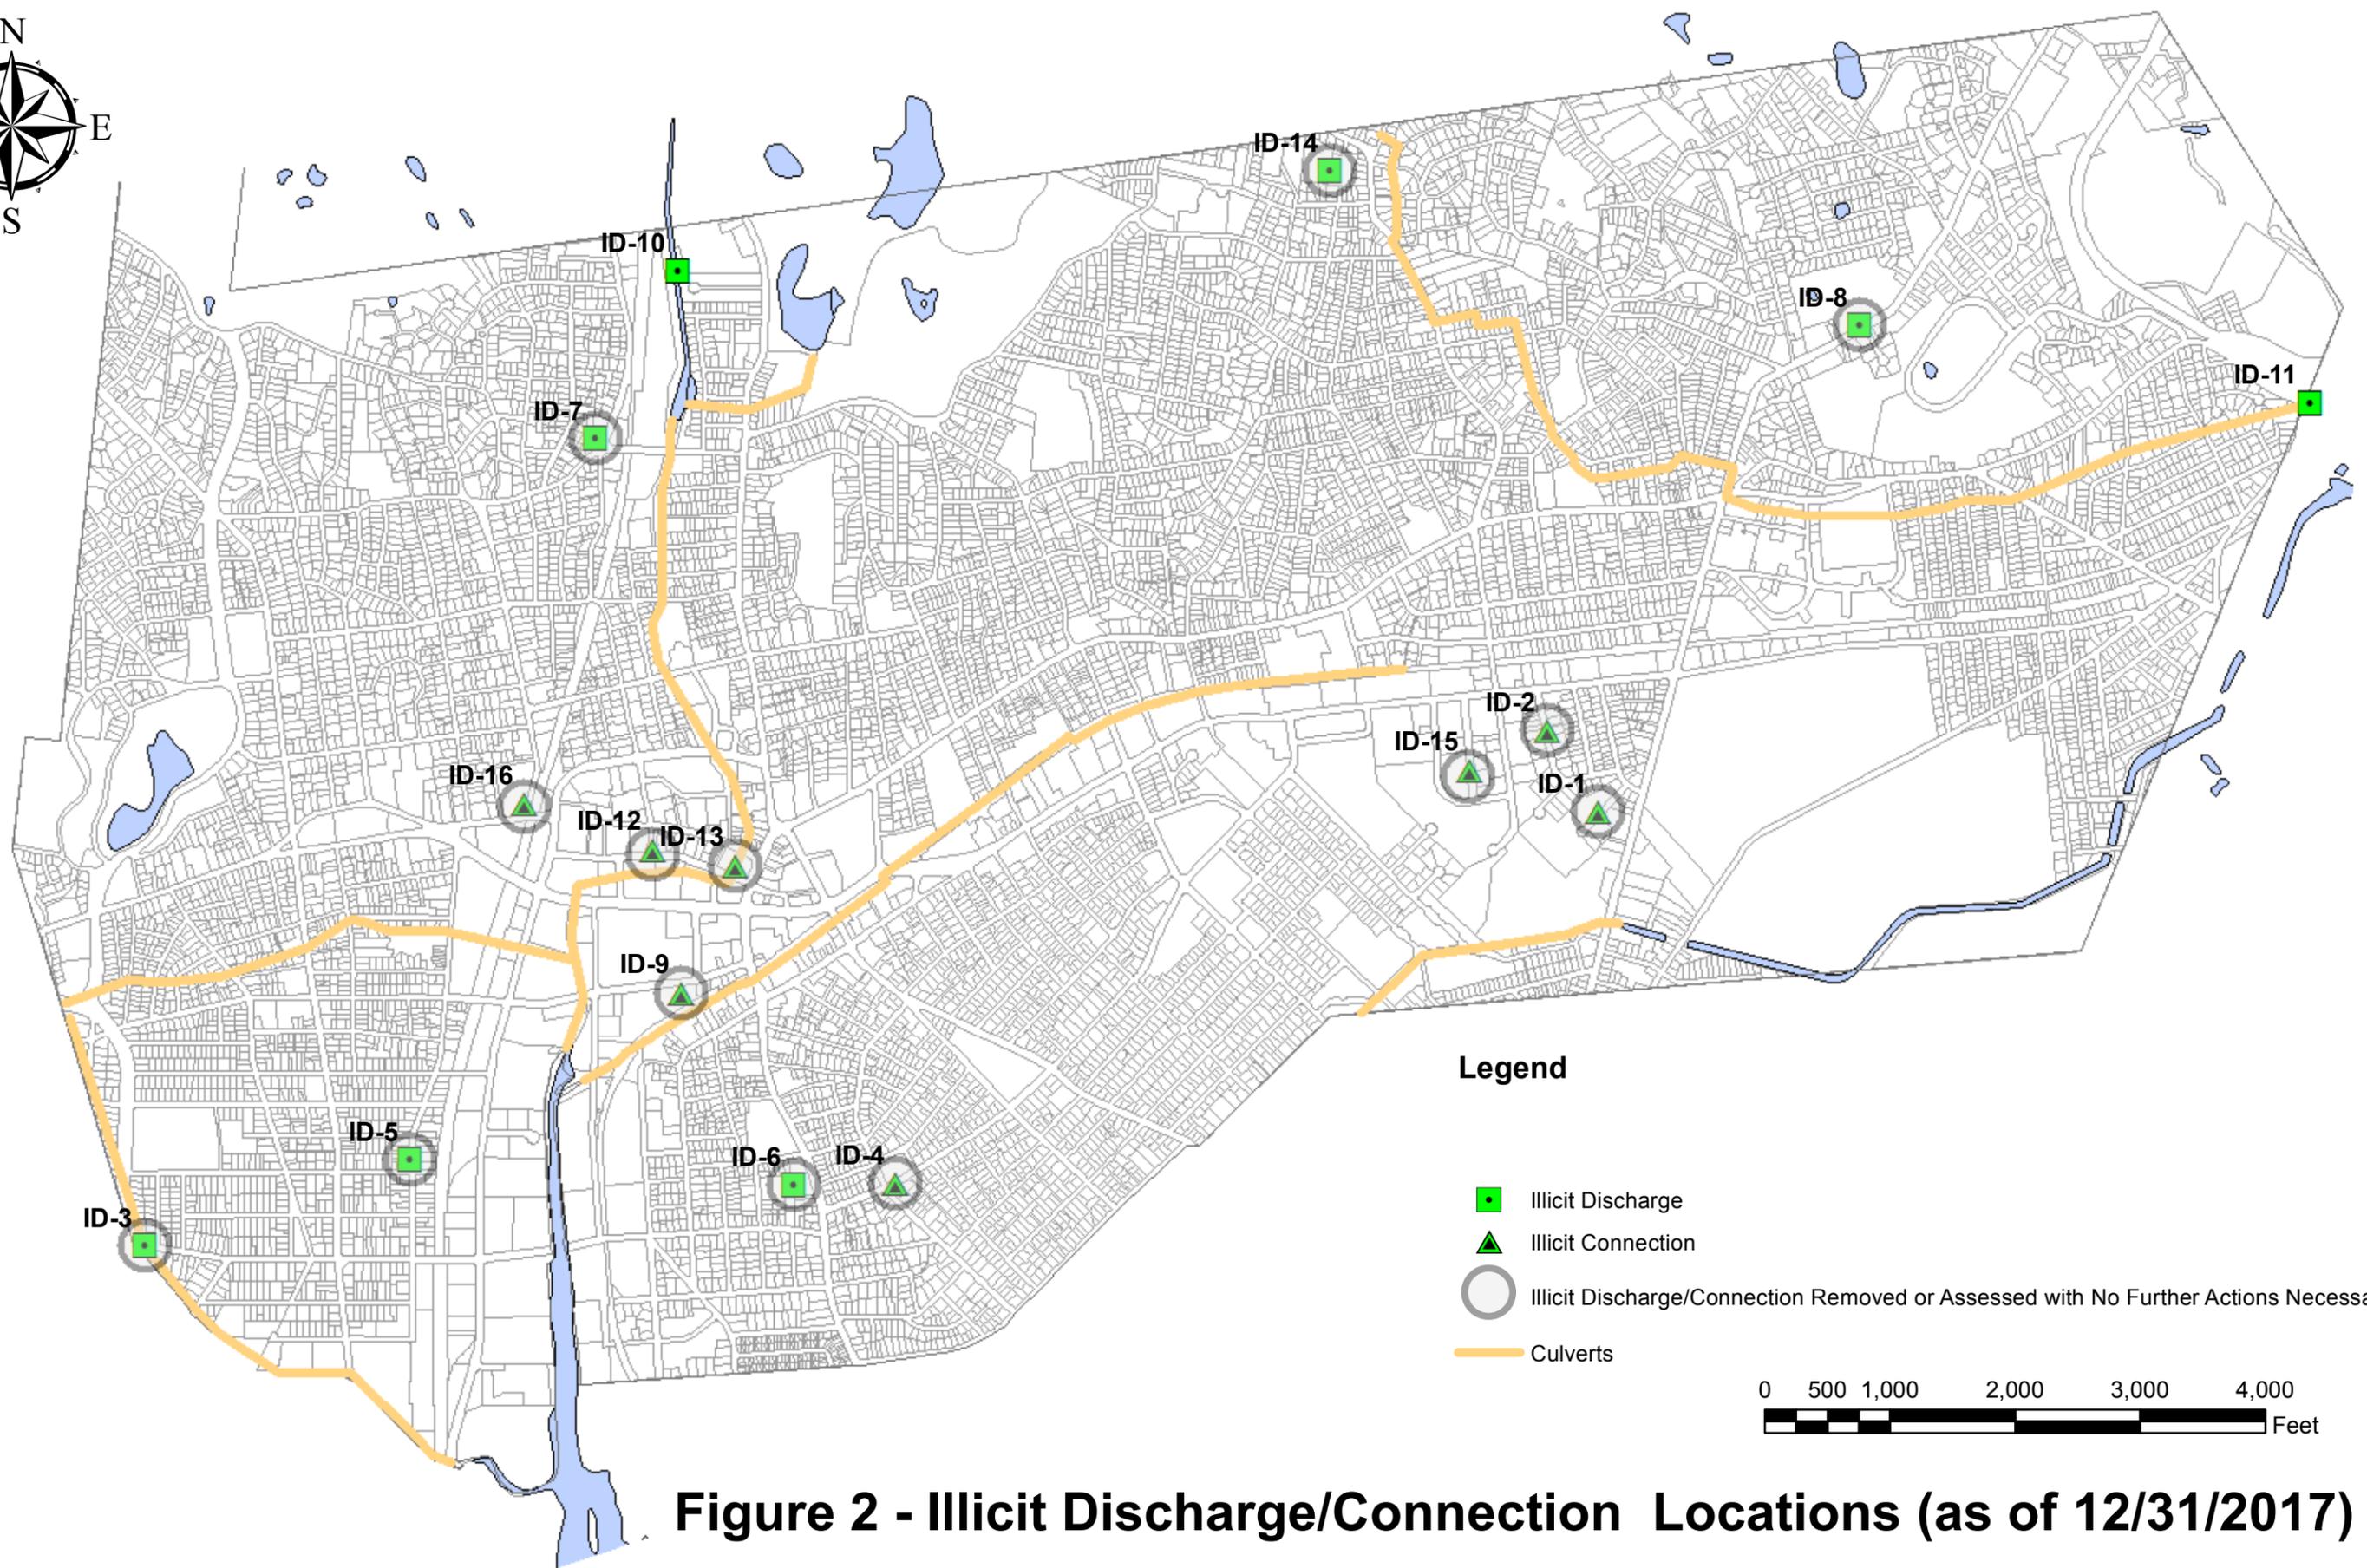
**Figure 2 - Illicit Discharge/Connection Locations (as of 12/31/2017)**

During this reporting period, no illicit discharges/connections were identified. A summary of the illicit discharges/connections identified to date is presented on Figure 2 and Table 1.0.

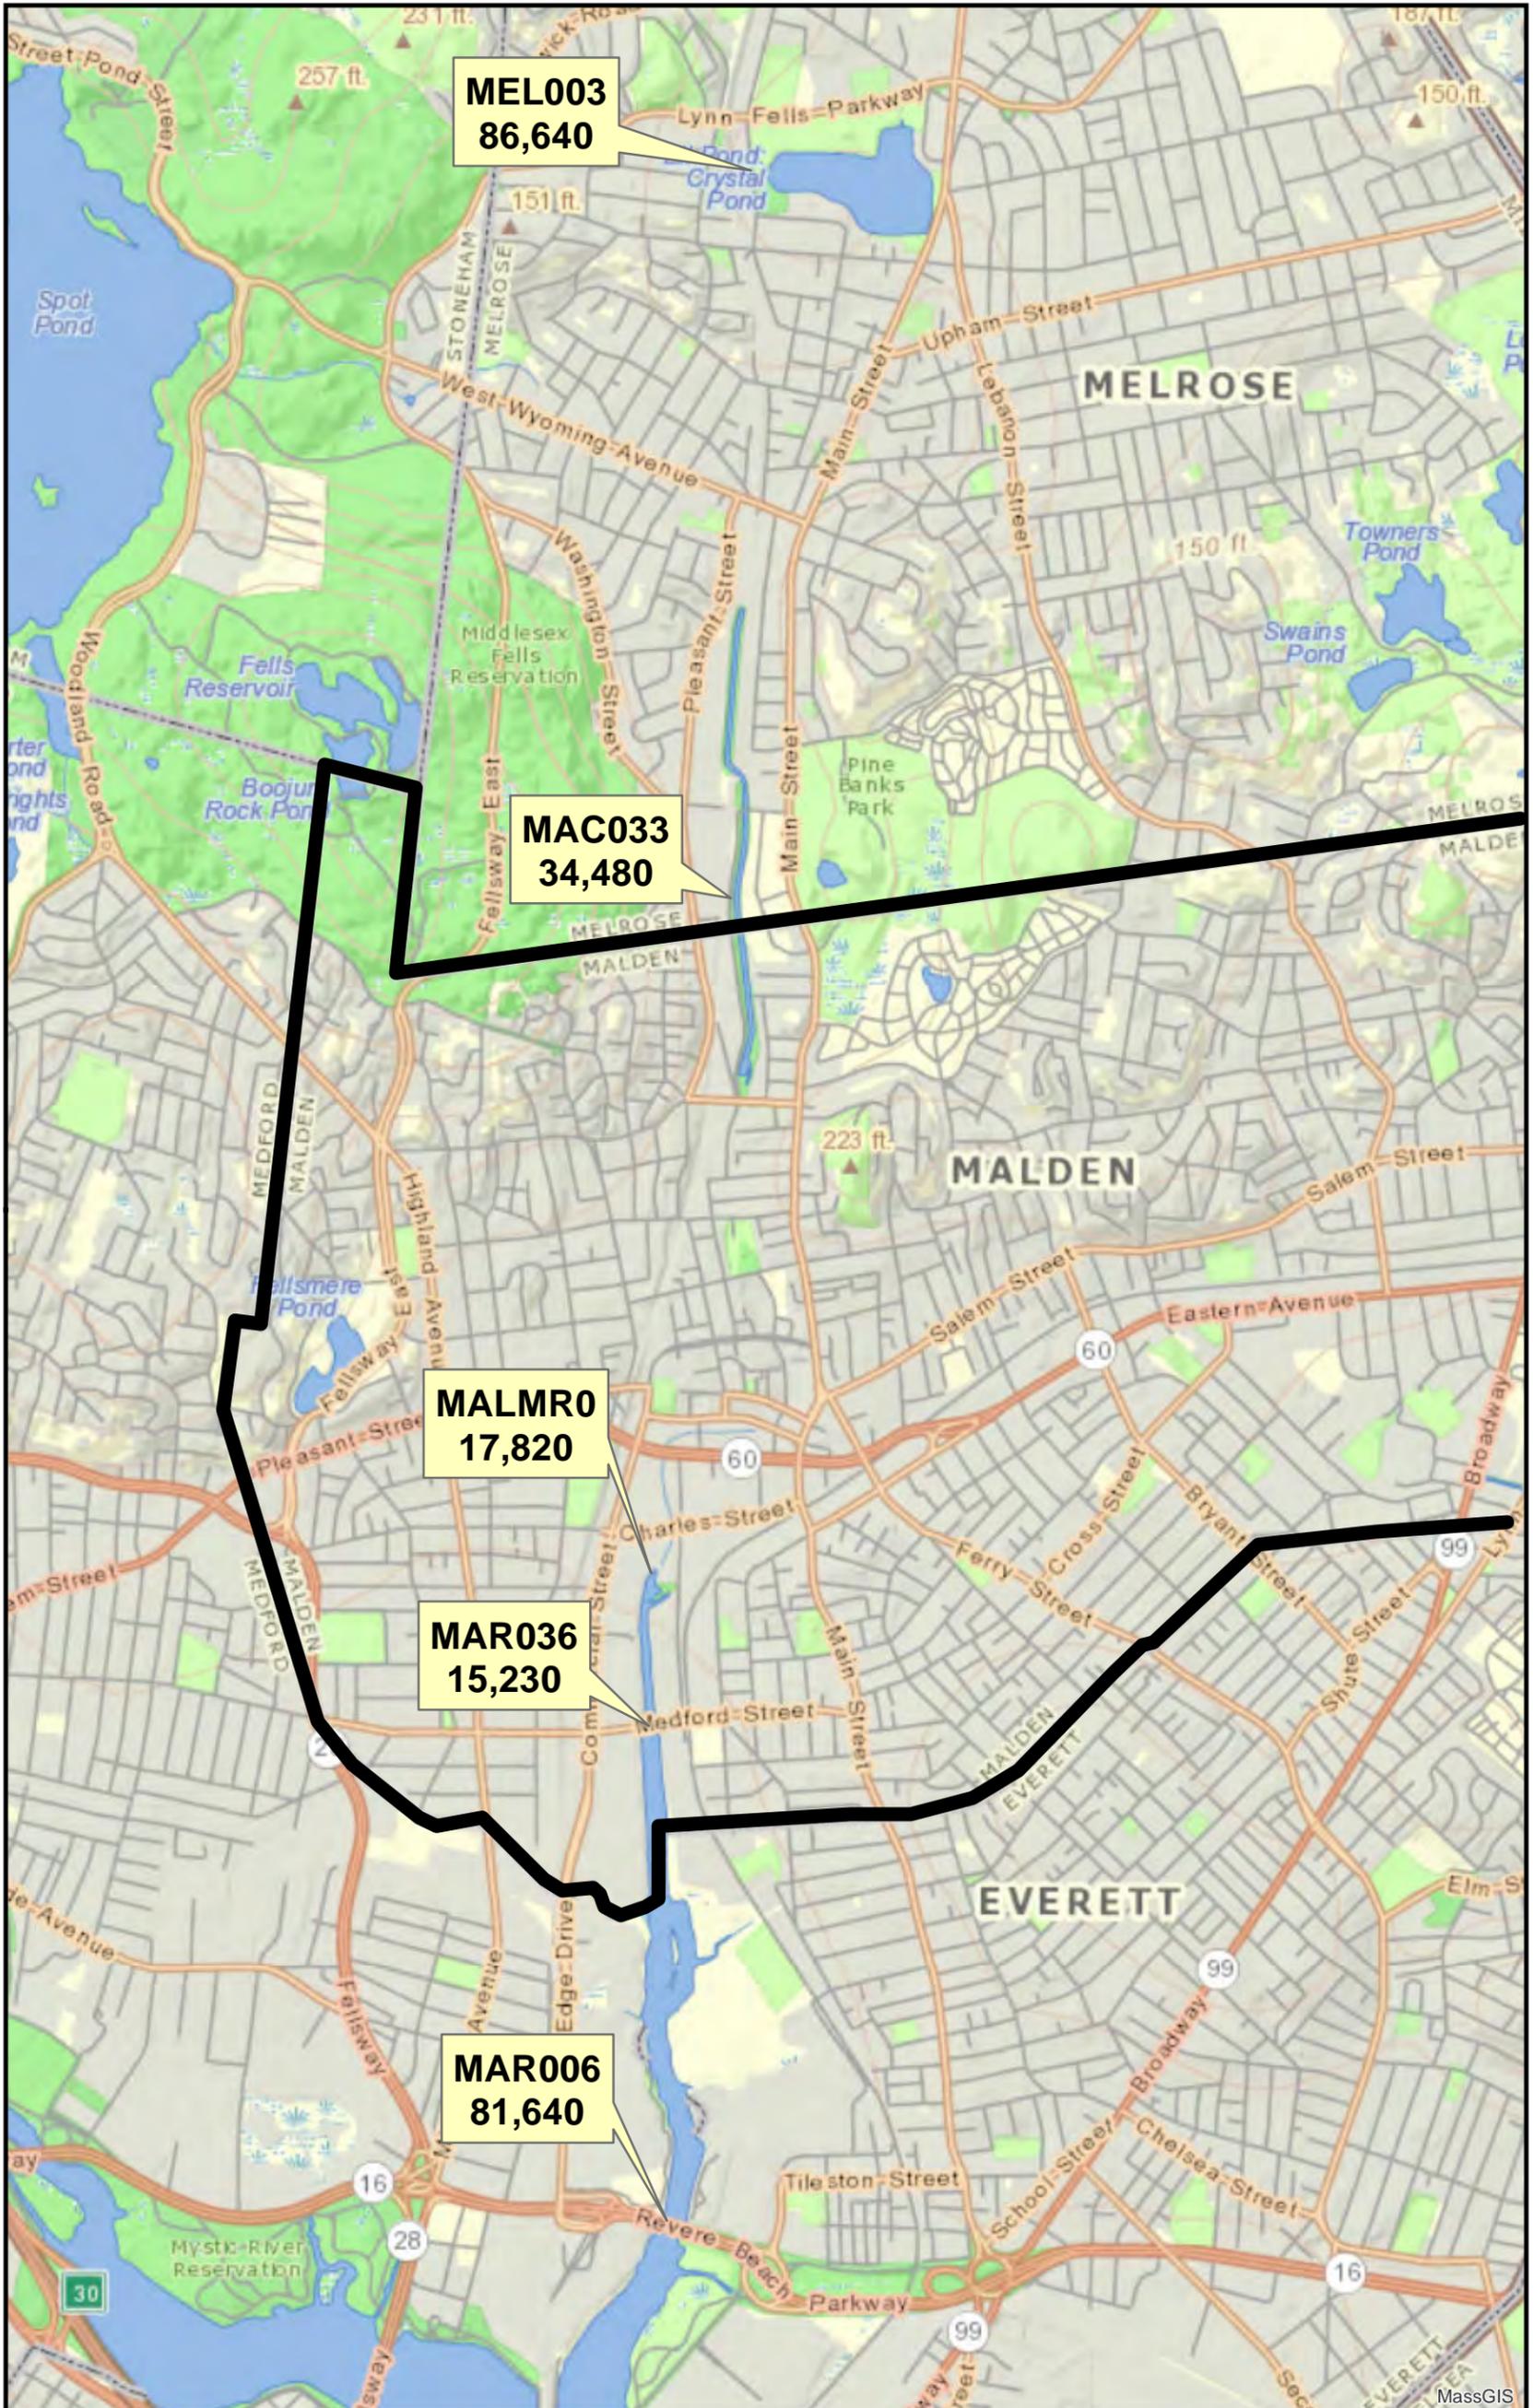
Figure 7

As referenced in Section 1.0, Malden is a flow through community that receives surface water flows from neighboring communities, which have been found to contain elevated levels of bacteria entering into the City’s drainage system. One example of this is depicted on Figure 7, which demonstrates the elevated levels of E. coli emanating from Ell Pond in Melrose. As shown, E coli levels of 86,640 MPN/100ml were detected at Ell Pond, which exhibited a consistent decline throughout downstream sampling locations in Malden, followed by a large increase at Route 16 in Everett (81,640 MPN/100ml). It is to be noted that elevated bacteria levels have been recorded at the Malden/Melrose town line through the period of IDDE plan implementation.

**June 1, 2015 Wet Weather Sampling E. Coli Results (MPN/100 ML)**

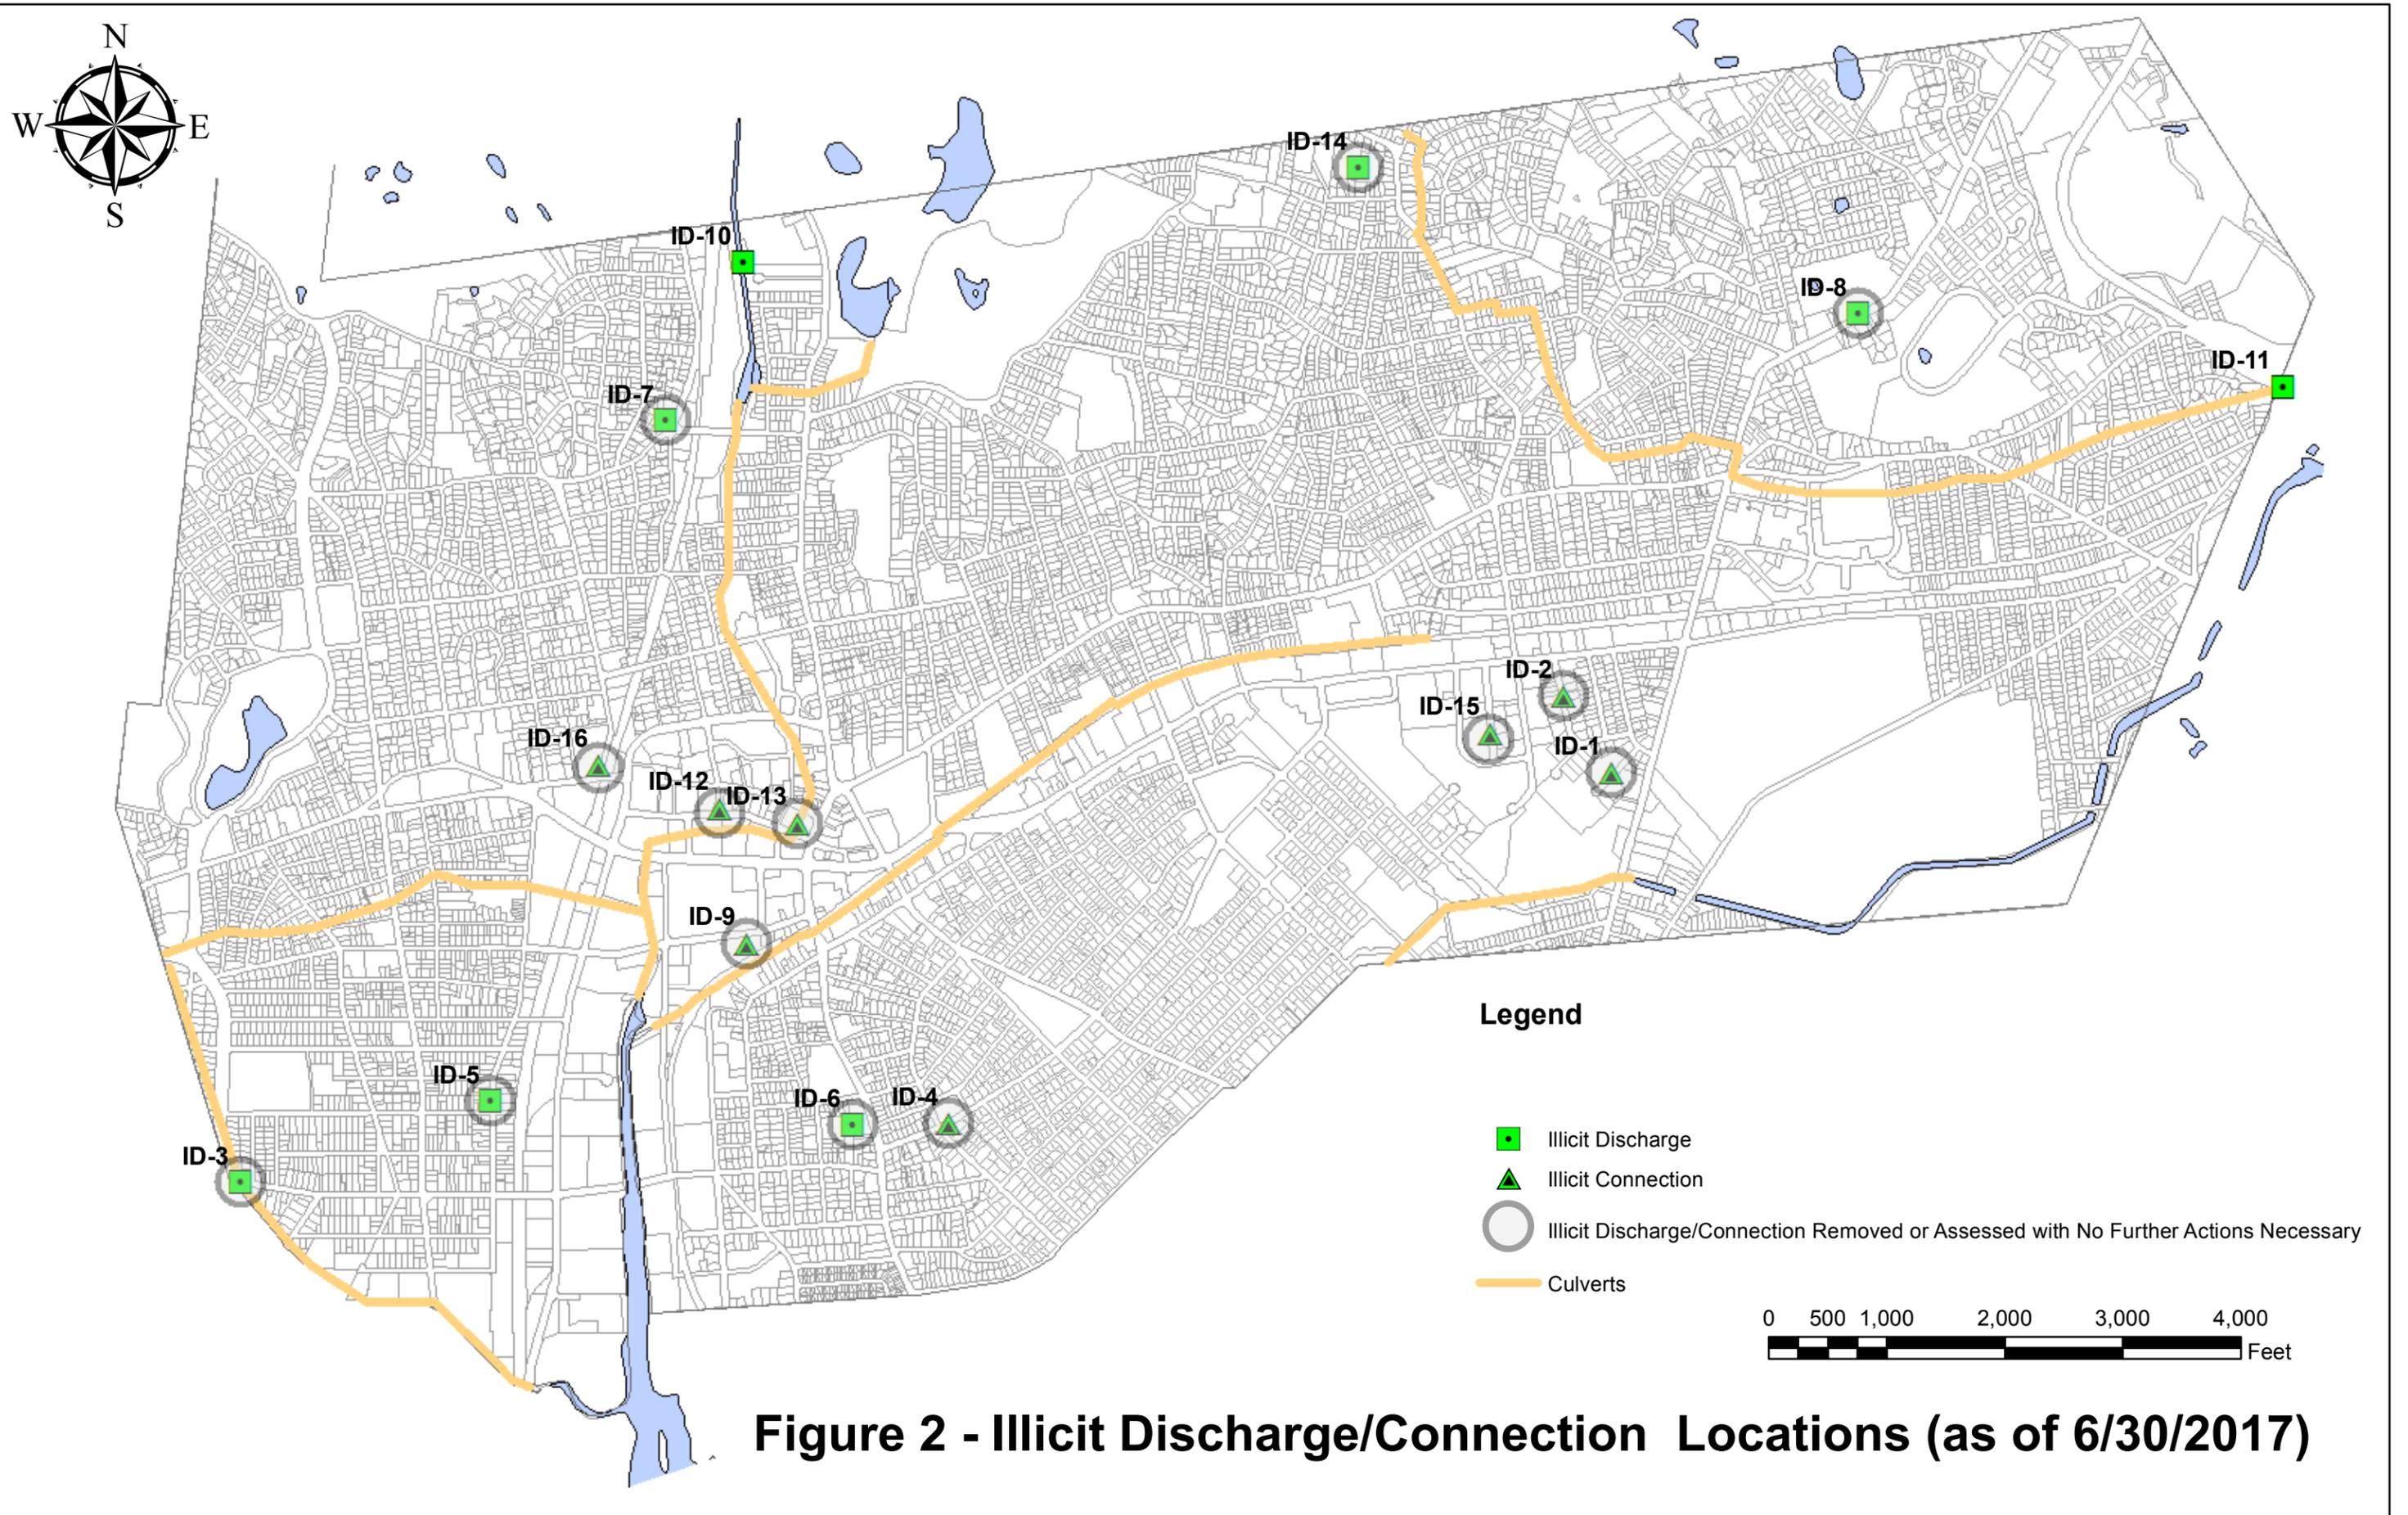
**Figure 2 - Illicit Discharge/Connection Locations (as of 6/30/2017)**

During this reporting period, no illicit discharges/connections were identified. A summary of the illicit discharges/connections identified to date is presented on Figure 2 and Table 1.0.

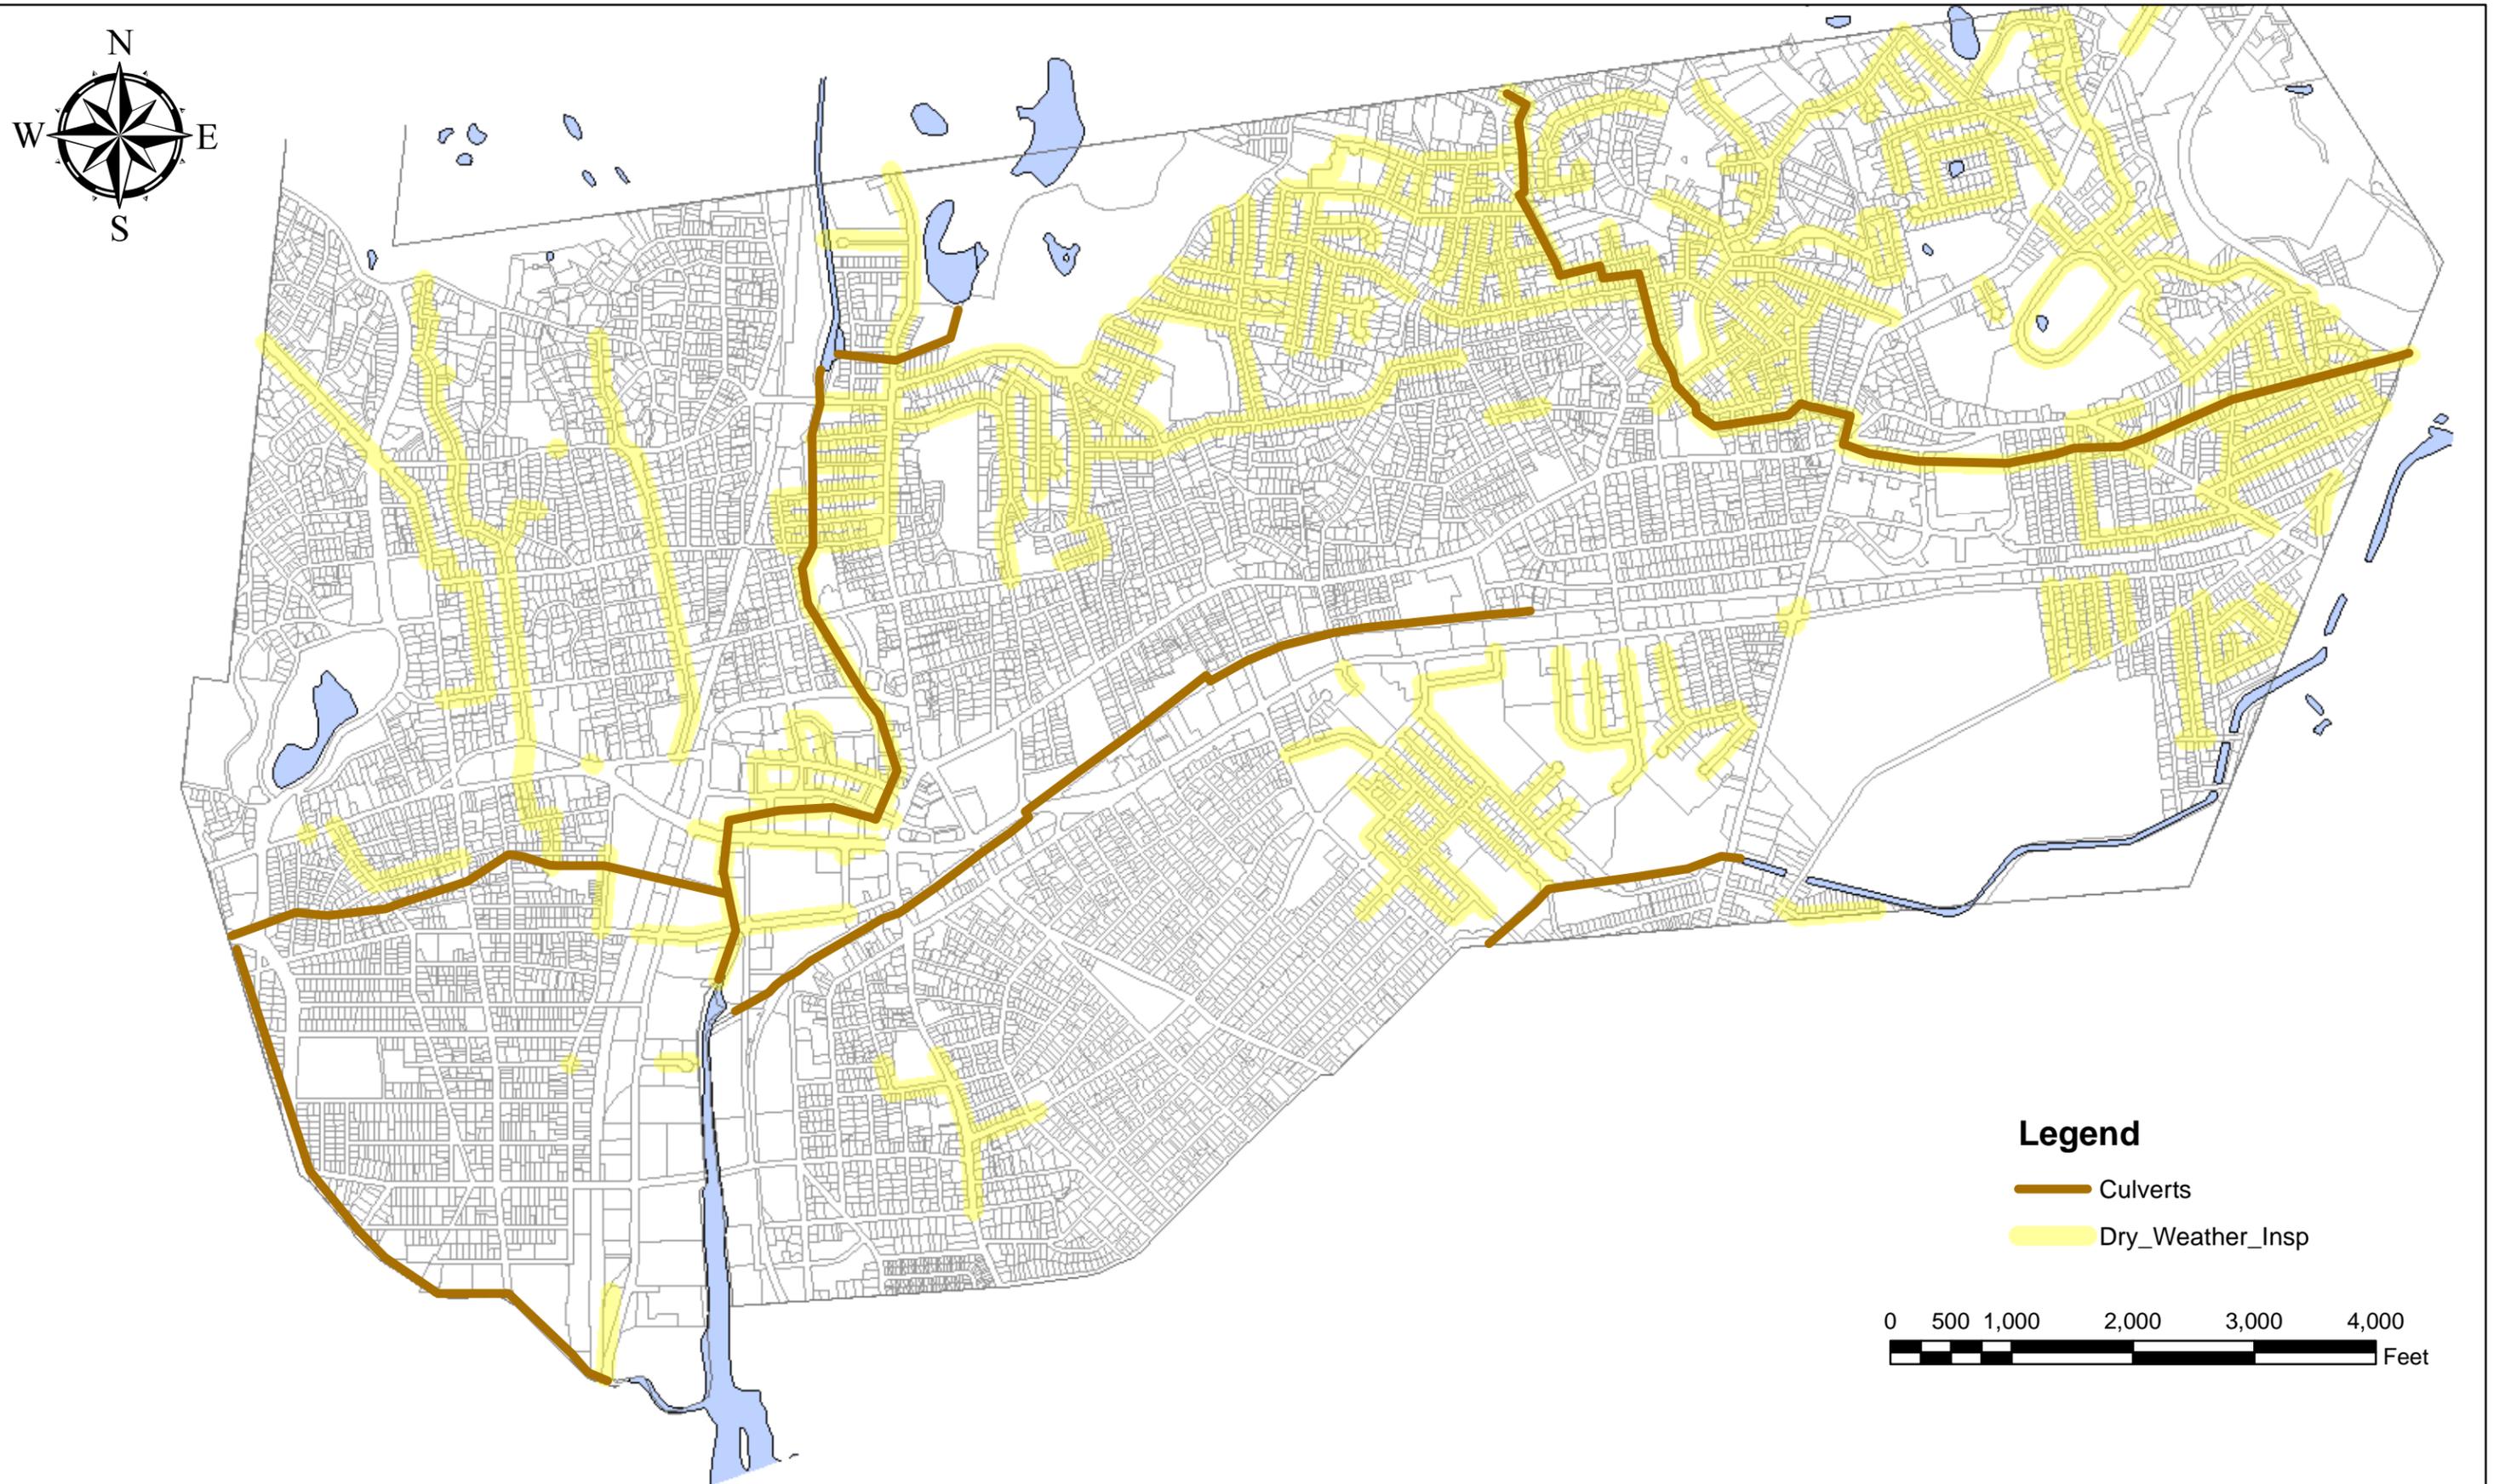
**Figure 3 - Dry Weather Inspection Areas (as of 6/30/2017)**

Historically, areas selected for inspection were generally based upon the results of the outfall sampling program and/or the identification of dry weather flows by MDPW staff during their routine maintenance and infrastructure locating program. As described in further detail in Section 3.1.1, the City continues to share sampling results with MyRWA and has performed targeted sampling events to investigate discharges to outfalls that have been sampled by MyRWA. A map depicting the approximate locations where targeted dry weather inspections have been conducted by NCA to date is presented as Figure 3. In addition, the drainage infrastructure is also

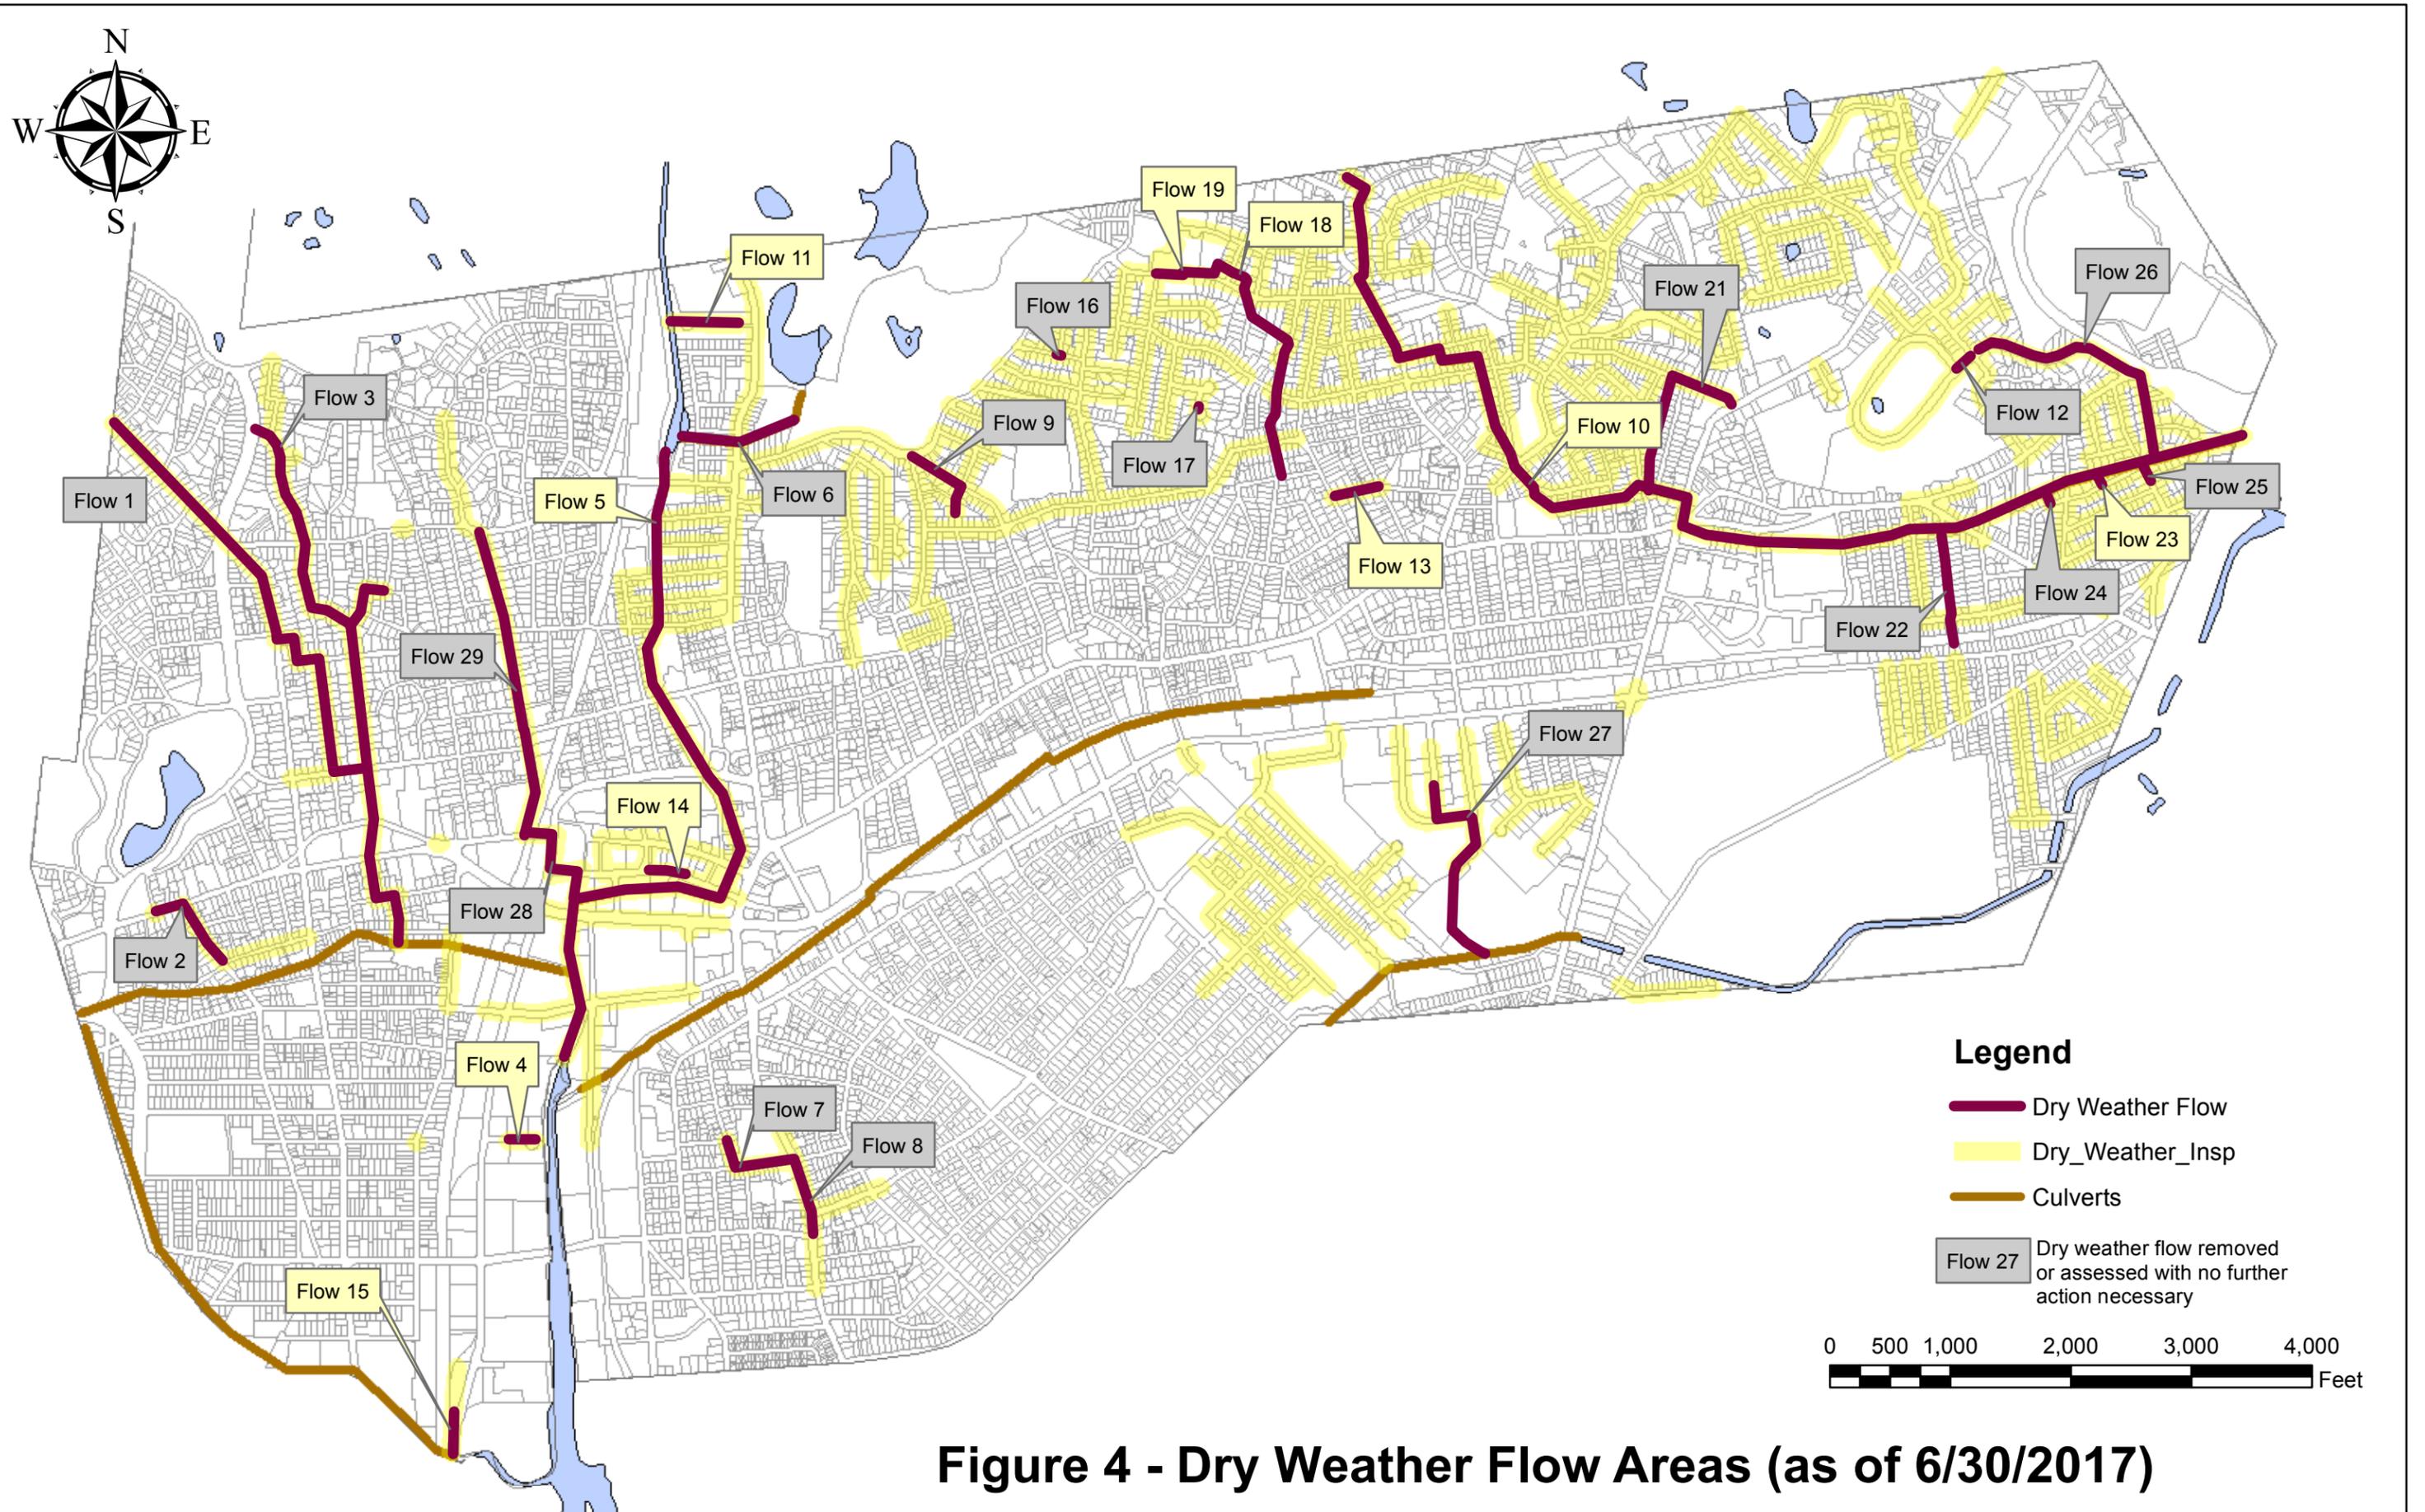
**Figure 4 - Dry Weather Flow Areas (as of 6/30/2017)**

During the inspection of Exchange Street drainage manhole E28BY-MH1, a strong sewage odor was identified and the evaluation of both the sewage and drainage infrastructure indicated that the invert elevations for the piping systems were very close, suggesting that possible exfiltration from the municipal sewage system was impacting the nearby drainage network. In response to the observations recorded within the Exchange Street area, representatives of CDM Smith Inc. (CDM) were requested to review the results of their inflow/ infiltration investigation in the area and according to CDM, no significant or obvious signs of infiltration or exfiltration were noted. To further investigate the drainage system in the area, the City contracted National Water Main Cleaning Company (National) to camera the area of concern. On 2 June 2016, National, under the direction of the City, CDM and NCA initiated the CCTV inspection.
