CITY OF MANCHESTER, NEW HAMPSHIRE

Stormwater Management Program

Annual Report

May 1, 2010 through April 30, 2011

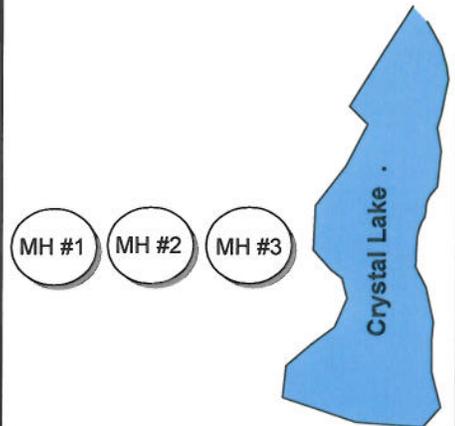
If cleaned, how much sand/grit was removed? 0.0 Cubic Yard

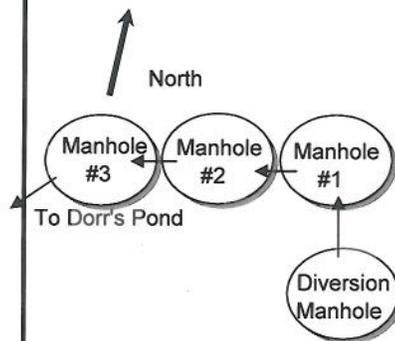
Water Appearance in 1st Port: dry odor oily H2O depth/in. 2 - 3 ft.
 Depth of sand: 1"- 3" 4"- 6" 7"- 9" 10"- 12" 1 - 2 feet > 2ft.
 Does the sand seem to be evenly distributed throughout the tank bottom? YES NO
 Structural Condition: Excellent Very Good Good Fair Poor Repair
 Weed/brush growth around tank: None Little Moderate Heavy
 Recommendations: The first chamber was cleaned.

If cleaned, how much sand/grit was removed? 1.0 Cubic Yards
