**REMOVAL PROGRAM
PRELIMINARY ASSESSMENT/
SITE INVESTIGATION REPORT
FOR THE
AEROVOX SITE
NEW BEDFORD, BRISTOL COUNTY, MASSACHUSETTS
2 AUGUST 2007 AND 15 THROUGH 16 AUGUST 2007**

U.S. Environmental Protection Agency
Region I
Emergency Planning and Response Branch
1 Congress Street, Suite 1100
Boston, MA 02114-2023

Weston Solutions, Inc.
Region I
Superfund Technical Assessment and Response Team III (START)
3 Riverside Drive
Andover, MA 01810

November 2007

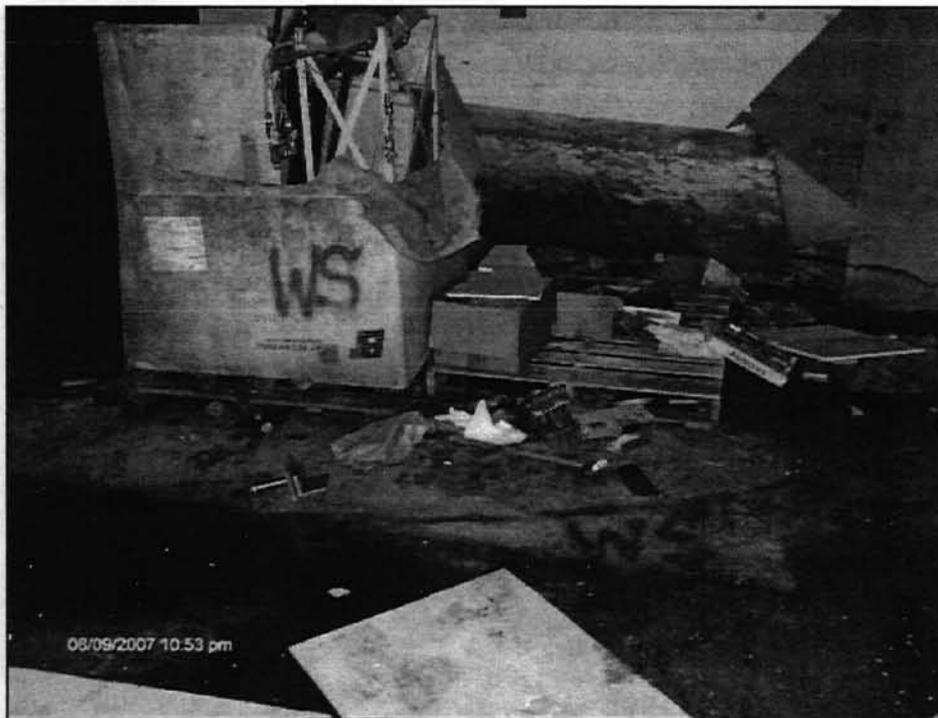
PHOTOGRAPH NO. : 24(HPIM0536.jpg)

SCENE: View of a box containing a flow meter in the northwest corner of the first floor of Aerovox building. Photograph taken facing west.
