UNITED STATES ENVIRONMENTAL PROTECTION AGENCY
REGION 1
5 Post Office Square, Suite 100
Boston, MA 02109-3912

Memorandum

Date: April 27, 2010
Subject: Post-flood Inspection of April, 15, 2010
To: Memo to CMRP Site File
From:

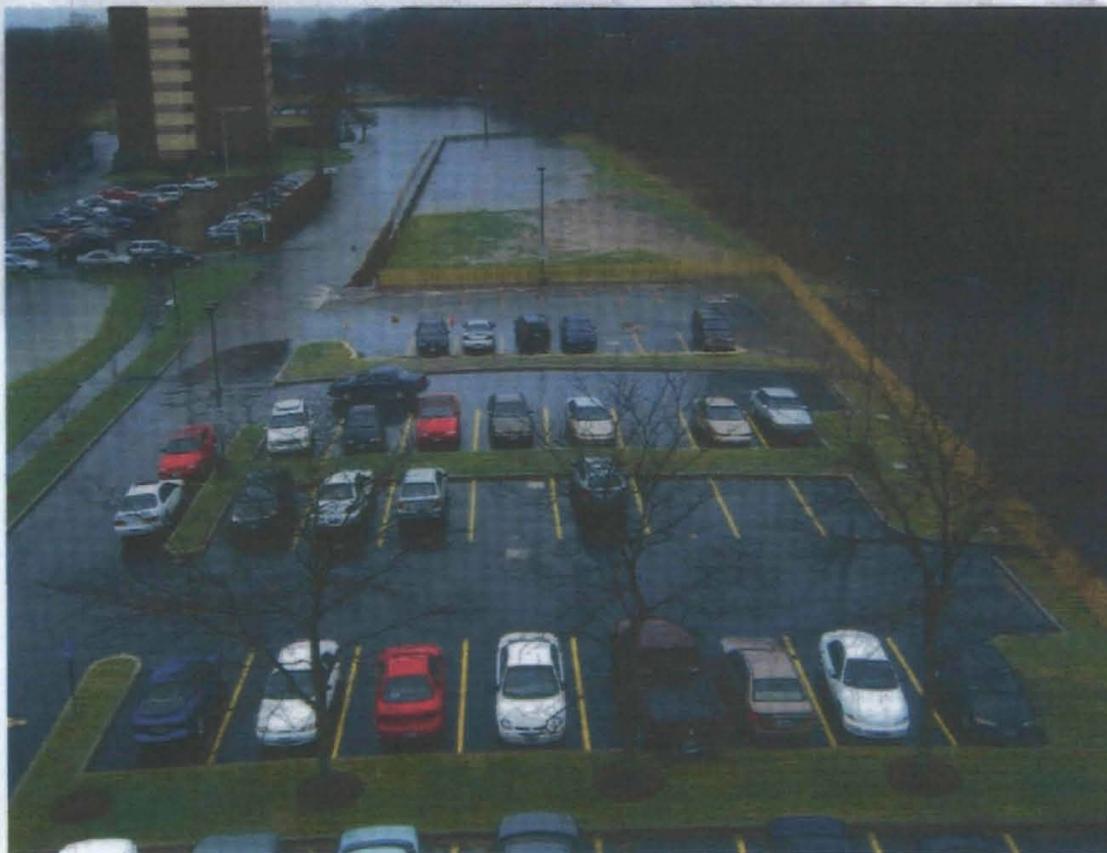
On April 15, 2010 OSC Ted Bazenas met with David Scotti and Jeff Loureiro of LEA, Inc. at the Centredale Manor Restoration Project Site in North Providence, RI to observe, document and evaluate areas of erosion that were caused by the flooding event that had occurred on March 30, 2010 following very heavy rainfall. Photographs from LEA taken on March 30 documented that the Woonasquatucket River had overflowed its eastern bank near the southern end of the Brook Village parking lots. River water flowed down gradient, through a new cedar fence, over the clean backfill and topsoil that had been placed in the fall. The water then flowed toward the main driveway and across the northern Centredale Manor parking area before entering the standing water in the tailrace.
