# AERIAL PHOTOGRAPHIC ANALYSIS CENTREDALE MANOR SITE SUBAREA

## North Providence, Rhode Island

TS-PIC-20001120S  
July 2000

AERIAL PHOTOGRAPHIC ANALYSIS  
CENTREDALE MANOR SITE SUBAREA

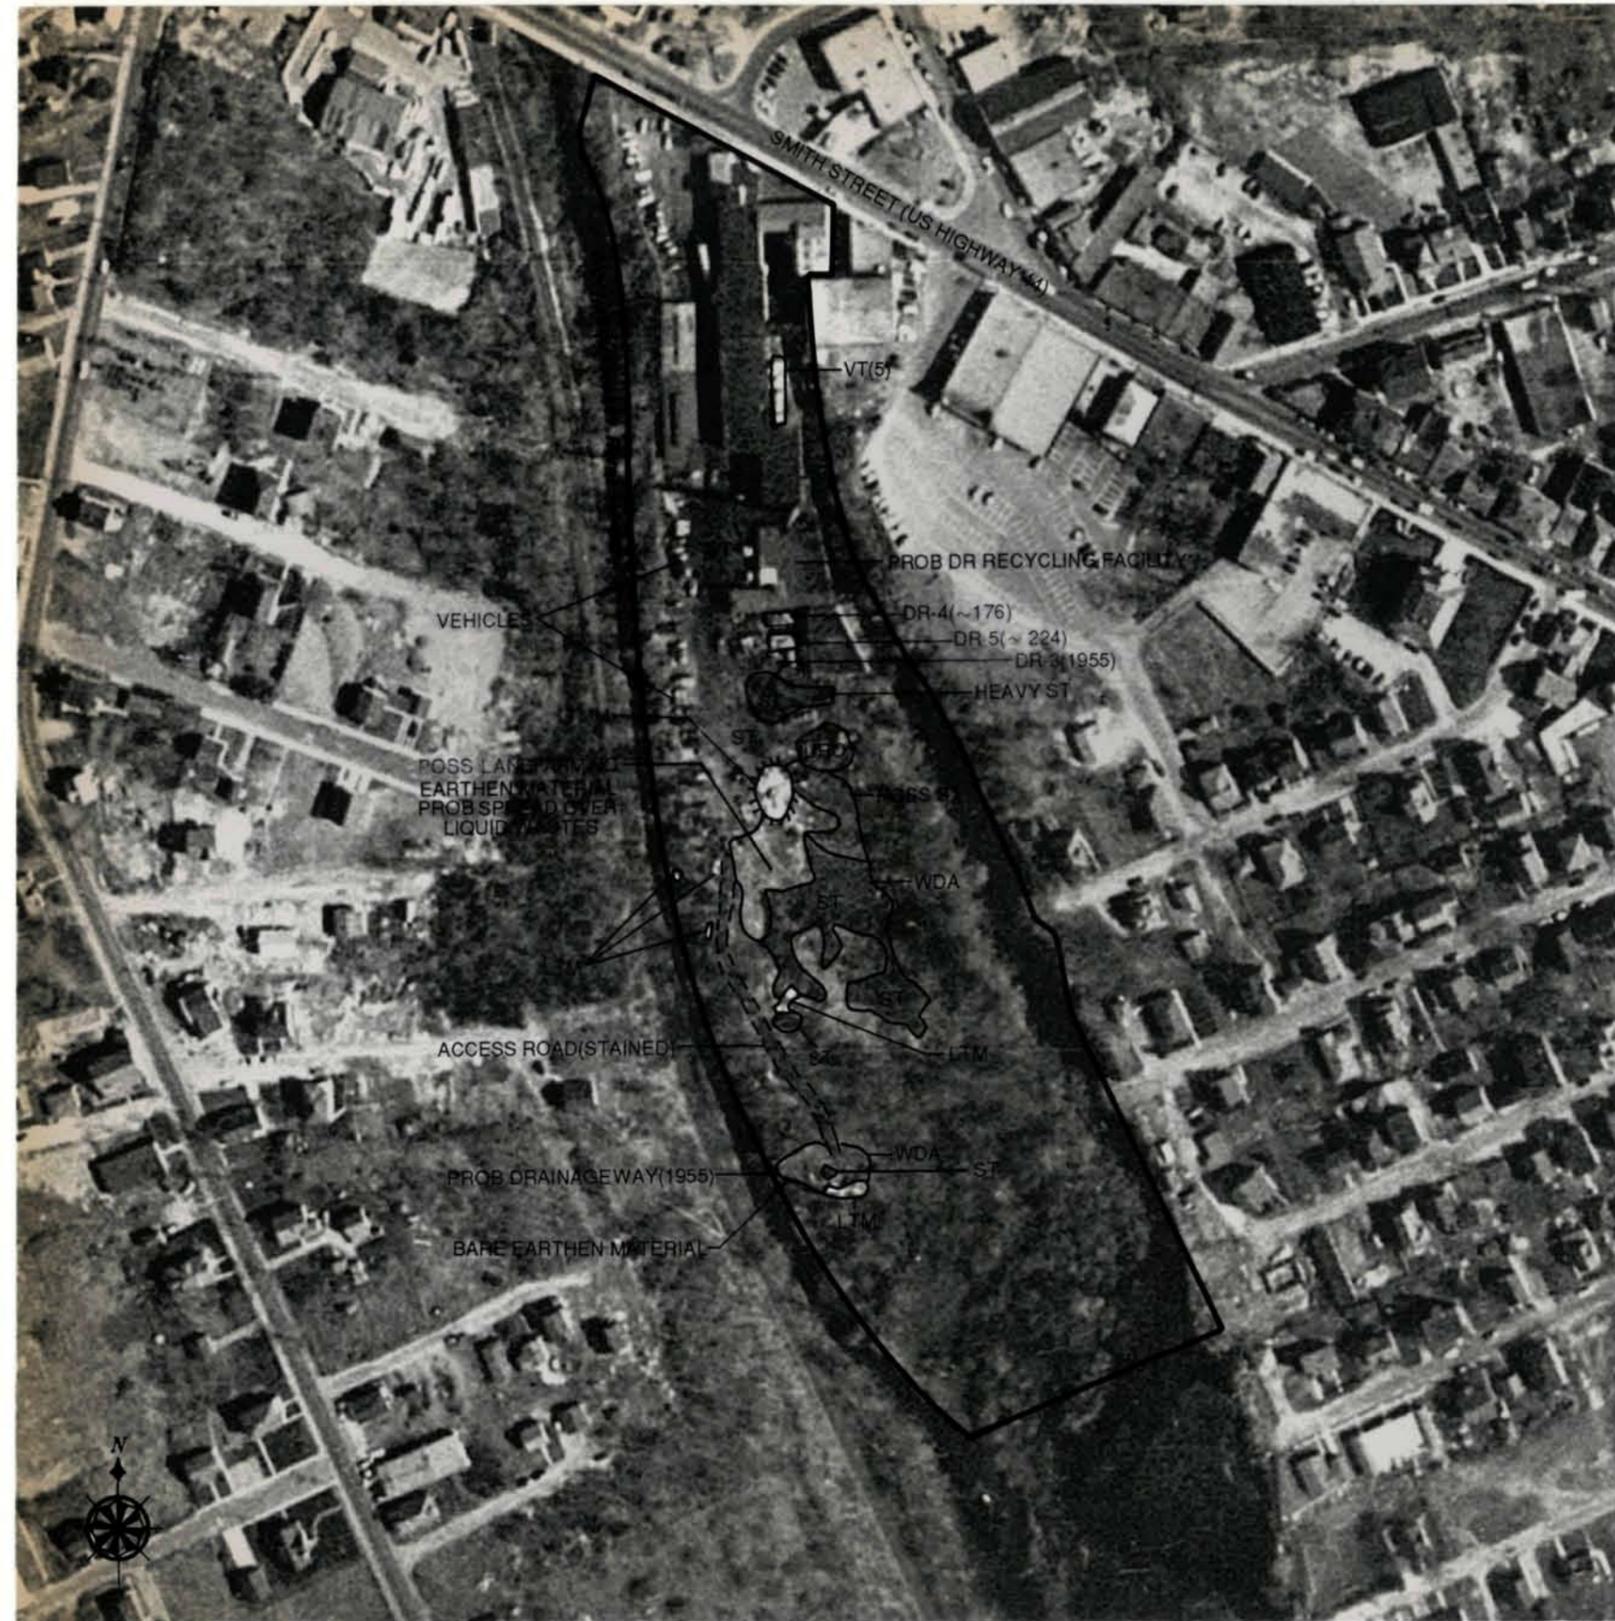
Table 4. Approximate Probable Drum Count, and Areal Extent of Impoundments/Pits, Centredale Manor Subarea 1956.

Drum/Impoundment Name	Approx. Probable Drum Count	Approximate Areal Extent of Impoundment/Pit
DR-4	176	-
DR-5	224	-
Total	400	-

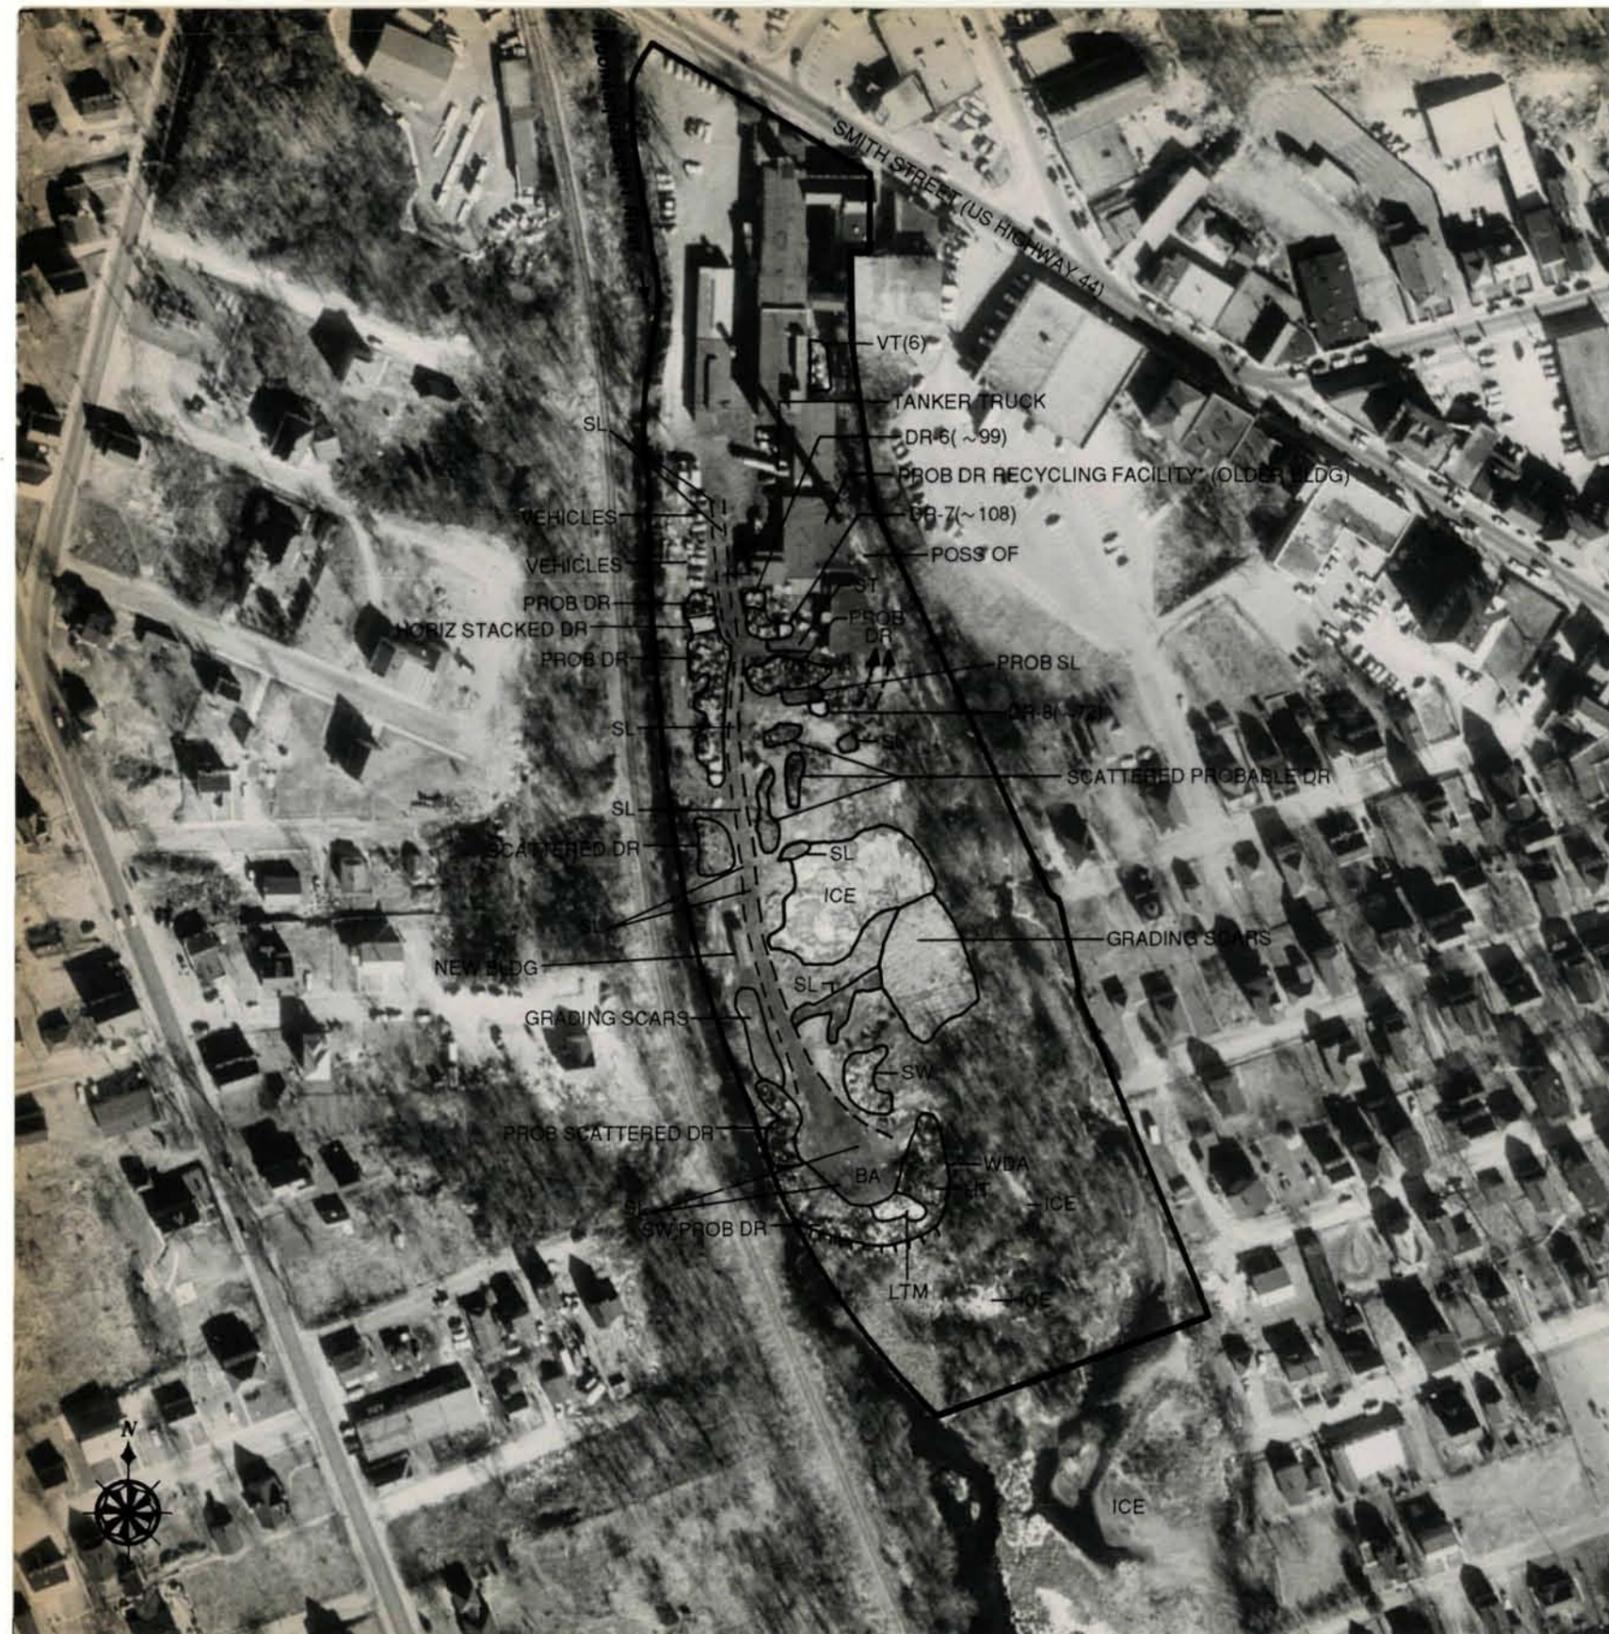
Table 5. Approximate Probable Drum Count, and Areal Extent of Impoundments/Pits, Centredale Manor Subarea 1962.

Drum/Impoundment Name	Approx. Probable Drum Count	Approximate Areal Extent of Impoundment/Pit
DR-6	99	-
DR-7	108	-
DR-8	72	-
Total	279	-

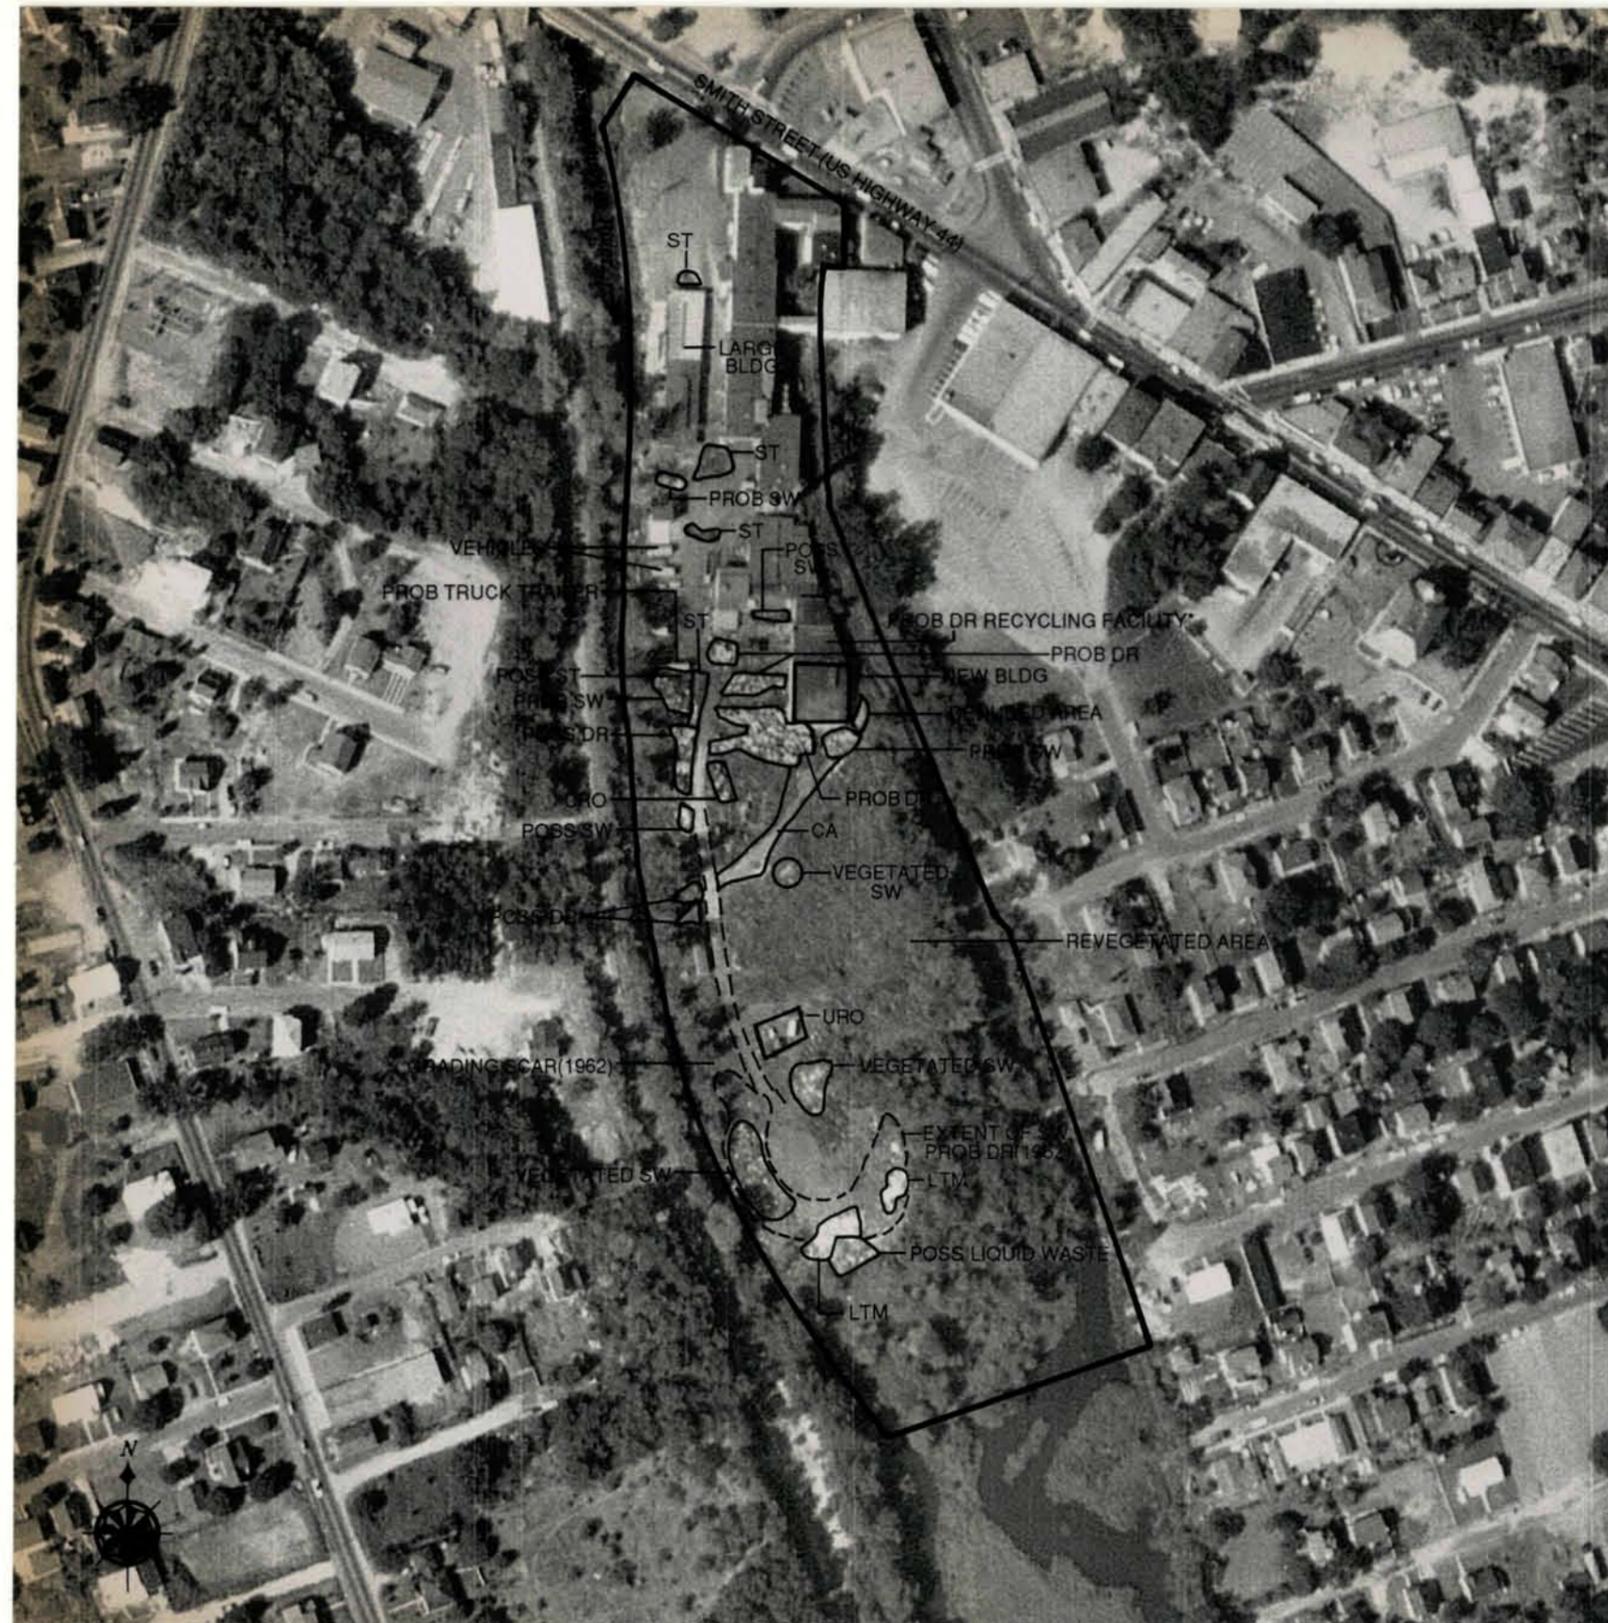
On the west side of the subarea from north to south near the Woonasquatucket River are areas of probable solid waste, two vehicles, a probable truck trailer, another deposit of probable solid waste, staining, possible staining, possible drums, possible solid waste, and two additional areas of possible drums. The grading scars evident in 1962 are no longer present.

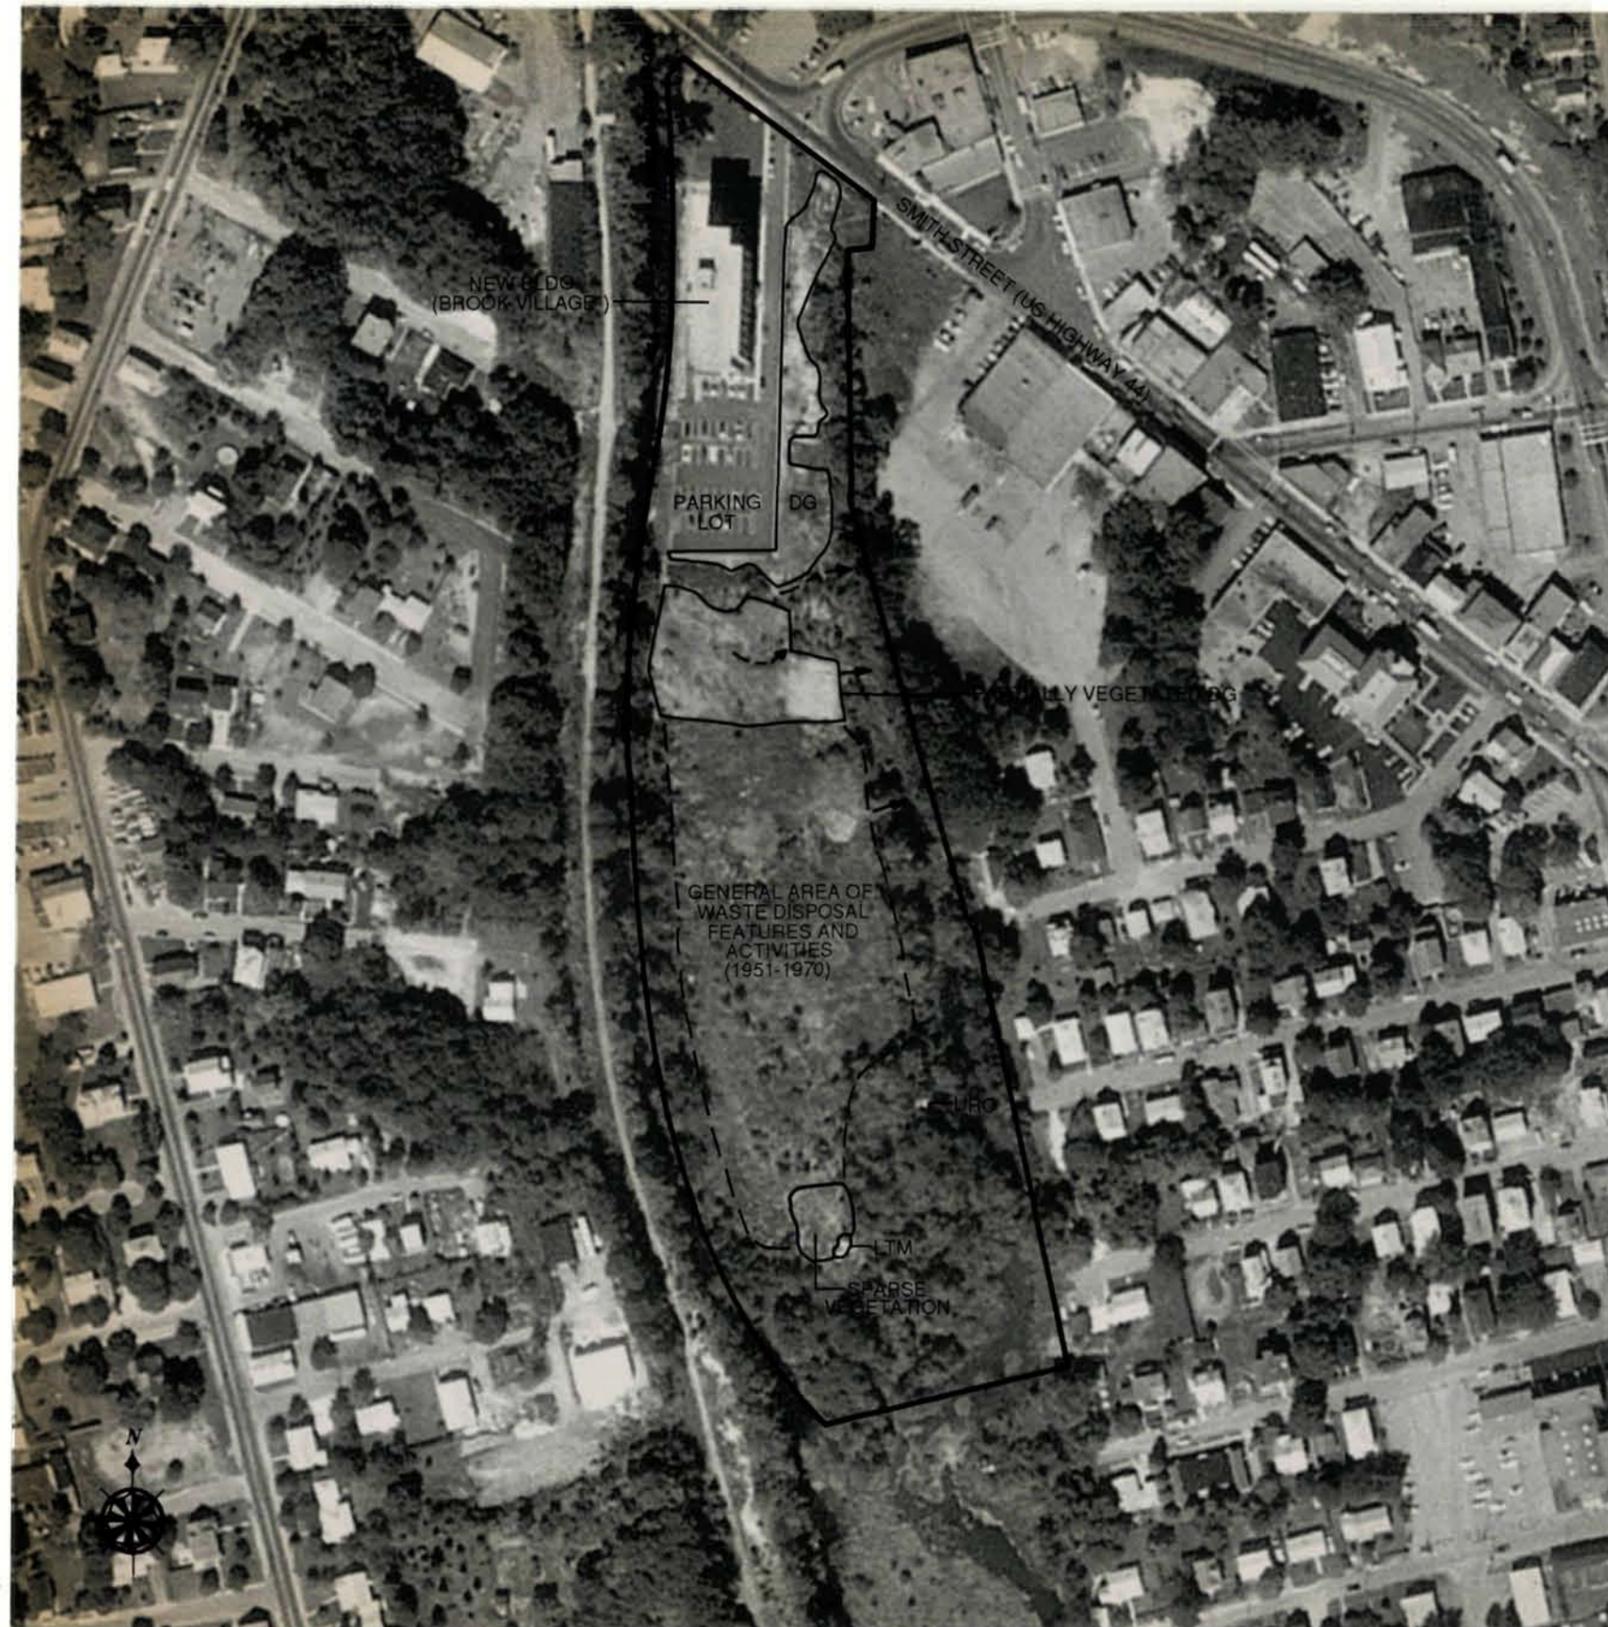
All buildings present at the subarea in 1970 have been removed. A new large building and associated parking lot exists on the northwestern portion of the subarea (the Brook Village property). Disturbed ground, probably associated with construction activities, is present adjacent to the south and east of the parking lot and new building. Further to the south is an area of partially vegetated disturbed ground; however, the cause of this disturbance could not be ascertained. Drainageways trending to the east are noted immediately northeast of this area and also within the eastern portion of the disturbed area. Further south, the general area where waste disposal features and activities which were present from 1951 through 1970 is covered with vegetation. Mottled photographic tones in this vegetated area (not annotated) may indicate the presence of conditions that cause vegetation stress. At the southern end of the subarea is a sparsely vegetated area, an area of light-toned material, and an unidentified object. The light-toned material was also present in 1970. No drums or waste disposal-related activity is observed.

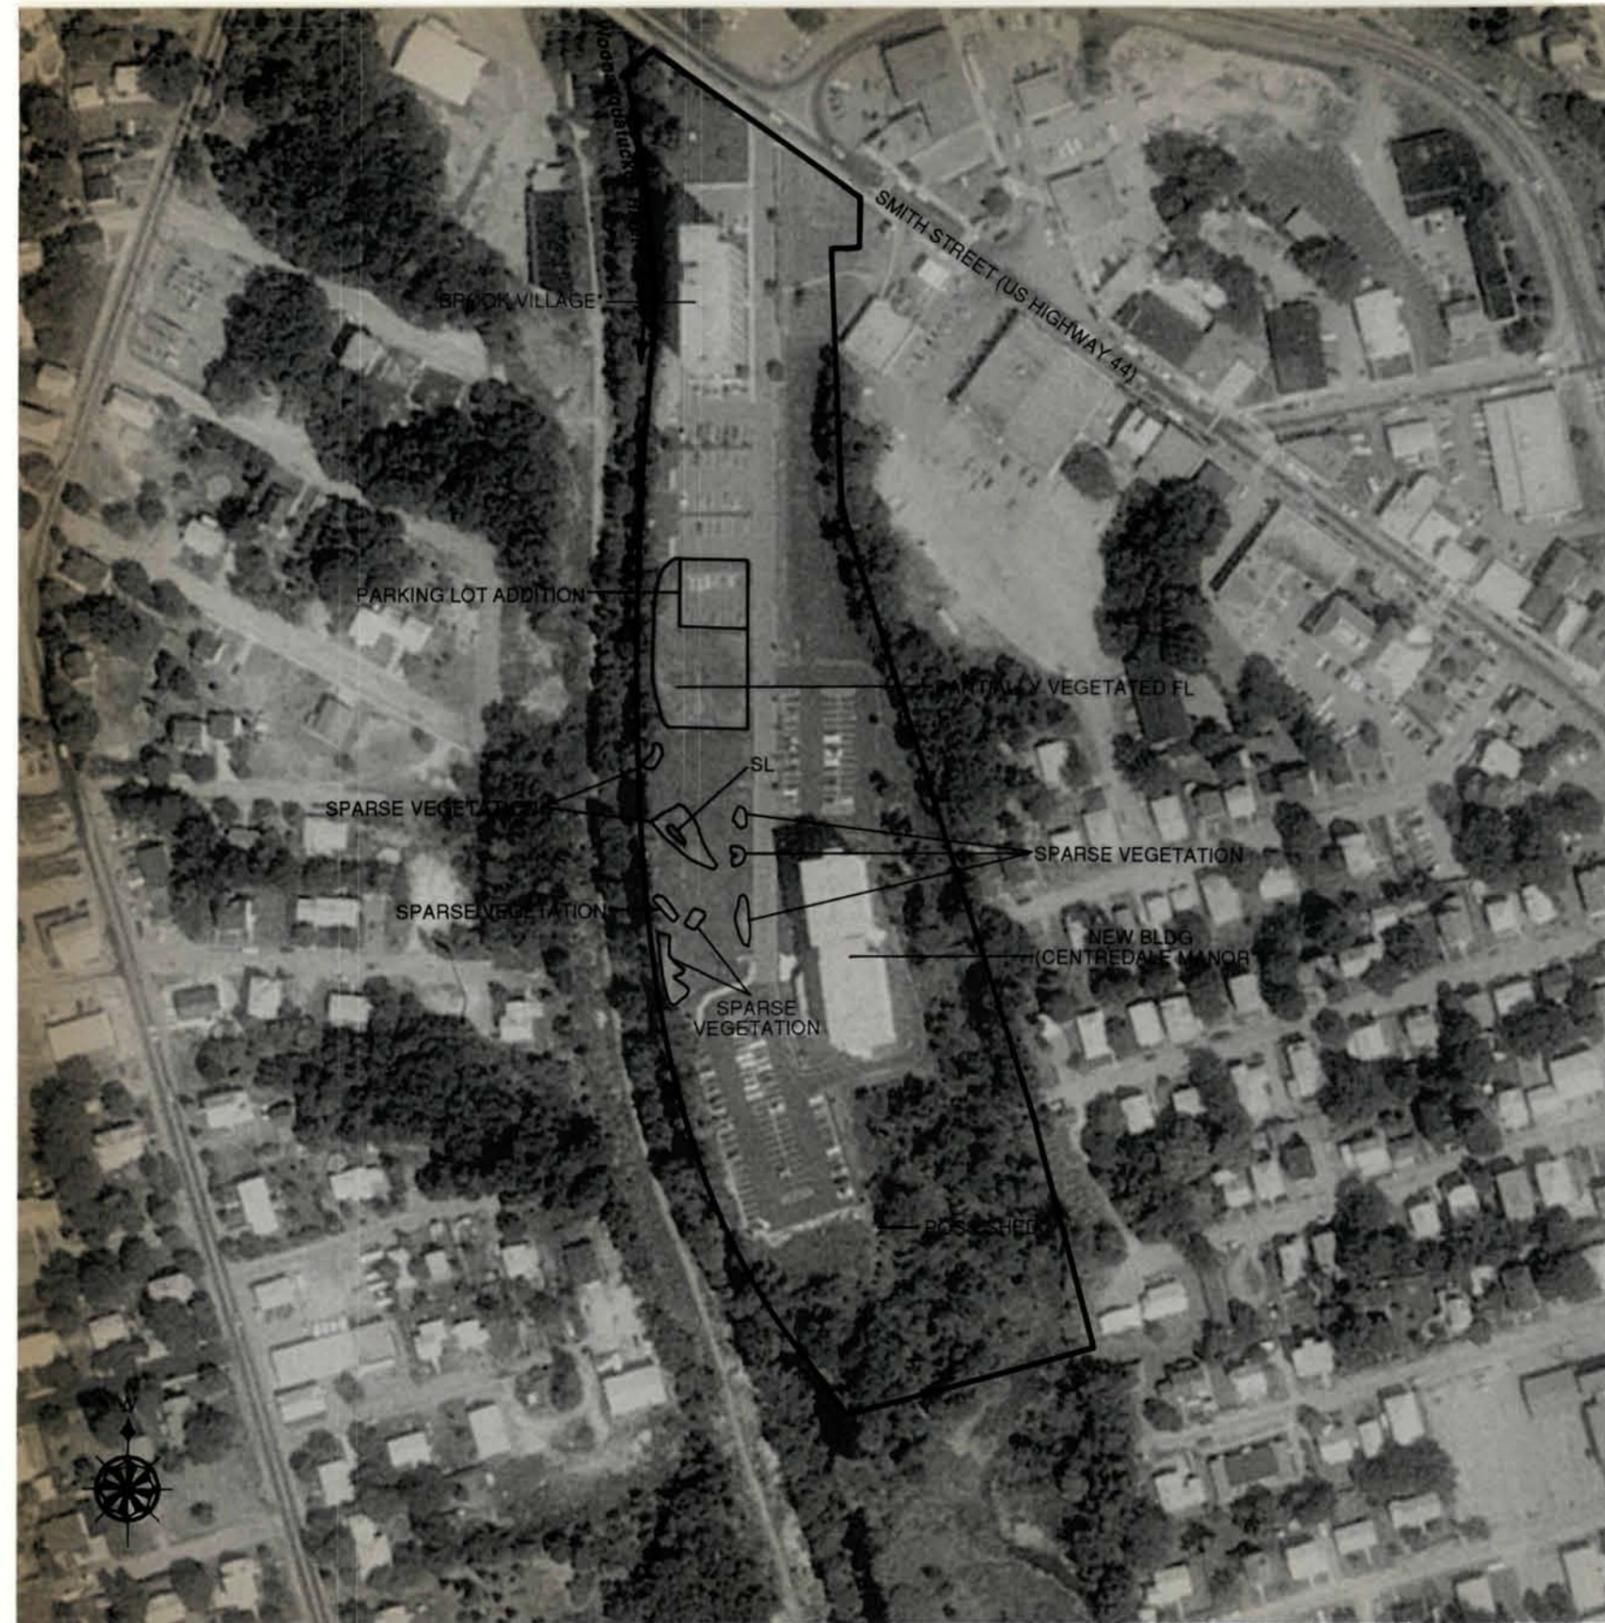
The Brook Village property parking lot has been extended to the south and partially vegetated fill (FL) is observed adjacent to it. To the south near the river are several areas of sparse vegetation that may be indicative of vegetation stress. One small area of standing liquid is also present. A small possible shed is observed south of the parking lot of a new large building (Centredale Manor\*) that has been constructed since 1981.

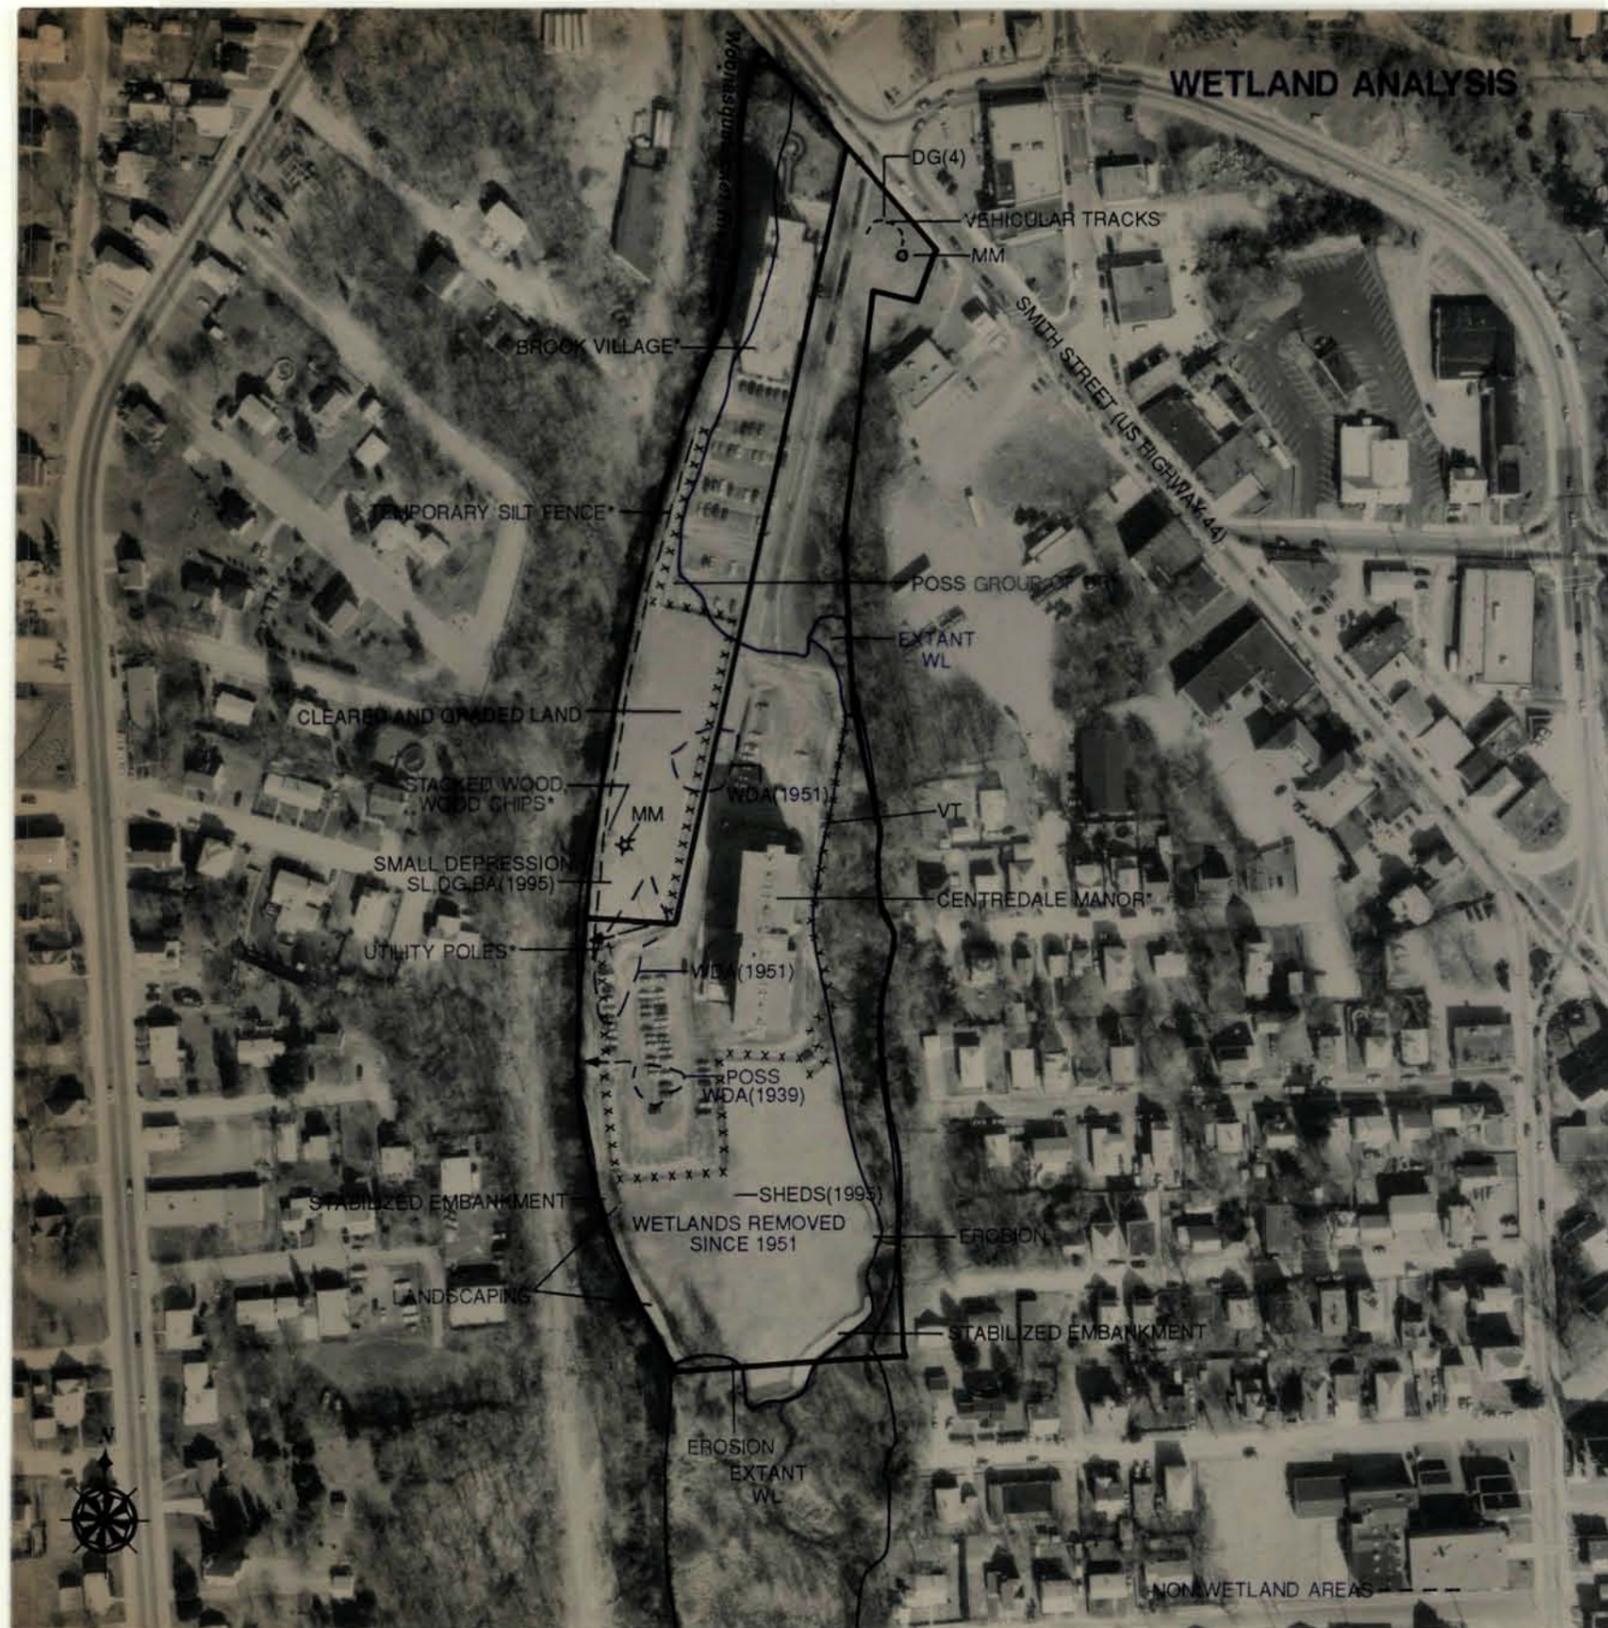
Wetlands remaining in 2000 are approximately 0.33 hectare (0.83 acre) in extent. Wetland vegetation removed since 1951 is depicted on the Wetland Analysis overlay. The approximate areal extent of wetlands removed from 1951 to 2000 is 2.6 hectares (6.5 acres). Wetlands have been removed primarily from the central and northwestern portions of the subarea. Nonwetland areas, e.g., a small possible waste disposal area observed in 1939, and two waste disposal areas evident in 1951 are also depicted.
