**Third Five-Year Review Report**  
**for**  
**Charles George Land Reclamation Trust Landfill Superfund Site**  
**Tyngsborough,**  
**Middlesex County, Massachusetts**

**June 2005**

**United States Environmental Protection Agency**  
**Region 1**  
**Boston, Massachusetts**

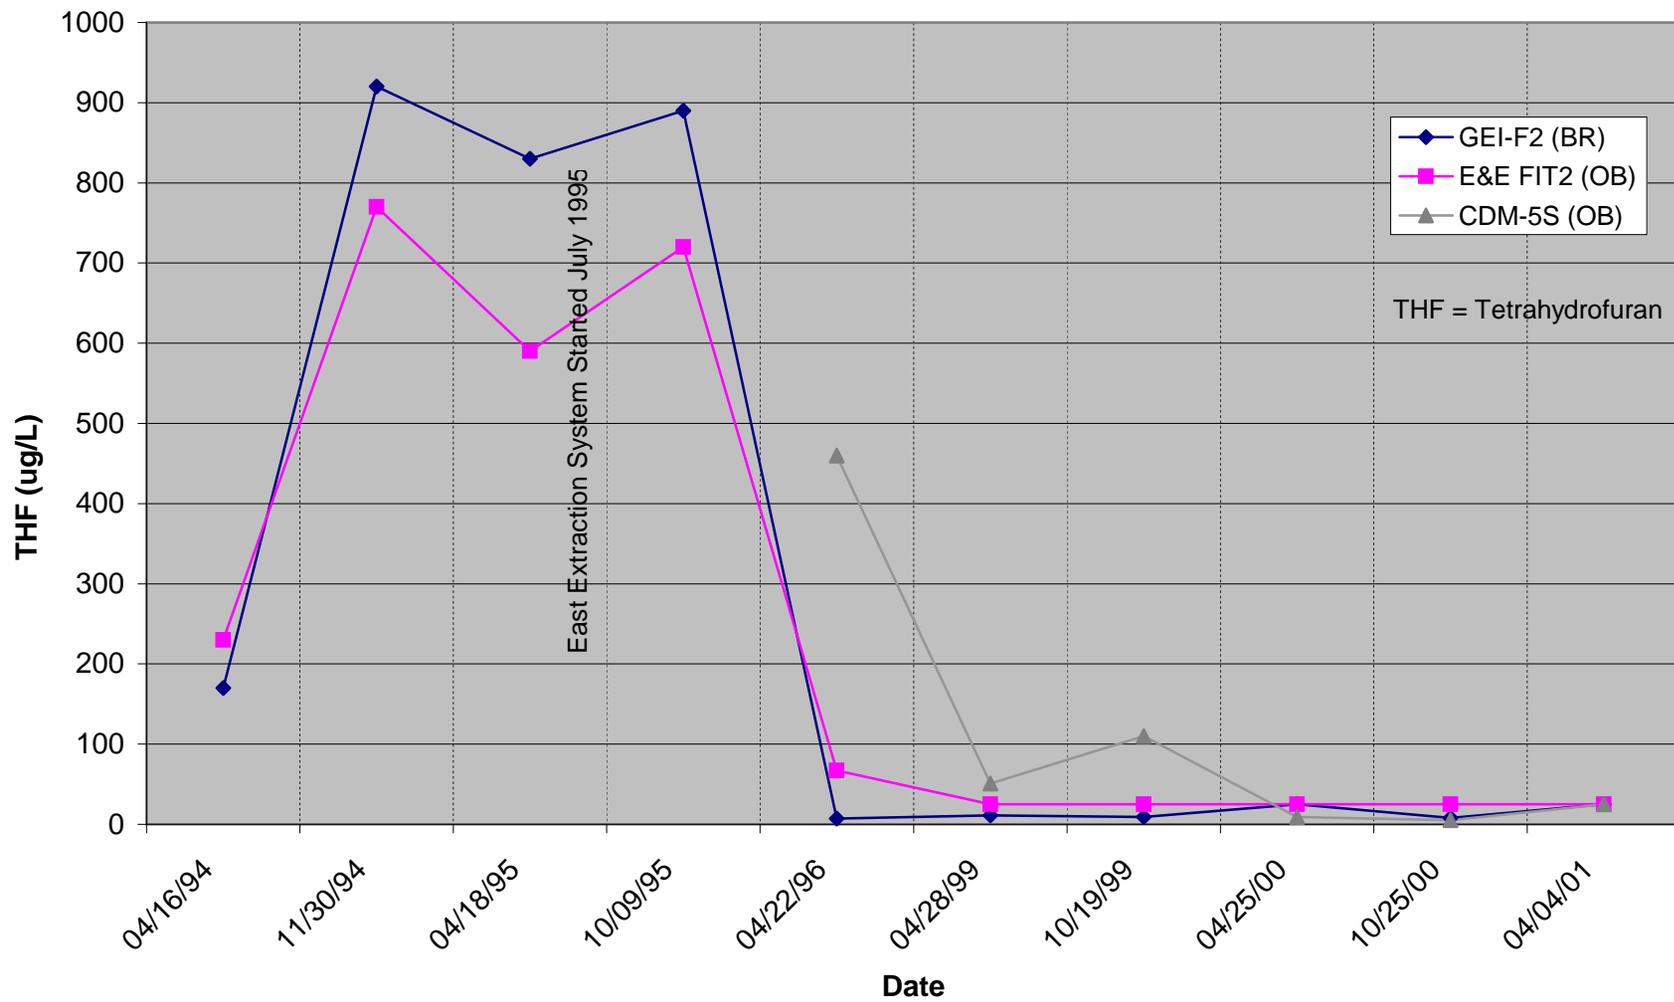
**Figure 4**  
**THF Concentrations in Groundwater**  
**East Extraction Area**  
**Charles George Landfill, Tyngsboro, MA**

Line plots of the THF, benzene, and 1,4-dioxane data (Figures 4, 5, and 6a, 6b, and 6c) show the following :

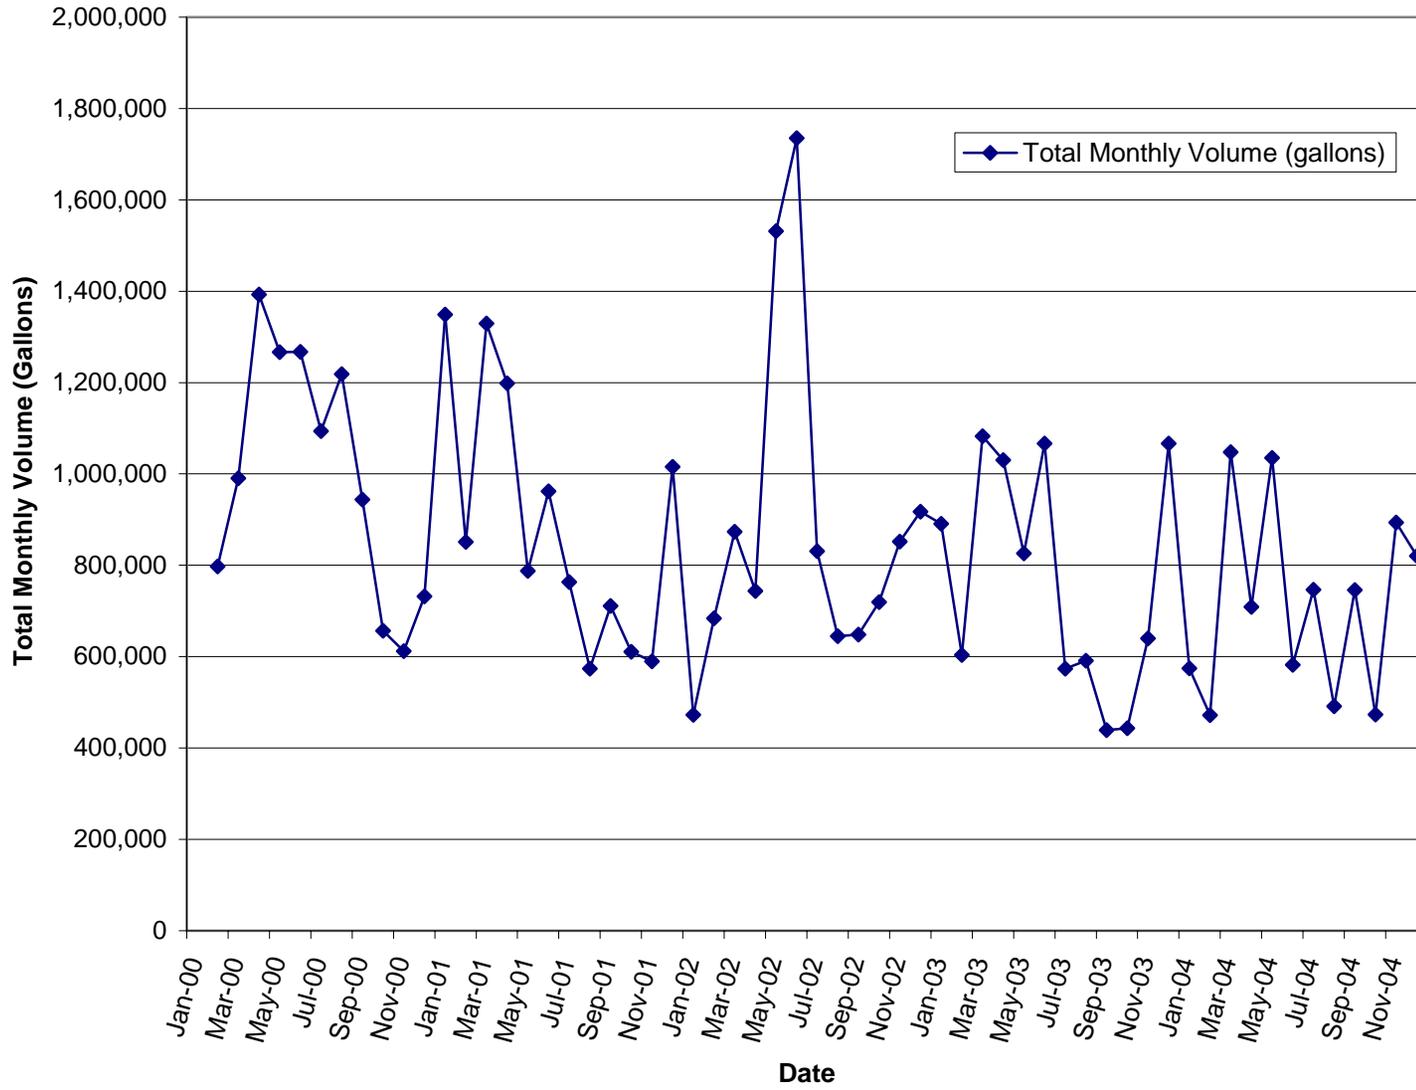
Figure 8  
Monthly Effluent Discharge Volume  
Charles George Landfill

Monthly discharge rates for the Effluent Monitoring Station from 2000 to 2004, as summarized by the Army Corps, are plotted in Figure 8. As shown in Figure 8, the flow data does not indicate any significant changes in flow over this period, with the exception of regular seasonal fluctuations. The monthly discharge volume was typically between 600,000 and 1,000,000 gallons. The Industrial Sewer Discharge permit allows for a discharge flow of up to 86,400 gallons per day, or approximately 2,500,000 gallons per month. Thus, monthly discharge volumes are well below the limit allowed under the permit.

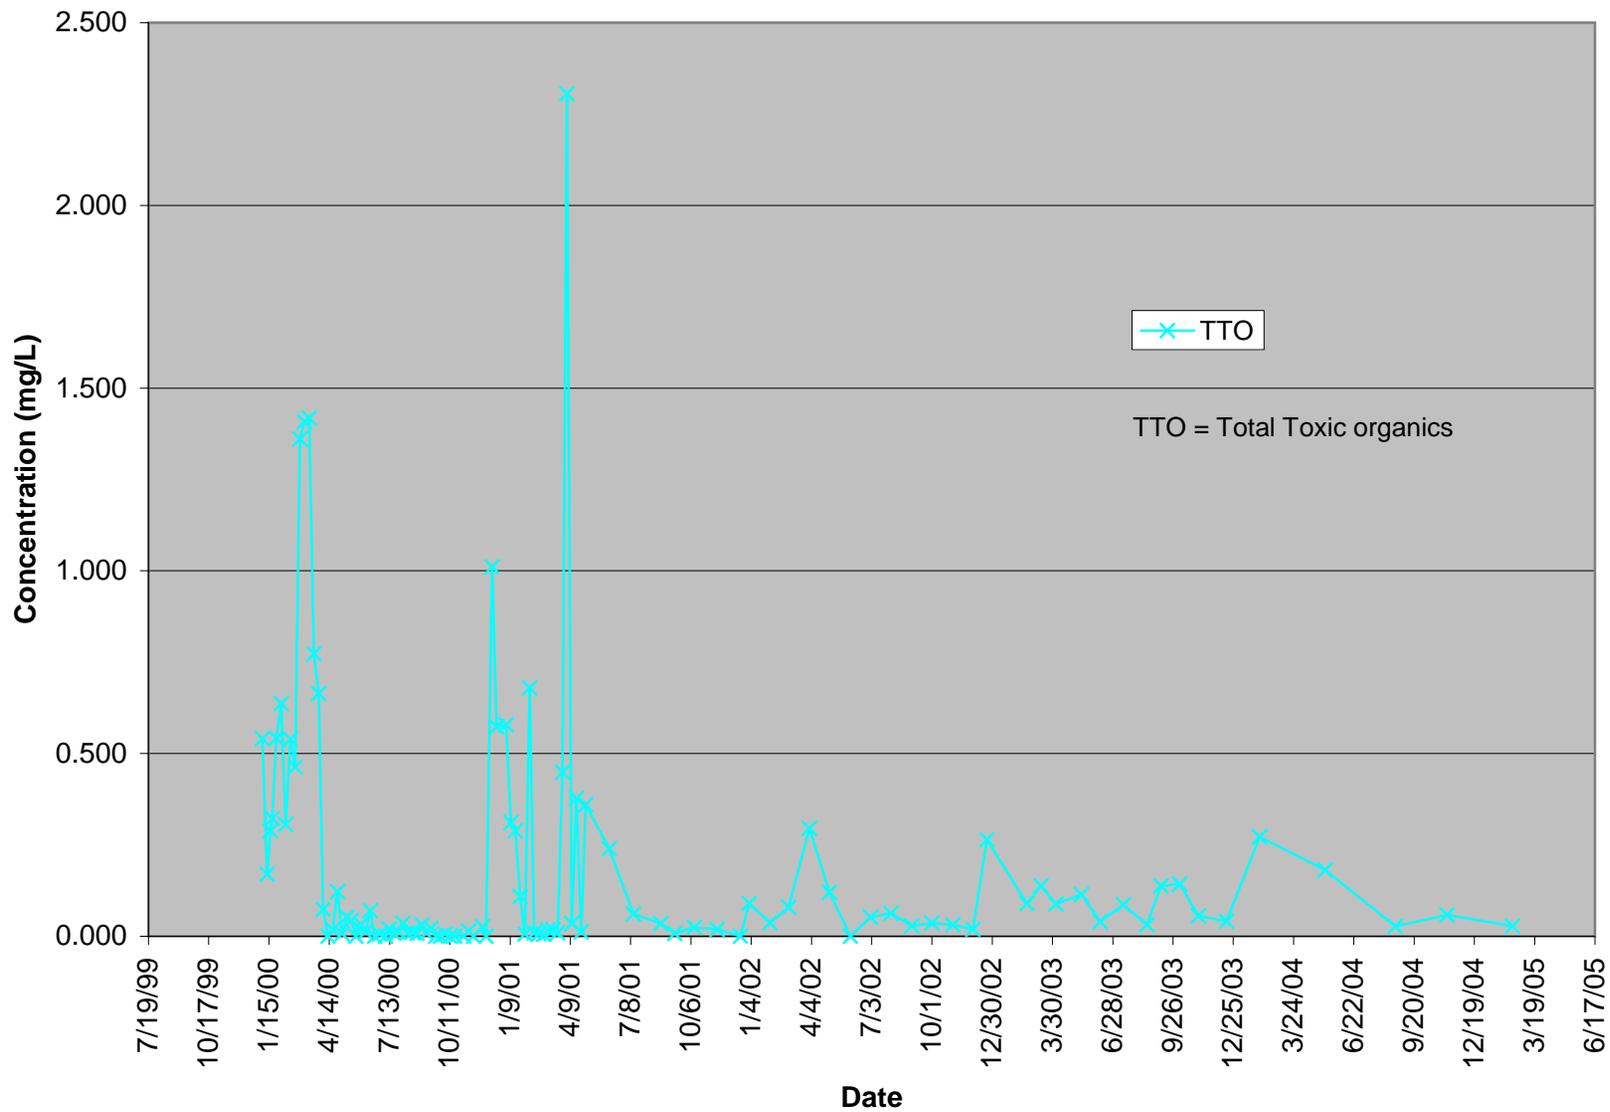
**Figure 9**  
**TTO (mg/L) at Effluent Monitoring Station**  
**Charles George Landfill, Tyngsborough, MA**

Sampling (grab samples) and analysis of the Effluent Monitoring Station discharge for Total Toxic Organics (TTO) has been performed since January 2000 on a monthly or quarterly schedule by the Army Corps in accordance with the requirements of the Industrial Sewer Discharge permit. TTO is a measurement of the total concentration of organic compounds considered toxic including 1,4-dioxane, acetone, and tetrahydrofuran. The TTO data shows some seasonal fluctuation with apparent peak concentrations often occurring in the winter and early spring months (i.e., December through April; see Figure 9). The data also shows that peak concentrations in 2002-2005 decreased from those measured during 2000-2001. The drop in peak TTO concentrations may be due to source reduction (landfill cap) and continued operation of the groundwater collection system.

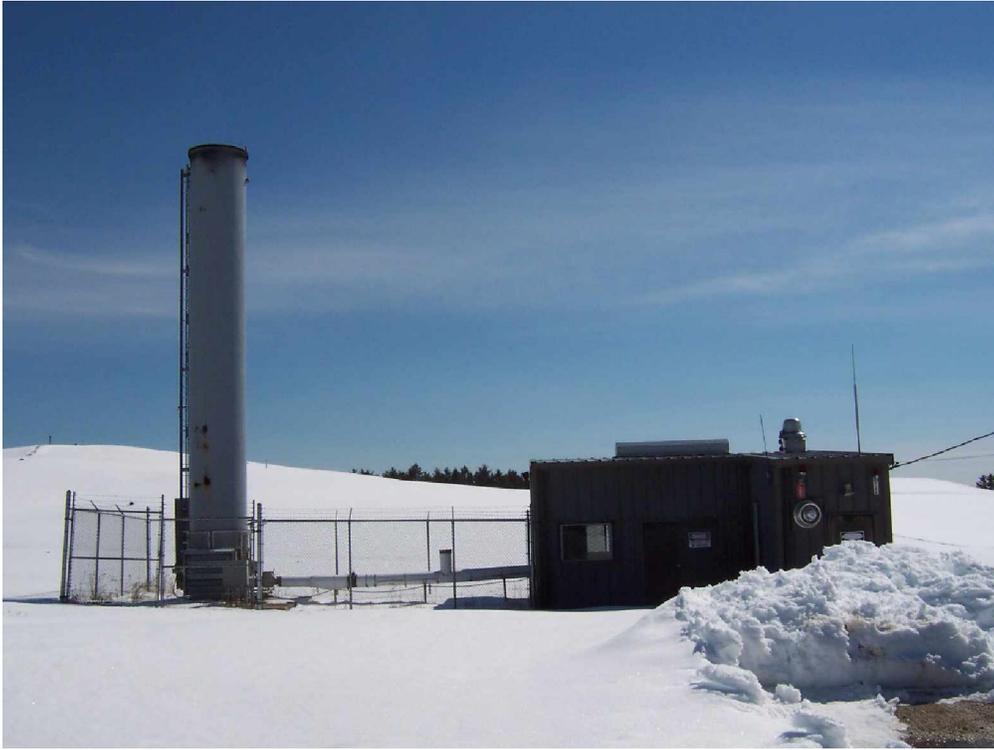
**Photo 17: Landfill gas flare.**

The March 2000 to December 2003 weekly inspection logs prepared by Clean Harbors were reviewed to evaluate flare O&M activities. Figure 7 is a plot showing the percentage of Site visits for which the flare was found to be operational during each semiannual or quarterly reporting period. Weekly flare inspection logs indicate that overall, the flare has had no major operational or maintenance problems, but has had more down time than operating time since the last Five Year Review.

As seen in Figure 7, the percentage of time the flare was operational appears to have decreased steadily over the past five years, from approximately 35% during the first quarter of 2000, to approximately 21% for the most recent Semi-Annual Status Report during the first half of 2004. Clean Harbors technicians reported that the flare typically runs between eight (8) and 24 hours per week. Their weekly observations have indicated that most of the time when the flare is off, it is a result of automatic shutdown due to a low temperature alarm in the stack. This information indicates that the flare temperature decreases after several hours or days of burning, regularly causing the flare to be extinguished. This likely occurs at a point when the levels of collected methane gas become too low to fuel the flare, and the levels of oxygen in the system are too high. However, the flare control system does not measure methane, so there is no real-time verification of low methane levels triggering the flare shutdowns. Clean Harbors technicians responsible for O&M of the flare indicated that intrusion of oxygen into the gas collection system has been an ongoing problem since the start up of the enclosed flare in April 1998. This apparent intrusion was also a problem during operation of the open flare system.
