**FIVE-YEAR REVIEW REPORT FOR
KEARSARGE METALLURGICAL CORPORATION SUPERFUND SITE
CARROLL COUNTY, NEW HAMPSHIRE**

**U.S. Environmental Protection Agency
Region I
Boston, Massachusetts**

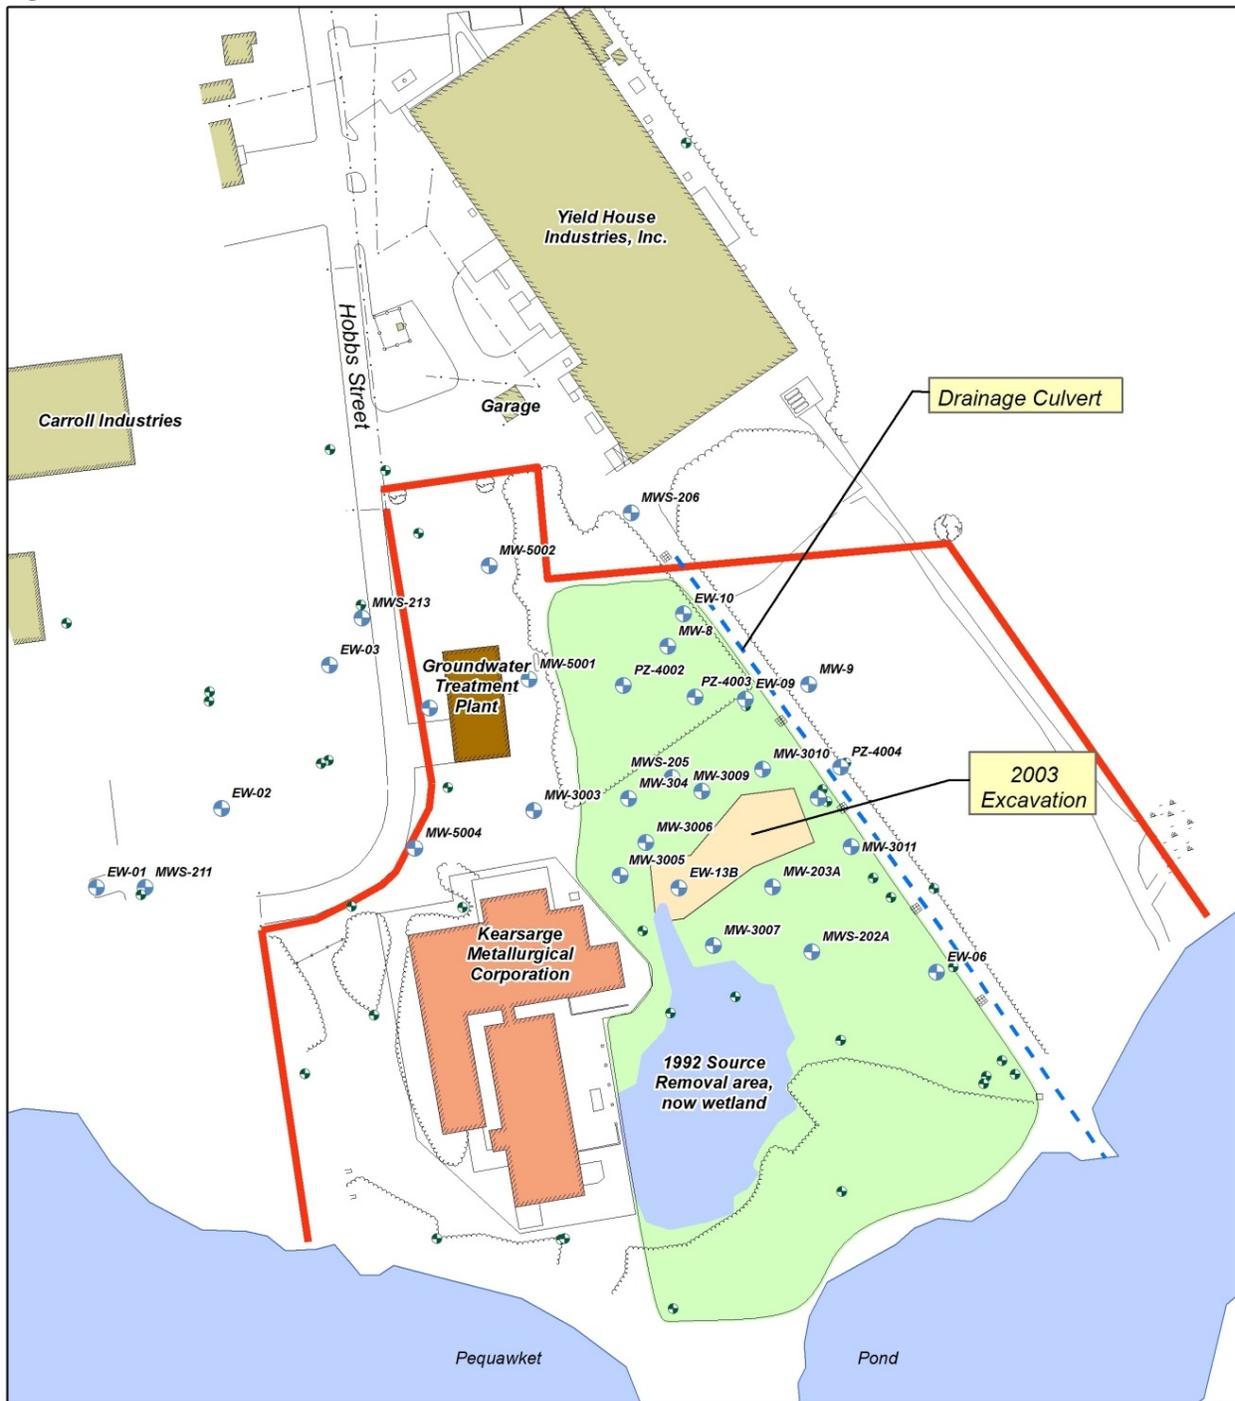
Figure 2: Site Features.

part of the lot and a 4,000 ft² groundwater treatment plant built by EPA in 1993 lies on the northern part of the lot. The entire, original KMC building is shown on Figure 2. The eastern-most, dilapidated portions of the building were removed in December 2012 by the Town and what remains, the former western wing, is a sheet metal building covering approximately 2000 ft².

Wells MW-3010 and MW-3008 are 80 and 40 feet away from MW-3011, respectively, but all three wells are within 10 feet of a storm drain (See Figure 2 in the Five Year Review and Figure D1 above). The rapid transmission of water in the drainage culvert affects water levels, and perhaps concentrations, dramatically in these wells.

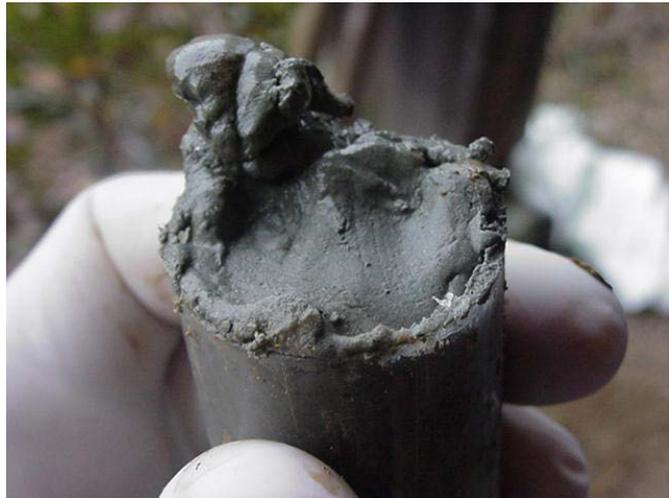
Photo 1 – Material from the Silty-Clay underlying the Site. This sample was recovered east of the old KMC building at a depth of 12-feet by Weston Solutions, Inc., during the November 2002 geoprobe investigation.

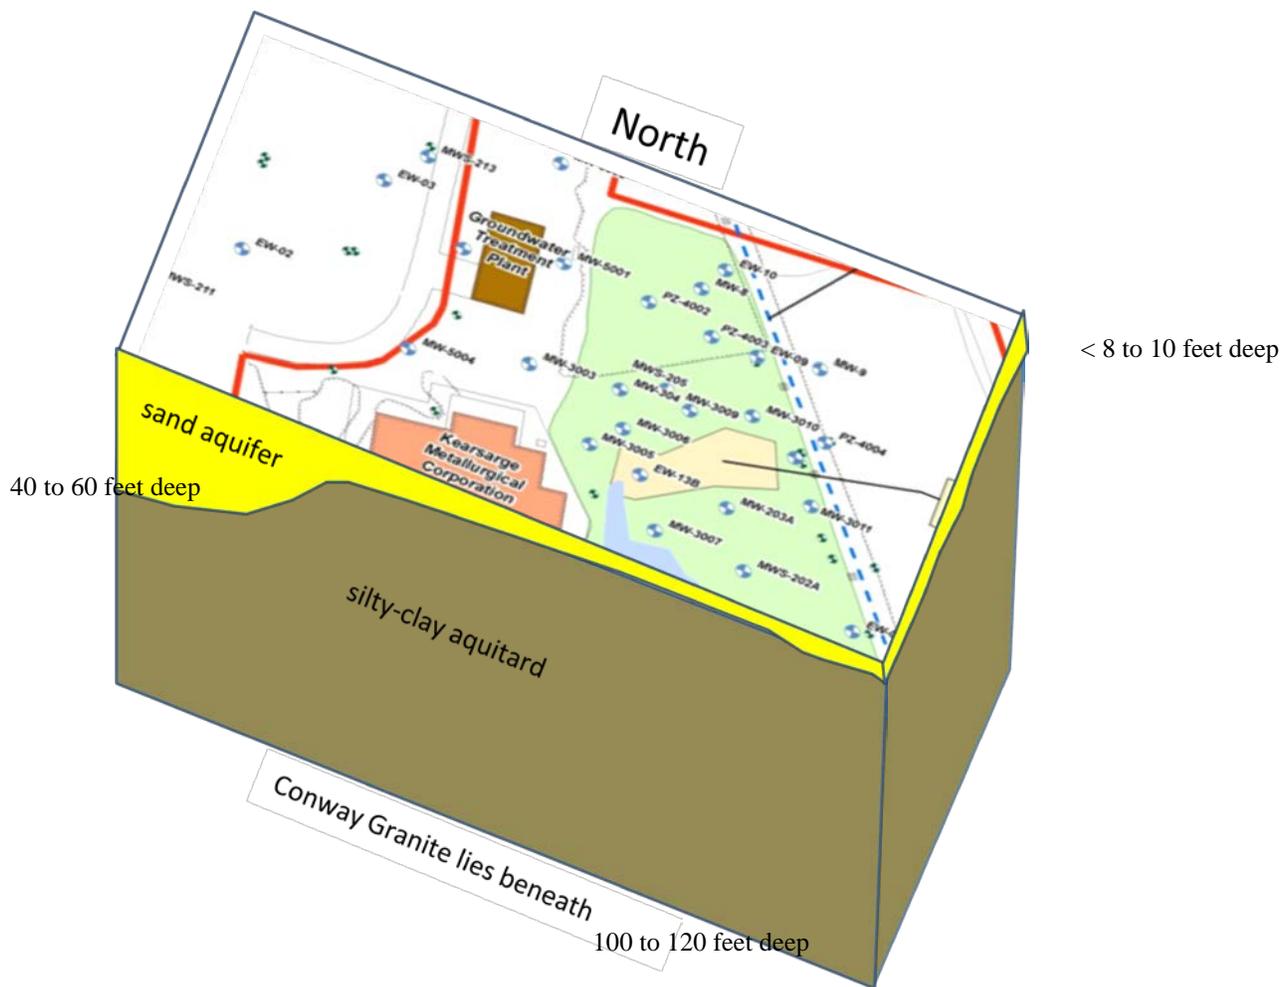
Figure 3. A block diagram shows a schematic of the underlying geology at the Site. The drainage culvert is the dashed blue line on the right side of the plan view. The plan view is taken from Figure 2.

The bedrock beneath the Site is the Conway Granite, the top of which varies from a low of 318 ft NGVD to a high of 364 ft NGVD, and is approximately 100 to 120 ft below ground surface (bgs). The bedrock has two major fracture orientations trending north-south and east-west. Figure 3 shows a general schematic of Site geology.
