APPENDIX A

SITE PHOTOGRAPHS

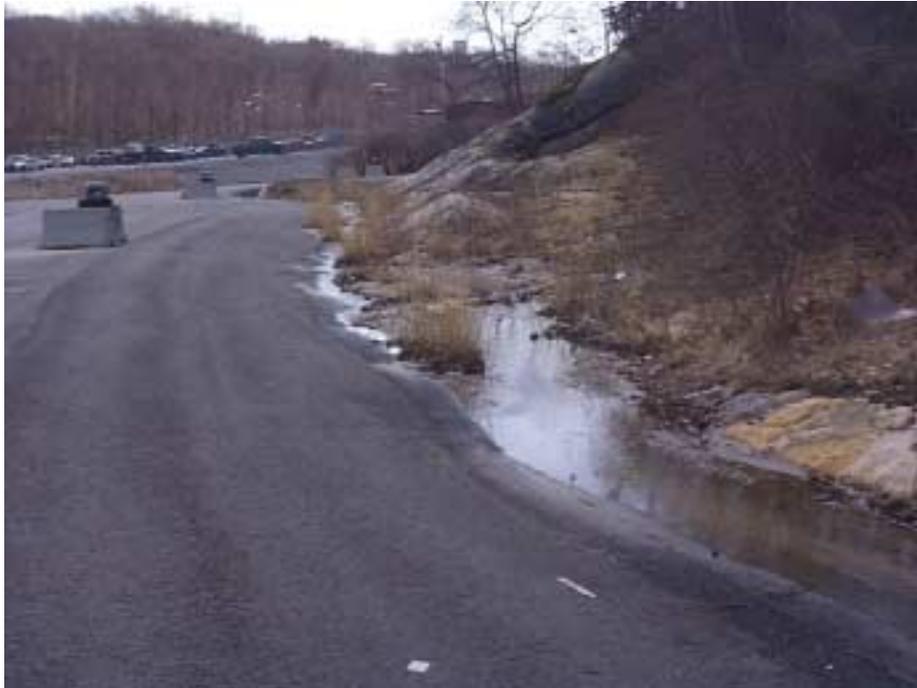
SITE 2 – AREA A LANDFILL AND WETLAND
VIEW OF NORTH CHANNEL LOOKING IN EAST DIRECTION
APRIL 10, 2001
NSB-NLON, GROTON, CONNECTICUT. CTO 0816

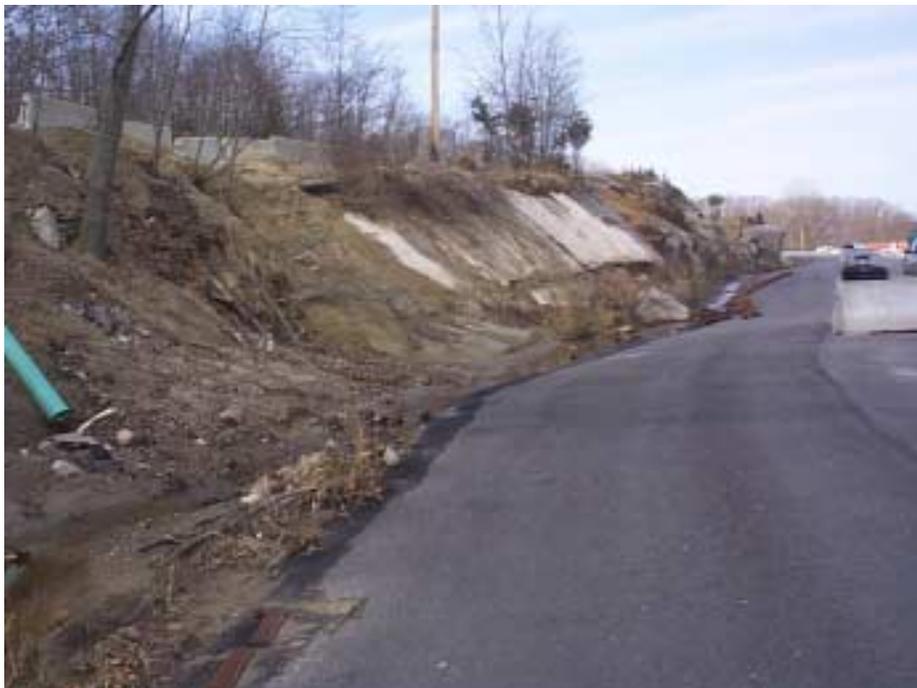
SITE 2 – AREA A LANDFILL AND WETLAND
VIEW OF NORTH CHANNEL LOOKING TO THE WEST
APRIL 10, 2001
NSB-NLON, GROTON, CONNECTICUT. CTO 0816

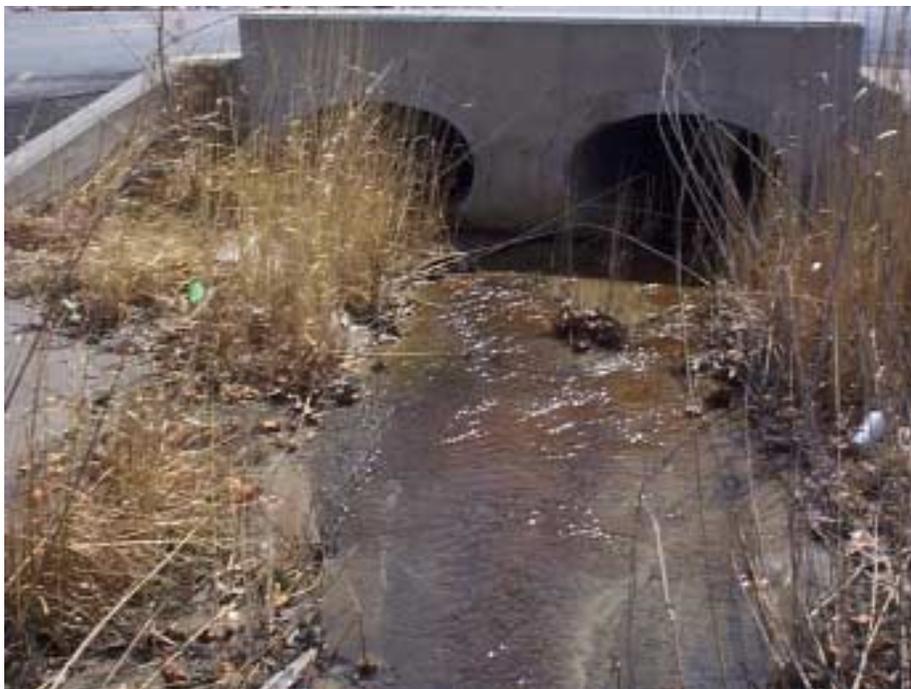
SITE 2 – AREA A LANDFILL AND WETLAND
HEADWALL OF CULVERT ON NORTH SIDE OF LANDFILL.
APRIL 10, 2001
NSB-NLON, GROTON, CONNECTICUT. CTO 0816

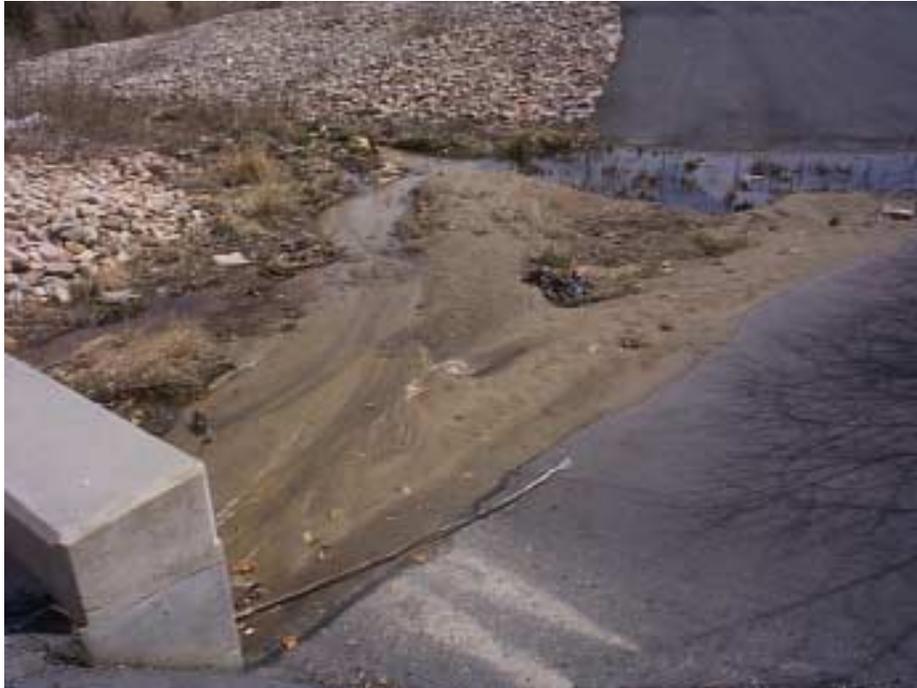
SITE 2 – AREA A LANDFILL AND WETLAND
VIEW OF ENDWALL OF CULVERT FOR NORTHERN DRAINAGE CHANNEL.
APRIL 10, 2001
NSB-NLON, GROTON, CONNECTICUT. CTO 0816

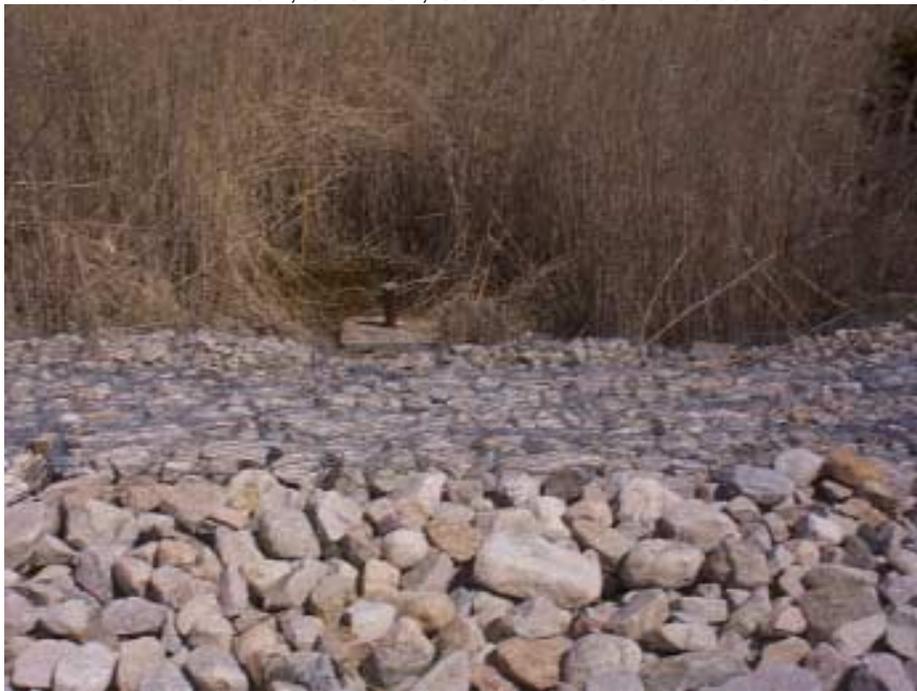
SITE 2 – AREA A LANDFILL AND WETLAND
VIEW OF MONITORING WELL 2WMW45S WHICH IS INCLUDED IN SITE 2 GROUNDWATER
MONITORING PROGRAM AND IS LOCATED NORTH OF DEPLOYED PARKING AREA.
APRIL 10, 2001
NSB-NLON, GROTON, CONNECTICUT. CTO 0816

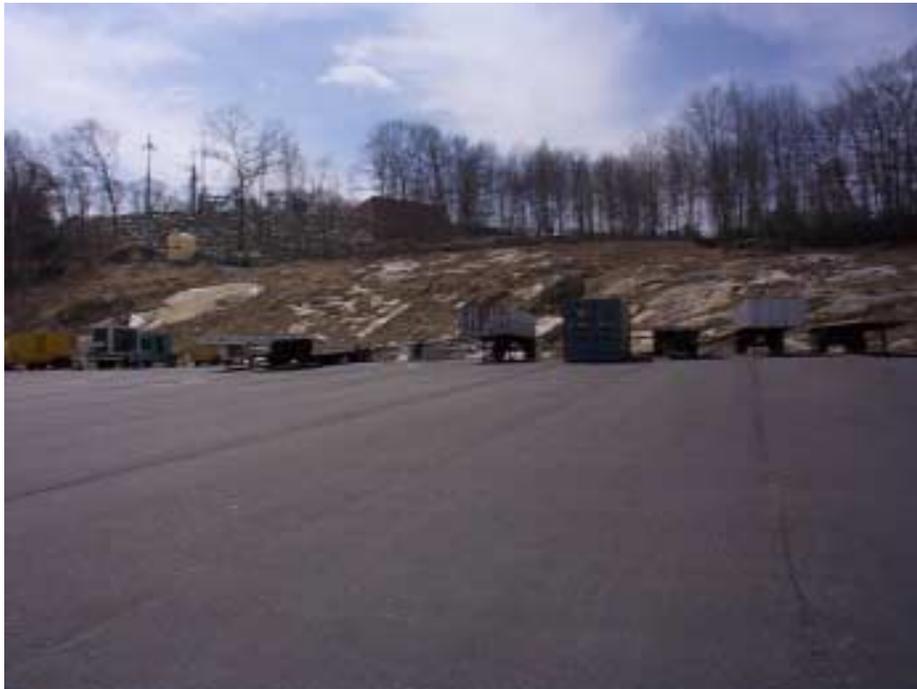
SITE 2 – AREA A LANDFILL AND WETLAND
VIEW OF EQUIPMENT STORED AND SITE 4–RUBBLE FILL AREA AT BUNKER A-86
APRIL 10, 2001
NSB-NLON, GROTON, CONNECTICUT. CTO 0816

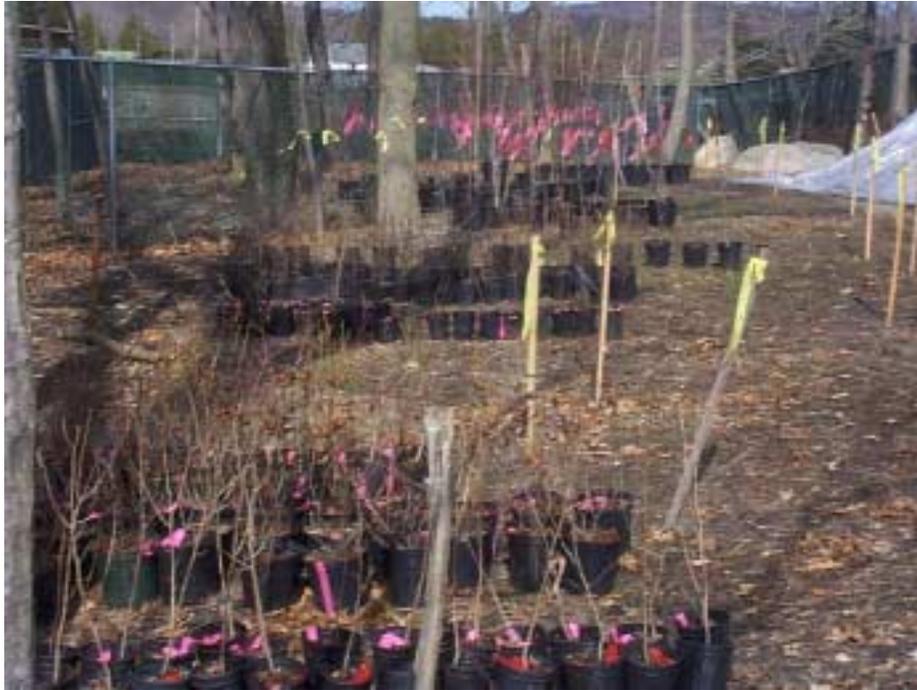
SITE 3 – AREA A DOWNSTREAM/OBDA
TREES USED FOR PLANTING DURING RESTORATION AFTER REMEDIAL ACTION.
APRIL 10, 2001
NSB-NLON, GROTON, CONNECTICUT. CTO 0816

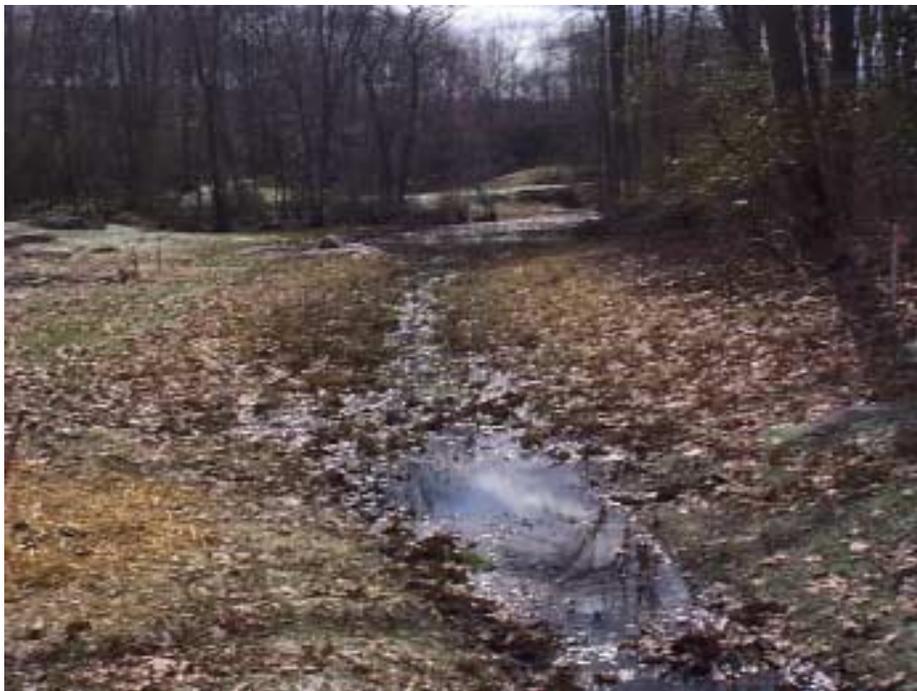
SITE 3 – AREA A DOWNSTREAM/OBDA
VIEW OF STREAM 2 AND LOWER POND LOOKING EAST.
APRIL 10, 2001
NSB-NLON, GROTON, CONNECTICUT. CTO 0816

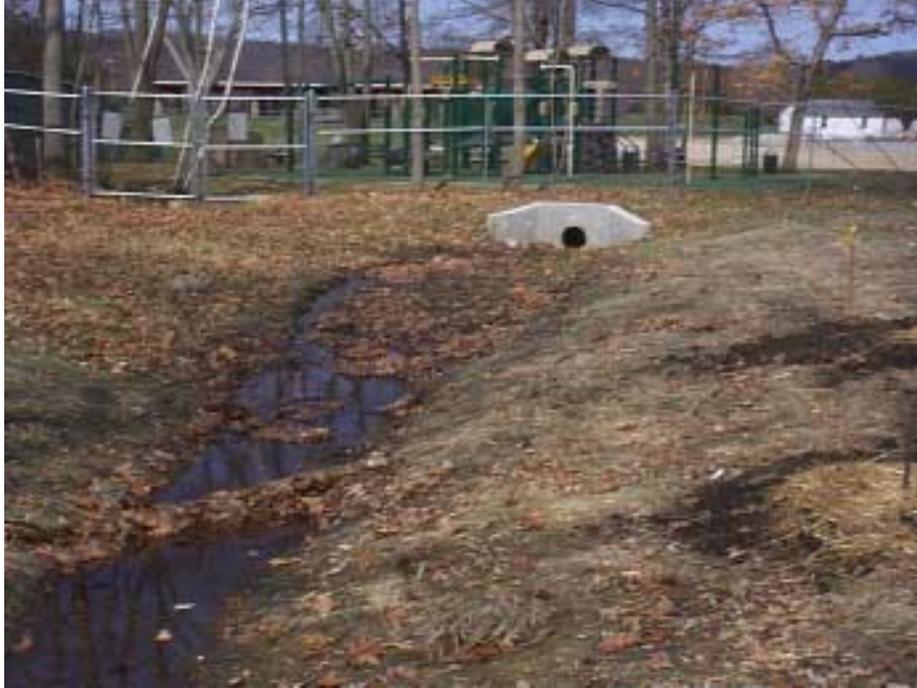
SITE 3 – AREA A DOWNSTREAM/OBDA
HEADWALL OF STREAM 2 LOOKING WEST.
APRIL 10, 2001
NSB-NLON, GROTON, CONNECTICUT. CTO 0816

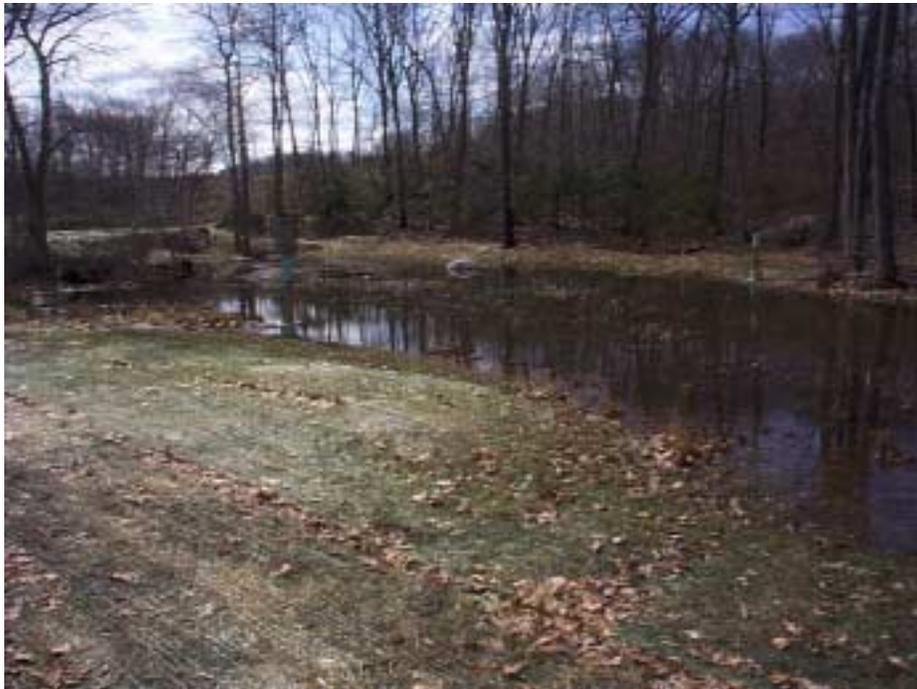
SITE 3 – AREA A DOWNSTREAM/OBDA
LOWER POND LOOKING SOUTHEAST.
APRIL 10, 2001
NSB-NLON, GROTON, CONNECTICUT. CTO 0816

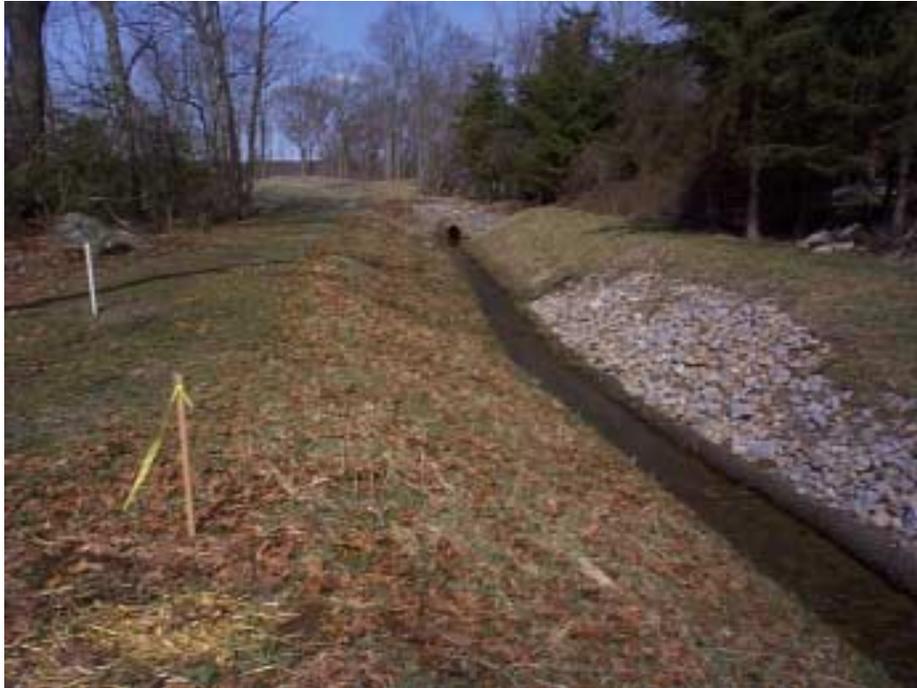
SITE 3 – AREA A DOWNSTREAM/OBDA
VIEW OF STREAM 3 LOOKING NORTHWEST.
CULVERT TO STREAM 5 SHOWN AT DISTANCE.
APRIL 10, 2001
NSB-NLON, GROTON, CONNECTICUT. CTO 0816

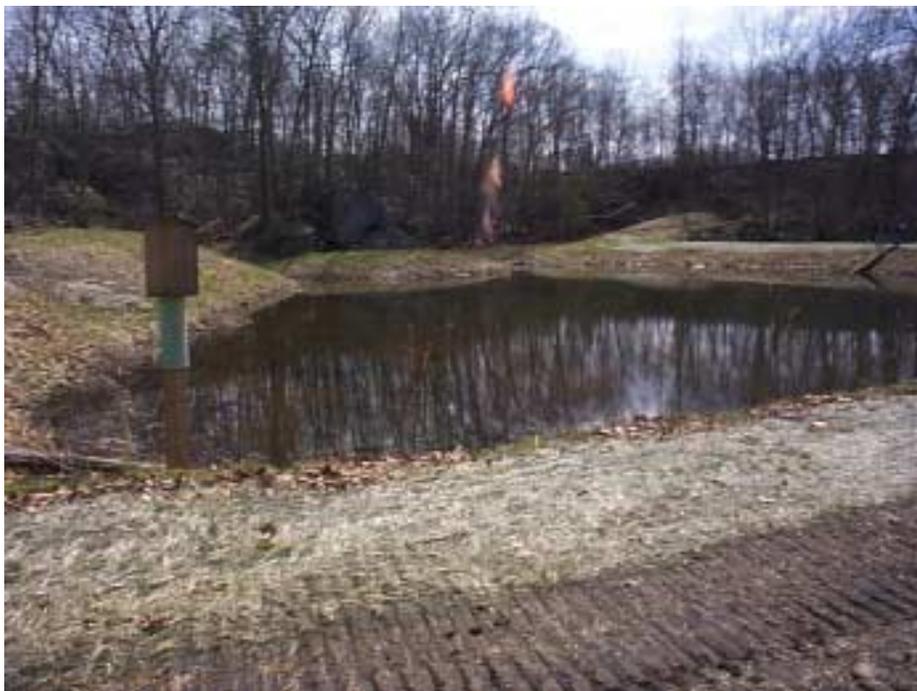
SITE 3 – AREA A DOWNSTREAM/OBDA
VIEW OF UPPER POND TOWARD STREAM 4 LOOKING EAST.
APRIL 10, 2001
NSB-NLON, GROTON, CONNECTICUT. CTO 0816

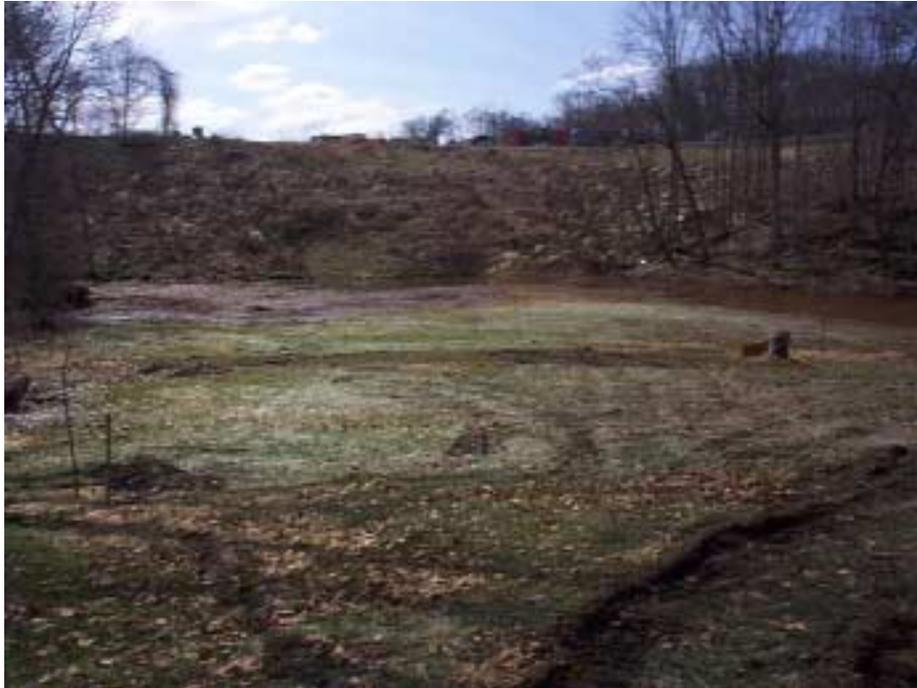
SITE 3 – AREA A DOWNSTREAM/OBDA
VIEW OF OBDA POND LOOKING EAST TOWARD OBDA.
APRIL 10, 2001
NSB-NLON, GROTON, CONNECTICUT. CTO 0816

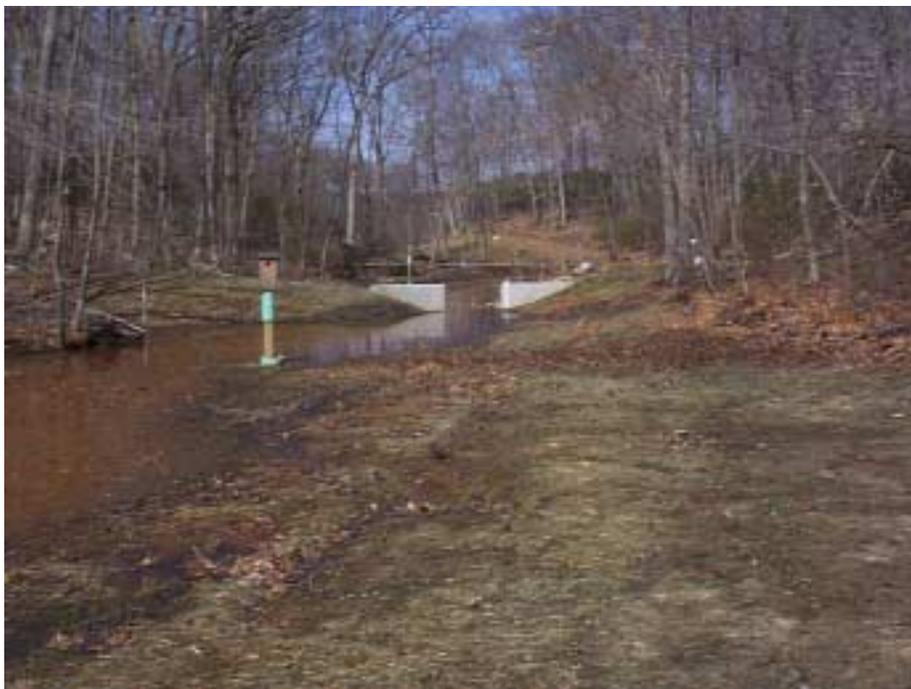
SITE 3 – AREA A DOWNSTREAM/OBDA
VIEW OF STREAM 1 LEAVING OBDA POND LOOKING WEST.
APRIL 10, 2001
NSB-NLON, GROTON, CONNECTICUT. CTO 0816

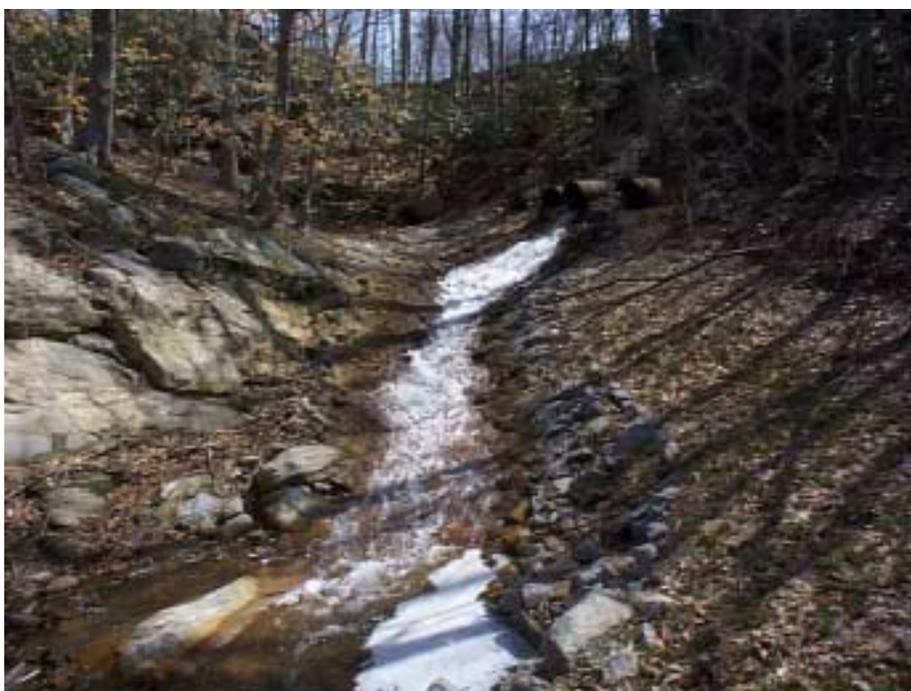
SITE 3 – AREA A DOWNSTREAM/OBDA
VIEW OF HEADWATERS OF STREAM 4 LOOKING SOUTHEAST.
AREA WHERE PESTICIDE CONTAMINATION WAS CAPPED AND LEFT IN PLACE.
APRIL 10, 2001
NSB-NLON, GROTON, CONNECTICUT. CTO 0816

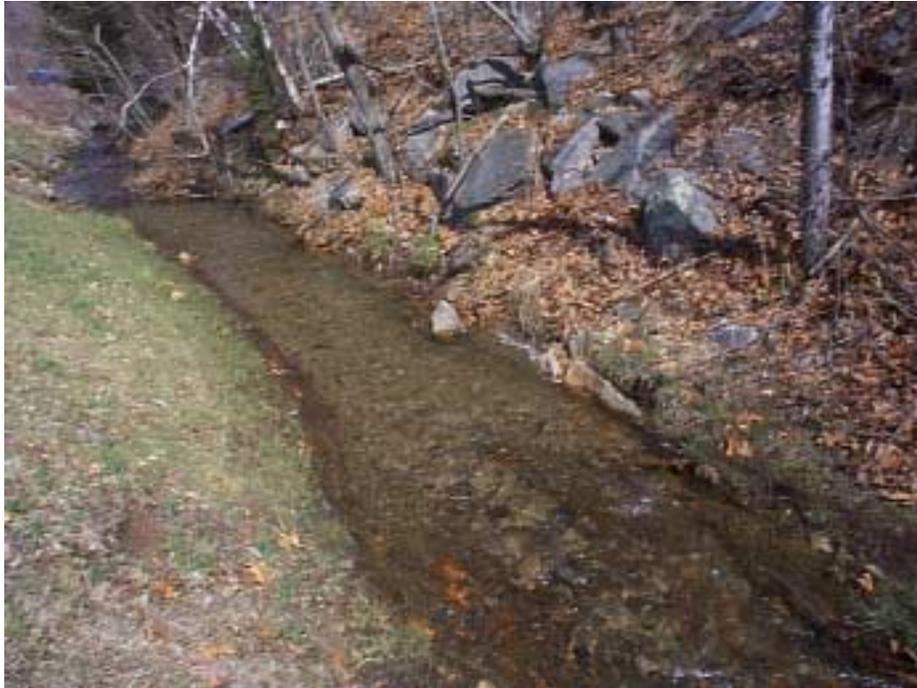
SITE 3 – AREA A DOWNSTREAM/OBDA
VIEW OF STREAM 5 LOOKING WEST.
APRIL 10, 2001
NSB-NLON, GROTON, CONNECTICUT. CTO 0816

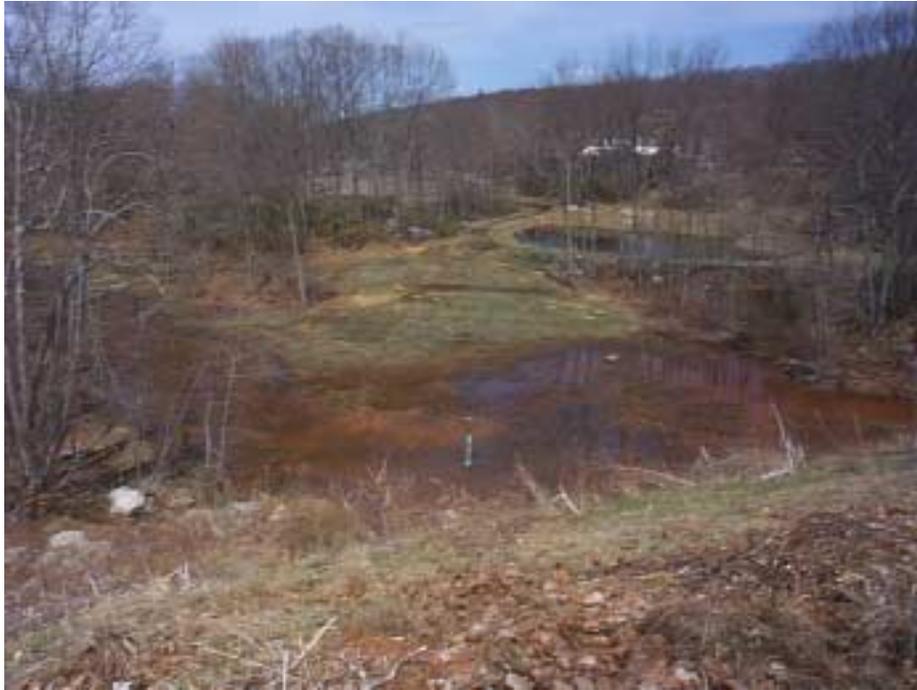
SITE 3 – AREA A DOWNSTREAM/OBDA
VIEW OF OBDA POND AND UPPER POND LOOKING NORTH.
APRIL 10, 2001
NSB-NLON, GROTON, CONNECTICUT. CTO 0816

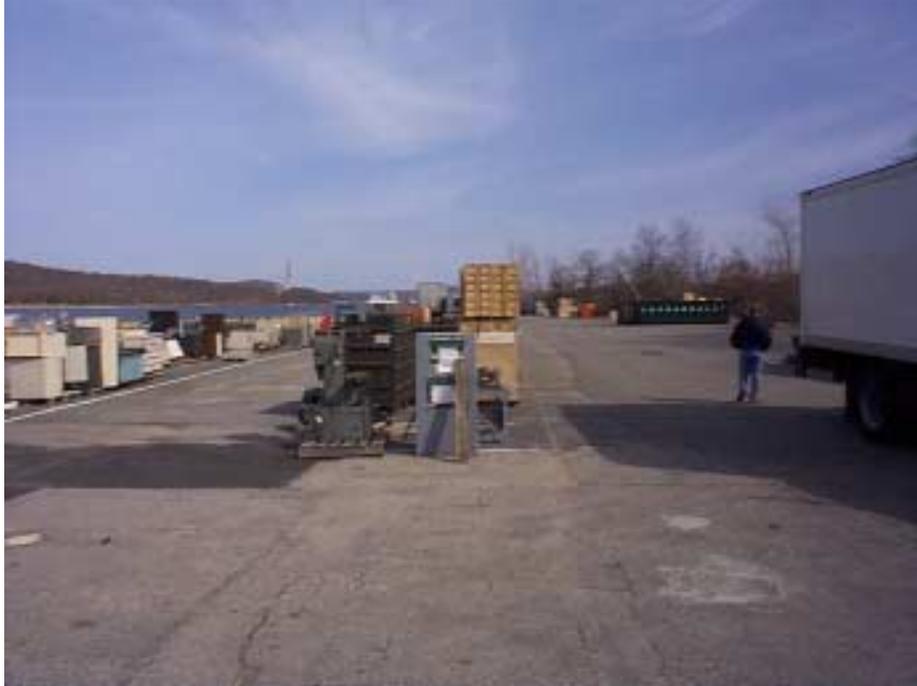
SITE 6 – DRMO
VIEW OF THE SITE FROM THE BUILDING 479 LOOKING NORTH.
APRIL 11, 2001
NSB-NLON, GROTON, CONNECTICUT. CTO 0816

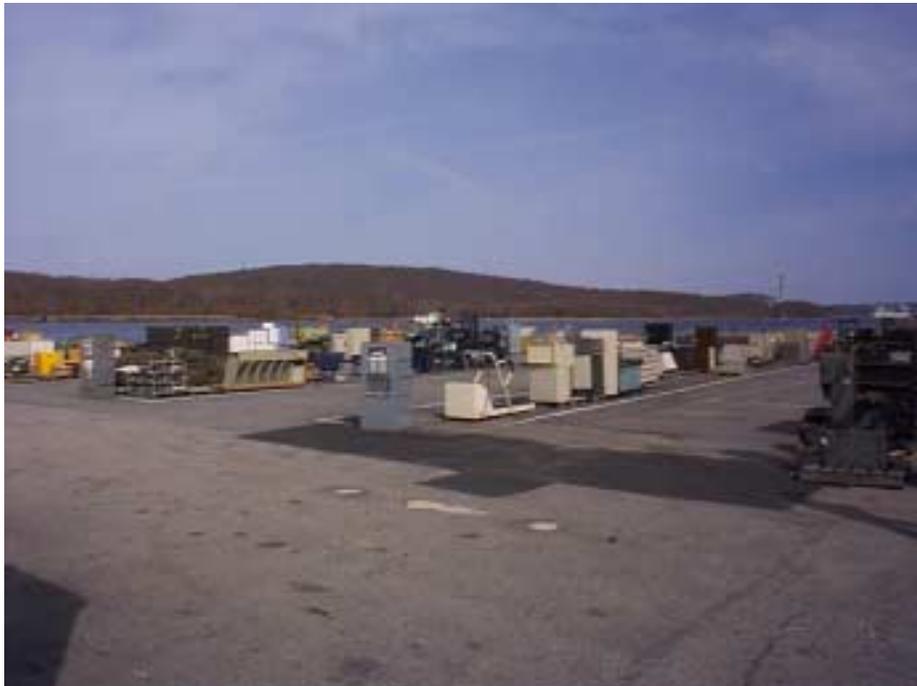
SITE 6 – DRMO
VIEW OF THE SITE LOOKING NORTHWEST FROM BUILDING 479.
APRIL 11, 2001
NSB-NLON, GROTON, CONNECTICUT. CTO 0816

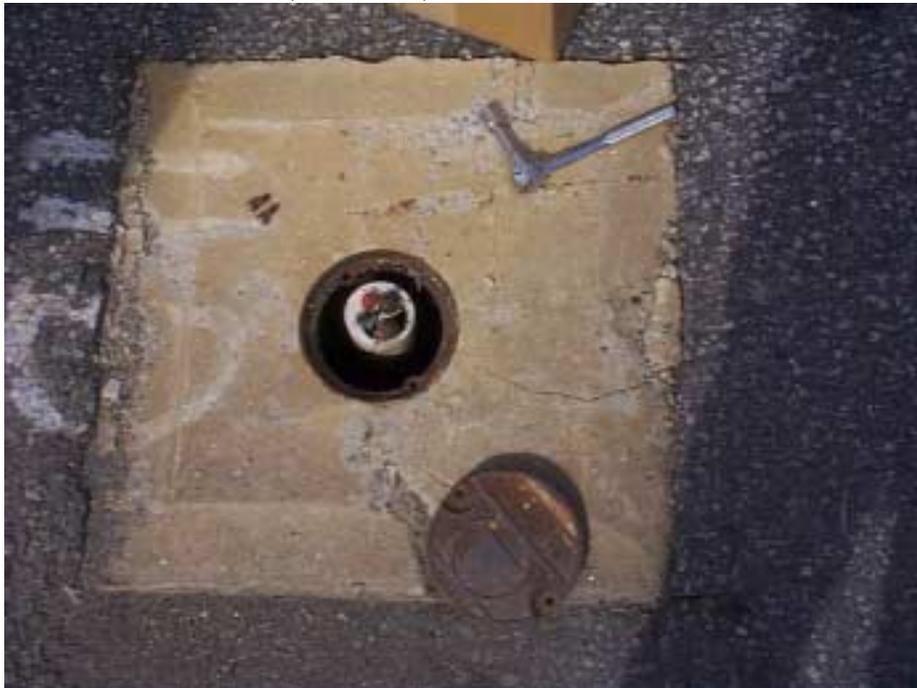
SITE 6 – DRMO
VIEW OF MONITORING WELL 6MW11D AND DEDICATED SAMPLE COLLECTION TUBING.
APRIL 11, 2001
NSB-NLON, GROTON, CONNECTICUT. CTO 0816

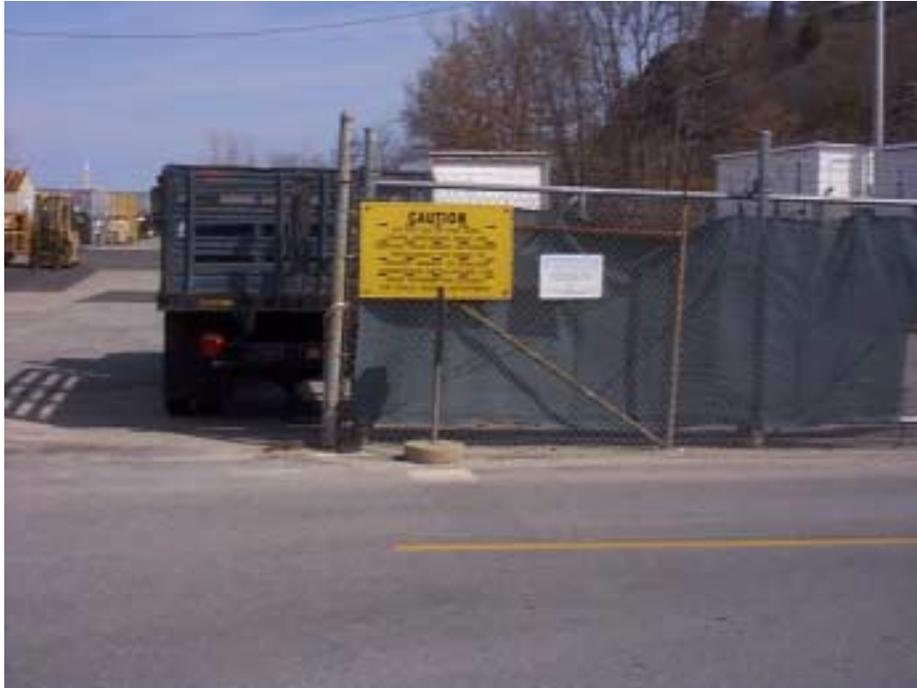
SITE 6 – DRMO
VIEW OF THE “DO NOT DIG” SIGN LOCATED AT THE SOUTHERN GATE ENTRANCE.
APRIL 11, 2001
NSB-NLON, GROTON, CONNECTICUT. CTO 0816

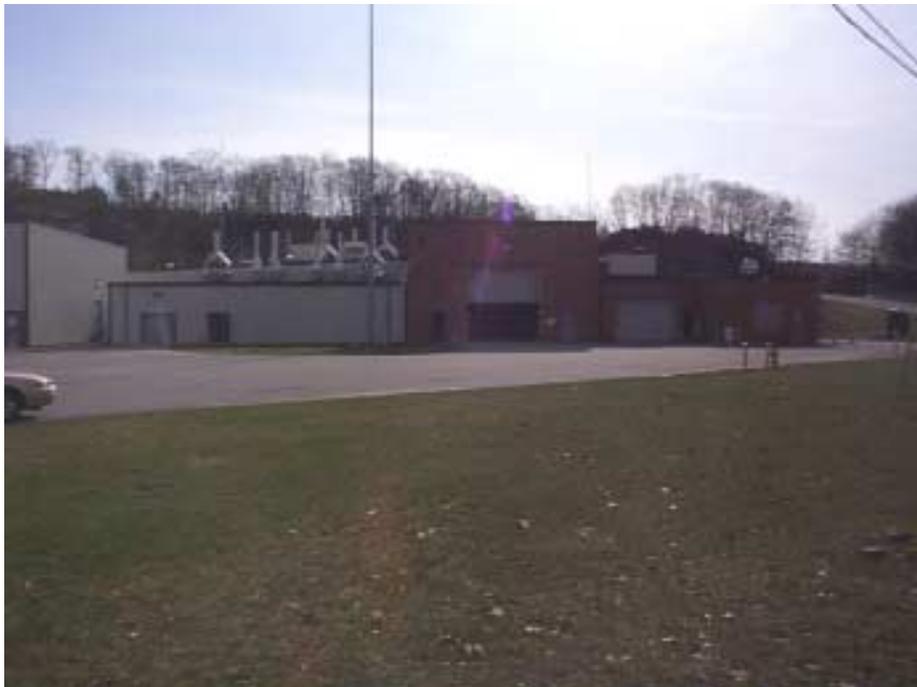
SITE 7 – TORPEDO SHOPS
VIEW OF BUILDING 325 LOOKING EAST.
APRIL 11, 2001
NSB-NLON, GROTON, CONNECTICUT. CTO 0816

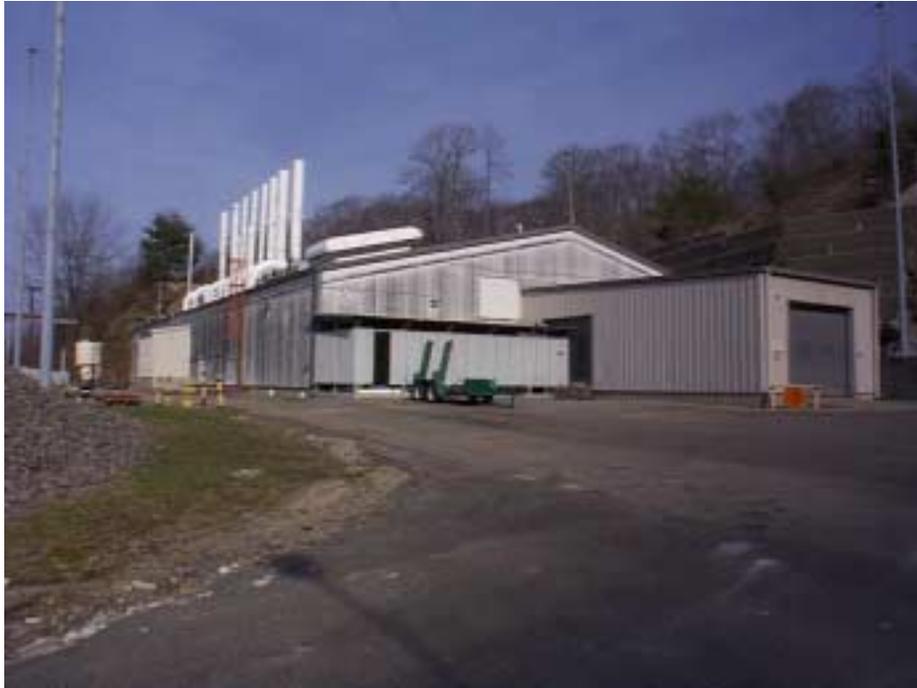
SITE 7 – TORPEDO SHOPS
VIEW OF BUILDING 450 LOOKING WEST.
APRIL 11, 2001
NSB-NLON, GROTON, CONNECTICUT. CTO 0816

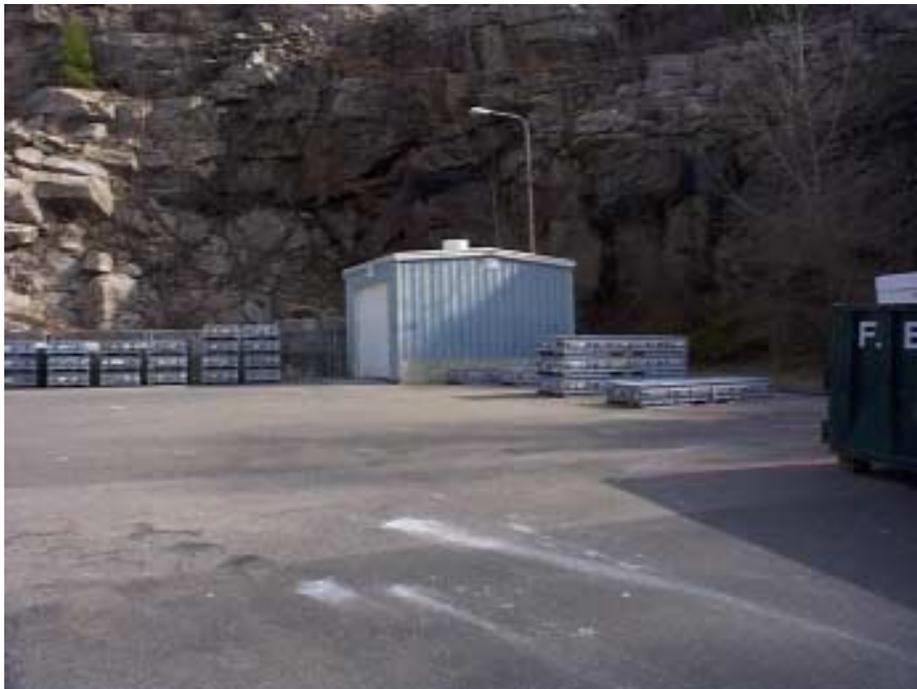
SITE 7 – TORPEDO SHOPS
VIEW OF BUILDING 477, SHED USED FOR SOLVENT STORAGE.
APRIL 11, 2001
NSB-NLON, GROTON, CONNECTICUT. CTO 0816

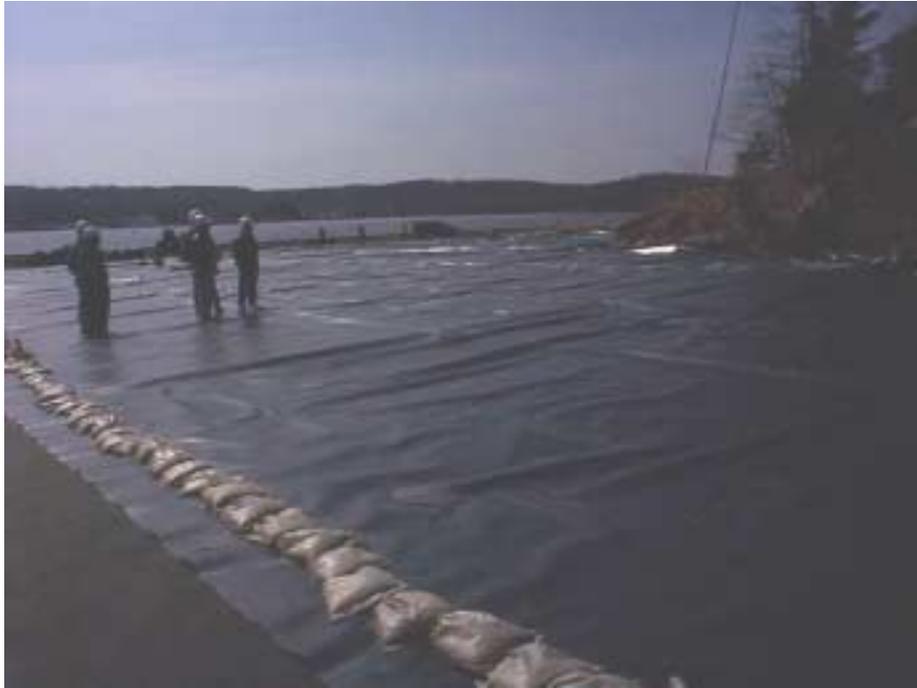
SITE 8 – GOSS COVE LANDFILL
VIEW OF INSTALLATION OF LANDFILL COVER LOOKING WEST.
APRIL 10, 2001
NSB-NLON, GROTON, CONNECTICUT. CTO 0816

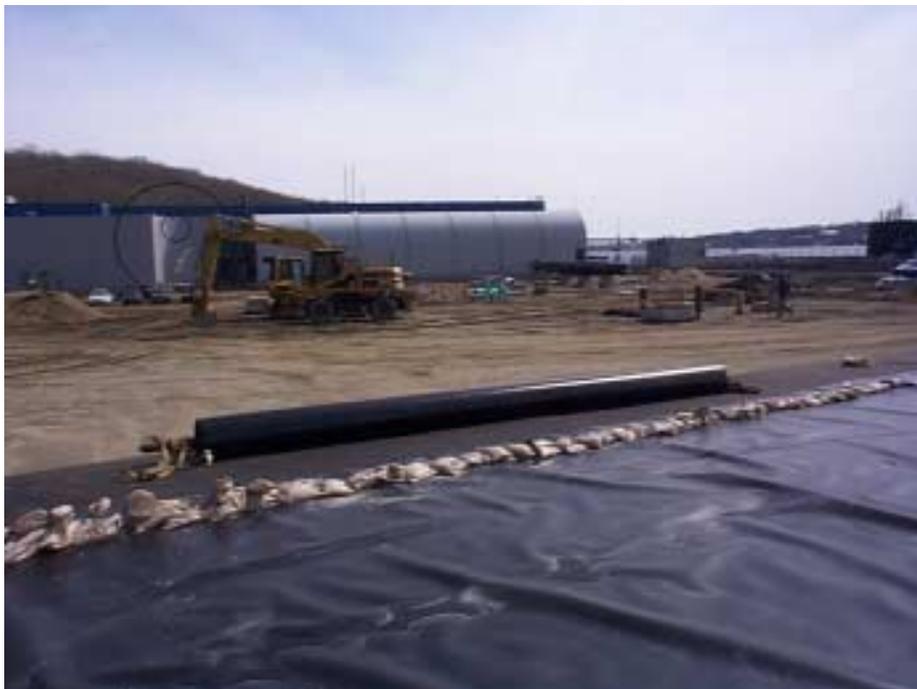
SITE 8 – GOSS COVE LANDFILL. VIEW OF SITE LOOKING SOUTH.
APRIL 10, 2001
NSB-NLON, GROTON, CONNECTICUT. CTO 0816

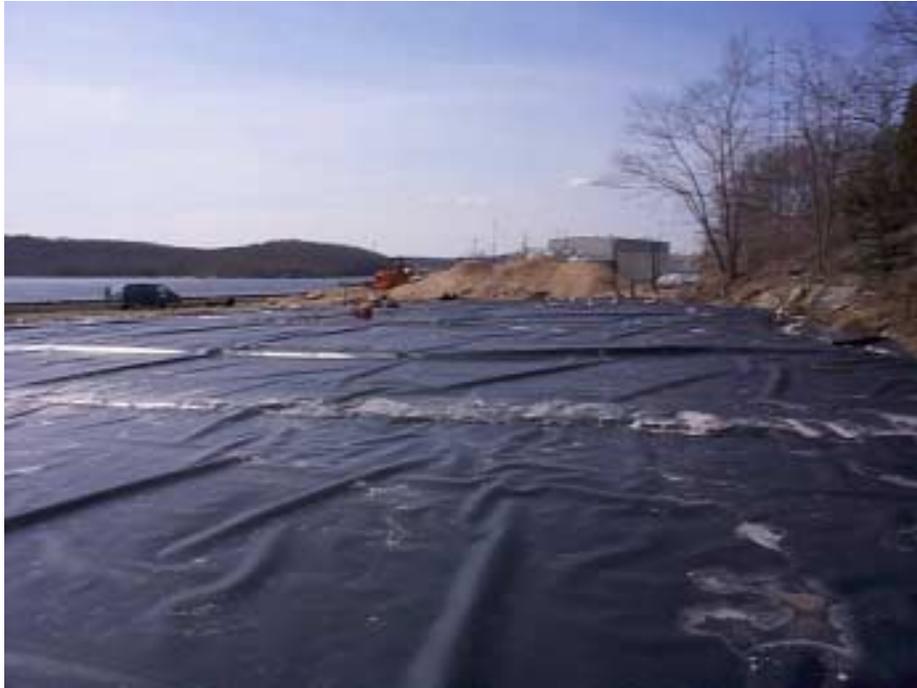
SITE 8 – GOSS COVE LANDFILL
VIEW OF SITE LOOKING NORTH.
APRIL 10, 2001
NSB-NLON, GROTON, CONNECTICUT. CTO 0816

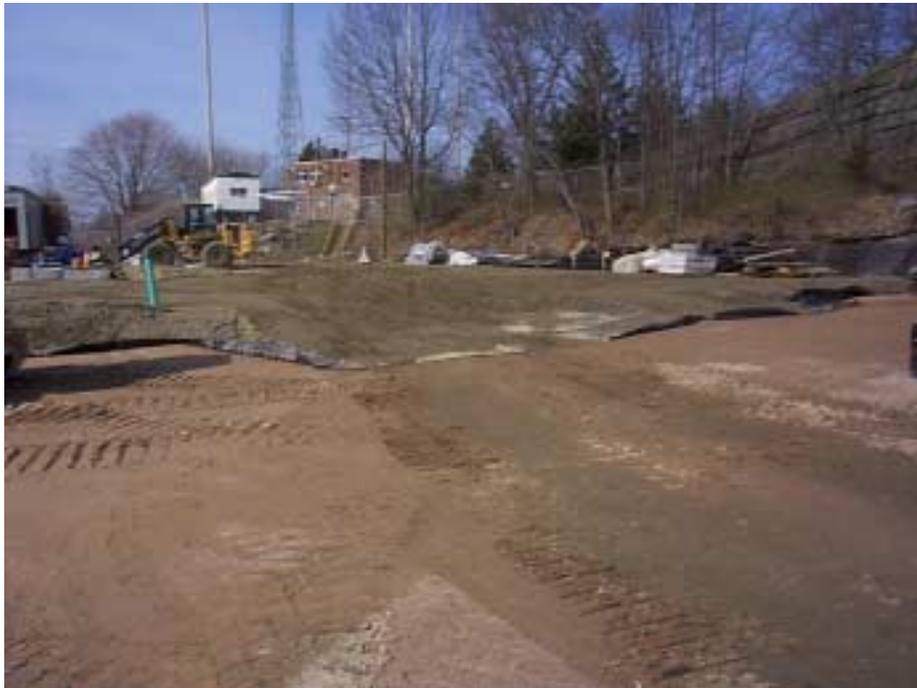
SITE 8 – GOSS COVE LANDFILL
VIEW OF NORTHERN-MOST END OF LANDFILL LOOKING NORTH.
APRIL 10, 2001
NSB-NLON, GROTON, CONNECTICUT. CTO 0816

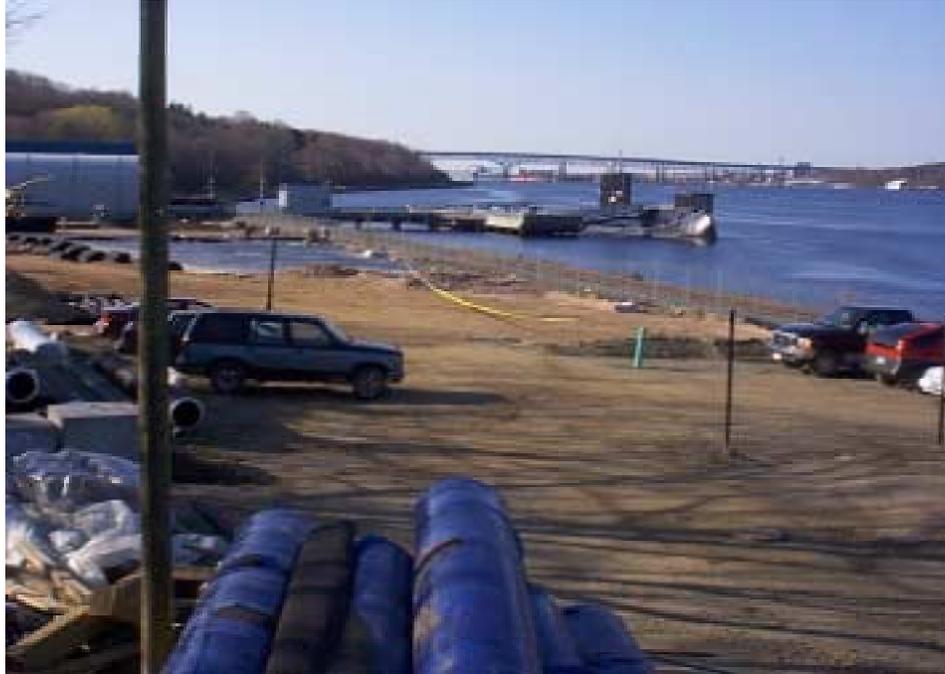
SITE 8 – GOSS COVE LANDFILL
CAP CONSTRUCTION
APRIL 19, 2001
NSB-NLON, GROTON, CONNECTICUT. CTO 0275

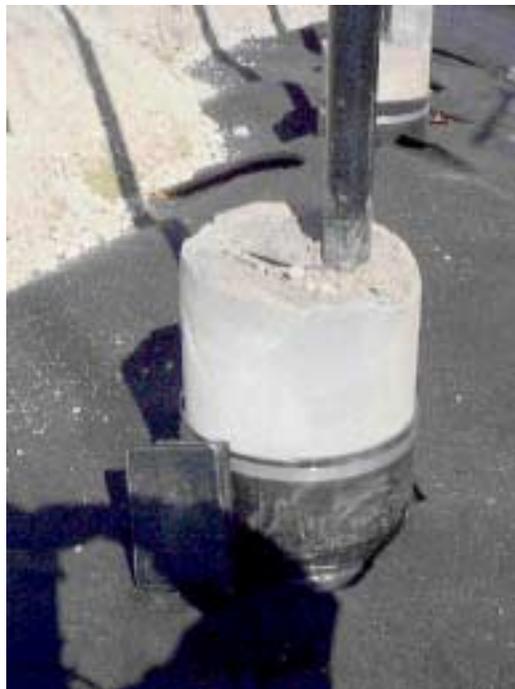
SITE 8 GOSS COVE LANDFILL
CAP CONSTRUCTION
APRIL 19, 2001
NSB-NLON, GROTON, CONNECTICUT. CTO 0275

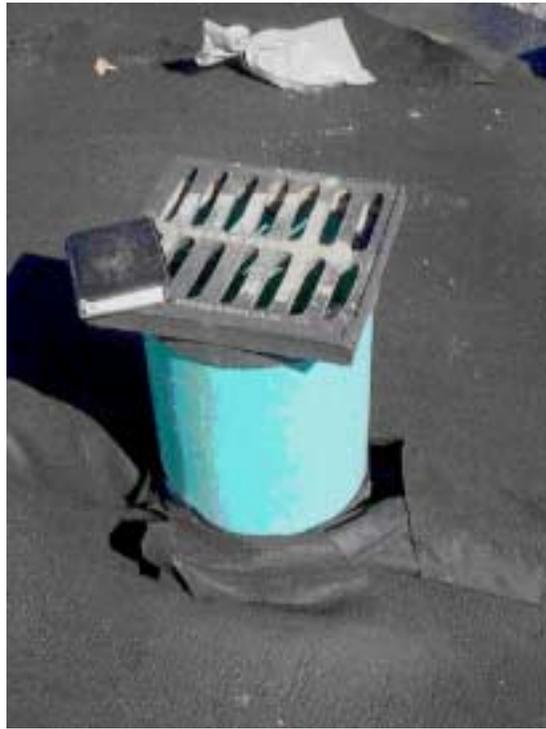
SITE 8 – GOSS COVE LANDFILL
CAP CONSTRUCTION
APRIL 19, 2001
NSB-NLON, GROTON, CONNECTICUT. CTO 0275

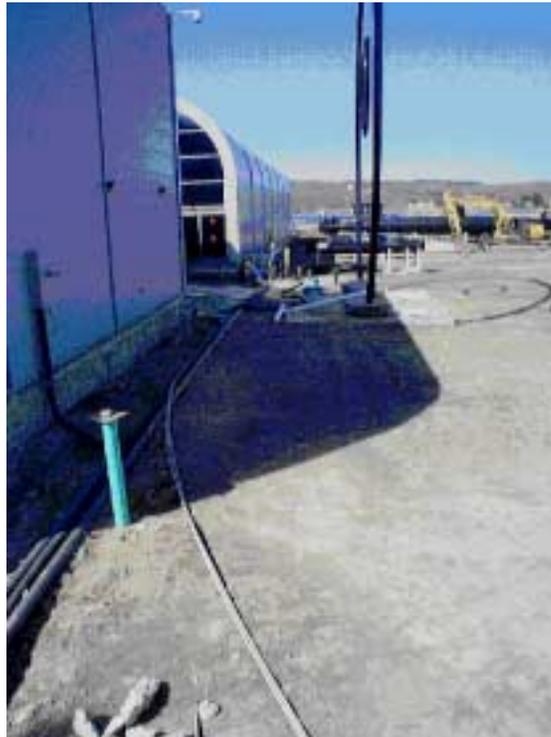
SITE 8 – GOSS COVE LANDFILL
CAP CONSTRUCTION
APRIL 19, 2001
NSB-NLON, GROTON, CONNECTICUT. CTO 0275

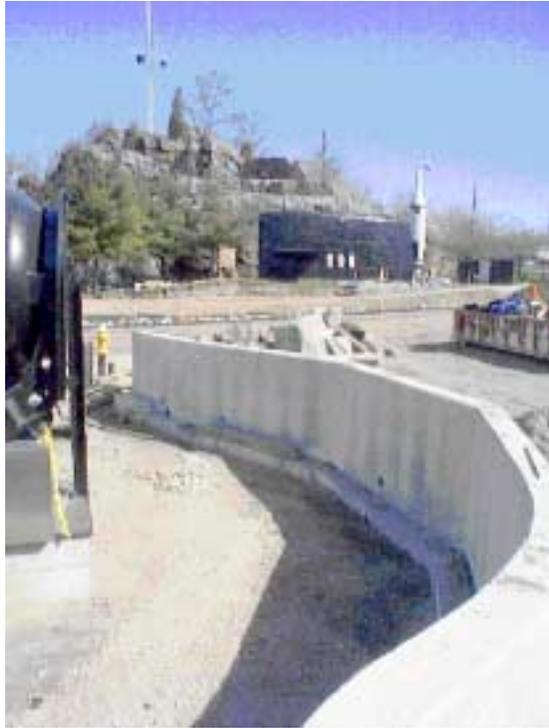
SITE 8 – GOSS COVE LANDFILL
CAP CONSTRUCTION
APRIL 19, 2001
NSB-NLON, GROTON, CONNECTICUT. CTO 0275

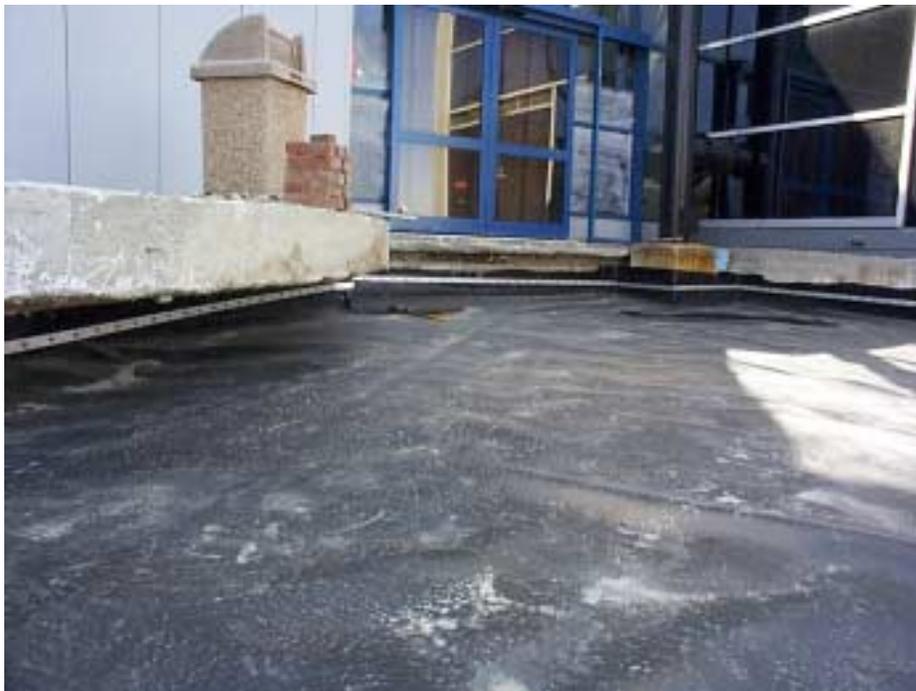
SITE 8 – GOSS COVE LANDFILL
CAP CONSTRUCTION
APRIL 19, 2001
NSB-NLON, GROTON, CONNECTICUT. CTO 0275

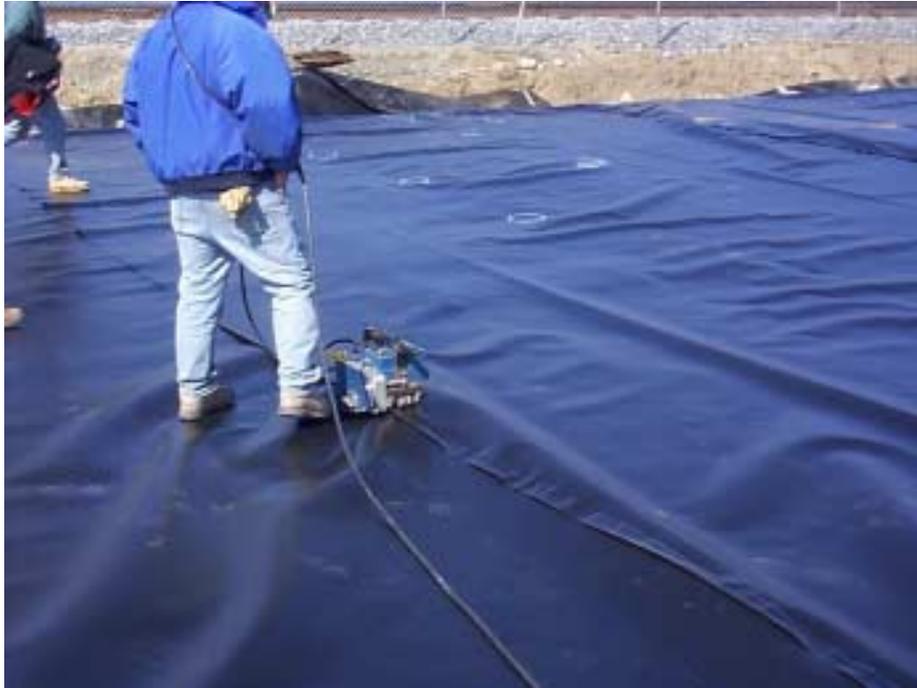
SITE 8 – GOSS COVE LANDFILL
CAP CONSTRUCTION
APRIL 19, 2001
NSB-NLON, GROTON, CONNECTICUT. CTO 0275

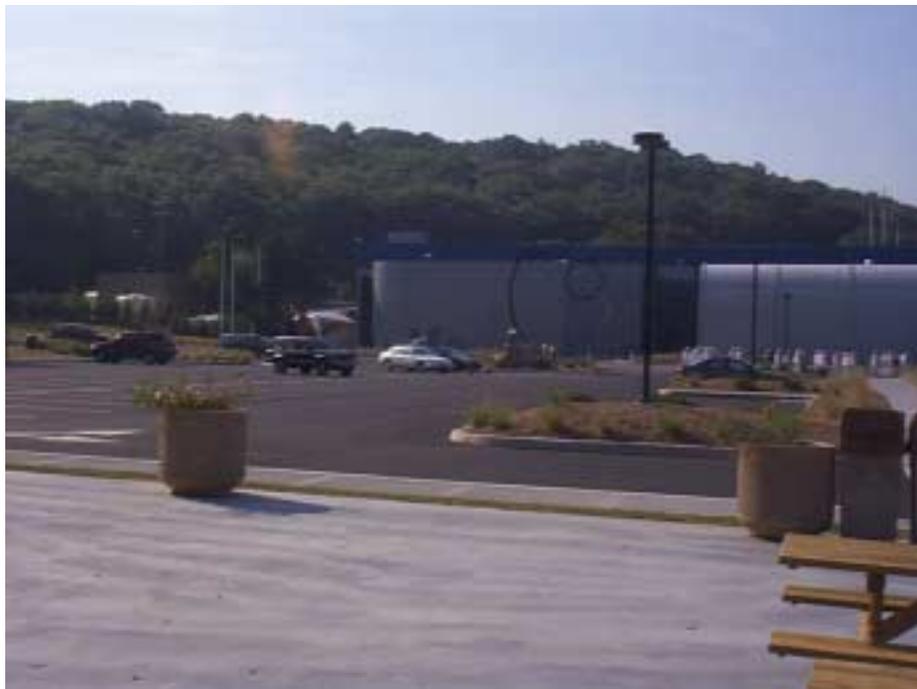
SITE 8 - GOSS COVE LANDFILL
FINAL CAP SURFACE LOOKING SOUTH
AUGUST 9, 2001
NSB - NLON, GROTON, CONECTICUT. CTO 0816
