APPENDIX A

SITE PHOTOGRAPHS

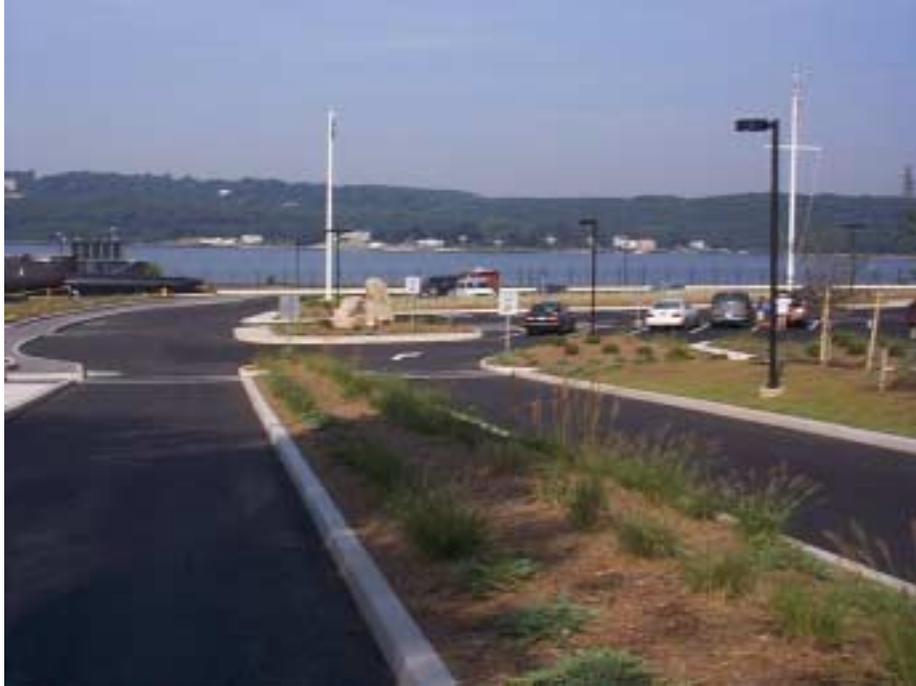
SITE 8 - GOSS COVE LANDFILL
SITE ENTRANCE AND FINAL CAP SURFACE LOOKING WEST
AUGUST 9, 2001
NSB-NLON, GROTON, CONNECTICUT. CTO 0816

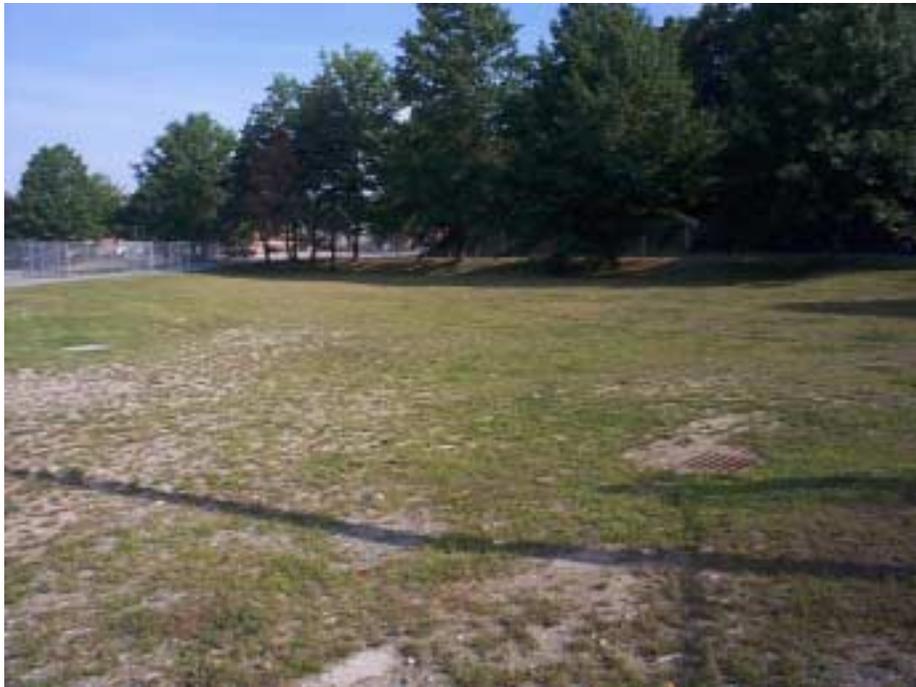
SITE 9 - FORMER WASTE OIL TANK OT-5
VIEW OF SITE LOOKING NORTHWEST
AUGUST 9, 2001
NSB-NLON, GROTON, CONNECTICUT. CTO 0816

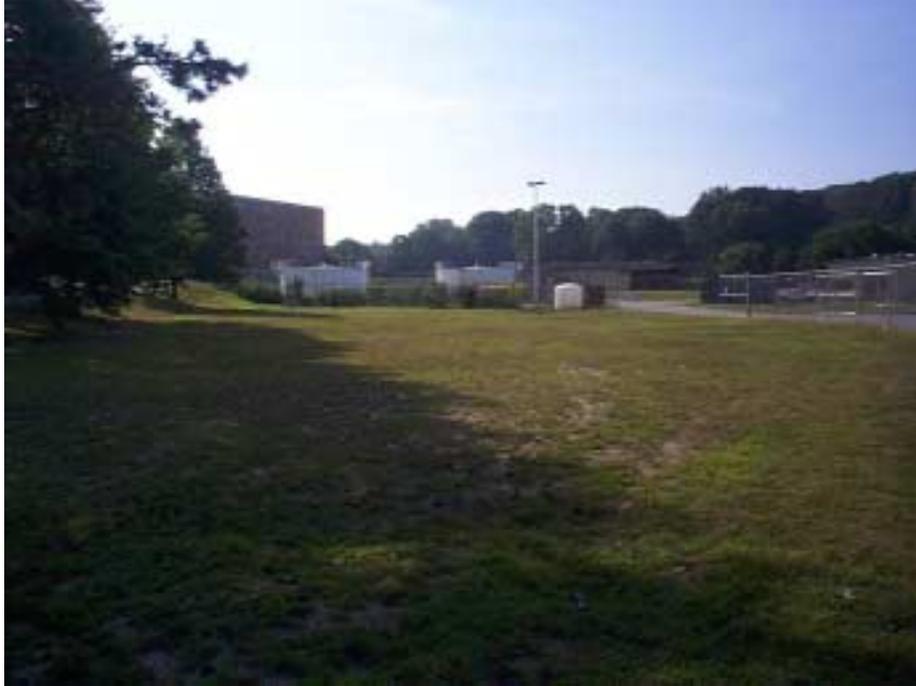
SITE 9 - FORMER WASTE OIL TANK OT-5
VIEW OF SITE LOOKING SOUTHEAST
AUGUST 9, 2001
NSB-NLON, GROTON, CONNECTICUT. CTOP 0816

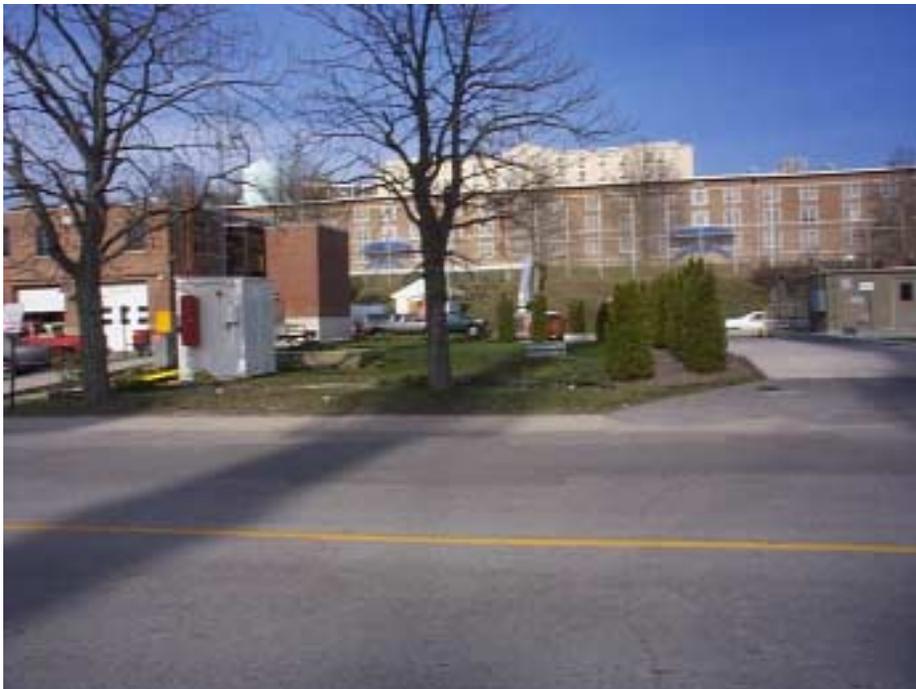
SITE 10 – FUEL STORAGE TANKS AND TANK 54-H
VIEW OF SITE LOOKING EAST.
APRIL 10, 2001
NSB-NLON, GROTON, CONNECTICUT. CTO 0816

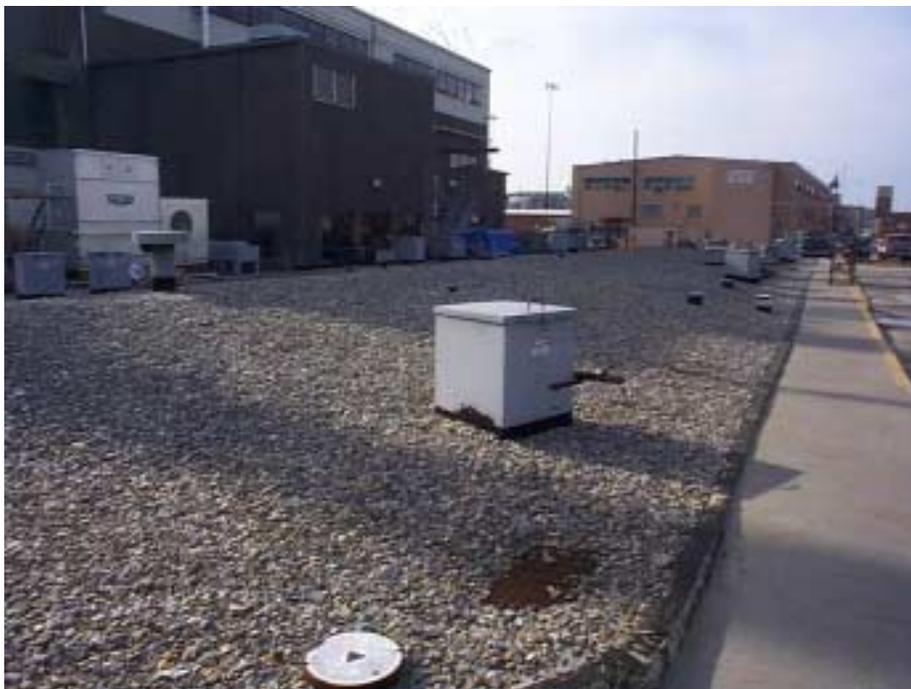
SITE 11 – POWER PLANT OIL TANKS
VIEW OF SITE LOOKING NORTH.
APRIL 10, 2001
NSB-NLON, GROTON, CONNECTICUT. CTO 0816

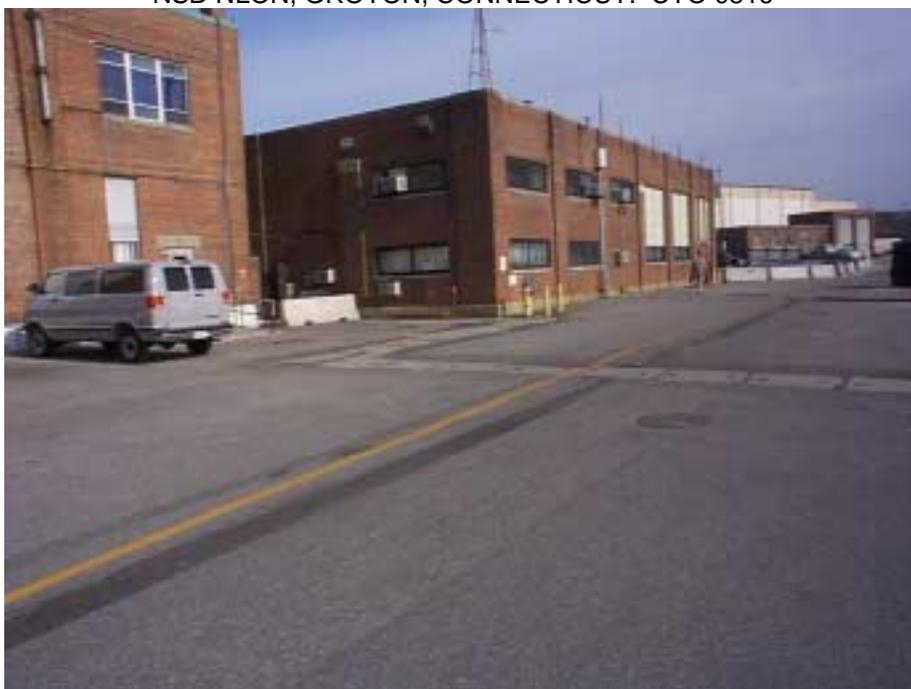
SITE 13 – BUILDING 79 WASTE OIL PIT
VIEW OF THE SITE LOOKING EAST.
APRIL 10, 2001
NSB-NLON, GROTON, CONNECTICUT. CTO 0816

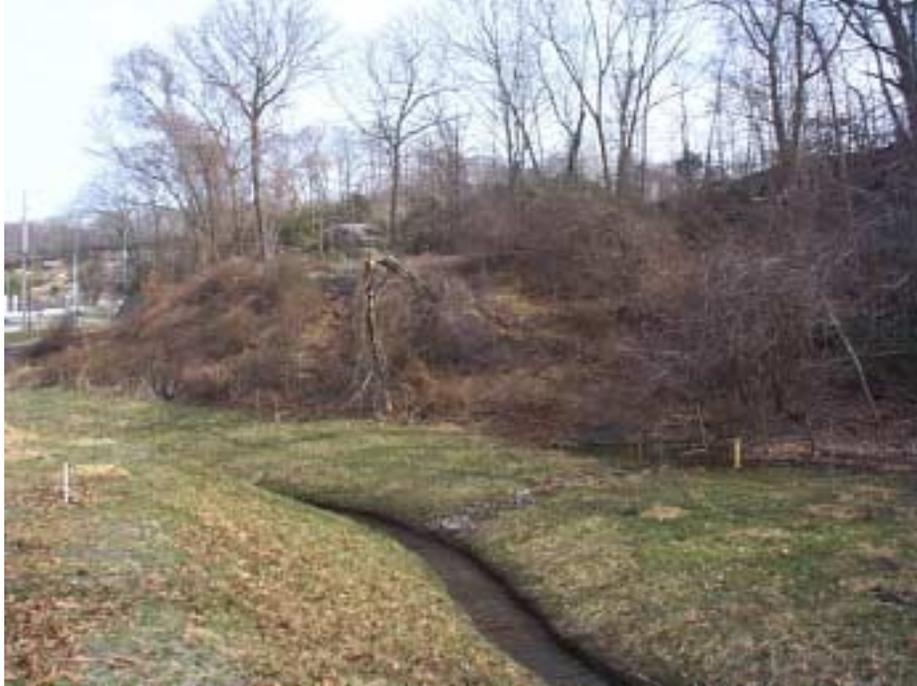
SITE 14 – OBDANE
VIEW OF THE SITE LOOKING NORTH.
APRIL 11, 2001
NSB-NLON, GROTON, CONNECTICUT. CTO 0816

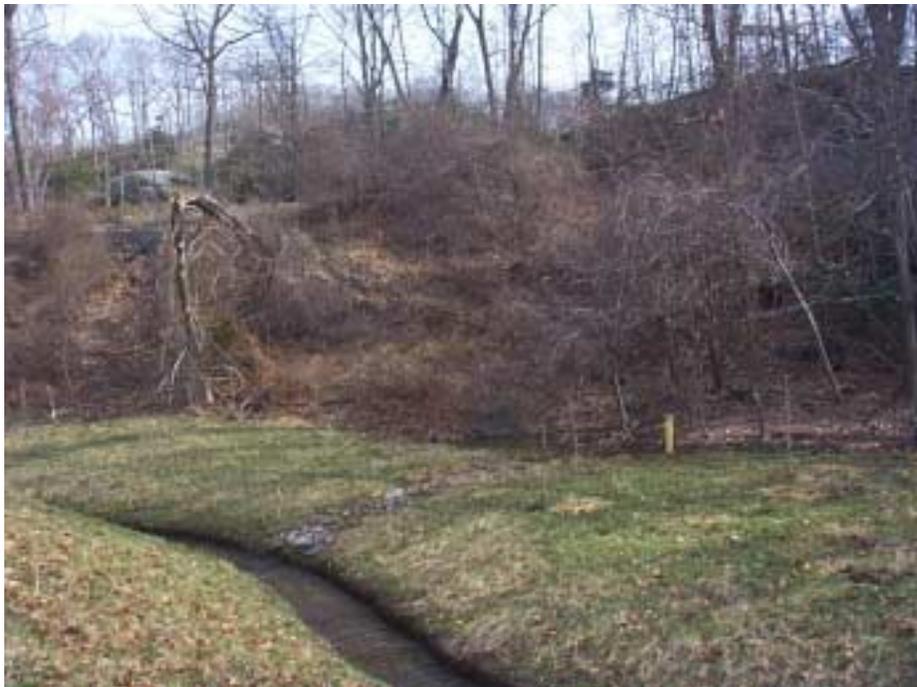
SITE 14 – OBDANE
CLOSE UP VIEW OF THE SITE LOOKING NORTH. YELLOW STICK-UP CASING FOR
MONITORING WELL 14MW1S EVIDENT IN PICTURE.
APRIL 11, 2001
NSB-NLON, GROTON, CONNECTICUT. CTO 0816

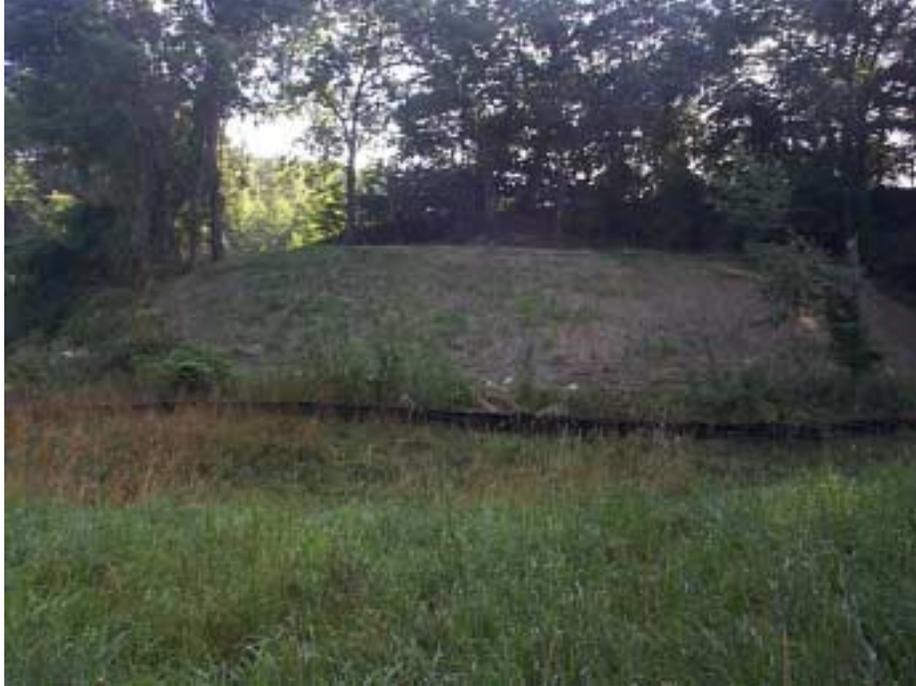
SITE 14 - OBDANE
VIEW OF THE SITE AFTER REMOVAL ACTION LOOKING NORTH
AUGUST 9, 2001
NSB-NLON, GROTON, CONNECTICUT. CTO 0816

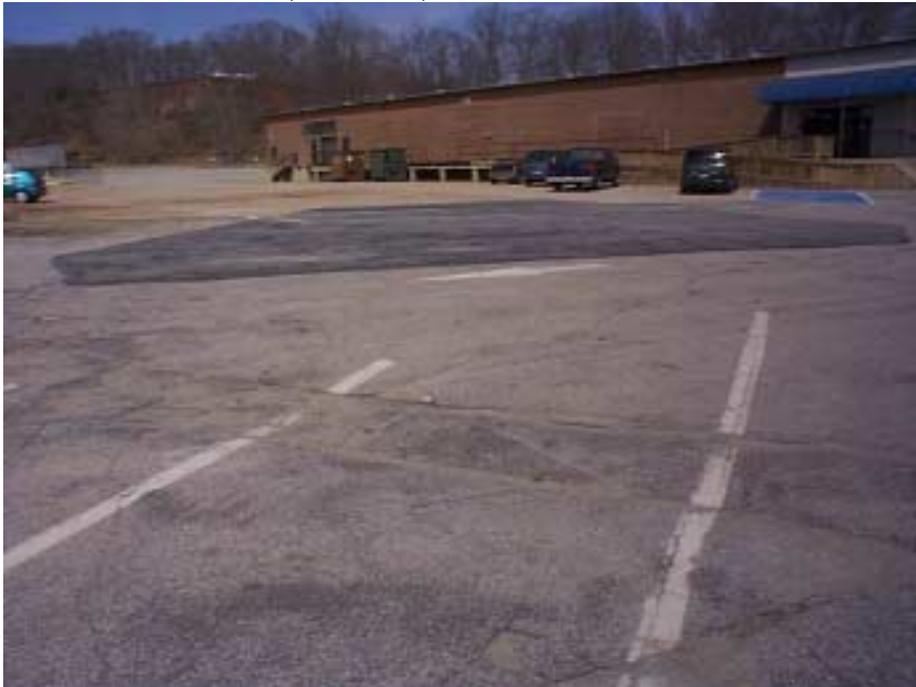
SITE 15 – SPENT ACID STORAGE AND DISPOSAL AREA
VIEW OF THE SITE LOOKING NORTHEAST.
APRIL 10, 2001
NSB-NLON, GROTON, CONNECTICUT. CTO 0816

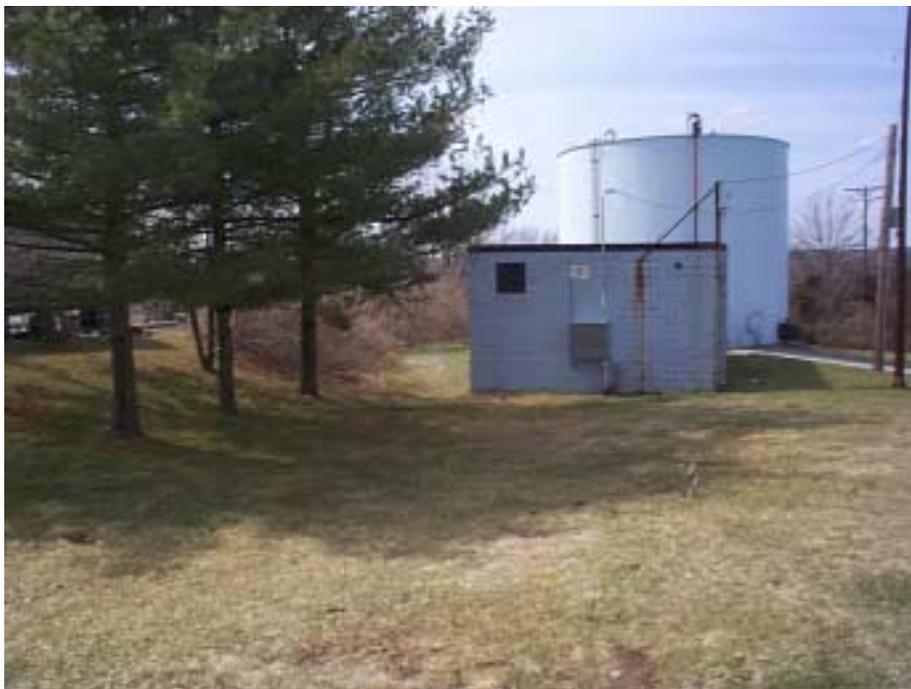
SITE 16A – HOSPITAL INCINERATOR
VIEW OF SITE LOOKING SOUTHWEST.
APRIL 10, 2001
NSB-NLON, GROTON, CONNECTICUT. CTO 0816

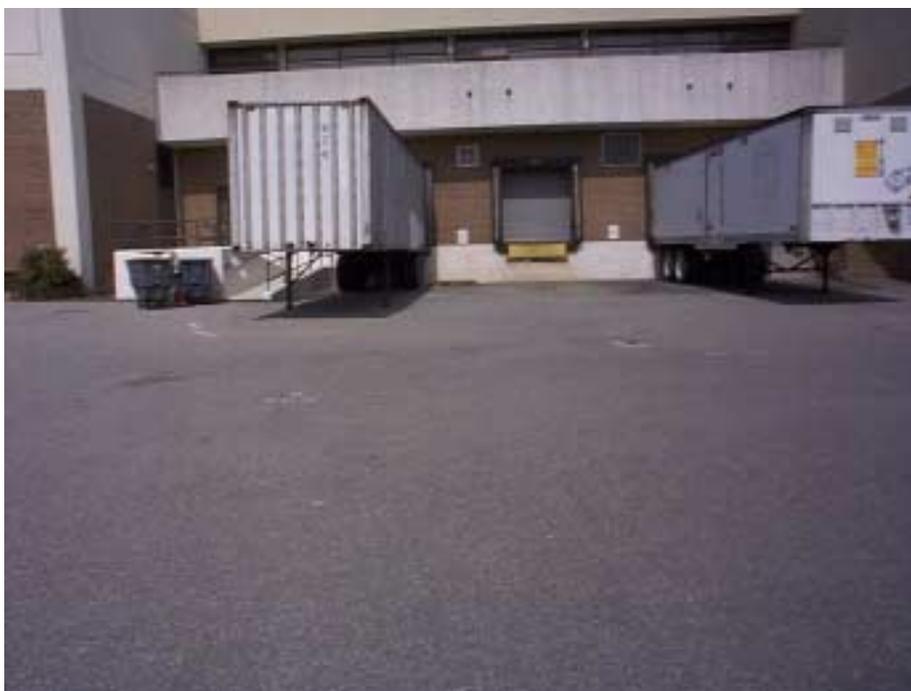
SITE 16B – HOSPITAL INCINERATOR
VIEW OF SITE LOOKING NORTHEAST.
APRIL 10, 2001
NSB-NLON, GROTON, CONNECTICUT. CTO 0816

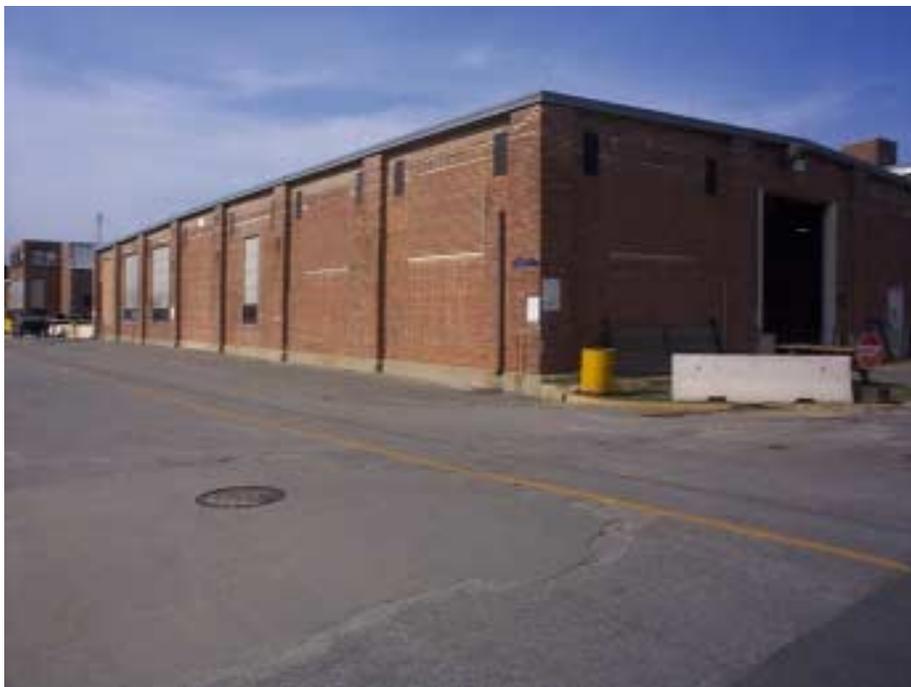
SITE 17 – HAZARDOUS MATERIALS/SOLVENT STORAGE AREA – BUILDING 31
VIEW OF SITE LOOKING NORTHEAST.
APRIL 10, 2001
NSB-NLON, GROTON, CONNECTICUT. CTO 0816

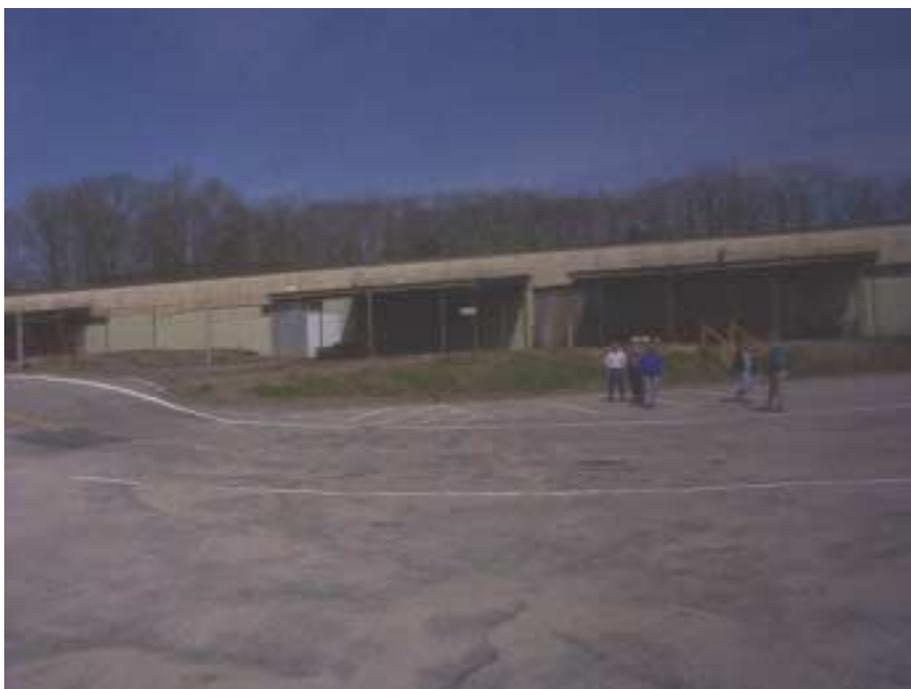
SITE 18 – SOLVENT STORAGE AREA – BUILDING 33
VIEW OF SITE LOOKING EAST.
APRIL 10, 2001
NSB-NLON, GROTON, CONNECTICUT. CTO 0816

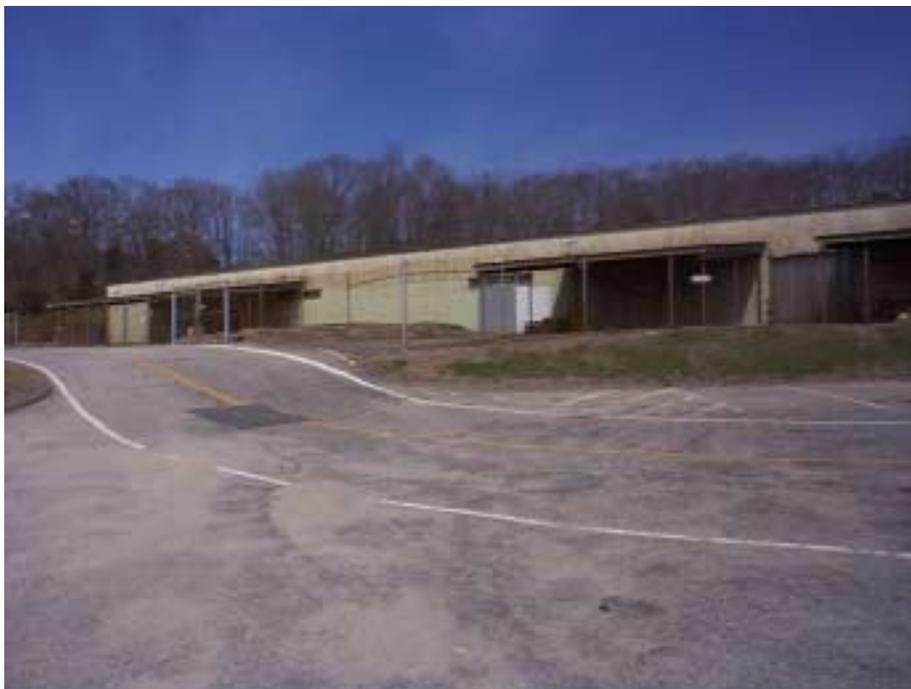
SITE 18 – SOLVENT STORAGE AREA – BUILDING 33
VIEW OF SITE LOOKING NORTH.
APRIL 10, 2001
NSB-NLON, GROTON, CONNECTICUT. CTO 0816

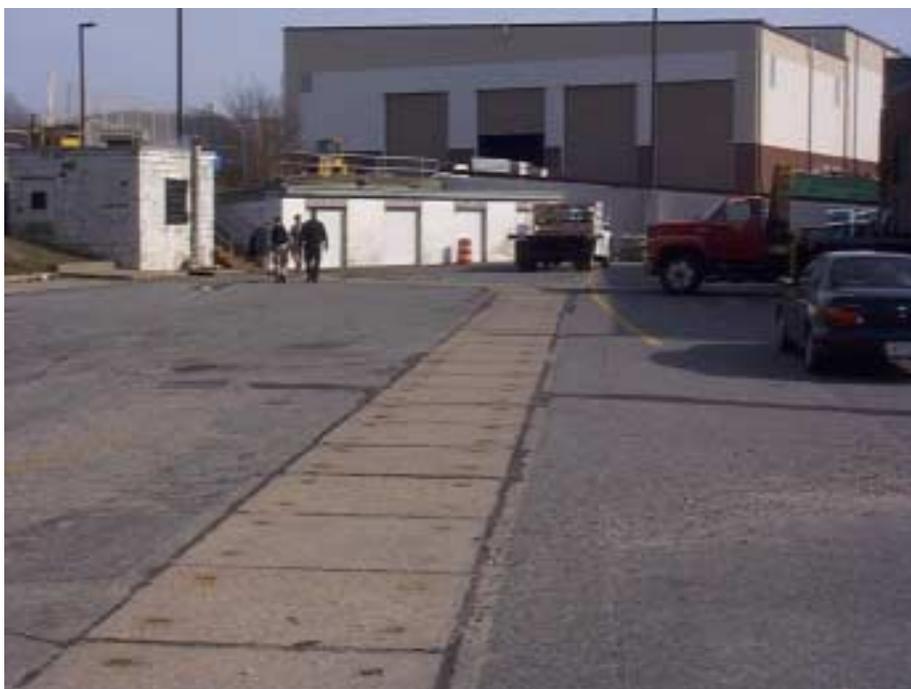
SITE 19 – SOLVENT STORAGE AREA – BUILDING 316
VIEW OF SITE LOOKING SOUTH.
APRIL 10, 2001
NSB-NLON, GROTON, CONNECTICUT. CTO 0816

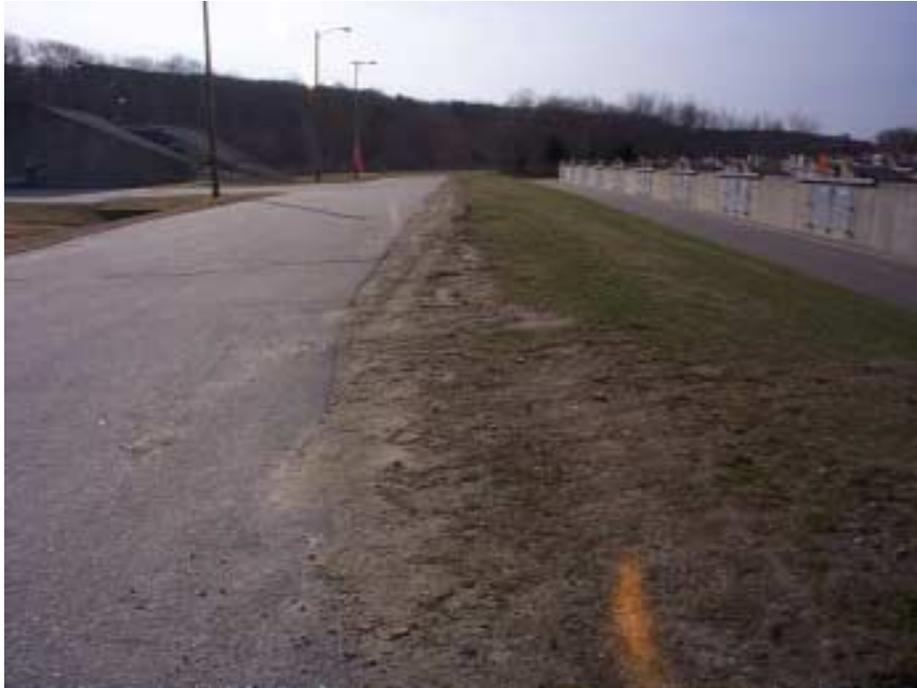
SITE 20 – AREA A WEAPONS CENTER
VIEW OF SITE LOOKING NORTHEAST. AREA TO BE REMEDIATED.
APRIL 11, 2001
NSB-NLON, GROTON, CONNECTICUT. CTO 0816

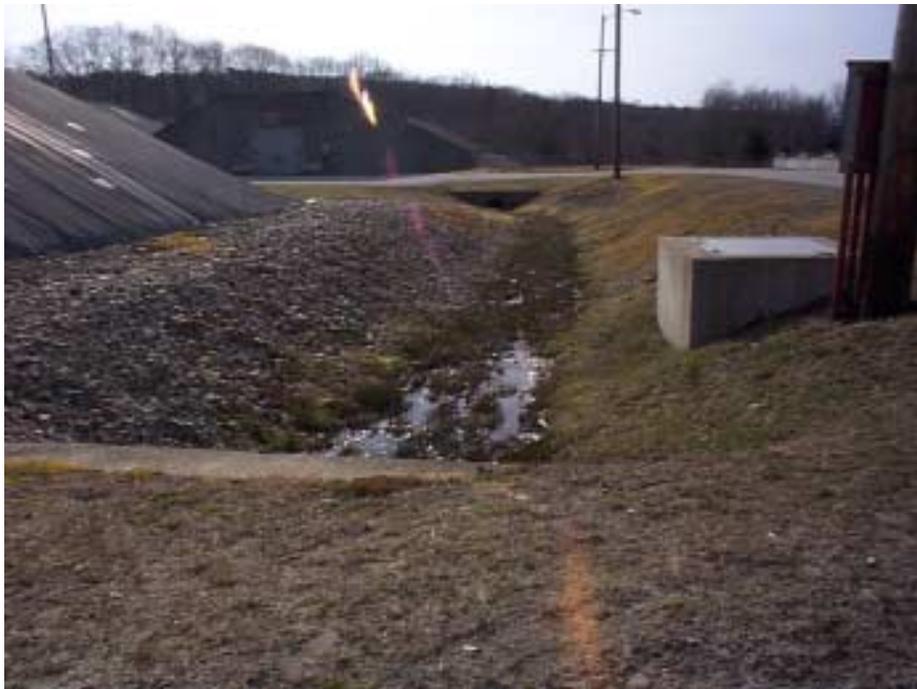
SITE 20 – AREA A WEAPONS CENTER.
VIEW OF SOUTHERN DRAINAGE DITCH LOOKING NORTHEAST. AREA TO BE
REMEDIED.
APRIL 11, 2001
NSB-NLON, GROTON, CONNECTICUT. CTO 0816

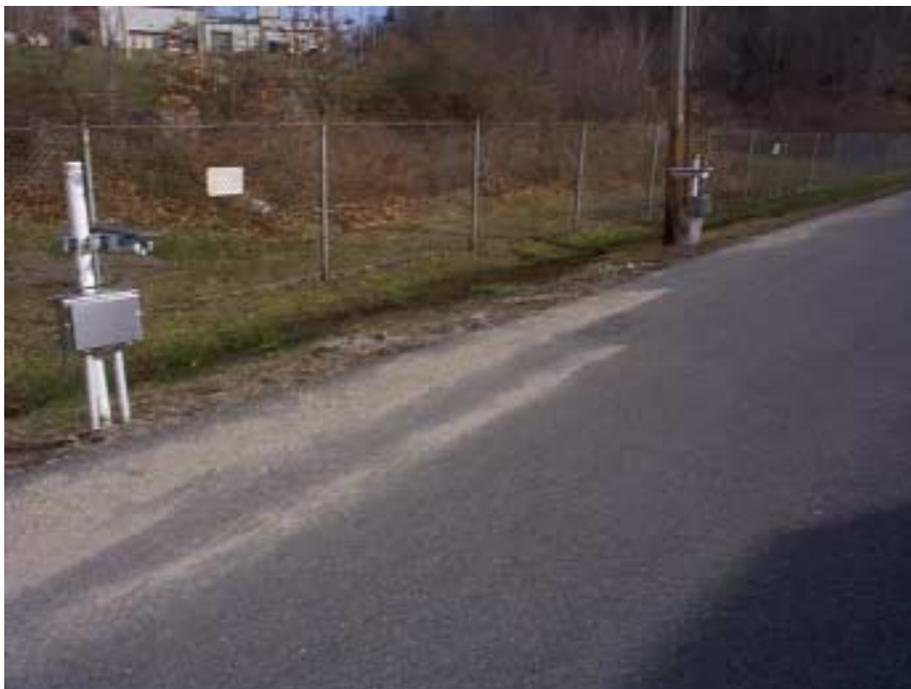
SITE 20 – AREA A WEAPONS CENTER
VIEW OF WESTERN DRAINAGE DITCH LOOKING NORTHEAST.
AREA TO BE REMEDIATED.
APRIL 11, 2001
NSB-NLON, GROTON, CONNECTICUT. CTO 0816

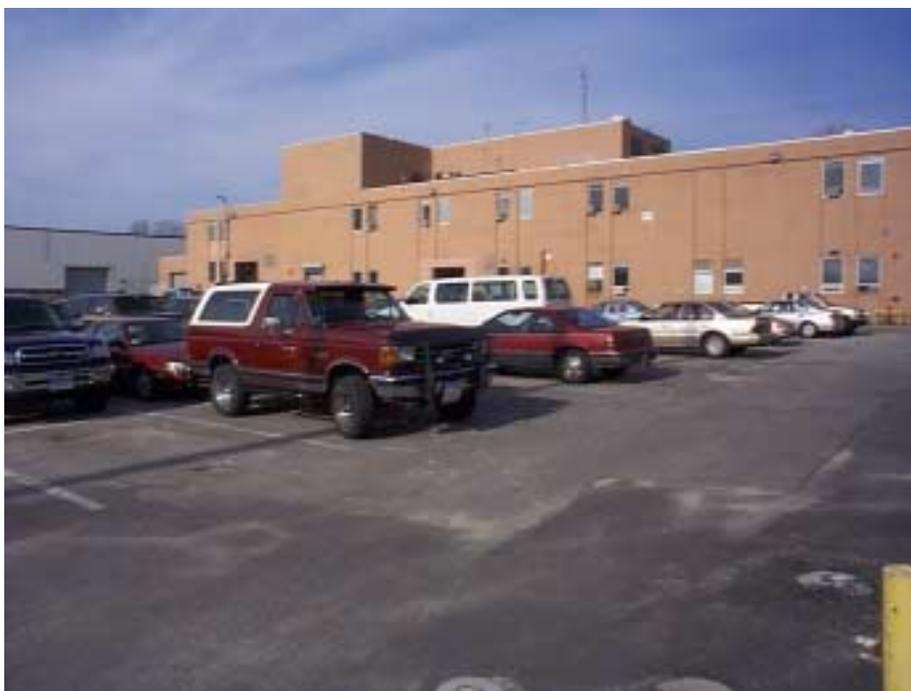
SITE 21 – BERTH 16
VIEW OF SITE LOOKING EAST.
APRIL 10, 2001
NSB-NLON, GROTON, CONNECTICUT. CTO 0816

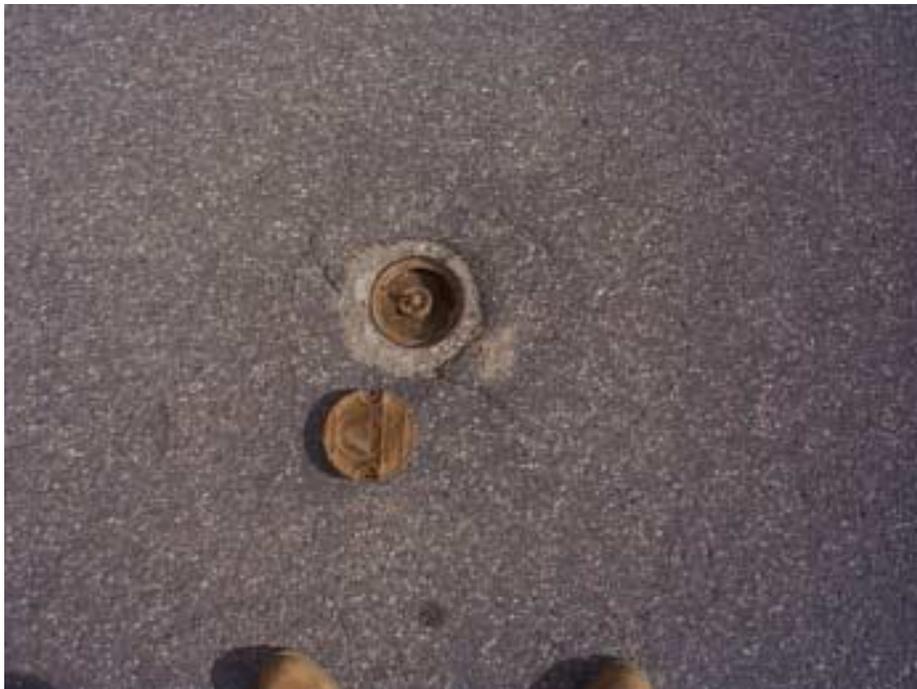
SITE 21 – BERTH 16
CLOSE UP VIEW OF MONITORING WELL 20MW6.
APRIL 10, 2001
NSB-NLON, GROTON, CONNECTICUT. CTO 0816

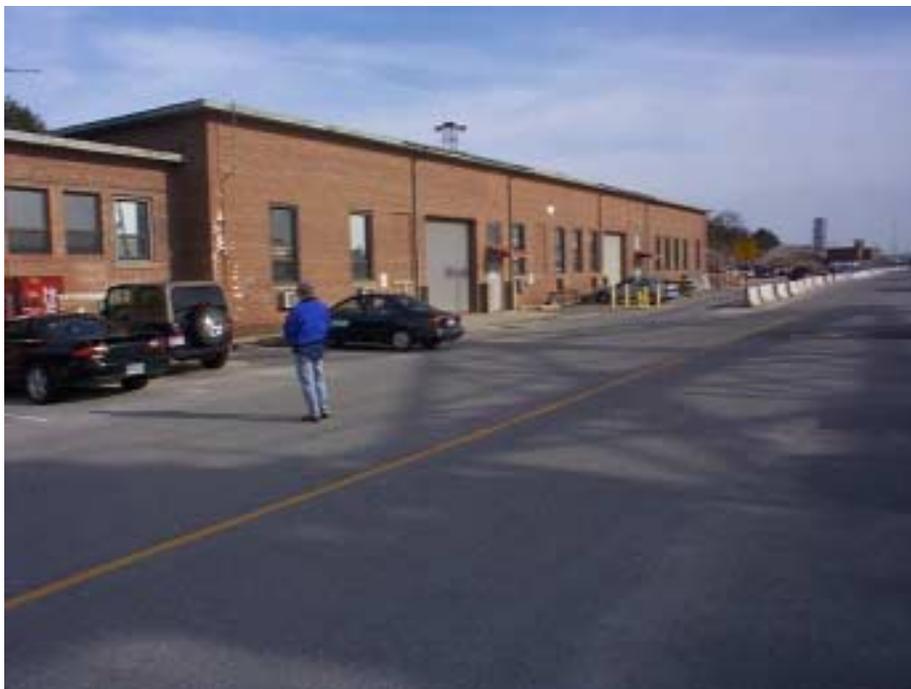
SITE 22 – PIER 33
VIEW OF SITE LOOKING SOUTHEAST.
APRIL 10, 2001
NSB-NLON, GROTON, CONNECTICUT. CTO 0816

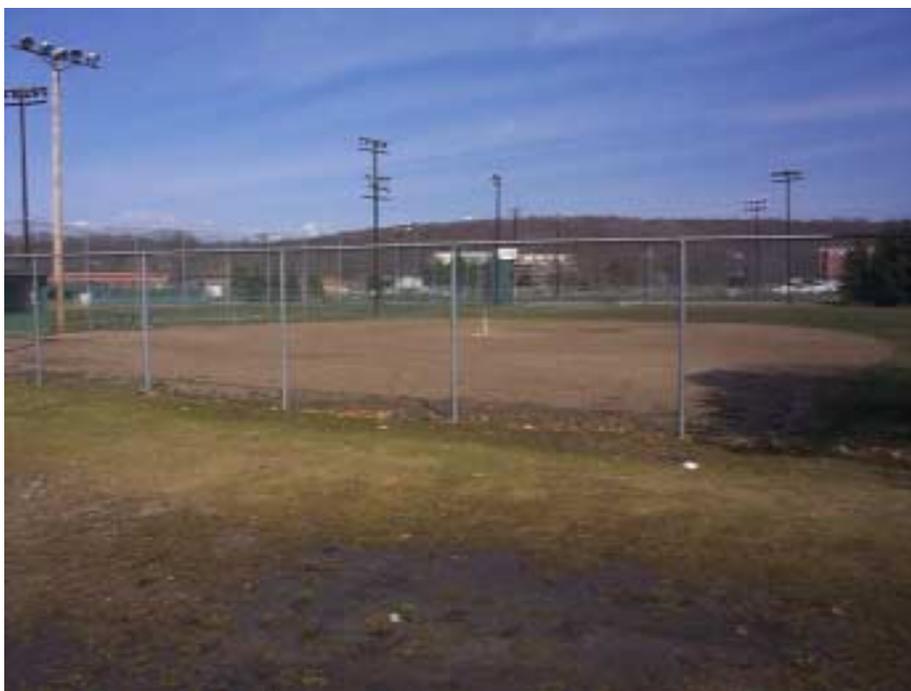
SITE 23 – TANK FARM
VIEW OF SITE LOOKING EAST.
APRIL 10, 2001
NSB-NLON, GROTON, CONNECTICUT. CTO 0816

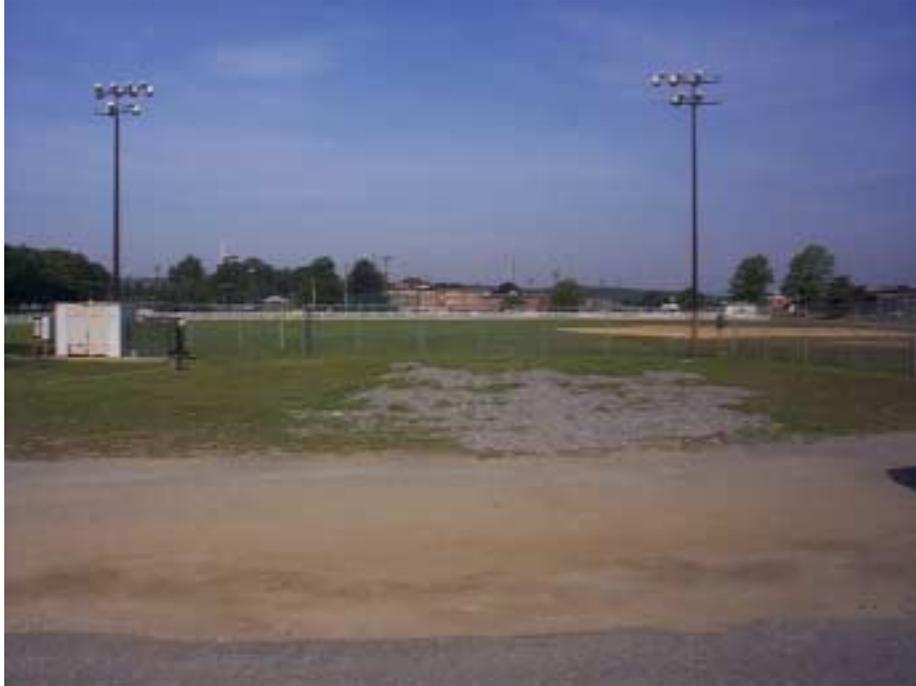
SITE 23 - TANK FARM
VIEW OF SITE LOOKING WEST
AUGUST 9, 2001
NSB-NLON, GROTON, CONNECTICUT. CTO 0816

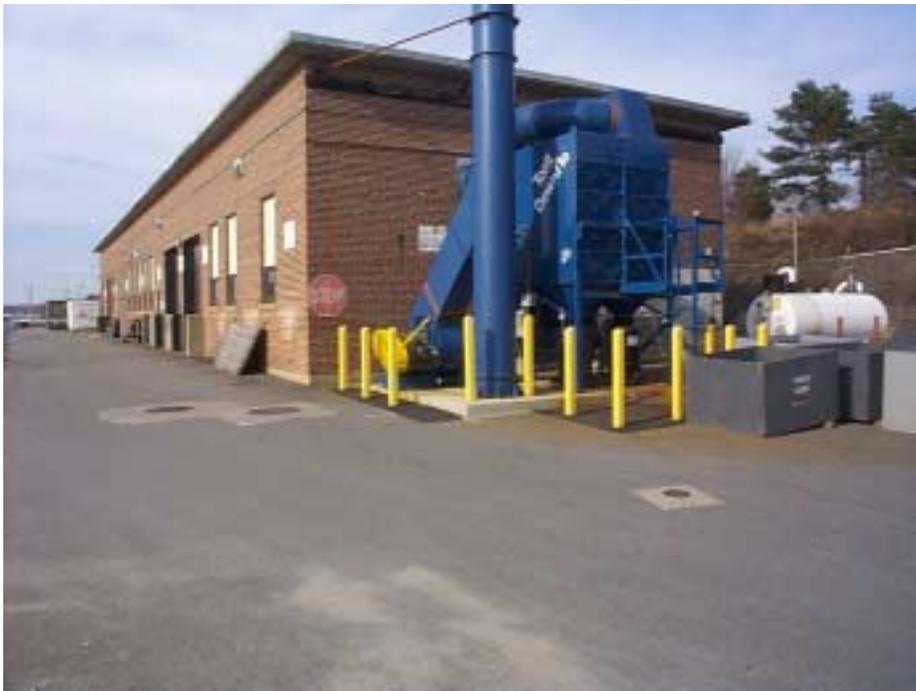
SITE 24 – CENTRAL POINT ACCUMULATION AREA – BUILDING 174
VIEW OF SITE LOOKING NORTHEAST.
APRIL 10, 2001
NSB-NLON, GROTON, CONNECTICUT. CTO 0816

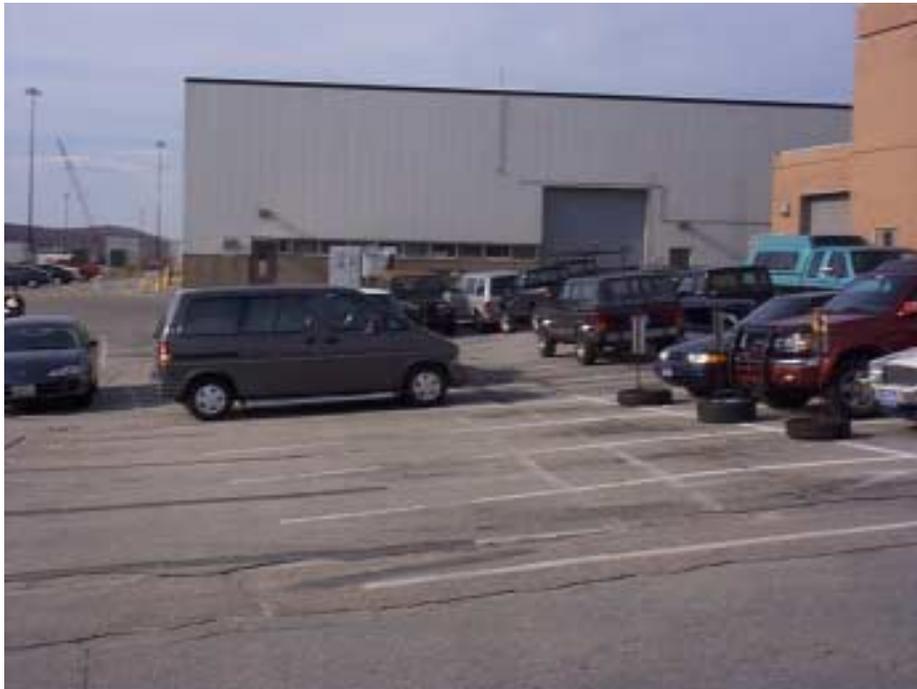
SITE 25 – CLASSIFIED MATERIAL INCINERATOR.
VIEW OF SITE LOOKING NORTH.
APRIL 10, 2001
NSB-NLON, GROTON, CONNECTICUT. CTO 0816
