Re Third Five-Year Review for the Naval Submarine Base New London Superfund Site

Thank you for the opportunity to review the *Third Five-Year Review for CERCLA Sites at Naval Submarine Base New London, Groton, CT*, dated December 2011. EPA reviewed this document in light of its compliance with the *Comprehensive Five-Year Review Guidance* (OSWER No 9355 7-03B-P dated June 2001). This statutory review is consistent with the guidance provided in the OSWER directives. Upon review, EPA concurs with the findings that the remedies that have been implemented at the Area A Landfill, the Goss Cove Landfill, the Defense Reutilization and Marketing Office, the Area A Downstream/Over Bank Disposal Area, the Area A Weapons Center, the Torpedo Shops, and Basewide Groundwater are protective of human health and the environment.

During EPA's site walkover on April 6, 2011, numerous issues were identified with respect to the on-going maintenance of several remedies currently in place. These issues are summarized appropriately in Table 18-2 of the *Third Five-Year Review* report along with corresponding recommendations to address them. EPA is pleased that the Navy has already put in place plans to

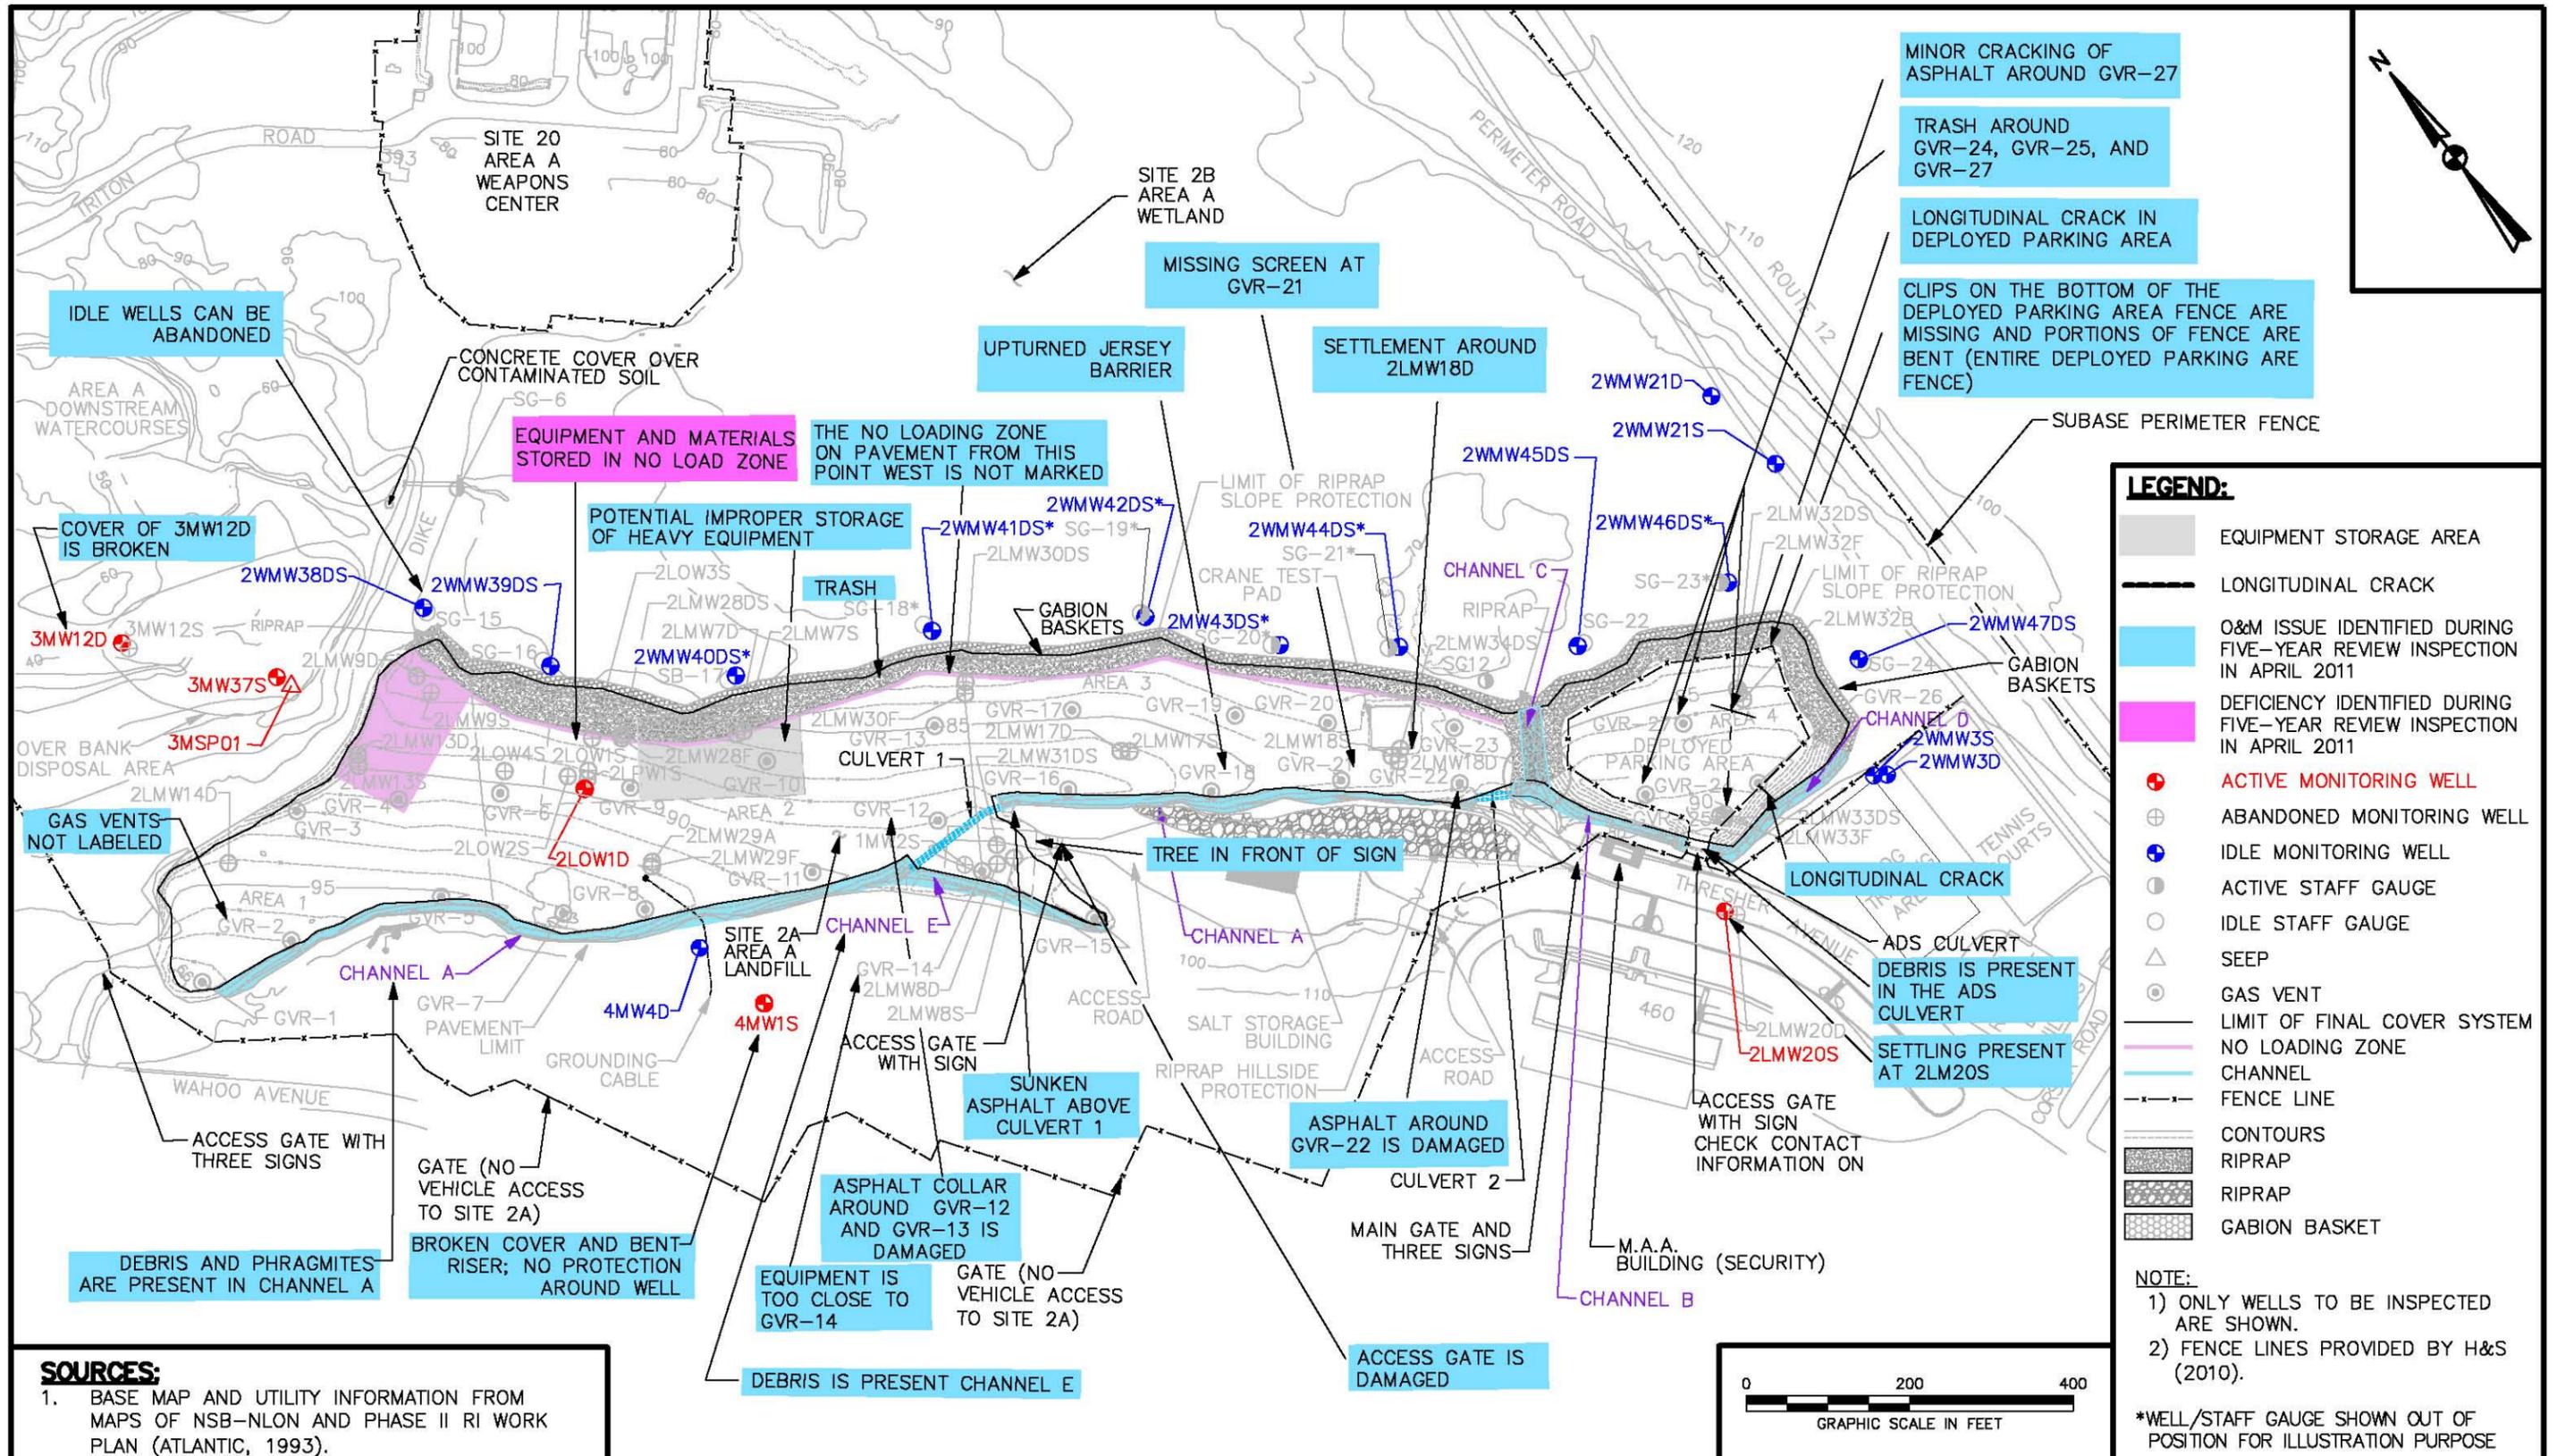
Issue	Effects Protectiveness?	
	Current	Future Potential
<b>SITE 2A – AREA A LANDFILL</b>		
<b>Deficiencies</b>		
Equipment and materials continue to be improperly stored within the no-load zone.	N	Y
<b>O&amp;M Issues</b>		
Heavy equipment that may exceed the weight limit is being stored on the cap.	N	Y
Longitudinal cracks are present in the asphalt.	N	Y
Gate near the Salt Storage Building is damaged and cannot be locked.	N	N
Sign at gate near the Salt Storage Building does not include contact information and is partially obscured by vegetation.	N	N
The deployed parking area fence posts are bent and bottom clips are missing.	N	N
Debris and vegetation ( <i>Phragmites</i> ) clog portions of Channels A, B (the ADS culvert area), and E.	N	Y
The no load zone between GVR-13 and SG-15 is not marked.	N	Y
A minor depression in the asphalt has formed above Culvert 1.	N	Y
The cover of monitoring well 4MW1S is broken and the riser is bent.	N	Y

Minor settling of concrete has occurred around well 2LMW20S.	N	N
The cover on Site 3 monitoring well 3MW12D is broken.	N	N
Debris (e.g., canvas bags and trash) has been placed on the northern edge of the site.	N	N
Maintenance needs were identified around gas vents.	N	Y
<b>SITE 2B – AREA A WETLAND</b>		
<b>O&amp;M Issues</b>		
Some <i>Phragmites</i> remain around open water areas.	N	N

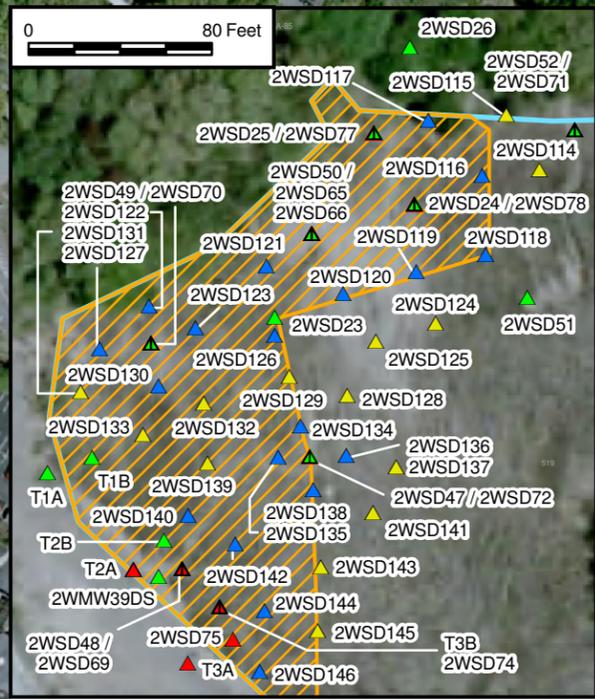
CONTRACT NUMBER	CTO NUMBER
3386	WE33
APPROVED BY	DATE
CAR	05/24/11
APPROVED BY	DATE
FIGURE NO.	REV
FIGURE 2-2	0

The site inspection included visual observations of the current condition of the Site 2B wetland. During the site inspection, the team found that the land use for the site has not changed from the decision document. In general, the removal of *Phragmites* from the wetland was successful and the wetland is in good condition; however, one O&M issue was identified during the site inspection that needs to be addressed to improve the quality of the wetland. This issue, noted in the site inspection checklist provided in Appendix C and on Figure 2-2, is that some *Phragmites* remain around open water areas. The USEPA recommended that the remaining *Phragmites* should be cut or treated to enhance wetland habitat. As noted above, under the CTDEP Wetlands Habitat and Mosquito Management Program, additional herbicide treatment of the *Phragmites* was completed in October 2011. Further invasive species control will be conducted under the Navy's Natural and Cultural Resources Program.

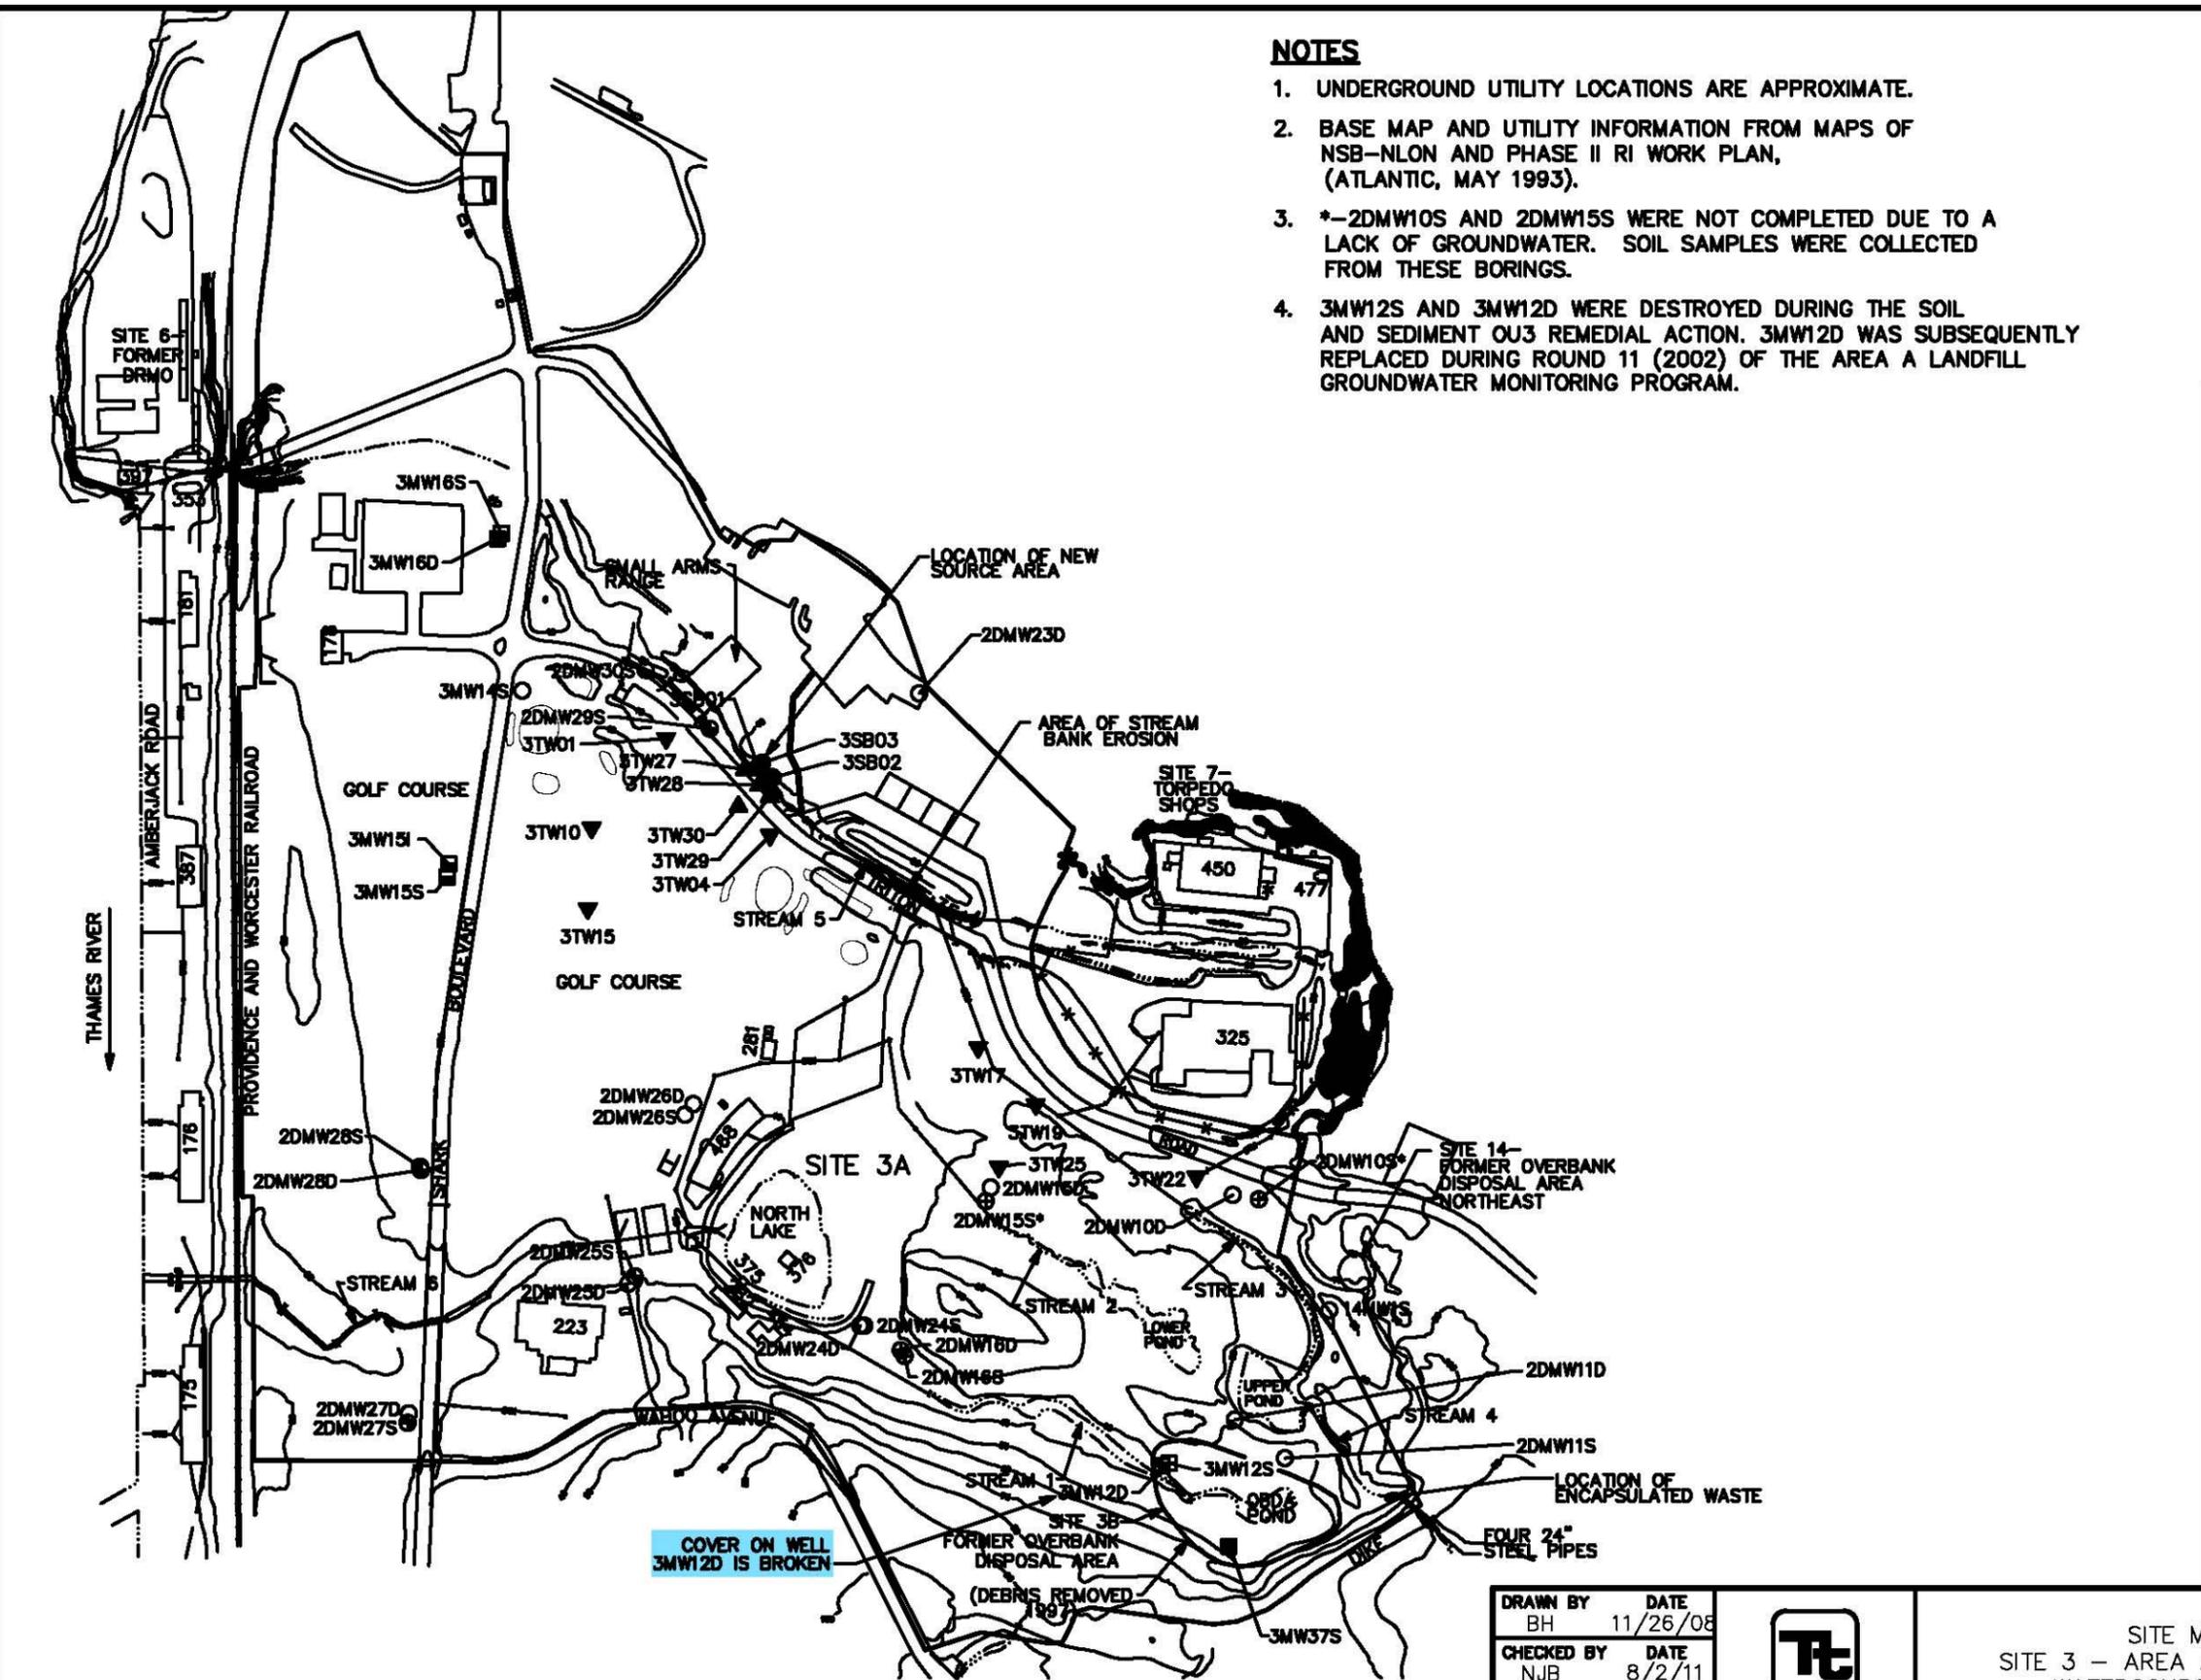
CONTRACT NO. WE.33	
OWNER NO. 3386	
APPROVED BY CAR	DATE 8/2/11
DRAWING NO. FIGURE 3-1	REV. 1

During the site inspection, the team found that the land use for the site had not changed since the remedial action and second five-year review were completed. The area remains a natural, undeveloped area with streams, ponds, and wetlands. A future off-site land use change was noted during the inspection (i.e., the Shooting Range will be moved to a new location near Site 2A). The site inspection found that the concrete cap was in good condition and working as intended. The wetland restoration was successful and the planted vegetation and ponds are in good condition. It was noted that the cover on a well in Site 3 that is part of the Site 2A monitoring program (3MW12D) is broken, which could negatively affect the Site 2A long-term groundwater monitoring program and needs to be repaired. This O&M issue is included in Table 3-11 and the site inspection checklist provided in Appendix C, and on Figure 3-1.

<b>O&amp;M Issues</b>	<b>Effects Protectiveness?</b>	
	<b>Current</b>	<b>Future Potential</b>
The cover on well 3MW12D is broken.	N	N

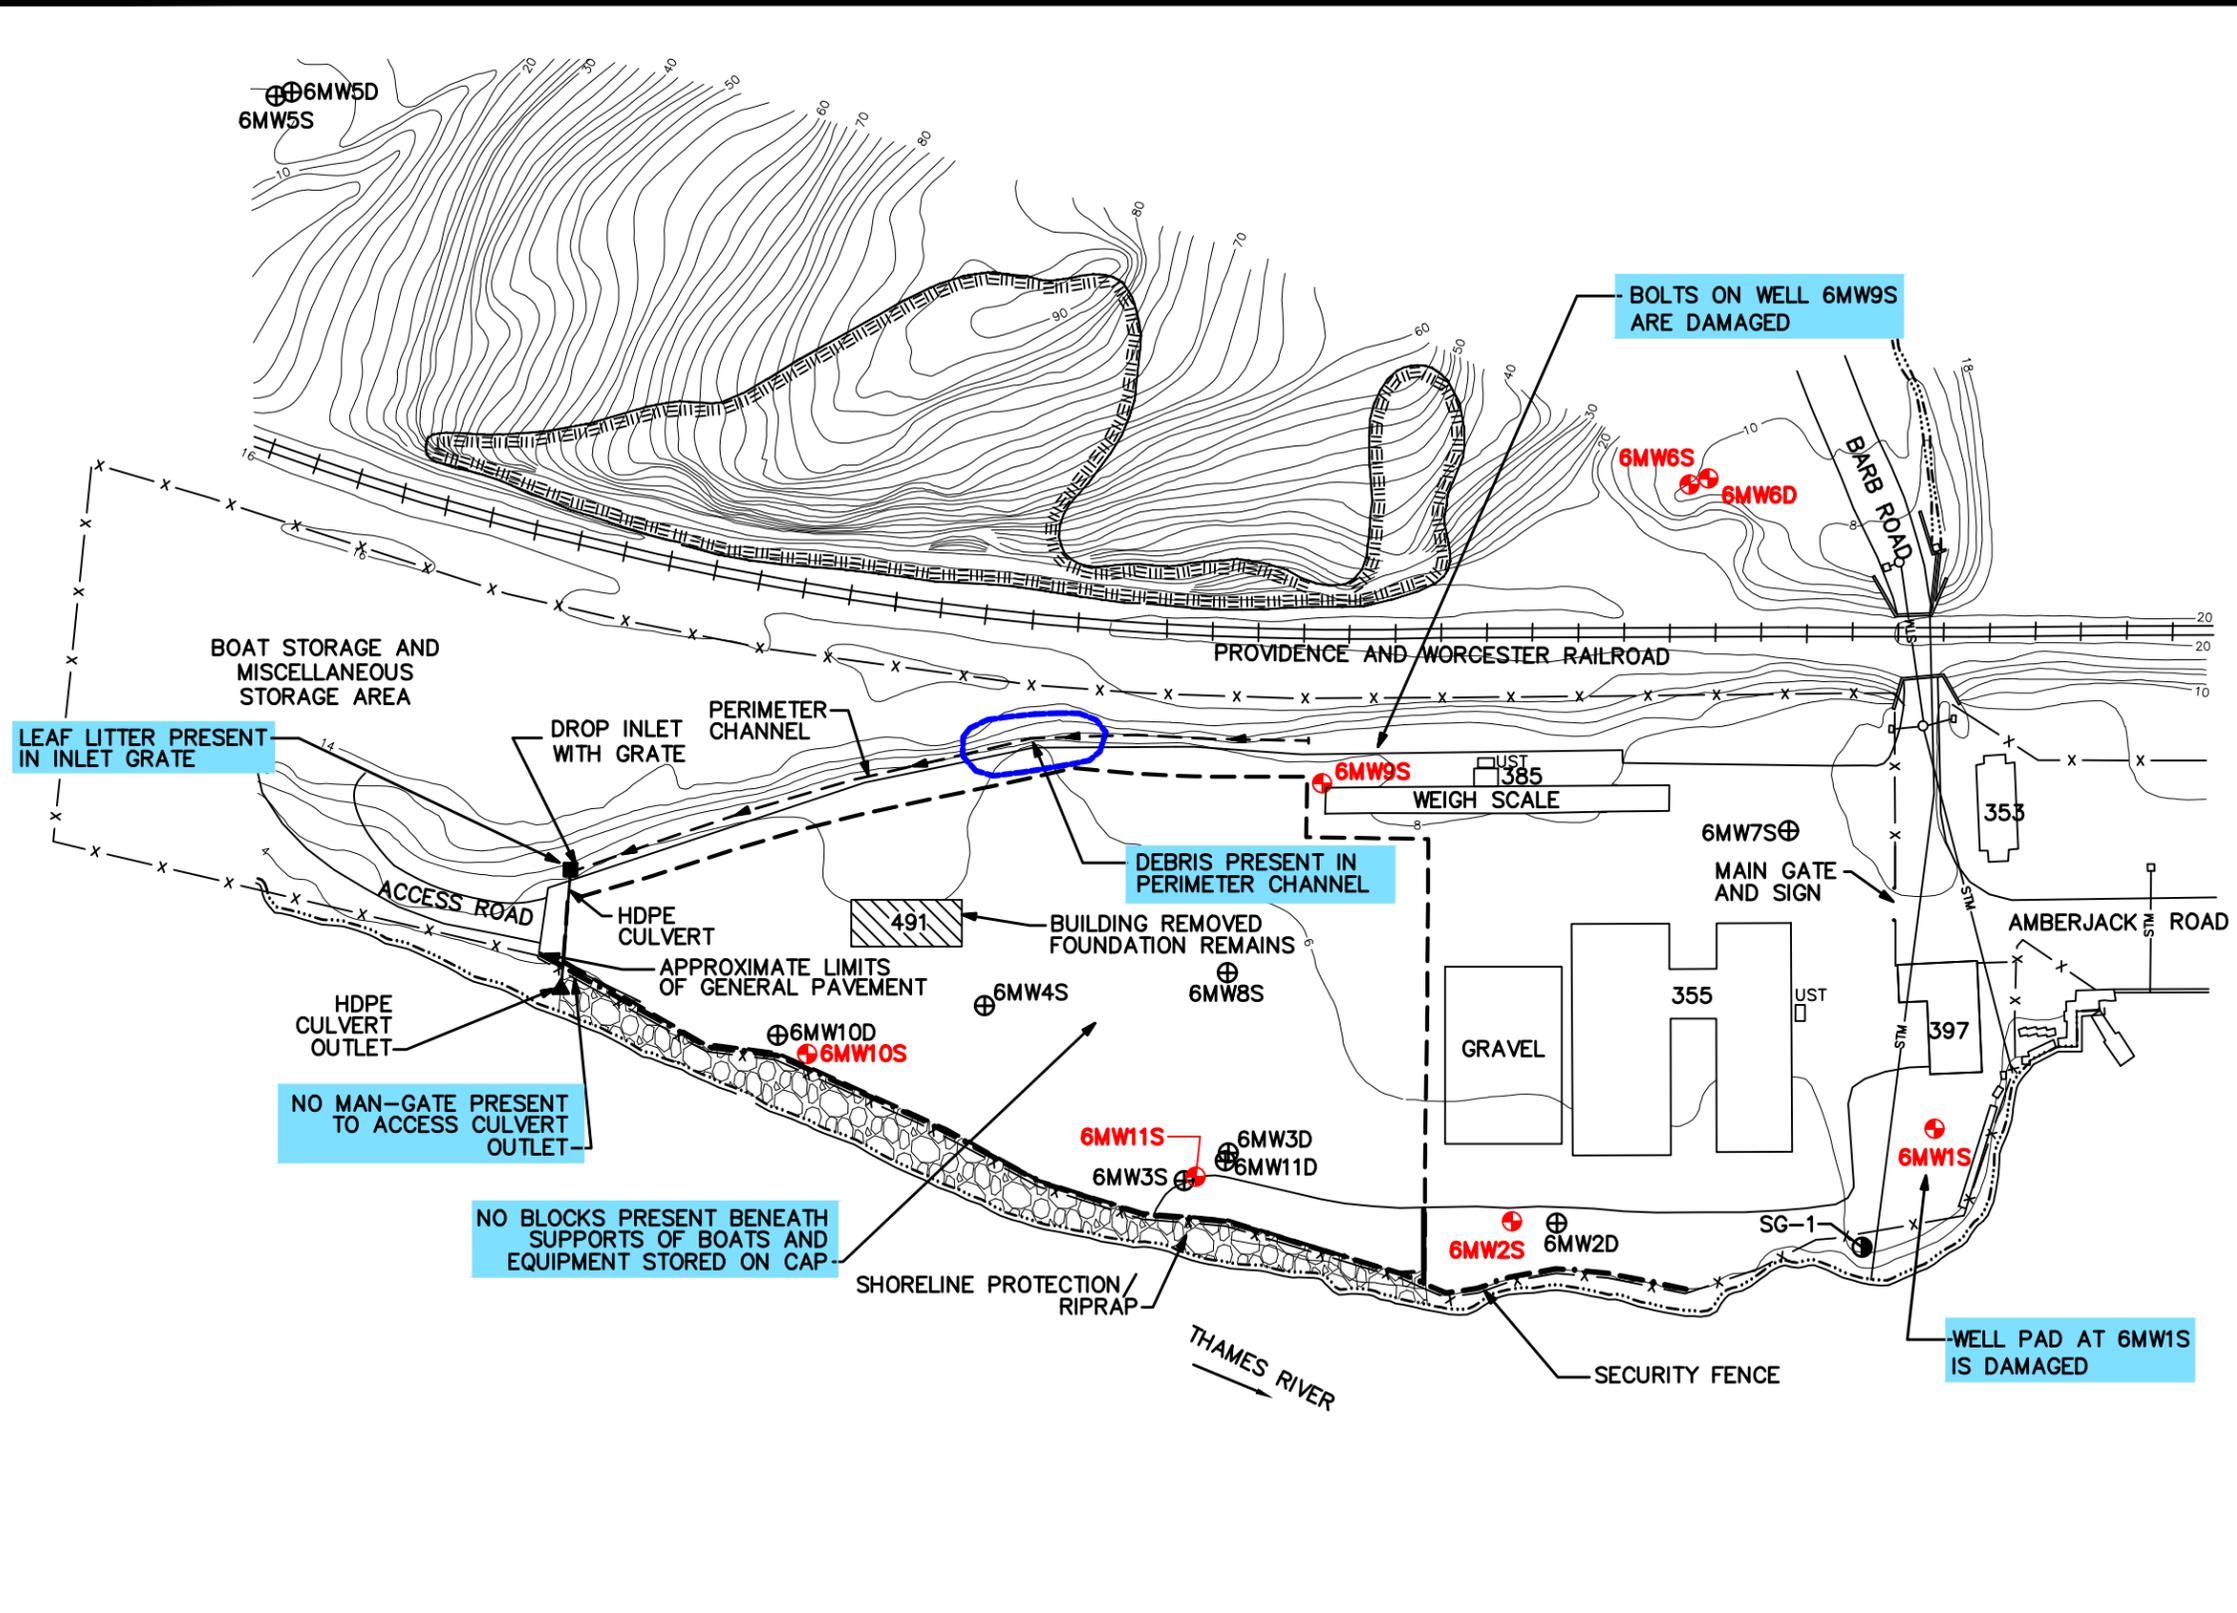
CONTRACT NO. WE33	
OWNER NO. 3386	
APPROVED BY CAR	DATE 5/16/11
DRAWING NO. FIGURE 4-1	REV. 2

team was not required to do so and was not escorted by site personnel throughout the inspection. In general, the site inspection found that the cap system was working as intended. However, even though the Navy has implemented an O&M program for Site 6 and corrective actions have been taken, a number of O&M issues were identified during the site inspection that, if not addressed, could negatively affect the long-term performance of the cap system. These issues are noted in the site inspection checklist provided in Appendix C and on Figure 4-1. The issues and their potential long-term impacts on the cap system are as follows:

Issues	Effects Protectiveness?	
	Current	Future
<b>Deficiencies</b>		
Boats are being stored without blocking to protect cap.	N	Y
<b>O&amp;M Issues</b>		
Longitudinal cracks are present in the asphalt.	N	Y
The well pad for well 6MW1S is damaged.	N	Y
A bolt on well 6MW9S is damaged.	N	N
Leaf litter and other debris have accumulated in the perimeter channel.	N	Y
Leaf litter has accumulated around the drop inlet.	N	N
The outlet structure could not be accessed during inspection. Outlet appears to be functioning properly.	N	N
Investigate warning signs and update as needed.	N	Y

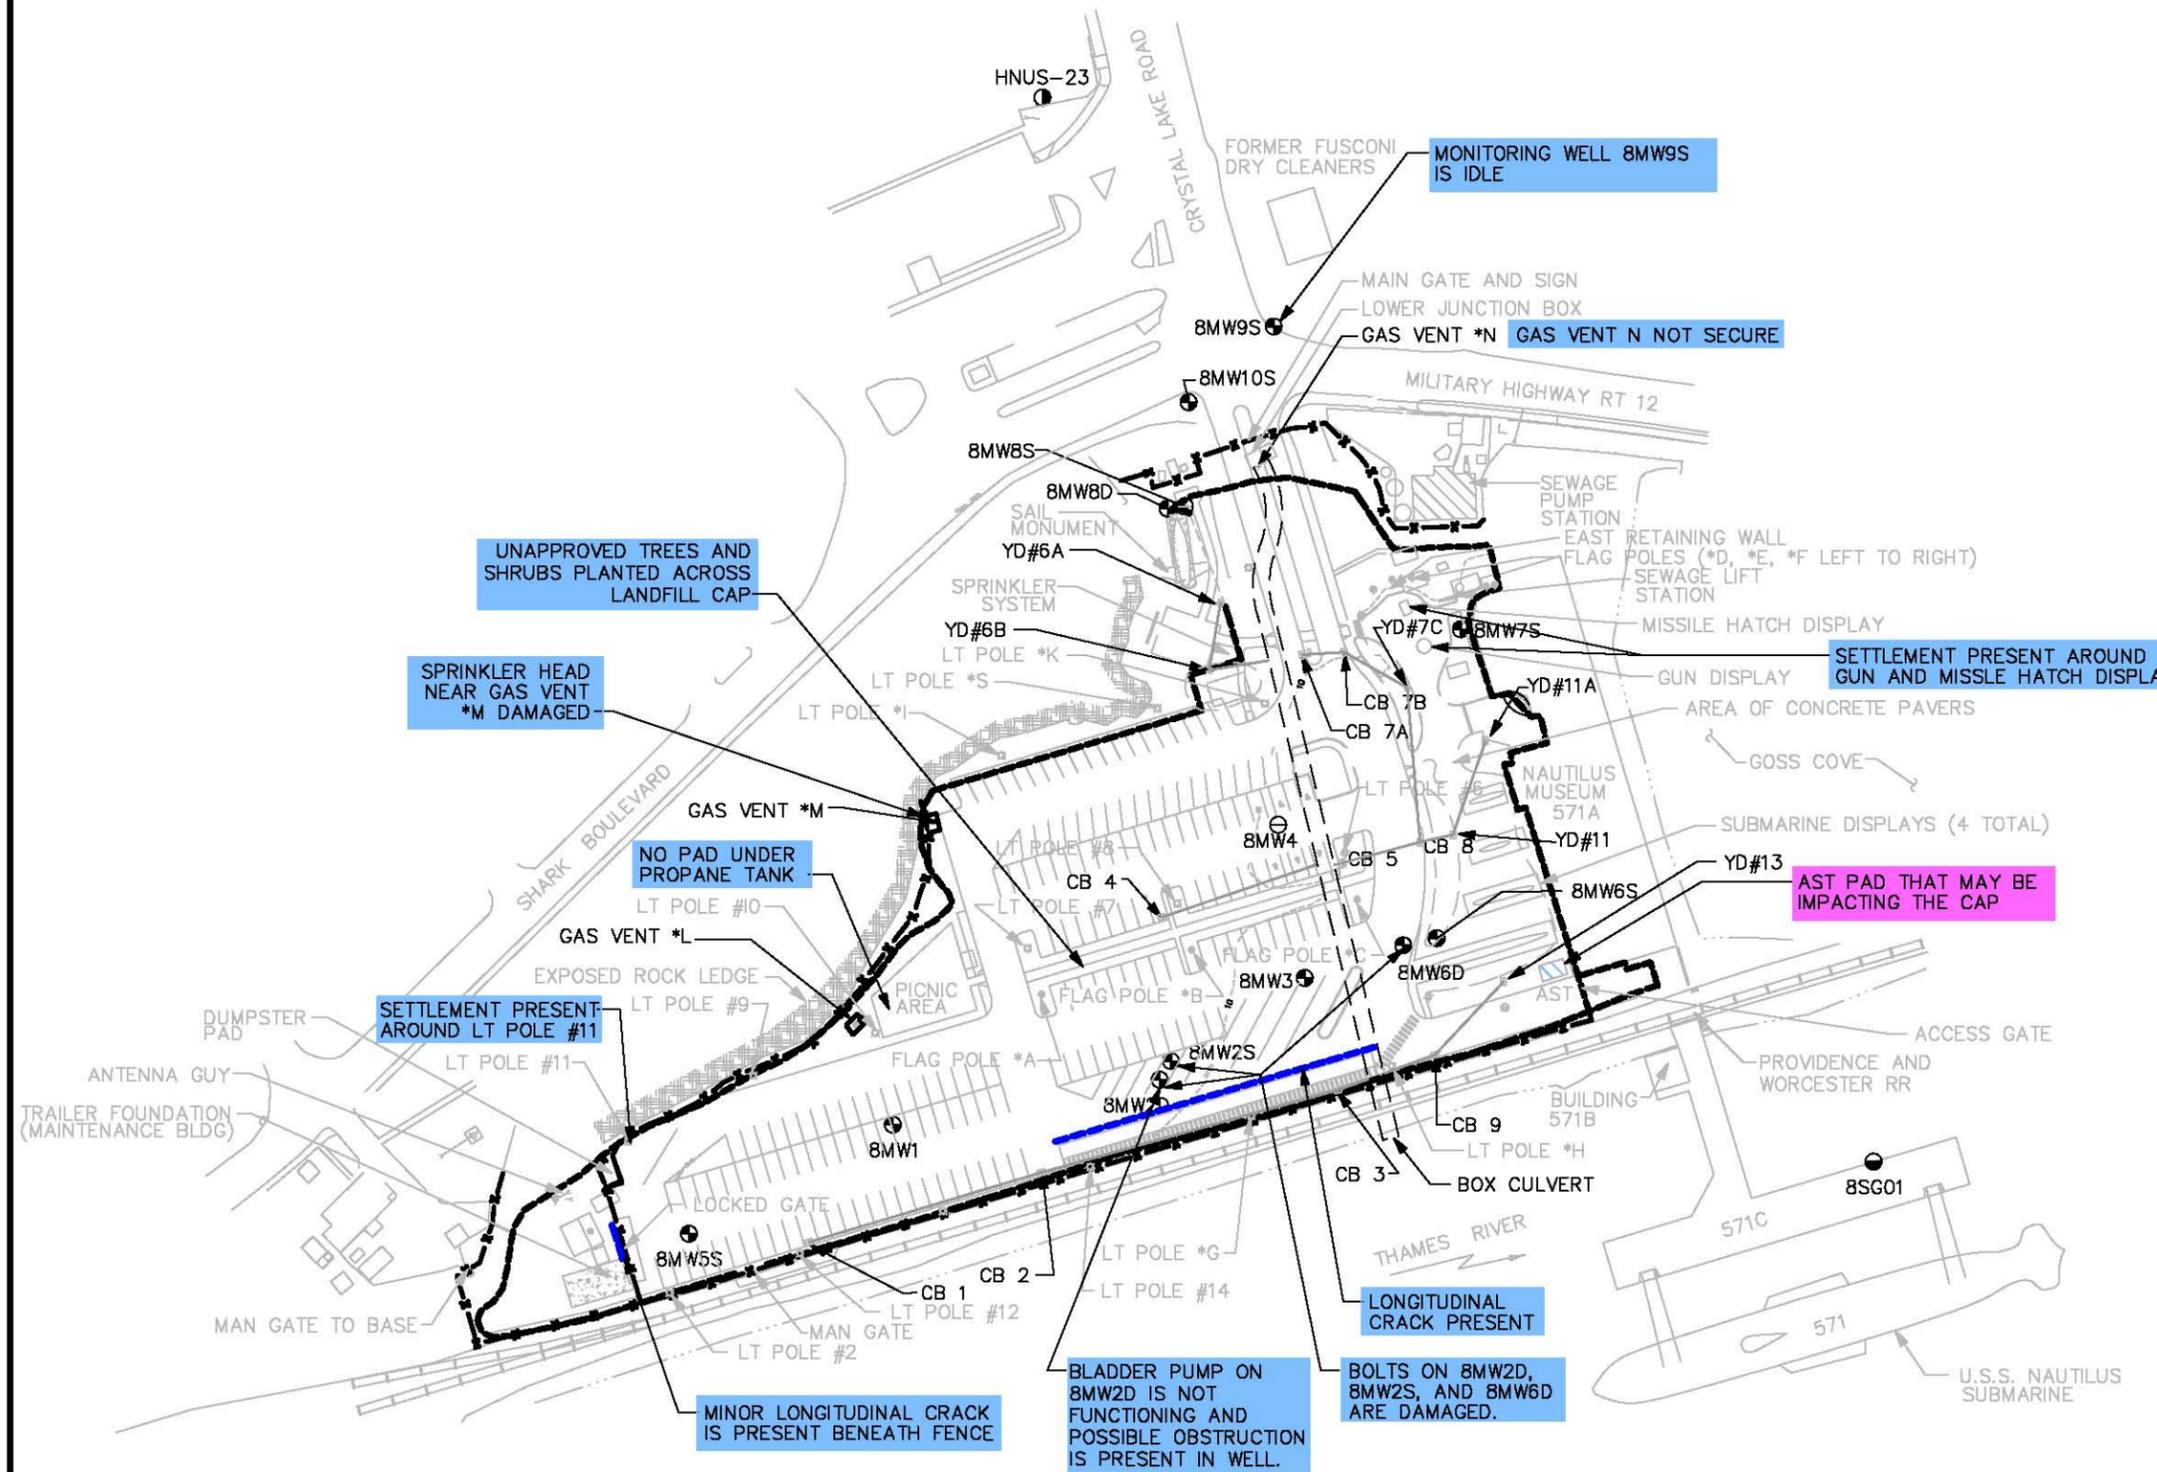
ISSUE	Effects Protectiveness?	
	Current	Future Potential
<b>Deficiencies</b>		
LUCs were not effectively implemented to prevent unauthorized excavation in the landfill cap to install an AST, foundation, and piping.	N	Y
<b>O&amp;M Issues</b>		
Trees and shrubs have been planted on the cap. Their roots may penetrate deep enough to damage the geomembrane.	N	Y
There is apparent settling of pavers beneath gun and missile hatch displays.	N	Y
LPG tank in the snack/picnic area is beginning to sink into ground	N	Y
Sprinkler head near Gas Vent M is damaged.	N	Y
The man gate at the north end of the cap was unlocked during the inspection.	N	N
Minor settling of asphalt around Light Pole 11.	N	Y
Minor longitudinal cracks are present in the asphalt.	N	Y
Gas Vent N is not secured.	N	N
Cover bolts are missing for wells 8MW6D, 8MW2S, and 8MW2D.	N	N
The well 8MW2D bladder pump may be malfunctioning.	N	N
There is an apparent obstruction in well 8MW2D.	N	N

Well 8MW9S is no longer sampled but has not been properly abandoned. Subsequent to the inspection, this well was paved over.	N	N
Investigate warning signs and update as needed.	N	Y

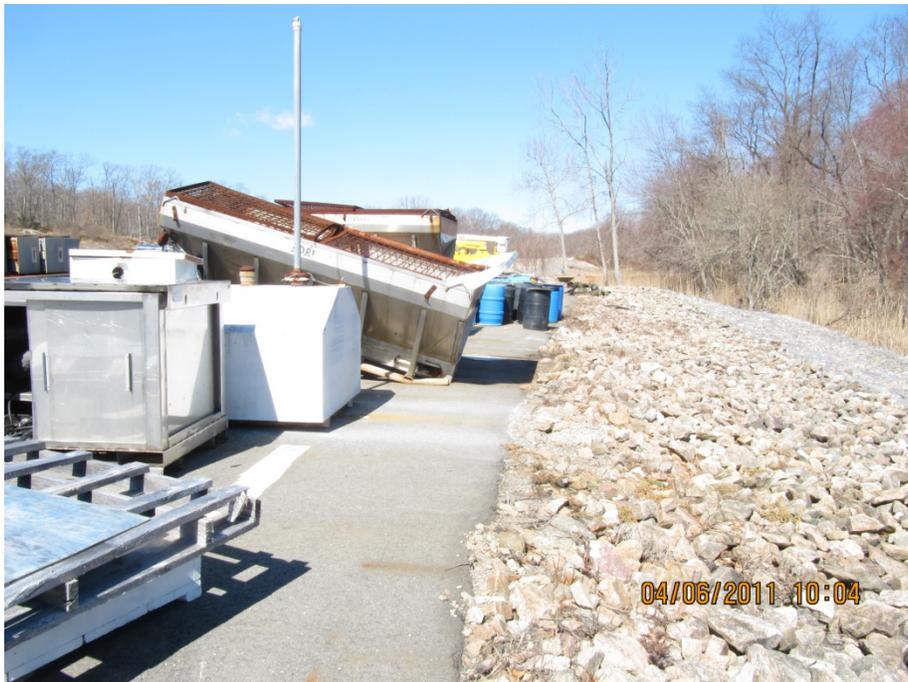
SITE 2A – AREA A LANDFILL  
STORAGE OF EQUIPMENT AND MATERIALS IN NO LOADING ZONE; LOOKING NORTH  
APRIL 6, 2011  
NSB-NLON, GROTON, CONNECTICUT. CTO WE33

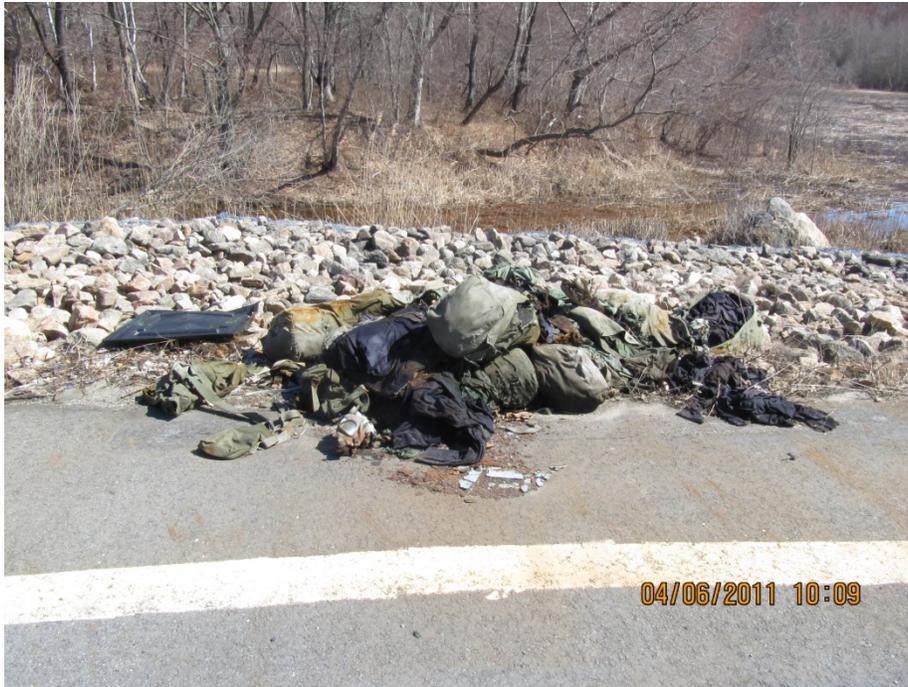
SITE 2A – AREA A LANDFILL  
TRASH ON NORTHERN EDGE OF CAP; LOOKING NORTHEAST  
APRIL 6, 2011  
NSB-NLON, GROTON, CONNECTICUT. CTO WE33

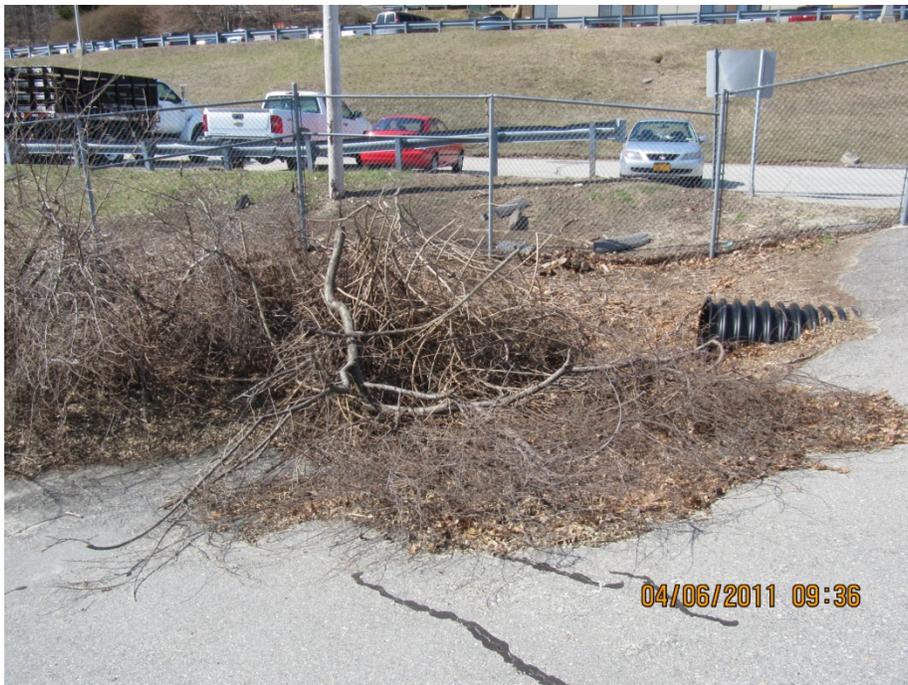
SITE 2A – AREA A LANDFILL  
DEBRIS PILE IN ADS CULVERT; LOOKING SOUTHEAST  
APRIL 6, 2011  
NSB-NLON, GROTON, CONNECTICUT. CTO WE33

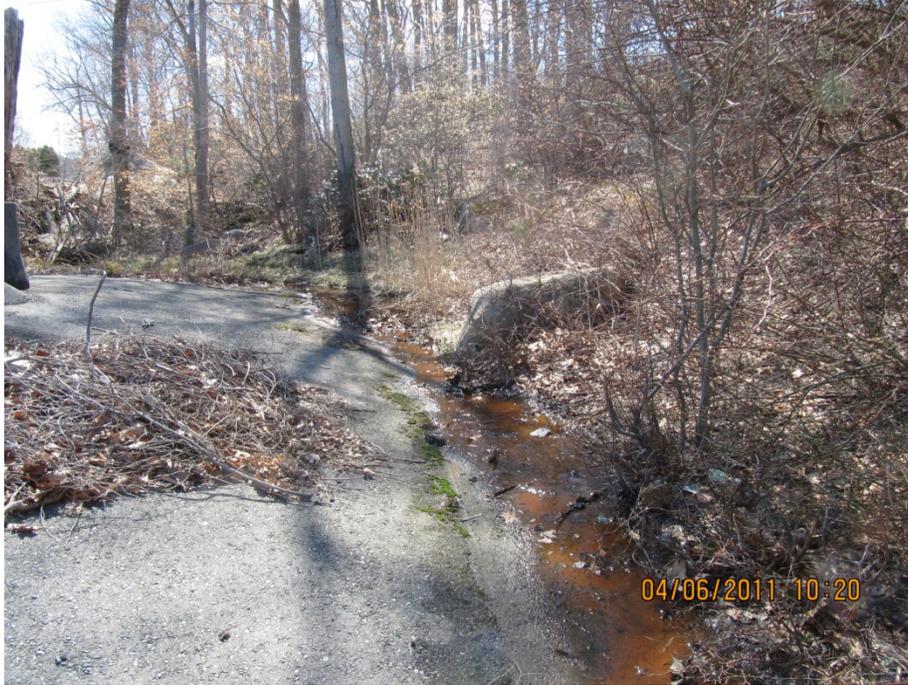
SITE 2A – AREA A LANDFILL  
DEBRIS AND VEGETATION CLOGGING CHANNEL E; LOOKING SOUTH  
APRIL 6, 2011  
NSB-NLON, GROTON, CONNECTICUT. CTO WE33

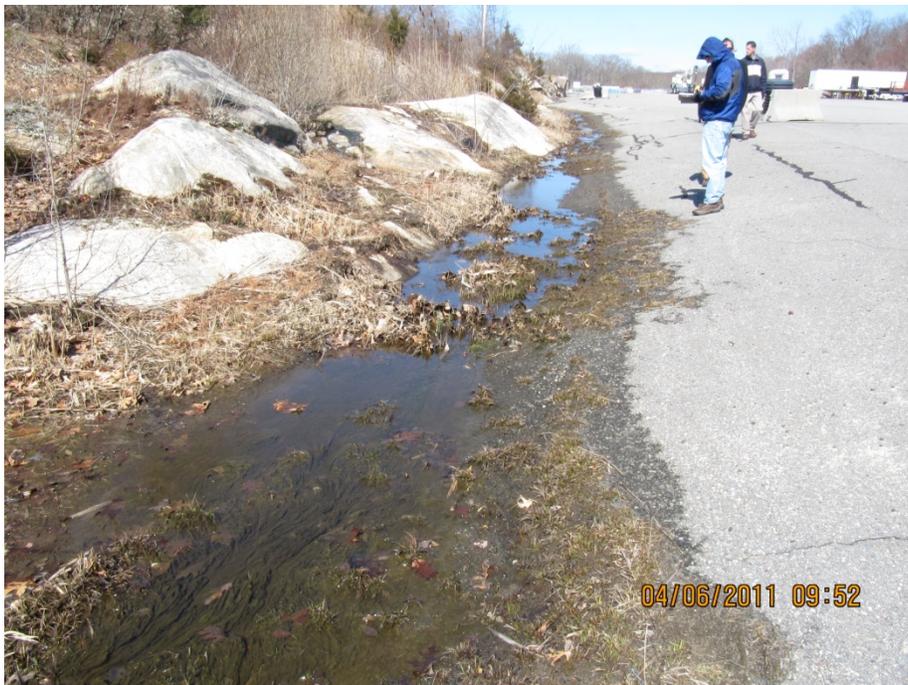
SITE 2A – AREA A LANDFILL  
DEBRIS CLOGGING CHANNEL A; LOOKING WEST  
APRIL 6, 2011  
NSB-NLON, GROTON, CONNECTICUT. CTO WE33

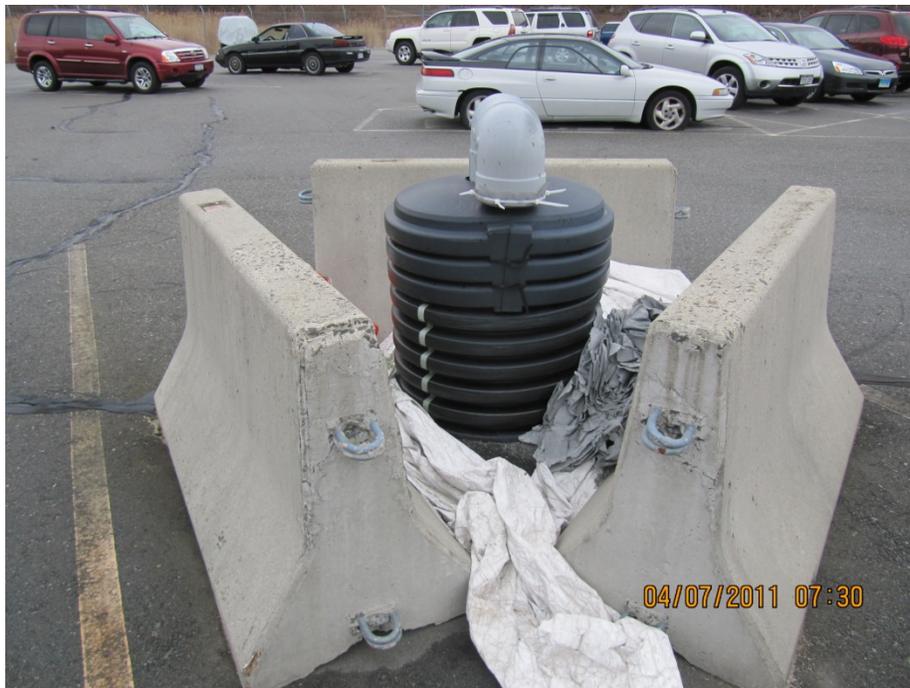
SITE 2A – AREA A LANDFILL  
TRASH AROUND GAS VENT 24; LOOKING EAST  
APRIL 6, 2011  
NSB-NLON, GROTON, CONNECTICUT. CTO WE33

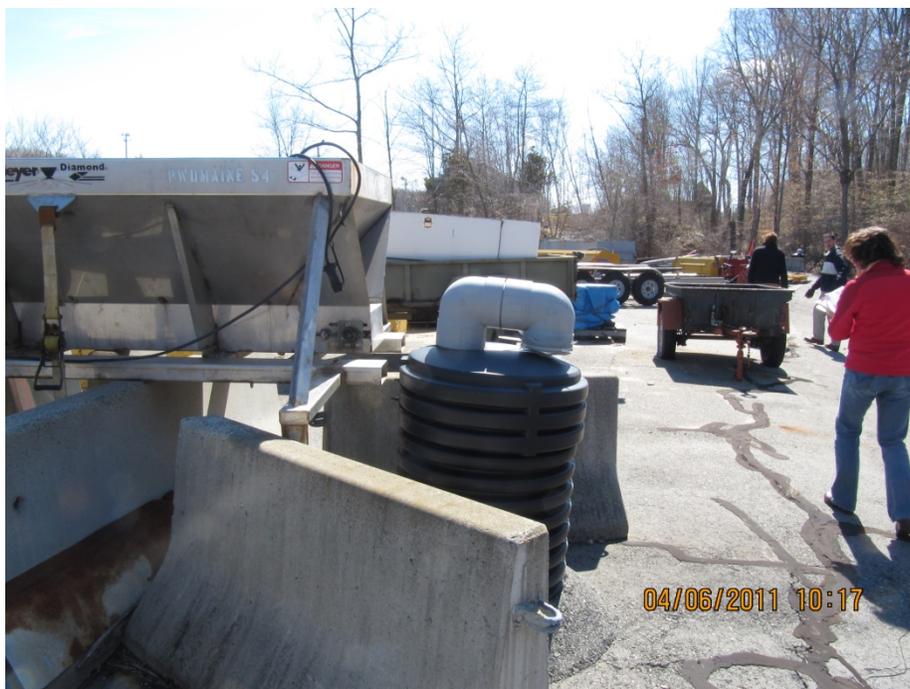
SITE 2A – AREA A LANDFILL  
EQUIPMENT TOO CLOSE TO GAS VENT 14; LOOKING EAST  
APRIL 6, 2011  
NSB-NLON, GROTON, CONNECTICUT. CTO WE33

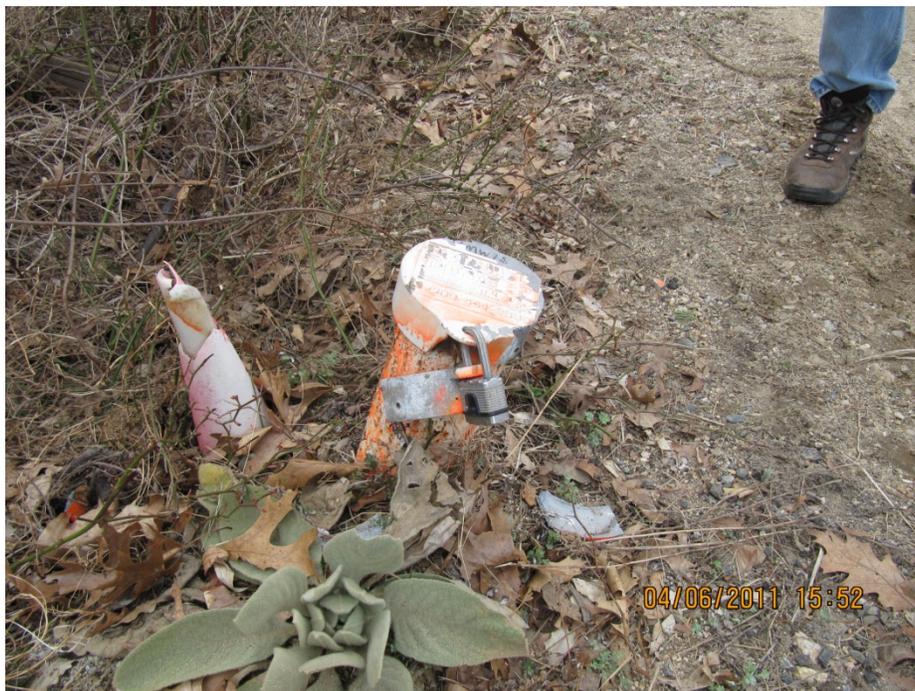
SITE 2A – AREA A LANDFILL  
DAMAGED MONITORING WELL 4MW1S  
APRIL 6, 2011  
NSB-NLON, GROTON, CONNECTICUT. CTO WE33

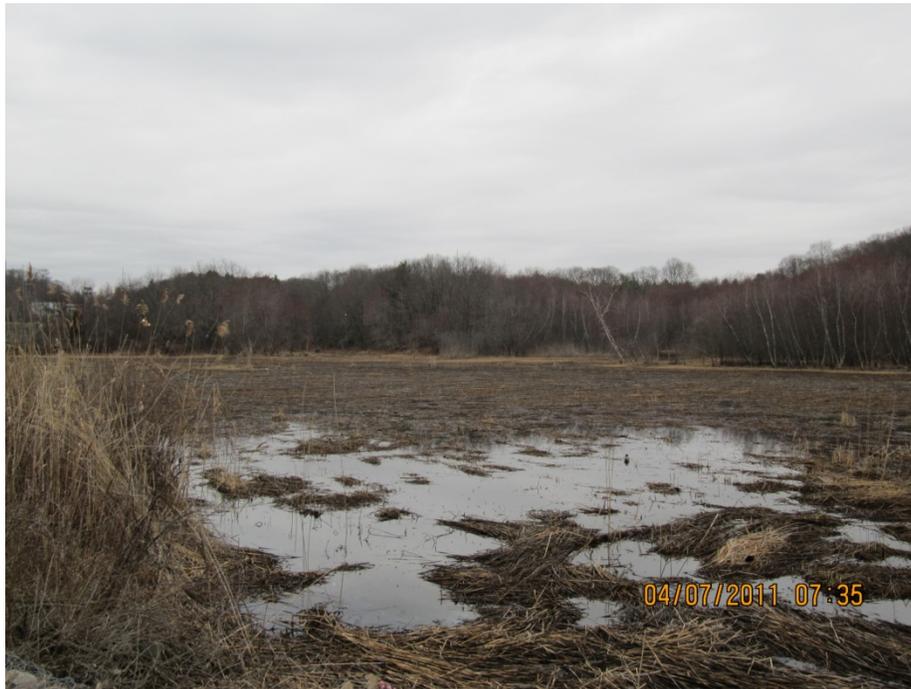
SITE 2B – AREA A WETLAND  
SUCCESSFUL REMOVAL OF PHRAGMITES; LOOKING NORTH  
APRIL 6, 2011  
NSB-NLON, GROTON, CONNECTICUT. CTO WE33
