Re Third Five-Year Review for the Naval Submarine Base New London Superfund Site

Thank you for the opportunity to review the *Third Five-Year Review for CERCLA Sites at Naval Submarine Base New London, Groton, CT*, dated December 2011. EPA reviewed this document in light of its compliance with the *Comprehensive Five-Year Review Guidance* (OSWER No 9355 7-03B-P dated June 2001). This statutory review is consistent with the guidance provided in the OSWER directives. Upon review, EPA concurs with the findings that the remedies that have been implemented at the Area A Landfill, the Goss Cove Landfill, the Defense Reutilization and Marketing Office, the Area A Downstream/Over Bank Disposal Area, the Area A Weapons Center, the Torpedo Shops, and Basewide Groundwater are protective of human health and the environment.

During EPA's site walkover on April 6, 2011, numerous issues were identified with respect to the on-going maintenance of several remedies currently in place. These issues are summarized appropriately in Table 18-2 of the *Third Five-Year Review* report along with corresponding recommendations to address them. EPA is pleased that the Navy has already put in place plans to

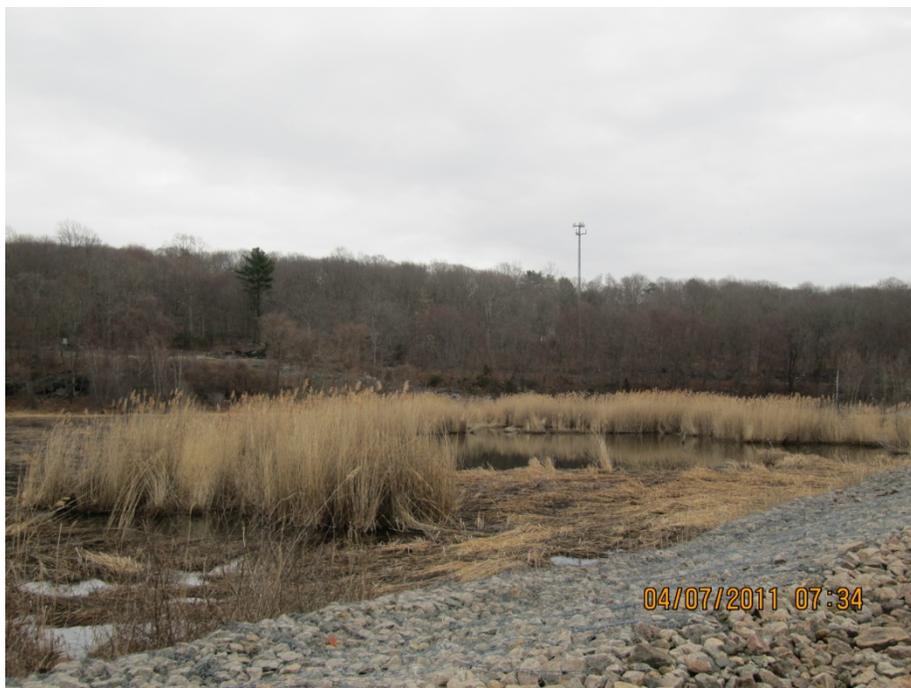
SITE 2B – AREA A WETLAND  
REMAINING PHRAGMITES TO BE CLEARED; LOOKING EAST  
APRIL 6, 2011  
NSB-NLON, GROTON, CONNECTICUT. CTO WE33

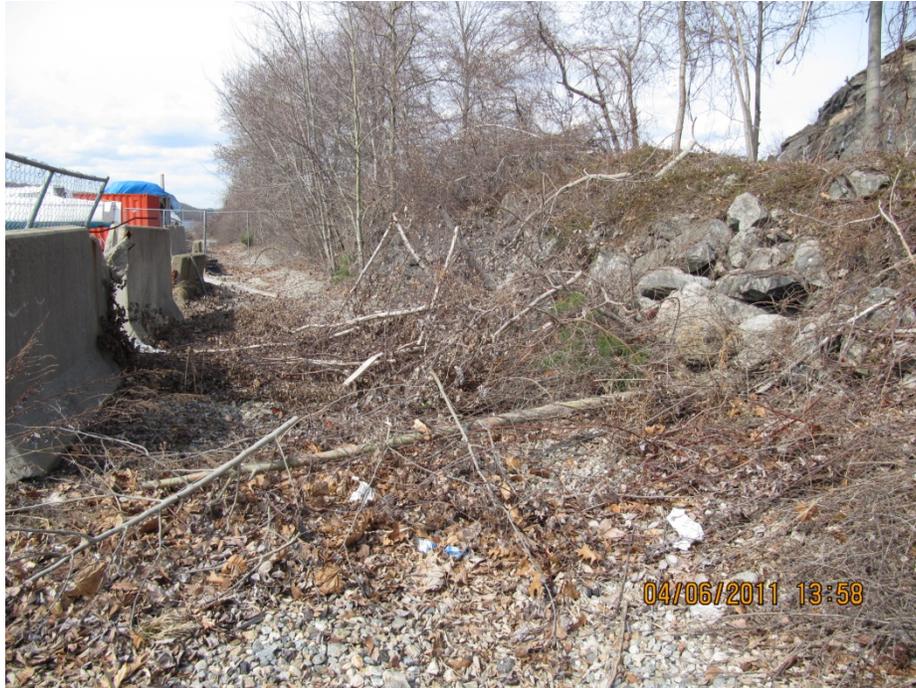
SITE 6 – DRMO  
LEAF LITTER ACCUMULATION IN DROP INLET  
APRIL 6, 2011  
NSB-NLON, GROTON, CONNECTICUT. CTO WE33

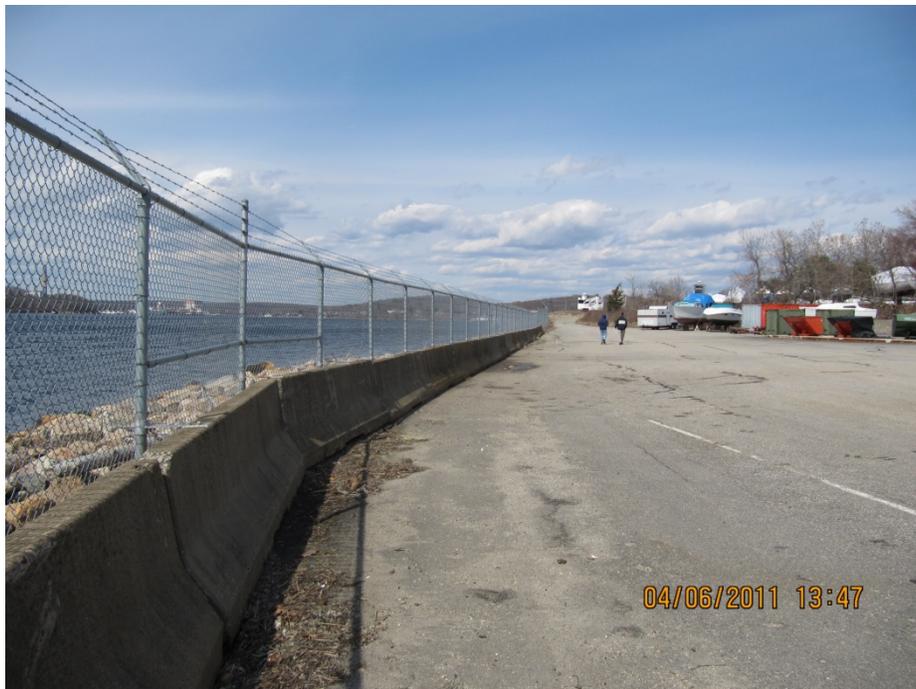
SITE 6 – DRMO  
DEBRIS IN PERIMETER CHANNEL ALONG EASTERN SIDE OF CAPPED AREA  
APRIL 6, 2011  
NSB-NLON, GROTON, CONNECTICUT. CTO WE33

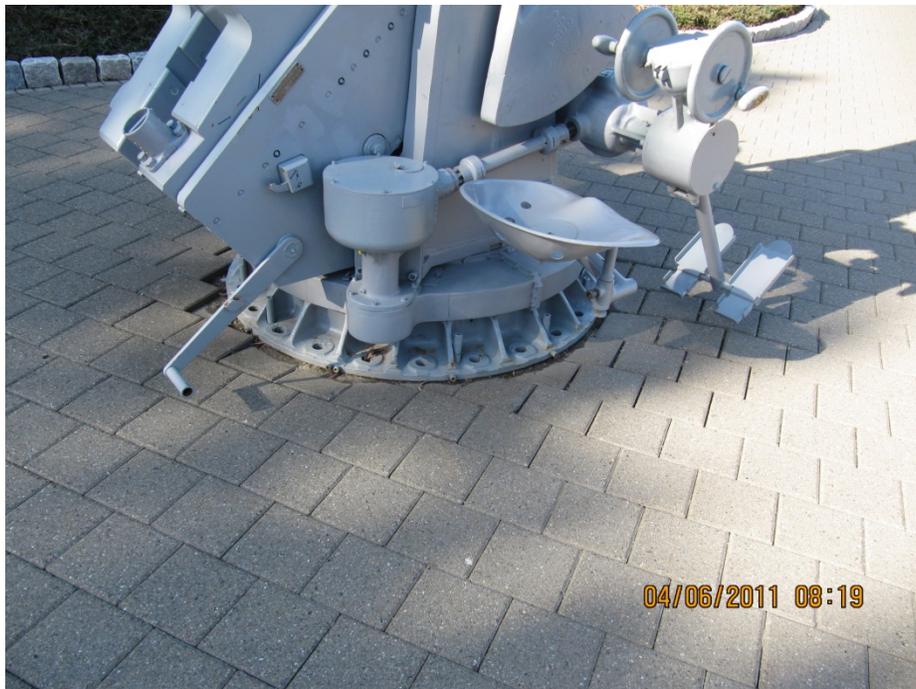
SITE 8 – GOSS COVE LANDFILL  
SLIGHT SAGGING OF PAVERS AROUND MISSILE HATCH DISPLAY, LOOKING NORTH  
APRIL 6, 2011  
NSB-NLON, GROTON, CONNECTICUT. CTO WE33

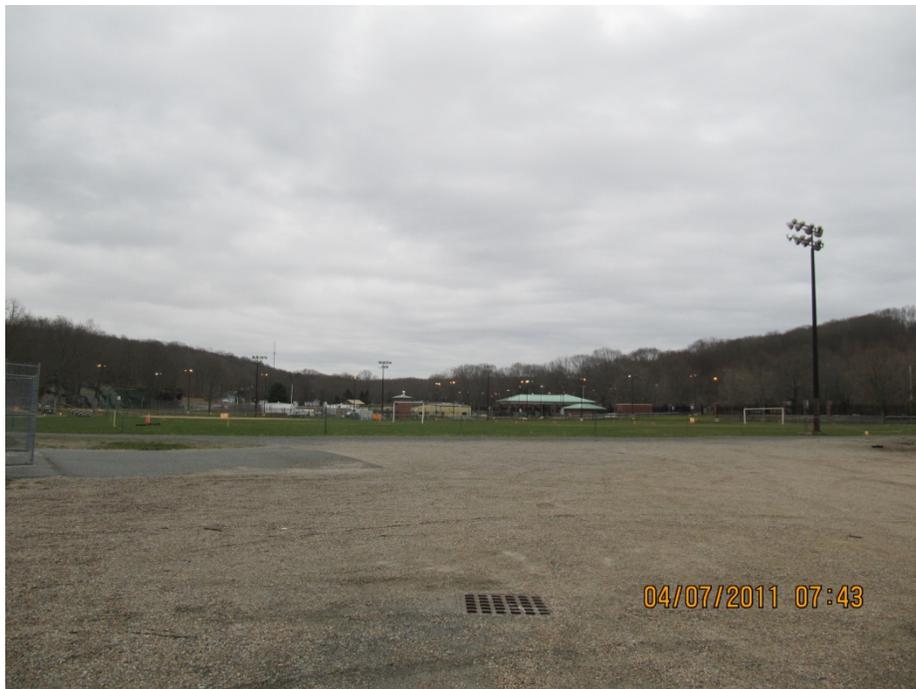
SITES 9/23 – OT-5 AND TANK FARM  
LOOKING SOUTHWEST AT LOCATION OF SITE 23 (TANK FARM)  
APRIL 7, 2011  
NSB-NLON, GROTON, CONNECTICUT. CTO WE33

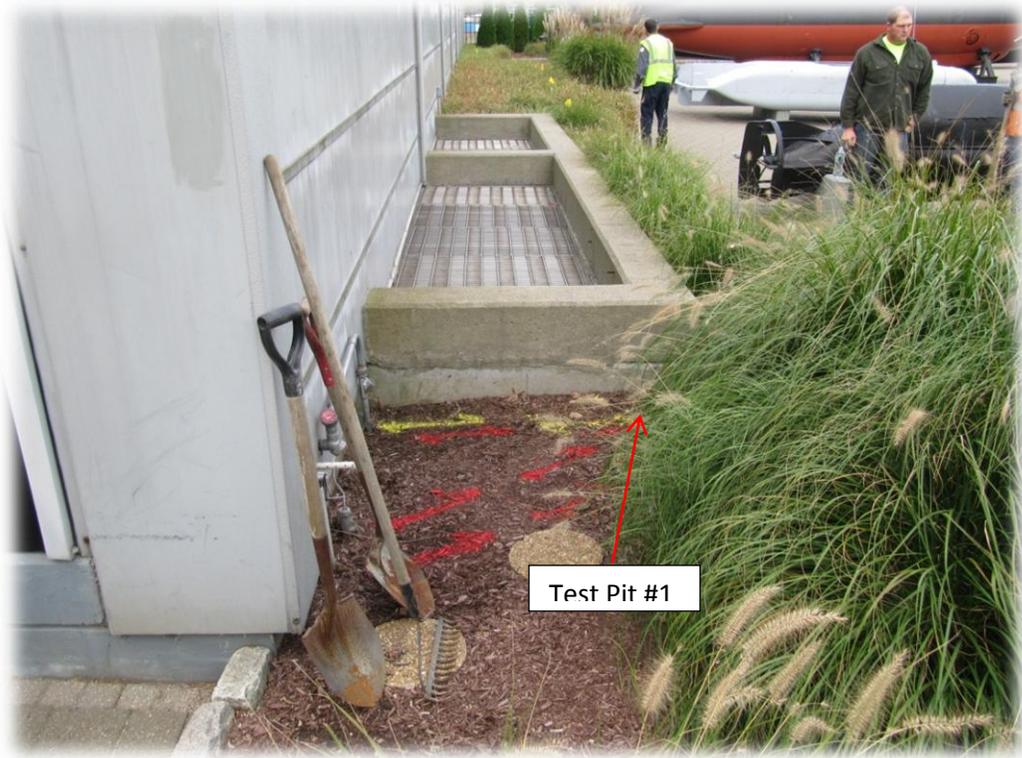
Test Pit #1

Pre-excavation view looking east to west from where fuel lines enter building back toward AST (behind green evergreen shrubs).

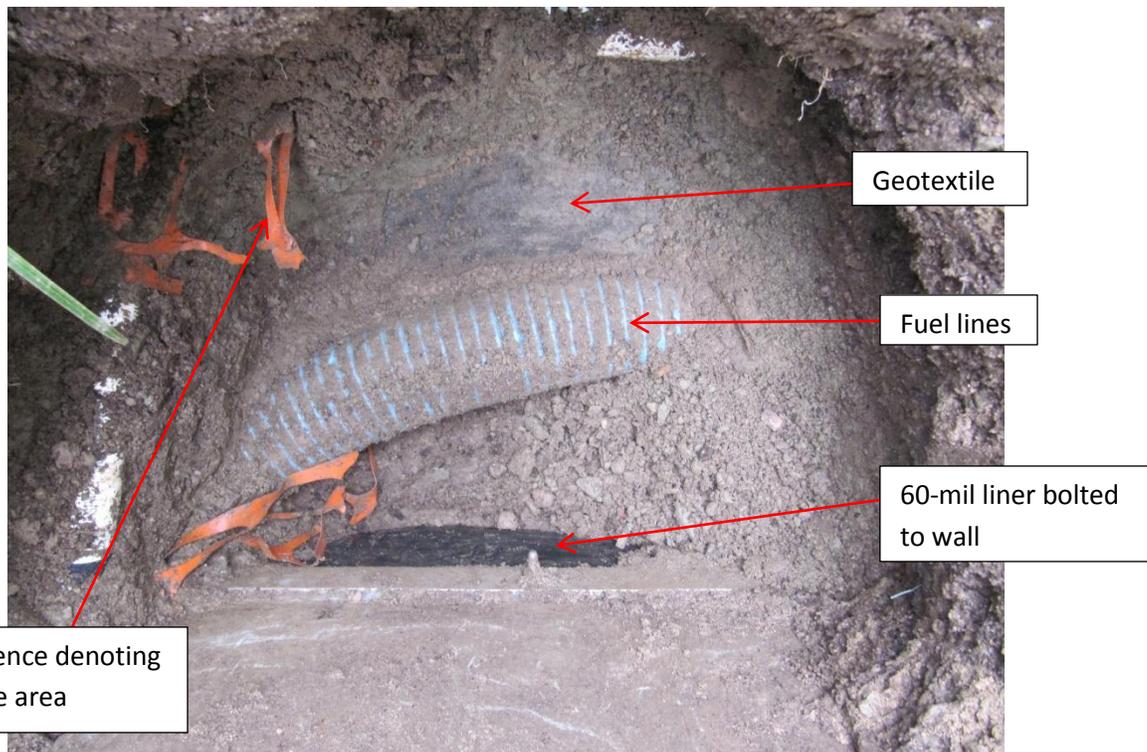
**Test Pit #1**

View of buried fuel lines (run inside the blue corrugated piping). Geotextile and orange snow fence are also depicted.

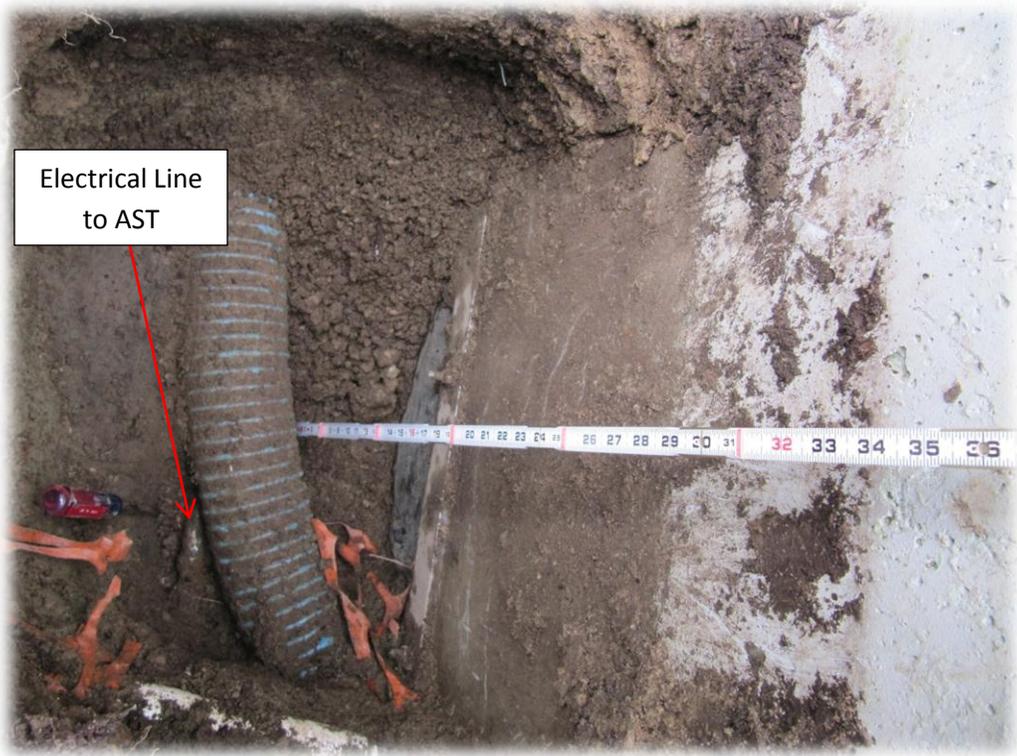
**Test Pit #1**

Electrical line to AST is run in same trench below fuel lines at approximately 30 inches below grade.

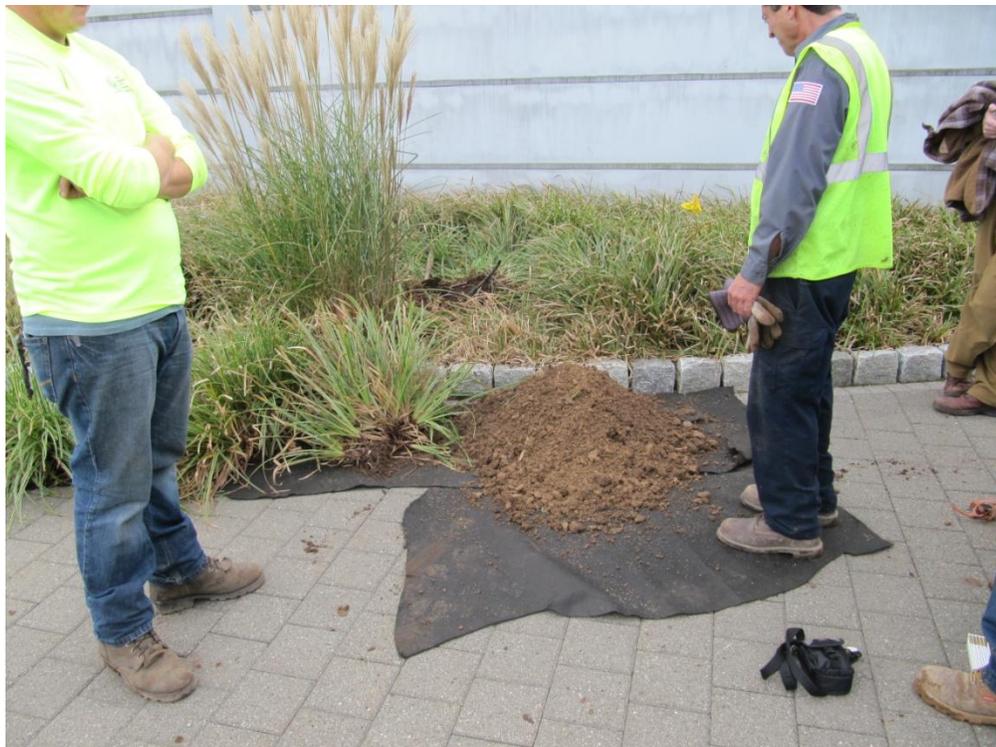
**Test Pit #2**

View of test pit as it was installed.

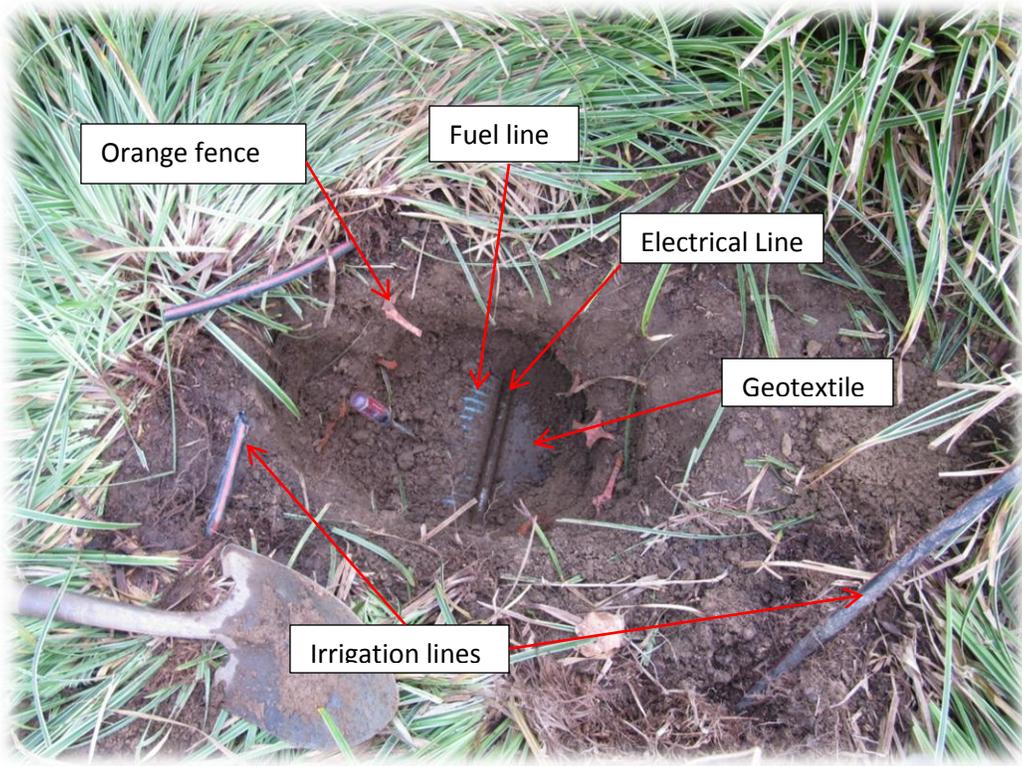
**Test Pit #2**

Picture showing fuel/electrical lines immediately on top of geotextile. Orange snow fence also depicted.

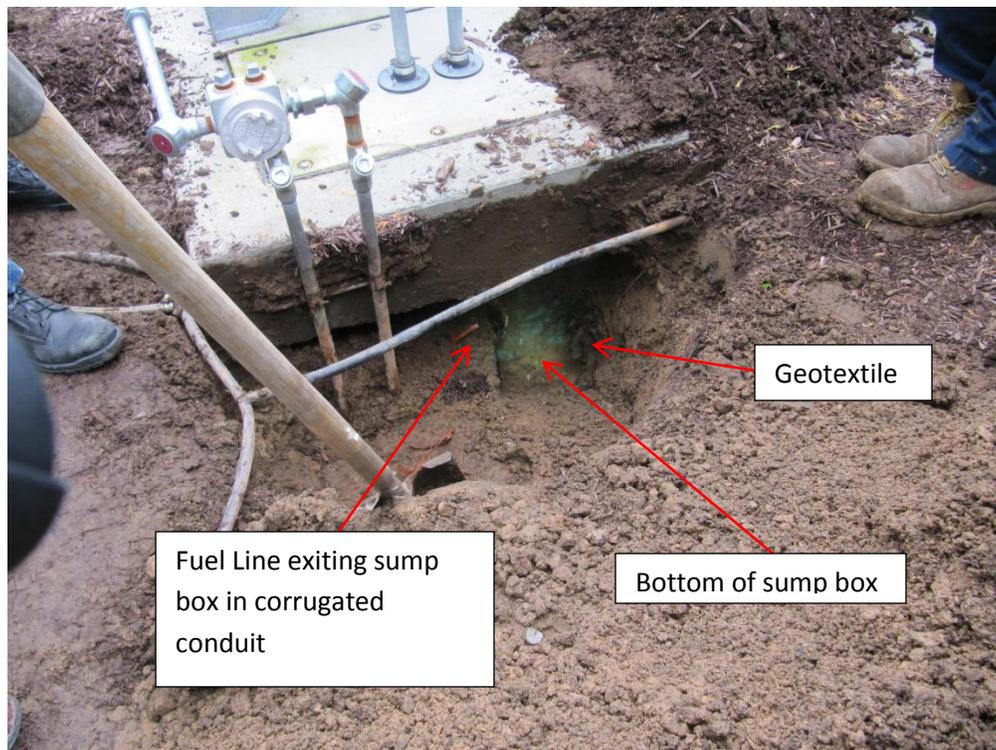
### Test Pit #3

View of exposed fuel line and piece of geotextile. The bottom of the sump box is also shown.

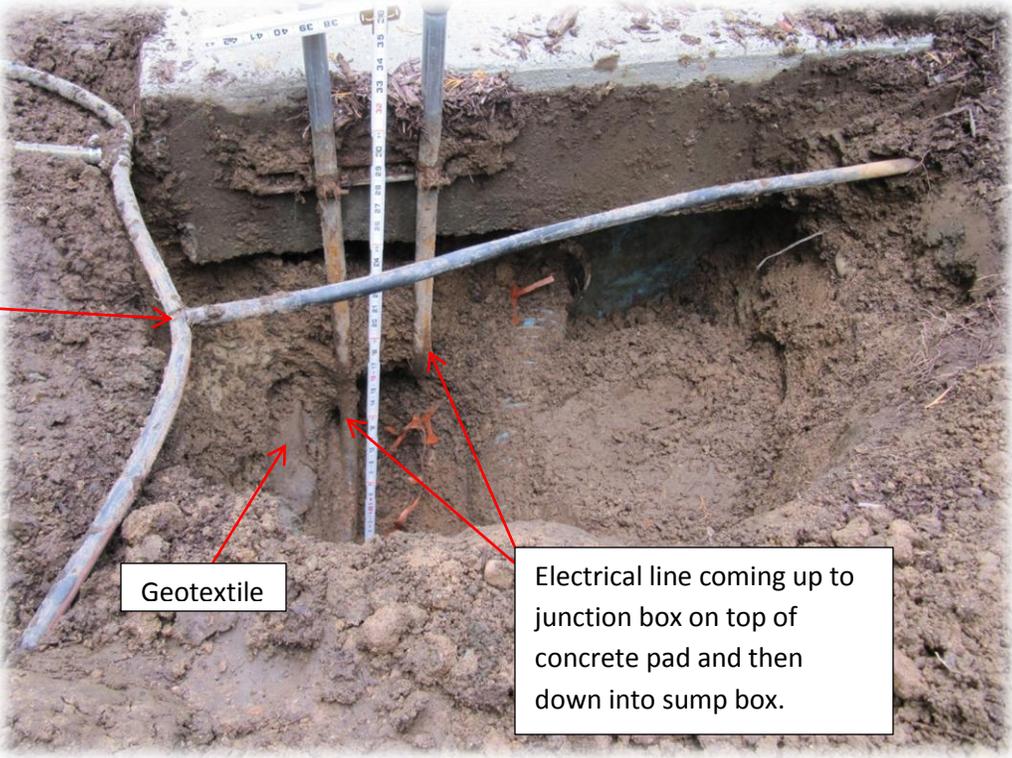
### Test Pit #3

Electrical line coming up to  
junction box on top of  
concrete pad and then  
down into sump box.

Picture showing electrical line coming into and out of AST concrete pad at approximately 30 inches below grade.

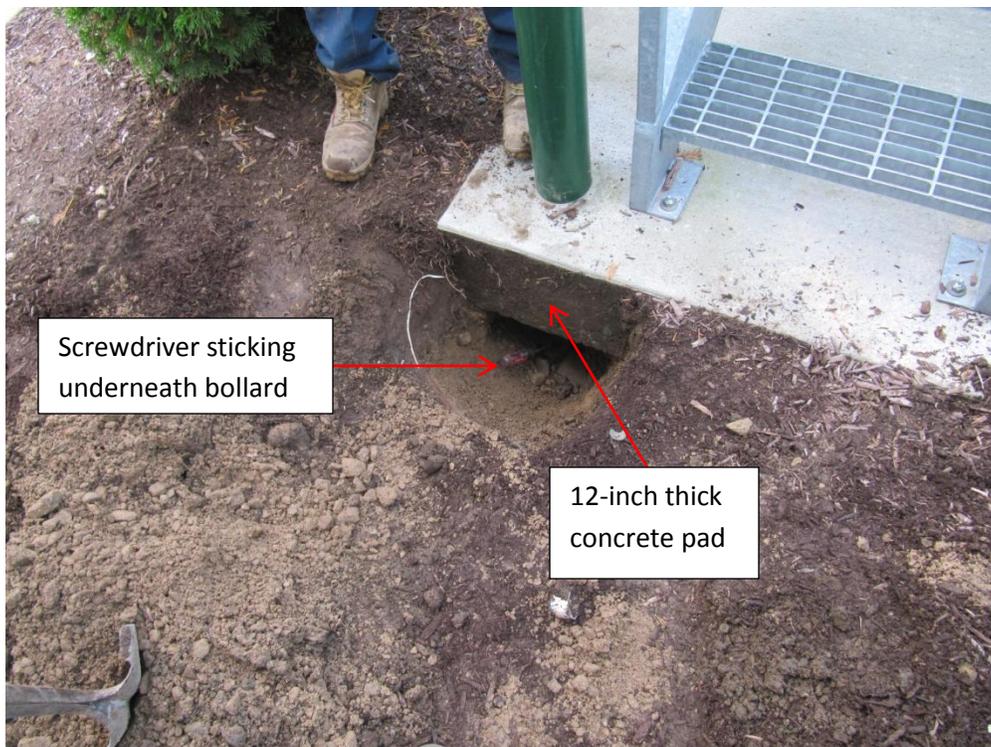
**Test Pit #4**

Picture showing excavation at bollard located on the southwest corner of the concrete AST pad.

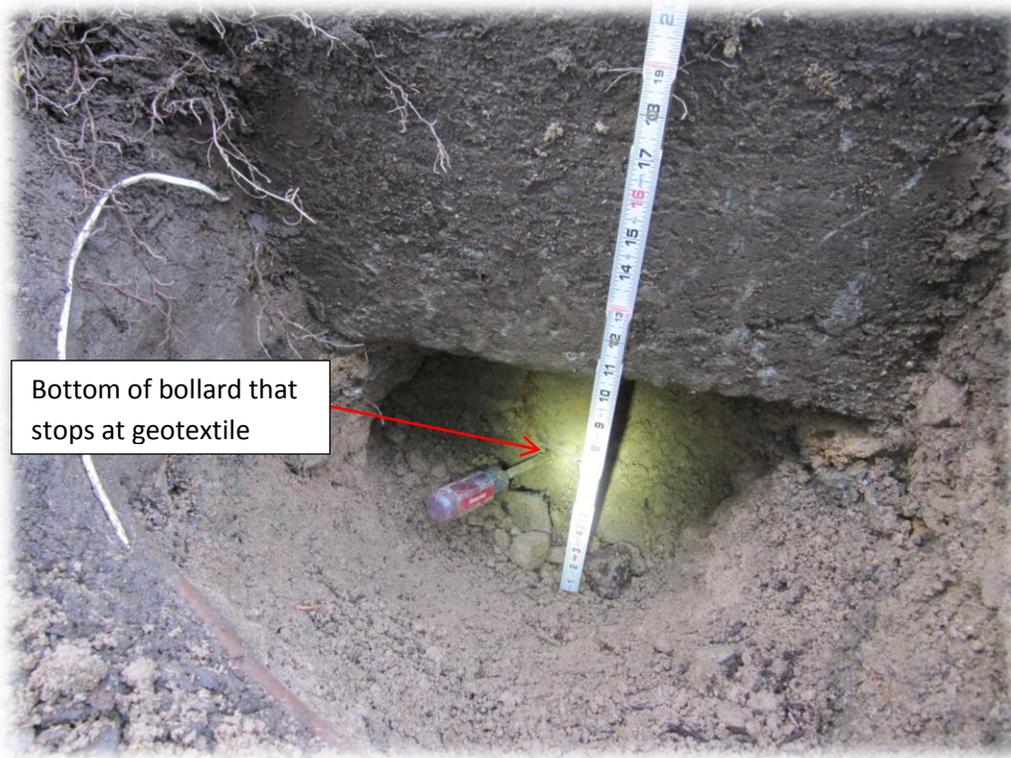
**Test Pit #4**

Bottom of bollard that stops at geotextile

View of bollard bottom (screwdriver sticking under it). Bollard extended approximately 24 inches below the top of the 12-inch thick concrete pad.
