DRAFT  
YEAR 5 INTERIM MONITORING REPORT—  
TERMINAL 4 PHASE I REMOVAL ACTION  
PORT OF PORTLAND, PORTLAND, OREGON

Port of Portland  
Portland, Oregon

Anchor QEA, LLC  
421 SW Sixth Avenue, Suite 750  
Portland, Oregon 97204

**January 2014**

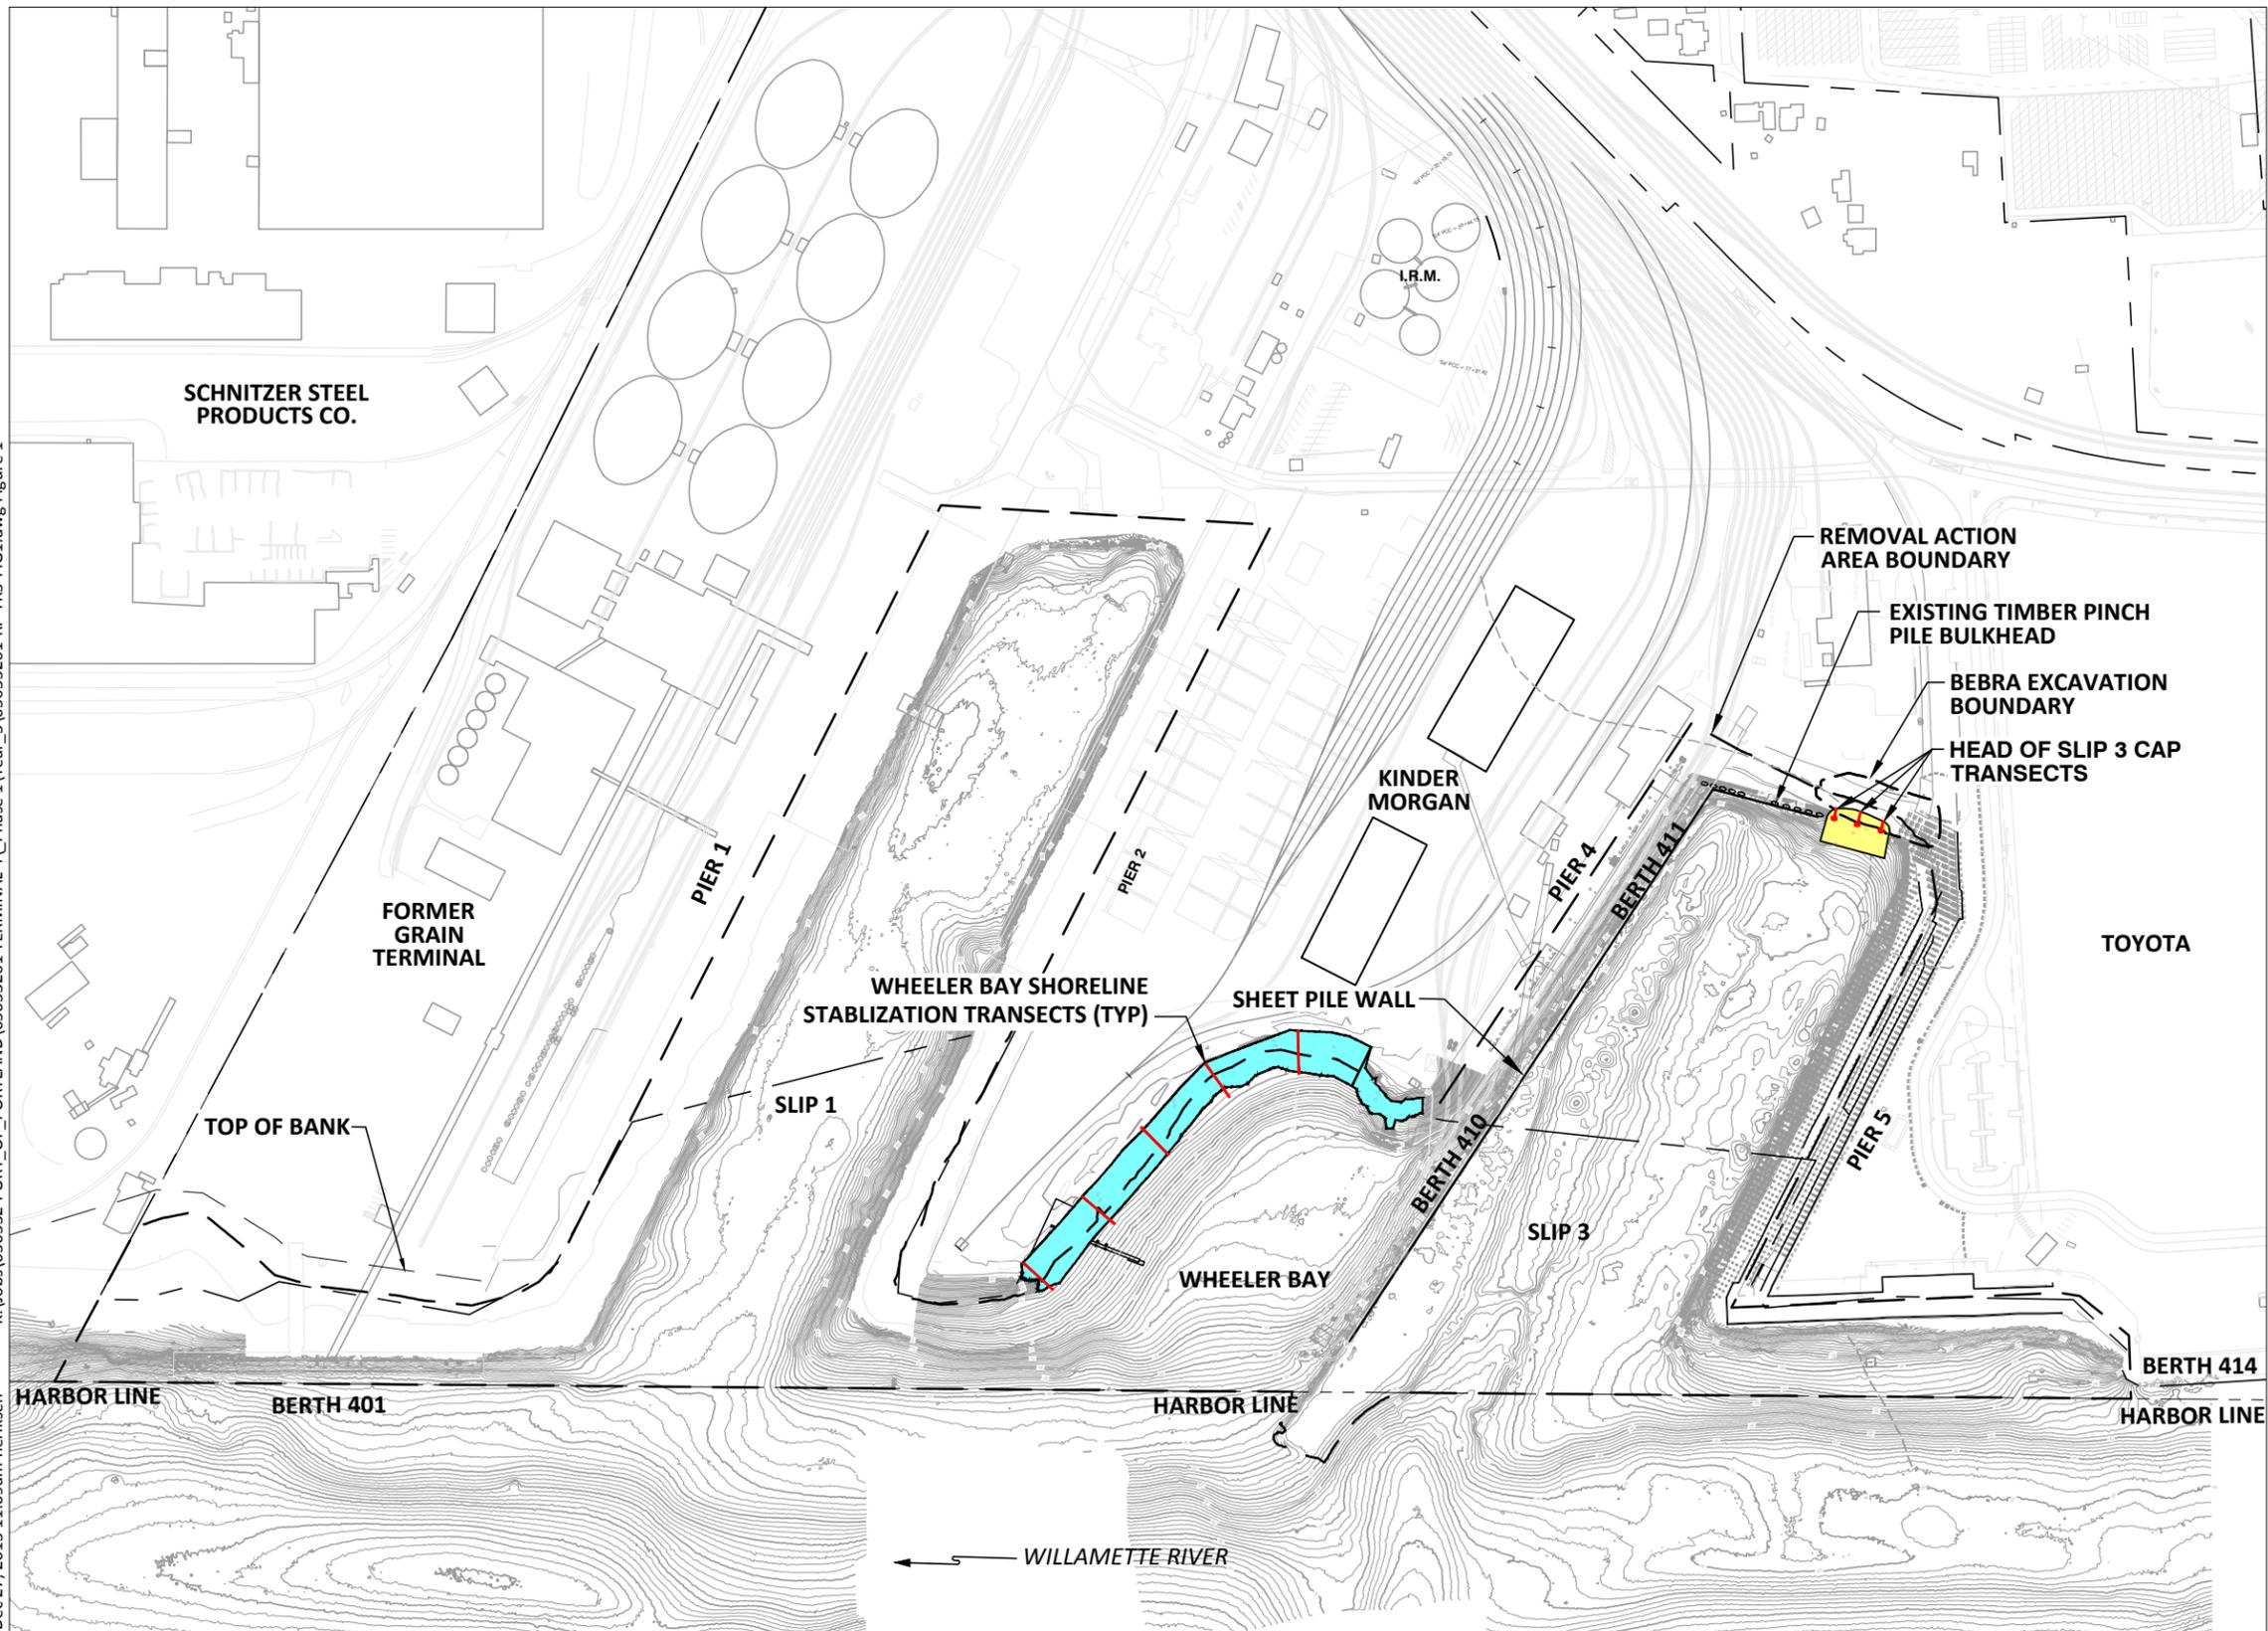
K:\Jobs\050332-PORT\_OF\_PORTLAND\05033201\_TERMINAL\_4\_Phase 1\Year\_5\05033201-RP-YR5-FIG1.dwg Figure 1  
Dec 27, 2013 11:09am heriksen

This document provides a summary of the fifth-year monitoring results for the head of Slip 3 cap and Wheeler Bay (WB) shoreline stabilization. Interim monitoring survey locations are depicted in Figure 1. Monitoring was conducted in accordance with the requirements of the *Interim Monitoring and Reporting Plan* (IMRP; see *Appendix C to the Final Design Analysis Report*; Anchor 2008) and the *Final Year 4 Interim Monitoring Report* (Year 4 Monitoring Report; Anchor QEA 2013). A description of the observed site conditions and relevant data summaries are provided in this report.

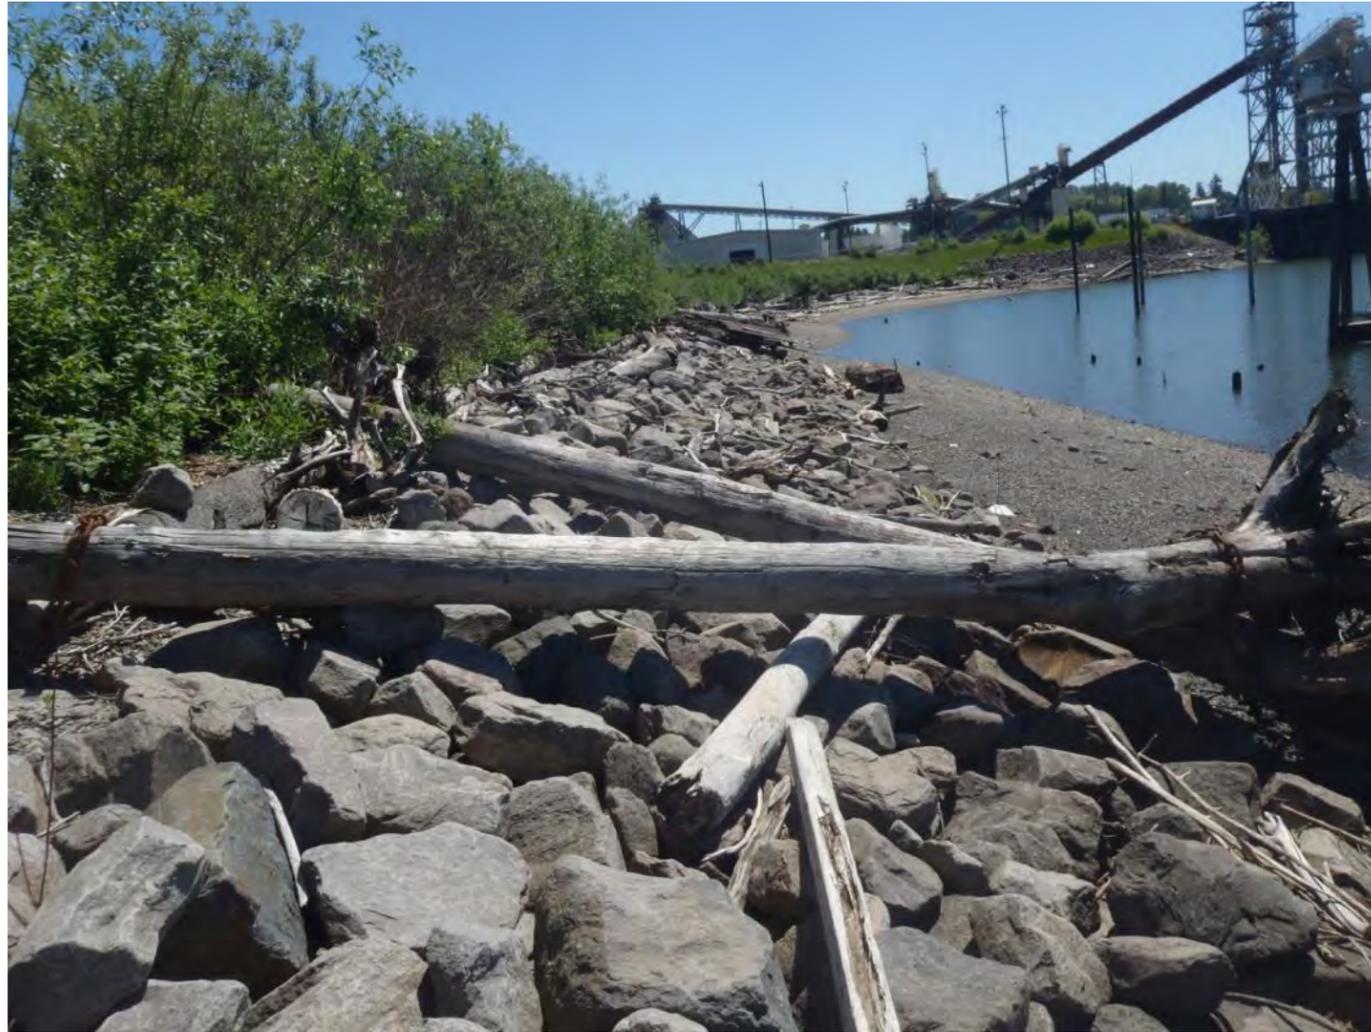
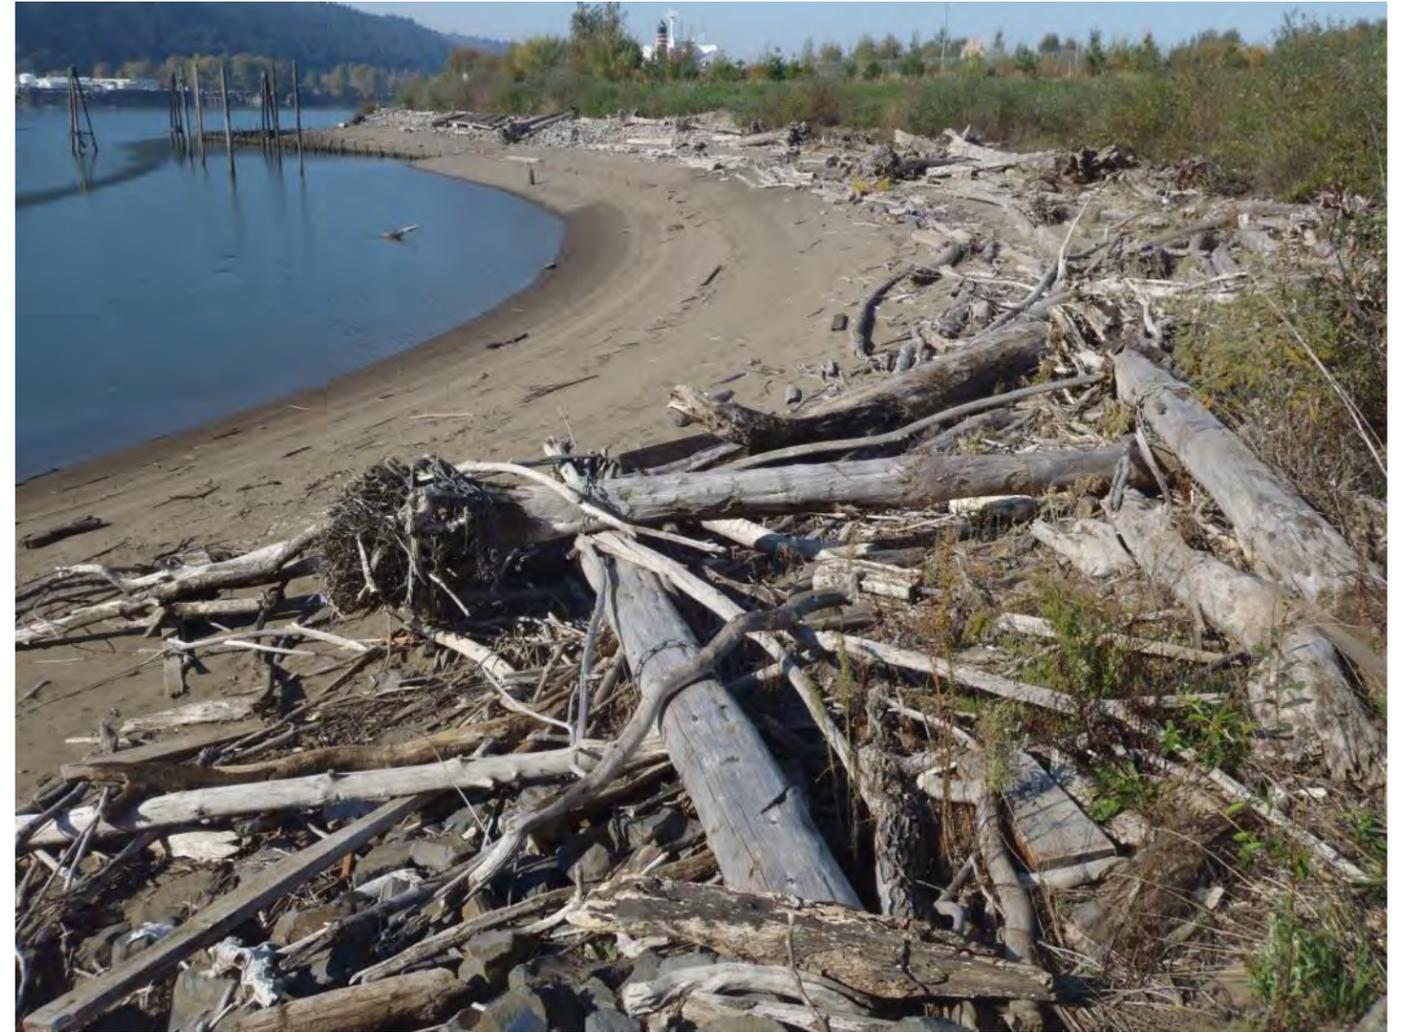
K:\Jobs\050332-PORT\_OF\_PORTLAND\05033201\_TERMINAL\_4\_Phase 1\Year\_5\05033201-RP-YR5-FIG3.dwg Figure 3  
Dec 27, 2013 11:06am heriksen

A total of five slope observation transects were established perpendicular to the shoreline at approximately 0, 150, 300, 450, and 600 feet from the mouth of the bay, as depicted in Figure 3. Transects were established with a field measuring tape, and monitoring staff walked from the upslope edge of the grass planting area down to the water. Notes and photographs were taken to document slope stability at each transect (see Appendix A: Attachments A-1 [field data sheets] and A-2 [photographs]). Photographs were taken in

Transects were established perpendicular to the shoreline at 150-foot centers, as described in Section 3.1 and depicted in Figure 3. Monitoring staff walked along the transects looking for evidence of erosion within the armor layer. Notes and photographs were taken of the armor layer at each transect (see Appendix A: Attachments A-1 [field data sheets] and A-2 [photographs]). The armor layer showed no signs of instability, sloughing, or erosion. All woody debris installed as part of the original design and repair activities was in place, stable, and in good condition.

A sand and gravel habitat material mixture was placed over the armor layer on a 3 horizontal to 1 vertical (3H:1V) slope from approximate elevations +10 to +15 feet NGVD29 during the Terminal 4 Phase I Removal Action construction in 2008 (see Figure 3). The habitat layer serves no function of armoring. The intent of the habitat material is to allow it to naturally accrete or erode and provide normative ecological functions. Pursuant to the Biological

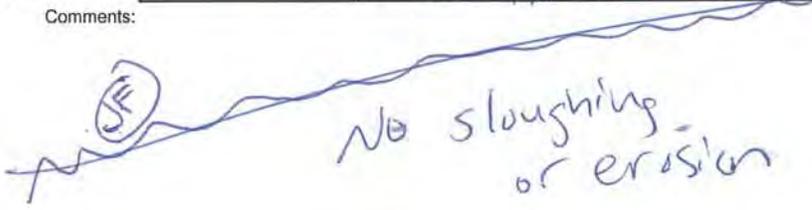
| <b>Transect 4</b> | #38 Upslope | | Downslope #39 | |

| Comments:<br><br>No slaughting<br>or erosion | | | | |

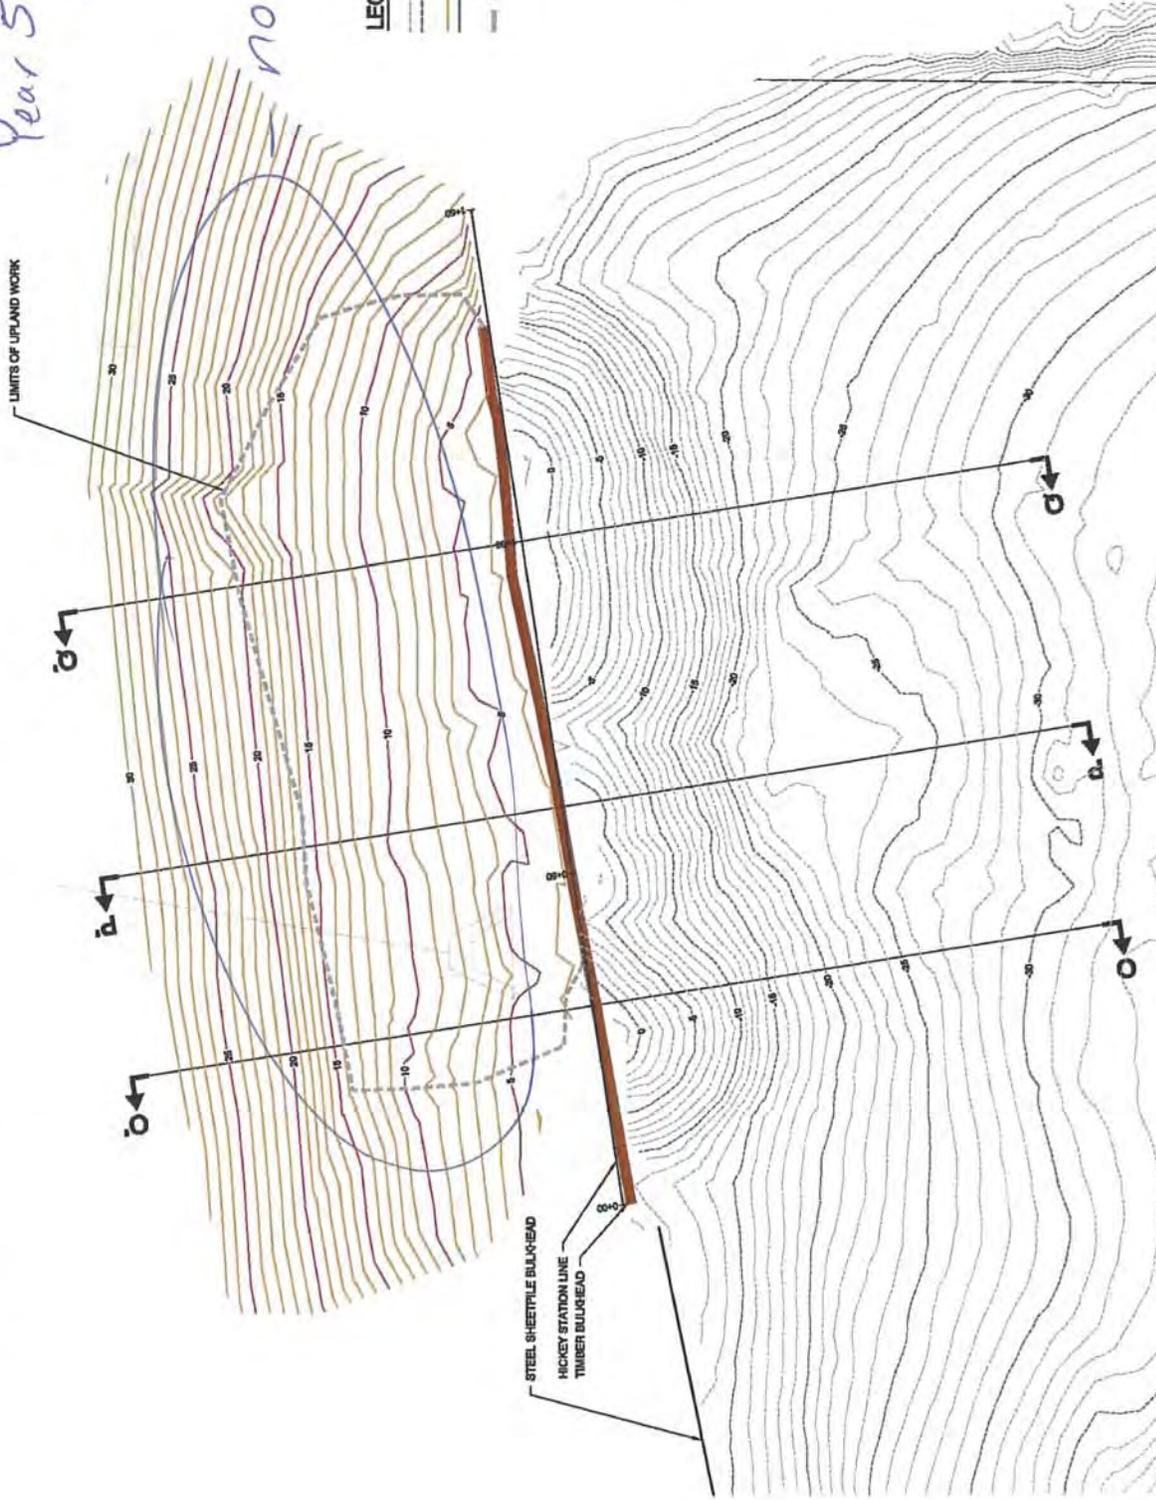
*Year 5 Slope Observation  
at Head of Slip 3*

*no sloughing or  
erosion.*

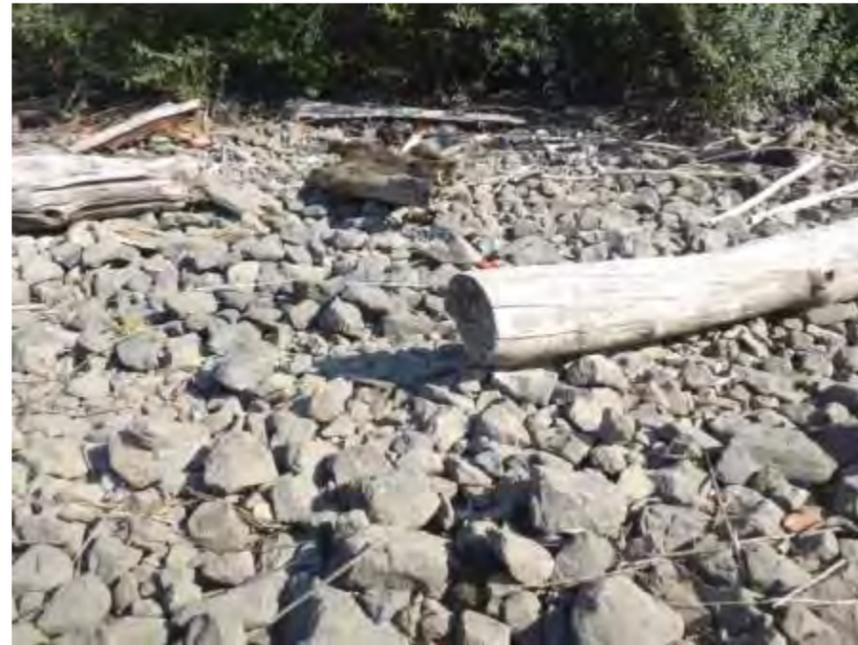
North Transect, looking up-slope

No areas of instability were observed along any portion of the stabilized slope. Armor rock material was stable and free of erosion and sloughing. No sheen was observed during either of the sheen observation events.
