**Field Oversight Report  
For Wheeler Bay Repair  
October 2011**

**Work Assignment No.: 343-VOBB-10BC  
Terminal 4  
EPA RPM: Sean Sheldrake  
CDM Project Manager: Lance Peterson**

**December 16, 2011**

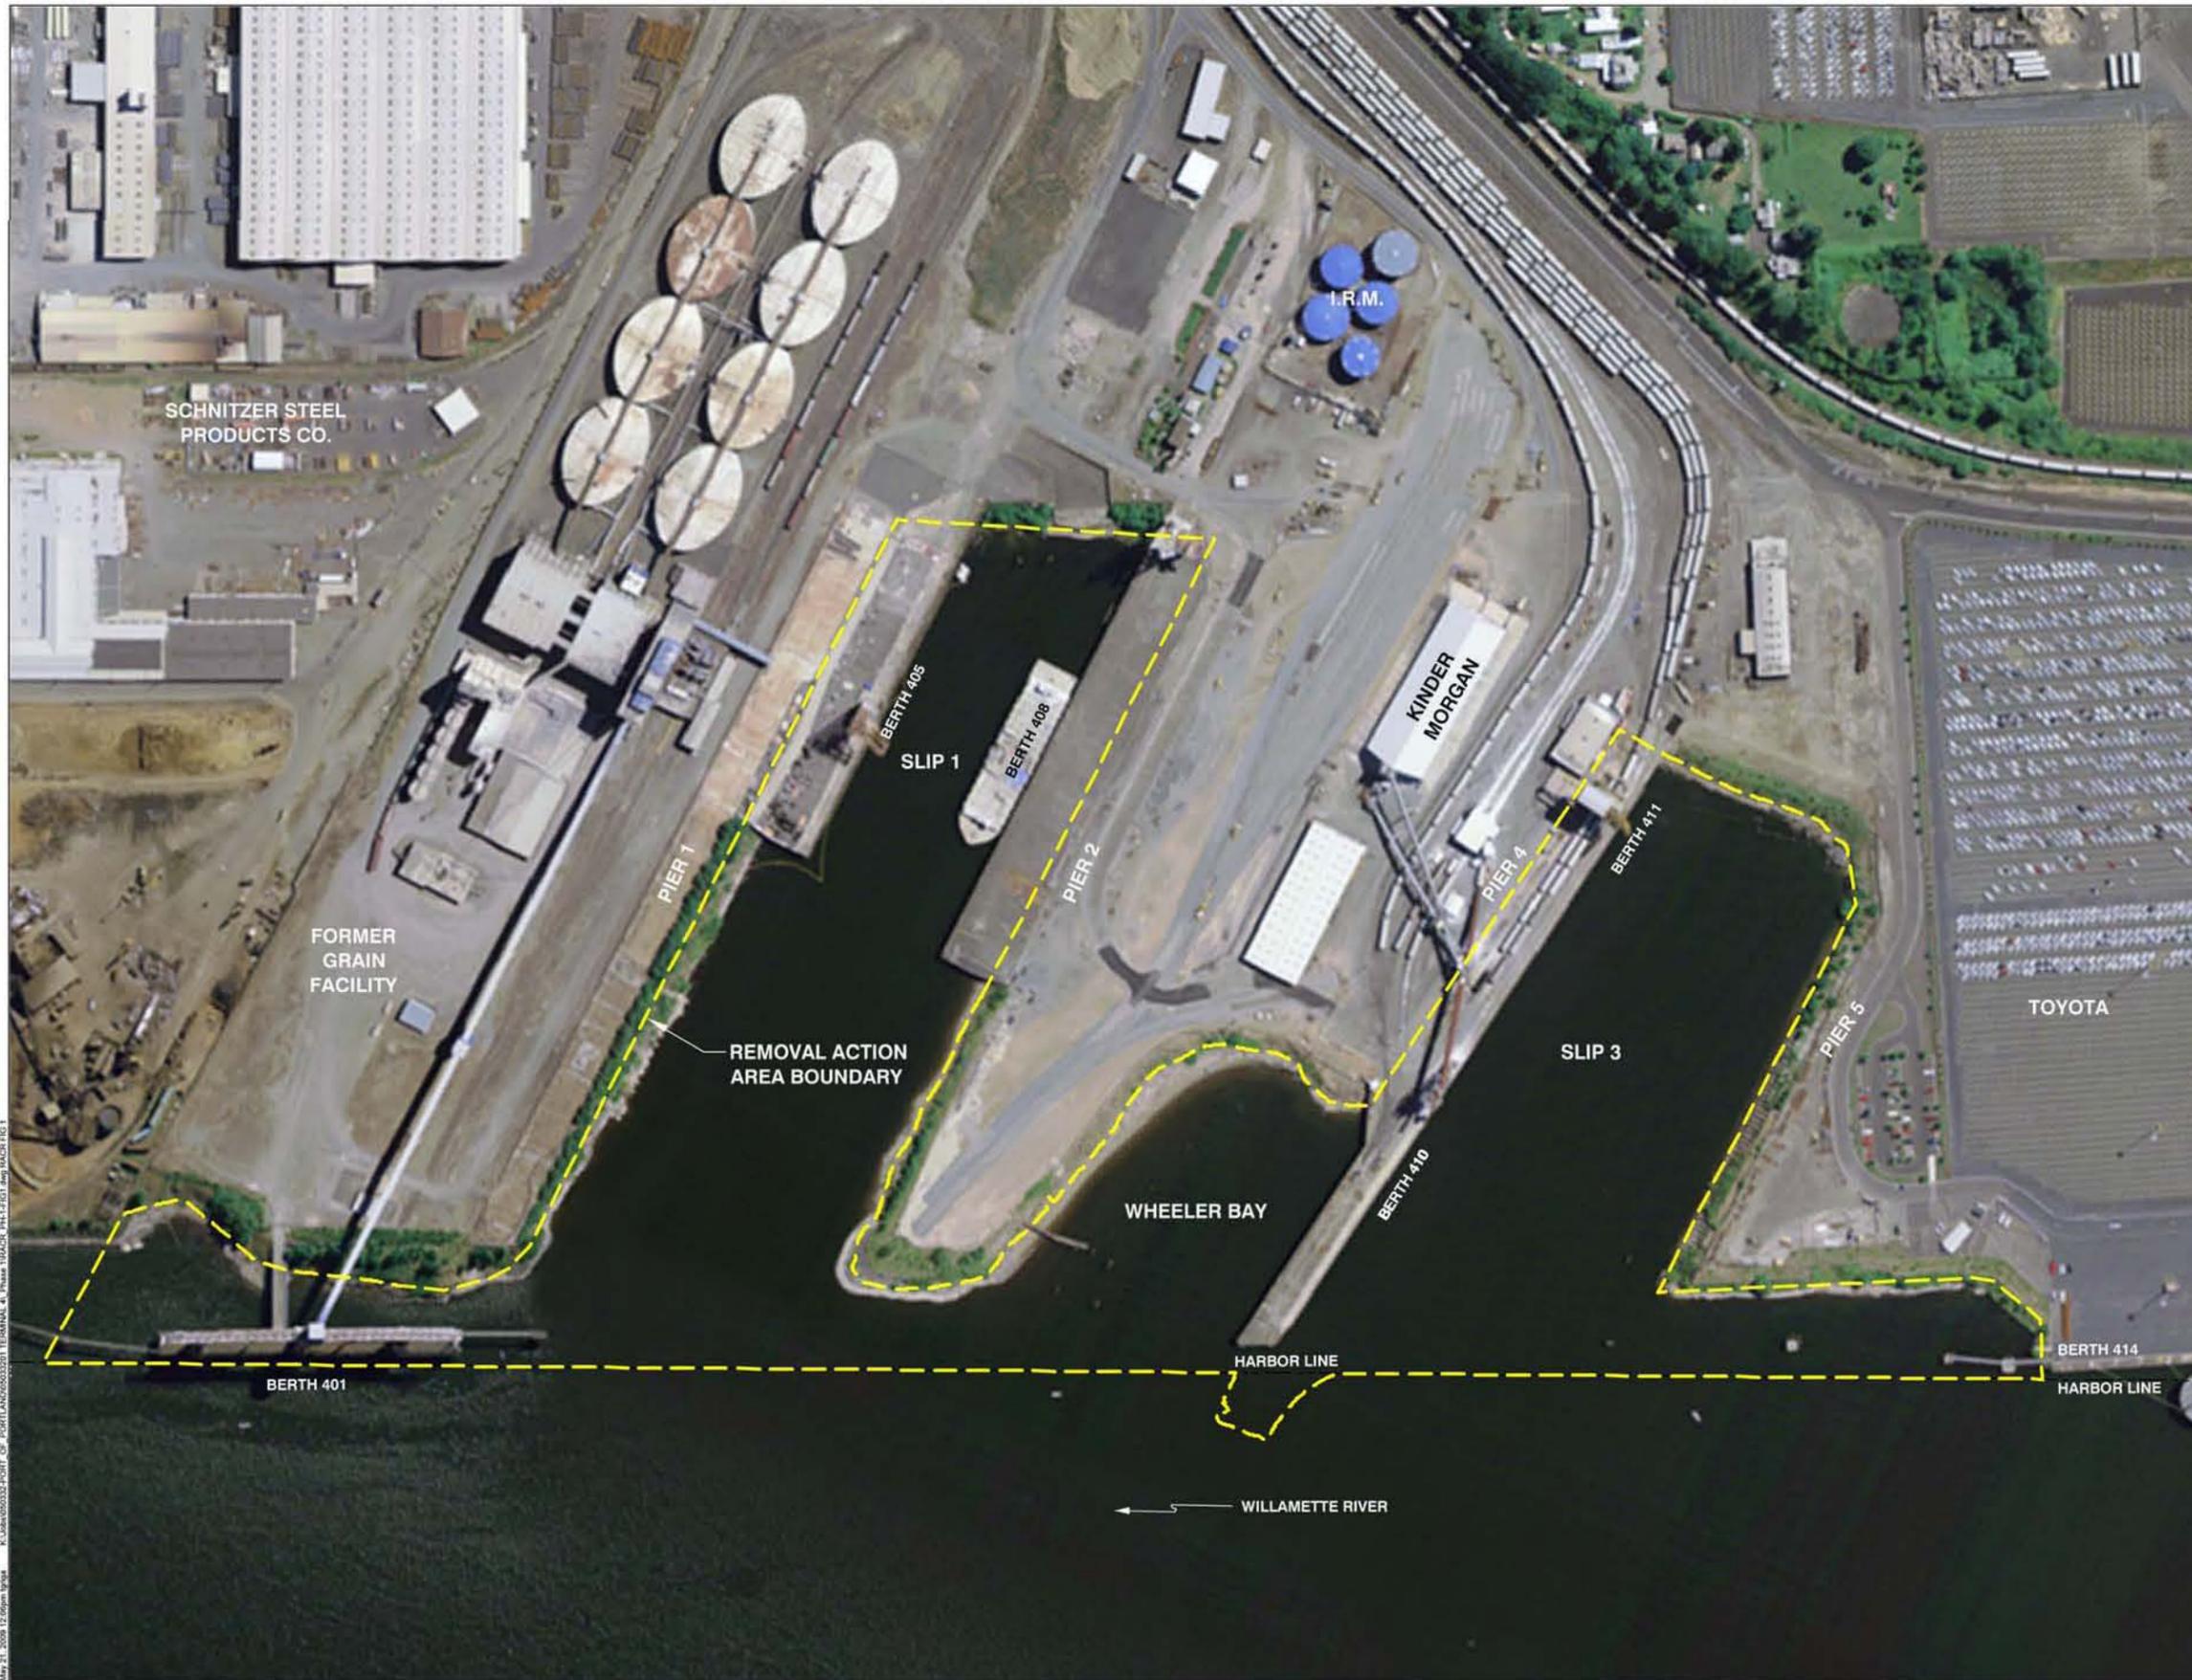
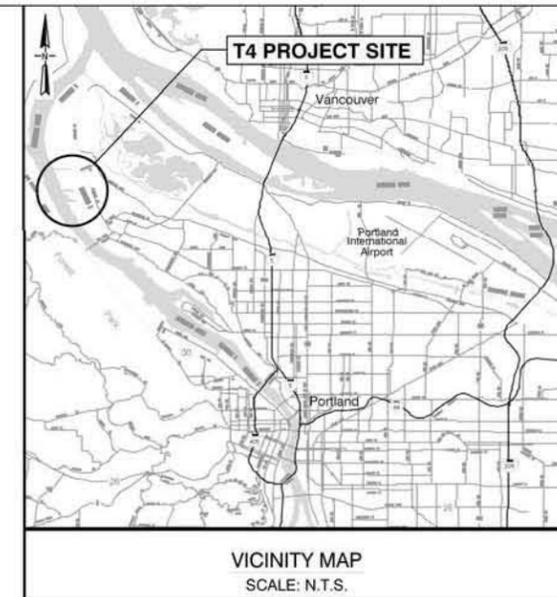
**Figure 1**  
Site Plan and Vicinity Map  
Terminal 4 Phase I Removal Action - Removal Action Completion Report  
Portland, Oregon

The Port of Portland completed a Phase I Removal Action project at the Site in October 2008 that included dredging and capping activities within portions of Slip 3 and shoreline stabilization in Wheeler Bay. **Figure 1 in Appendix A** obtained from Anchor QEA's *Final Removal Action Completion Report* (Anchor QEA 2009) has been provided to show the Site layout, including the location of Wheeler Bay.

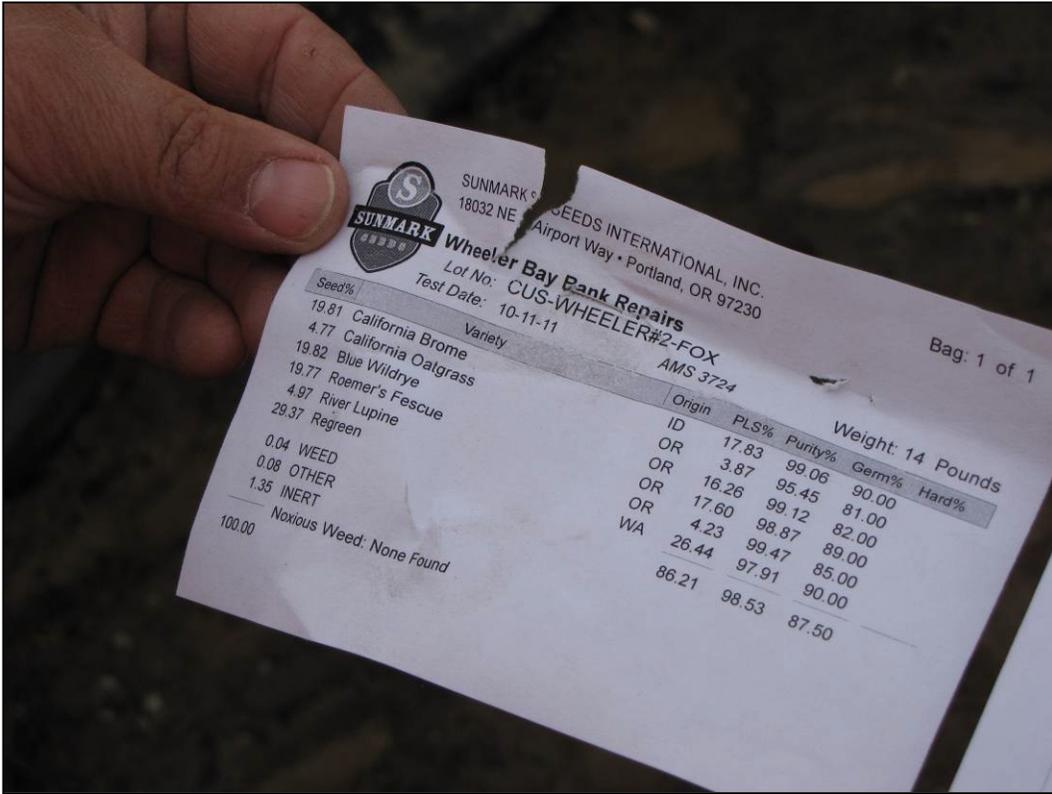
Photos 001 and 002

CDM was onsite from 09:00 hours to 10:30 hours for oversight. At 09:45 hours, a Northwest Earthmovers representative arrived onsite with personnel from Fox Erosion Control and Landscape, Inc., the hydroseeding subcontractor. The temporary access path and other disturbed areas were hydroseeded as the final restoration step per the work plan. A photograph of the packing slip provided with the hydroseed (October 13, 2011 Photo 001 in **Appendix C**) shows the composition of the seed mixture used at the Site.
