**YEAR 5 INTERIM MONITORING REPORT—
TERMINAL 4 PHASE I REMOVAL ACTION
PORT OF PORTLAND, PORTLAND, OREGON**

Port of Portland
7200 Northeast Airport Way
Portland, Oregon 97218

Anchor QEA, LLC
421 Southwest Sixth Avenue, Suite 750
Portland, Oregon 97204

March 2014

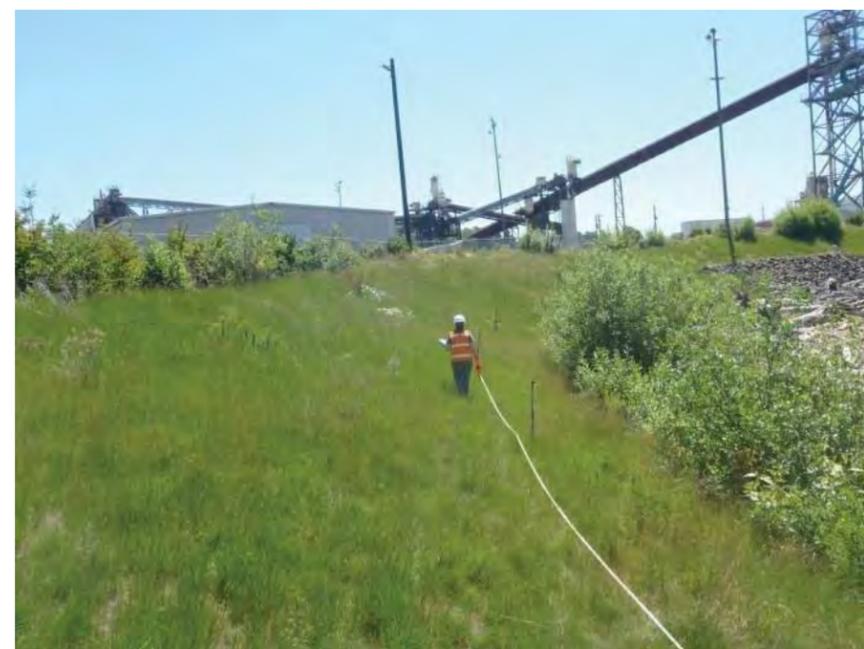
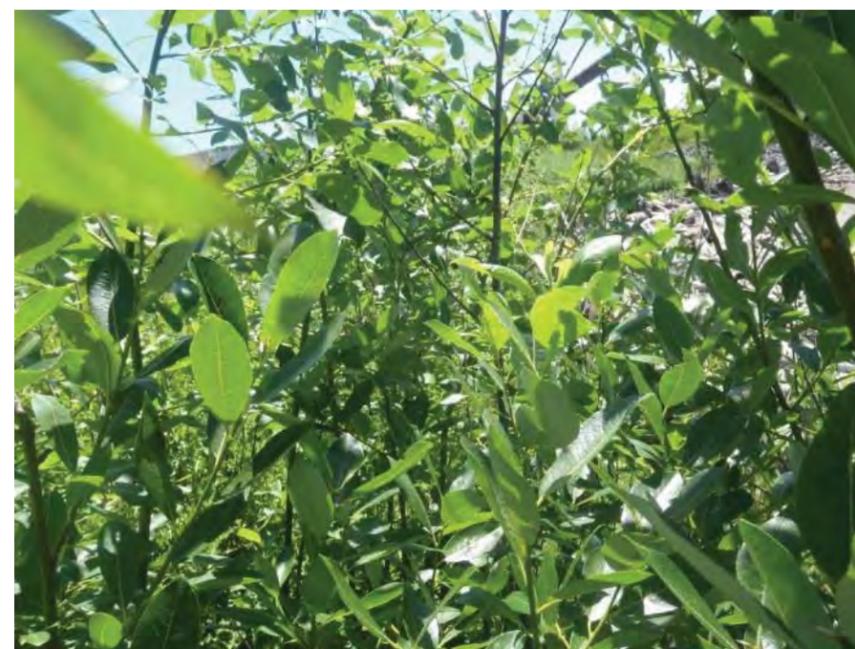
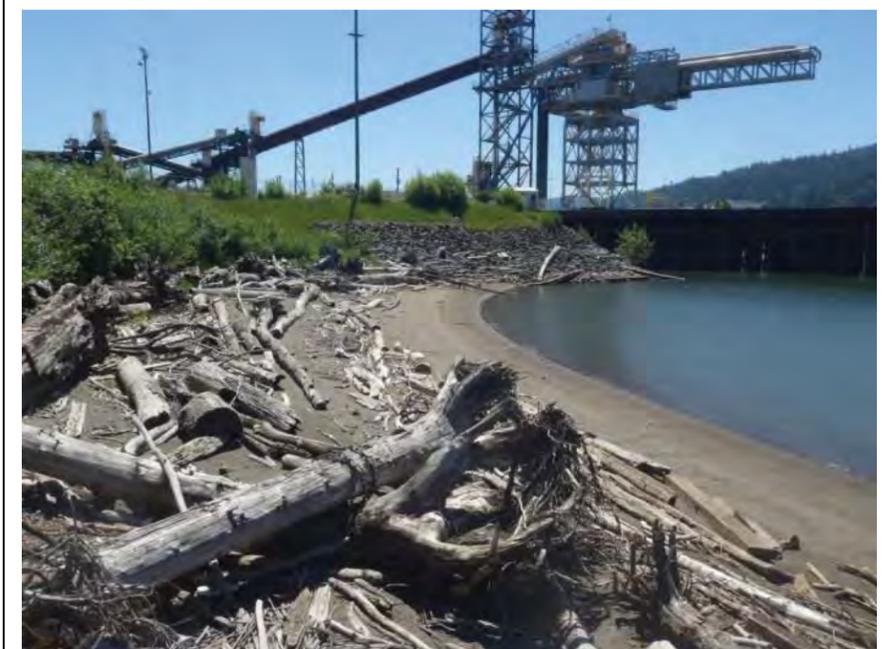
Transect 04+50 at 140 Degrees (Grass, Willow, Armor Rock)

During the October 24, 2013 observation, it was noted that at Station 04+50, a 20-foot swath of the grass planting area had approximately 50-percent live grass coverage with the remainder of coverage consisting of dead grass. The areas of dead grass did not appear to affect the stability of the slope. No other sloughing, instability, or other areas of erosion were observed in the willow or grass planting areas (elevations +15 to +25 feet NGVD29).

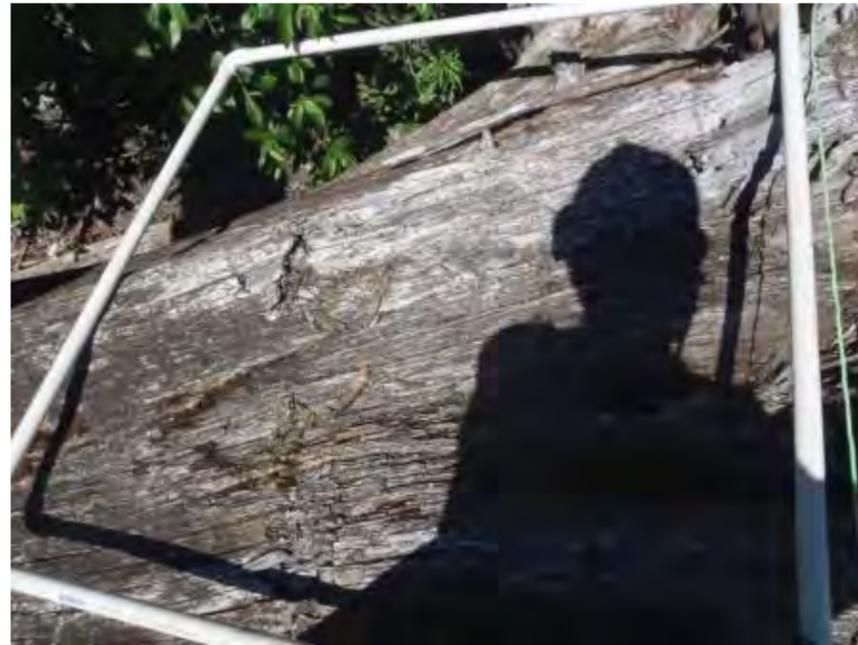
Transect 03+75 (Top)

slope where habitat material was placed over armor rock. Armor rock was observed on the surface in approximately 4 percent of the overall area. The total thickness of habitat material and other non-armor rock material above armor rock averaged 9 inches, with an average of 7 inches consisting of habitat material.

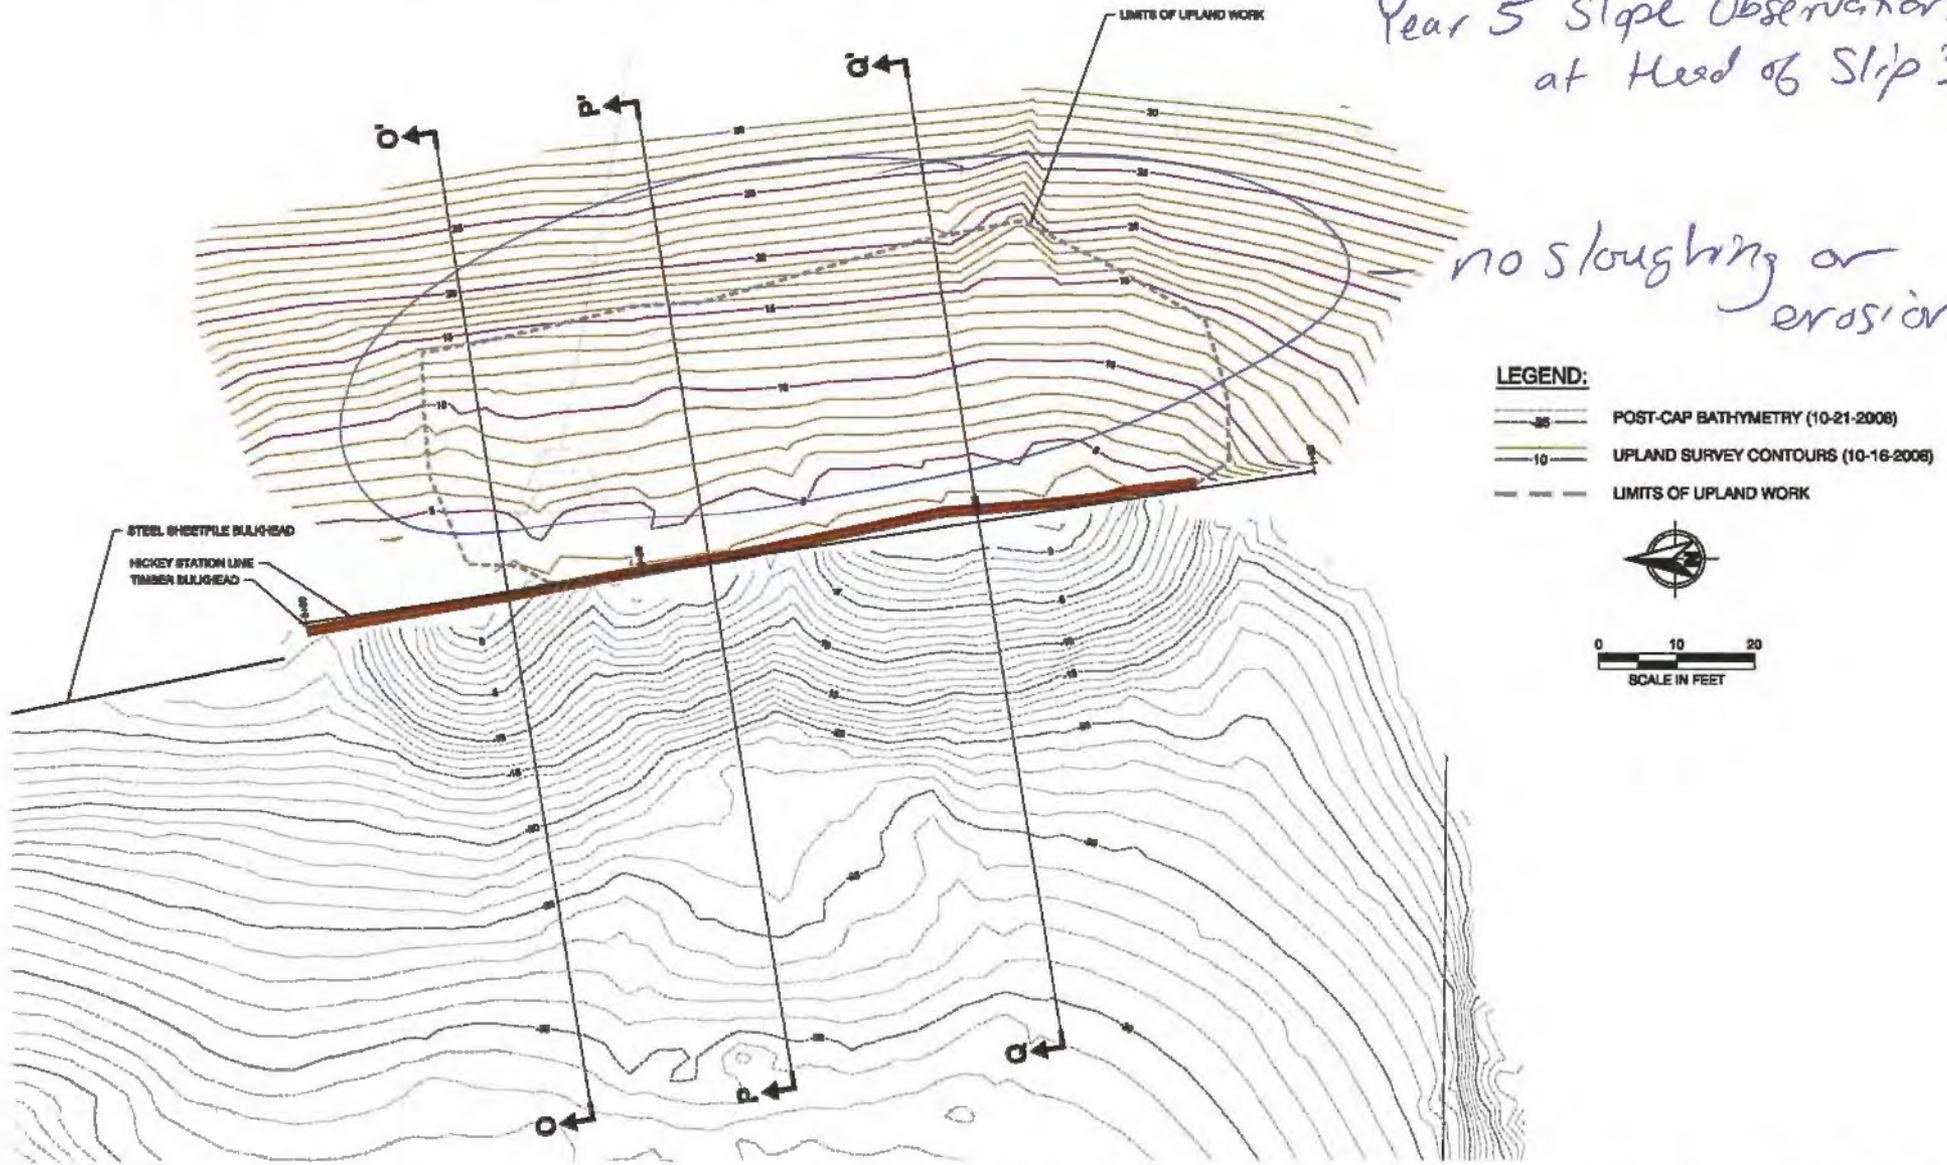
As-built Head of Slip 3 Capping and Upland Plan View and Cross Section Locations
Terminal 4, Portland, Oregon

No instability, sloughing, or sheen was observed.

no sloughing or
erosion.

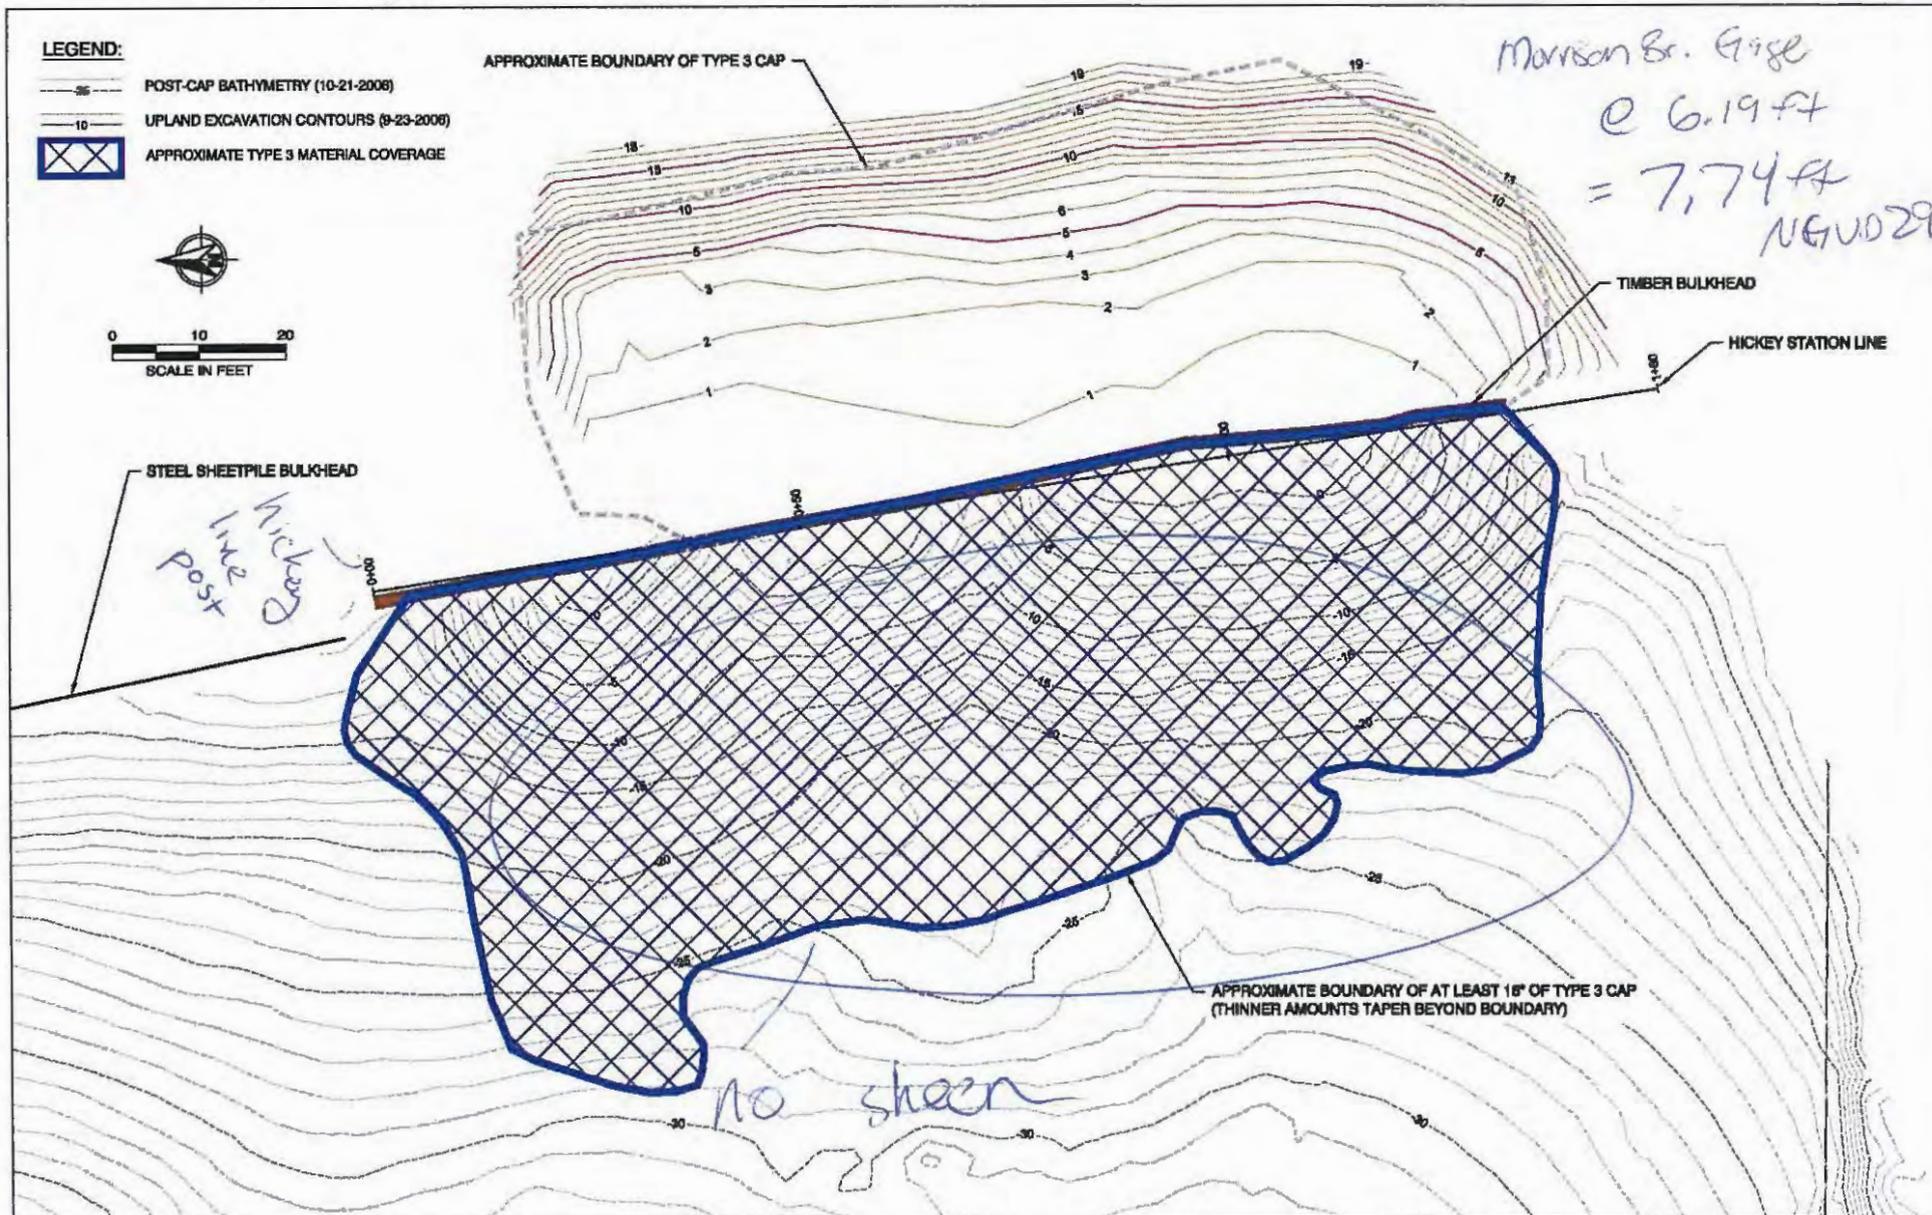
Extent of Type 3 Cap Placement and Extent of Upland Excavation -Head of Slip 3
Terminal 4, Portland, Oregon

Date 15:15
0/4/13

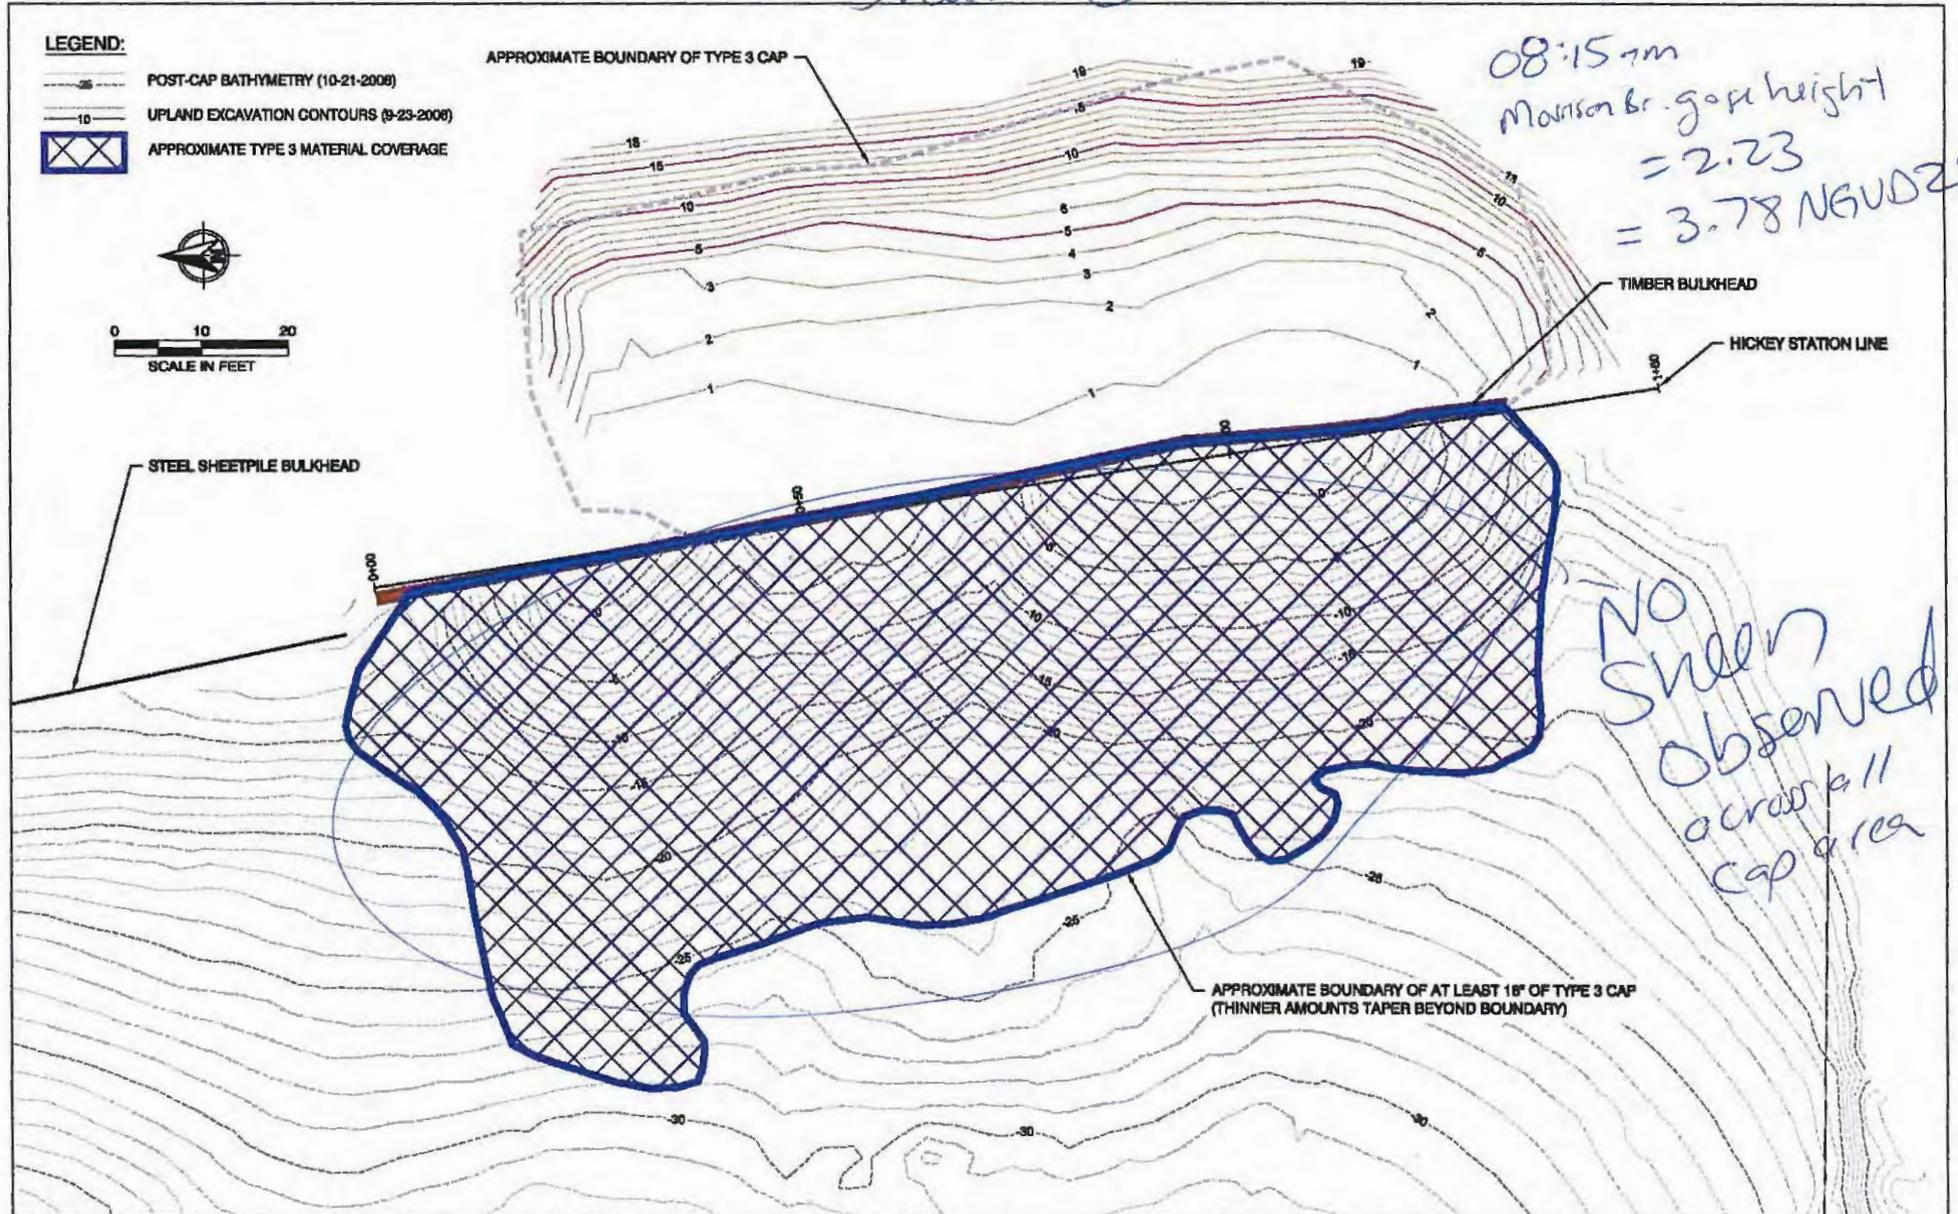
Extent of Type 3 Cap Placement and Extent of Upland Excavation -Head of Slip 3

Low water
Sheet obs

Date 9/12/13
