**Subject: Terminal 4 Removal Action – Wheeler Bay Bank Repairs
Construction Weekly Progress Report for October 25 through 29, 2010**

ATTACHMENT A
PORT OF PORTLAND DAILY CONSTRUCTION REPORTS

PROJECT	Terminal 4, Wheeler Bay Bank Repairs	CONTRACT NO.	10D015/820027
CONTRACTOR	Northwest Earthmovers	SUPERINTENDENT	Carl Johnson (NEI)
DAY OF WEEK & DATE:	Monday October 25, 2010	REPORT NO.	13
WEATHER	Partly Cloudy, NW wind 0-10 mph	TEMPERATURE	L:50 H:60 degrees F

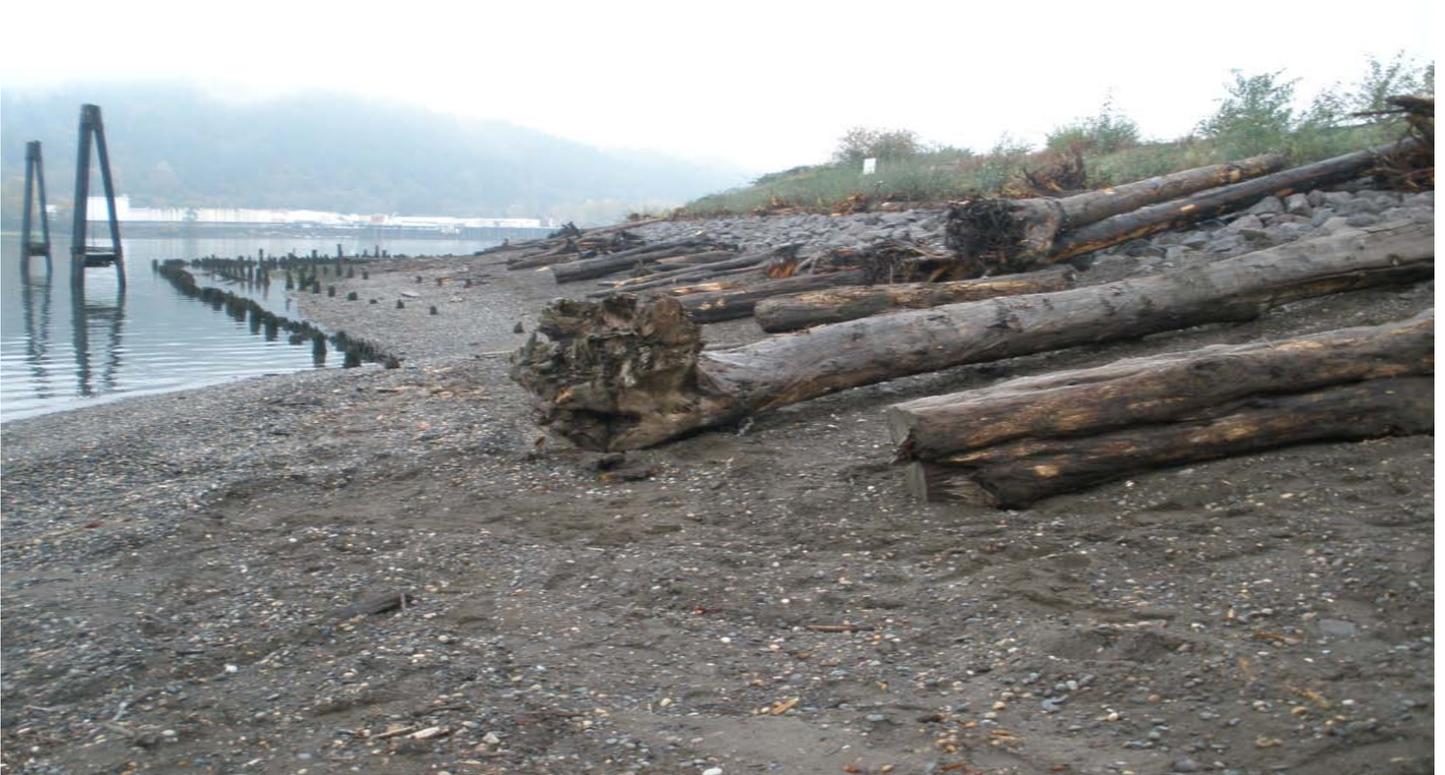
10:15 Kelly Madalinski, Roger Anderson, Lyle Larson (POP); Jeff Hargens, Philip Hansen (NEI); Tim Stone (AQ/POP) on site to perform final construction completion inspection. PHOTO 2 shows the completed conditions looking from station 3+00 toward station 7+00. PHOTO 3 shows the completed conditions looking from station 3+00 toward station 0-20.
NEI removes treated wood from shoreline as indicated by Ken Fellows (PMX) on 10/28. Wood debris was stamped as shown in PHOTO 4. Shoreline is free of incidental garbage and debris.
POP maintenance staff reconnects irrigation control wiring at the point it had been disconnected to construct the construction access ramp.
