FINAL
YEAR 4 INTERIM MONITORING REPORT—
TERMINAL 4 PHASE I REMOVAL ACTION
PORT OF PORTLAND, PORTLAND, OREGON

Port of Portland
Portland, Oregon

Anchor QEA, LLC
421 SW Sixth Avenue, Suite 750
Portland, Oregon 97204

March 2013

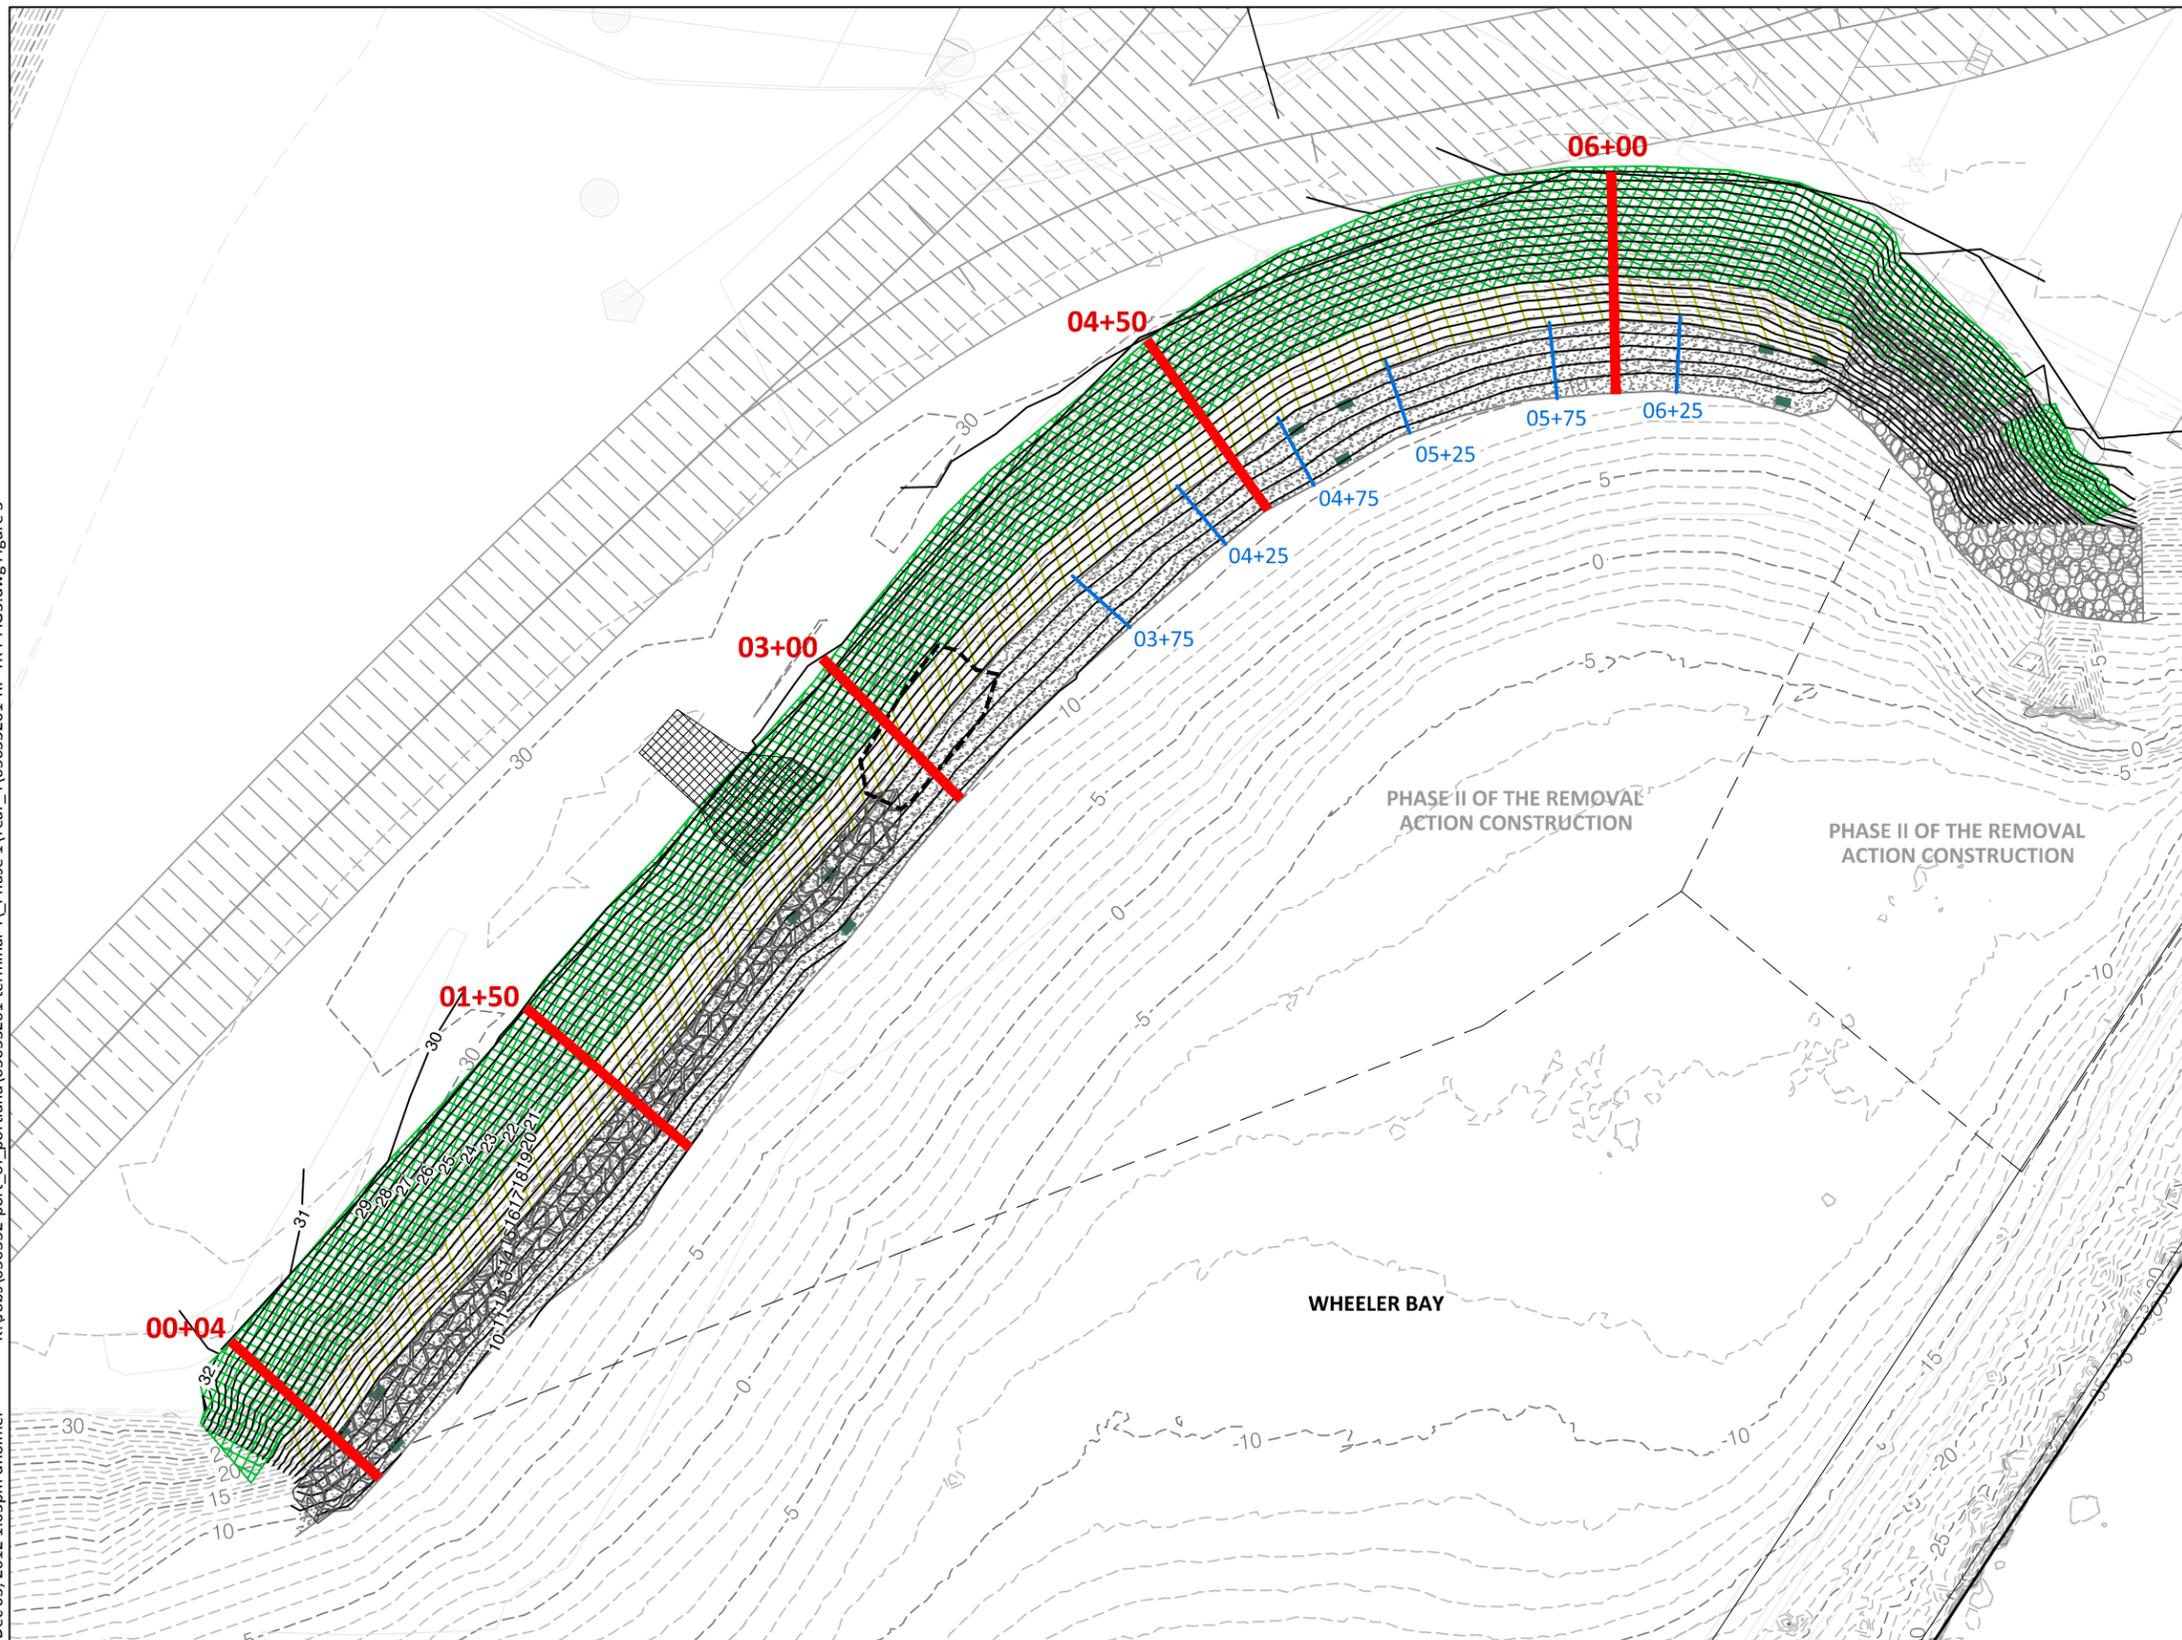
Figure 3
Wheeler Bay Year 4 Slope Stability Transect Locations
Year 4 Interim Monitoring Report - Terminal 4 Phase I Removal Action
Port of Portland

Transects were established perpendicular to the shoreline at 150-foot centers, as described in Section 3.1 and as depicted on Figure 3. Monitoring staff walked along the transects looking for evidence of erosion within the armor layer. Notes and photographs (provided as Attachments A-1 and A-2 to Appendix A, respectively) were taken of the armor layer at each transect. The armor layer showed no signs of instability, sloughing, or erosion. All woody debris installed as part of the original design and repair activities was in place, stable, and in good condition.

A sand and gravel habitat material mixture was placed over the armor layer on a 3 horizontal to 1 vertical (3H:1V) slope from approximate elevations +10 to +15 feet NGVD during the Terminal 4 Phase I Removal Action construction in 2008 (see Figure 3). The habitat layer serves no function of armoring. The intent of the habitat material is to allow it to naturally accrete or erode and provide normative ecological functions. Pursuant to the Biological Opinion (NMFS 2008), the Port has monitored the habitat material layer over the past 4 years to determine if the habitat layer is eroding or accreting.

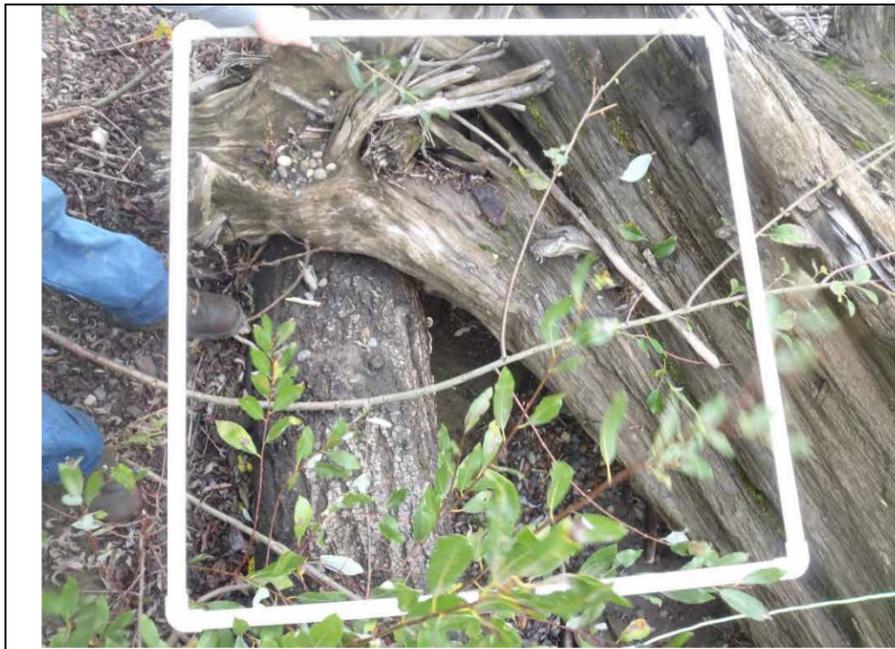
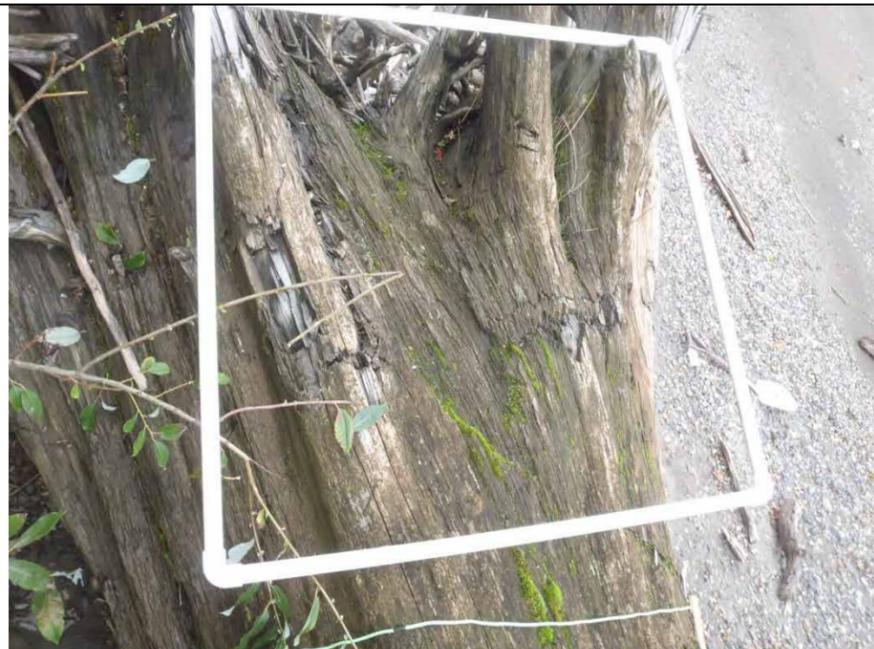
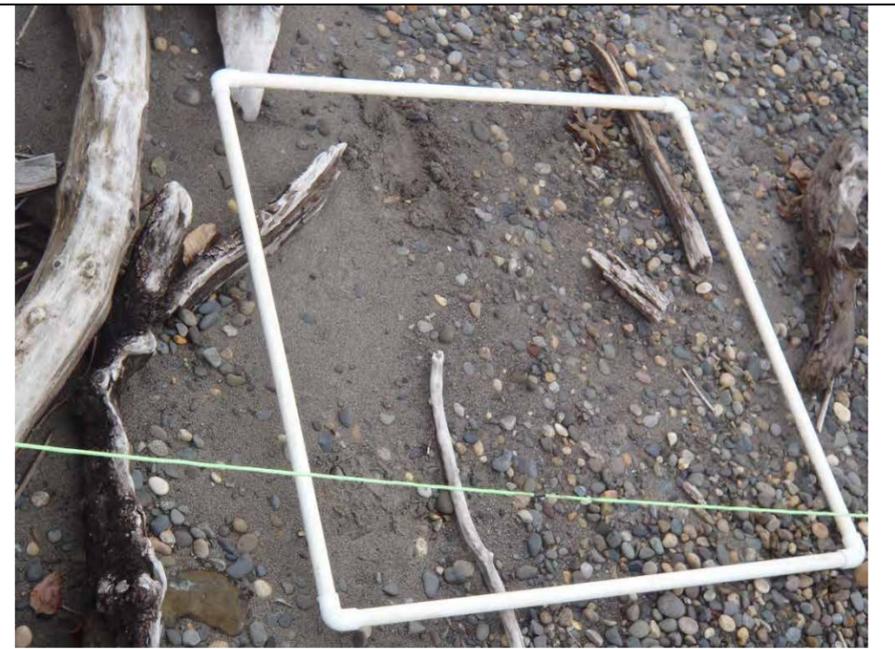
Transect 03+75 (T,M,B)

As expected, the condition of the habitat layer in areas protected by the piles underneath Berth 410 (between Station 3+75 and 6+25) continues to be shielded from erosive forces. Year 4 coverage and thickness of the habitat material is consistent with Years 2 and 3 habitat material evaluation results.

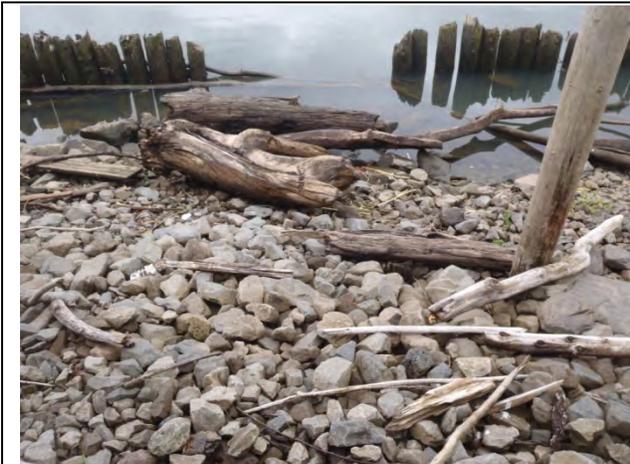
North Transect, looking down-slope

No areas of instability were observed along any portion of the stabilized slope. Armor rocks were stable and free of erosion and sloughing. No sheens were observed during either of the sheen observation events.

No instability, sloughing, or sheens were observed; therefore, no further monitoring action beyond what is required in the IMRP is recommended for the head of Slip 3 cap at this time.
