FINAL  
YEAR 2 INTERIM MONITORING REPORT –  
TERMINAL 4 PHASE I REMOVAL ACTION  
PORT OF PORTLAND, PORTLAND, OREGON

Port of Portland  
Portland, Oregon

Anchor QEA, LLC  
6650 SW Redwood Lane, Suite 333  
Portland, Oregon 97224

**February 2011**

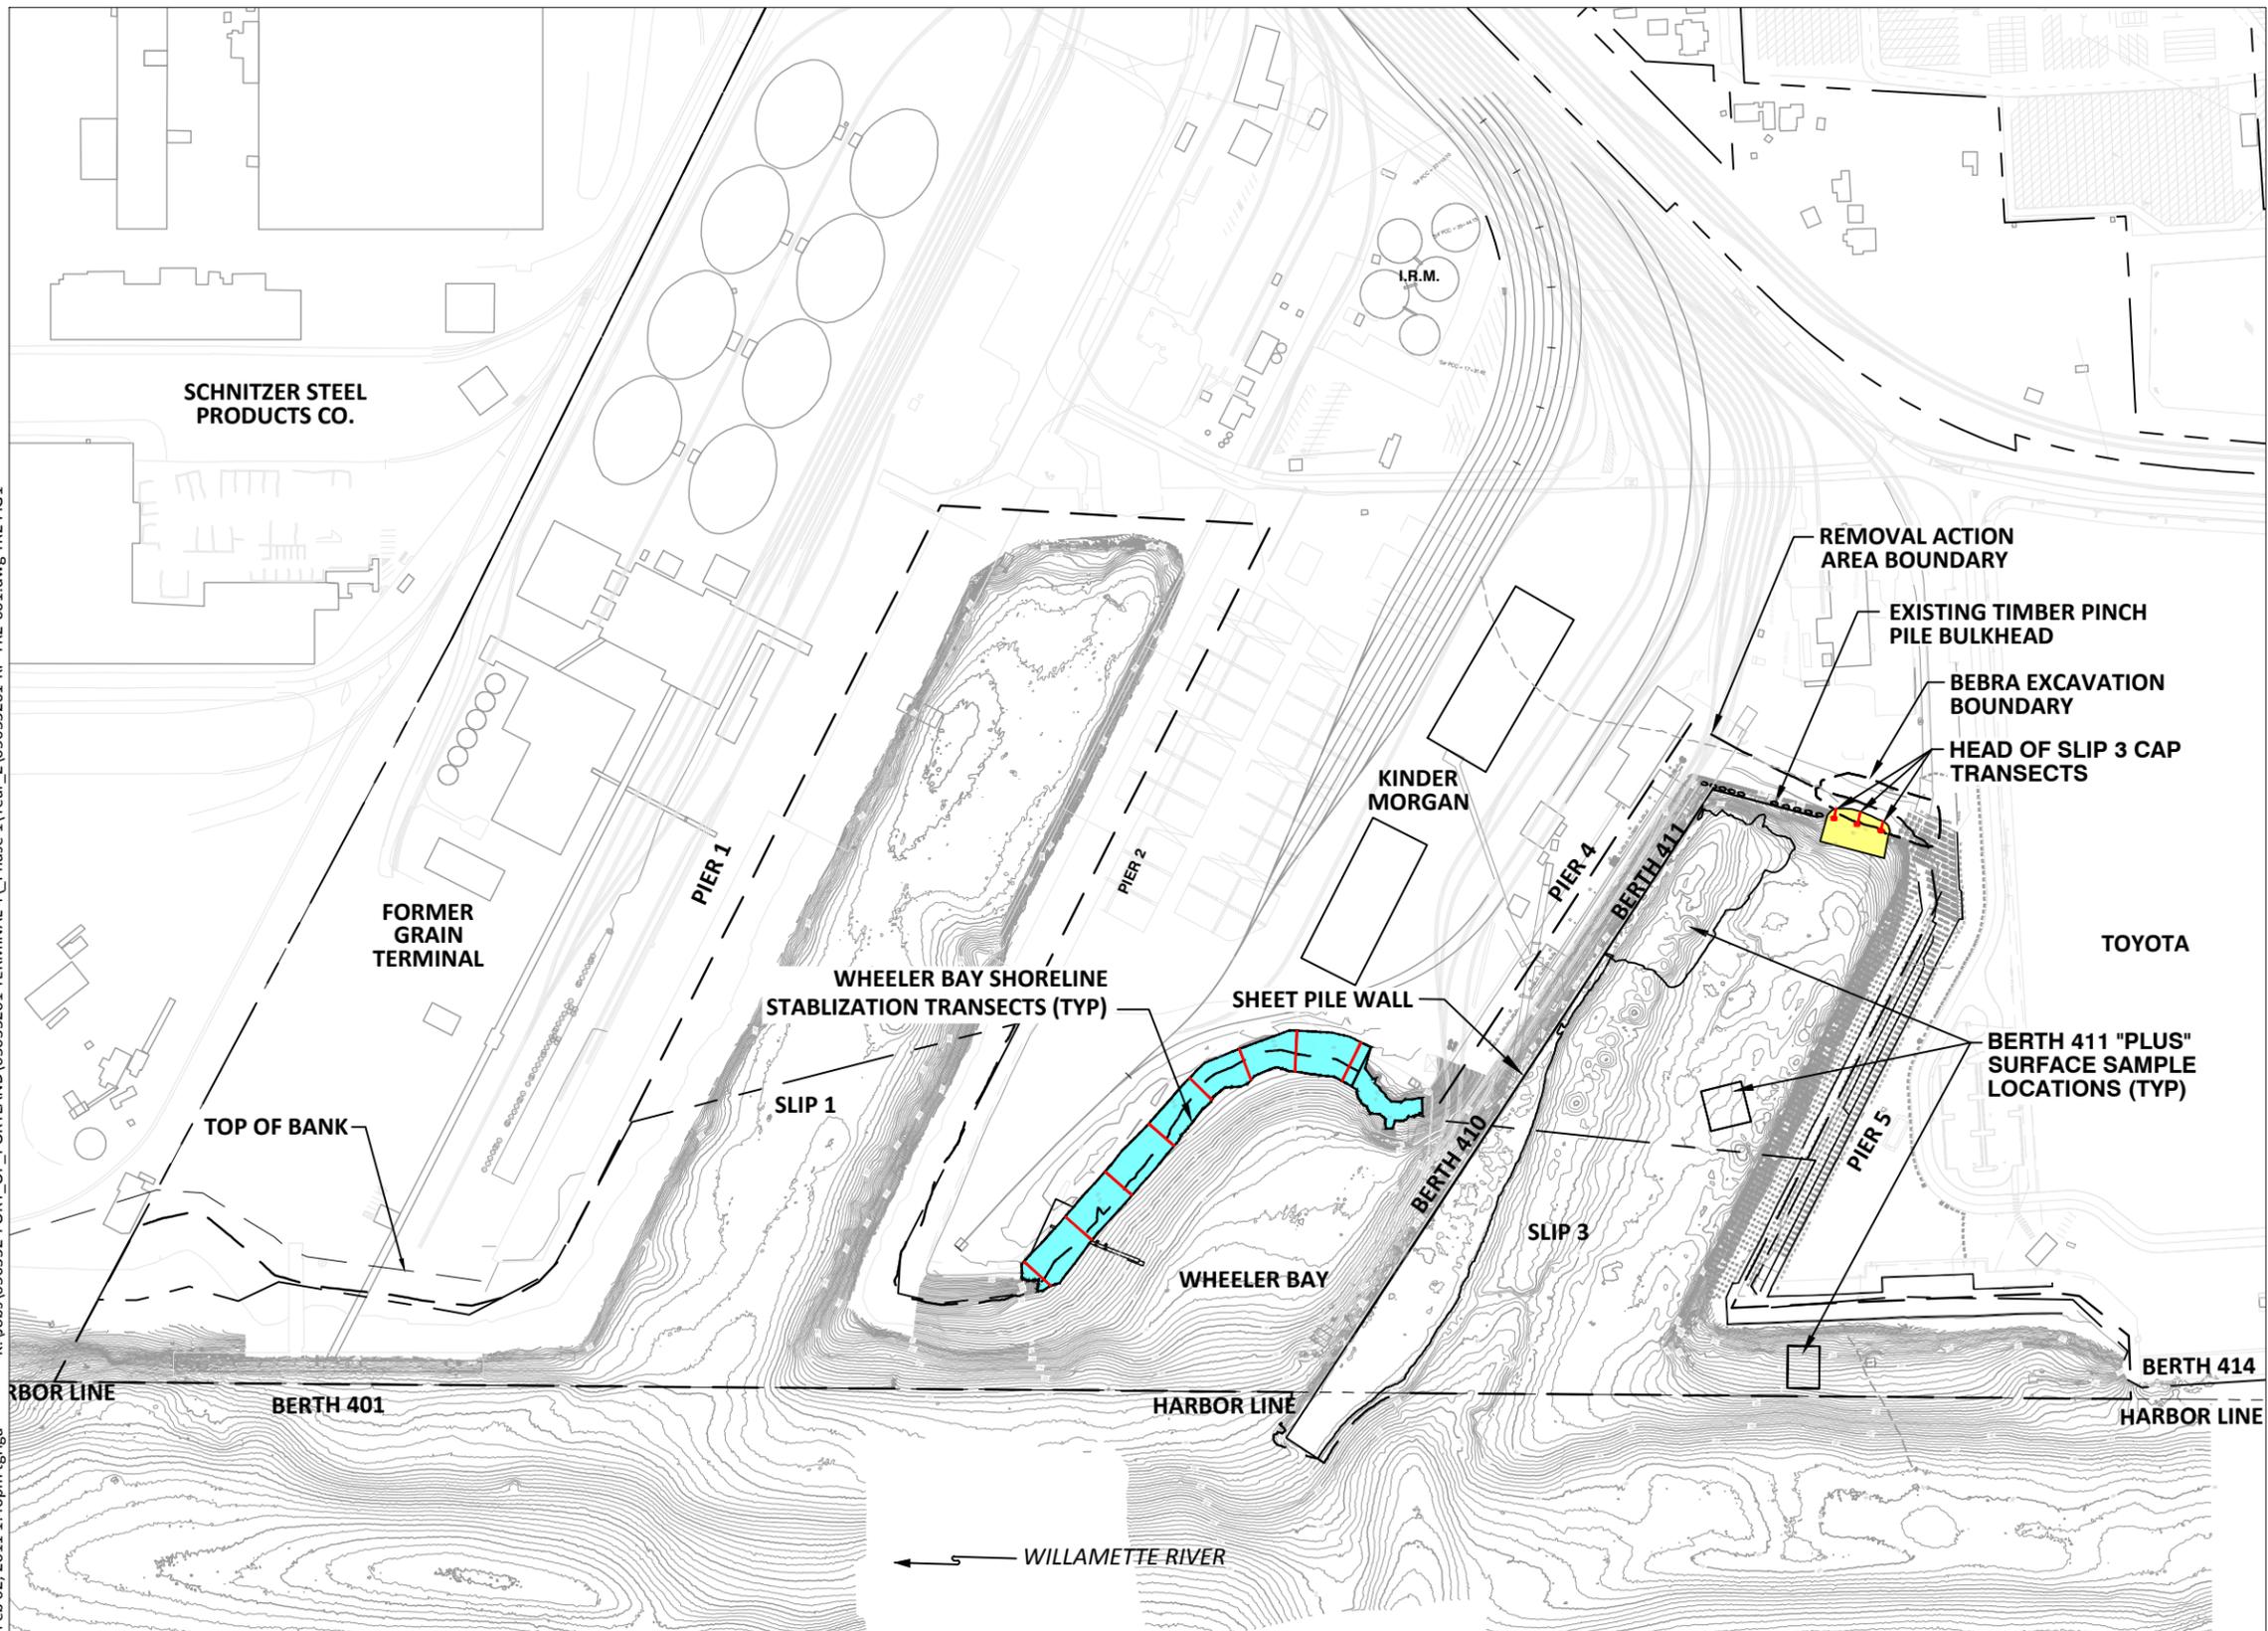
This document provides a summary of the second year monitoring results for the head of Slip 3 cap and Wheeler Bay (WB) shoreline stabilization. Interim monitoring survey locations are depicted on Figure 1. Monitoring was conducted in accordance with the requirements of the *Interim Monitoring and Reporting Plan* (IMRP; Design Analysis Report [DAR] Appendix C; Anchor 2008). A description of the observed site conditions and relevant data summaries are provided in this report. A repair of the WB shoreline was completed during the second year of monitoring to address areas where erosion had occurred. A brief summary of the repair is provided in Section 4, and detailed construction information was provided to the U.S. Environmental Protection Agency (USEPA) on September 17, 2010, in the Removal Action Work Plan for the repair work (Anchor QEA 2010). Post-construction, no areas of erosion were noted during the Year 2 monitoring activities; therefore, recommended corrective actions and a schedule for implementing the corrective actions are not included in this report.

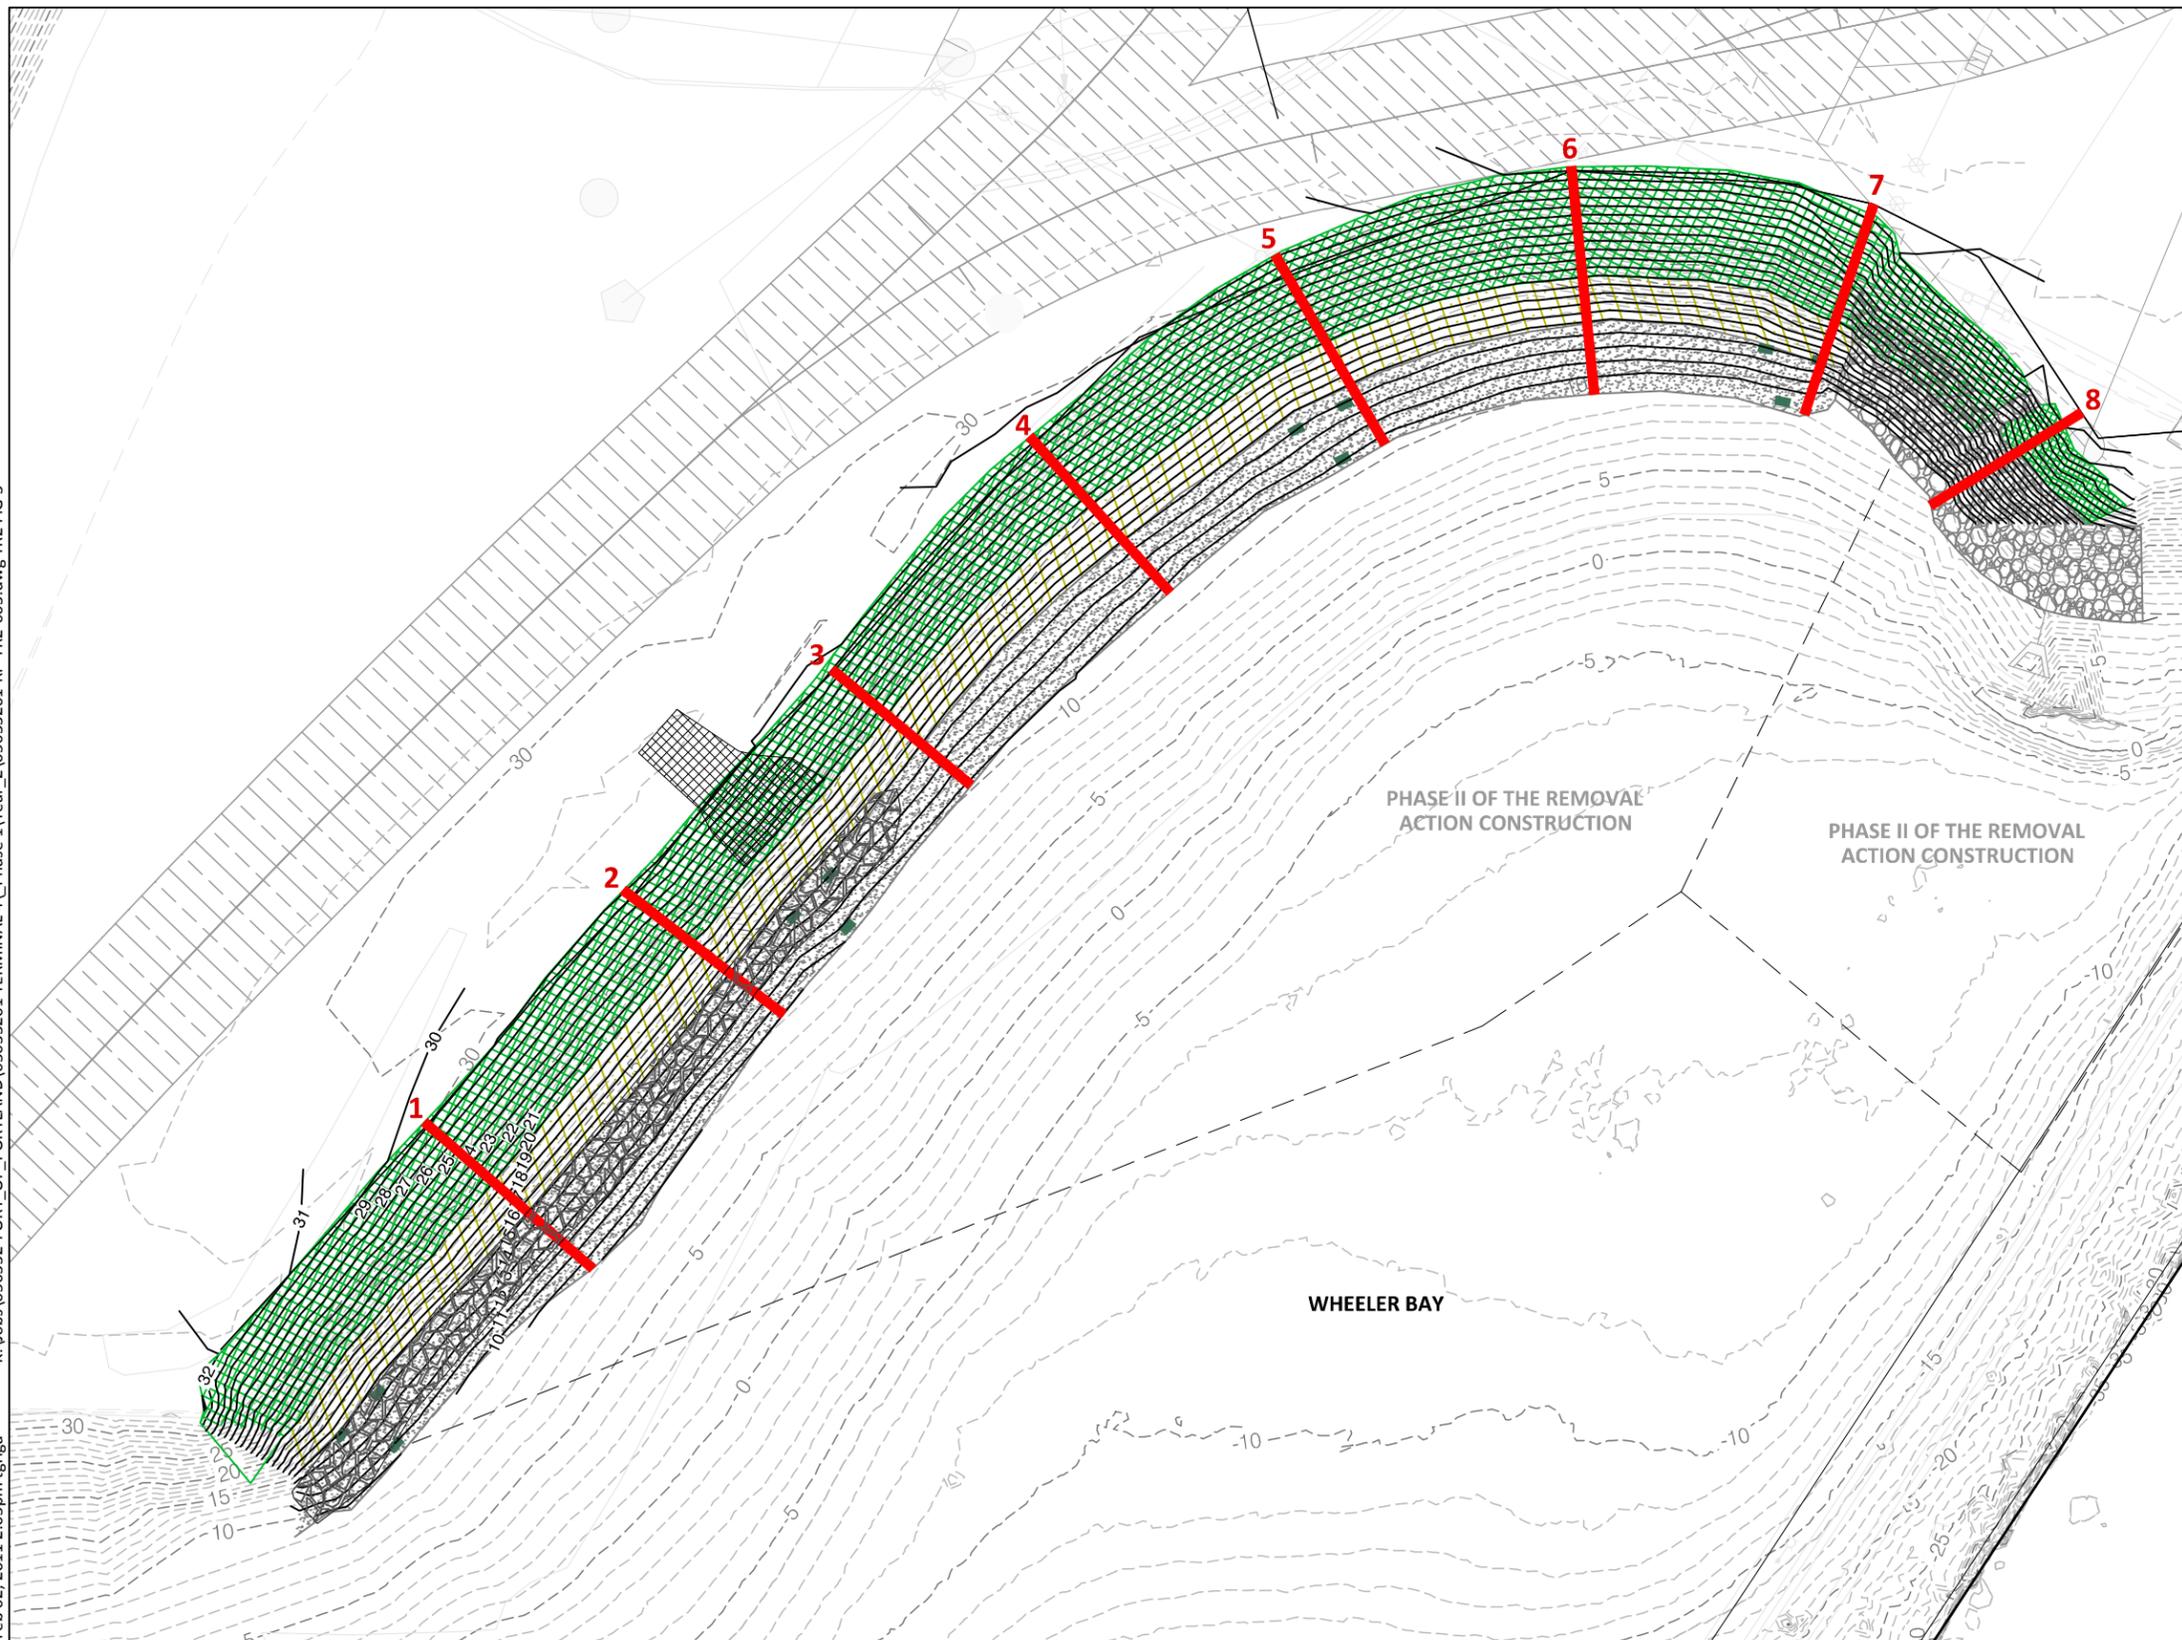
**Figure 3**  
 Wheeler Bay Year 2 Slope Stability Transect Locations  
 Year 2 Interim Monitoring Report - Terminal 4 Phase I Removal Action  
 Port of Portland

Visual slope stability observations were made during a site visit on November 9, 2010 after the completion of WB repair work. In accordance with the IMRP, Year 1 transects were re-established, perpendicular to the shoreline at 100-foot centers. A total of eight transects were established and upslope and downslope GPS points were taken for each transect. The transects are depicted on Figure 3. Transects were marked with flags and monitoring staff walked from the upslope edge of the grass planting down to the water. Notes and photographs (provided as Attachments A-1 and A-2 to Appendix A, respectively) were taken to document slope stability at each transect. No sloughing, instability, or erosion was observed in the willow or grass planting areas (the willow planting area is between elevations +15 to +20 feet NGVD and the grass planting area is between elevations +20 to +30 feet NGVD).

Transects were established perpendicular to the shoreline at 100-foot centers as described in Section 3.1 and as depicted on Figure 3. Monitoring staff walked along the transects looking for evidence of erosion within the armor layer. Notes and photographs (provided as

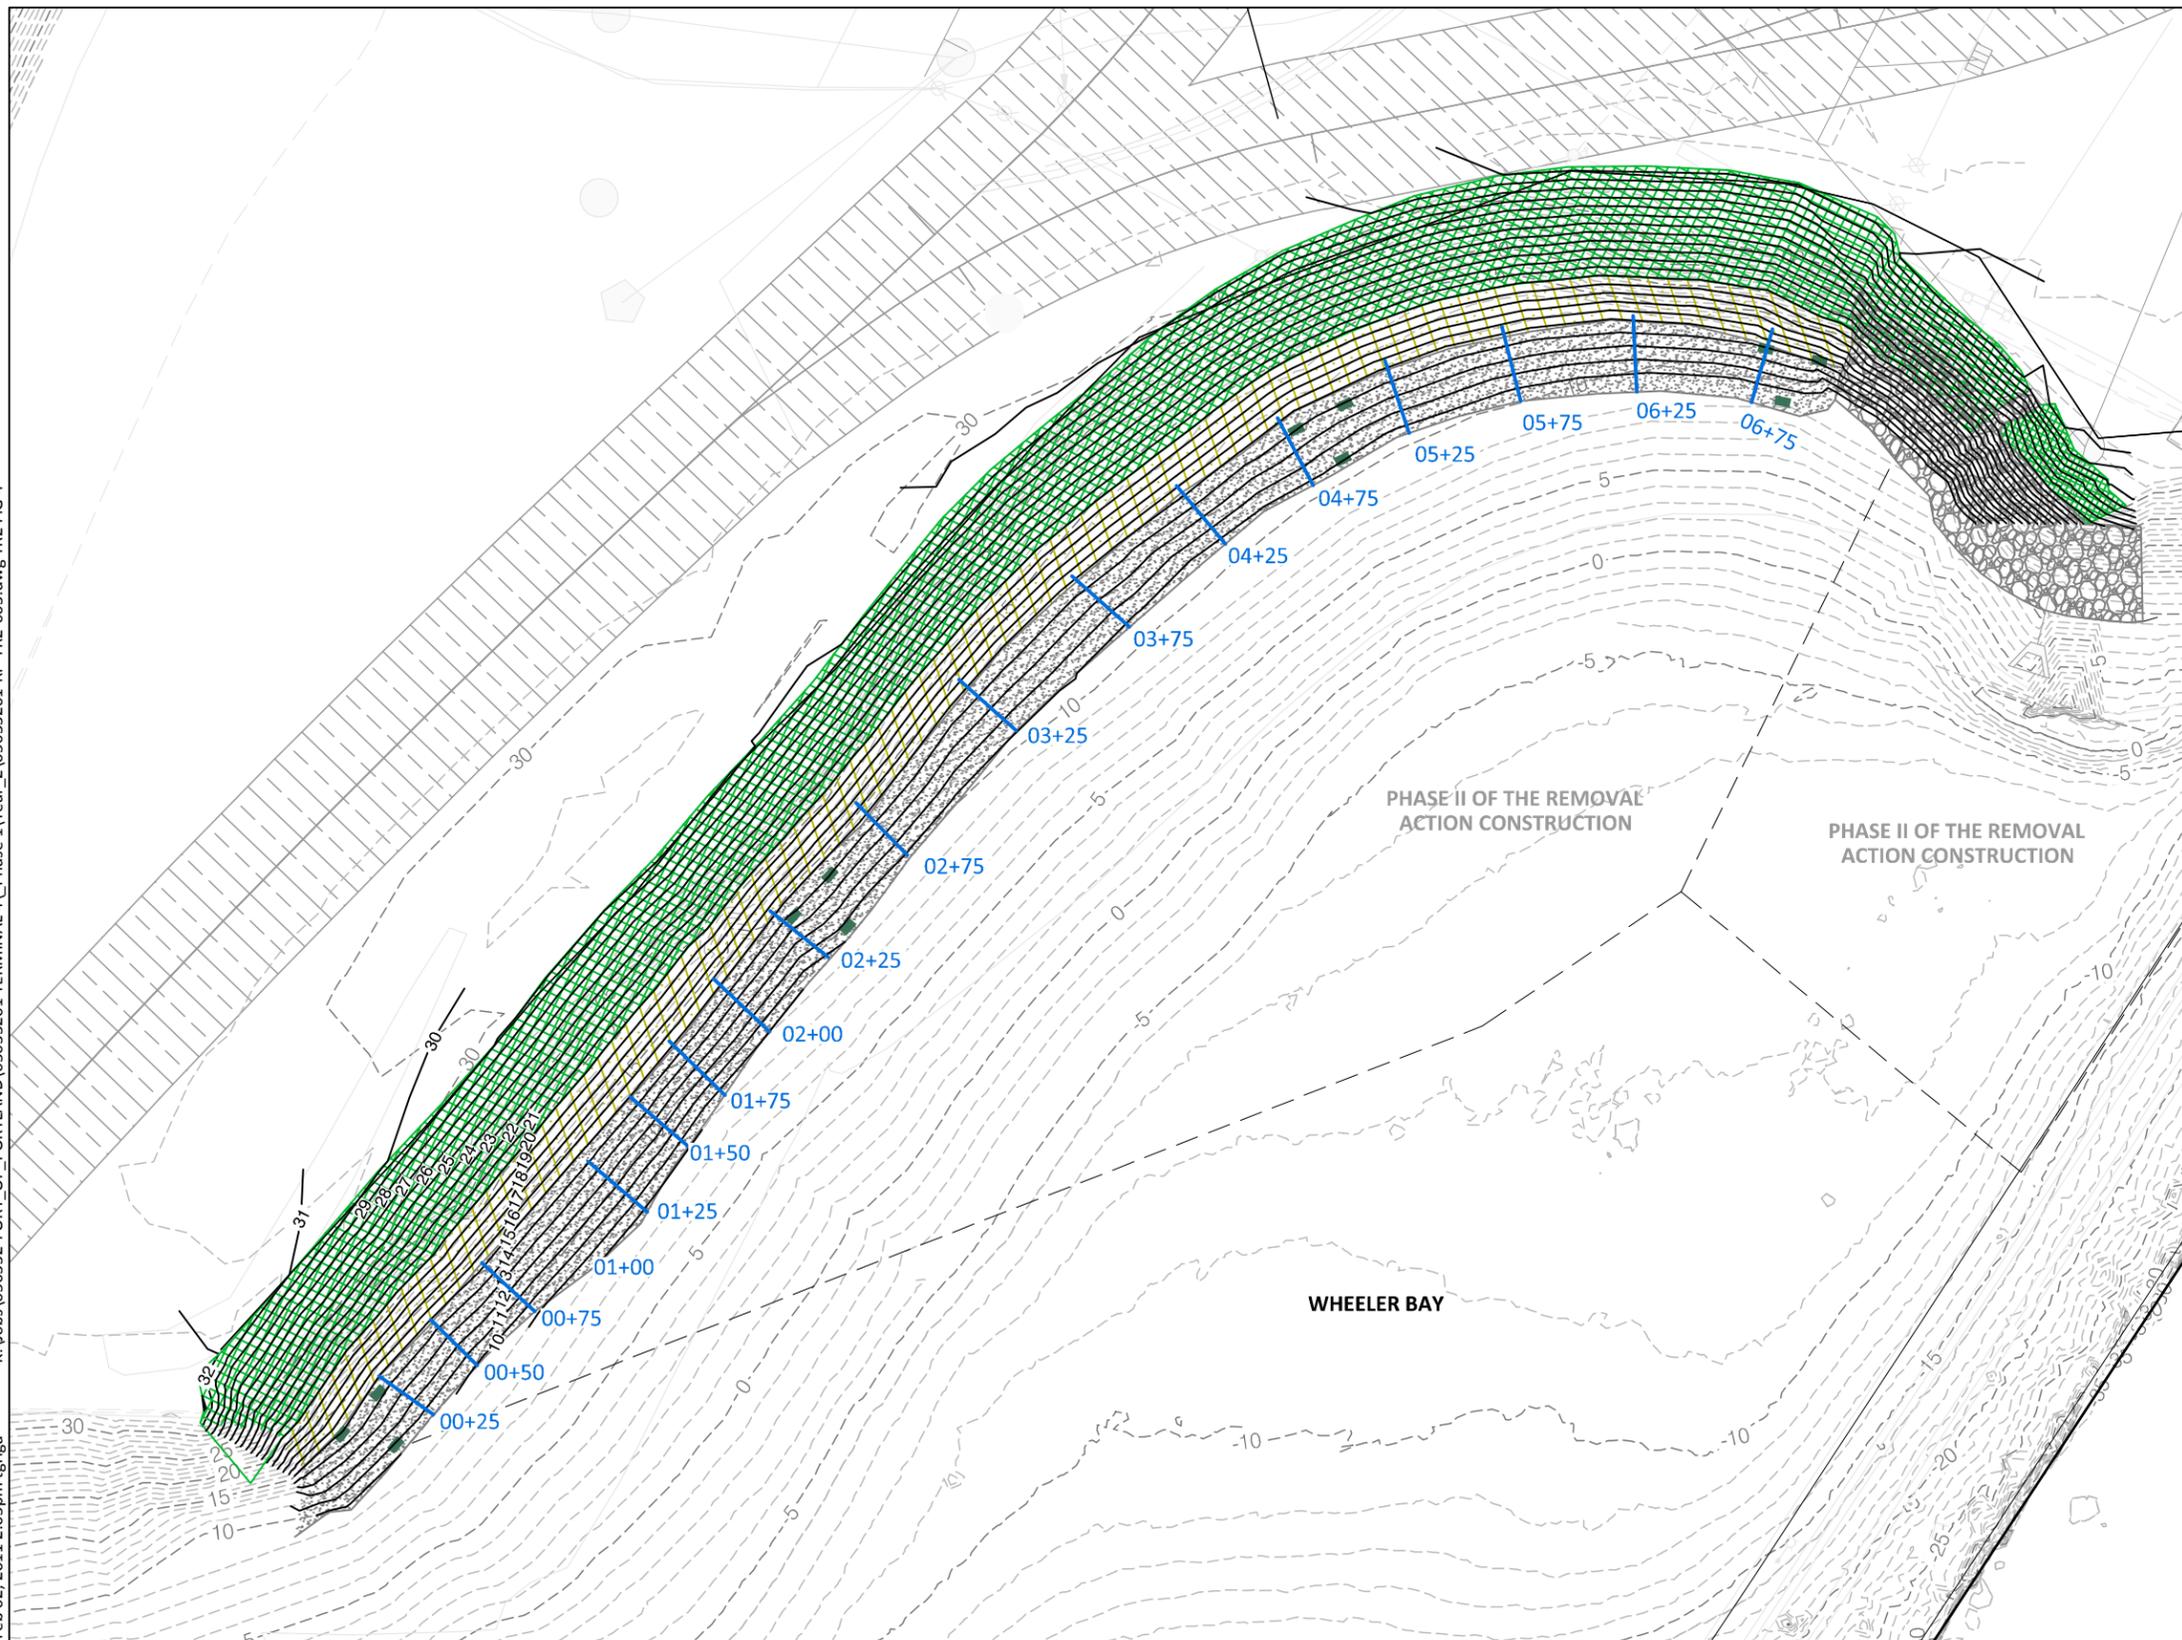
**Figure 4**  
 Wheeler Bay Year 2 Habitat Layer Transect Locations and 2008 As-Built  
 Year 2 Interim Monitoring Report - Terminal 4 Phase I Removal Action  
 Port of Portland

A sand and gravel habitat material mixture was placed over the armor layer on a 3H:1V slope from approximate elevations +10 to +15 feet NGVD during the Terminal 4 Phase I Removal Action construction in 2008 (Figure 4). The habitat layer serves no function of armoring. The intent of the habitat material is to allow it to naturally accrete or erode and provide normative ecological functions. Pursuant to the Biological Opinion, the Port has monitored the habitat material layer over the past 2 years to determine if the habitat layer is eroding or accreting.

- A 670-foot transect was established at approximately elevation +15 feet NGVD from the mouth of the bay to the end of the willow planting area.
- Perpendicular transects (as shown on Figure 4) were established every 25 feet in the high erosion area (0 to 225 feet from the mouth of the bay), and every 50 feet in the less erosion-impacted areas (225 feet to the end of the willow planting area, 670 feet from the mouth of the bay).
- Perpendicular transects extended over the armor rock-placed area from approximate elevations +15 to +10 feet NGVD.
- A quadrat (3 feet by 3 feet) was placed at the top, middle, and bottom of the perpendicular transects. Substrate type was recorded as a percent of area within the quadrat.
- Habitat material thickness up to 12 inches was determined for a single quadrat in each perpendicular transect, alternating between top, middle, and bottom quadrats.

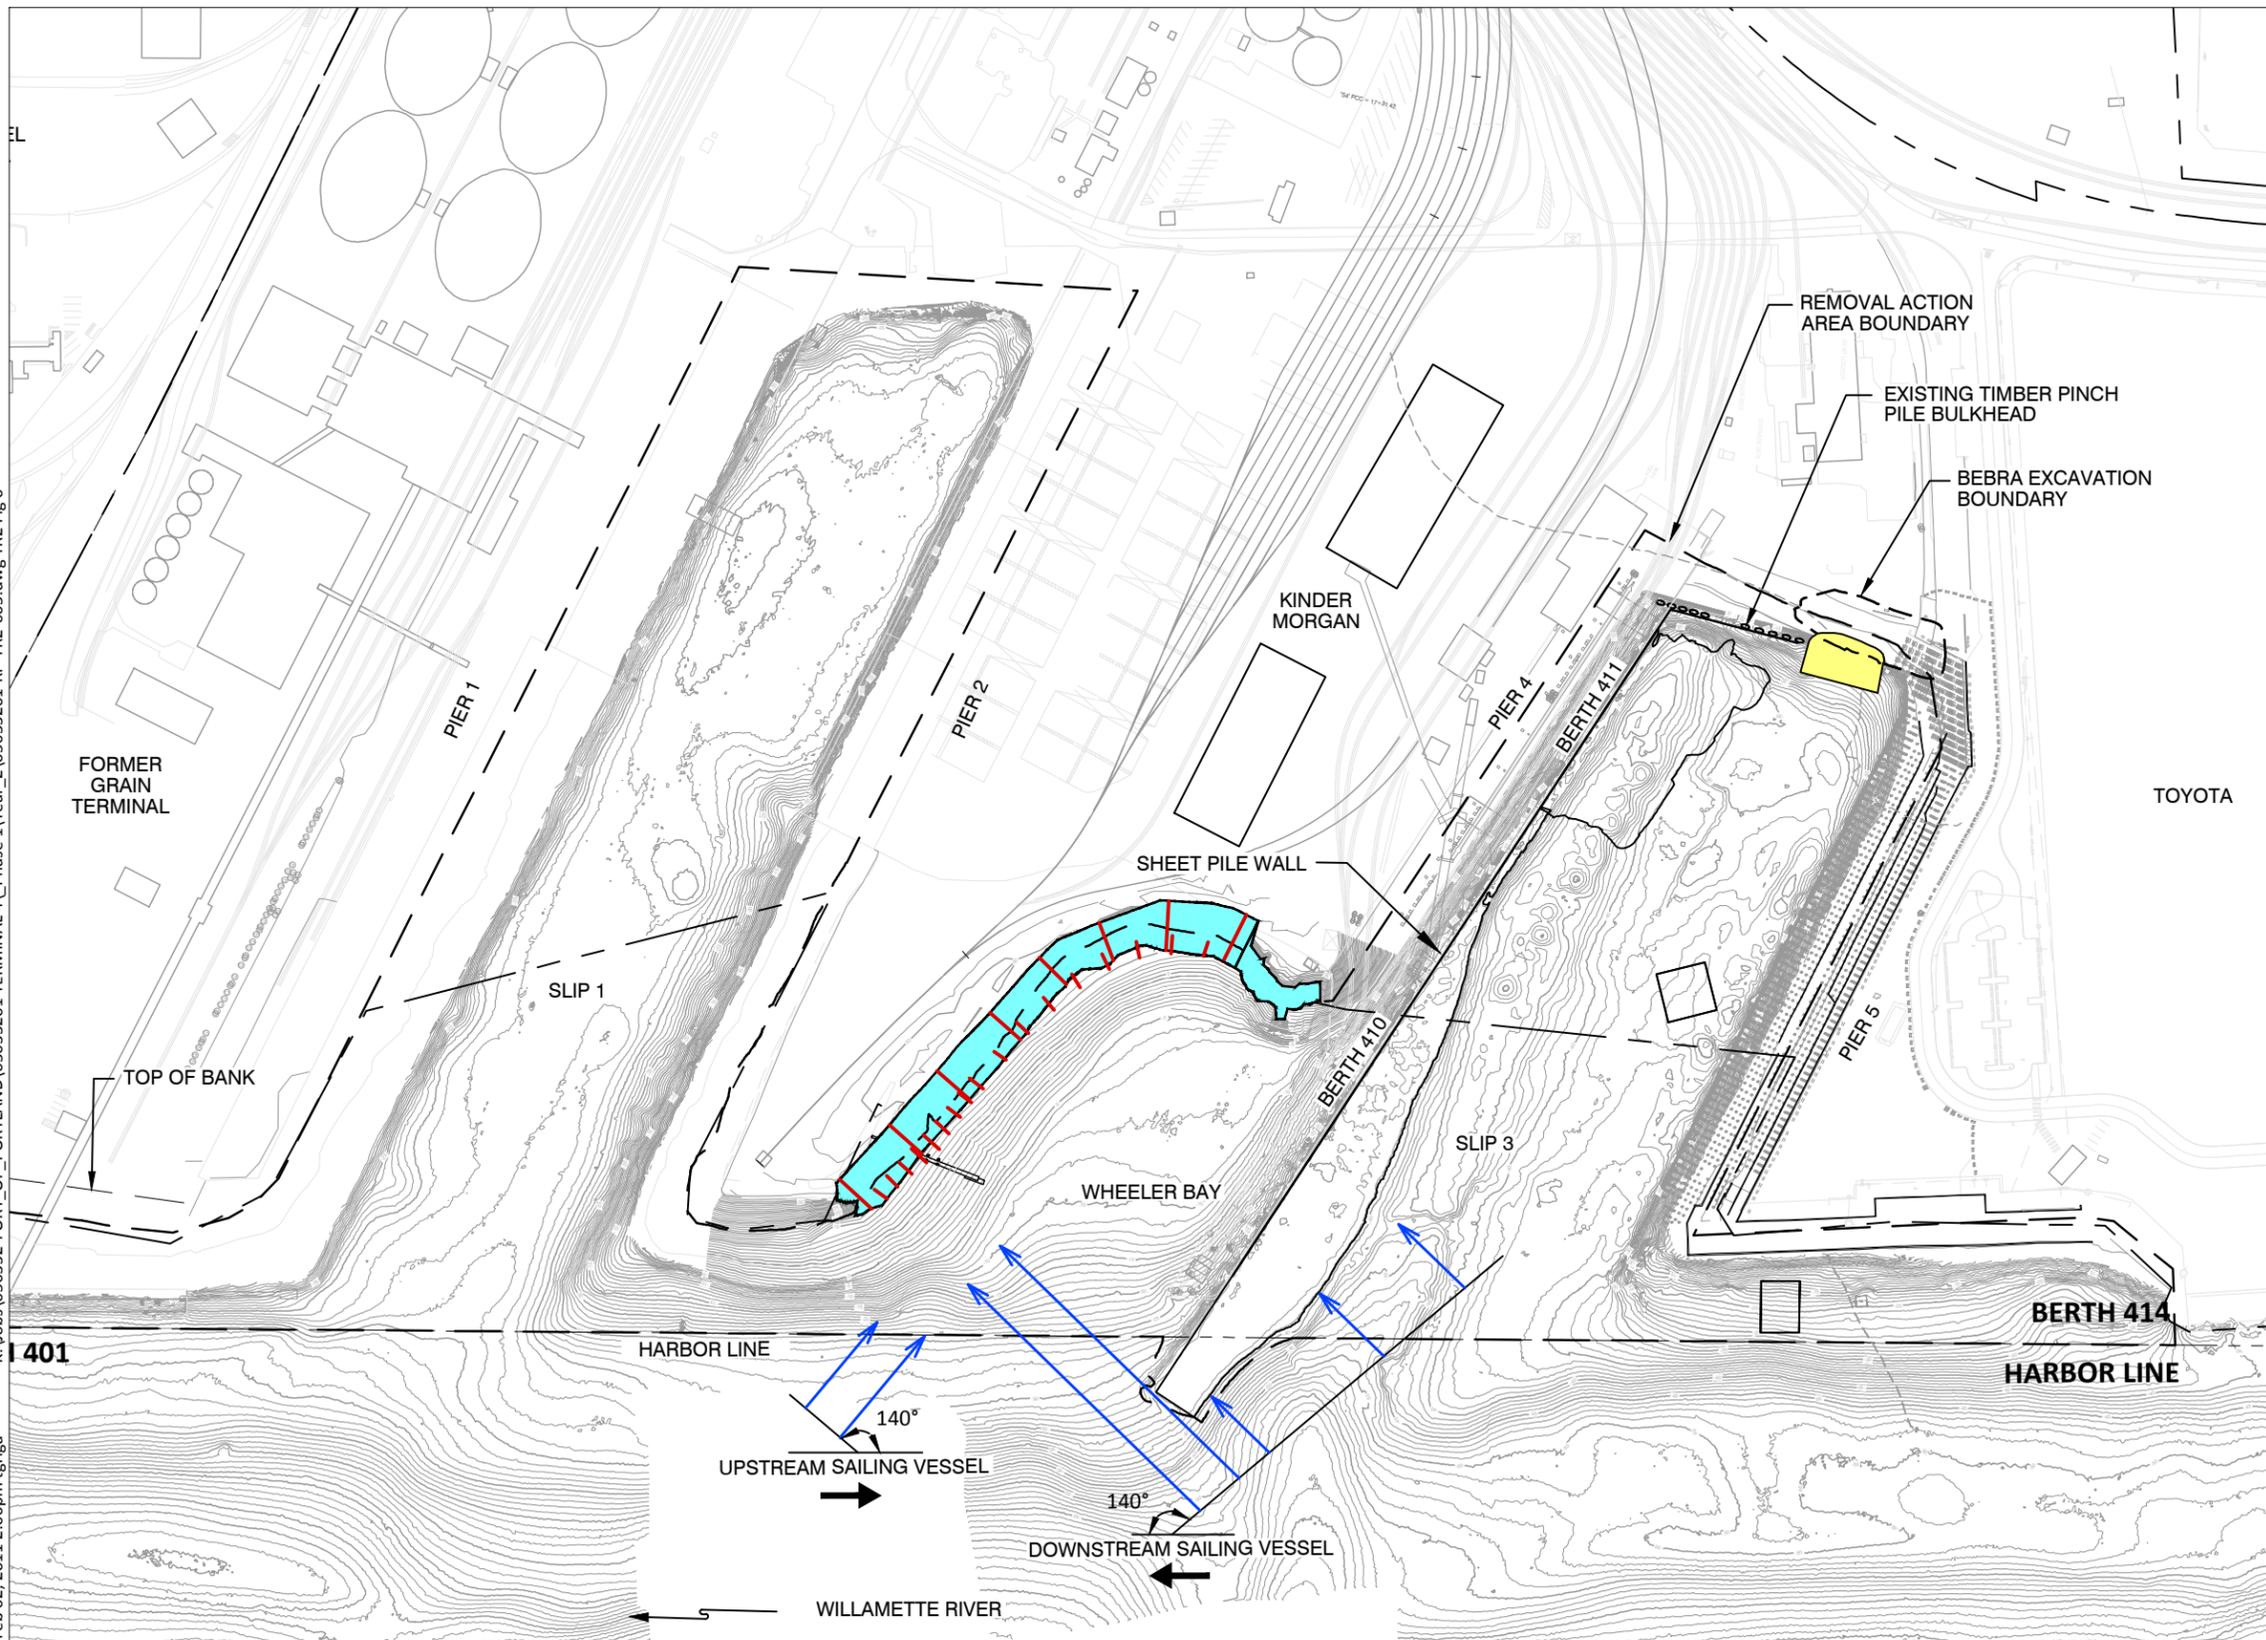
Because current-induced water velocities are low within WB, breaking waves are the largest contributors to the redistribution of the habitat material layer. Waves are generated via vessels (tugs, barges, ships, and personal watercraft) sailing up and down the river. As vessels travel through the water, waves leave the vessels at approximately 140 degrees to the direction of sail (Sorensen 1997), and then break once they hit the shoreline. The majority of the energy in waves generated from vessels sailing downstream past Terminal 4 is dissipated by the piles located under the Berth 410 dock (Figure 6). These waves generally do not break on shore, although some waves do break on the shoreline that is not protected by the piles associated with Berth 410 near Transects 1, 2, and 3. These sections of shoreline correspond to the areas where the most significant erosion was observed during the monitoring activities (Table 2). In addition, waves generated from vessels sailing in the upstream direction break once they hit shore near Transect 7; however, these waves have farther to travel to hit the shoreline, and this area is protected by a significant amount of deposited LWD that acts as armor. As such, minimal erosion has been observed in this area.
