Final Report

Taylor Lumber and Treating Superfund Site Final Construction Report

Prepared for
U.S. Environmental Protection Agency

March 2009

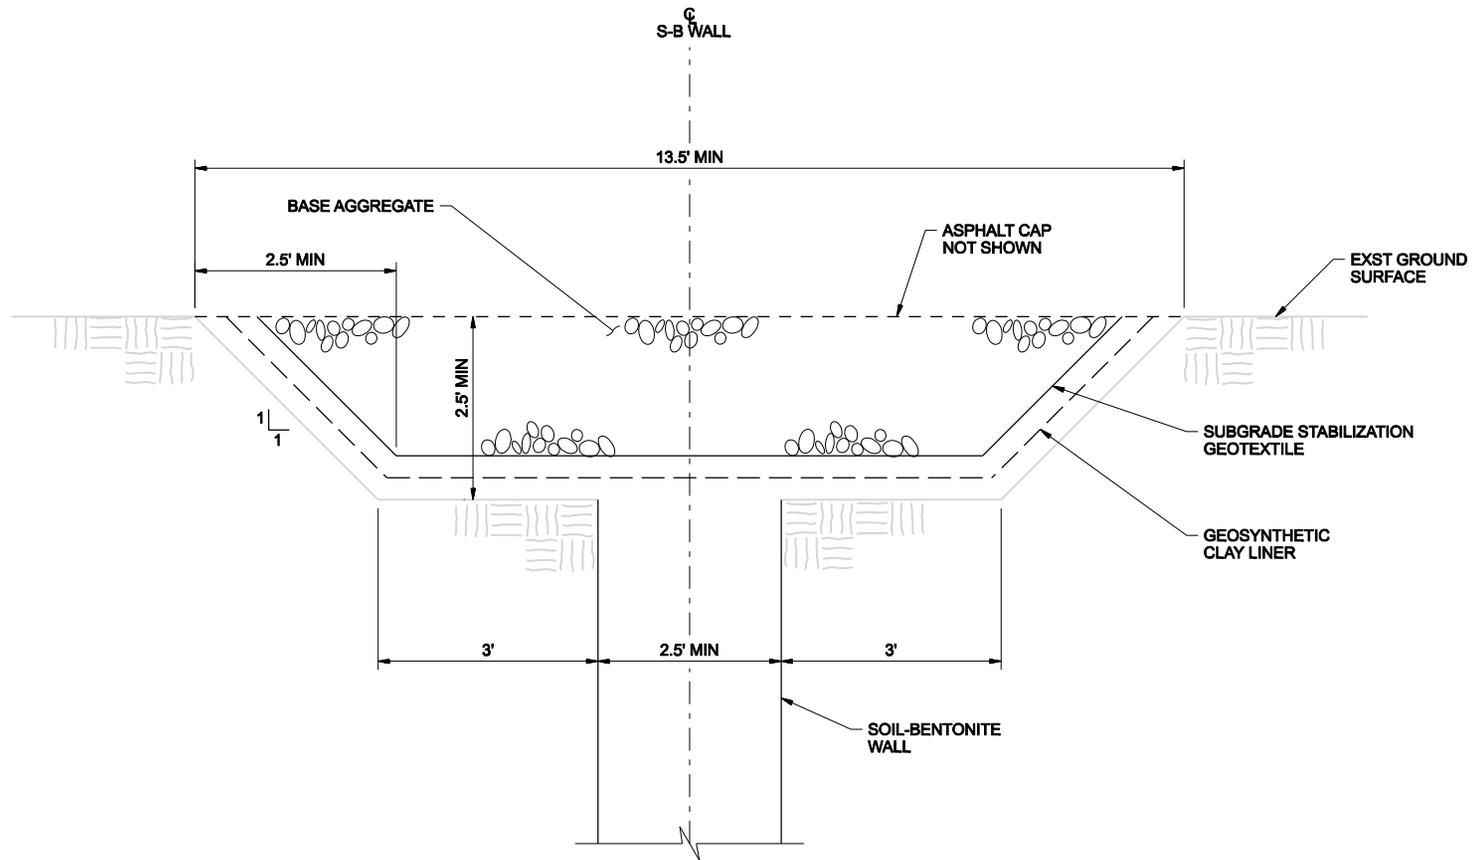
FIGURE 1-3
BARRIER WALL PROTECTIVE CAP DETAIL
 TAYLOR LUMBER AND TREATING SUPERFUND SITE

A protective cap was installed over the top of the barrier wall to protect the wall from heavy equipment traffic. Figure 1-3 provides a detail of the barrier wall protective cap. The cap consists of base aggregate a minimum of 30 inches thick by 8.5 feet wide. An additional 2.5 feet of width were added to the as-built cap with a 1:1 slope on the side walls, for a total minimum cap width of 13.5 feet. The base and walls of the cap trench were covered with a low permeability (specified at 4×10^{-12} cm/sec) geosynthetic clay liner that was overlain by a subgrade stabilization geotextile, which in turn was overlain by the compacted base aggregate. The asphalt cap was constructed over this protective cap.

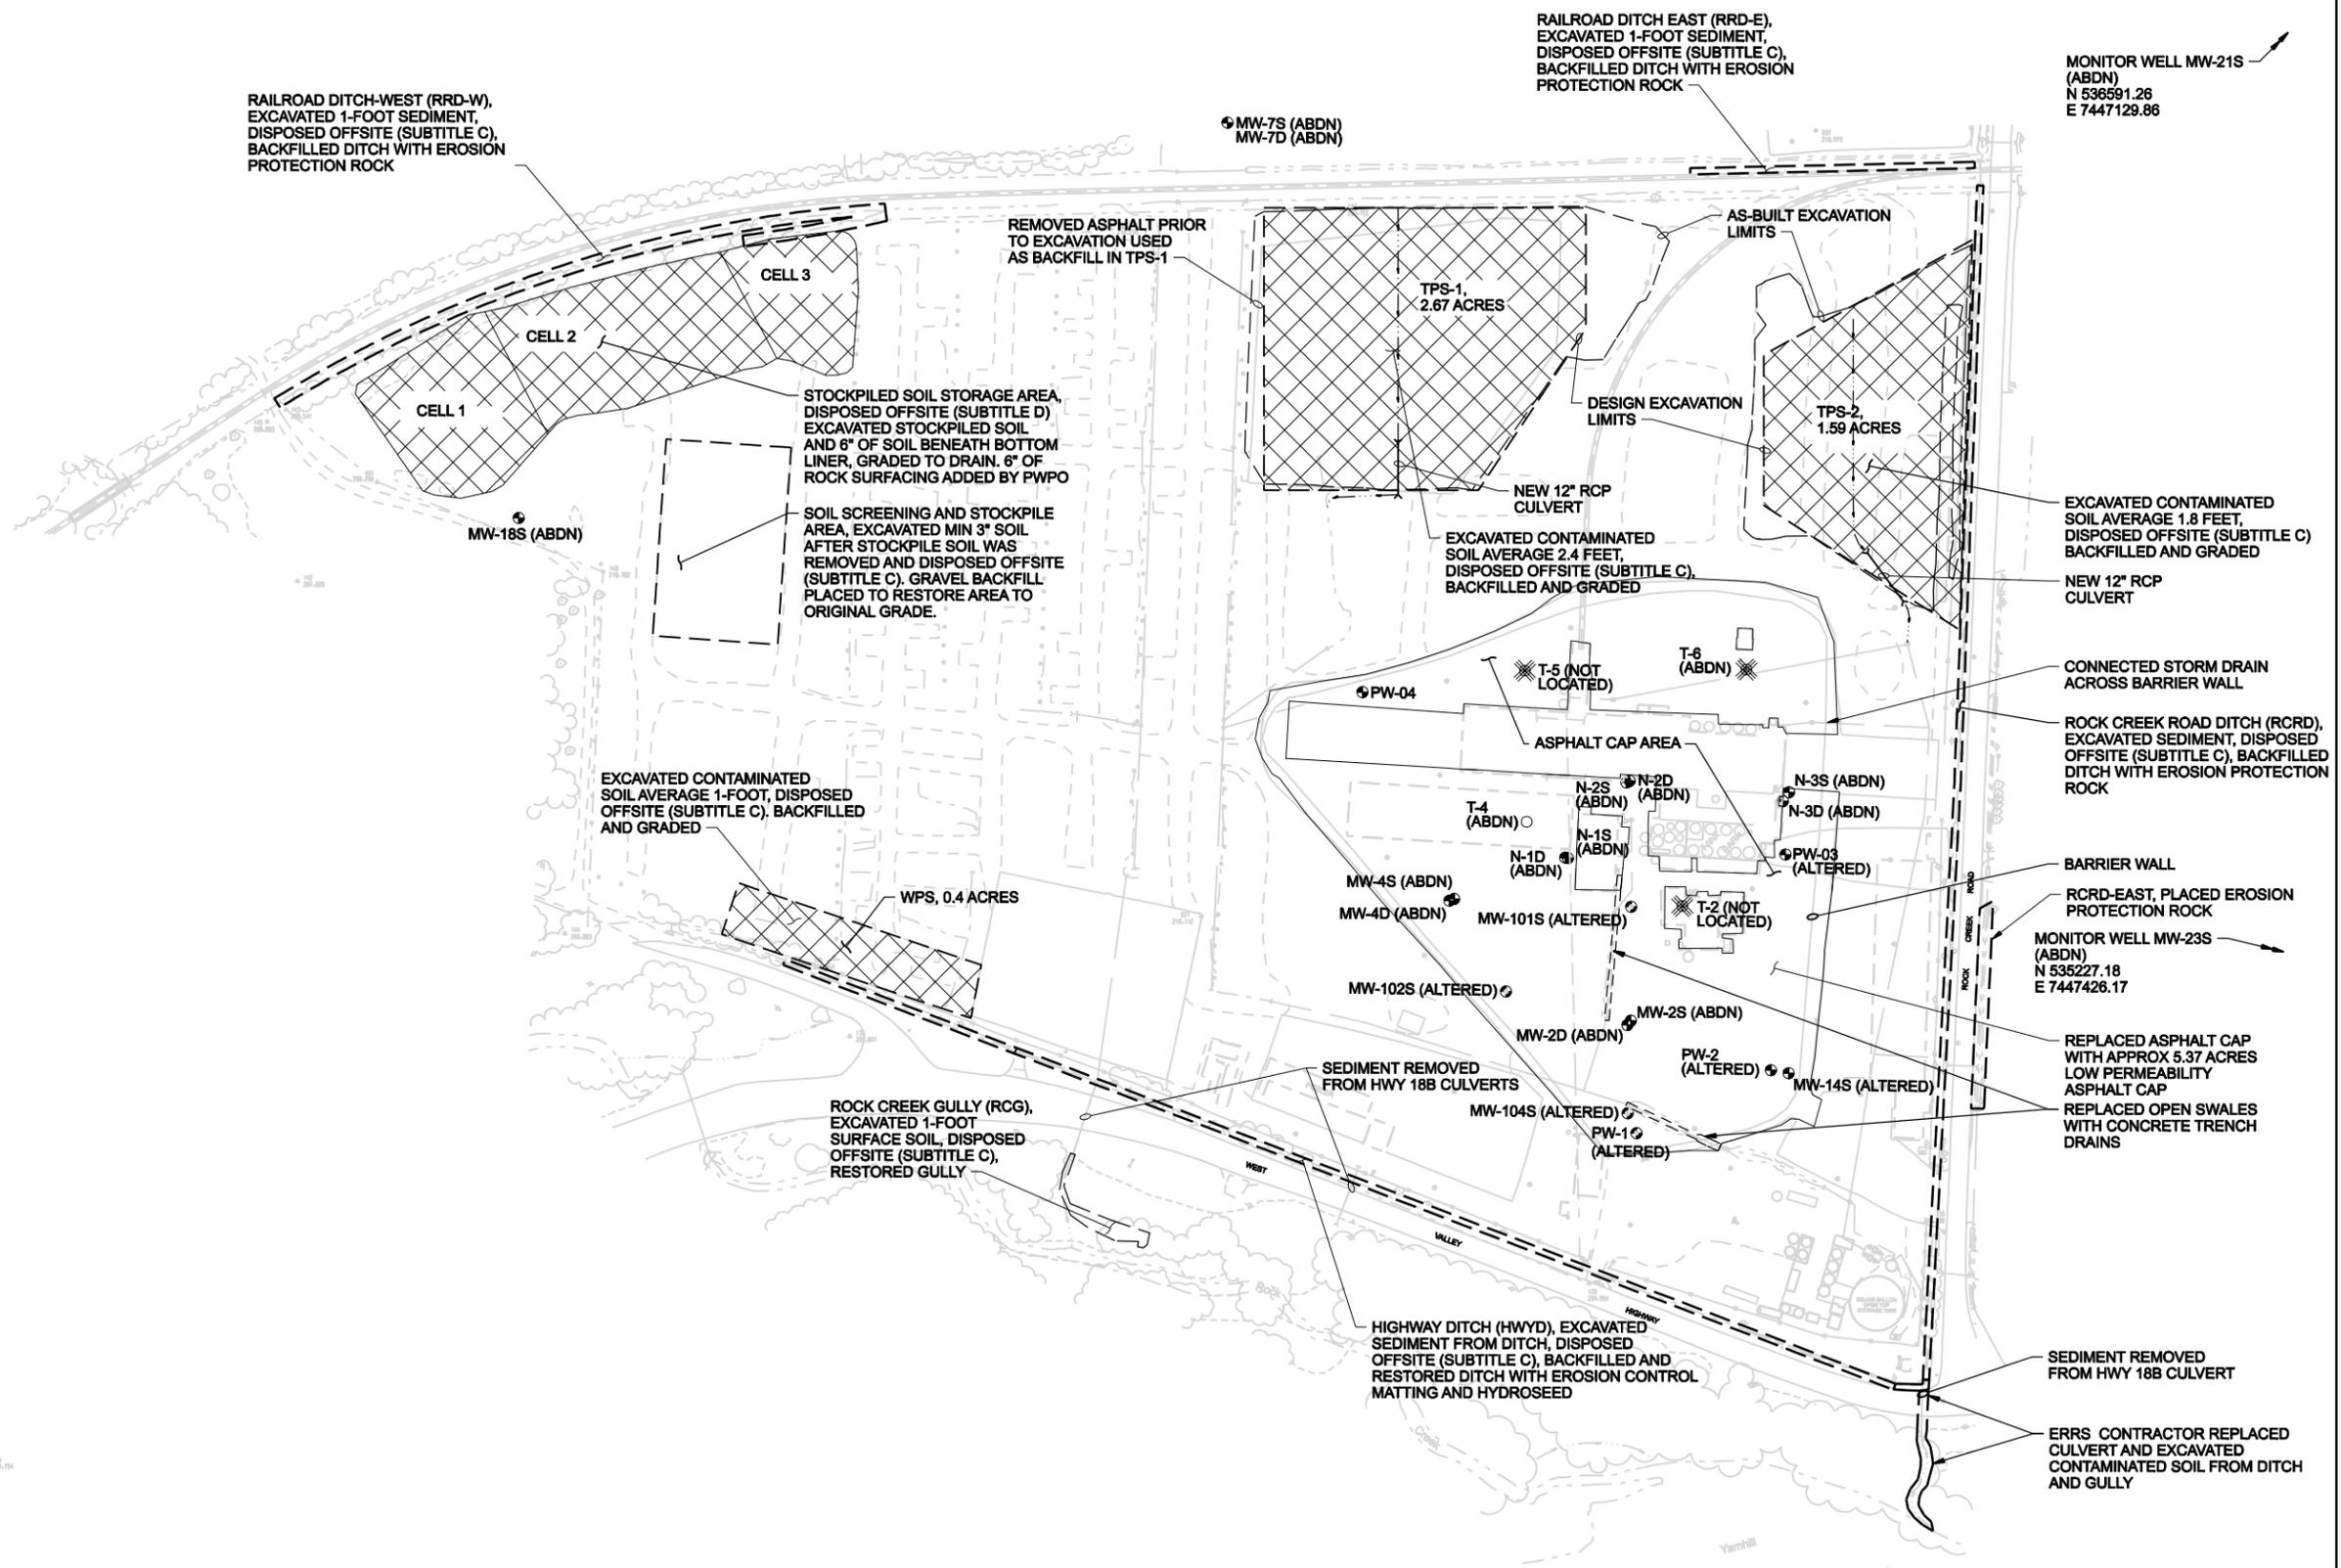
FIGURE 1-4
KEY ELEMENTS OF COMPLETED REMEDIAL ACTION
 TAYLOR LUMBER AND TREATING SUPERFUND SITE

Figure 1-4 provides an overview of key elements of work completed during the RA construction. A detailed summary of RA construction activities is provided in [Section 2](#) of this FCR. In addition to the scope of work defined in the remedial design drawings and specifications, additional scope was added under separate EPA contracts based on field observations during RA construction. These items are discussed in [Section 3](#) of this FCR.

A soil screening and stockpile area was set up in the WPS Area just south of Soil Storage Cells 2 and 3. Silt fence was installed around the perimeter of the area, which measured approximately 180 feet x 220 feet (see Figure 1-4).

Excavation activities included removal of non-hazardous soils for offsite disposal at a Resource Conservation and Recovery Act (RCRA) Subtitle D disposal facility. Non-hazardous soils were removed from the following onsite areas (see Figure 1-4):

Excavation activities included removal of hazardous soils for offsite disposal at a RCRA Subtitle C disposal facility. Hazardous soils were removed from the following onsite areas (see Figure 1-4):

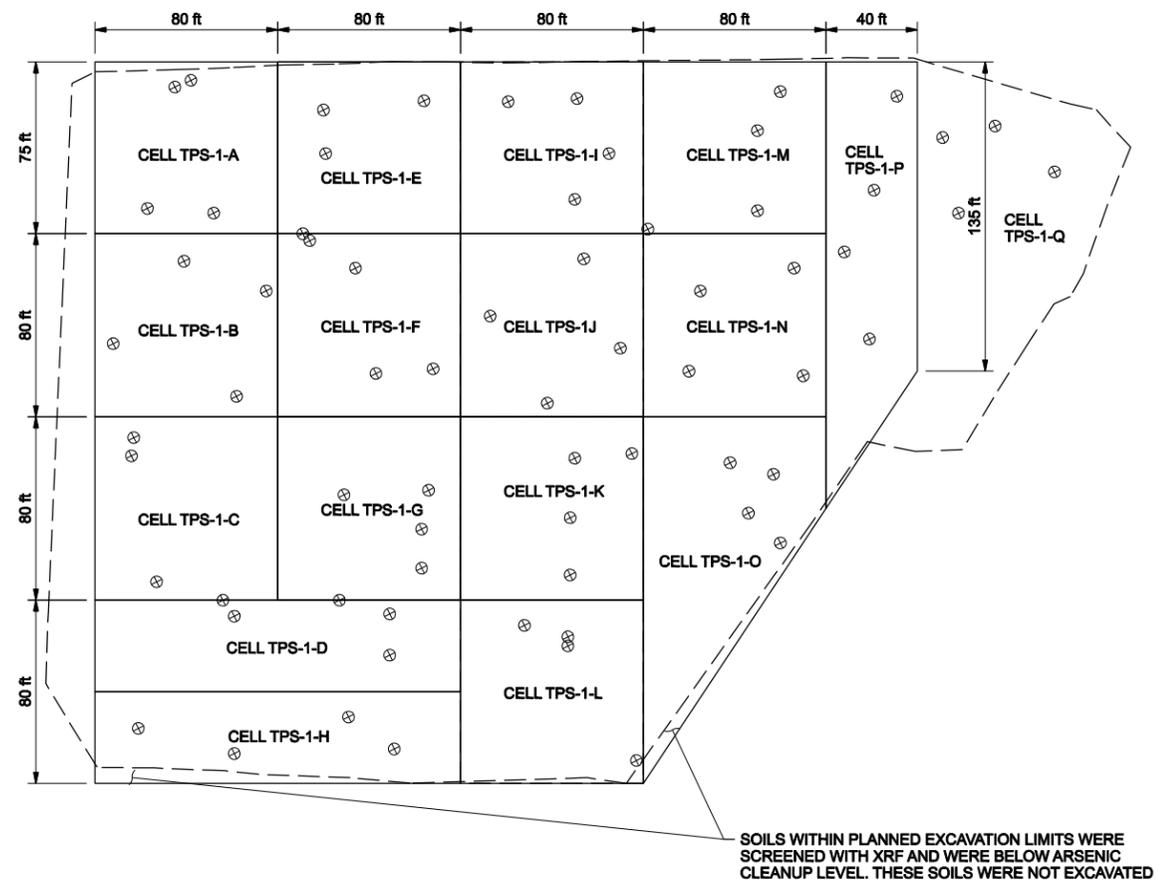
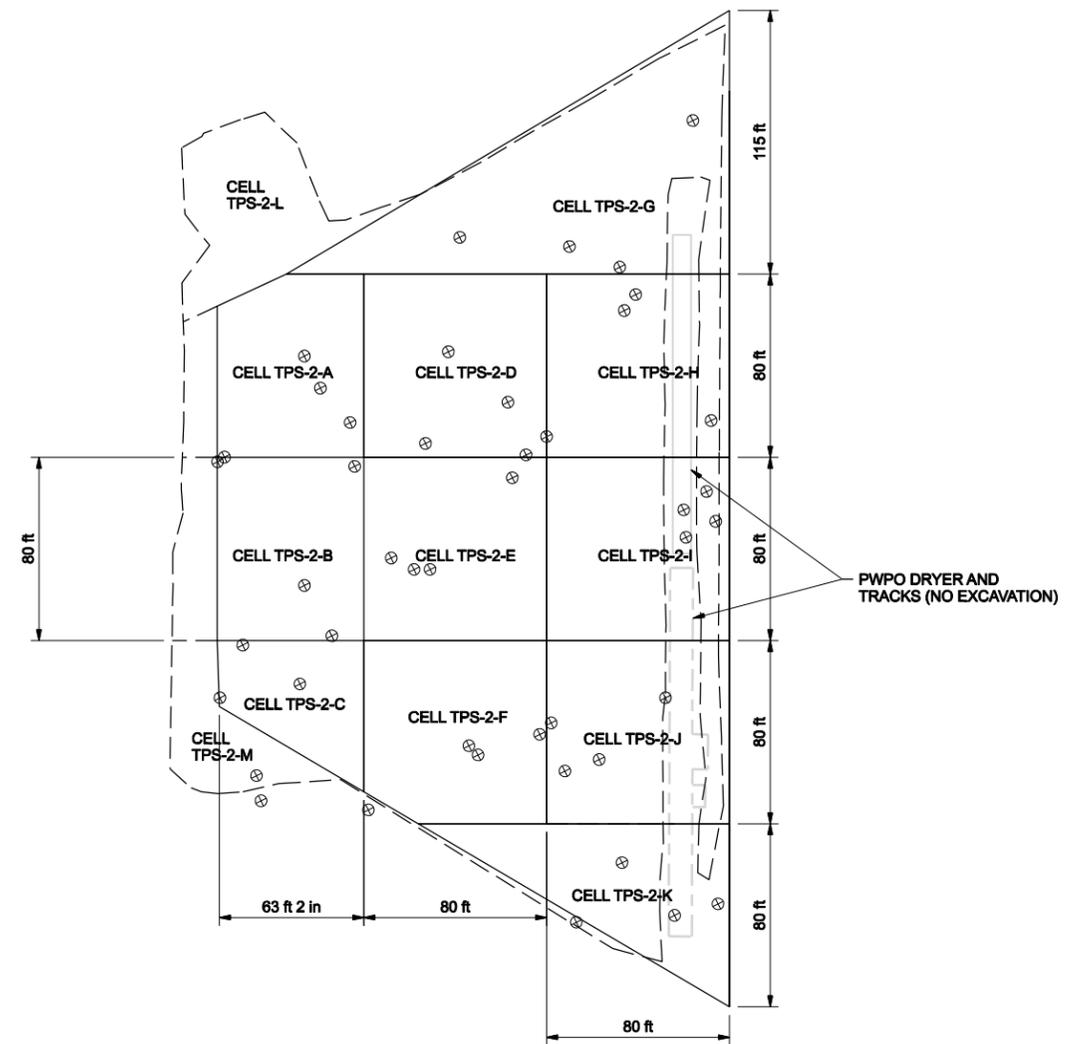
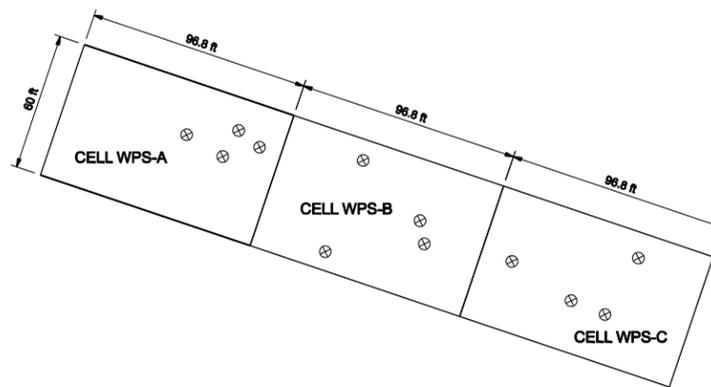
**FIGURE 2-2
CONFIRMATION SAMPLING LOCATIONS**

Prior to initiation of soil excavation at the site, the EPA Region 10 Laboratory staff, which includes ESAT contractors, provided support to conduct a site-specific study to compare field XRF (Innov-X Systems Inc. 4000a SL) results to fixed laboratory (EPA Method 200.2 and 200.7) results (EPA, 2008a). On-site samples were analyzed for arsenic by field XRF with a subset of the samples shipped to the Region 10 Laboratory for confirmation. The purpose was to determine whether the field XRF results would meet the required precision and accuracy for the project. Four possible preparation techniques were examined: in situ, homogenization, sieving and oven drying and grinding. Results are tabulated in **Table 2-2** and depicted in Figure 2-2. Samples that were only bagged and homogenized prior to being

1. Reference: Final results for arsenic soil analyses, confirmational sample results, Remedial Action, Taylor Lumber and Treating Superfund site. Data Release and Quality Assurance Memoranda for May 24 through July 9, 2007; July 18 through July 27, 2007; and August 8 through 24, 2007. Gerald Dodo (EPA Region 10 Laboratory) to Karen Keeley (EPA Region 10 Superfund), Seattle, Washington (EPA, 2007g)
2. Sample locations are shown in Table 2-4 and Figure 2-2.
