July 1960 - Tank #2 - Red Hill

Red Hill Storage Facility Tank #13

**PRL 96-21
Emergency Repairs for Red Hill Tanks**

EMERGENCY REPAIRS FOR RED HILL TANKS

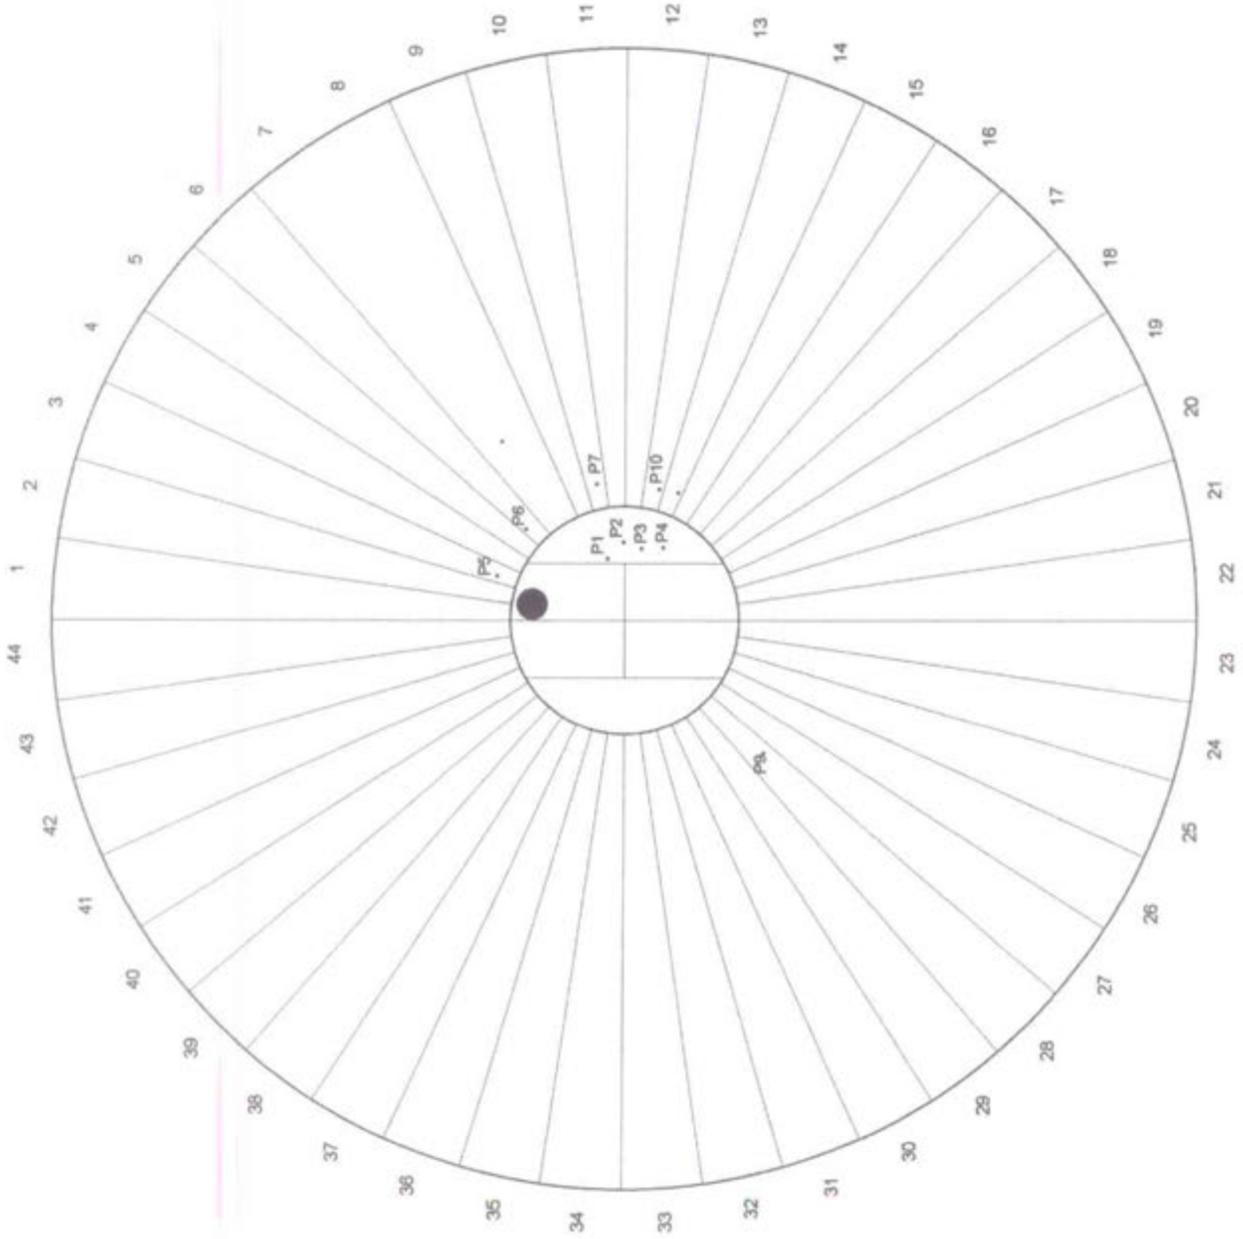
7.5.2 Bottom Layout & Thickness Measurements

- P1 = 0.08
- P2 = 0.09
- P3 = 0.10
- P4 = 0.07
- P5 = 0.07
- P6 = 0.06
- P7 = 0.09
- P8 = 0.11
- P9 = 0.12
- P10 = 0.11

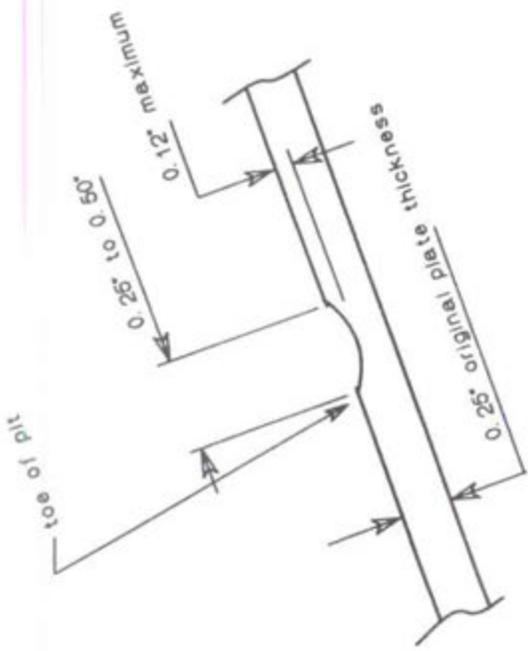
SECTION VIEW AT TYPICAL PIT

- 5.0 A drawing showing the contour of the pits and pictures taken at the bottom are attached to this report.
- 6.0 Mid Atlantic identified 20 pits in the first ascending plates, which measured over 0.06 inches deep. There were an estimated 100 that measured less than 0.06 inches deep. Mid Atlantic does not consider this to be excessive or abnormal for steel, which has been in service for nearly 60 years.

Twenty pits were identified and measured on the first ascending plates in the area to be coated at the bottom of tank #10. The deepest pit measured 0.12 inches. A sketch showing the dimensions of a typical pit is shown below.

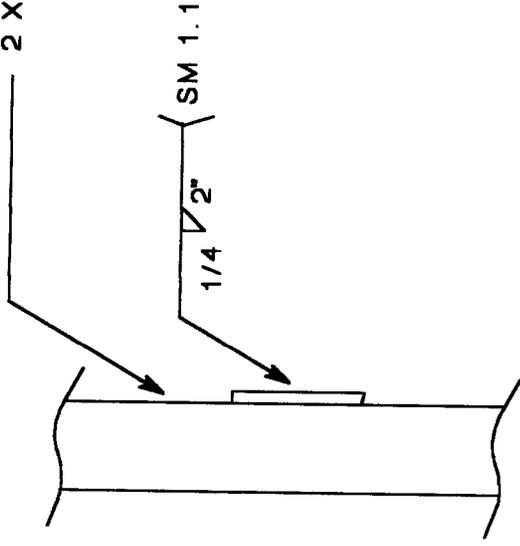
MID ATLANTIC ENVIRONMENTAL	
EMERGENCY REPAIRS FOR RED HILL TANKS	
Tank #7 RECOMMENDED REPAIR DRAWINGS	
Repair No.: 001	File: 7r001
Upper Dome	Quadrant: D
Course: B	Plate: 19
Drawn by: Tom Kitchen	Date: 5/4/98

INSPECTED 3/27/98 BY JF & TK

2 X 1/4 flat bar

TYPE 10 REPAIR

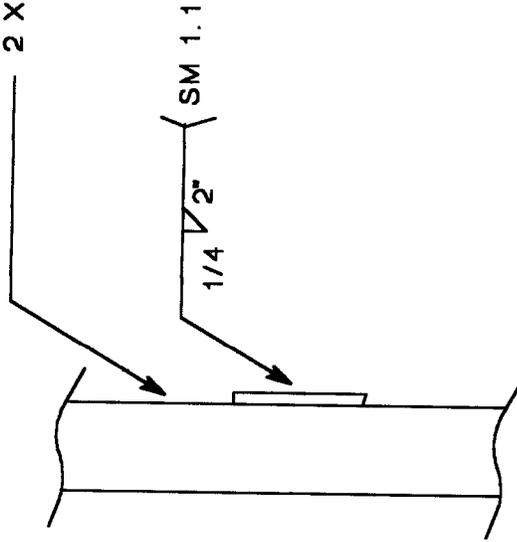
MID ATLANTIC ENVIRONMENTAL	
EMERGENCY REPAIRS FOR RED HILL TANKS	
Tank #7 AS BUILT DRAWINGS	
Repair No.: 002	File: 7r002
Upper Dome	Quadrant: D
Course: B	Plate: 22
Drawn by: Tom Kitchen	Date: 5/4/98

INSPECTED 3/27/98 BY JF & TK

2 X 1/4 flat bar

TYPE 10 REPAIR

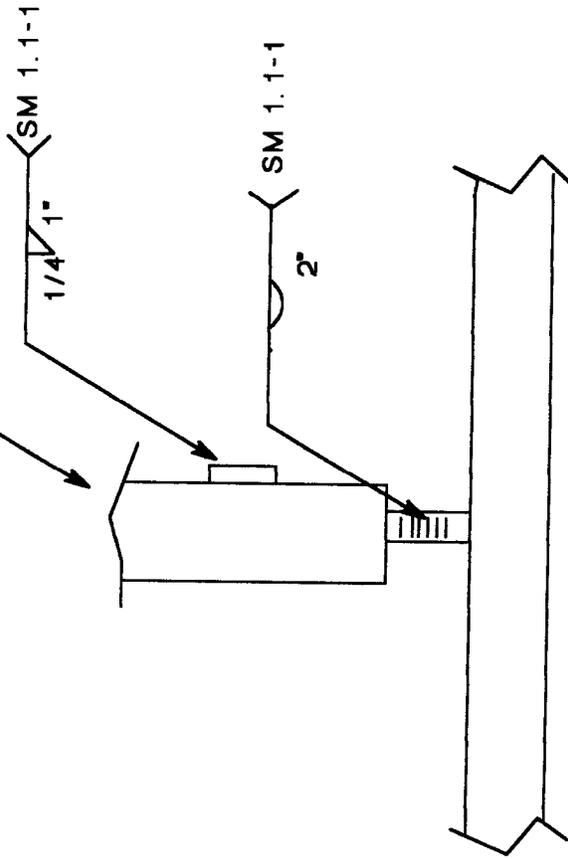
MID ATLANTIC ENVIRONMENTAL	
EMERGENCY REPAIRS FOR RED HILL TANKS	
Tank #7 AS BUILT DRAWINGS	
Repair No.: 003	File: 7R003
Upper Dome	Quadrant: D
Course: A	Plate: 22
Drawn by: Tom Kitchen	Date: 5/4/98

DEFECT INSPECTED 3/27/98 BY JF & TK

EXISTING 1/4 X 2 FLATBAR

TYPE 10 REPAIR

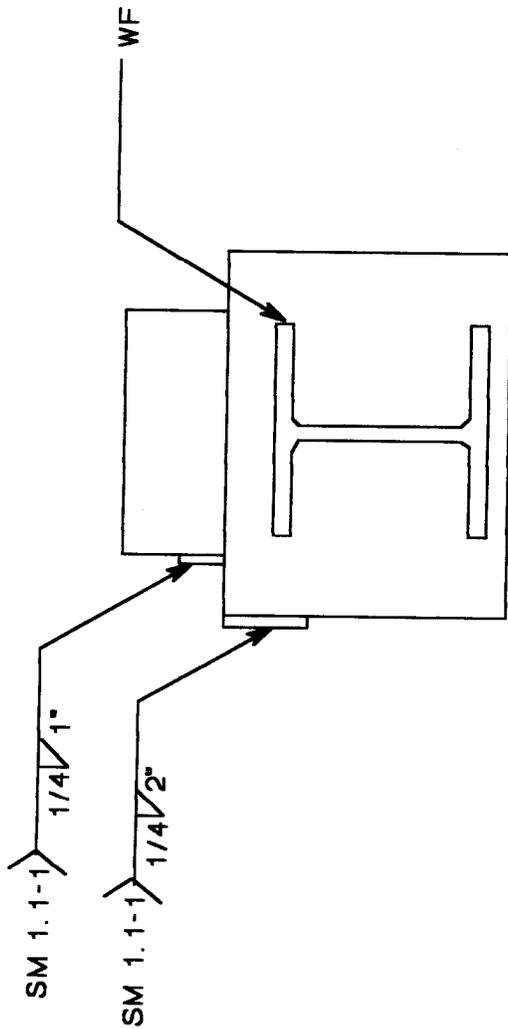
MID ATLANTIC ENVIRONMENTAL	
EMERGENCY REPAIRS FOR RED HILL TANKS	
Tank #7 AS BUILT DRAWINGS	
Repair No.: 004	File: 7R004
Upper Dome	Quadrant: A
Course: A	Plate 22
Drawn by: Tom Kitcher	Date: 5/4/98

Defect Inspected 3/27/98 by JF 7 TK

TYPE 10 REPAIR

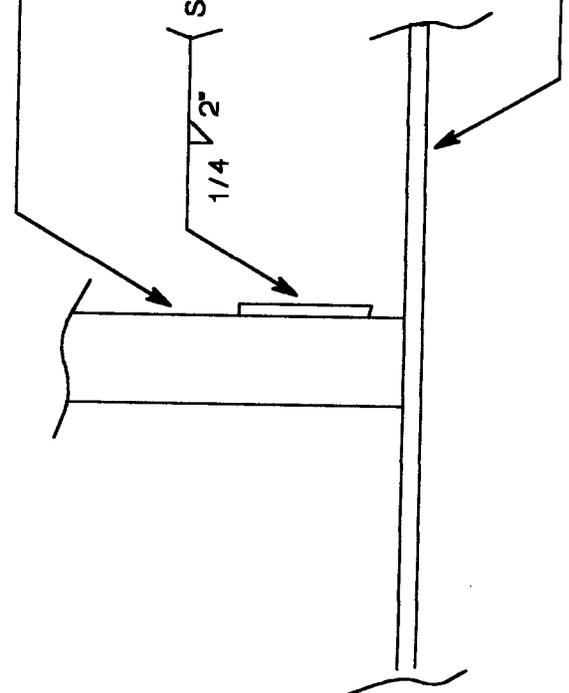
MID ATLANTIC ENVIRONMENTAL	
EMERGENCY REPAIRS FOR RED HILL TANKS	
Tank #7 REPAIR DRAWING	
Repair No.: 005	File: 7R005
Upper Dome	Quadrant: A
Course: A	Plate: 22
Drawn by: Tom Kitchen	Date: 5/4/98

1/4 V 2" SM 1.1-1

SPRINGLINE PLATE

TYPE 10 REPAIR

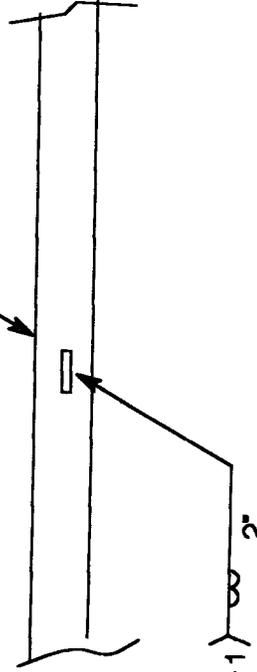
MID ATLANTIC ENVIRONMENTAL	
EMERGENCY REPAIRS FOR RED HILL TANKS	
Tank #7 REPAIR DRAWING	
Repair No. : 008	File:7R008
Upper Dome	Quadrant: D
Course: EXTENSION	Plate: 22
Drawn by: Tom Kitchen	Date: 5/4/98

Inspected 3/27/98 by JF & TK

2 X 1/4 flat bar

TYPE 10 REPAIR

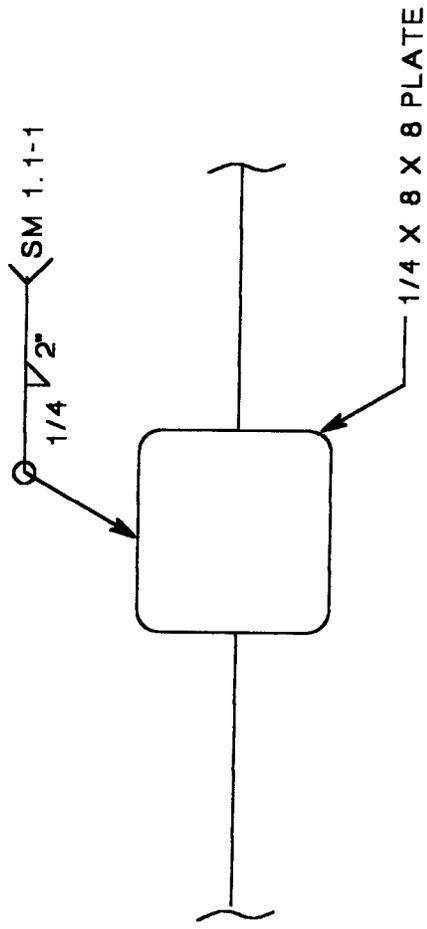
MID ATLANTIC ENVIRONMENTAL	
EMERGENCY REPAIRS FOR RED HILL TANKS	
Tank #7 REPAIR DRAWING	
Repair No.: 009	File: 7R009
CYLINDER	Quadrant: D
Course: 7	Plate: 22
Drawn by: Tom Kitchen	Date: 5/4/98

Inspected 3/27/98 by JF & TK

TYPE 5 REPAIR

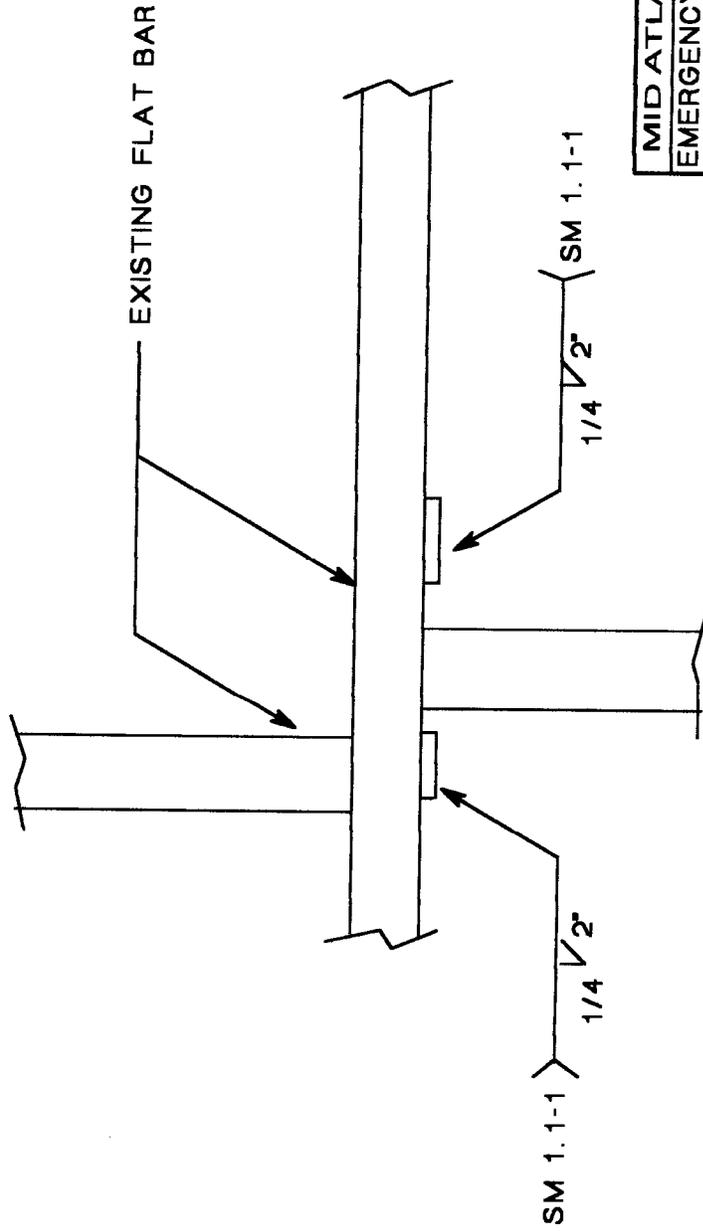
MID ATLANTIC ENVIRONMENTAL	
EMERGENCY REPAIRS FOR RED HILL TANKS	
Tank #7 REPAIR DRAWING	
Repair No.: 011	File: 7R011
UPPER DOME	Quadrant: C
Course: A	Plate: 17
Drawn by: Tom Kitchen Date: 5/4/98

Inspected 3/27/98 by JF & TK

TYPE 10 REPAIR

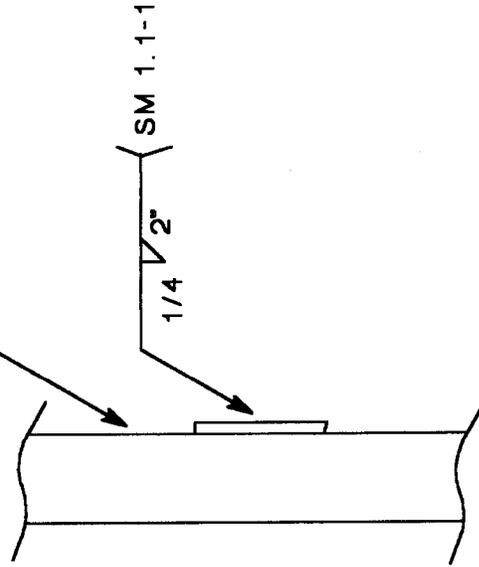
MID ATLANTIC ENVIRONMENTAL	
EMERGENCY REPAIRS FOR RED HILL TANKS	
Tank #7 RECOMMENDED REPAIR DRAWINGS	
Repair No.: 013	File: 7R013
Upper Dome	Quadrant: D
Course: A	Plate: 22
Drawn by: Tom Kitchen Date: 5/4/98

Inspected 3/27/98 by JF & TK

2 X 1/4 flat bar

TYPE 10 REPAIR

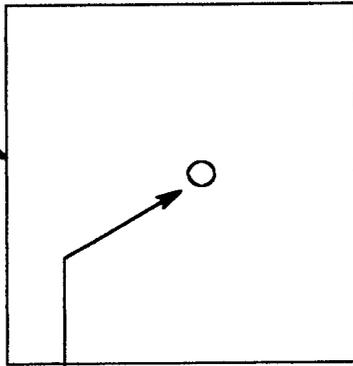
MID ATLANTIC ENVIRONMENTAL	
EMERGENCY REPAIRS FOR RED HILL TANKS	
Tank #7 RECOMMENDED REPAIR DRAWINGS	
Repair No. : 015	File:7R015
Upper Dome	Quadrant: D
Course: A	Plate: 21
Drawn by: Tom Kitchen	Date: 5/4/98

DEEP GOUGE IN PLATE- WELD OVERLAY AND RECOAT

6 X 6 COATING REPAIR

TYPE 2 REPAIR

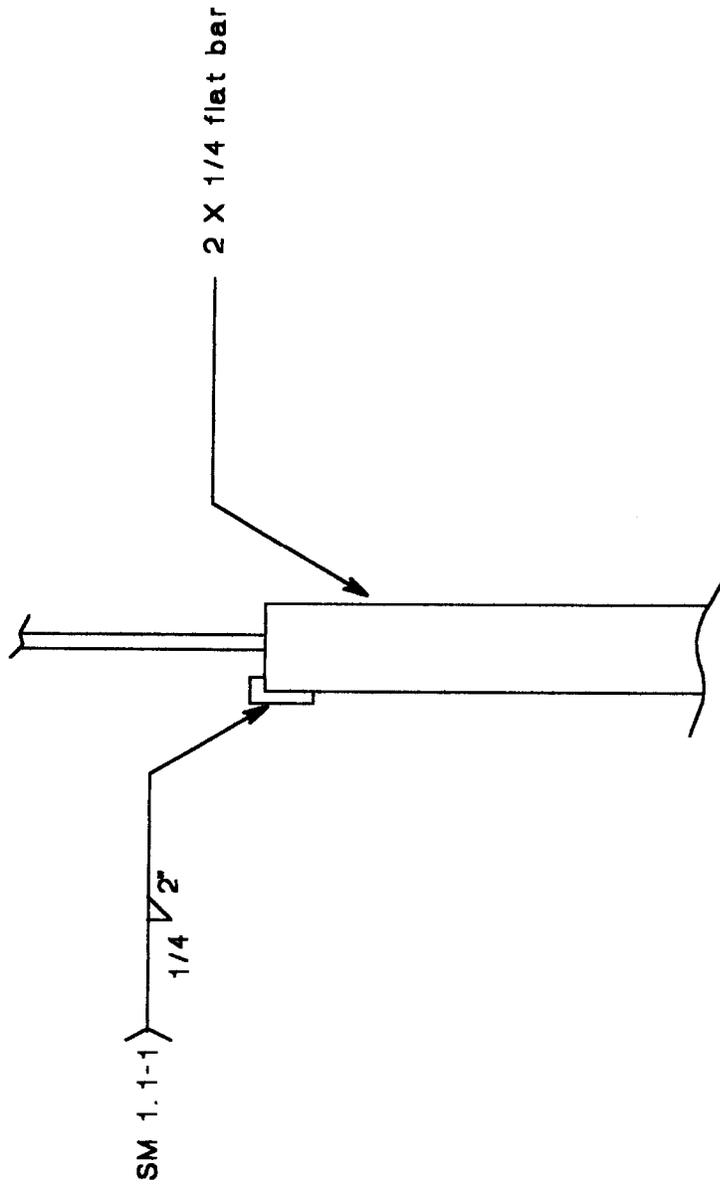
MID ATLANTIC ENVIRONMENTAL	
EMERGENCY REPAIRS FOR RED HILL TANKS	
Tank #7 RECOMMENDED REPAIR DRAWINGS	
Repair No.: 016	File: 7R016
Upper Dome	Quadrant: D
Course: A	Plate: 21
Drawn by: Tom Kitchen Date: 5/4/98

Inspected 3/27/98 by JF & TK

TYPE 10 REPAIR

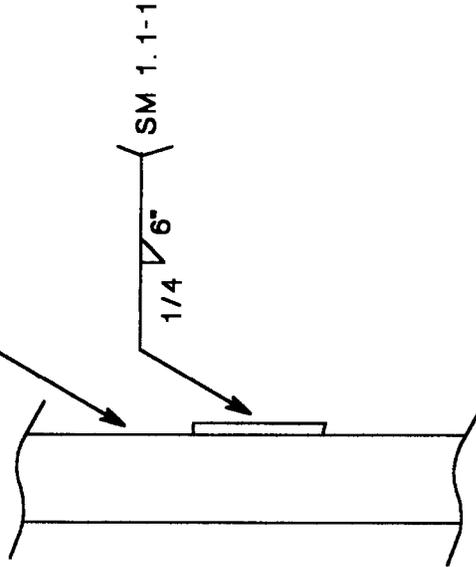
MID ATLANTIC ENVIRONMENTAL	
EMERGENCY REPAIRS FOR RED HILL TANKS	
Tank #7 RECOMMENDED REPAIR DRAWINGS	
Repair No.: 017	File: 7R017
Upper Dome	Quadrant: D
Course: A	Plate: 19
Drawn by: Tom Kitchen	Date: 5/4/98

Inspected 3/27/98 by JF & TK

2 X 1/4 flat bar

TYPE 10 REPAIR

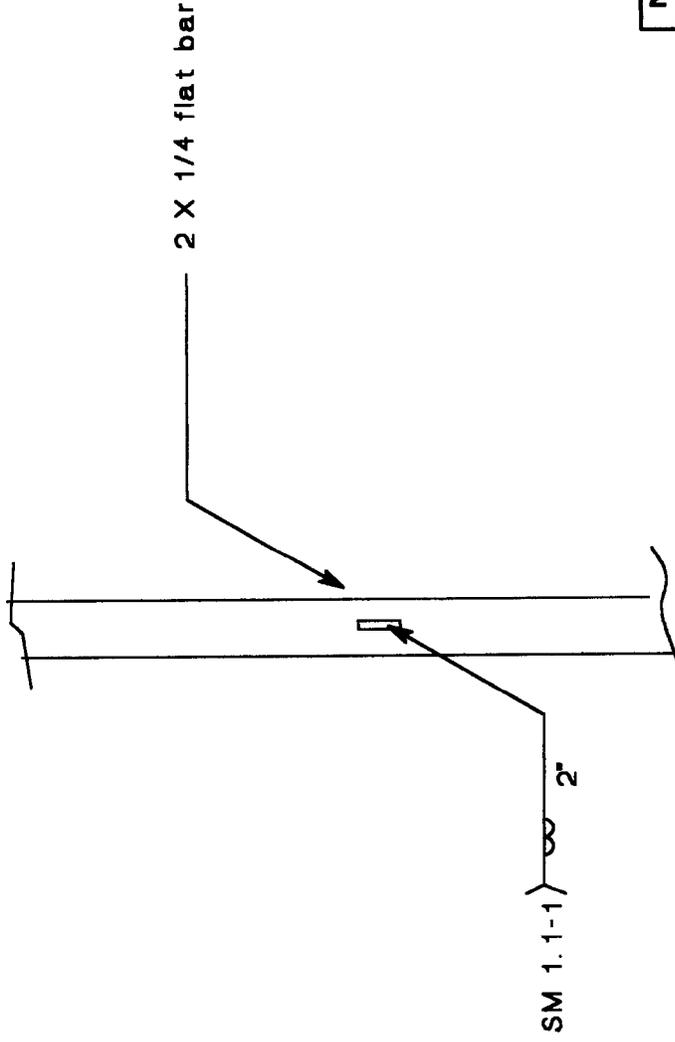
MID ATLANTIC ENVIRONMENTAL	
EMERGENCY REPAIRS FOR RED HILL TANKS	
Tank #7 RECOMMENDED REPAIR DRAWING	
Repair No.: 018	File: 7R018
Upper Dome	Quadrant: D
Course: A	Plate: 19
Drawn by: Tom Kitchen	Date: 5/4/98

Inspected 3/27/98 by JF & TK

TYPE 10 REPAIR

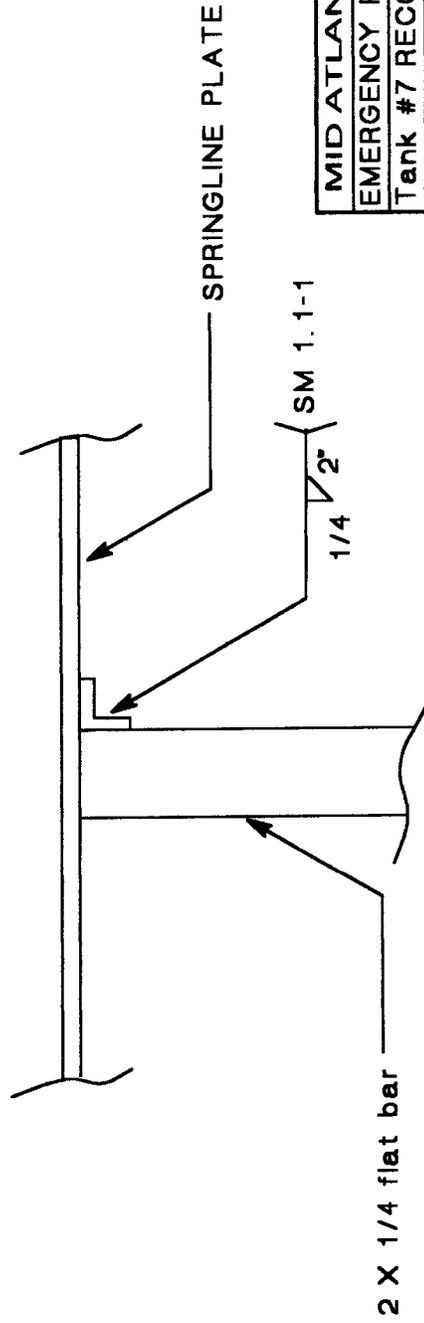
MID ATLANTIC ENVIRONMENTAL	
EMERGENCY REPAIRS FOR RED HILL TANKS	
Tank #7 RECOMMENDED REPAIR DRAWING	
Repair No.: 019	File: 7R019
Upper Dome	Quadrant: C
Course: EXTENSION	Plate: 18
Drawn by: Tom Kitchen	Date: 5/4/98

Inspected 3/27/98 by JF & TK

TYPE 10 REPAIR

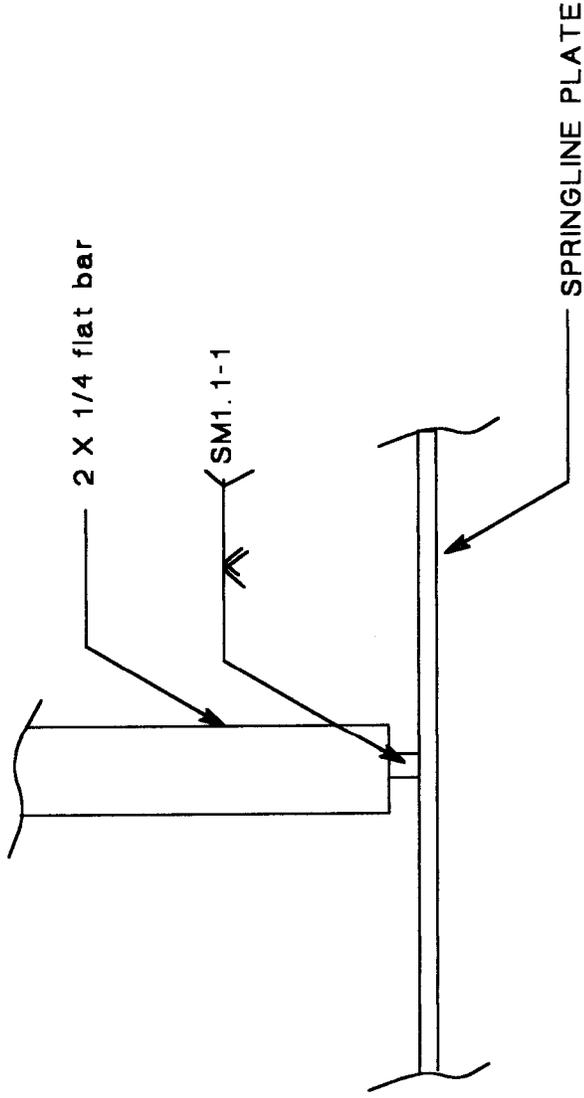
MID ATLANTIC ENVIRONMENTAL	
EMERGENCY REPAIRS FOR RED HILL TANKS	
Tank #7 RECOMMENDED REPAIR DRAWING	
Repair No.: 020	File: 7R020
Upper Dome	Quadrant: C
Course: A	Plate: 18
Drawn by: Tom Klitchen	Date: 5/4/98

Inspected 3/27/98 by JF & TK

TYPE 10 REPAIR

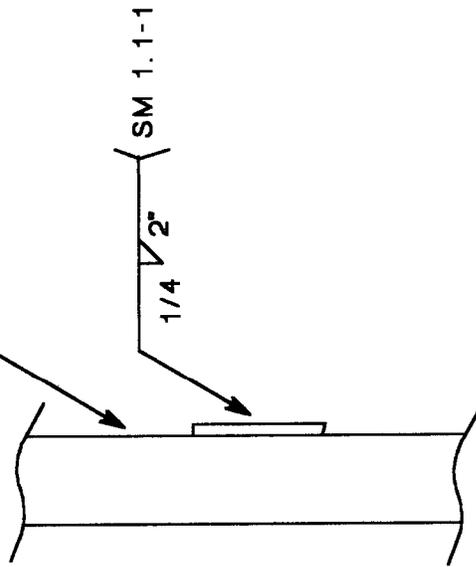
MID ATLANTIC ENVIRONMENTAL	
EMERGENCY REPAIRS FOR RED HILL TANKS	
Tank #7 RECOMMENDED REPAIR DRAWINGS	
Repair No.: 021	File: 7R021
Upper Dome	Quadrant: C
Course: A	Plate: 1C
Drawn by: Tom Kitchen	Date: 5/4/98

Inspected 3/27/98 by JF & TK

2 X 1/4 flat bar

TYPE 10 REPAIR

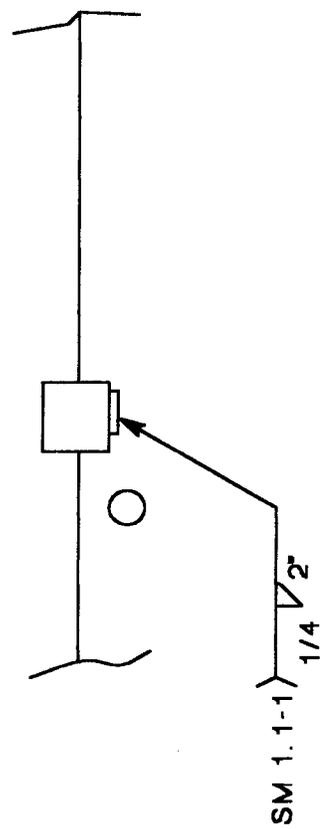
MID ATLANTIC ENVIRONMENTAL	
EMERGENCY REPAIRS FOR RED HILL TANKS	
Tank #7 RECOMMENDED REPAIR DRAWING	
Repair No. : 023	File: 7R023
CYLINDER	Quadrant: D
Course: 6	Plate: 21
Drawn by: Tom Klitchen	Date: 5/4/98

Inspected 3/27/98 by JF & TK

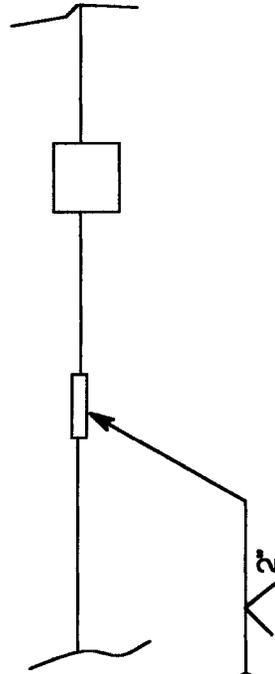
Inspected 3/27/98 by JF & TK

TYPE 9 REPAIR

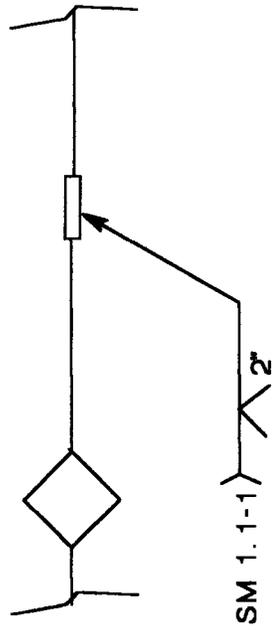
TYPE 9 REPAIR

MID ATLANTIC ENVIRONMENTAL	
EMERGENCY REPAIRS FOR RED HILL TANKS	
Tank #7 RECOMMENDED REPAIR DRAWING	
Repair No.: 026	File: 7R026
CYLINDER	Quadrant: D
Course: 13	Plate: 21
Drawn by: Tom Klitchen	Date: 5/4/98

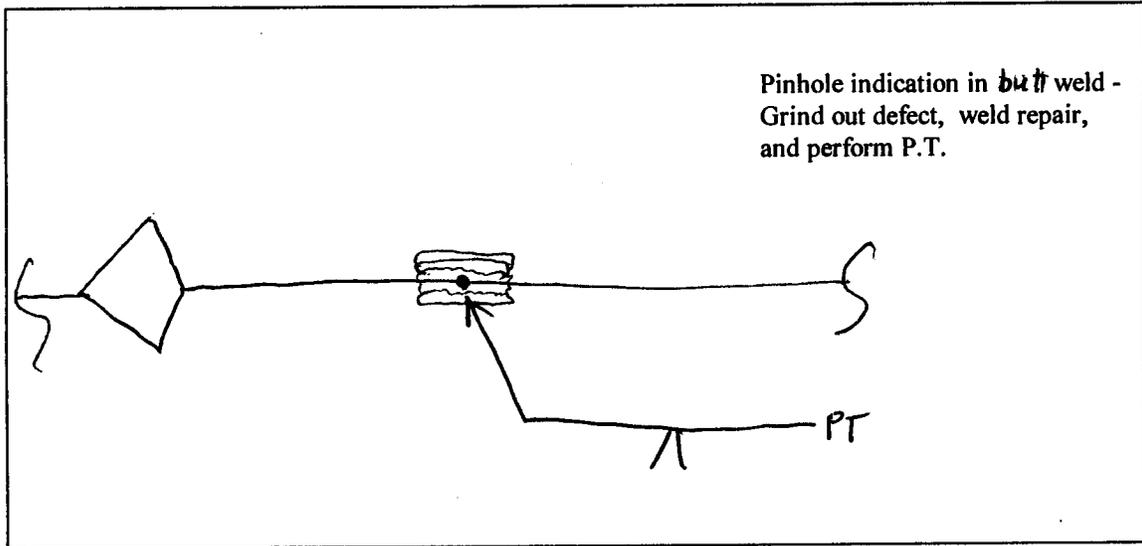
Tank No.: 7 Repair No.: 025 Type: 9 Location: D21-13

Sketch of Repair Area

Weld Repair

Coating Repair

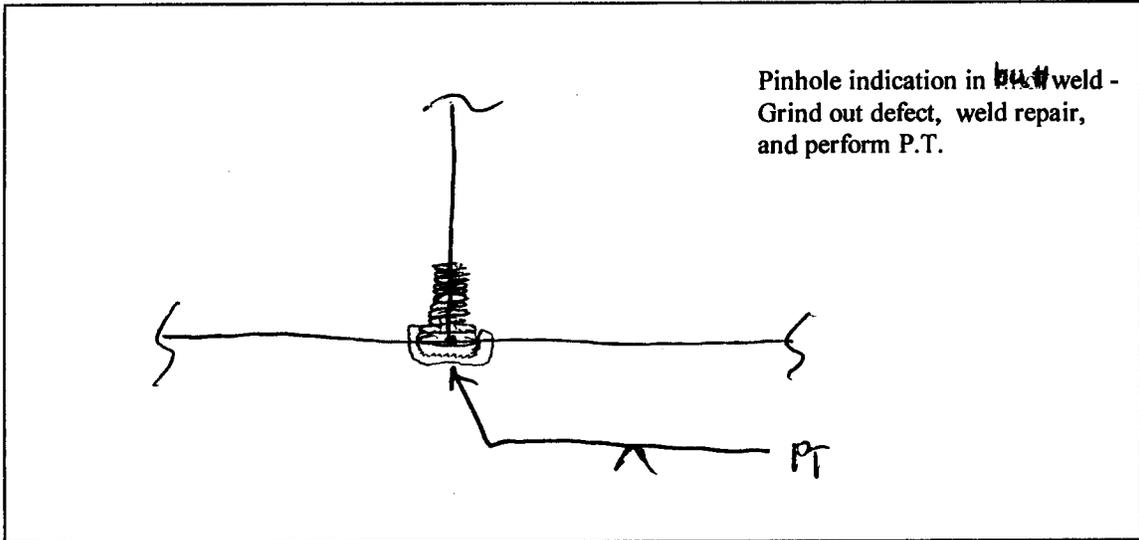
Tank No.: 7 Repair No.: 026 Type: 9 Location: D21-13

Sketch of Repair Area

Weld Repair

Coating Repair

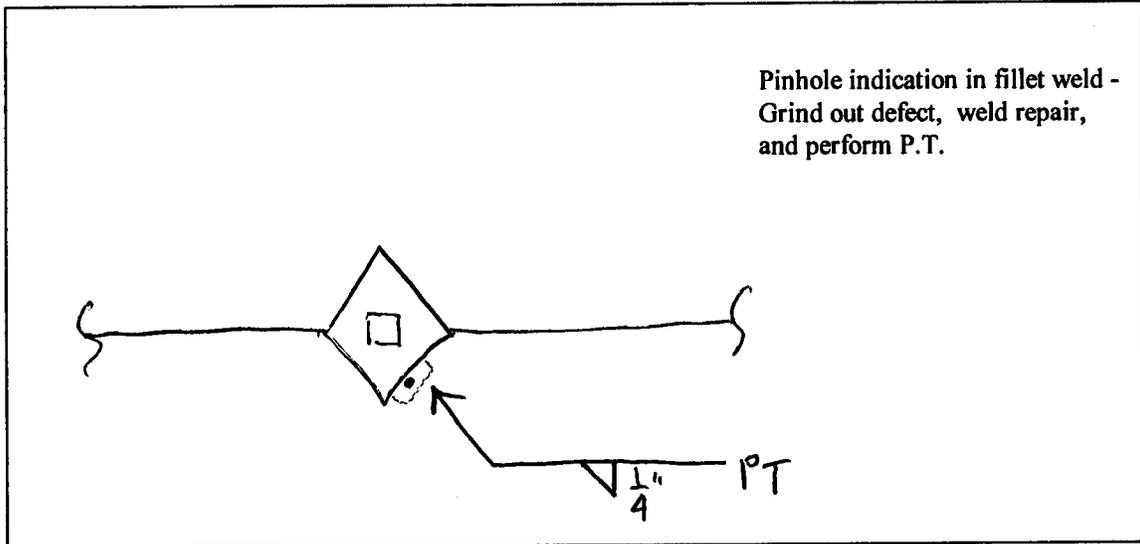
Tank No.: 7 Repair No.: 027 Type: 10 Location: D21-13

Sketch of Repair Area

Weld Repair

Coating Repair

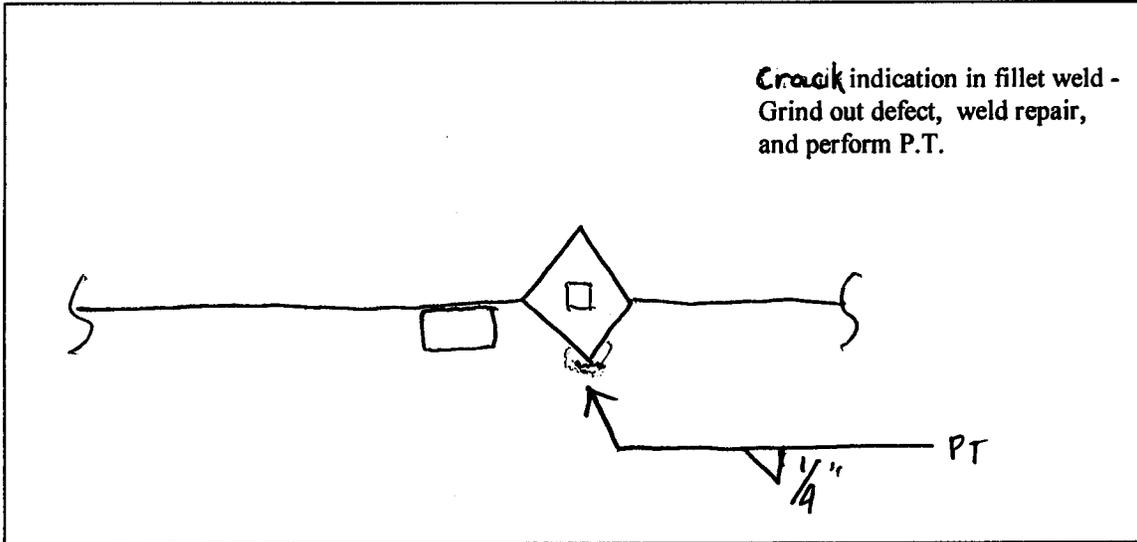
Tank No.: 7 Repair No.: 028 Type: 10 Location: D21-16

Sketch of Repair Area

Weld Repair

Coating Repair

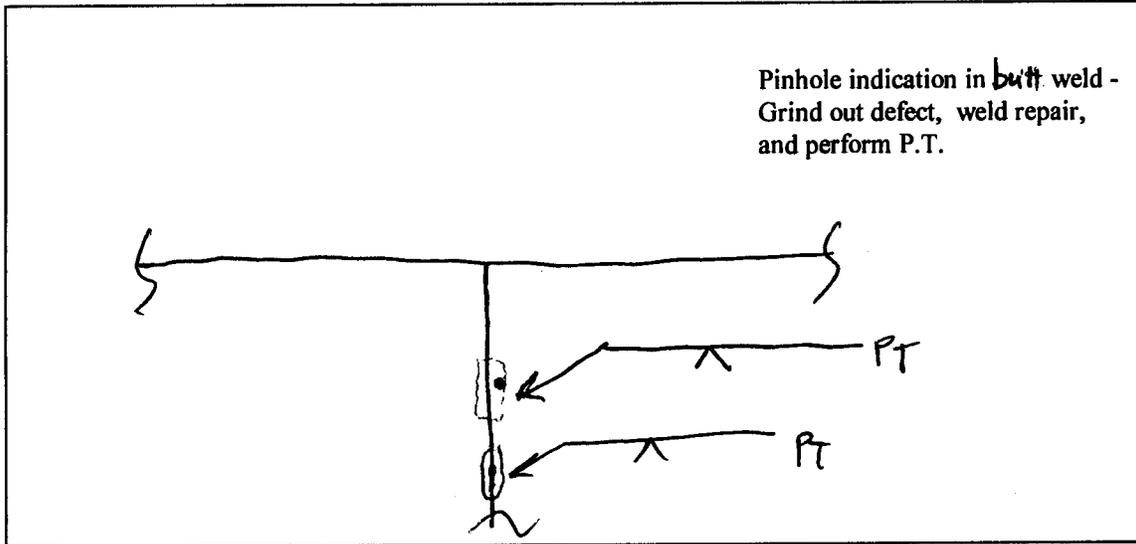
Tank No.: 7 Repair No.: 029 Type: 90 Location: C 19-22

Sketch of Repair Area

Weld Repair

Coating Repair

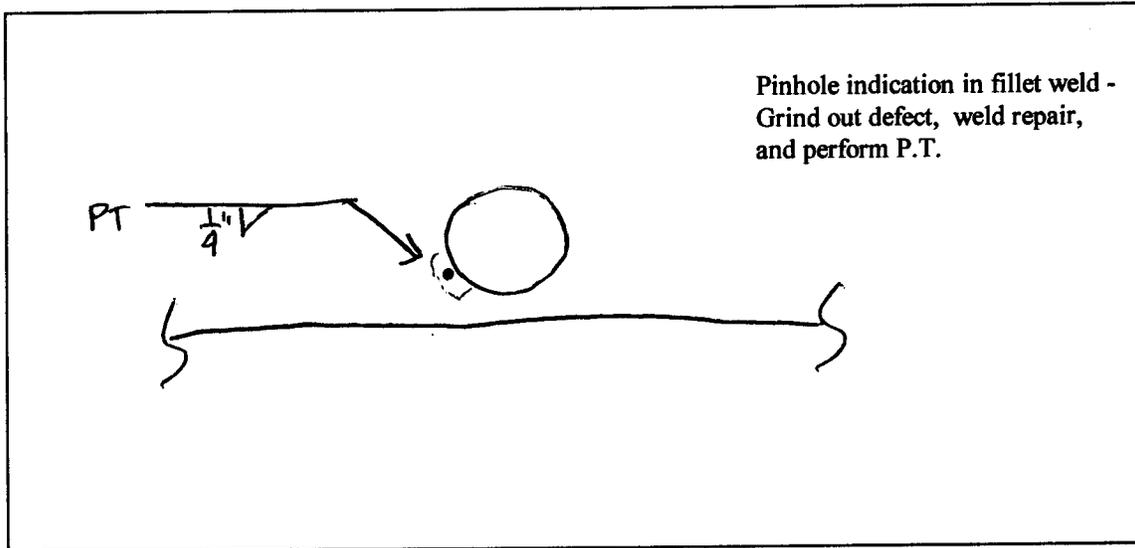
Tank No.: 7 Repair No.: 030 Type: 10 Location: C15 - 25

Sketch of Repair Area

Weld Repair

Coating Repair

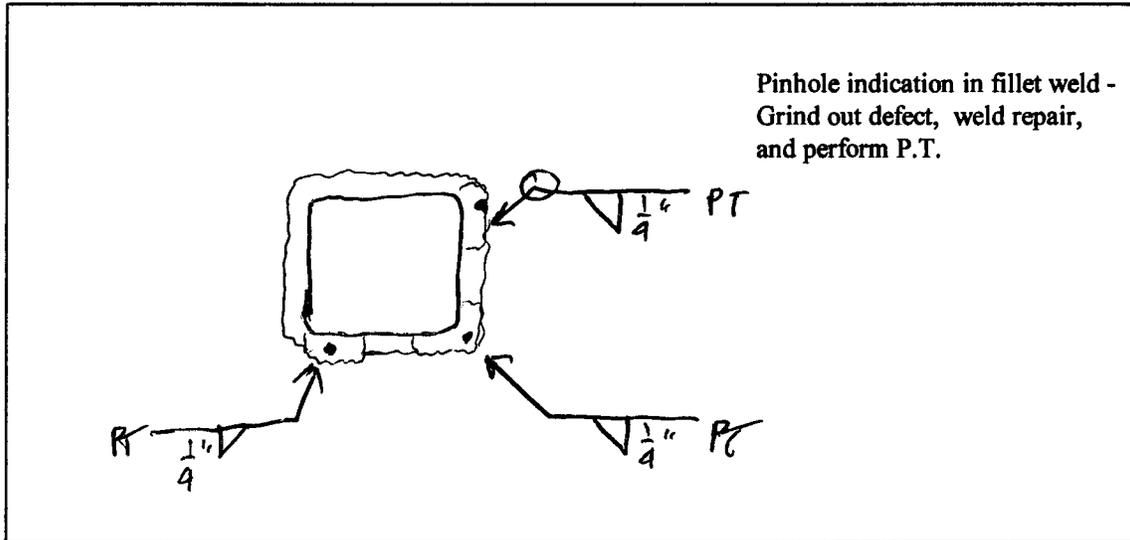
Tank No.: 7 Repair No.: 032 Type: 10 Location: C18-28

Sketch of Repair Area

Weld Repair

Coating Repair

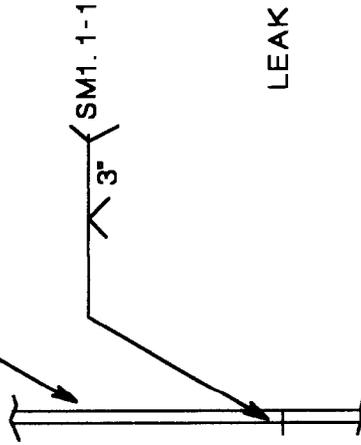
TYPE 10 REPAIR

VERTICAL WELD SEAM

LEAK IN WELD SEAM

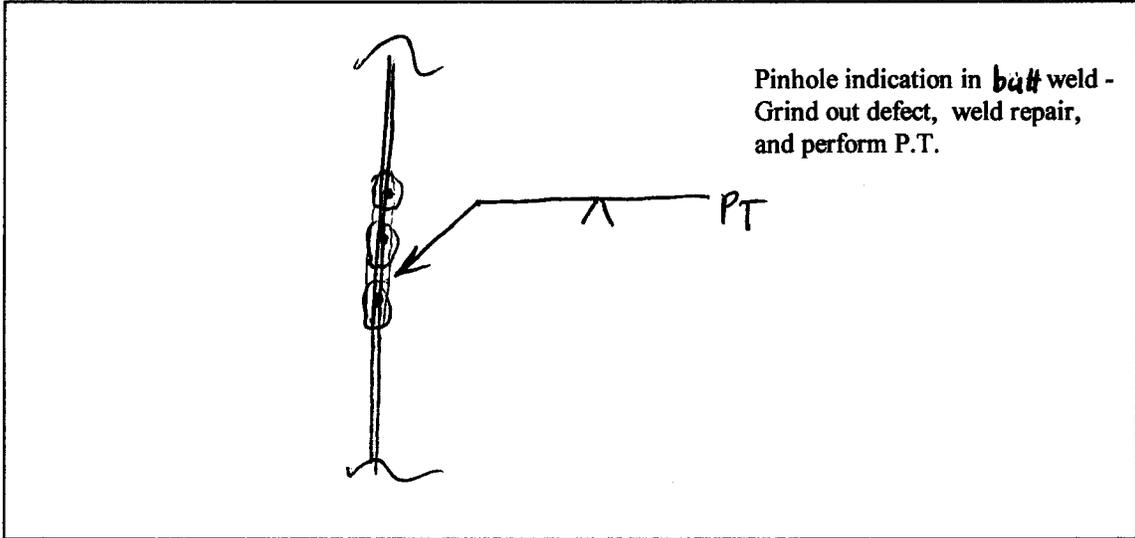
Tank No.: 7 Repair No.: 033 Type: 9 Location: D21-3

Sketch of Repair Area

Weld Repair

Coating Repair

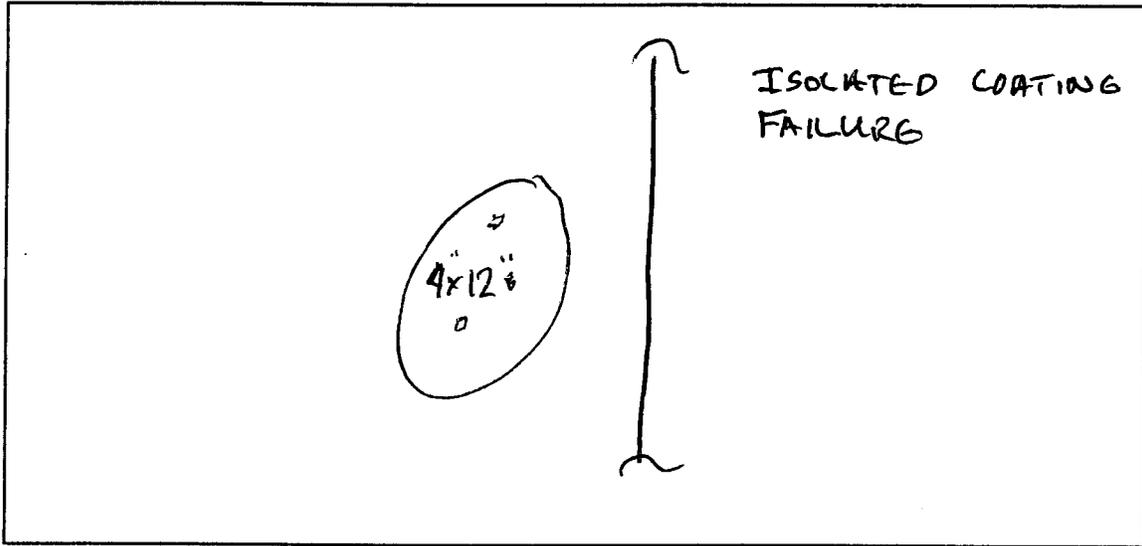
Tank No.: 7 Repair No.: 034 Type: 8 Location: C17-3

Sketch of Repair Area

Coating Repair

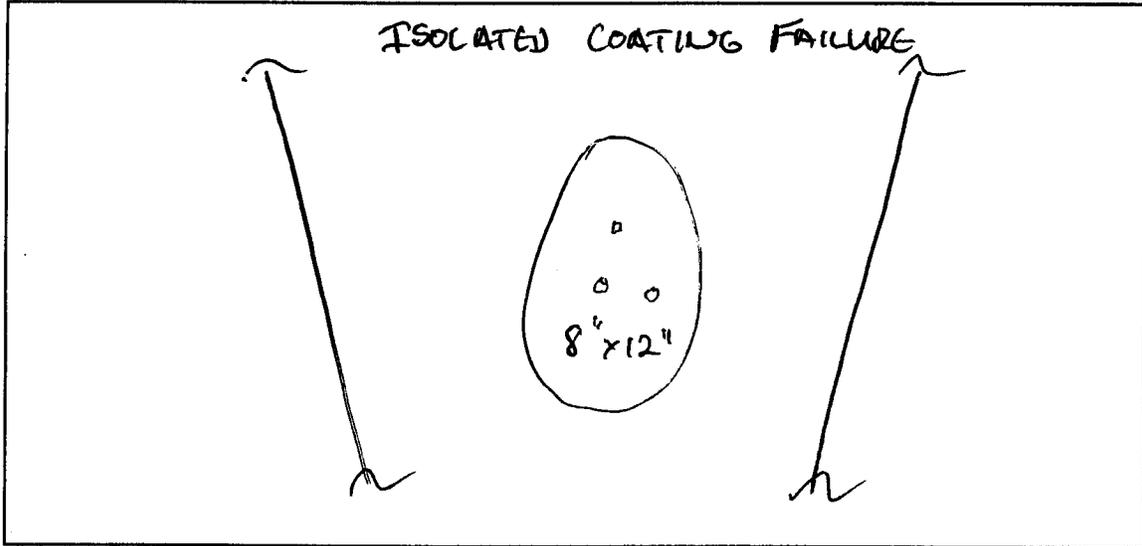
Tank No.: 7 Repair No.: 035 Type: 8 Location: C16-3

Sketch of Repair Area

Coating Repair

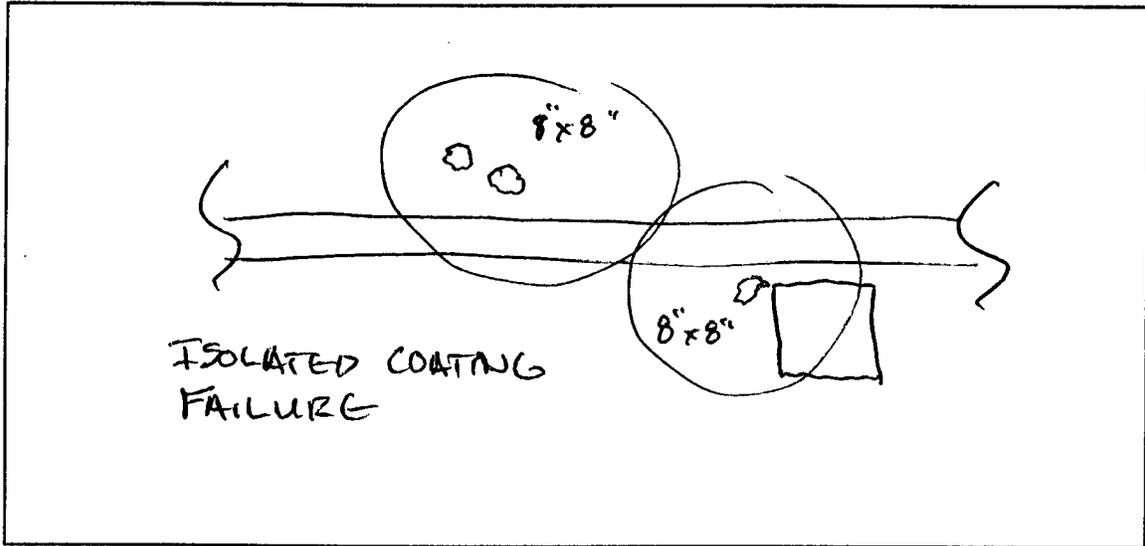
Tank No.: 7 Repair No.: 037 Type: 8 Location: C15-2

Sketch of Repair Area

Coating Repair

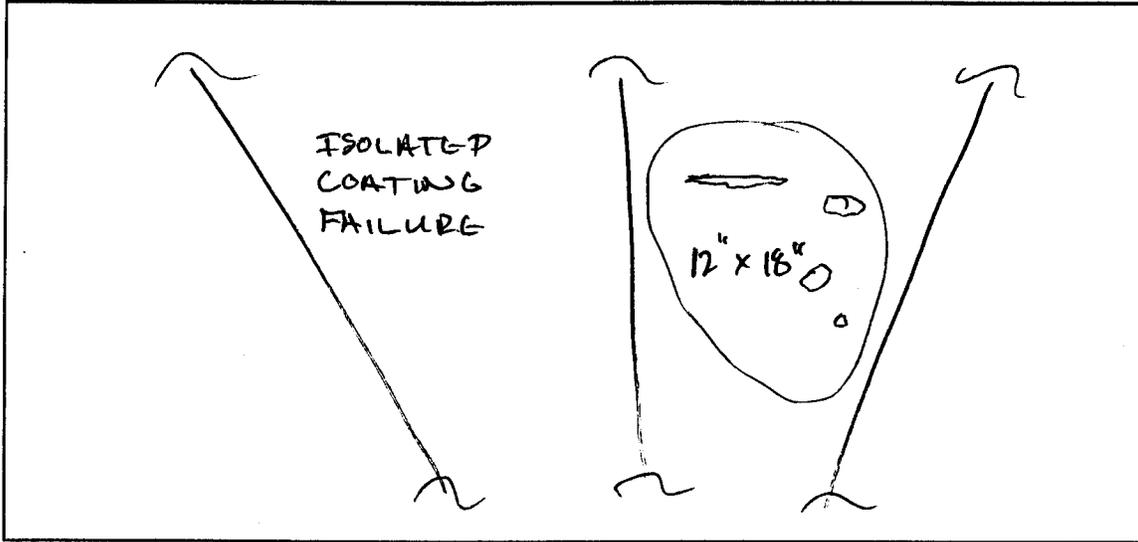
Tank No.: 7 Repair No.: 038 Type: 8 Location: D21-2

Sketch of Repair Area

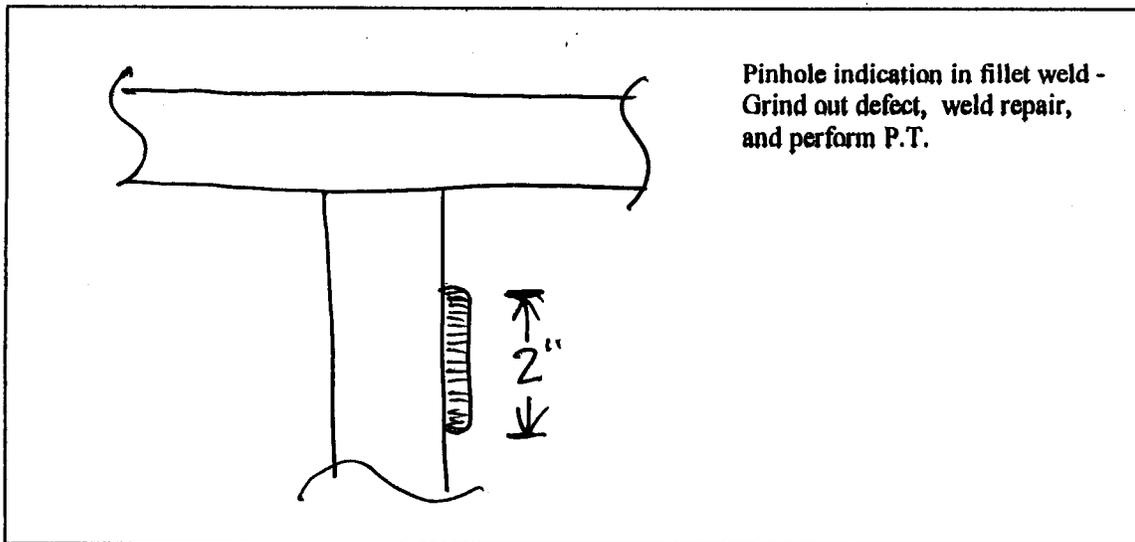
Tank No.: 7 Repair No.: 040 Type: 10 Location: B9-A

Sketch of Repair Area

Weld Repair

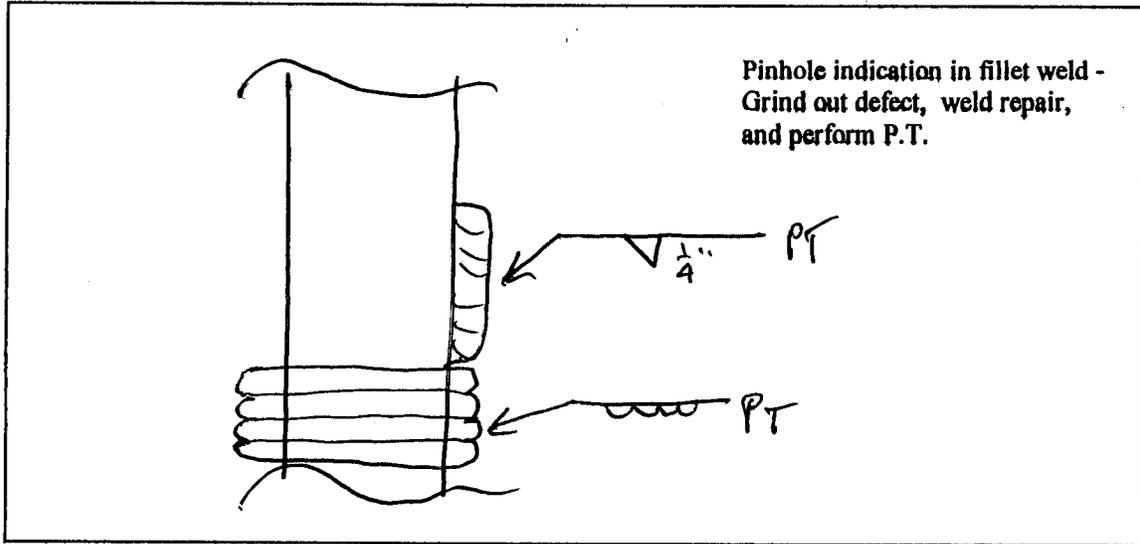
Tank No.: 7 Repair No.: 041 Type: 10 Location: A2 - A

Sketch of Repair Area

Weld Repair

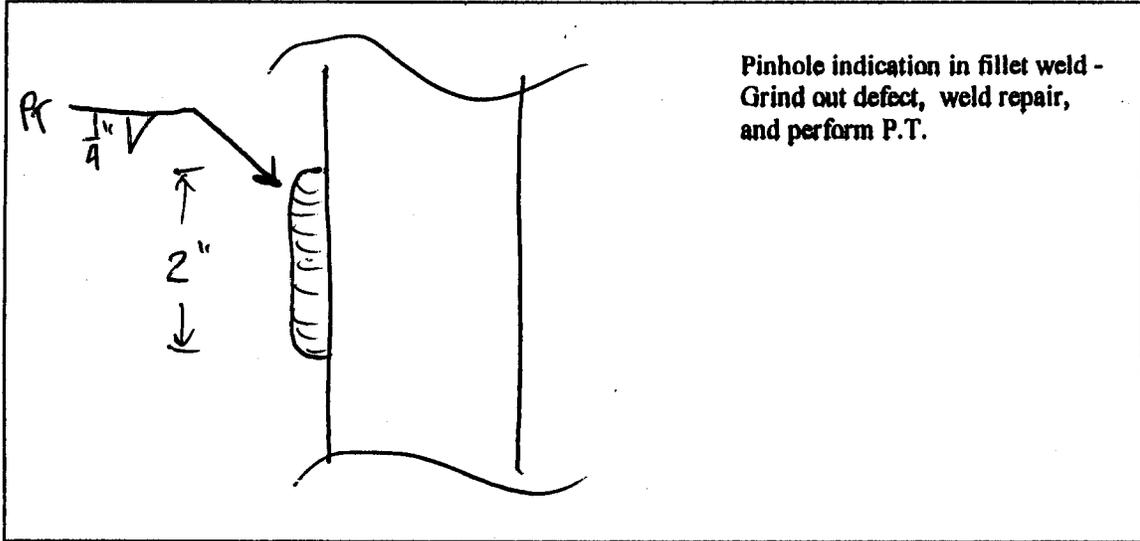
Tank No.: 7 Repair No.: 042 Type: 10 Location: A3-A

Sketch of Repair Area

Weld Repair

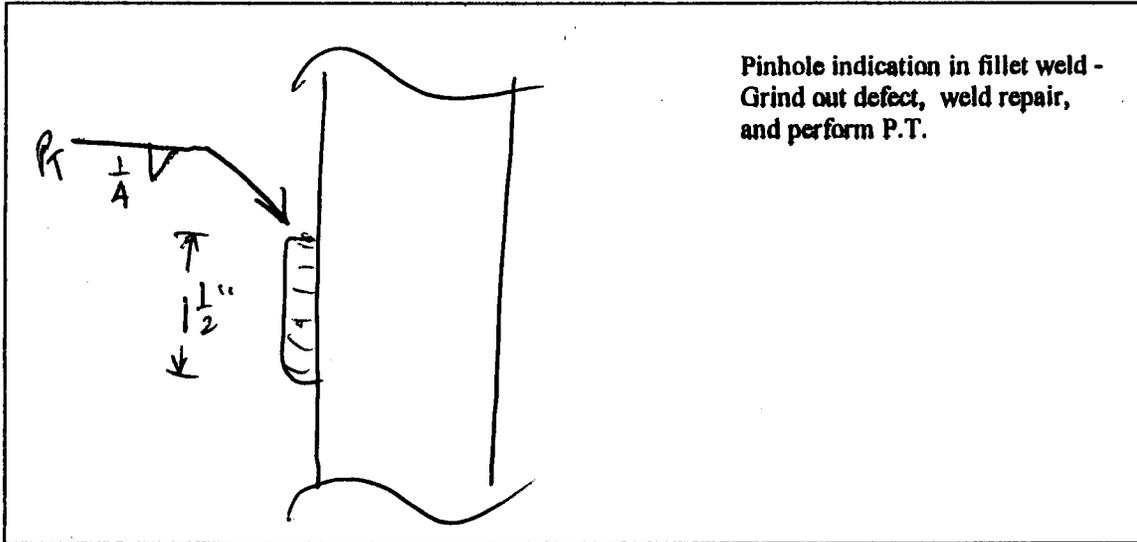
Tank No.: 7 Repair No.: 043 Type: 10 Location: A3-A

Sketch of Repair Area

Weld Repair

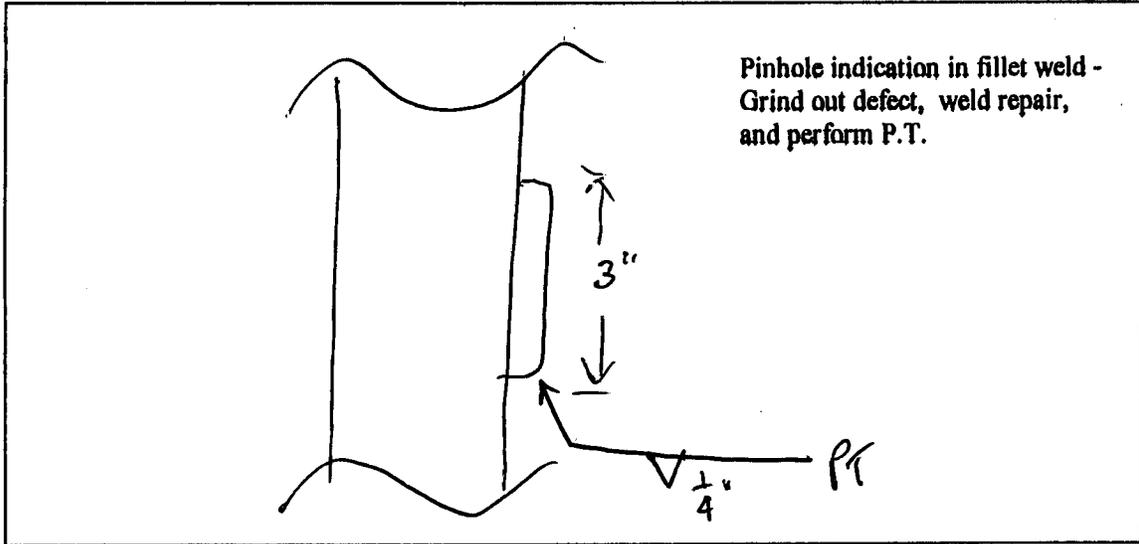
Tank No.: 7 Repair No.: 045 Type: 10 Location: A4-A

Sketch of Repair Area

Weld Repair

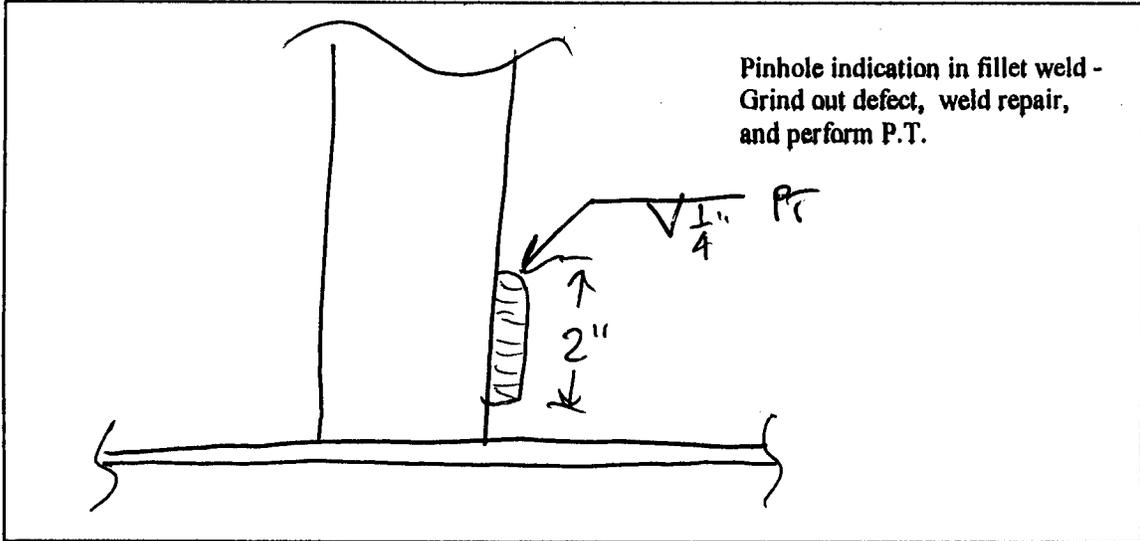
Tank No.: 7 Repair No.: 046 Type: 10 Location: B10-A

Sketch of Repair Area

Weld Repair
