July 1960 - Tank #2 - Red Hill

Red Hill Storage Facility Tank #13

**PRL 96-21
Emergency Repairs for Red Hill Tanks**

EMERGENCY REPAIRS FOR RED HILL TANKS

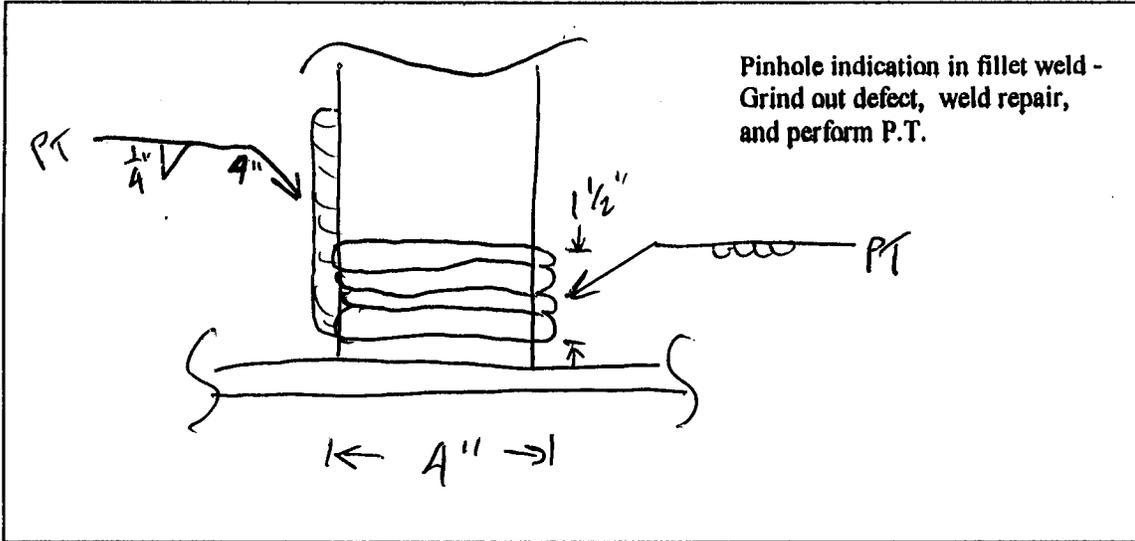
Tank No.: 7 Repair No.: 047 Type: 10 Location: B11-A

Sketch of Repair Area

Weld Repair

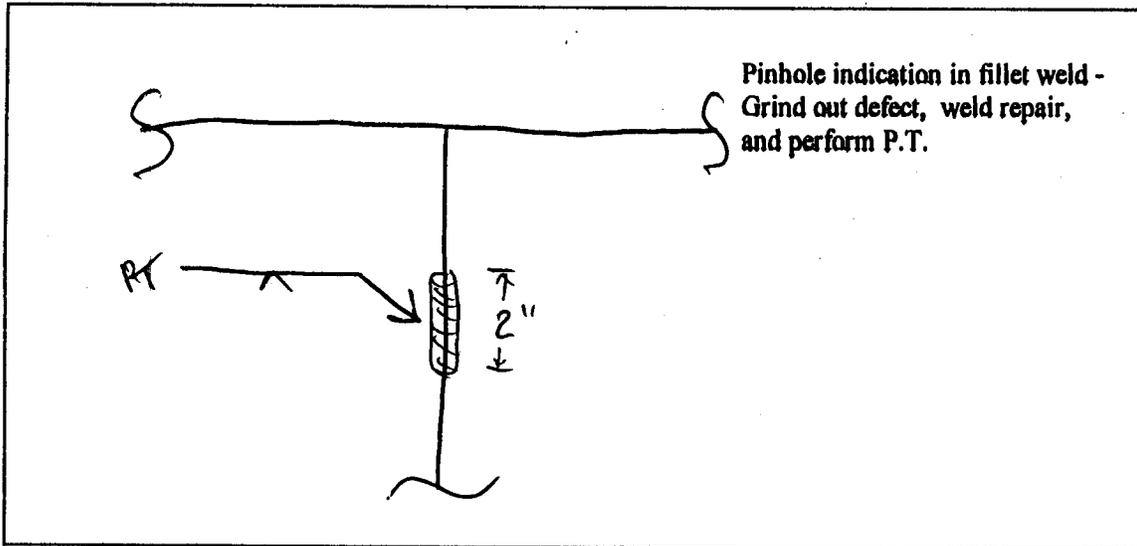
Tank No.: 7 Repair No.: 048 Type: 9 Location: B11-8

Sketch of Repair Area

Weld Repair

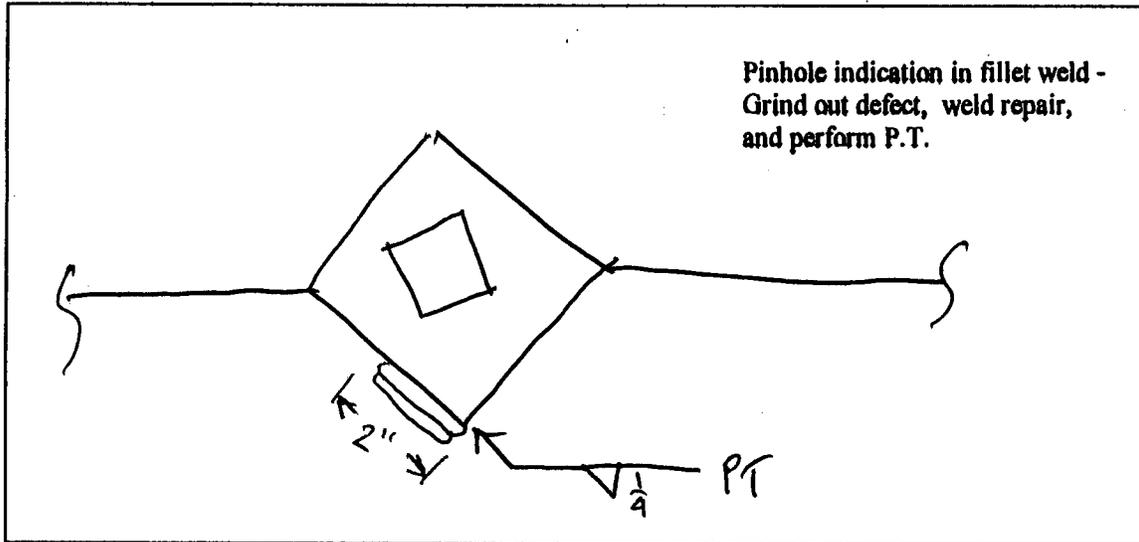
Tank No.: 7 Repair No.: 049 Type: 10 Location: B9-15

Sketch of Repair Area

Weld Repair

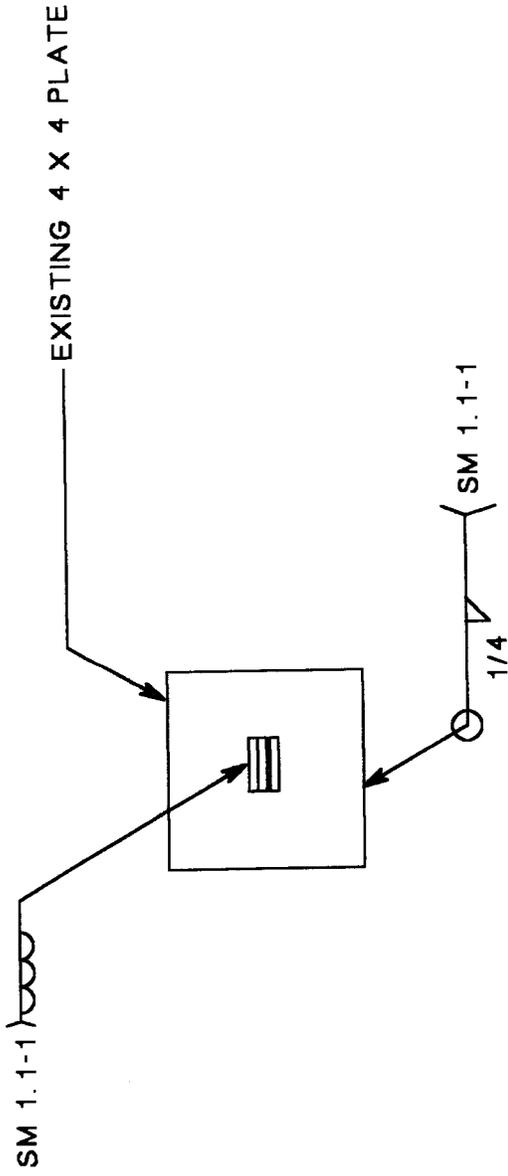
MID ATLANTIC ENVIRONMENTAL	
EMERGENCY REPAIRS FOR RED HILL TANKS	
Tank #7 REPAIR DRAWING	
Repair No.: 050	File: 7R050
CYLINDER	Quadrant: B
Course: 28	Plate: 11
Drawn by: Tom Kitchen	Date: 5/4/98

TYPE 10 REPAIR

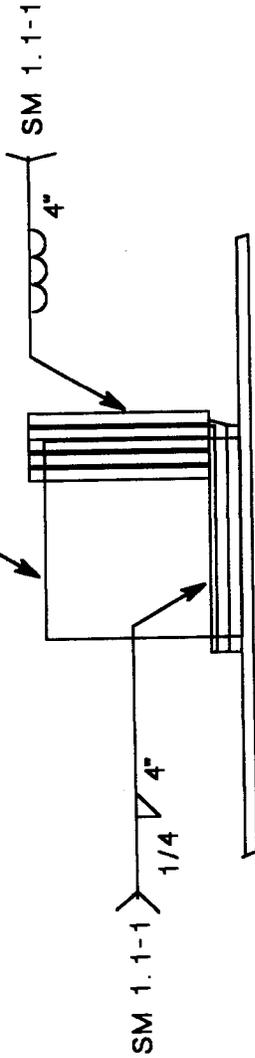
MID ATLANTIC ENVIRONMENTAL	
EMERGENCY REPAIRS FOR RED HILL TANKS	
Tank #7 REPAIR DRAWING	
Repair No.: 051	File: 7R051
CYLINDER	Quadrant: B
Course: 28	Plate: 8
Drawn by: Tom Kitchen	Date: 5/4/98

EXISTING 4 X 4 PLATE

TYPE 10 REPAIR

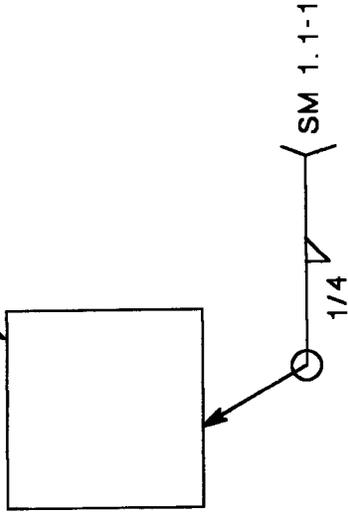
MID ATLANTIC ENVIRONMENTAL	
EMERGENCY REPAIRS FOR RED HILL TANKS	
Tank #7 REPAIR DRAWING	
Repair No.: 052	File: 7R052
CYLINDER	Quadrant: B
Course: 28	Plate: 7
Drawn by: Tom Kitchen	Date: 5/4/98

EXISTING 4 X 4 PLATE

TYPE 10 REPAIR

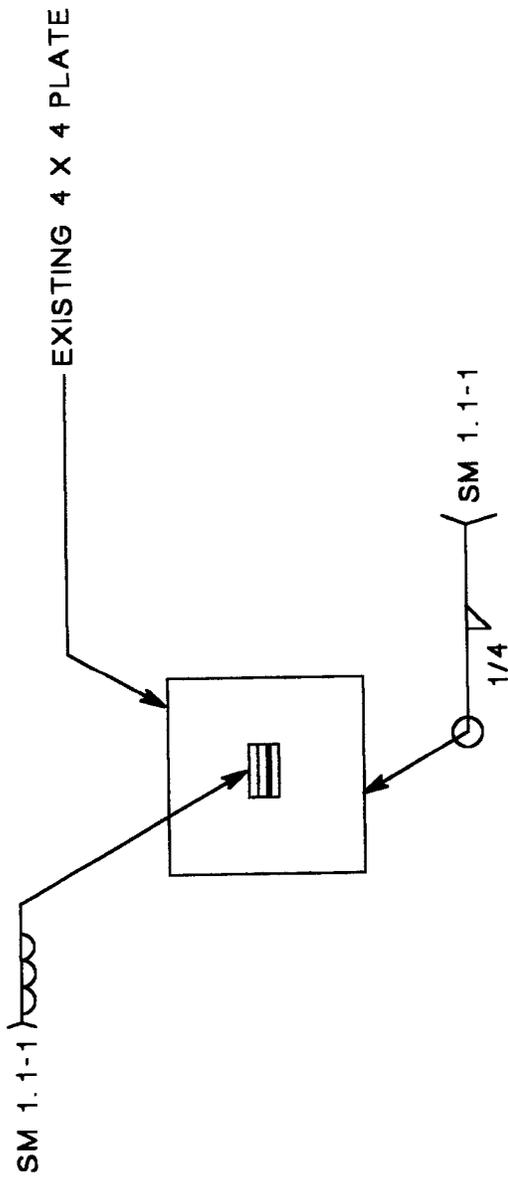
MID ATLANTIC ENVIRONMENTAL	
EMERGENCY REPAIRS FOR RED HILL TANKS	
Tank #7 RECOMMENDED REPAIR DRAWING	
Repair No. 053	File: 7R053
CYLINDER	Quadrant: B
Course: 28	Plate: 6
Drawn by: Tom Kitchen	Date: 5/4/98

TYPE 10 REPAIR

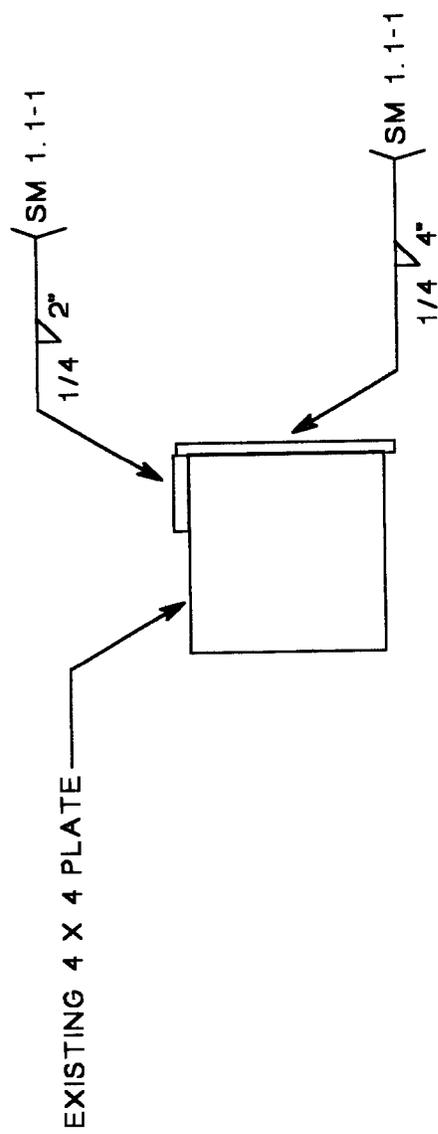
MID ATLANTIC ENVIRONMENTAL	
EMERGENCY REPAIRS FOR RED HILL TANKS	
Tank #7 RECOMMENDED REPAIR DRAWING	
Repair No.: 054	File: 7R054
CYLINDER	Quadrant: B
Course: 28	Plate: 5
Drawn by: Tom Kitchen	Date: 5/4/98

TYPE 10 REPAIR

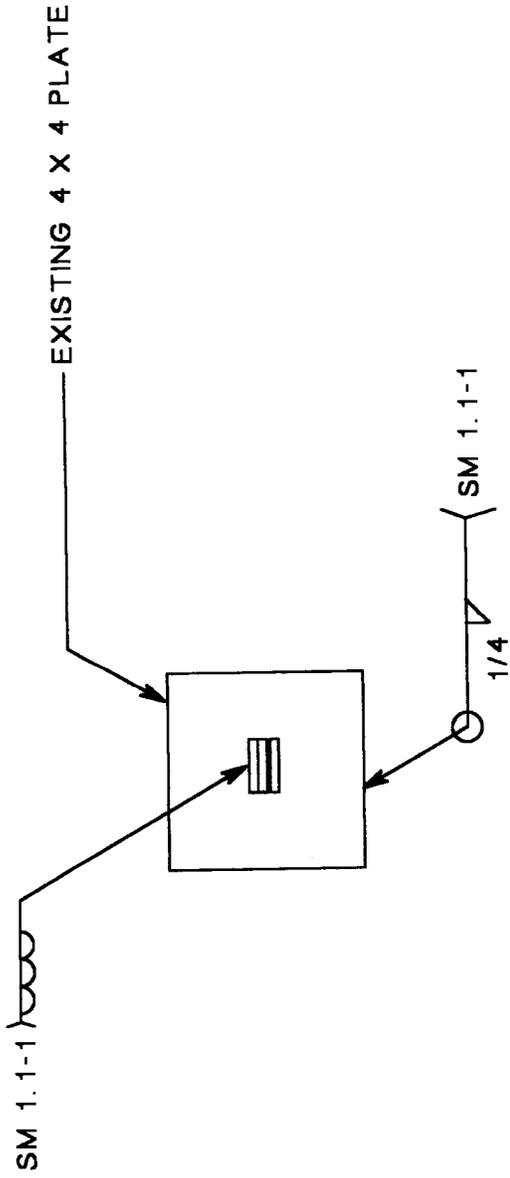
MID ATLANTIC ENVIRONMENTAL	
EMERGENCY REPAIRS FOR RED HILL TANKS	
Tank #7 RECOMMENDED REPAIR DRAWING	
Repair No.: 055	File: 7R055
CYLINDER	Quadrant: A
Course: 28	Plate: 4
Drawn by: Tom Kitchen	Date: 5/4/98

TYPE 10 REPAIR

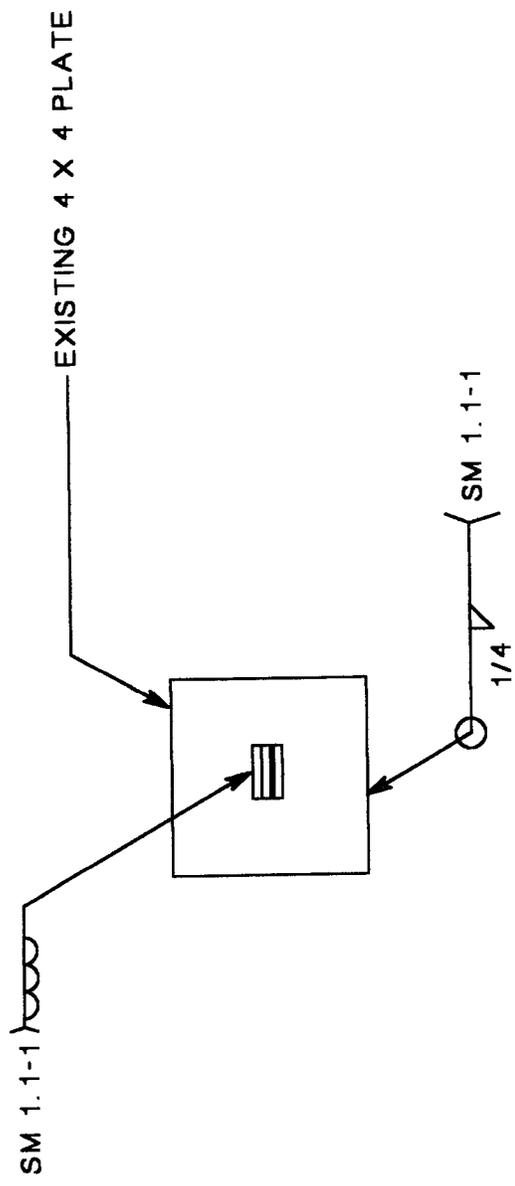
MID ATLANTIC ENVIRONMENTAL	
EMERGENCY REPAIRS FOR RED HILL TANKS	
Tank #7 RECOMMENDED REPAIR DRAWING	
Repair No. : 056	File: 7R056
CYLINDER	Quadrant: A
Course: 28	Plate: 2
Drawn by: Tom Kitchen	Date: 5/4/98

TYPE 10 REPAIR

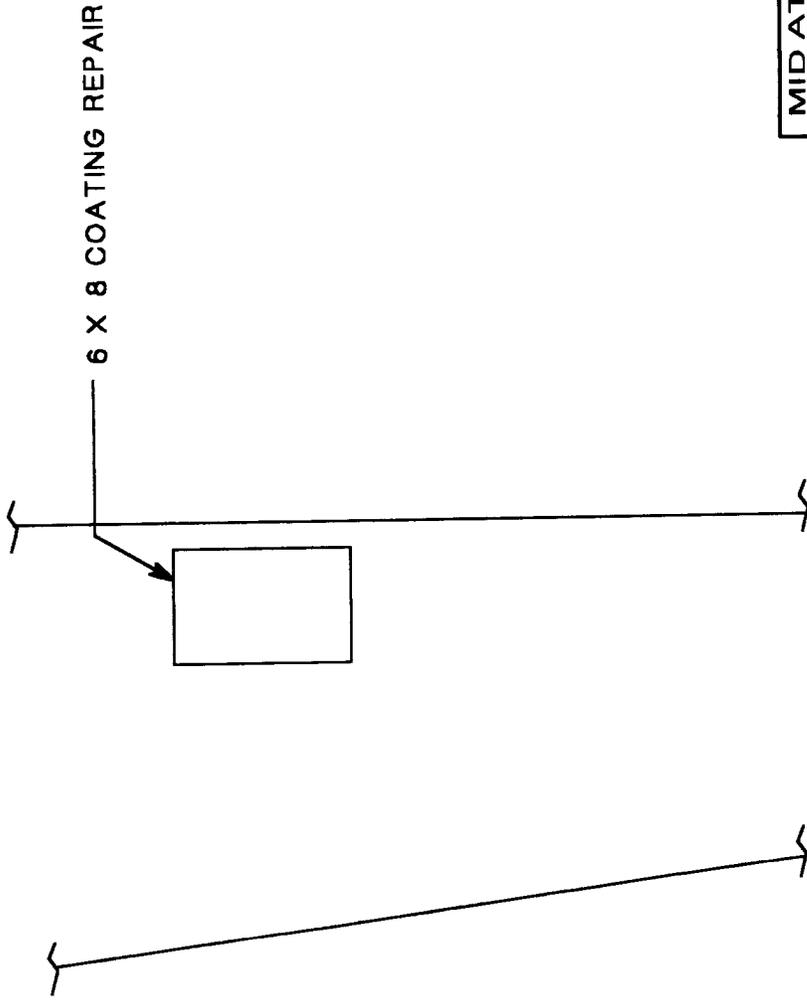
MID ATLANTIC ENVIRONMENTAL	
EMERGENCY REPAIRS FOR RED HILL TANKS	
Tank #7 RECOMMENDED REPAIR DRAWING	
Repair No.: 058	File: 7R058
Lower Dome	Quadrant: B
Course: 3	Plate: 11
Drawn by: Tom Kitchen	
Date: 5/4/98

TYPE 8 REPAIR

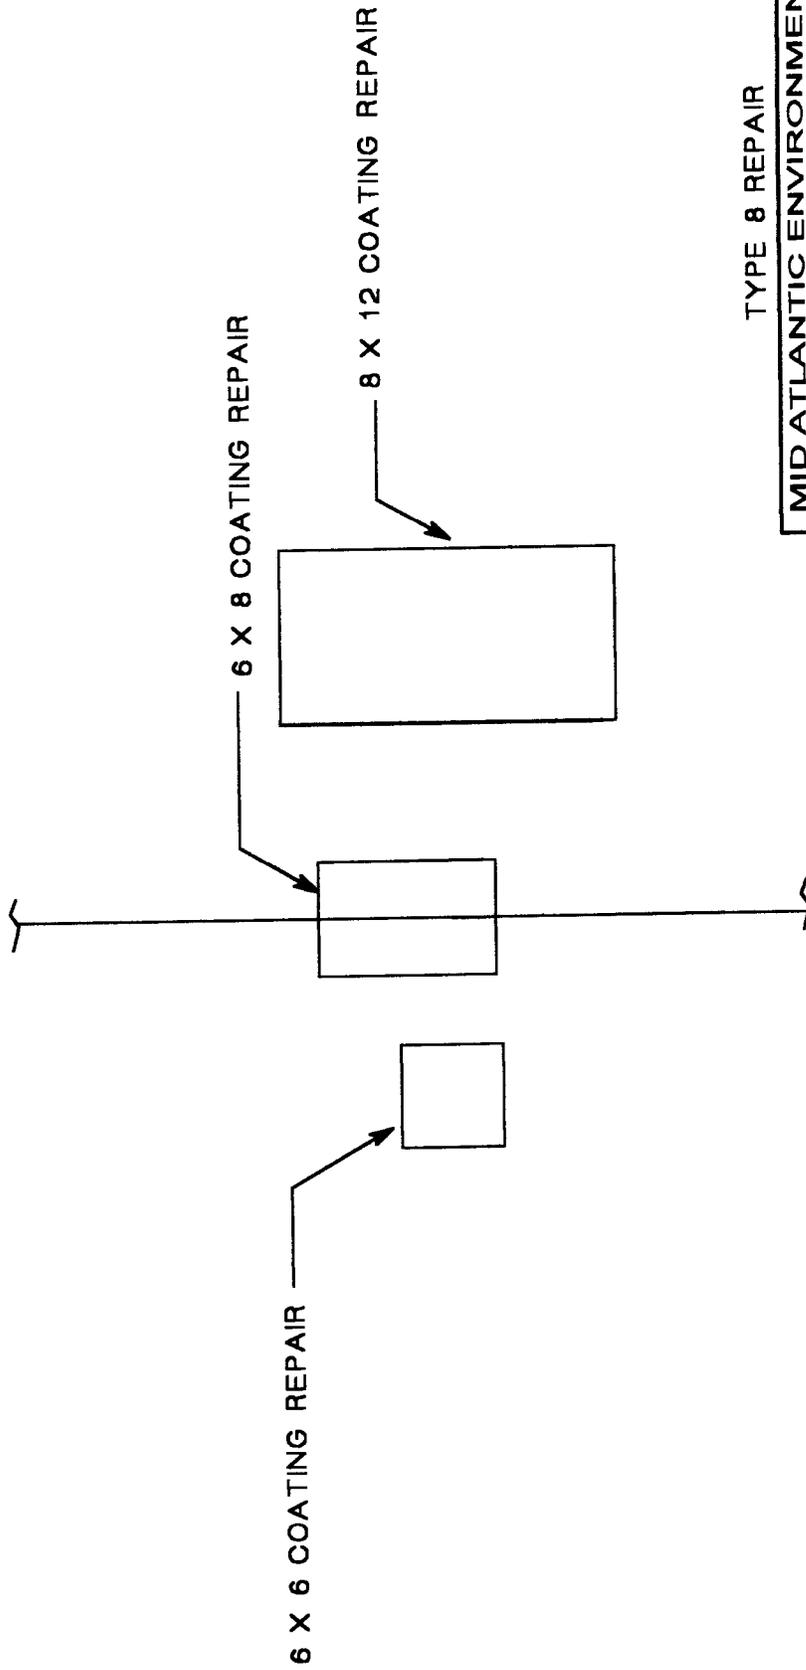
MID ATLANTIC ENVIRONMENTAL	
EMERGENCY REPAIRS FOR RED HILL TANKS	
Tank #7 RECOMMENDED REPAIR DRAWING	
Repair No.: 059	File: 7R059
Lower Dome	Quadrant: A
Course: 3	Plate: 3
Drawn by: Tom Kitchen	Date: 5/4/98

TYPE 8 REPAIR

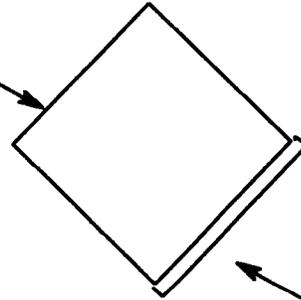
MID ATLANTIC ENVIRONMENTAL	
EMERGENCY REPAIRS FOR RED HILL TANKS	
Tank #7 RECOMMENDED REPAIR DRAWING	
Repair No.: 060	File: 7R060
CYLINDER	Quadrant: A
Course: 17	Plate: 1
Drawn by: Tom Kitchen	Date: 5/4/98

EXISTING 4 X 4 PLATE

TYPE 10 REPAIR

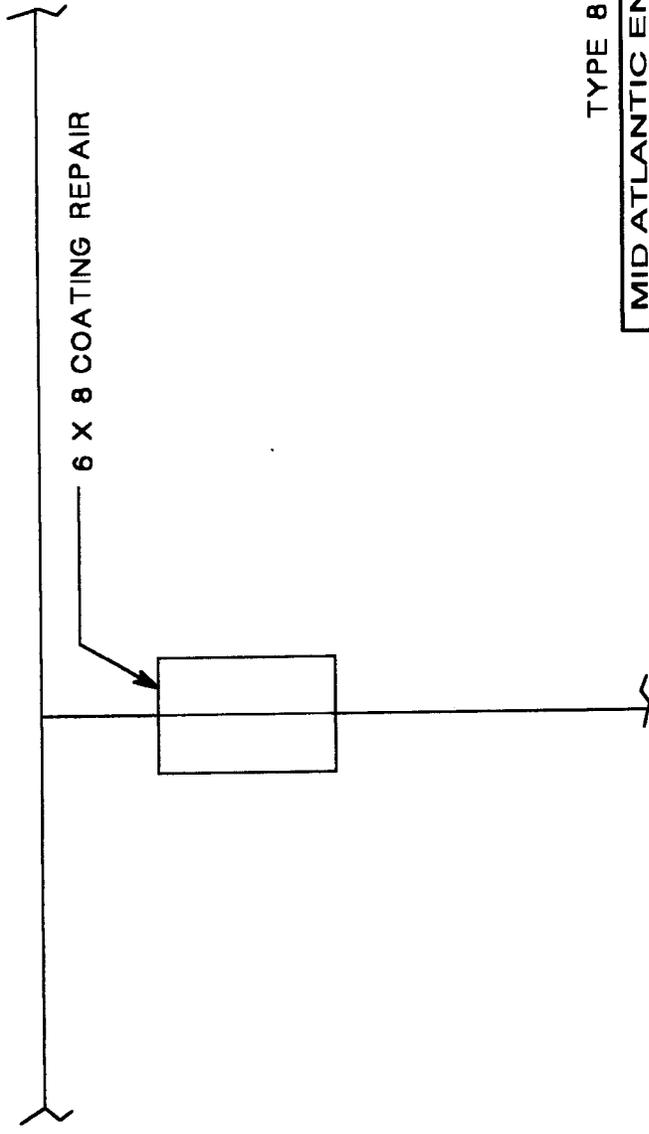
MID ATLANTIC ENVIRONMENTAL	
EMERGENCY REPAIRS FOR RED HILL TANKS	
Tank #7 RECOMMENDED REPAIR DRAWING	
Repair No. : 063	File: 7R063
Lower Dome	Quadrant: A
Course: 2	Plate: 7
Drawn by: Tom Kitchen	Date: 5/4/98

TYPE 8 REPAIR

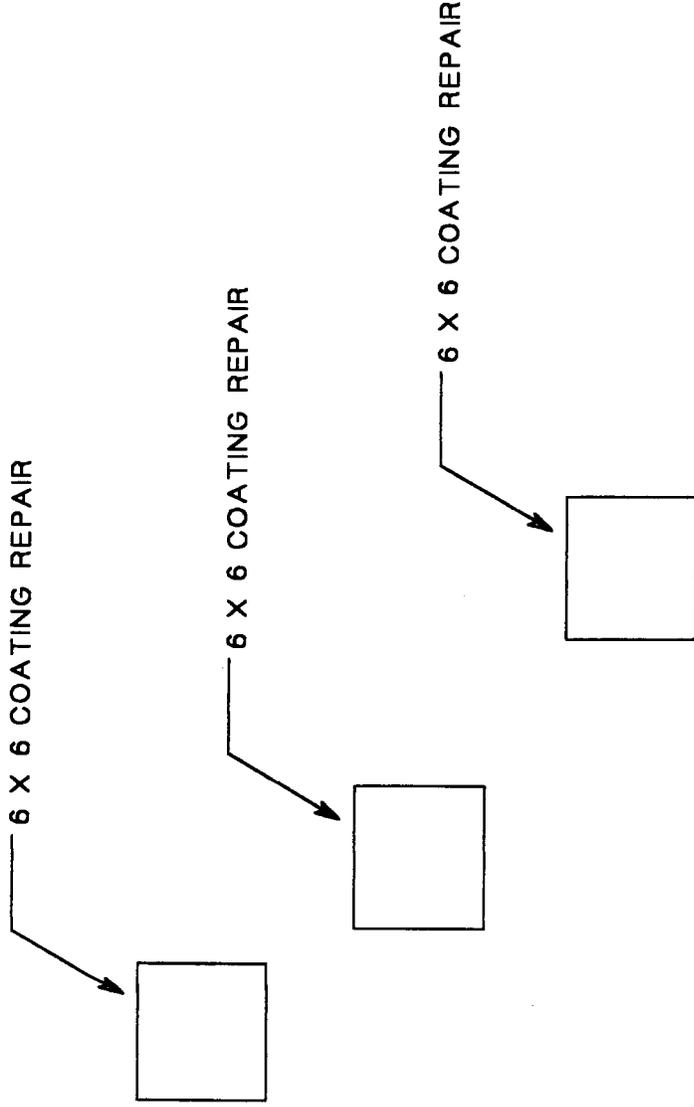
MID ATLANTIC ENVIRONMENTAL	
EMERGENCY REPAIRS FOR RED HILL TANKS	
Tank #7 RECOMMENDED REPAIR DRAWING	
Repair No. : 065	File:7R065
Lower Dome	Quadrant: A
Course: 1	Plate: 1
Drawn by: Tom Kitchen	Date: 5/4/98

TYPE 8 REPAIR

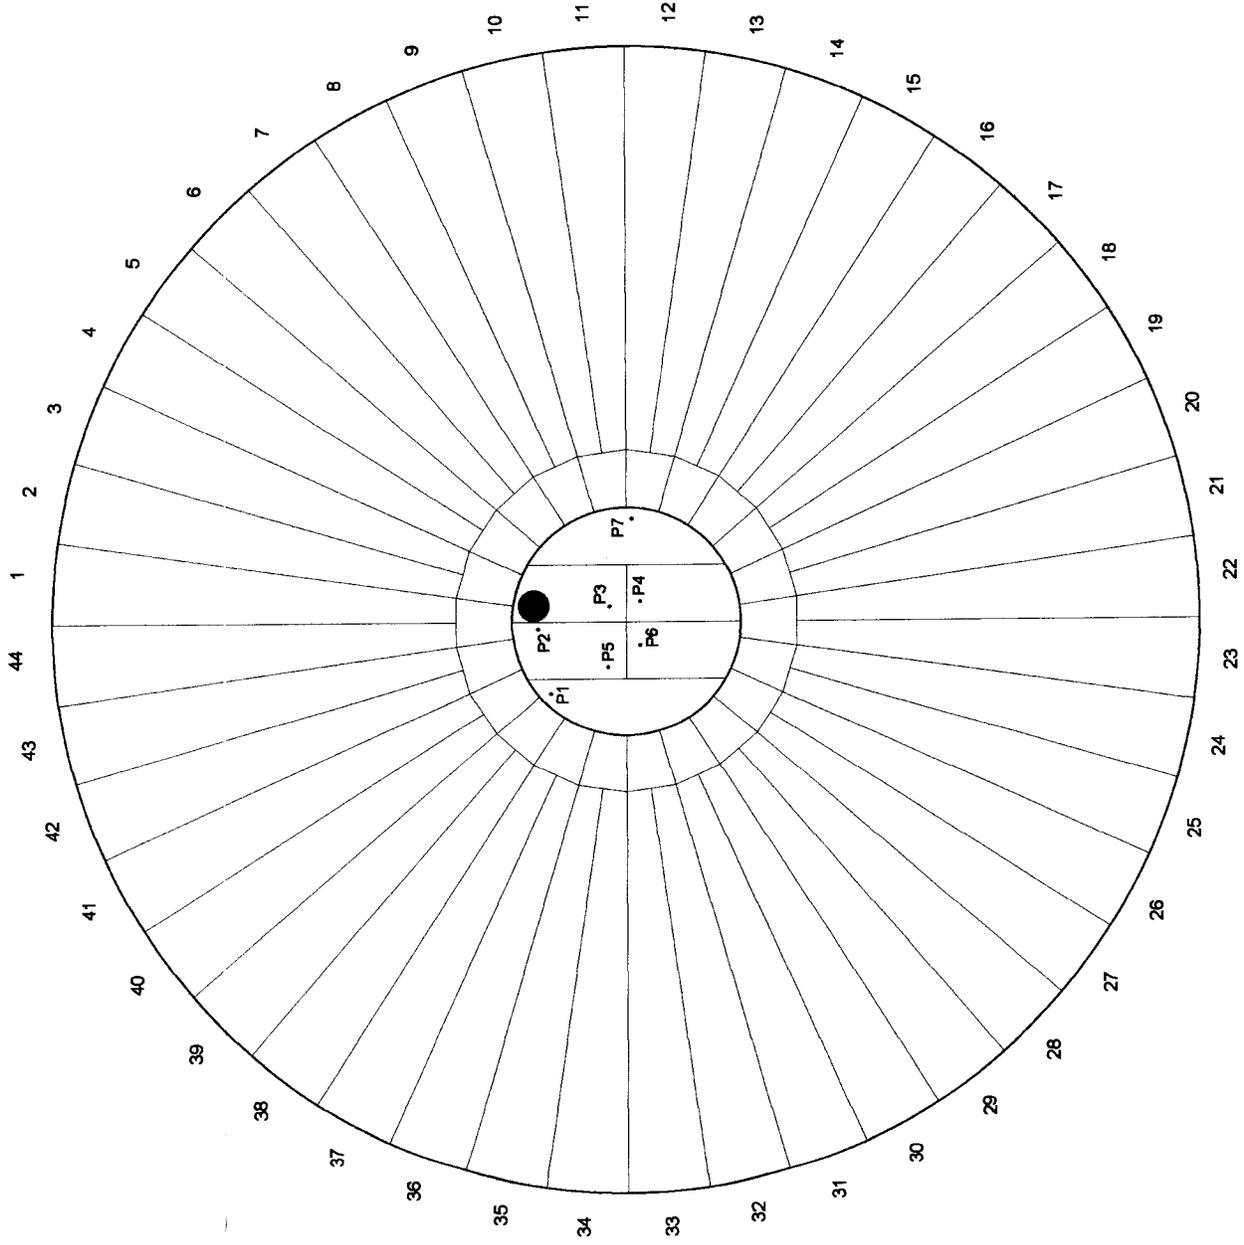
Remarks/Legend: Pitting was general over 30% of bottom

- P1 = 0.15
- P2 = 0.11
- P3 = 0.09
- P4 = 0.12
- P5 = 0.09
- P6 = 0.09
- P7 = 0.12

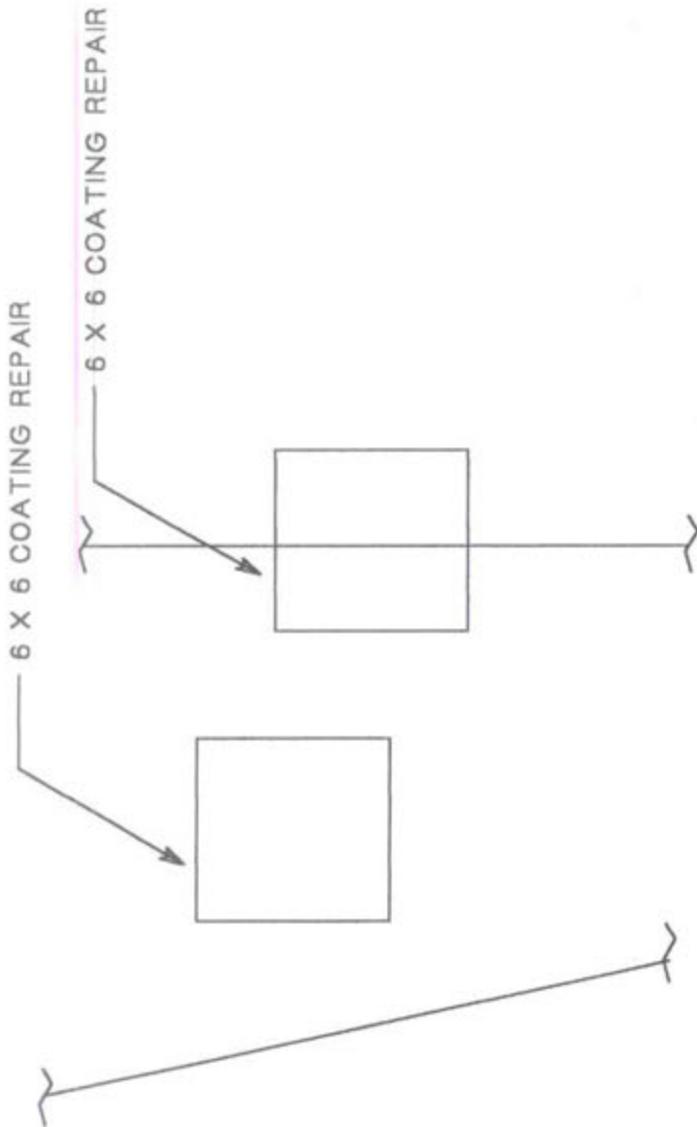
MID ATLANTIC ENVIRONMENTAL	
EMERGENCY REPAIRS FOR RED HILL TANKS	
Tank #8 RECOMMENDED REPAIR DRAWING	
Repair No. 014	File:8r014
LOWER DOME	Quadrant: B
Course: 3	PLATE: 10
Drawn by: Tom Kitchen	Date: 5/4/98

DEFECT INSPECTED BY TK & JF 3/16/98

TYPE 9 REPAIR

1. PATCH PLATES FOR UPPER DOME, DOME EXTENSION, BARREL OF TANK AND LOWER DOME TO BE 6mm THICK. PATCH PLATES FOR BOTTOM PLATE TO BE 11mm THICK.
2. ALL WELDS TO BE CONTINUOUS.
3. SANDBLAST PATCH PLATES BEFORE WELDING IN PLACE AND BREAK EXPOSED EDGE BY GRINDING CHAMFER OF 1.5 mm MINIMUM.
4. THE REPAIR PROCEDURE IS THE SAME, REGARDLESS OF THE LOCATION OF THE DAMAGE IN THE UPPER DOME, TANK BARREL, OR LOWER DOME.

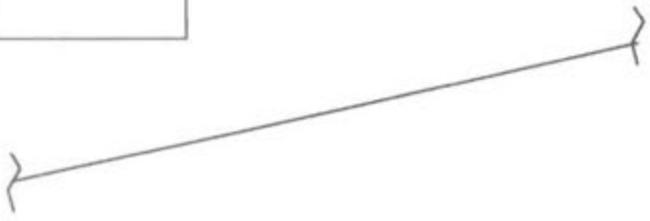
MID ATLANTIC ENVIRONMENTAL	
EMERGENCY REPAIRS FOR RED HILL TANKS	
Tank #8 RECOMMENDED REPAIR DRAWING	
Repair No.: 015	File: 8r015
LOWER DOME	Quadrant: B
Course: 3	PLATE: 10
Drawn by: Tom Kitchen	Date: 5/4/98

6 X 6 COATING REPAIR

TYPE 8 REPAIR

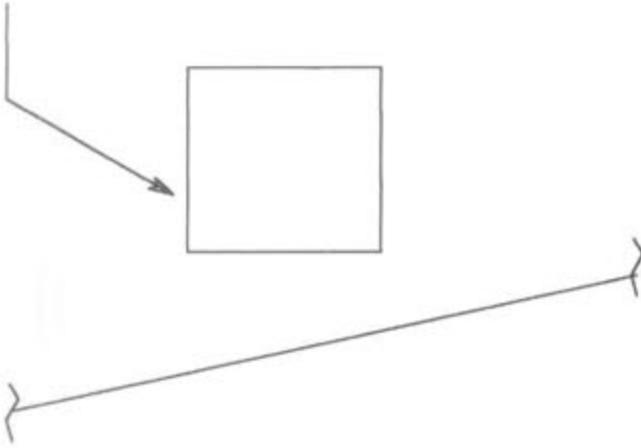
MID ATLANTIC ENVIRONMENTAL	
EMERGENCY REPAIRS FOR RED HILL TANKS	
Tank #8 RECOMMENDED REPAIR DRAWING	
Repair No.: 016	File: 8r016
LOWER DOME	Quadrant: B
Course: 3	PLATE: 19
Drawn by: Tom Kitchen	Date: 5/4/98

DEFECT INSPECTED BY TK & JF 3/16/98

6 X 6 COATING REPAIR

TYPE 8 REPAIR

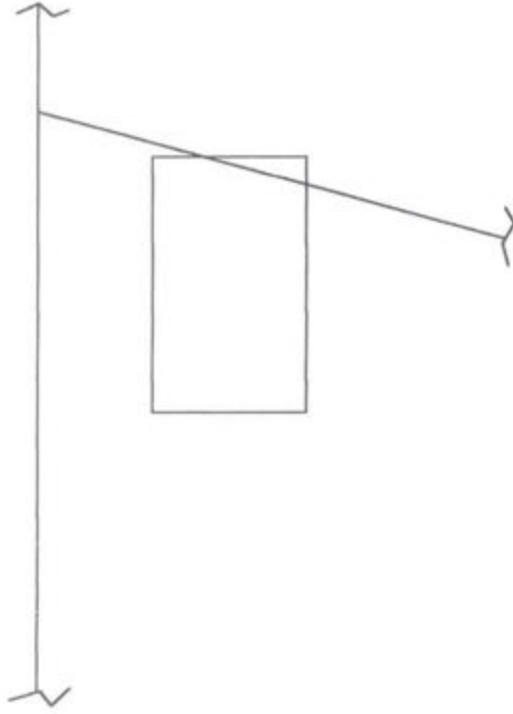
MID ATLANTIC ENVIRONMENTAL	
EMERGENCY REPAIRS FOR RED HILL TANKS	
Tank #8 RECOMMENDED REPAIR DRAWING	
Repair No. : 017	File:8r017
LOWER DOME	Quadrant: B
Course: 3	PLATE: 8
Drawn by: Tom Kitchen	Date: 5/4/98

DEFECT INSPECTED BY TK & JF 3/16/98

6 X 8 COATING REPAIR

TYPE 8 REPAIR

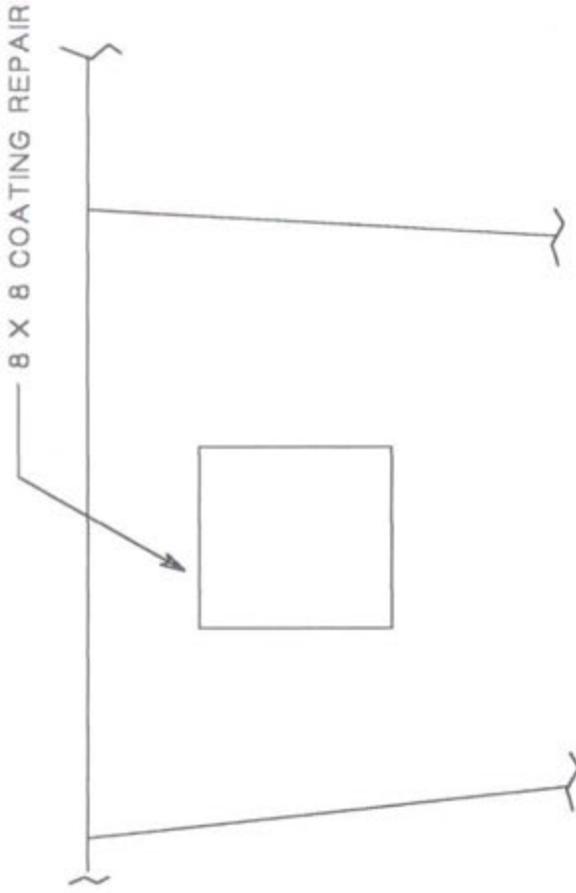
MID ATLANTIC ENVIRONMENTAL	
EMERGENCY REPAIRS FOR RED HILL TANKS	
Tank #8 RECOMMENDED REPAIR DRAWING	
Repair No.: 018	File: 8r018
LOWER DOME	Quadrant: B
Course: 2	PLATE: 10
Drawn by: Tom Kitchen	Date: 5/4/98

DEFECT INSPECTED BY TK & JF 3/16/98

TYPE 8 REPAIR

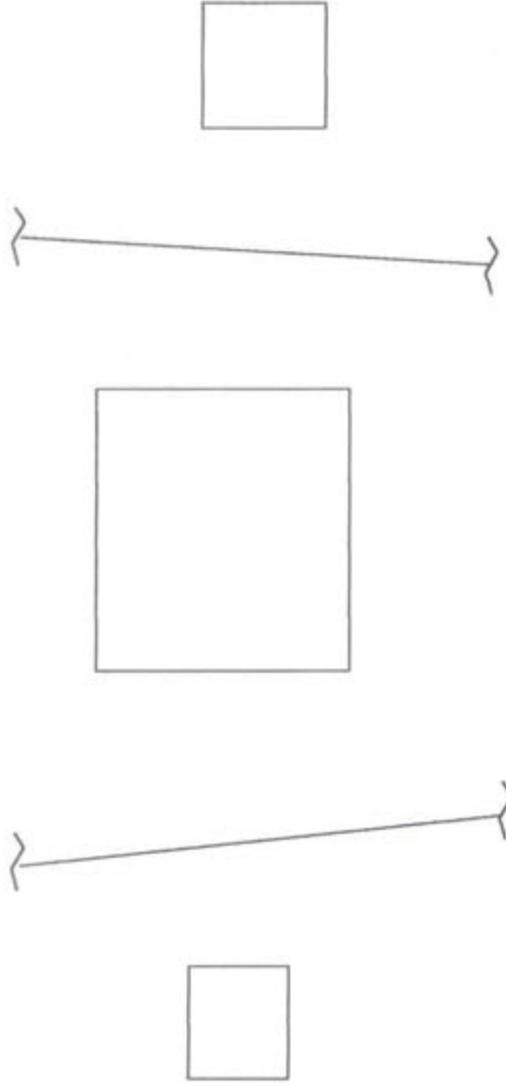
MID ATLANTIC ENVIRONMENTAL	
EMERGENCY REPAIRS FOR RED HILL TANKS	
Tank #8 RECOMMENDED REPAIR DRAWING	
Repair No.: 019 & 020	File: 8r019
LOWER DOME	Quadrant: B
Course: 2	PLATE: 11
Drawn by: Tom Kitchen	Date: 5/4/98

DEFECT INSPECTED BY TK & JF 3/16/98

SCATTERED BLISTERS APPROXIMATE AREA OF COATING
REPAIR EQUAL 2 SQUARE METERS

TYPE 8 REPAIR

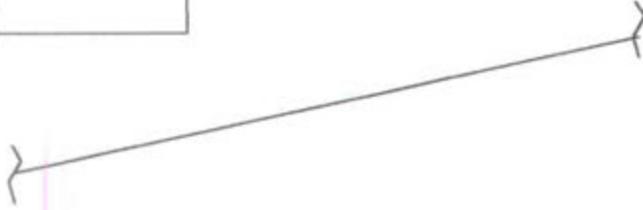
MID ATLANTIC ENVIRONMENTAL	
EMERGENCY REPAIRS FOR RED HILL TANKS	
Tank #8 RECOMMENDED REPAIR DRAWING	
Repair No.: 021	File: 8r021
LOWER DOME	Quadrant: A
Course: 2	PLATE: 2
Drawn by: Tom Kitchen	Date: 5/4/98

8 X 8 COATING REPAIR

TYPE 8 REPAIR

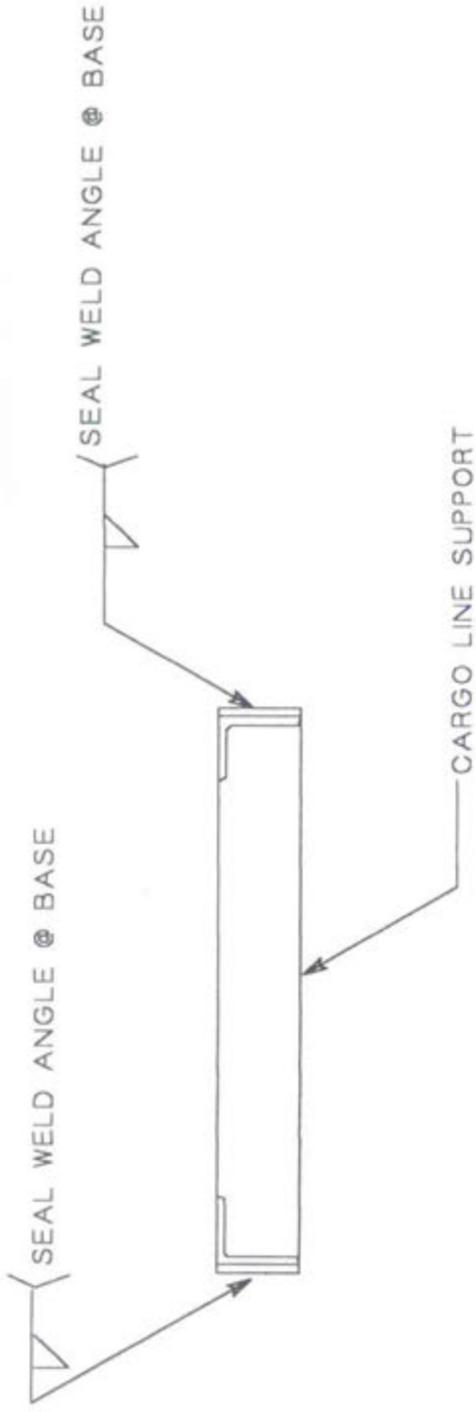
MID ATLANTIC ENVIRONMENTAL	
EMERGENCY REPAIRS FOR RED HILL TANKS	
Tank #8 RECOMMENDED REPAIR DRAWING	
Repair No. 022	File:Br022
LOWER DOME	Quadrant: B
Course: 1	PLATE: 12
Drawn by: Tom Kitchen	Date: 7/1/98

DEFECT INSPECTED BY TK & JF 7/1/98

TYPE 10 REPAIR

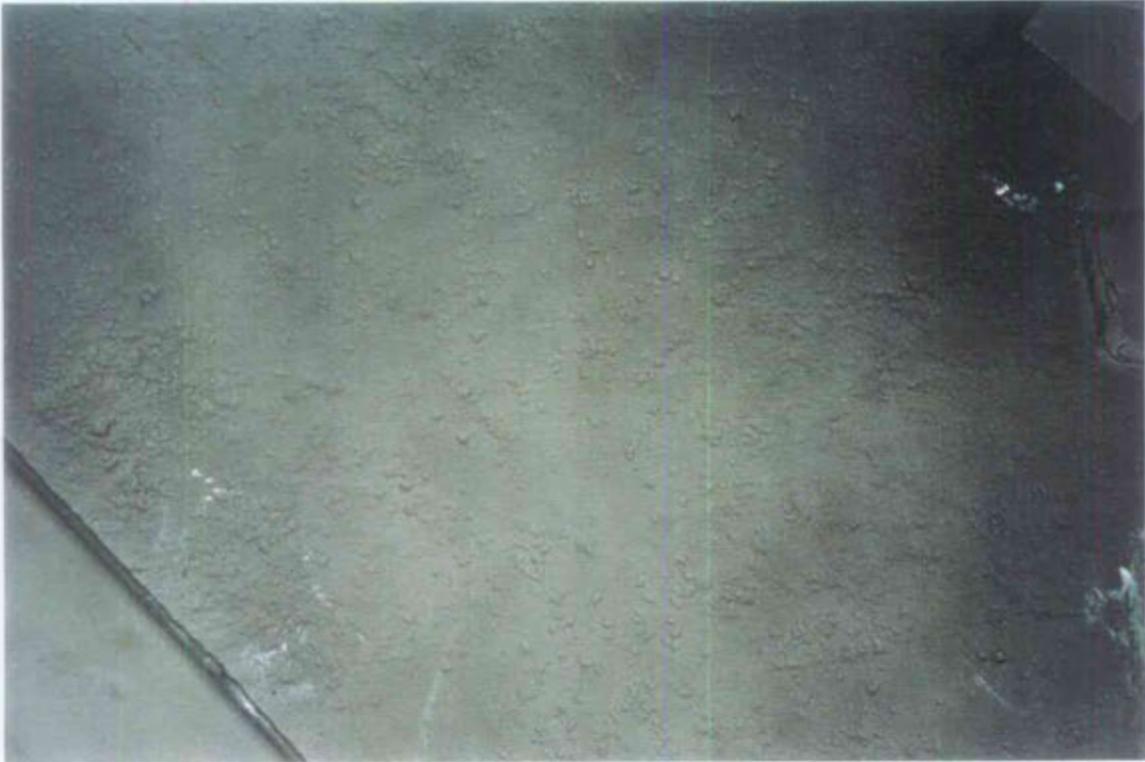
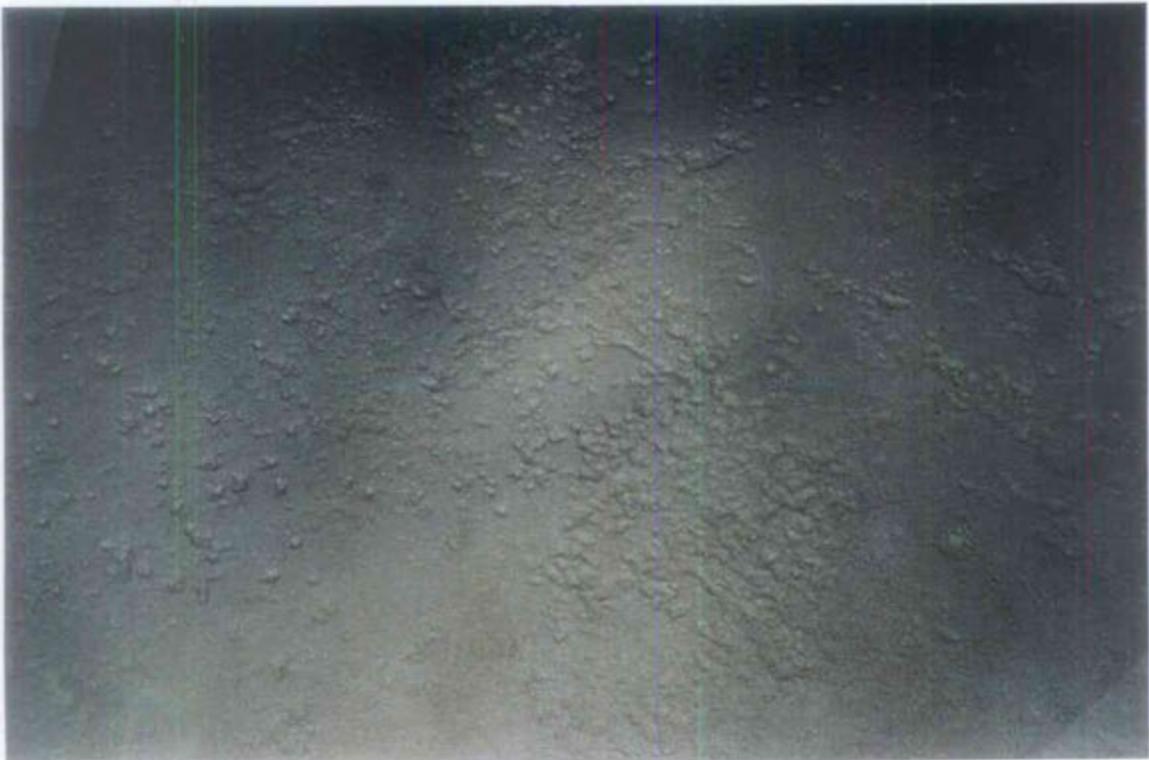
PICTURES OF PITTING AT BOTTOM OF TANK

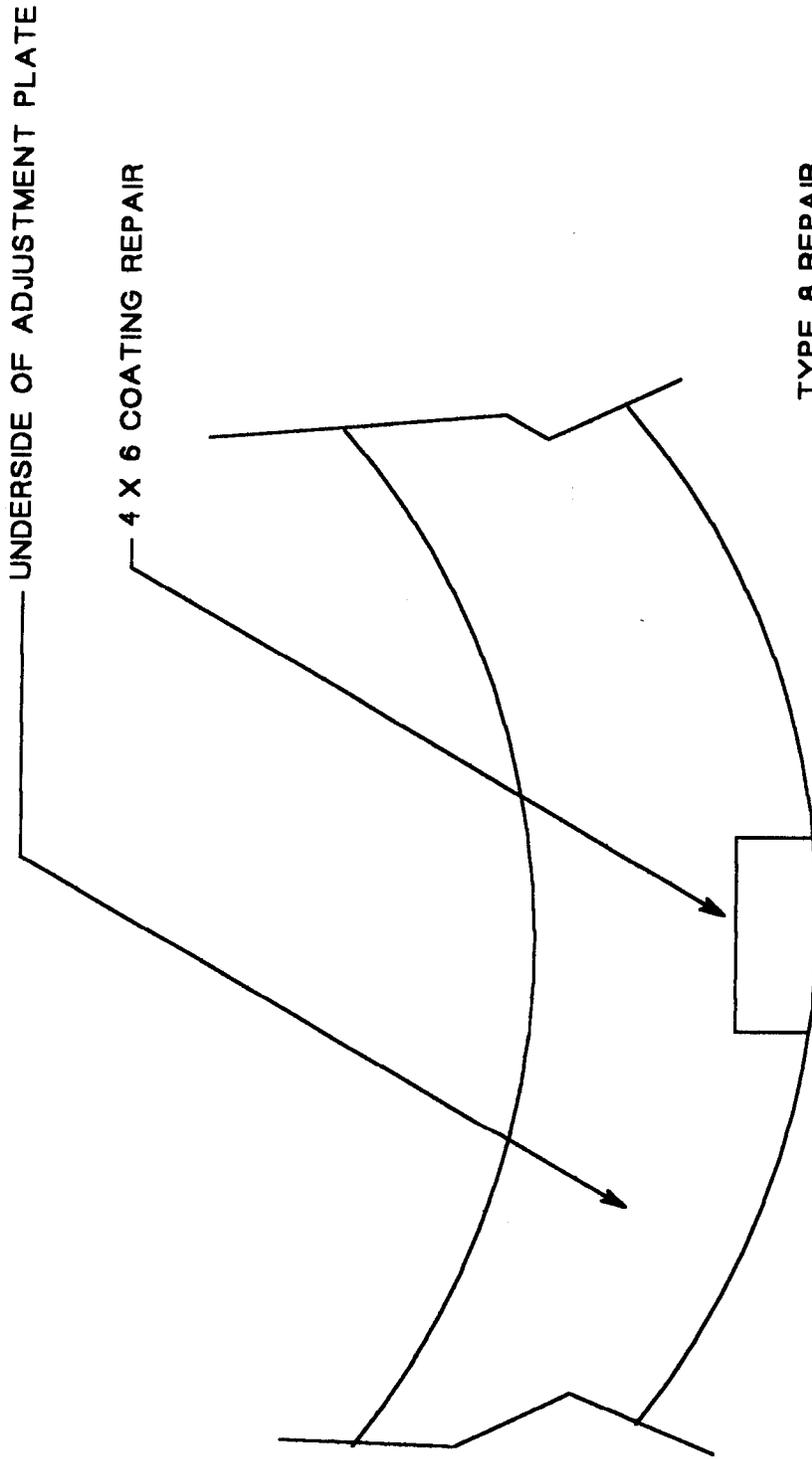
MID ATLANTIC ENVIRONMENTAL	
EMERGENCY REPAIRS FOR RED HILL TANKS	
Tank #8 AS BUILT DRAWINGS	
Repair No. : 001	File: 8R001
UPPER DOME	Quadrant: D
Course: EXTENSION	PLATE: 22
Drawn by: Tom Kitchen	Date: 5/4/98

DEFECT INSPECTED BY TK & JF 3/16/98

NOTE: AREA ~~EAS~~ FOUND TO BE GROUND TO BARE METAL

TYPE 8 REPAIR

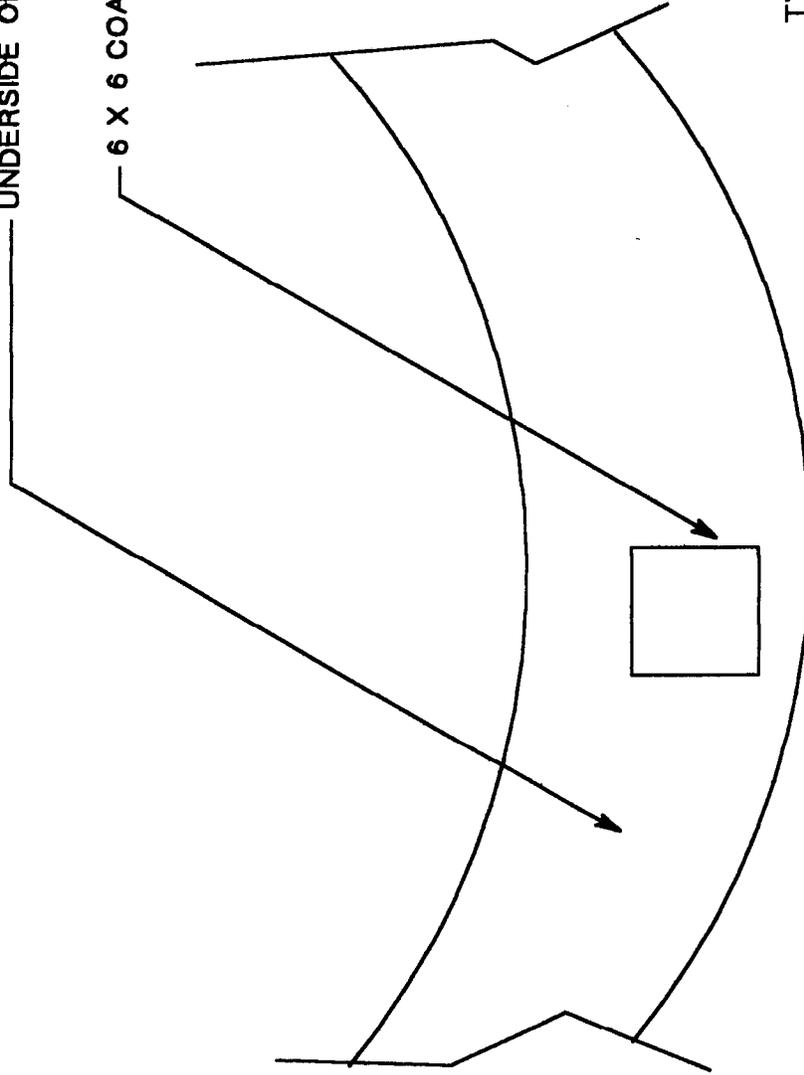
MID ATLANTIC ENVIRONMENTAL	
EMERGENCY REPAIRS FOR RED HILL TANKS	
Tank #8 AS BUILT DRAWINGS	
Repair No.: 002	File: 8R001
UPPER DOME	Quadrant: C
Course: EXTENSION	PLATE: 14
Drawn by: Tom Kitchen	Date: 5/4/98

DEFECT INSPECTED BY TK & JF 3/16/98

NOTE: AREA EAS FOUND TO BE GROUND TO BARE METAL

UNDERSIDE OF ADJUSTMENT PLATE

6 X 6 COATING REPAIR

TYPE 8 REPAIR

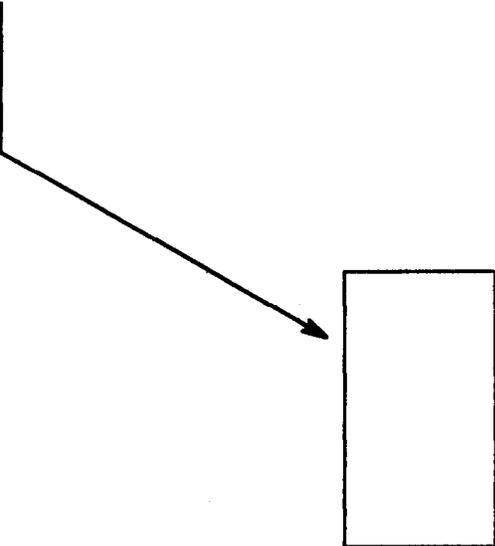
MID ATLANTIC ENVIRONMENTAL	
EMERGENCY REPAIRS FOR RED HILL TANKS	
Tank #8 AS BUILT DRAWING	
Repair No.: 005	File: 8005
LOWER DOME	Quadrant: D
Course: 2	PLATE: 18
Drawn by: Tom Kitchen	Date: 5/4/98

DEFECT INSPECTED BY TK & JF 3/20/98

30 X 50 COATING REPAIR

TYPE 8 REPAIR

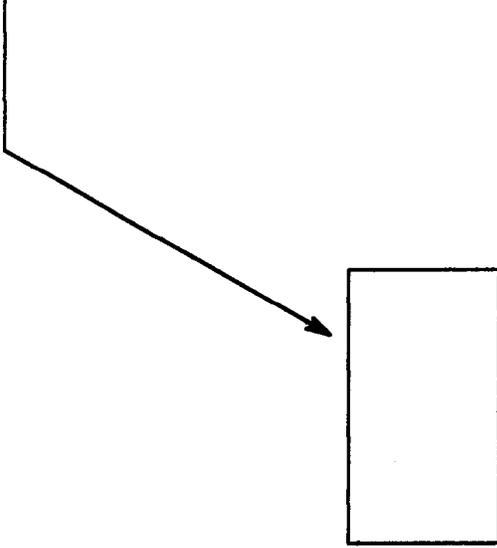
MID ATLANTIC ENVIRONMENTAL	
EMERGENCY REPAIRS FOR RED HILL TANKS	
Tank #8 AS BUILT DRAWING	
Repair No.: 006	File: 8-006
LOWER DOME	Quadrant: C
Course: 2	PLATE: 14
Drawn by: Tom Kitchen Date: 5/4/98

DEFECT INSPECTED BY TK & JF 3/25/98

30 X 50 COATING REPAIR

TYPE 8 REPAIR

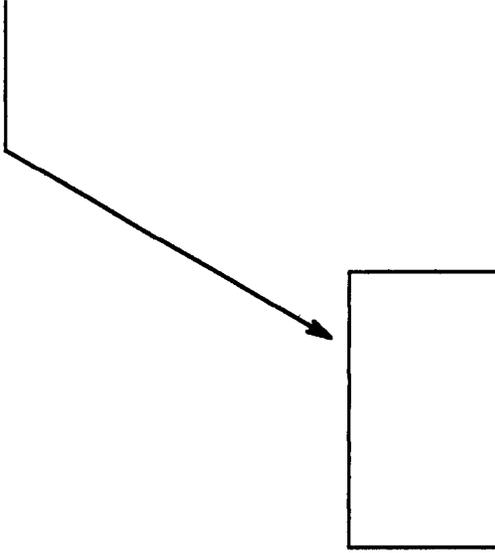
MID ATLANTIC ENVIRONMENTAL	
EMERGENCY REPAIRS FOR RED HILL TANKS	
Tank #8 AS BUILT DRAWING	
Repair No.: 007	File: 8-007
LOWER DOME	Quadrant: C
Course: 2	PLATE: 14
Drawn by: Tom Kitchen Date: 5/4/98

DEFECT INSPECTED BY TK & JF 3/25/98

30 X 50 COATING REPAIR

TYPE 8 REPAIR

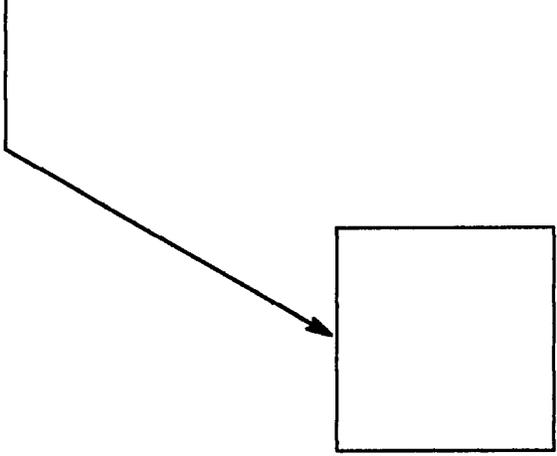
MID ATLANTIC ENVIRONMENTAL	
EMERGENCY REPAIRS FOR RED HILL TANKS	
Tank #8 AS BUILT DRAWING	
Repair No.: 008	File: 8-008
UPPER DOME	Quadrant: B
Course: EXTENSION	PLATE: 11
Drawn by: Tom Kitcher	Date: 5/4/98

DEFECT INSPECTED BY TK & JF 3/16/98

8 X 8 COATING REPAIR

TYPE 8 REPAIR

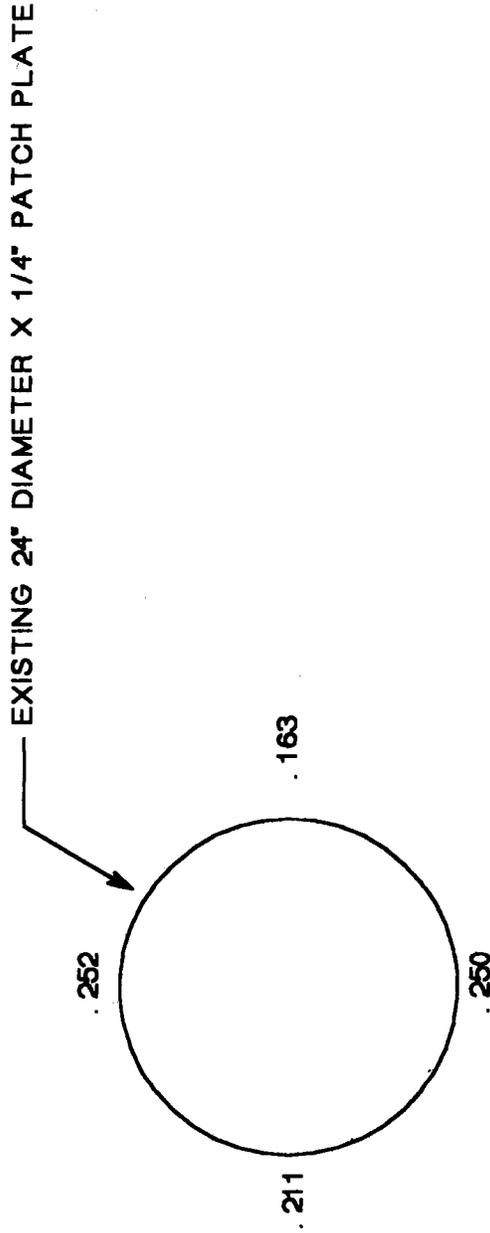
MID ATLANTIC ENVIRONMENTAL	
EMERGENCY REPAIRS FOR RED HILL TANKS	
Tank #8 AS BUILT DRAWING	
Repair No.: 010	File: 8r010
CYLINDER	Quadrant: C
Course: 11	PLATE: 14
Drawn by: Tom Kitchen	Date: 5/4/98

DEFECT INSPECTED BY TK & JF 3/20/98

UT READINGS AT EDGE OF PLATE INDICATE GOOD METAL
NO REPAIR NECESSARY

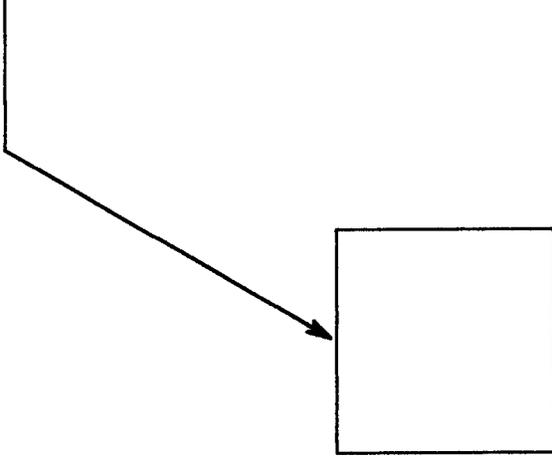
MID ATLANTIC ENVIRONMENTAL	
EMERGENCY REPAIRS FOR RED HILL TANKS	
Tank #8 RECOMMENDED REPAIR DRAWING	
Repair No.: 011	File: 8r011
LOWER DOME	Quadrant: A
Course: 2	PLATE: 8
Drawn by: Tom Kitchen	Date: 5/4/98

DEFECT INSPECTED BY TK & JF 3/16/98

8 X 8 COATING REPAIR

TYPE 8 REPAIR

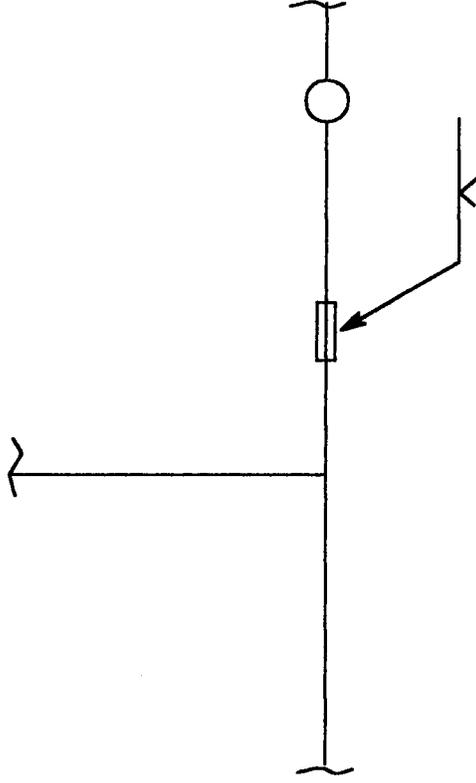
MID ATLANTIC ENVIRONMENTAL	
EMERGENCY REPAIRS FOR RED HILL TANKS	
Tank #8 RECOMMENDED REPAIR DRAWING	
Repair No.: 012	File: 8r012
CYLINDER	Quadrant: B
Course: 9	PLATE: 17
Drawn by: Tom Kitchen	Date: 5/4/98

DEFECT INSPECTED BY TK & JF 3/16/98

TYPE 9 REPAIR

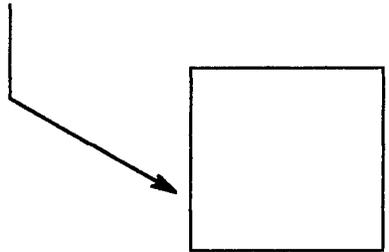
MID ATLANTIC ENVIRONMENTAL	
EMERGENCY REPAIRS FOR RED HILL TANKS	
Tank #8 RECOMMENDED REPAIR DRAWING	
Repair No.: 013	File: 8r013
LOWER DOME	Quadrant: B
Course: 3	PLATE: 11
Drawn by: Tom Klitchen	Date: 5/4/98

DEFECT INSPECTED BY TK & JF 3/16/98

8 X 8 COATING REPAIR

TYPE 9 REPAIR
