**Re: September 29, 2010 Clean Water Act Inspection
And Termination of EPA Administrative Order CWA-309(a)**

NPDES COMPLIANCE EVALUATION INSPECTION

NPDES Permittee: MYD Samoa, Inc.

Facility: Satala Shipyard
P.O. Box 7684, Pago Pago, Tutuila Island, American Samoa
(NPDES Permit No. AS0020026)

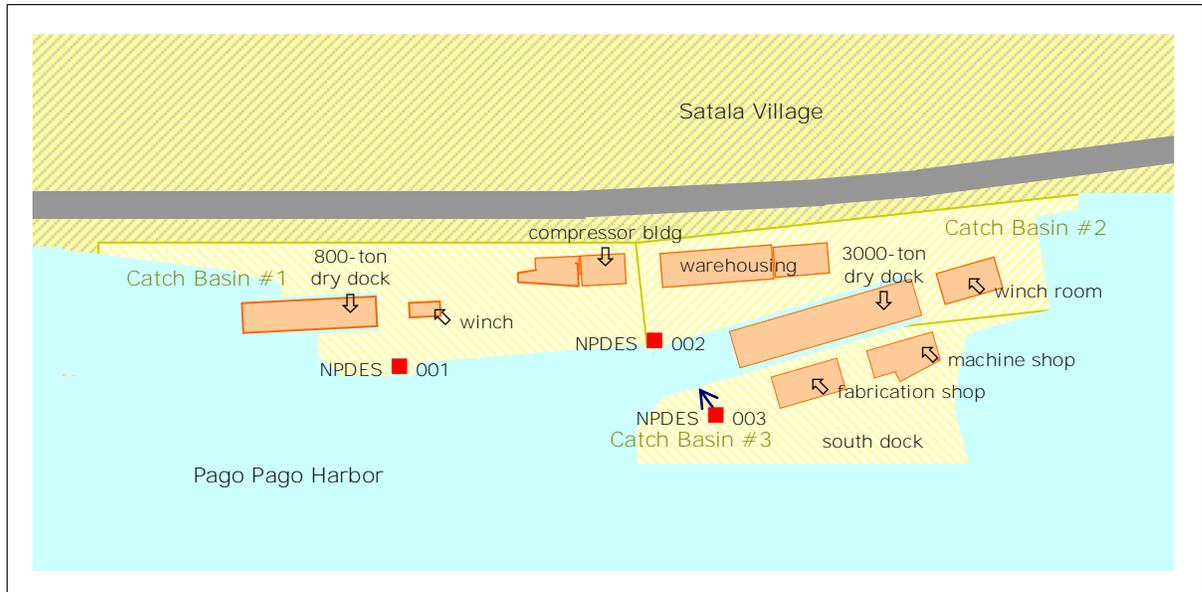
Figure 1.3
MYD Samoa Satala Shipyard Layout

On the date of this inspection, the shipyard had significant unrepaired damage still evident from the tsunami that hit one year before. See Figure 1.3 on the next page the facility layout.
