Third Five-Year Review Report

Coakley Landfill Superfund Site

North Hampton and Greenland
Rockingham County, New Hampshire

September, 2011

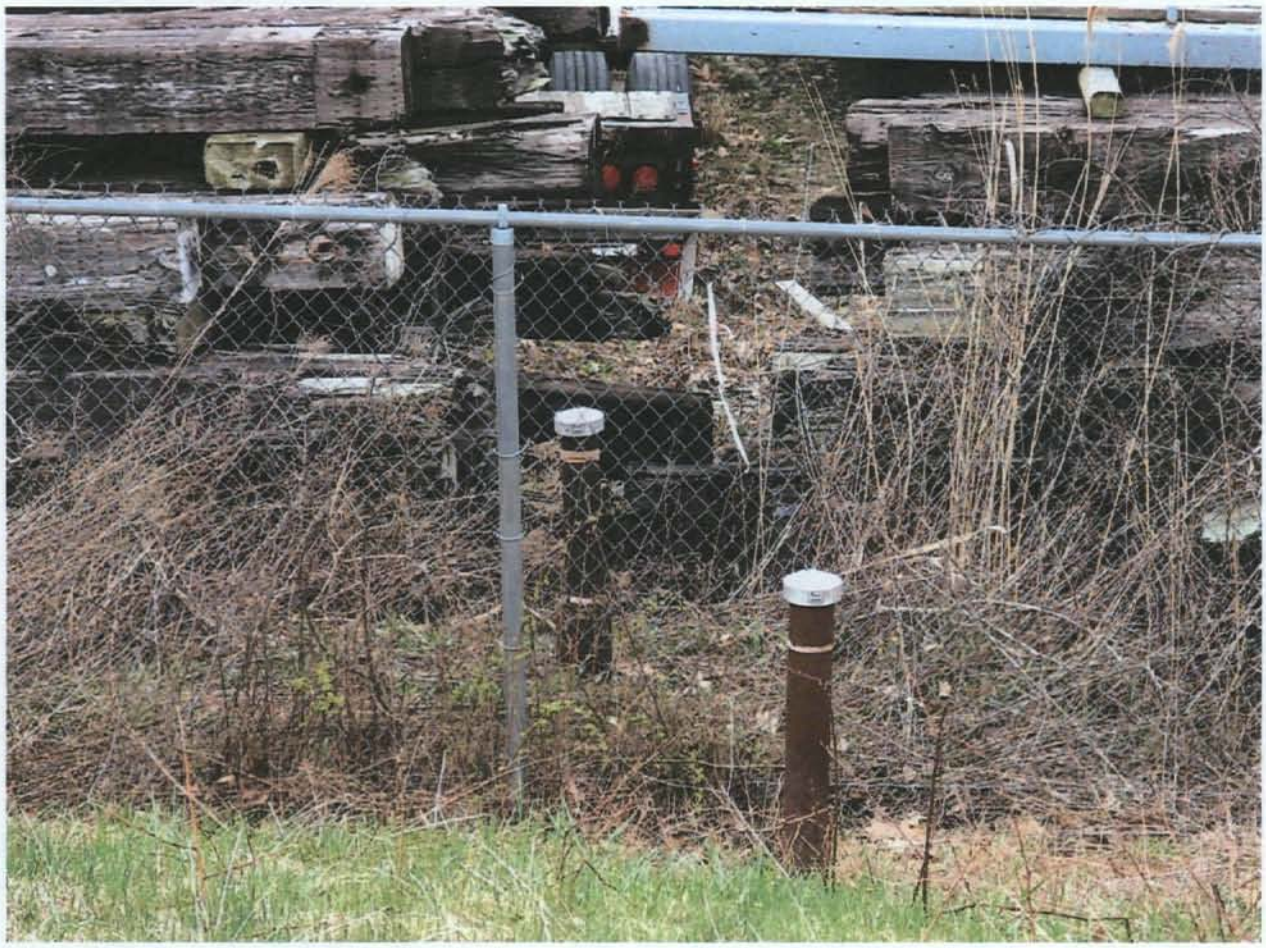
Figure 15. Wells MW-5S and MW-5D with posts directly behind.
