DOCUMENTATION OF ENVIRONMENTAL INDICATOR DETERMINATION

**RCRA Corrective Action
Environmental Indicator (EI) RCRIS code (CA725)**

Current Human Exposures Under Control

Facility Name: Clean Harbors of Natick, Inc.
Facility Address: 10 Mercer Road, Natick, MA
Facility EPA ID #: MAD980523203

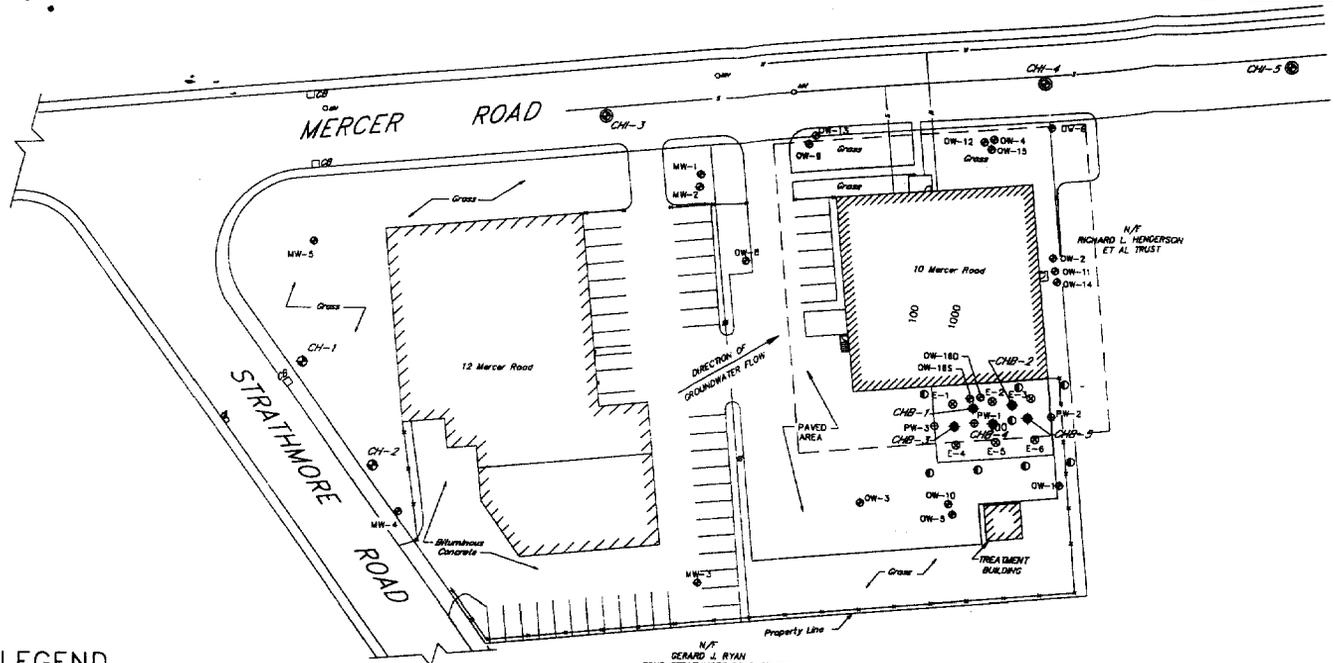
- OW-2 / GW-3 BOUNDARY DELINEATION
- S --- SEWER LINE
- W --- WATER LINE
- ☐ CATCH BASIN
- OW-12 ⊕ EXISTING MONITORING WELL (SEE NOTE 1)
- X --- X CHAIN LINK FENCE
- CH-3 ⊙ SMALL DIAMETER MONITORING WELL
- PW-3 ⊕ EXISTING GROUNDWATER EXTRACTION WELL
- E-10 ⊙ EXISTING VAPOR EXTRACTION WELL
- ⊙ EXISTING INDUCTION/VACUUM MONITORING WELL
- CHB-1 ⊙ BORING LOCATION

1. ALL OBSERVATION WELLS ARE SHALLOW EXCEPT FOR OW-16D & MW-2 WHICH ARE DEEP WELLS.

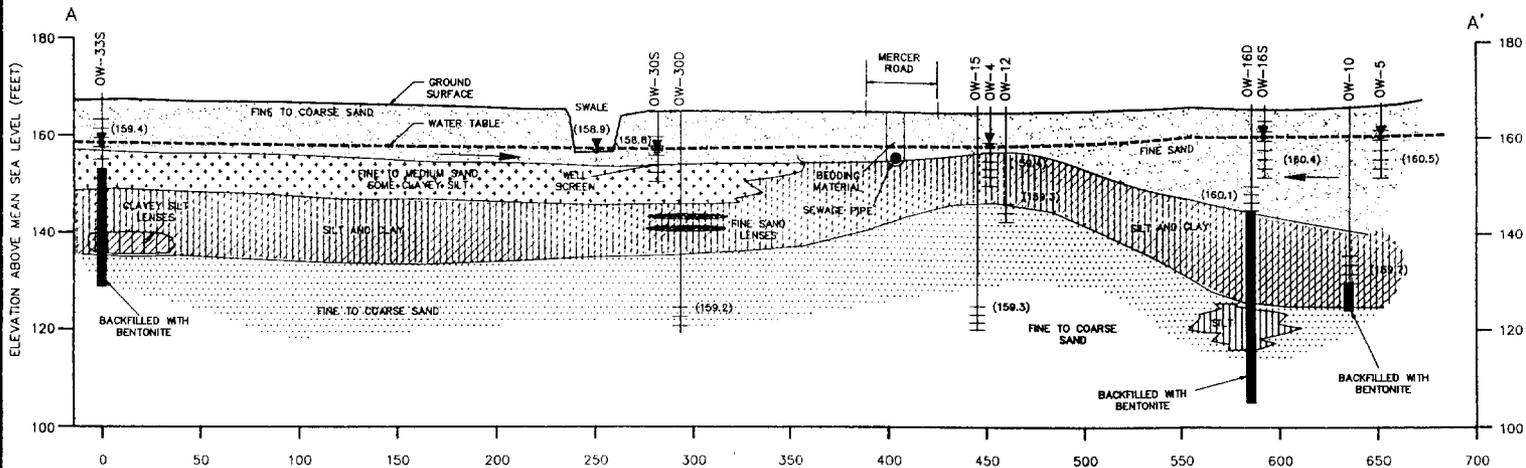
1. ELEVATION OF WATER IN WELLS MEASURED ON 2/21/92
2. WIDTH OF SWALE ESTIMATED USING TAPE MEASUREMENT. THESE MEASUREMENTS ARE ACCURATE ONLY TO THE DEGREE IMPLIED BY THE METHOD USED.
3. DEPTH OF SWALE ESTIMATED USING LEVEL ELEVATION SURVEY.
4. DEPTH AND LOCATION OF UTILITY CONDUIT OBTAINED FROM CITY OF NATICK MAP FOR MERCER ROAD. ORIGINAL SCALE: HORIZONTAL: 1"=40', VERTICAL SCALE: 1"=4'.
