# **CITY OF MANCHESTER, NEW HAMPSHIRE**

## ***Stormwater Management Program***

**Annual Report**

**May 1, 2011 through April 30, 2012**

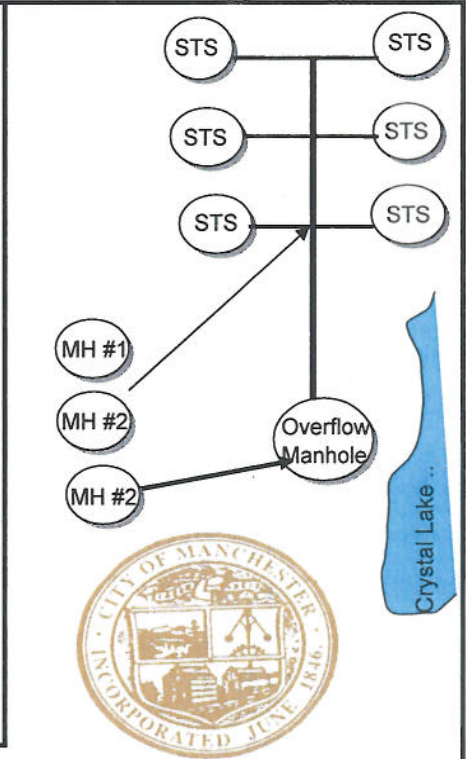
**Tank Name Corning Road** Date: 8/12/2011  
 Inspector(s): Rob Robinson & Jean Paul Gilbert

**1st Inspection Port Information** Elev. To rim 12.ft  
 Water Appearance in 1st Port: [ ] dry [ ] odor [ ] oily [X] H2O depth/in. 2 ft  
 Depth of sand: [X] 1"- 3" [ ] 4"- 6" [ ] 7"- 9" [ ] 10"- 12" [ ] 1 - 2 feet [ ] > 2ft.  
 Does the sand seem to be evenly distributed throughout the tank bottom? [X] YES [ ] NO  
 Structural Condition: [X] Excellent [ ] Very Good [ ] Good [ ] Fair [ ] Poor [ ] Repair  
 Weed/brush growth around tank: [X] None [ ] Little [ ] Moderate [ ] Heavy

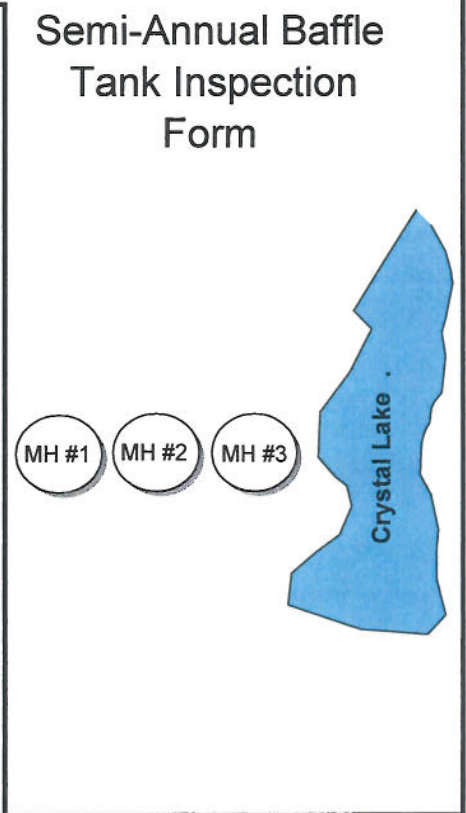
Tank Name Dorrs Pond - Opp Papa Gino's - Site 4 Date: 08/12/11 17' 5"  
 Inspector(s): Rob Robinson & Jean Paul Gilbert

**Inspect Diversion Manhole** Sand Depth  <6"  <12"  Full  
 Structural Condition:  Excellent  Very Good  Good  Fair  Poor  Repair

**3rd Inspection Port Information**  
 Water Appearance in 1st Port:  dry  odor  oily  H2O depth/in. 2 - 3 ft.  
 Depth of sand:  1"- 3"  4"- 6"  7"- 9"  10"- 12"  1 - 2 feet  > 2ft.  
 Does the sand seem to be evenly distributed throughout the tank bottom?  YES  NO  
 Structural Condition:  Excellent  Very Good  Good  Fair  Poor  Repair  
 Weed/brush growth around tank:  None  Little  Moderate  Heavy  
 Recommendations: Clean the first chamber.

If cleaned, how much sand/grit was removed? 0.0 Cubic Yards

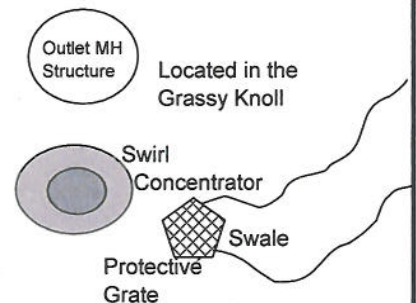
Tank Name Dorrs Pond - KFC - 16' - Site 5 Date: 08/12/11  
 Inspector(s): Rob Robinson & Jean Paul Gilbert

Inspect Diversion Manhole Sand Depth  <6"  <12"  Full  
 Structural Condition:  Excellent  Very Good  Good  Fair  Poor  Repair

Water Appearance in 1st Port:  dry  odor  oily  H2O depth/in. 2 - 3 ft.  
 Depth of sand:  1"- 3"  4"- 6"  7"- 9"  10"- 12"  1 - 2 feet  > 2ft.  
 Does the sand seem to be evenly distributed throughout the tank bottom?  YES  NO  
 Structural Condition:  Excellent  Very Good  Good  Fair  Poor  Repair  
 Weed/brush growth around tank:  None  Little  Moderate  Heavy  
 Recommendations: Cleaned all three chambers.

If cleaned, how much sand/grit was removed? 3.0 Cubic Yards

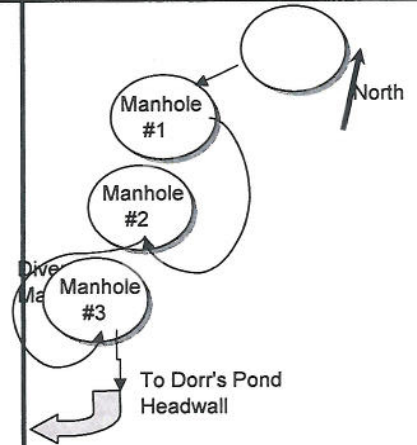
Tank Name Dorrs Pond - Headwall - 12' - Site 6 Date: 08/12/11  
 Inspector(s): Rob Robinson & Jean Paul Gilbert

Recommendations: Cleaned all three chambers.

If cleaned, how much sand/grit was removed? 3.0 Cubic Yards

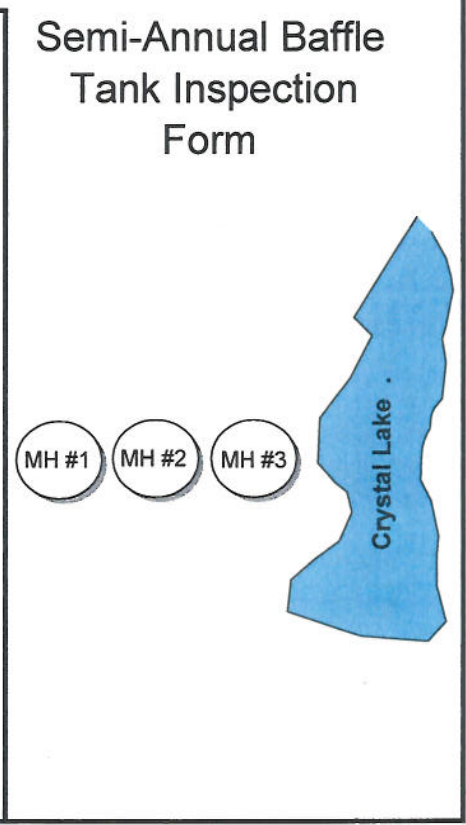
Tank Name Dorris Pond - Opp Papa Gino's - Site 4 Date: 11/28/11 17' 5"  
 Inspector(s): Rob Robinson & Jean Paul Gilbert

Inspect **Diversion Manhole** Sand Depth  <6"  <12"  Full  
 Structural Condition:  Excellent  Very Good  Good  Fair  Poor  Repair

Water Appearance in 1st Port:  dry  odor  oily  H2O depth/in. 2 - 3 ft.  
 Depth of sand:  1"- 3"  4"- 6"  7"- 9"  10"- 12"  1 - 2 feet  > 2ft.  
 Does the sand seem to be evenly distributed throughout the tank bottom?  YES  NO  
 Structural Condition:  Excellent  Very Good  Good  Fair  Poor  Repair  
 Weed/brush growth around tank:  None  Little  Moderate  Heavy  
 Recommendations: Cleaned the first chamber.

If cleaned, how much sand/grit was removed? 1.0 Cubic Yards

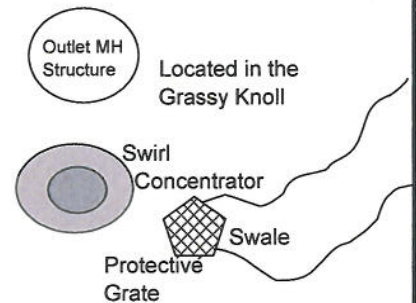
Tank Name Dorrs Pond - KFC - 16' - Site 5 Date: 11/28/11  
 Inspector(s): Rob Robinson & Jean Paul Gilbert

Inspect **Diversion Manhole** Sand Depth  <6"  <12"  Full  
 Structural Condition:  Excellent  Very Good  Good  Fair  Poor  Repair

Water Appearance in 1st Port:  dry  odor  oily  H2O depth/in. 2 - 3 ft.  
 Depth of sand:  1"- 3"  4"- 6"  7"- 9"  10"- 12"  1 - 2 feet  > 2ft.  
 Does the sand seem to be evenly distributed throughout the tank bottom?  YES  NO  
 Structural Condition:  Excellent  Very Good  Good  Fair  Poor  Repair  
 Weed/brush growth around tank:  None  Little  Moderate  Heavy  
 Recommendations: Clean all three chambers. One chamber was cleaned, will clean the other chambers in the spring.

If cleaned, how much sand/grit was removed? 1.0 Cubic Yards

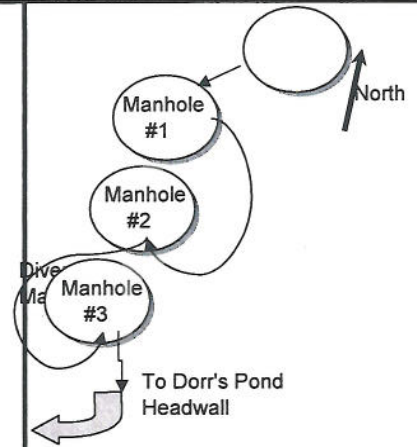
Tank Name Dorrs Pond - Headwall - 12' - Site 6 Date: 11/28/11  
 Inspector(s): Rob Robinson & Jean Paul Gilbert

Recommendations: Okay till spring.

If cleaned, how much sand/grit was removed? 0.0 Cubic Yards
