Site Information and Preplan

AEROVOX PLANT 'A'

Belleville Ave & Hadley St

New Bedford Fire Department Aerovox Preplan

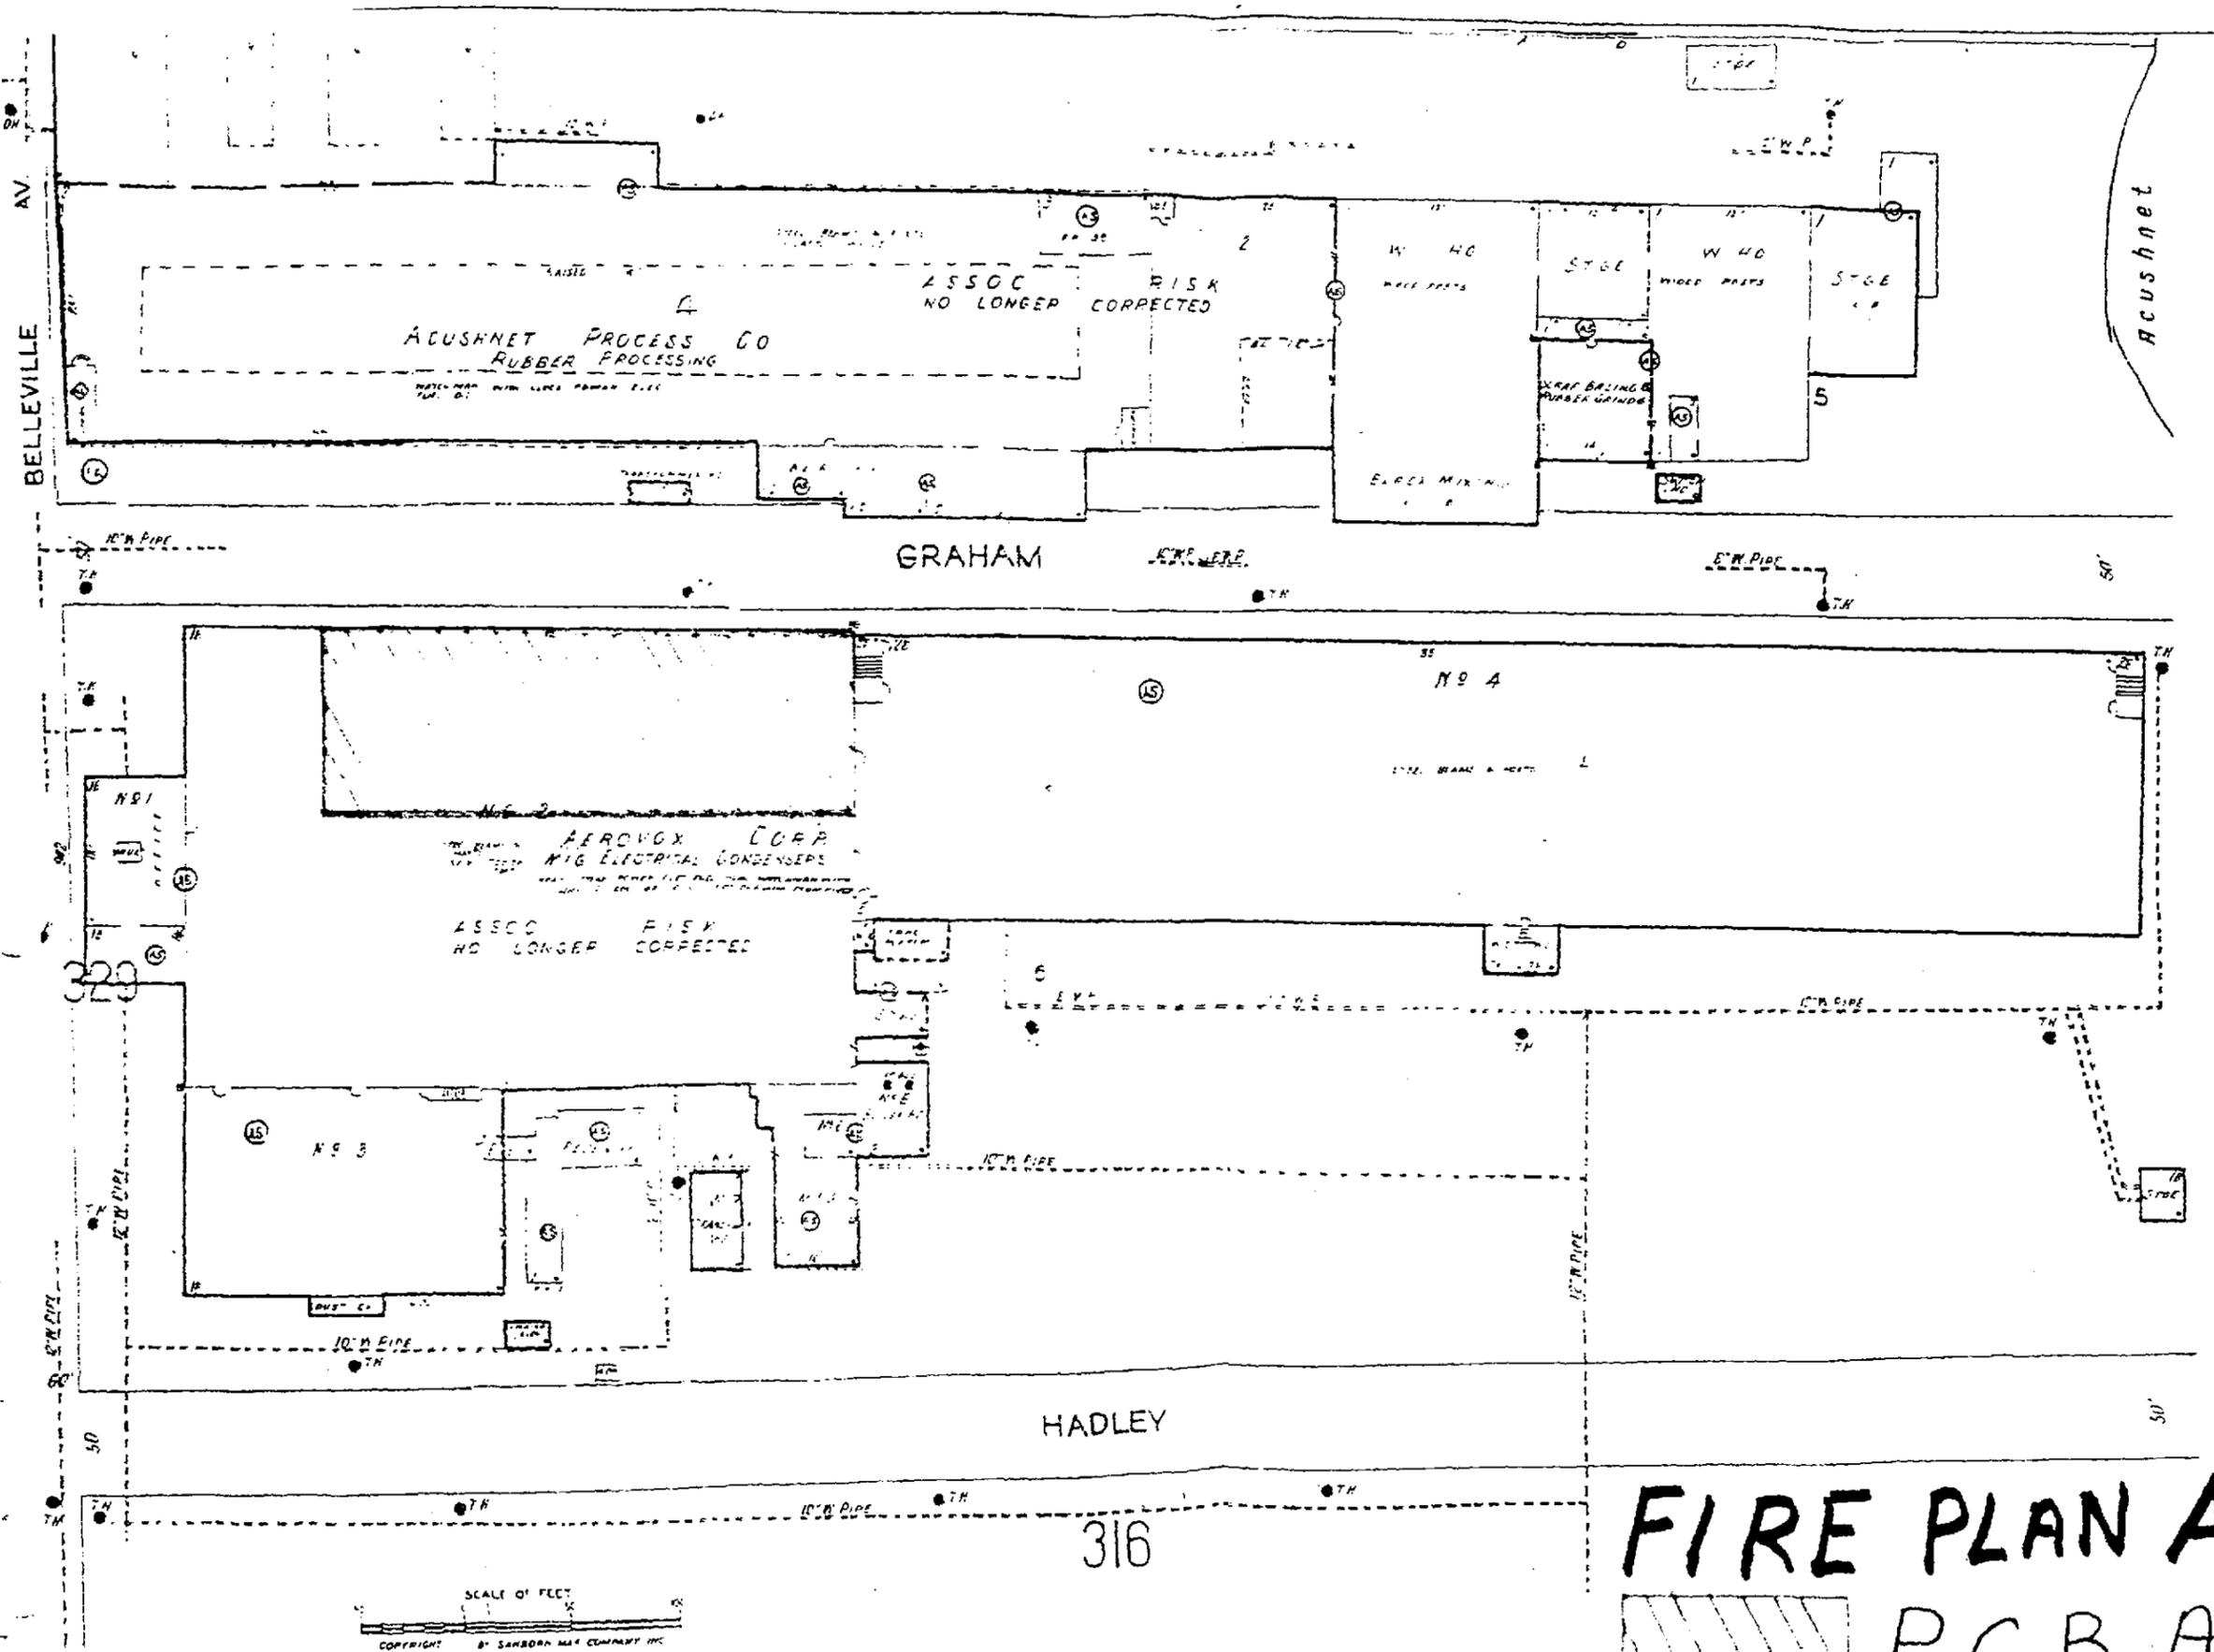
FIRE PLAN A

P.C.B. AREA

BELLEVILLE AV.

The placement of apparatus to defend the firewall and exposures B, C and A will be the strategic goal of this plan. In particular, aerial apparatus should be positioned to cover the firewall and combustibile roofs of exposure C and A. The first engine & ladder should approach by Hadley St. and gain access to the property through the gate on side A. Upon confirmation of a fire condition the incident commander should direct personnel to activate the sprinkler system. The system should be activated zone by zone from the fire location outward to contain fire spread to the area of origin.
