**FIFTH FIVE-YEAR REVIEW FOR  
BEACON HEIGHTS LANDFILL SUPERFUND SITE  
BEACON FALLS, CONNECTICUT**

**September 2013**

**U.S. Environmental Protection Agency  
Region 1  
Boston, Massachusetts**

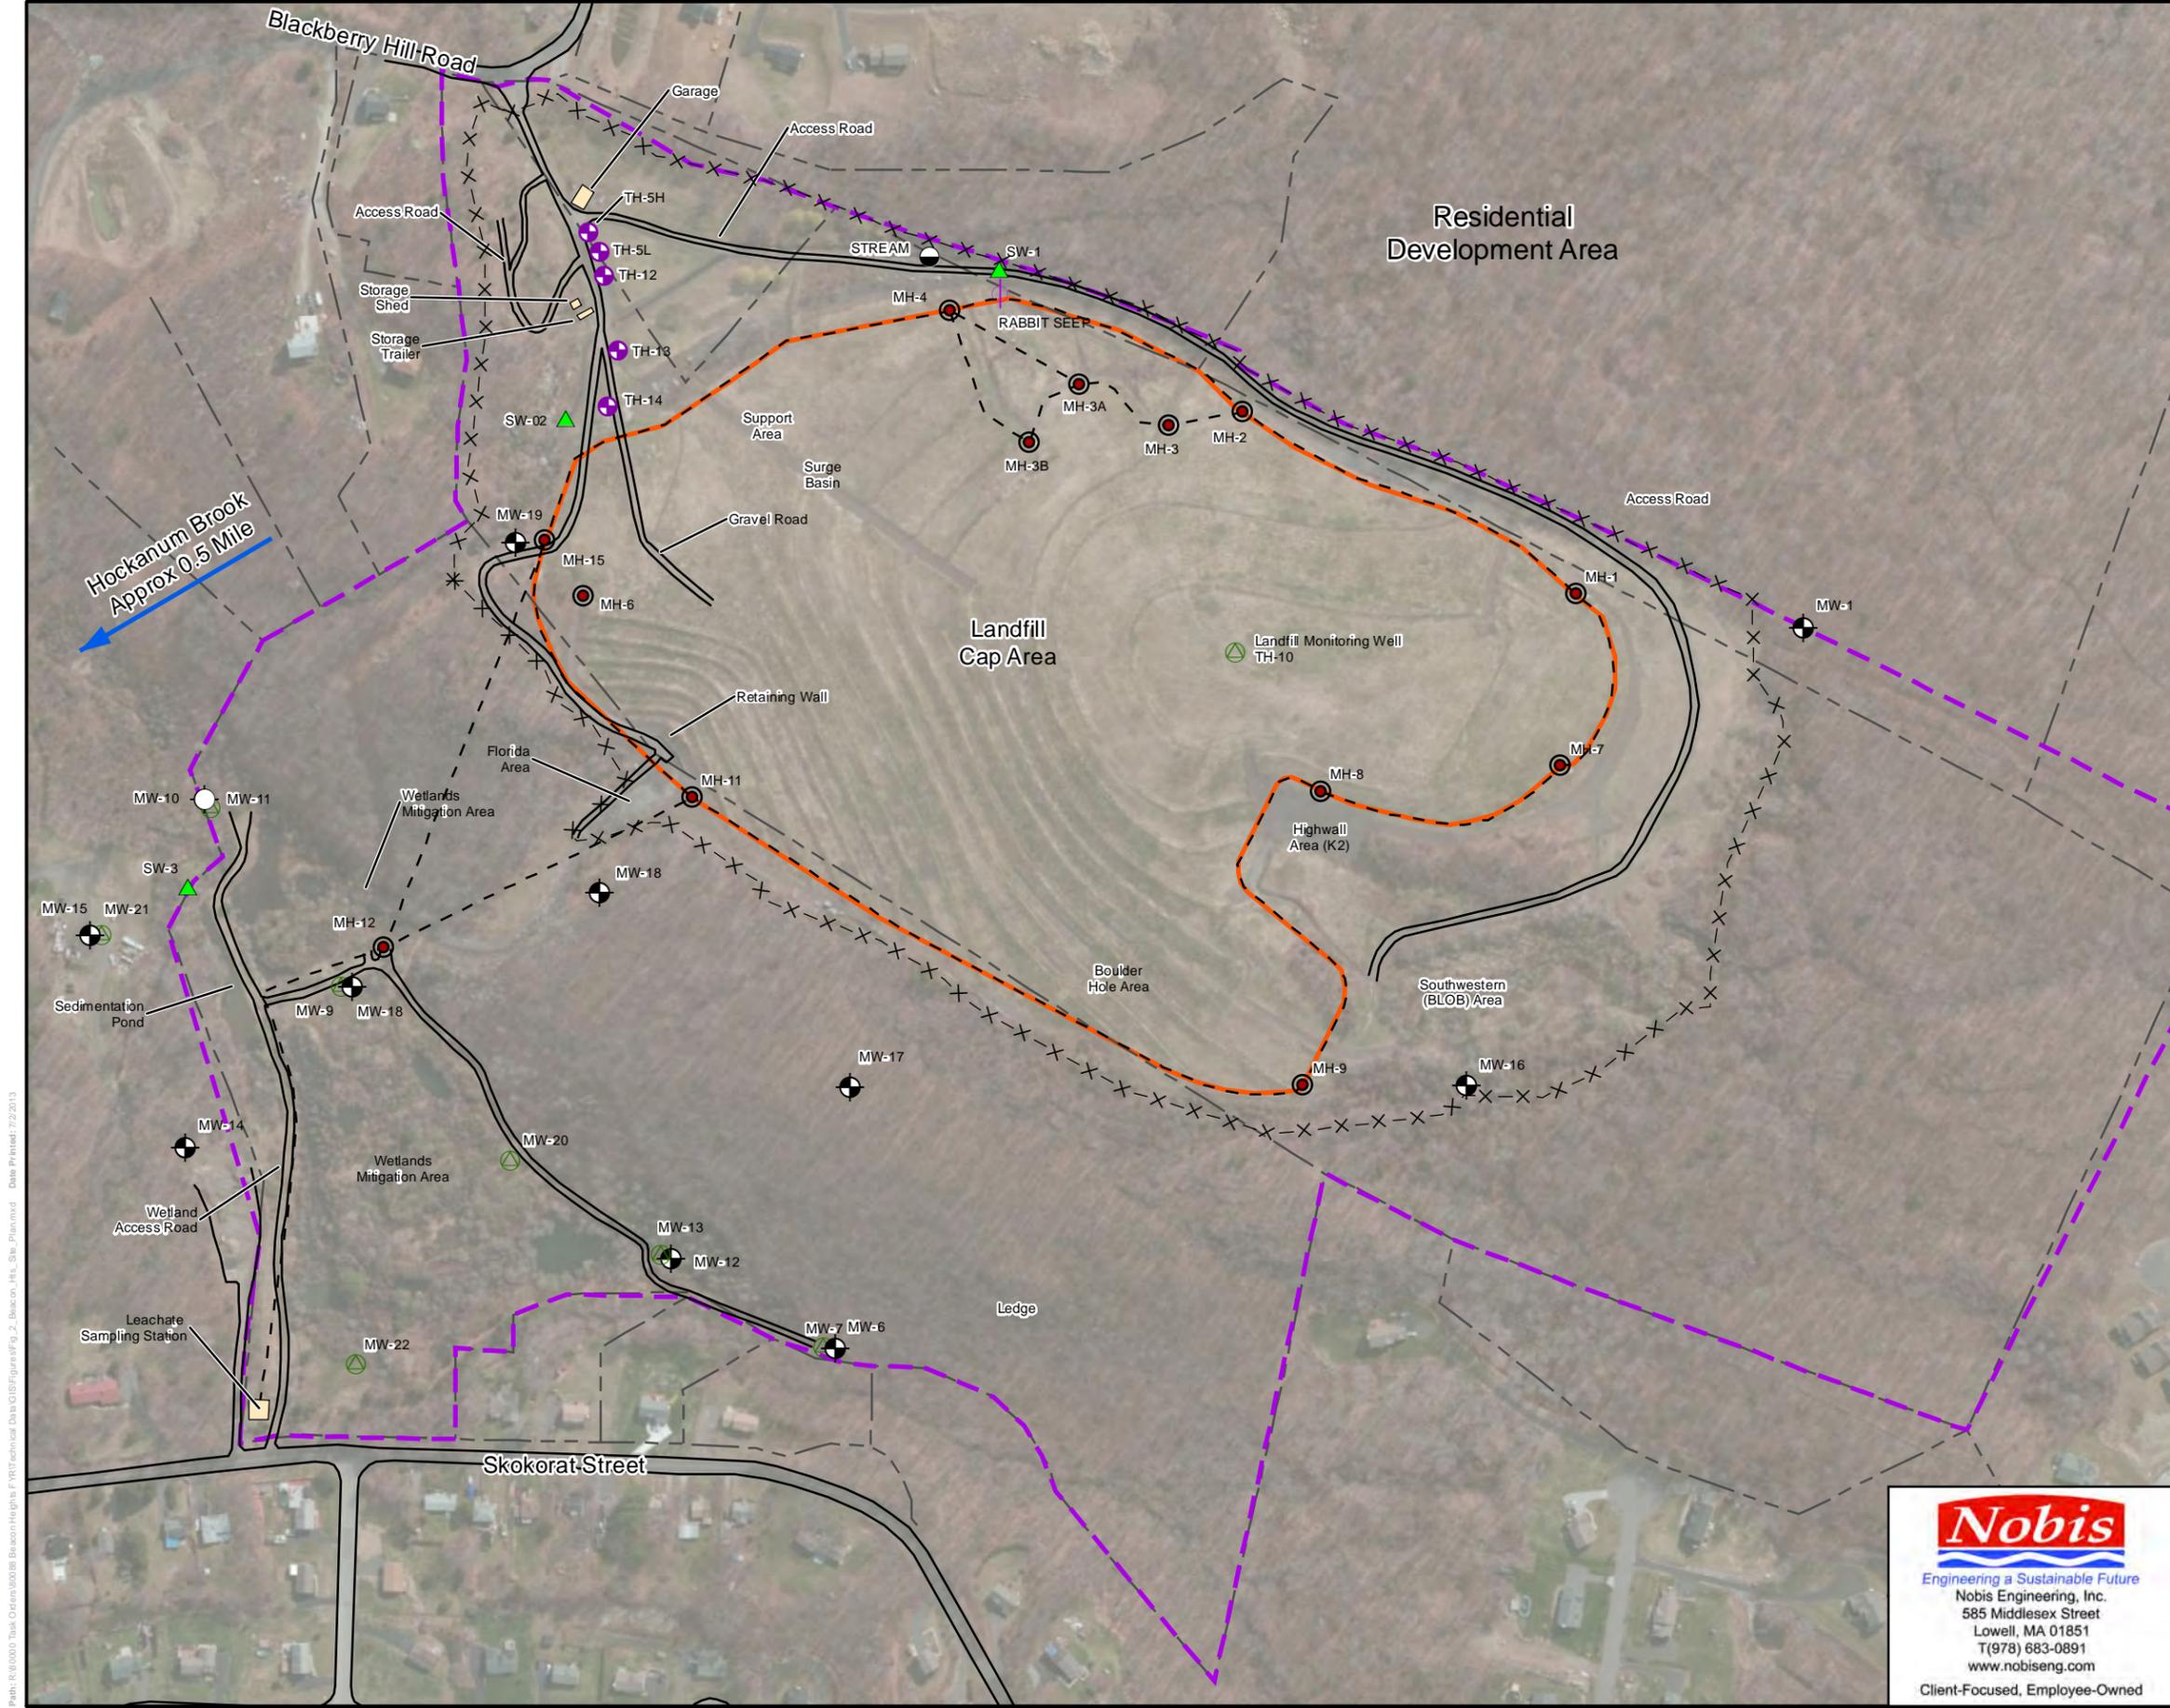
1. This site plan was developed from a plan by Arcadis.
2. Locations of site features depicted hereon are approximate and given for illustrative purposes only.

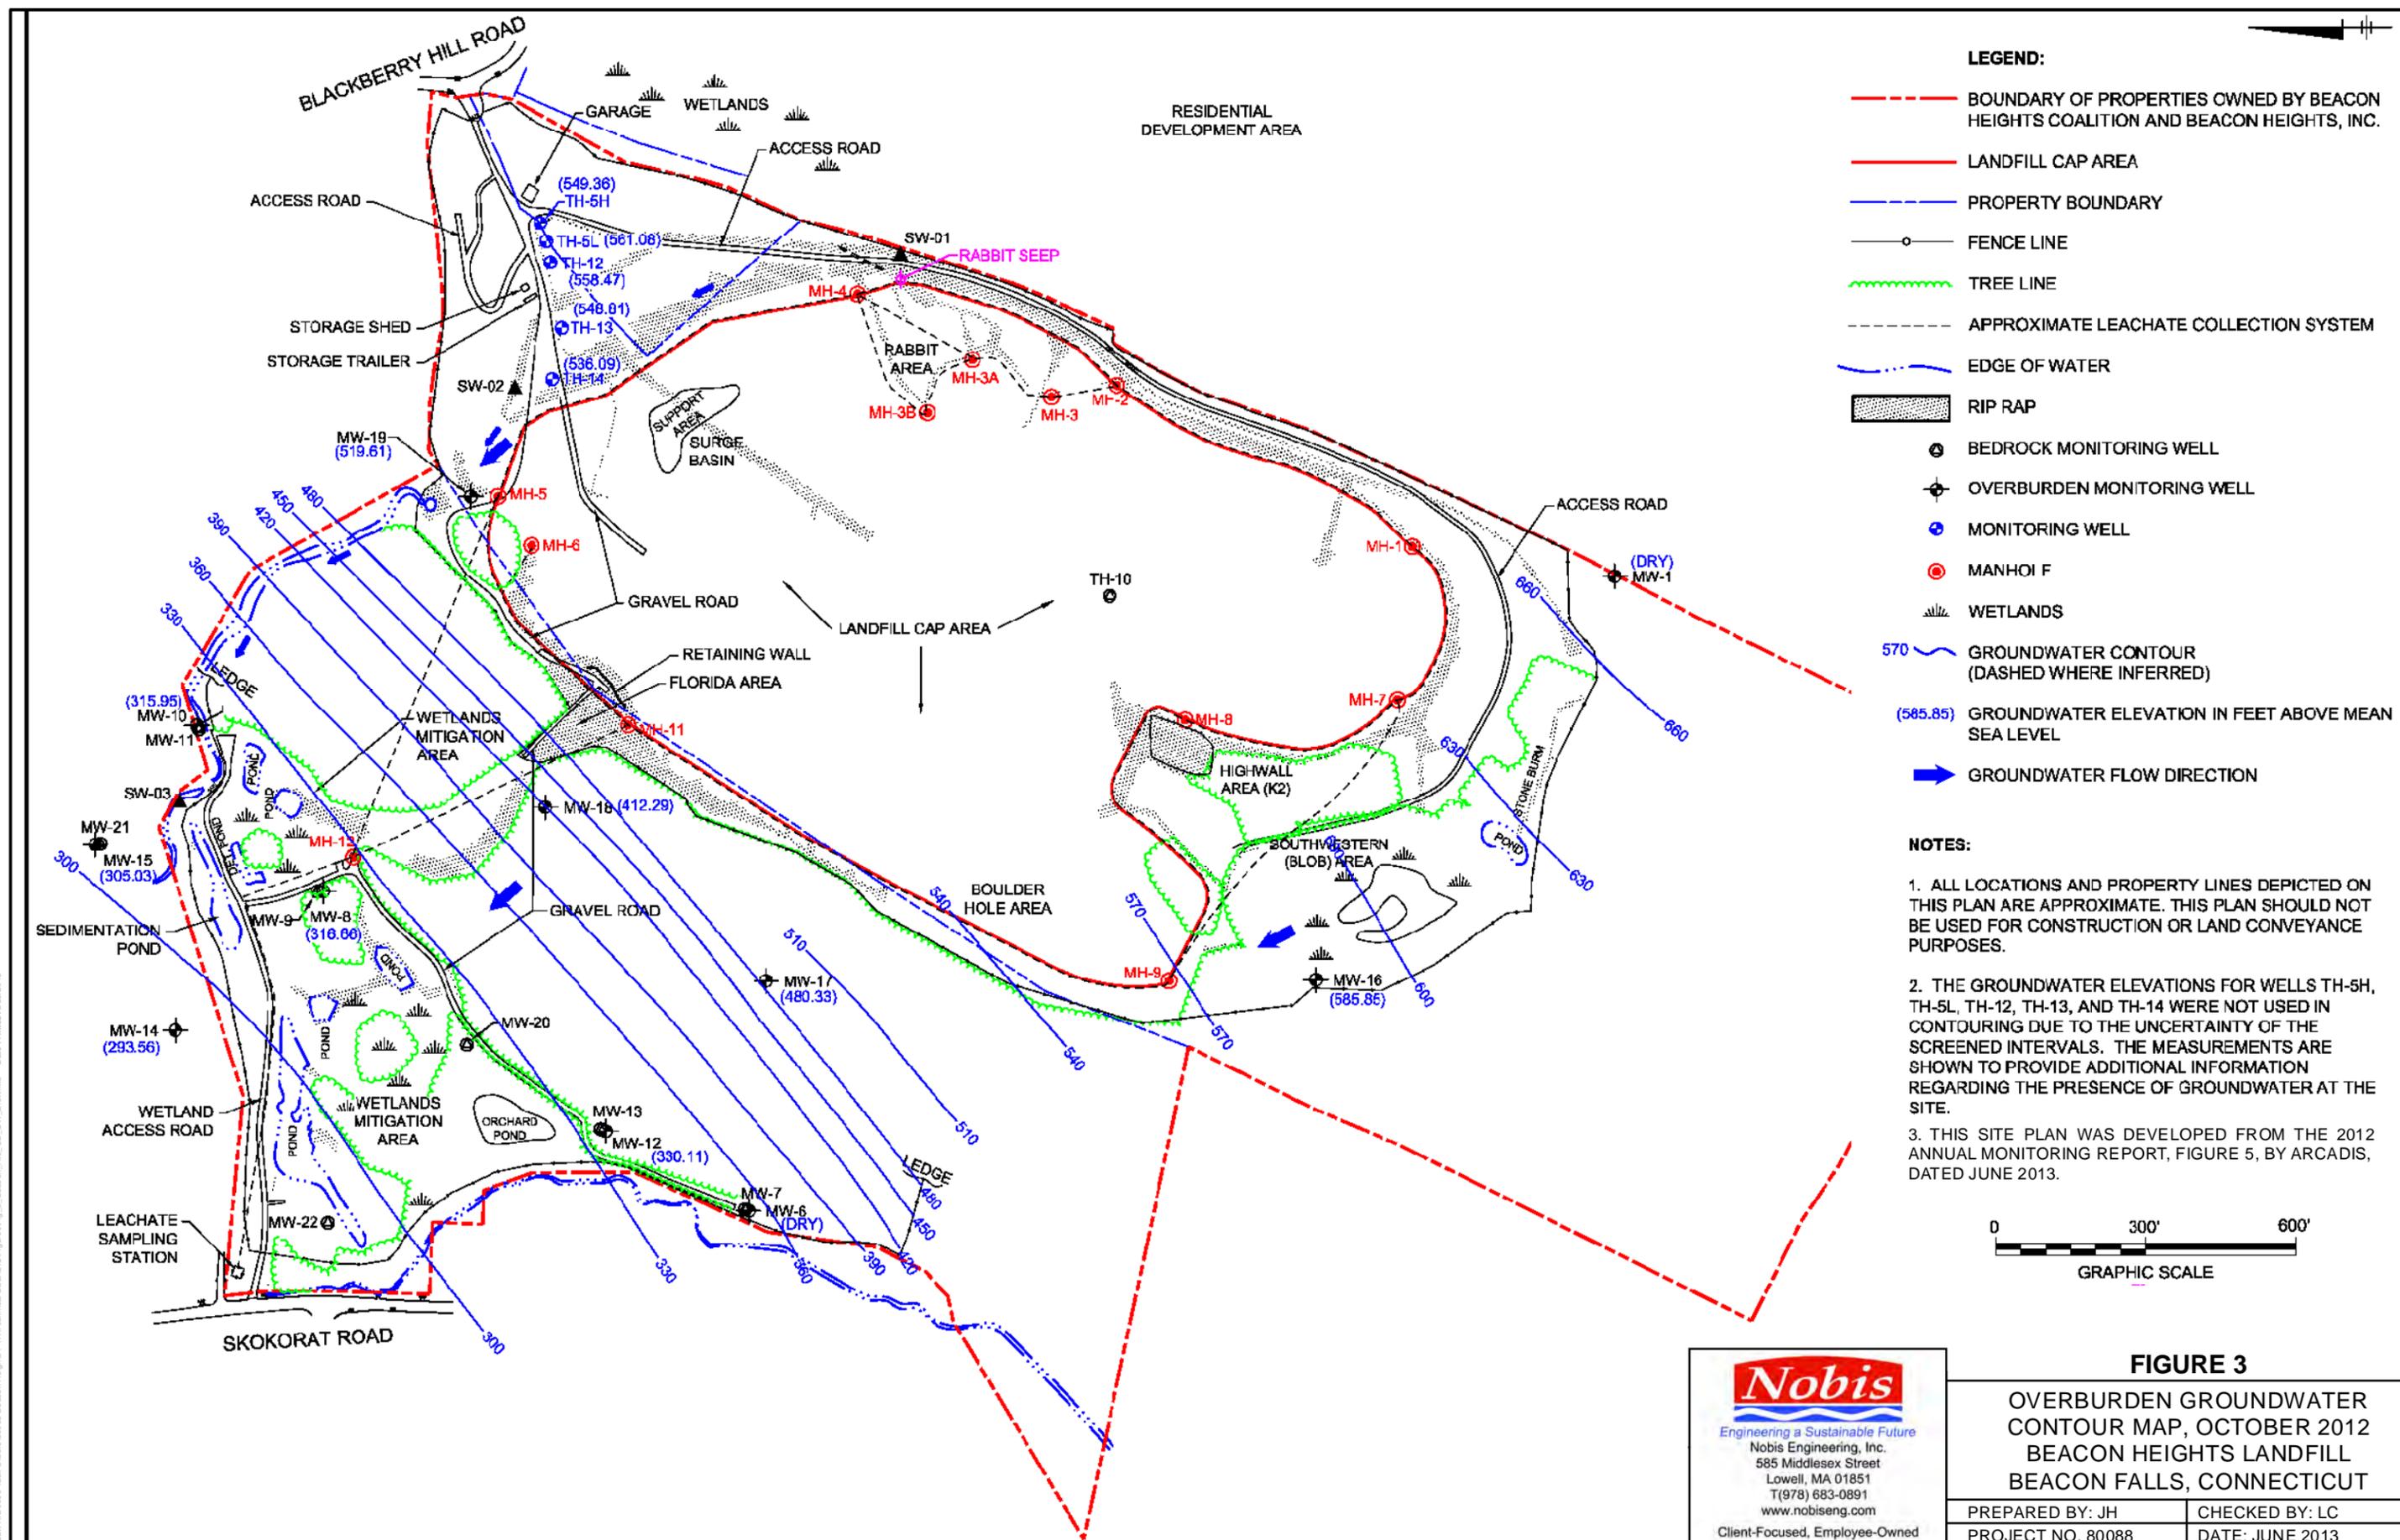
- LEGEND:**
- BOUNDARY OF PROPERTIES OWNED BY BEACON HEIGHTS COALITION AND BEACON HEIGHTS, INC.
  - LANDFILL CAP AREA
  - PROPERTY BOUNDARY
  - FENCE LINE
  - TREE LINE
  - APPROXIMATE LEACHATE COLLECTION SYSTEM
  - EDGE OF WATER
  - RIP RAP
  - BEDROCK MONITORING WELL
  - ⊕ OVERBURDEN MONITORING WELL
  - MONITORING WELL
  - MANHOLE
  - ▲ WETLANDS
  - 570 GROUNDWATER CONTOUR (DASHED WHERE INFERRED)
  - (585.85) GROUNDWATER ELEVATION IN FEET ABOVE MEAN SEA LEVEL
  - GROUNDWATER FLOW DIRECTION

- NOTES:**
1. ALL LOCATIONS AND PROPERTY LINES DEPICTED ON THIS PLAN ARE APPROXIMATE. THIS PLAN SHOULD NOT BE USED FOR CONSTRUCTION OR LAND CONVEYANCE PURPOSES.
  2. THE GROUNDWATER ELEVATIONS FOR WELLS TH-5H, TH-5L, TH-12, TH-13, AND TH-14 WERE NOT USED IN CONTOURING DUE TO THE UNCERTAINTY OF THE SCREENED INTERVALS. THE MEASUREMENTS ARE SHOWN TO PROVIDE ADDITIONAL INFORMATION REGARDING THE PRESENCE OF GROUNDWATER AT THE SITE.
  3. THIS SITE PLAN WAS DEVELOPED FROM THE 2012 ANNUAL MONITORING REPORT, FIGURE 5, BY ARCADIS, DATED JUNE 2013.

The Site is located within the Hockanum Brook drainage area. Hockanum Brook, a tributary of the Naugatuck River, is located about 0.5 miles northwest of the Site (Figure 1). Bedrock outcrops appear in many areas around the Site. The bedrock surface is fractured and dips from the south/southeast of the Site towards the north/northwest, parallel to surface water drainage. Groundwater in the vicinity of the Site occurs in both the unconsolidated deposits and in the bedrock and generally flows to the north/northwest. Figures 3 and 4 (Appendix A) depict the groundwater elevations in the bedrock and overburden aquifer units, respectively.

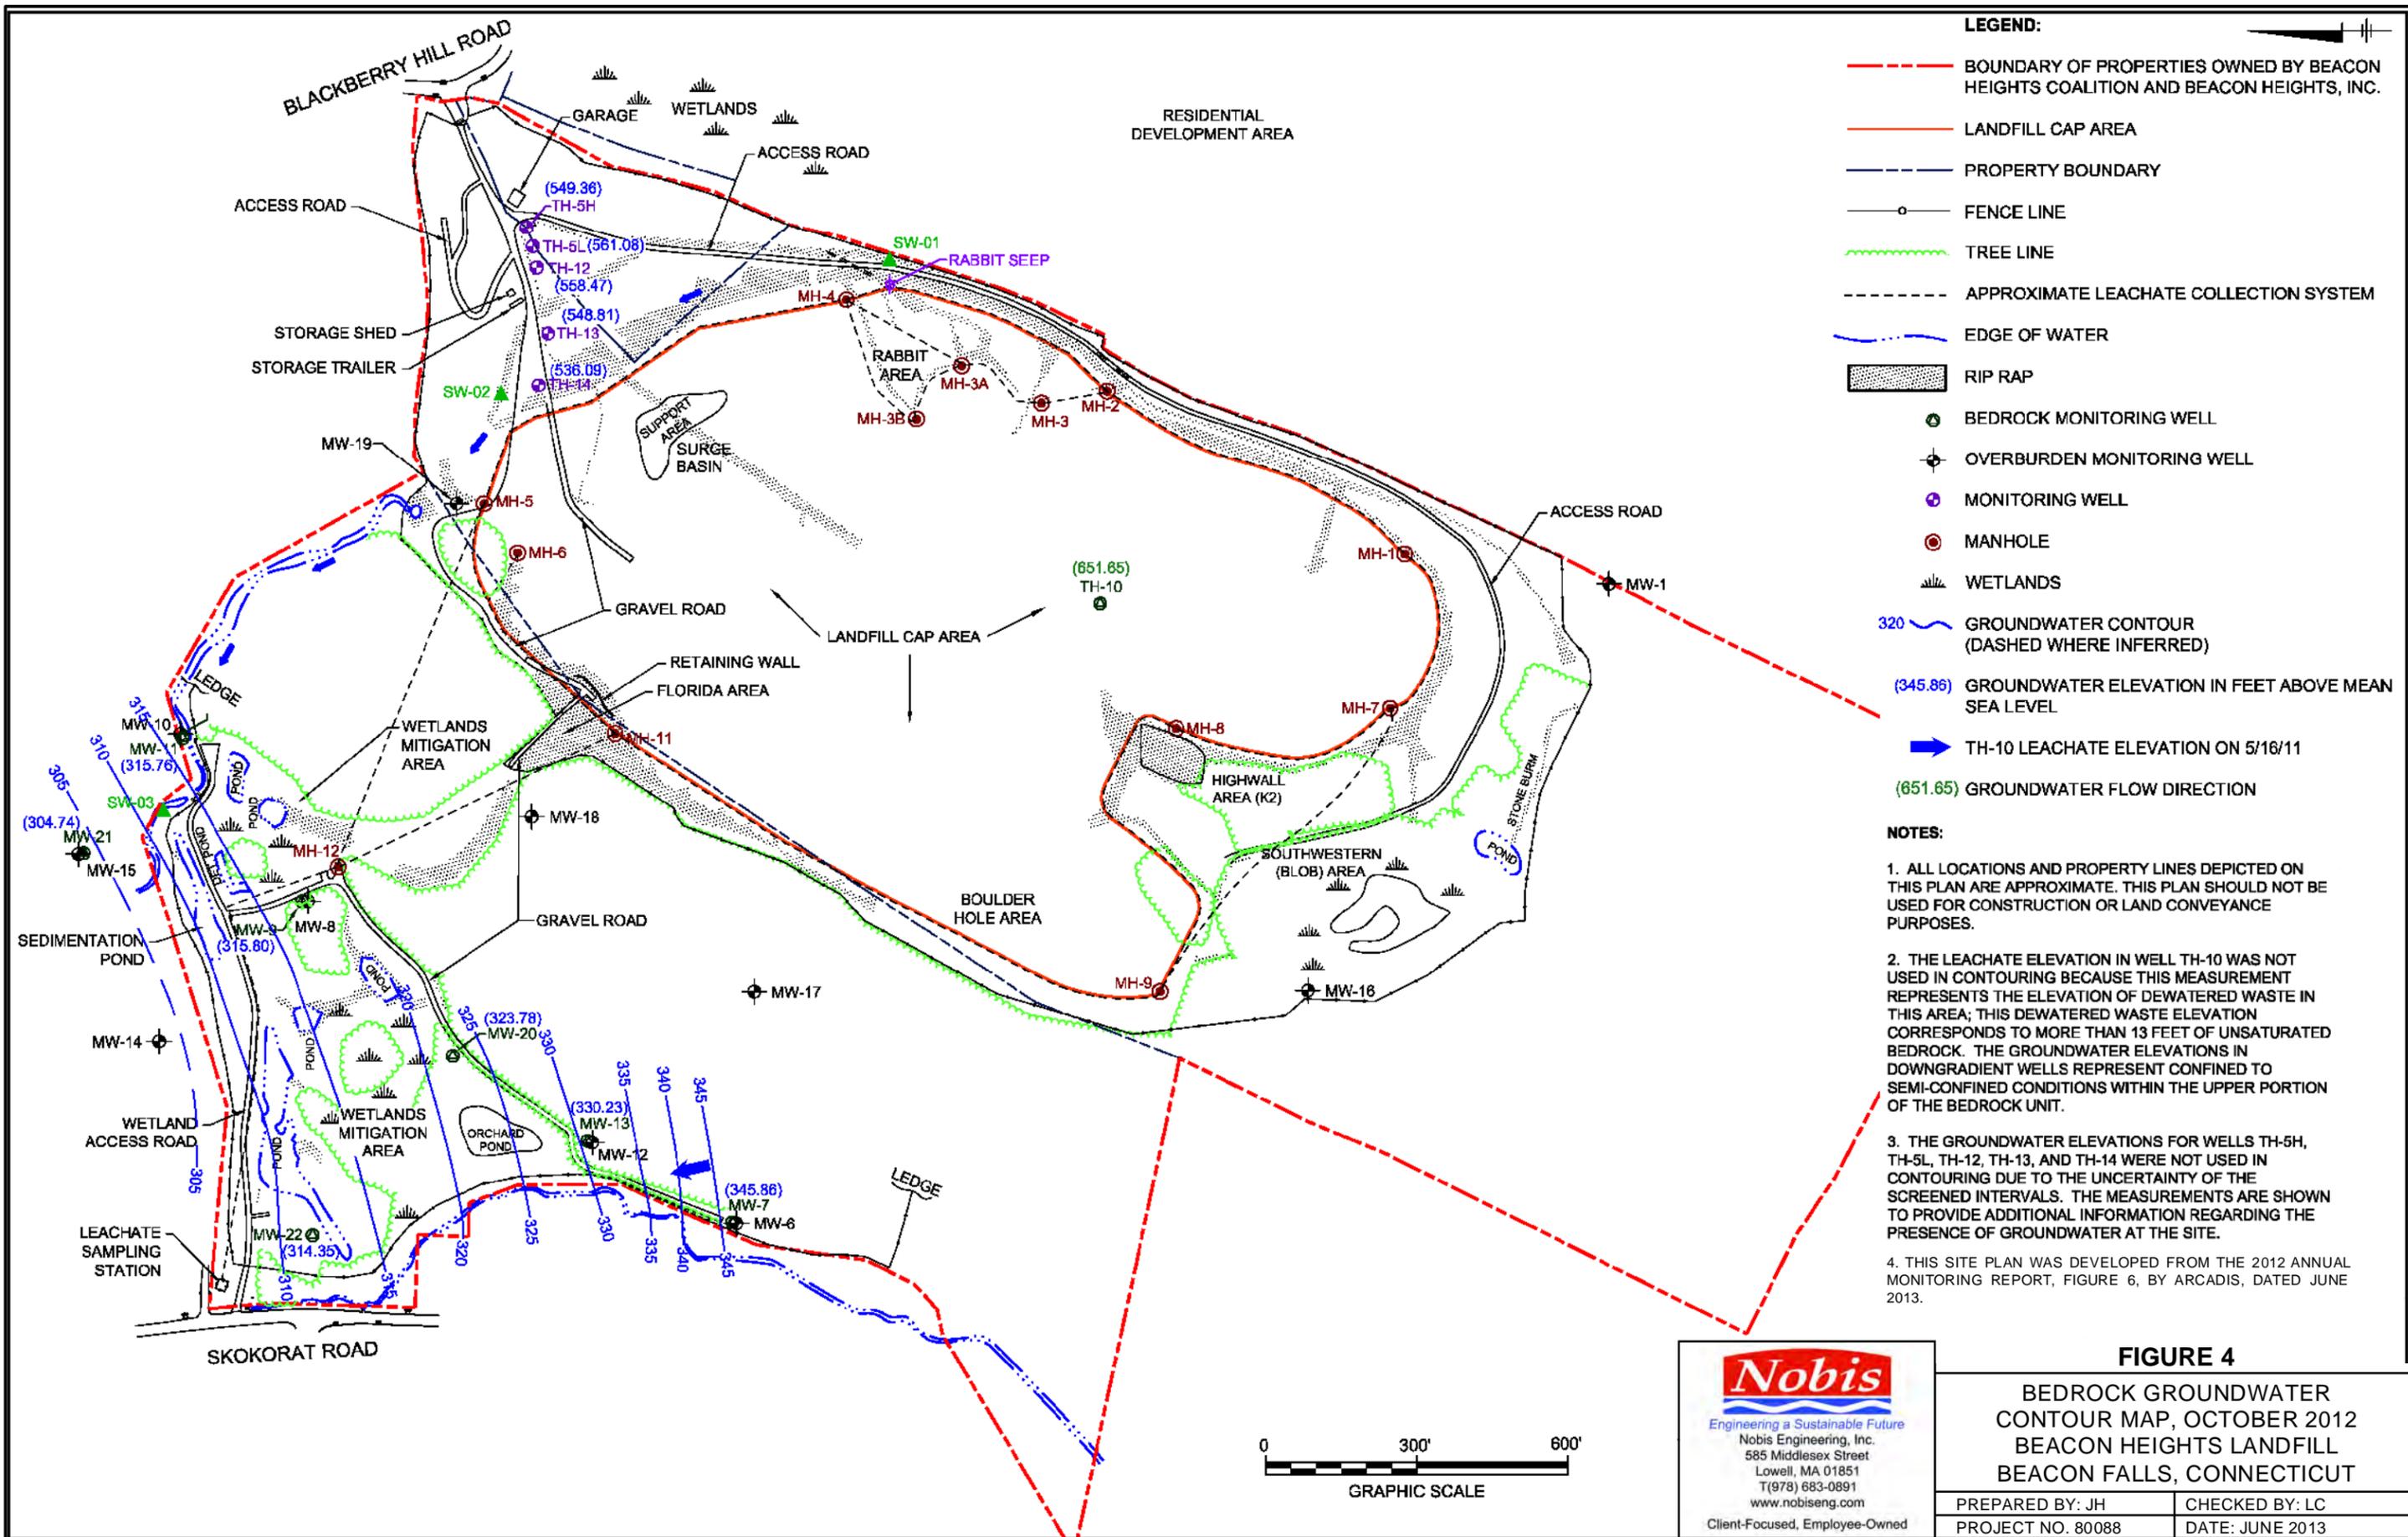
- LEGEND:**
- BOUNDARY OF PROPERTIES OWNED BY BEACON HEIGHTS COALITION AND BEACON HEIGHTS, INC.
  - LANDFILL CAP AREA
  - PROPERTY BOUNDARY
  - FENCE LINE
  - TREE LINE
  - APPROXIMATE LEACHATE COLLECTION SYSTEM
  - EDGE OF WATER
  - RIP RAP
  - BEDROCK MONITORING WELL
  - ⊕ OVERBURDEN MONITORING WELL
  - MONITORING WELL
  - MANHOLE
  - ▬ WETLANDS
  - 320 GROUNDWATER CONTOUR (DASHED WHERE INFERRED)
  - (345.86) GROUNDWATER ELEVATION IN FEET ABOVE MEAN SEA LEVEL
  - TH-10 LEACHATE ELEVATION ON 5/16/11
  - (651.65) GROUNDWATER FLOW DIRECTION

- NOTES:**
1. ALL LOCATIONS AND PROPERTY LINES DEPICTED ON THIS PLAN ARE APPROXIMATE. THIS PLAN SHOULD NOT BE USED FOR CONSTRUCTION OR LAND CONVEYANCE PURPOSES.

2. THE LEACHATE ELEVATION IN WELL TH-10 WAS NOT USED IN CONTOURING BECAUSE THIS MEASUREMENT REPRESENTS THE ELEVATION OF DEWATERED WASTE IN THIS AREA; THIS DEWATERED WASTE ELEVATION CORRESPONDS TO MORE THAN 13 FEET OF UNSATURATED BEDROCK. THE GROUNDWATER ELEVATIONS IN DOWNGRADIENT WELLS REPRESENT CONFINED TO SEMI-CONFINED CONDITIONS WITHIN THE UPPER PORTION OF THE BEDROCK UNIT.

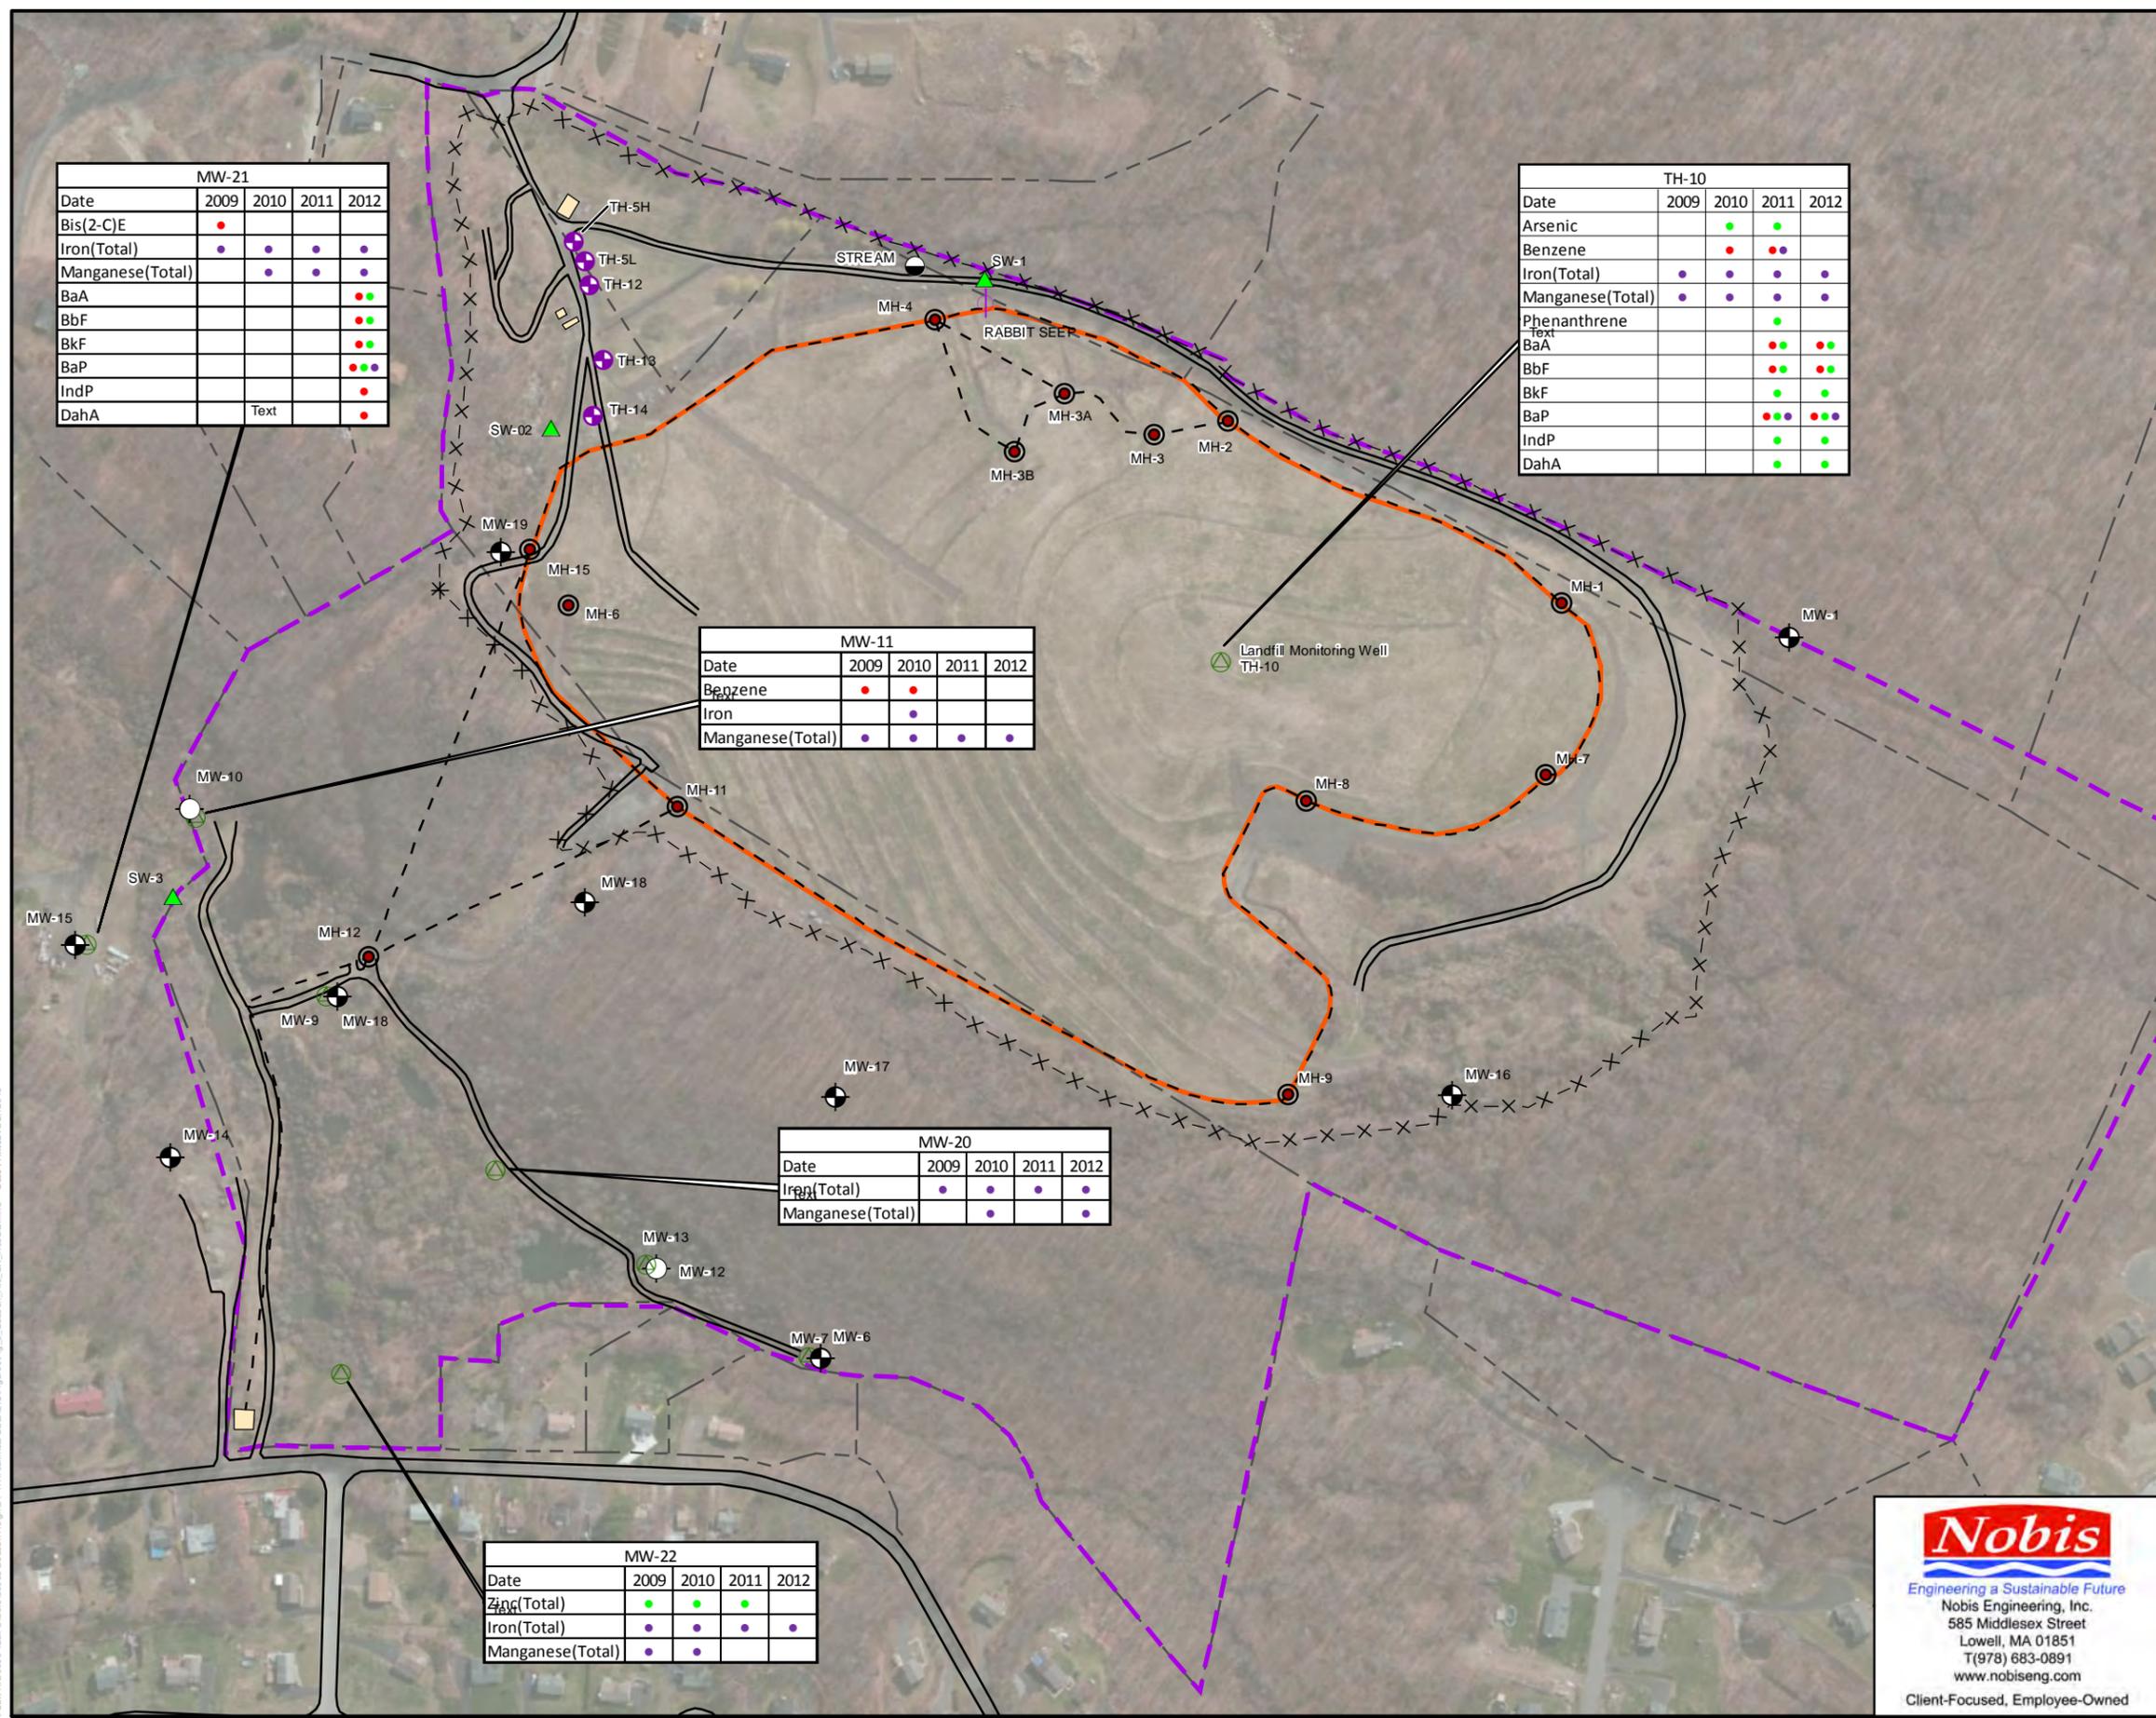
**BEDROCK GROUNDWATER RESULTS  
 BEACON HEIGHTS LANDFILL  
 BEACON FALLS, CONNECTICUT**

MW-21				
Date	2009	2010	2011	2012
Bis(2-C)E	●			
Iron(Total)	●	●	●	●
Manganese(Total)		●	●	●
BaA				●
BbF				●
BkF				●
BaP				●
IndP				●
DahA		Text		●

TH-10				
Date	2009	2010	2011	2012
Arsenic		●	●	
Benzene		●	●	
Iron(Total)	●	●	●	●
Manganese(Total)	●	●	●	●
Phenanthrene			●	
BaA			●	●
BbF			●	●
BkF			●	●
BaP			●	●
IndP			●	●
DahA			●	●

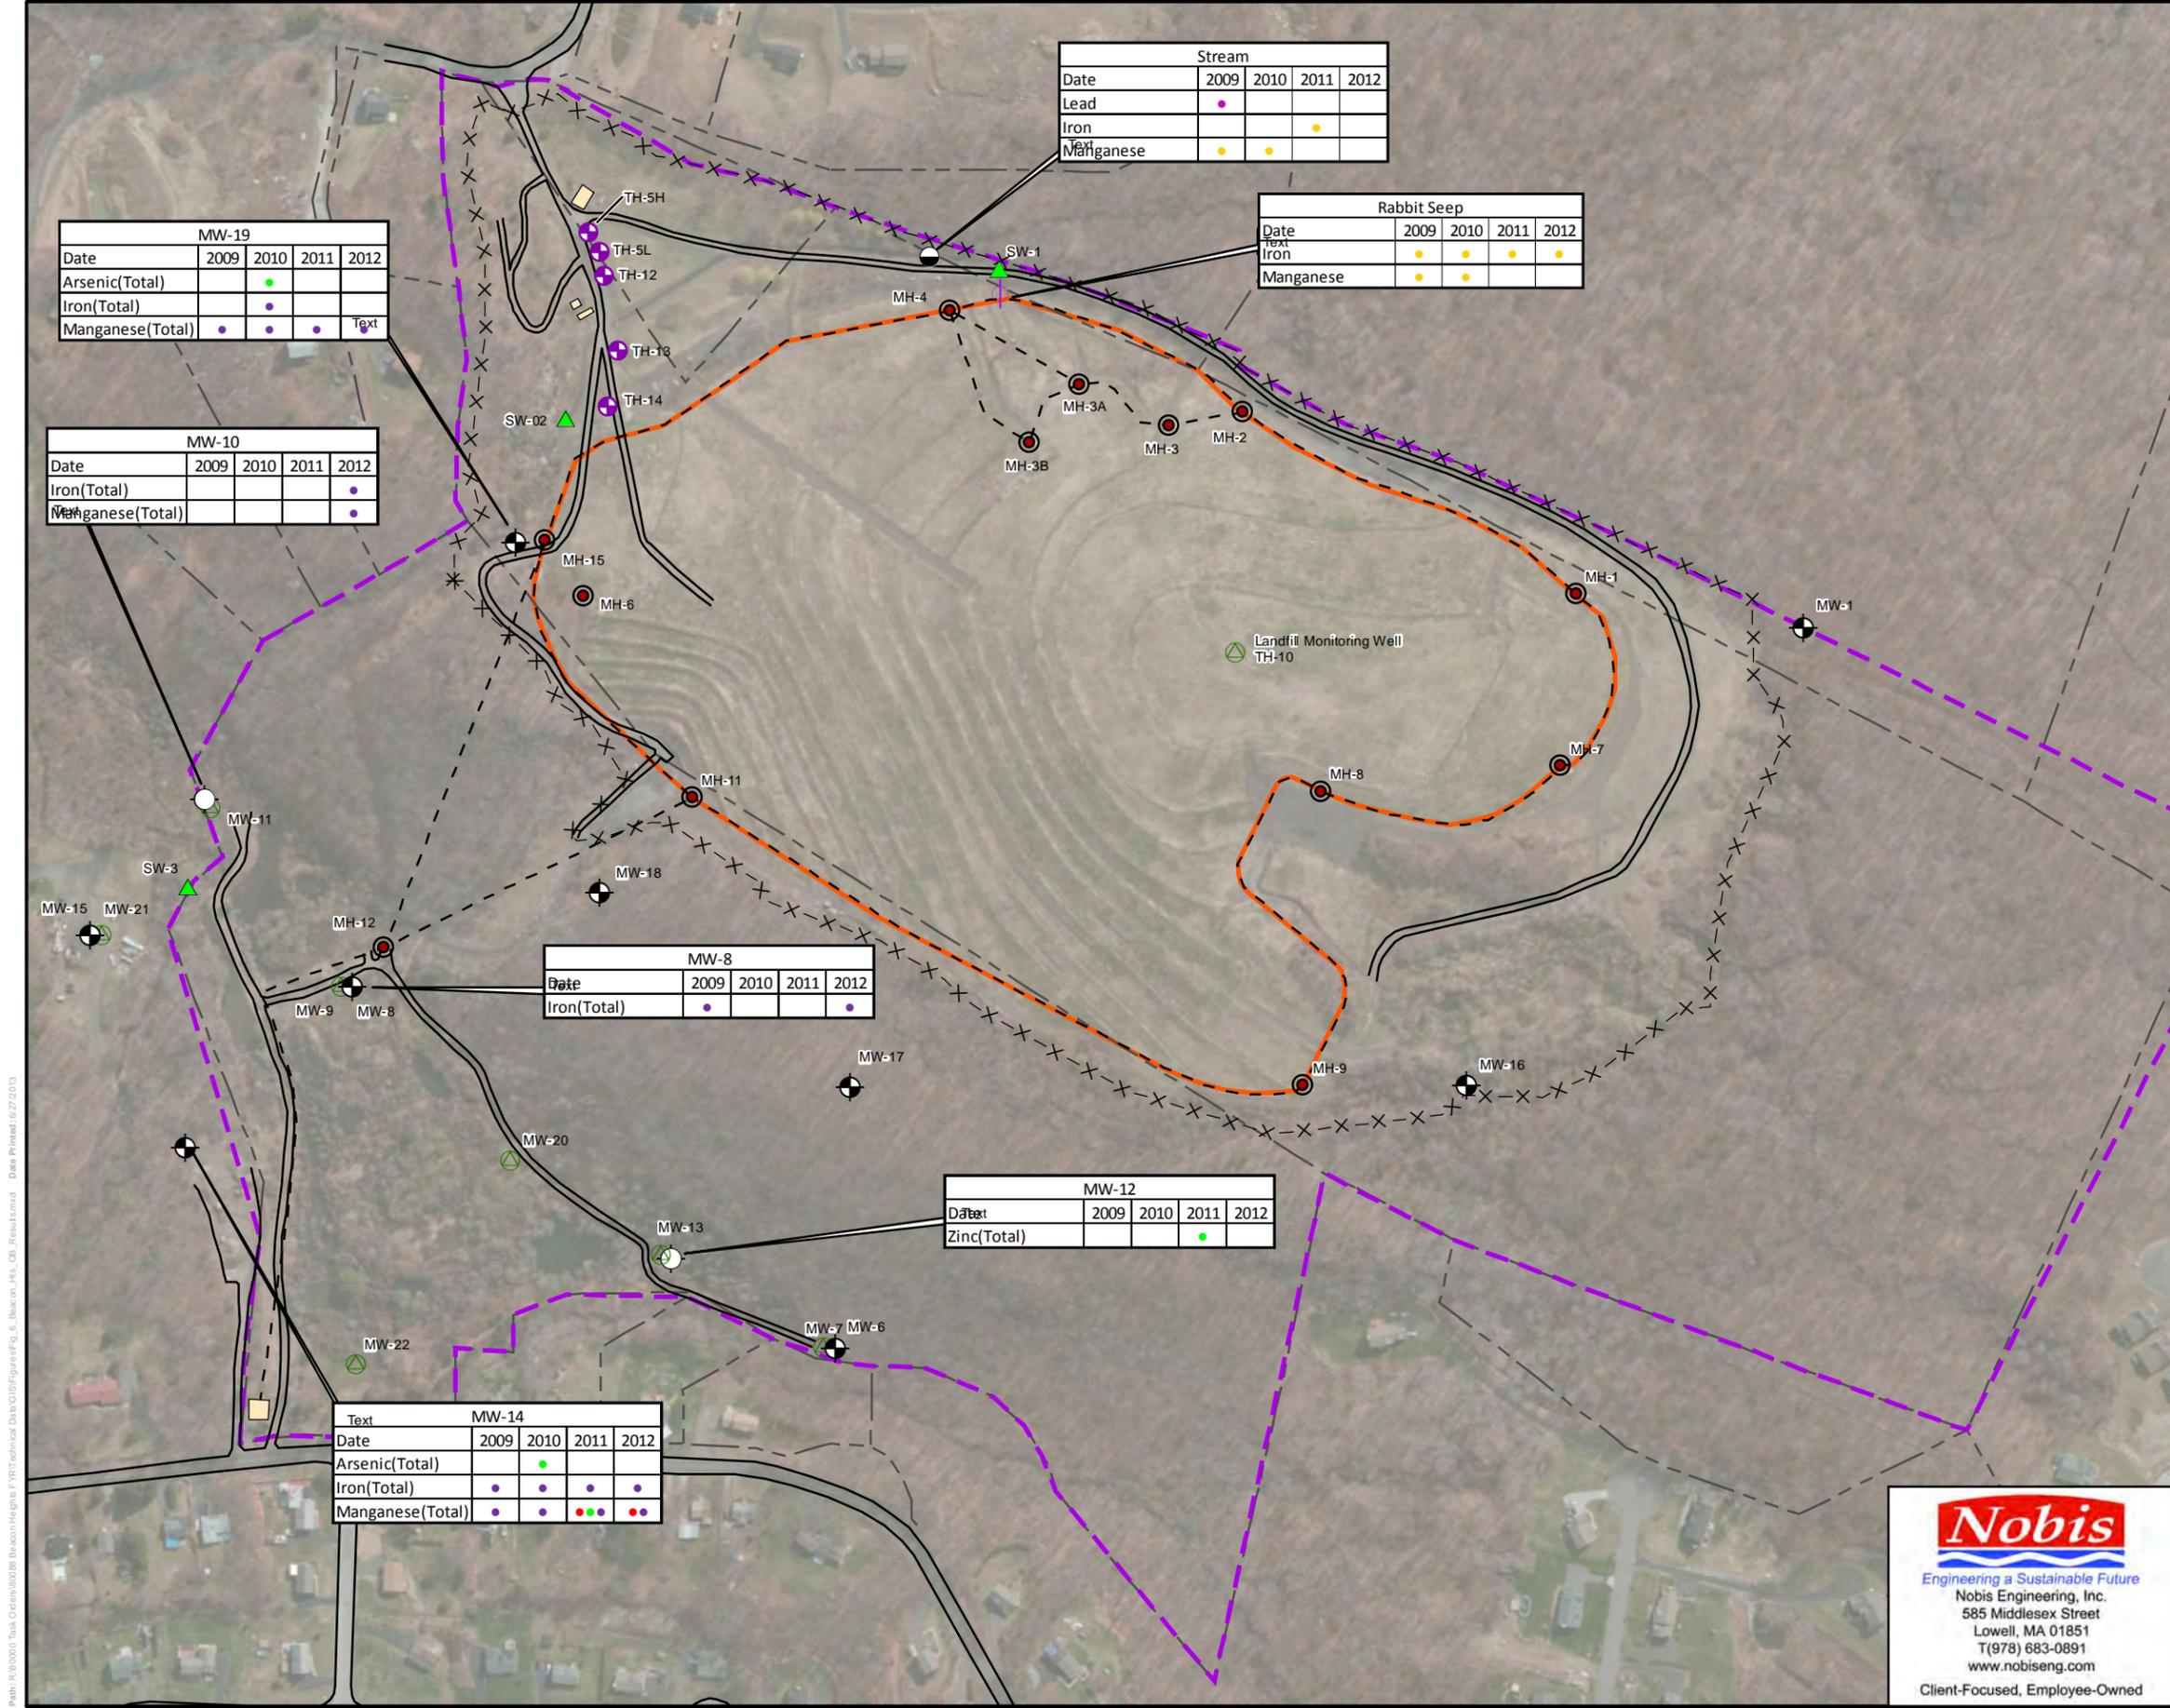
- Notes:**
1. This site plan was developed from the 2012 Annual Monitoring Report by Arcadis, dated June 2013.
  2. Exceedances are based on the maximum concentration detected of the two semiannual sampling events. The screening criteria are indicated below.
  3. Location of site features depicted hereon is approximate and given for illustrative purposes only.
