Second Five-Year Review Report

Hanscom Field/Hanscom Air Force Base Superfund Site

Bedford, Concord, Lexington, Lincoln

August 2002

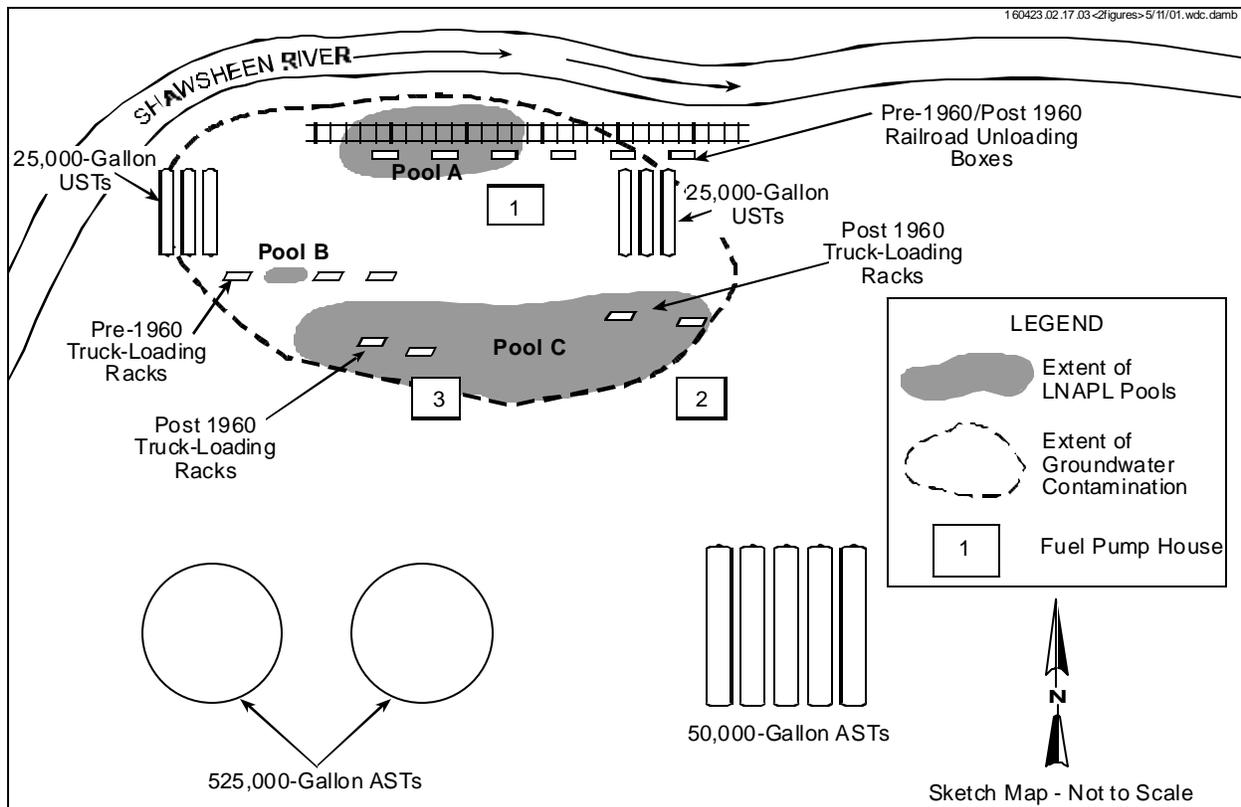
The diagram below presents the historical layout of the site. Prior to 1960 the fuel distribution and storage system at IRP Site 21 consisted of a railroad tank car siding where the fuel was unloaded, six 25,000-gallon underground storage tanks (USTs), and truck loading/unloading stations located on the northern portion of the site. Post-1960 the USTs and the truck loading/unloading stations were replaced

by two 525,000-gallon jet fuel and five 50,000-gallon aviation gasoline above-ground storage tanks (ASTs) and new truck loading/unloading stations located on the south side of the site. This post-1960 system also included three pump houses (#1, #2 & #3 in diagram below).
