21.0 SITE 22 – LOWER SUBBASE – PIER 33 (OU 4)

This five-year review is being conducted for Site 22 at the request of the USEPA. The site is still being investigated under CERCLA, and no decision documents have been prepared for the site.

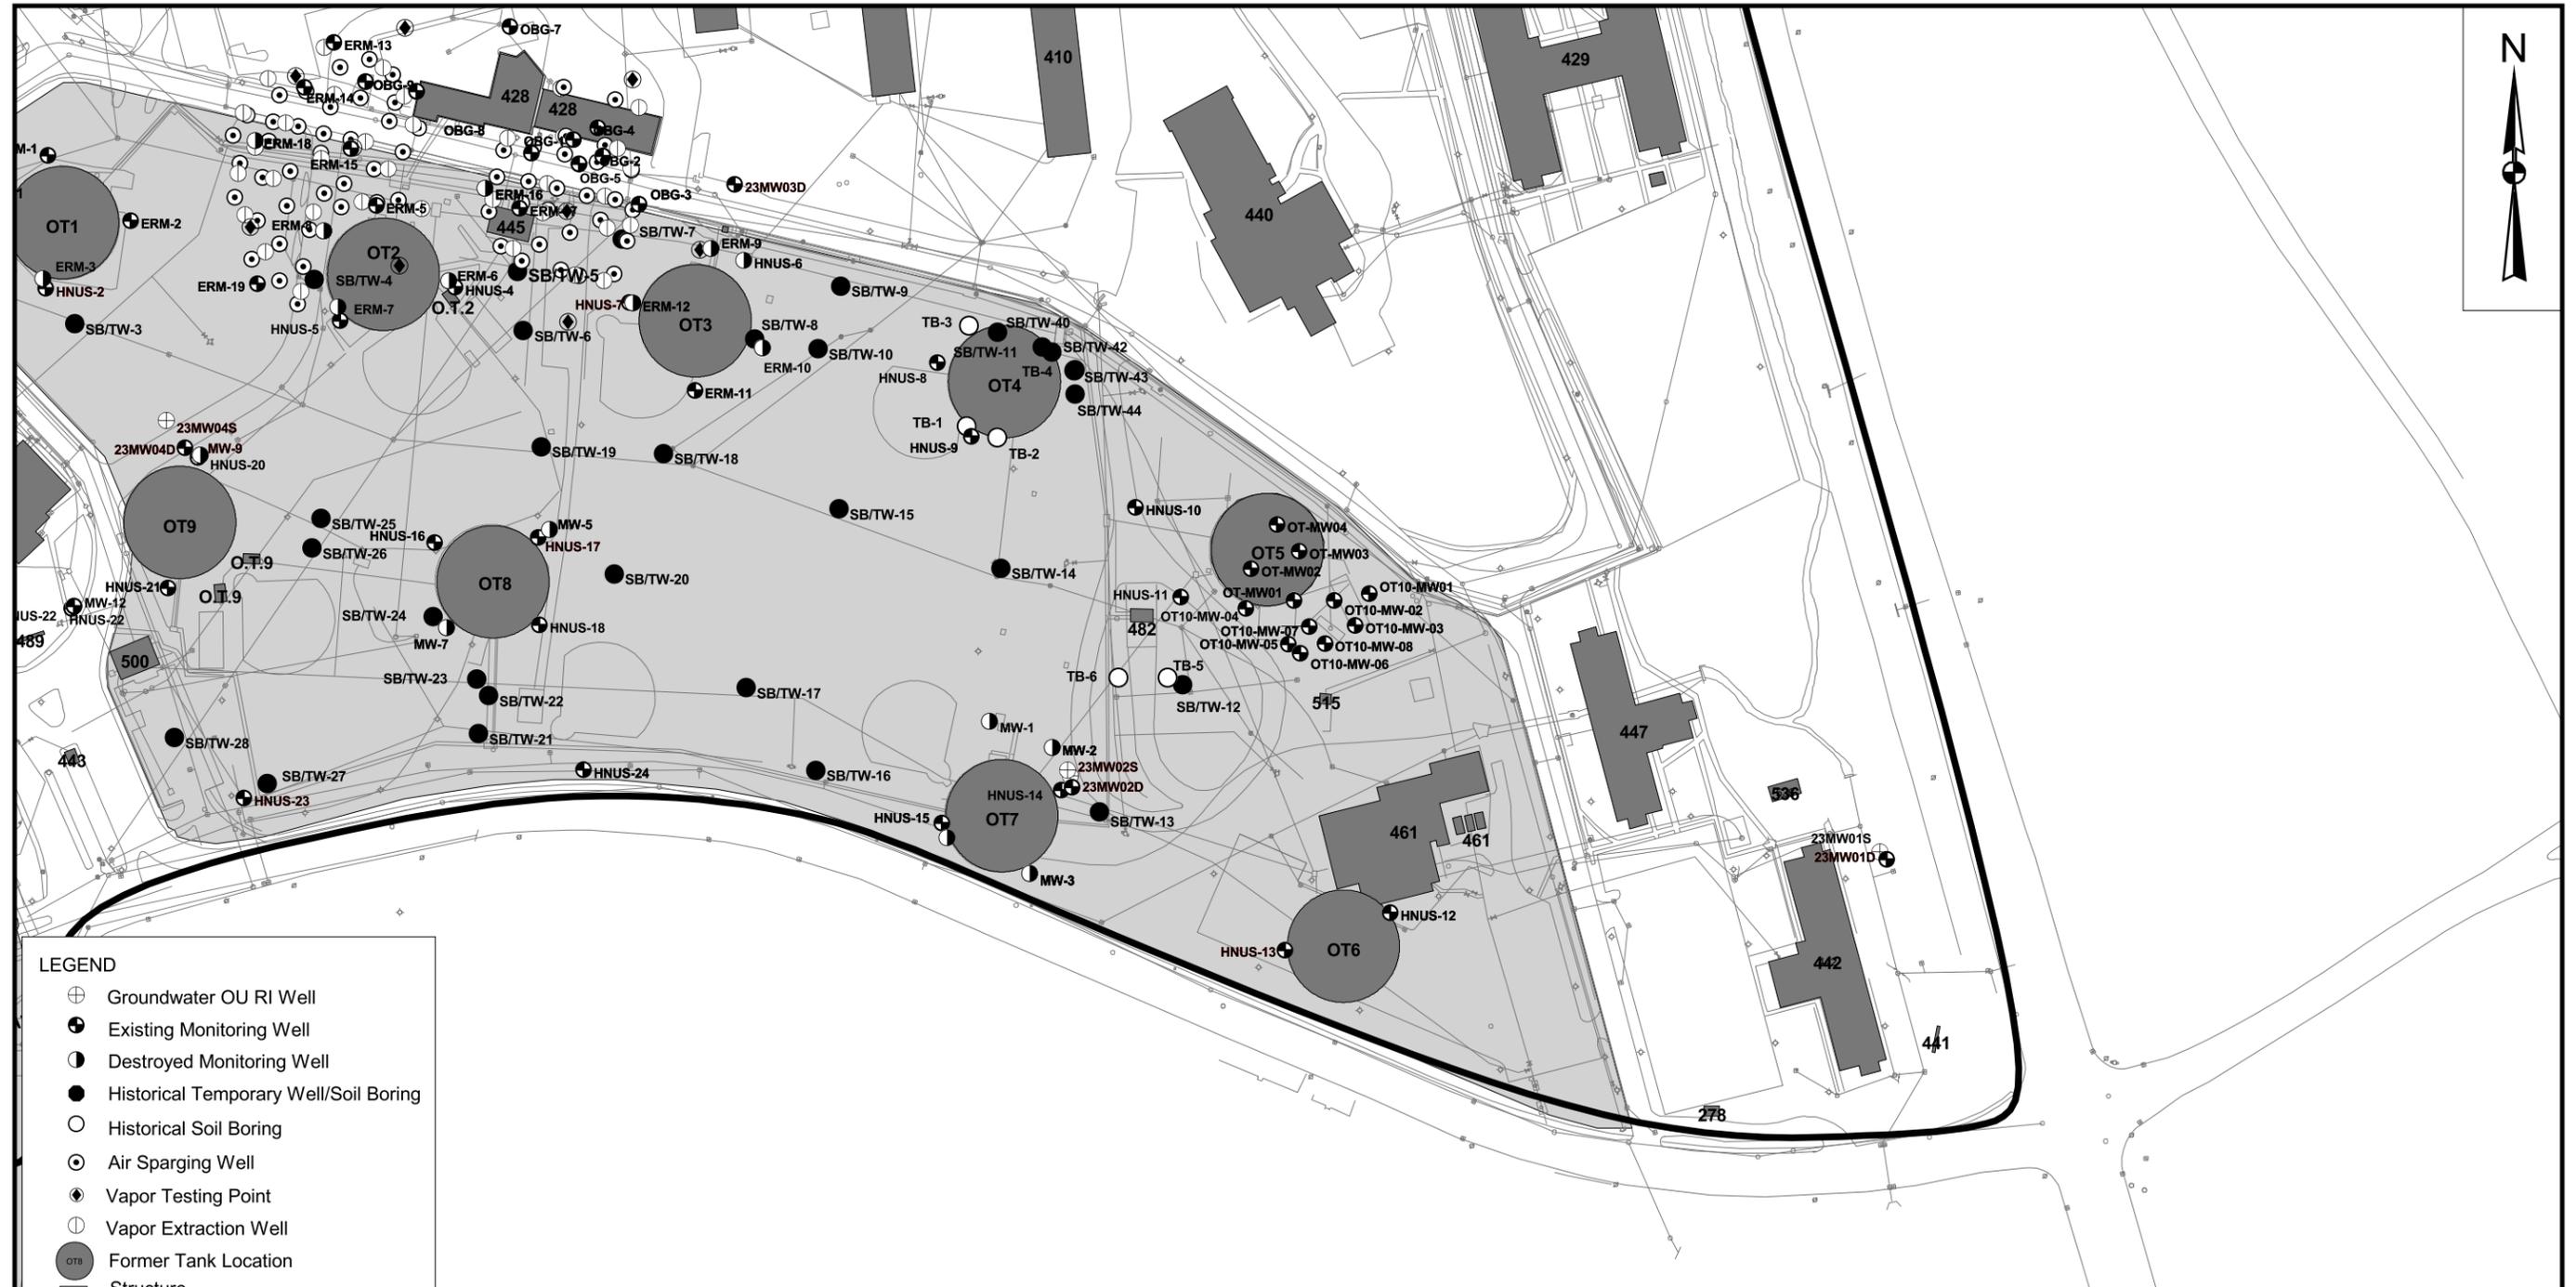
- ⊕ Groundwater OU RI Well
- Existing Monitoring Well
- ⦿ Destroyed Monitoring Well
- Historical Temporary Well/Soil Boring
- Historical Soil Boring
- ⊙ Air Sparging Well
- ⦿ Vapor Testing Point
- ⊖ Vapor Extraction Well
- Former Tank Location
- Structure
- Southern Region Boundary
