**DECLARATION
FOR THE

EXPLANATION OF SIGNIFICANT DIFFERENCES**

The Pownal Tannery Superfund Site is located in the Town of Pownal, Vermont.

Pownal Tannery Superfund Site Pownal, Vermont

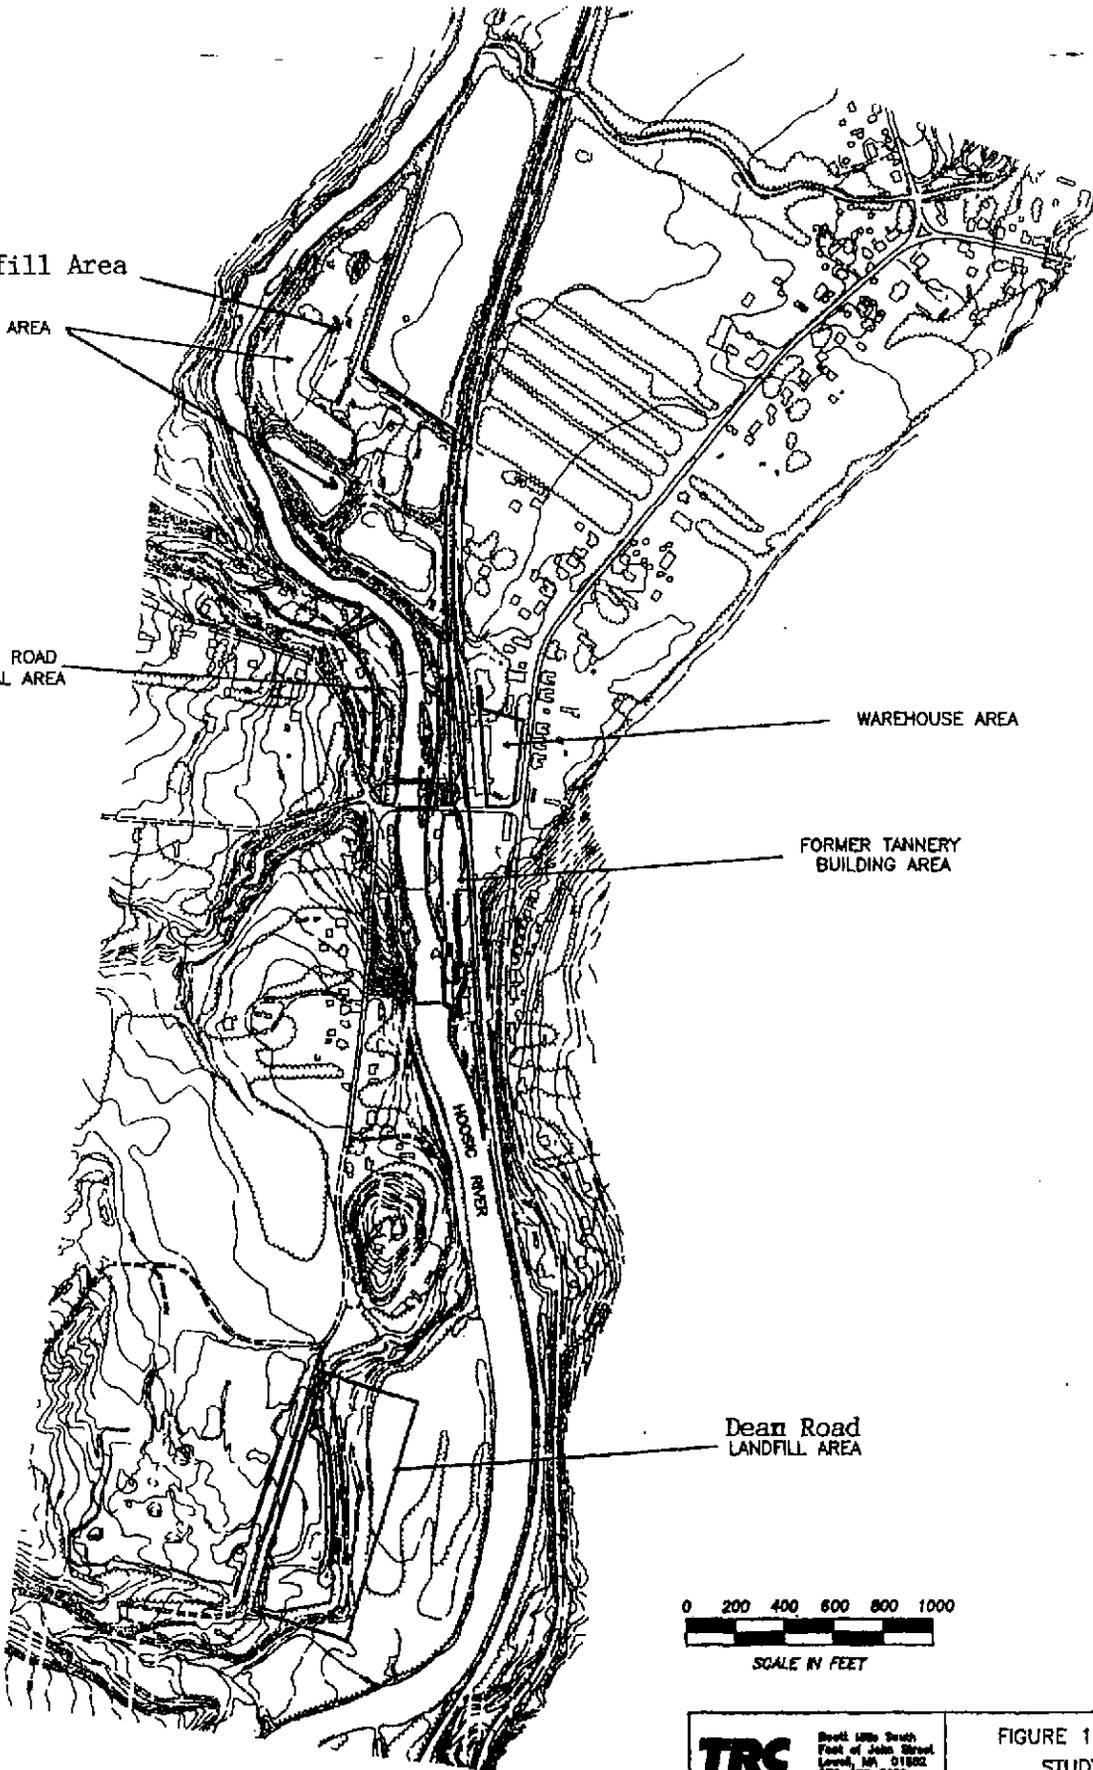
FORMER TANNERY BUILDING AREA

Dean Road LANDFILL AREA

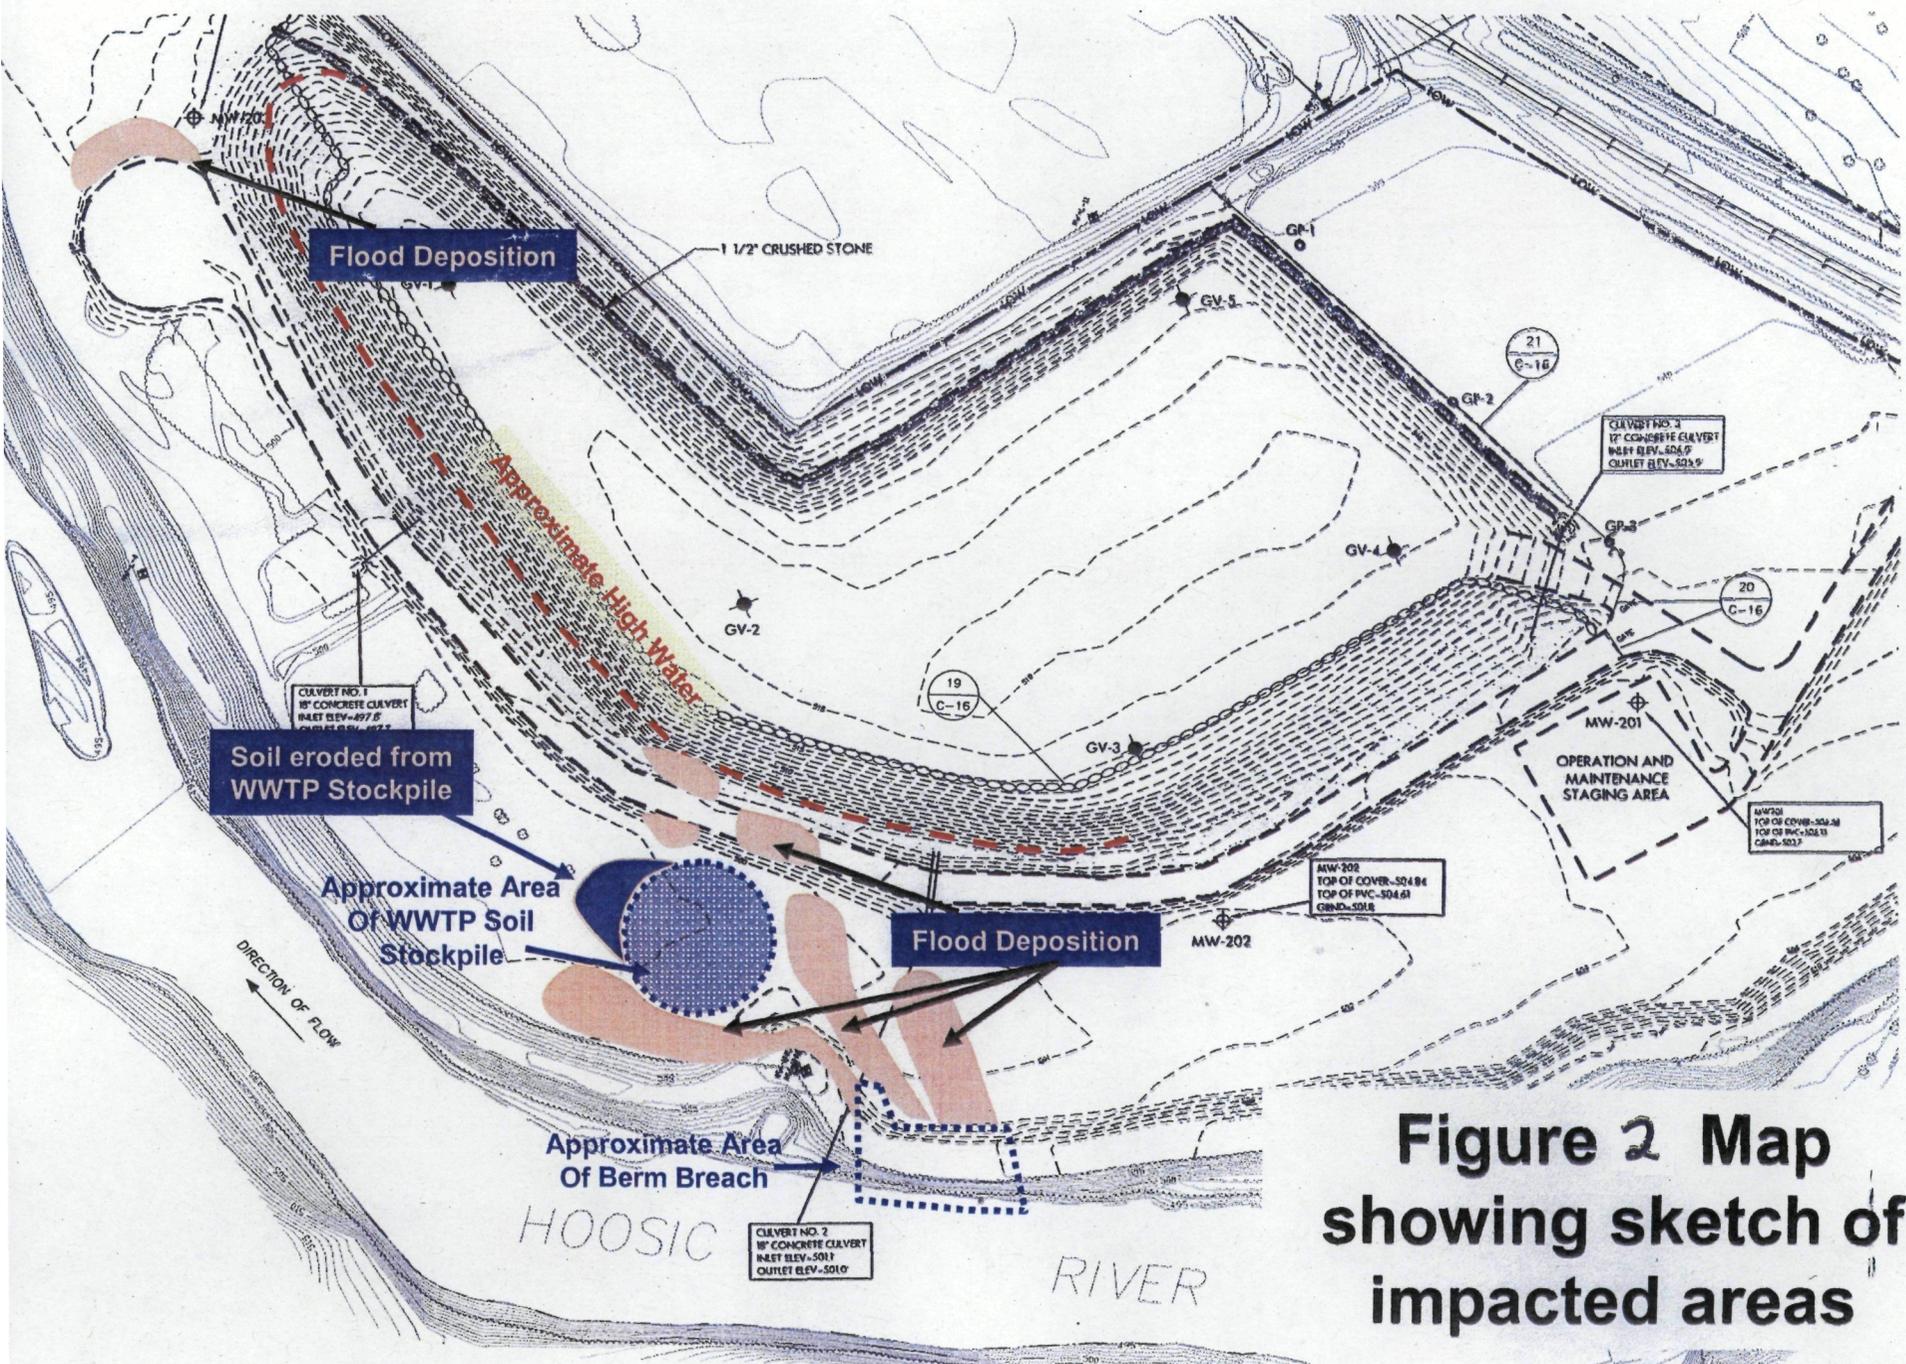
FIGURE 2

Figure 2 Map showing sketch of impacted areas

In October of 2005, a significant flood event altered a portion of the former facility's earthen berm that is located between the newly constructed Lagoon Area Landfill and the Hoosic River (Attachment A and Figure 2). While this flooding event did not damage the Landfill, it damaged the surrounding access road to the Landfill. The effects of the berm breach were likely exacerbated by the presence of a large soil stockpile in the engineered flood conveyance area. This stockpile was created without the knowledge of EPA or the VTDEC by the contractor building a town waste water treatment facility on-site. The Town of Pownal removed the stockpile and repaired the access road. It was determined by EPA and the VT DEC that the section of the berm that eroded did not alter the protectiveness of the remedy and should not be repaired. Furthermore, the breaching of the berm did not impair flood storage capacity or the protection of the Lagoon Area Landfill from future storm events (Attachment B). EPA and the VT DEC acknowledged that a portion of the remaining berm, not affected by the

2005 flood, has a small volume of waste under the berm that could not be addressed by the remediation and therefore requires that the limited section of the berm be maintained and that institutional controls be established to limit future disturbance/excavation in that area (e.g., deed restrictions) (Figure 2).

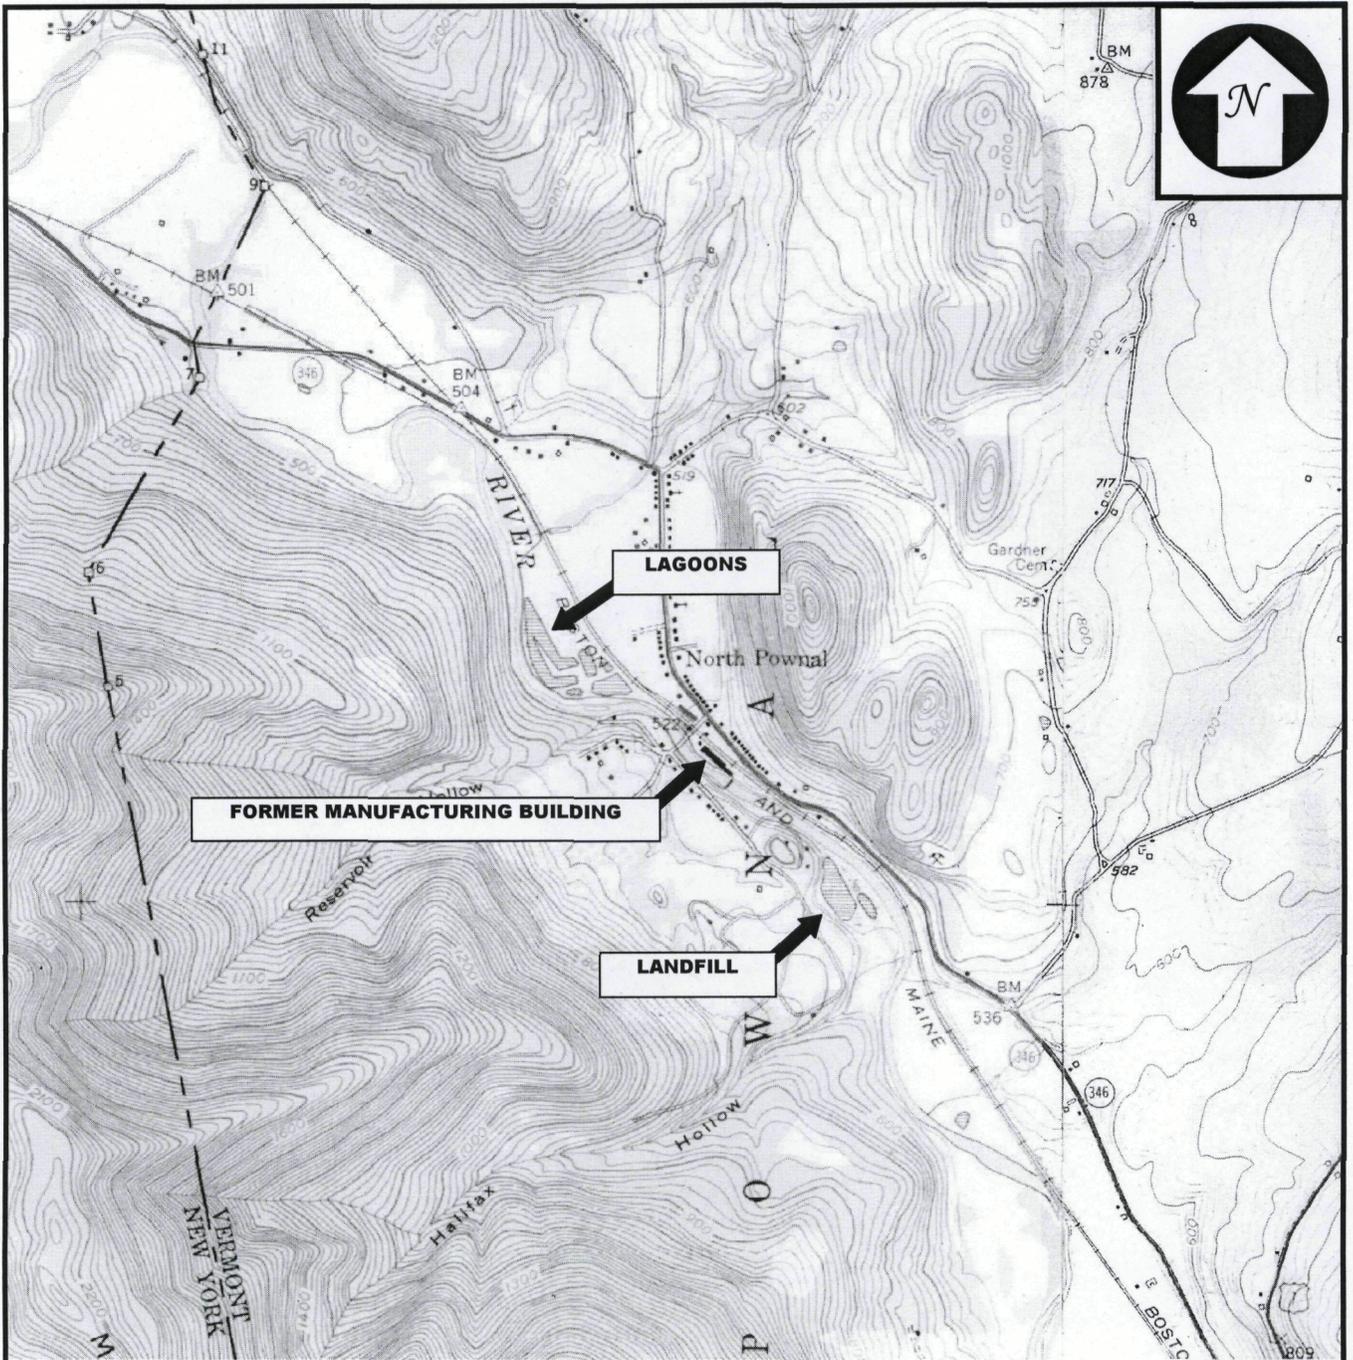
Dean Road Landfill

Lagoon Area

**BASE MAP IS A PORTION OF THE FOLLOWING 7.5' USGS TOPOGRAPHIC QUADRANGLES:
 POWNAL, VT, 1954; NORTH POWNAL, VT-NY, 1954, PHOTOREVISED 1980**

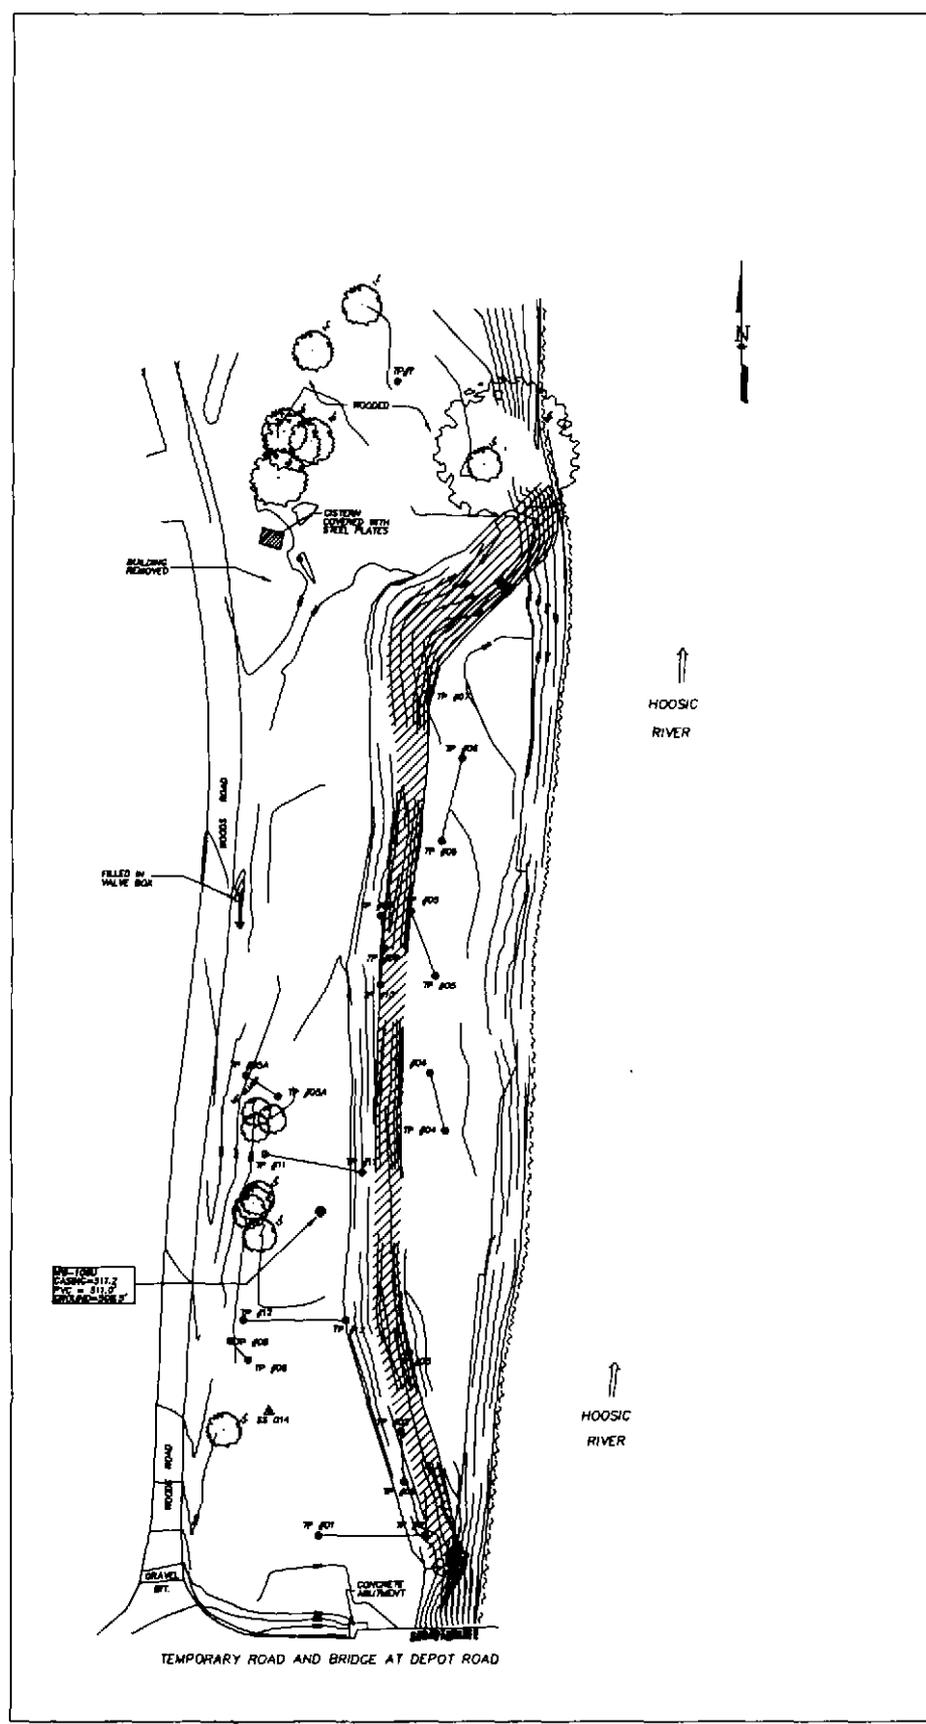
NOTES:

1. AS-BUILT TOPOGRAPHIC MEASUREMENTS MADE BY HILL-ENGINEERS ARCHITECTS, PLANNERS, INC. ON DECEMBER 11, 2000
2. ELEVATIONS SHOWN HEREON ARE BASED UPON AN ALTIMETER BENCH ELEVATION = 521.18'. BENCHMARK LOCATED ALONG RAILROAD RIGHT-OF-WAY, APPROXIMATELY 65' FEET SOUTHERLY OF THE MAIN ROAD INTO THE POWNALL TANNERY SITE.
3. APPROXIMATELY 16,840 SQ. FT. OF GEO-FABRIC PLACED OVER EXCAVATED AREA.
4. EXCAVATED VOLUME = 2,490 CY
5. HWRAP VOLUME = 224 CY

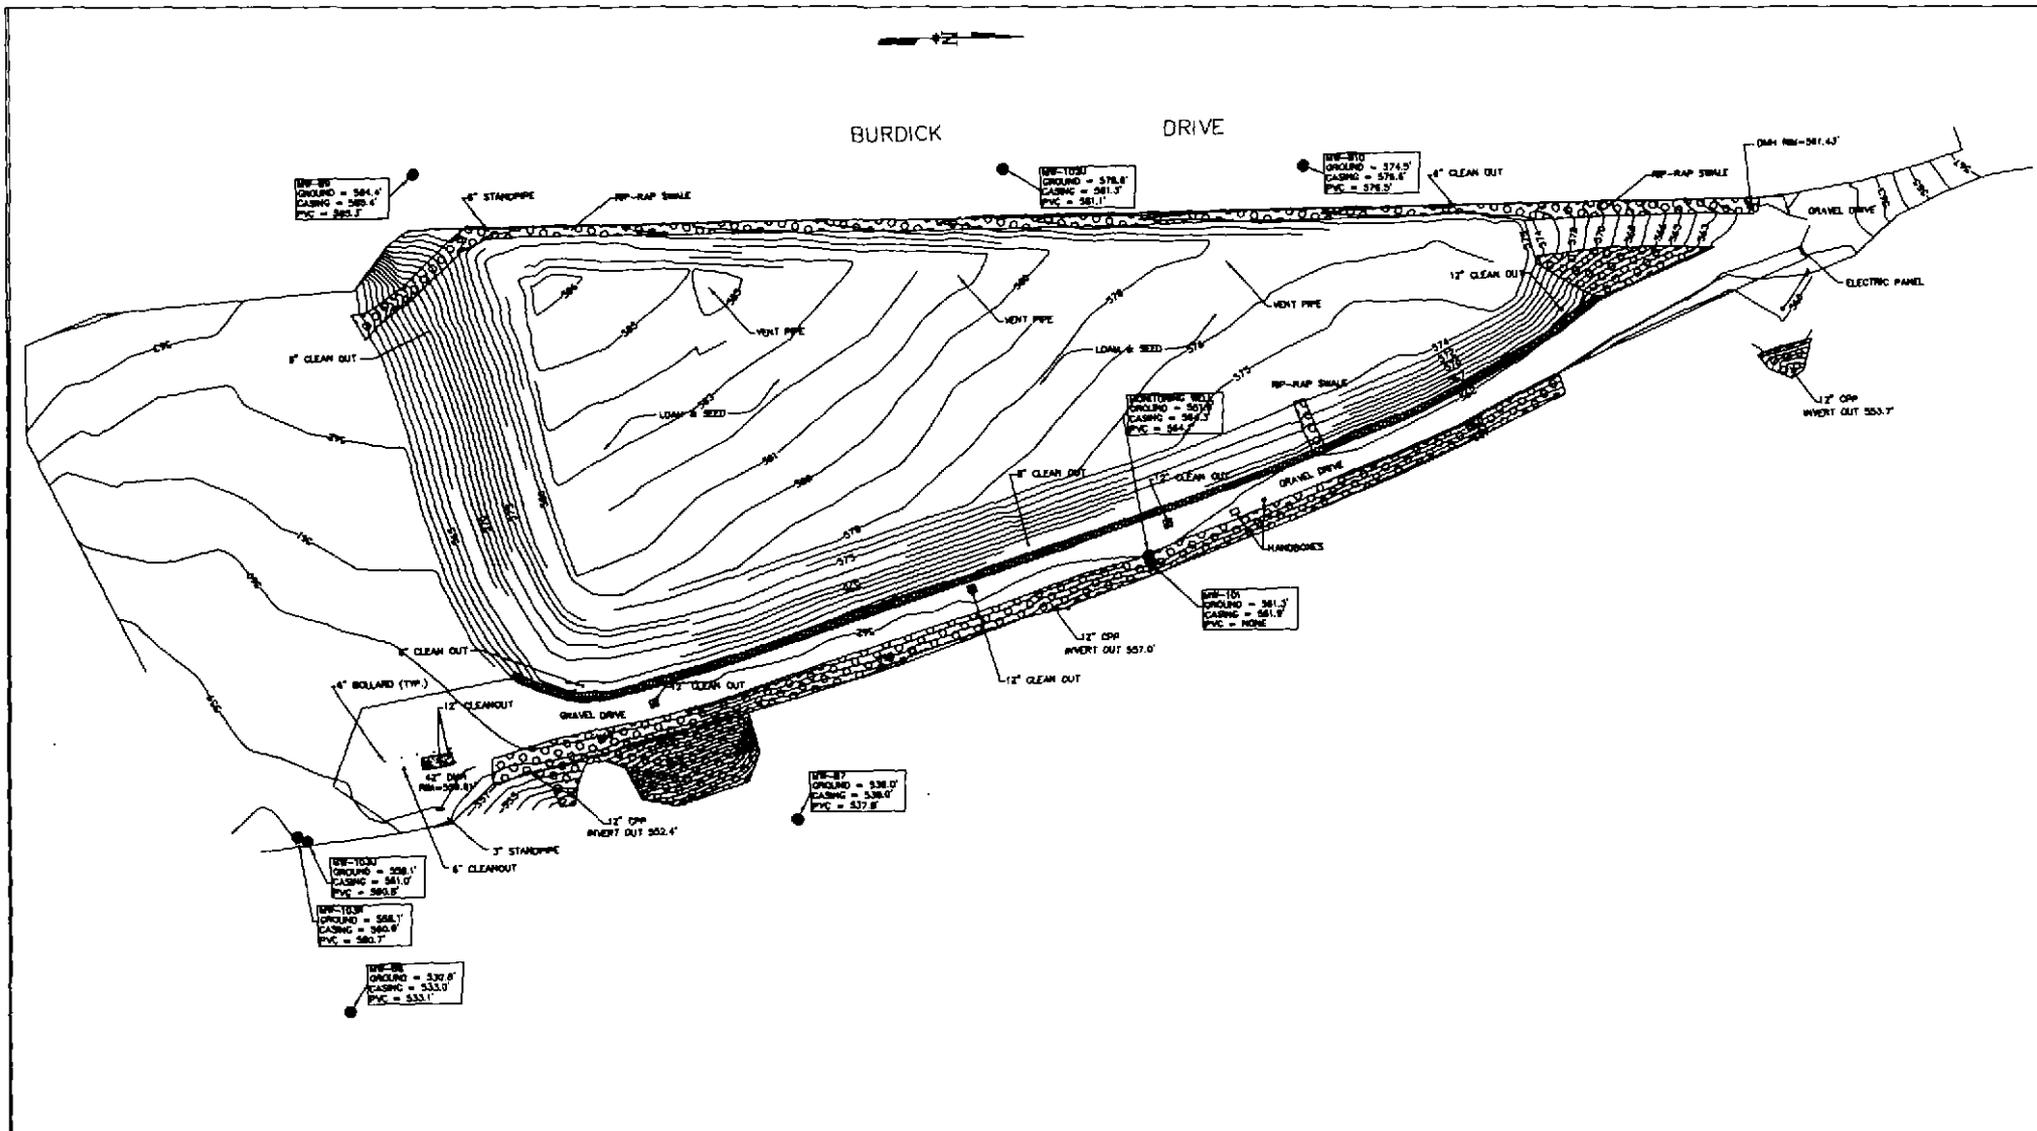
NOTES

1. AS-BUILT TOPOGRAPHIC SURVEY PERFORMED BY HILL-ENGINEERS, ARCHITECTS, PLANNERS, INC. ON NOVEMBER 14, 2000. ELEVATIONS AND TOPOGRAPHY BASED ON TOP OF FORMER MONITORING WELL CASING B-11, ELEVATION 584.36'. AS SHOWN ON SEA PLANTATIONS ENVIRONMENTAL SERVICES, LTD. PLAN ENTITLED "SLUDGE DISPOSAL SITE AS-BUILT PLAN" DATED JULY, 1982.
